REPORT TO  
MINISTRY OF TRANSPORTATION AND COMMUNICATIONS

STUDY OF WATER SEEPAGE  
THOROLD TUNNEL  
(WELLAND CANAL)  
THOROLD, ONTARIO

April, 1983

831-1038

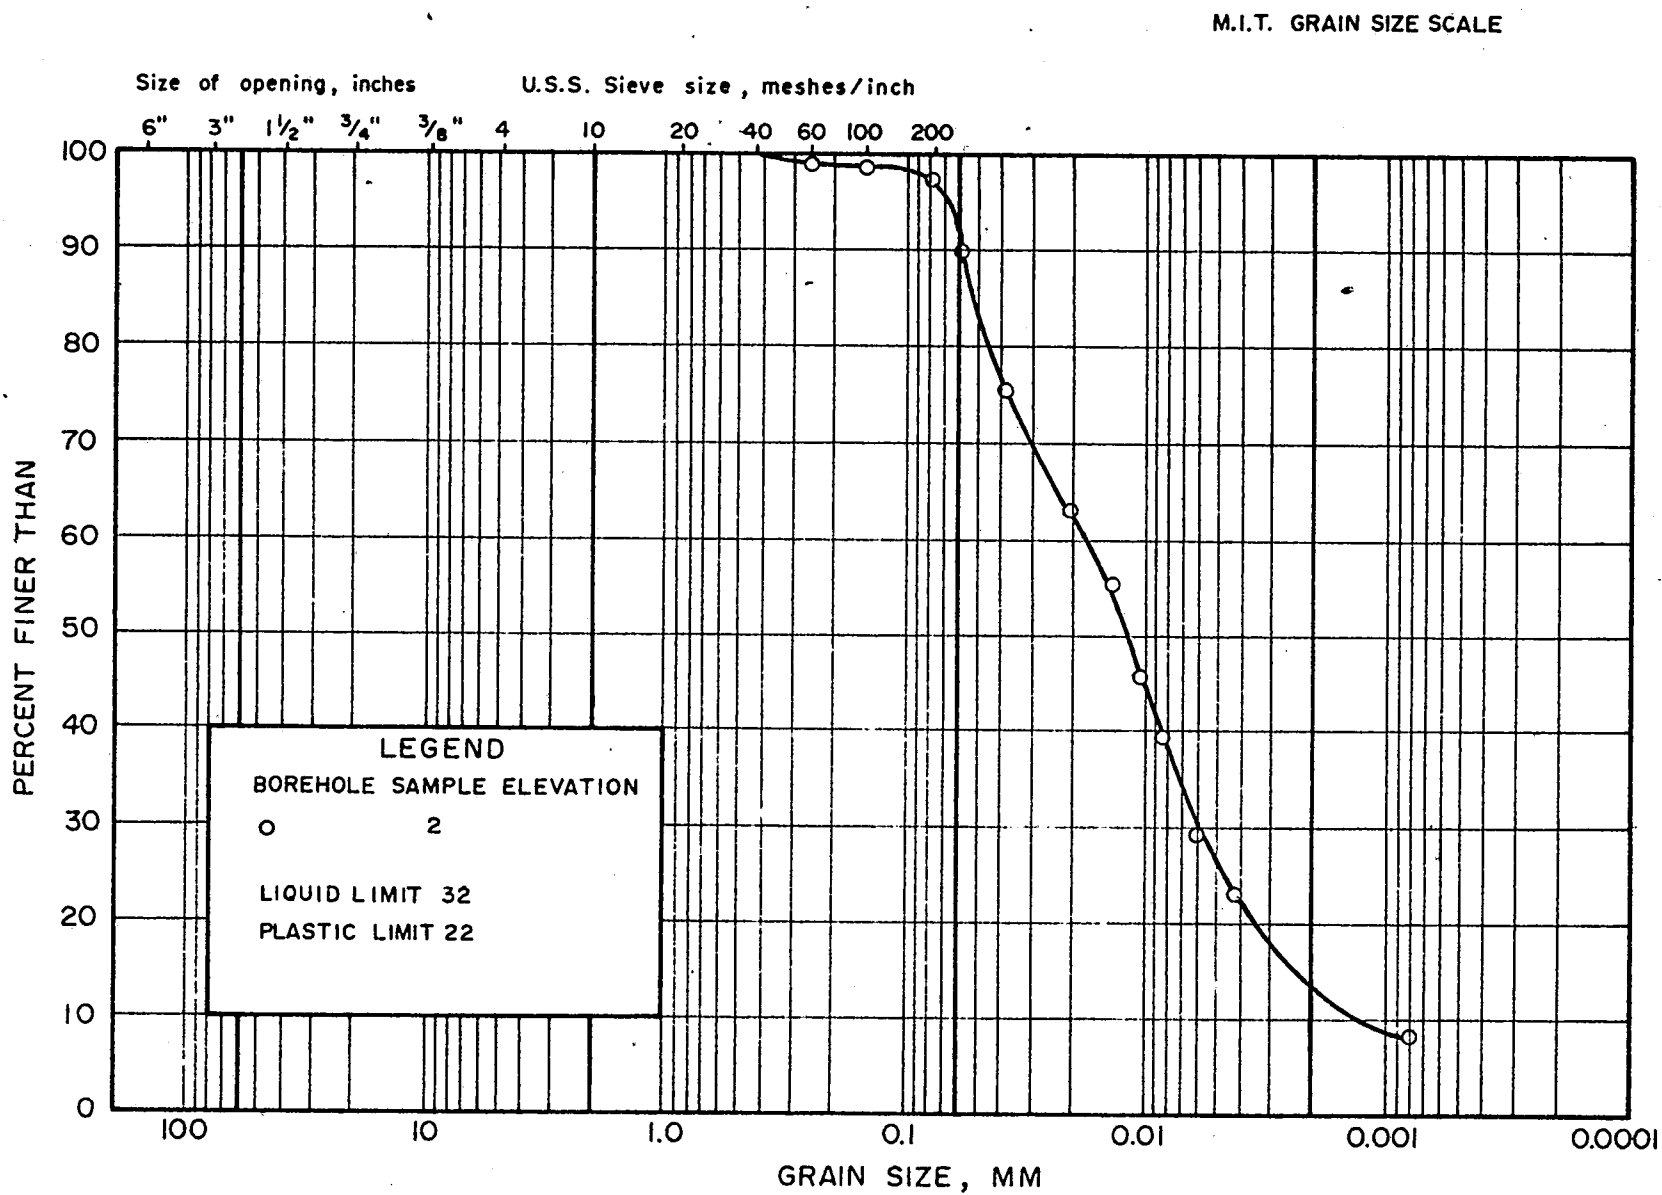
FIGURE 3

A grain size analysis and Atterberg limit test results for a sample of the clayey silt are given on Figure 3.

**GRAIN SIZE DISTRIBUTION**  
CLAYEY SILT OVER TUNNEL BETWEEN  
PONDAGE CANAL AND MAIN CANAL

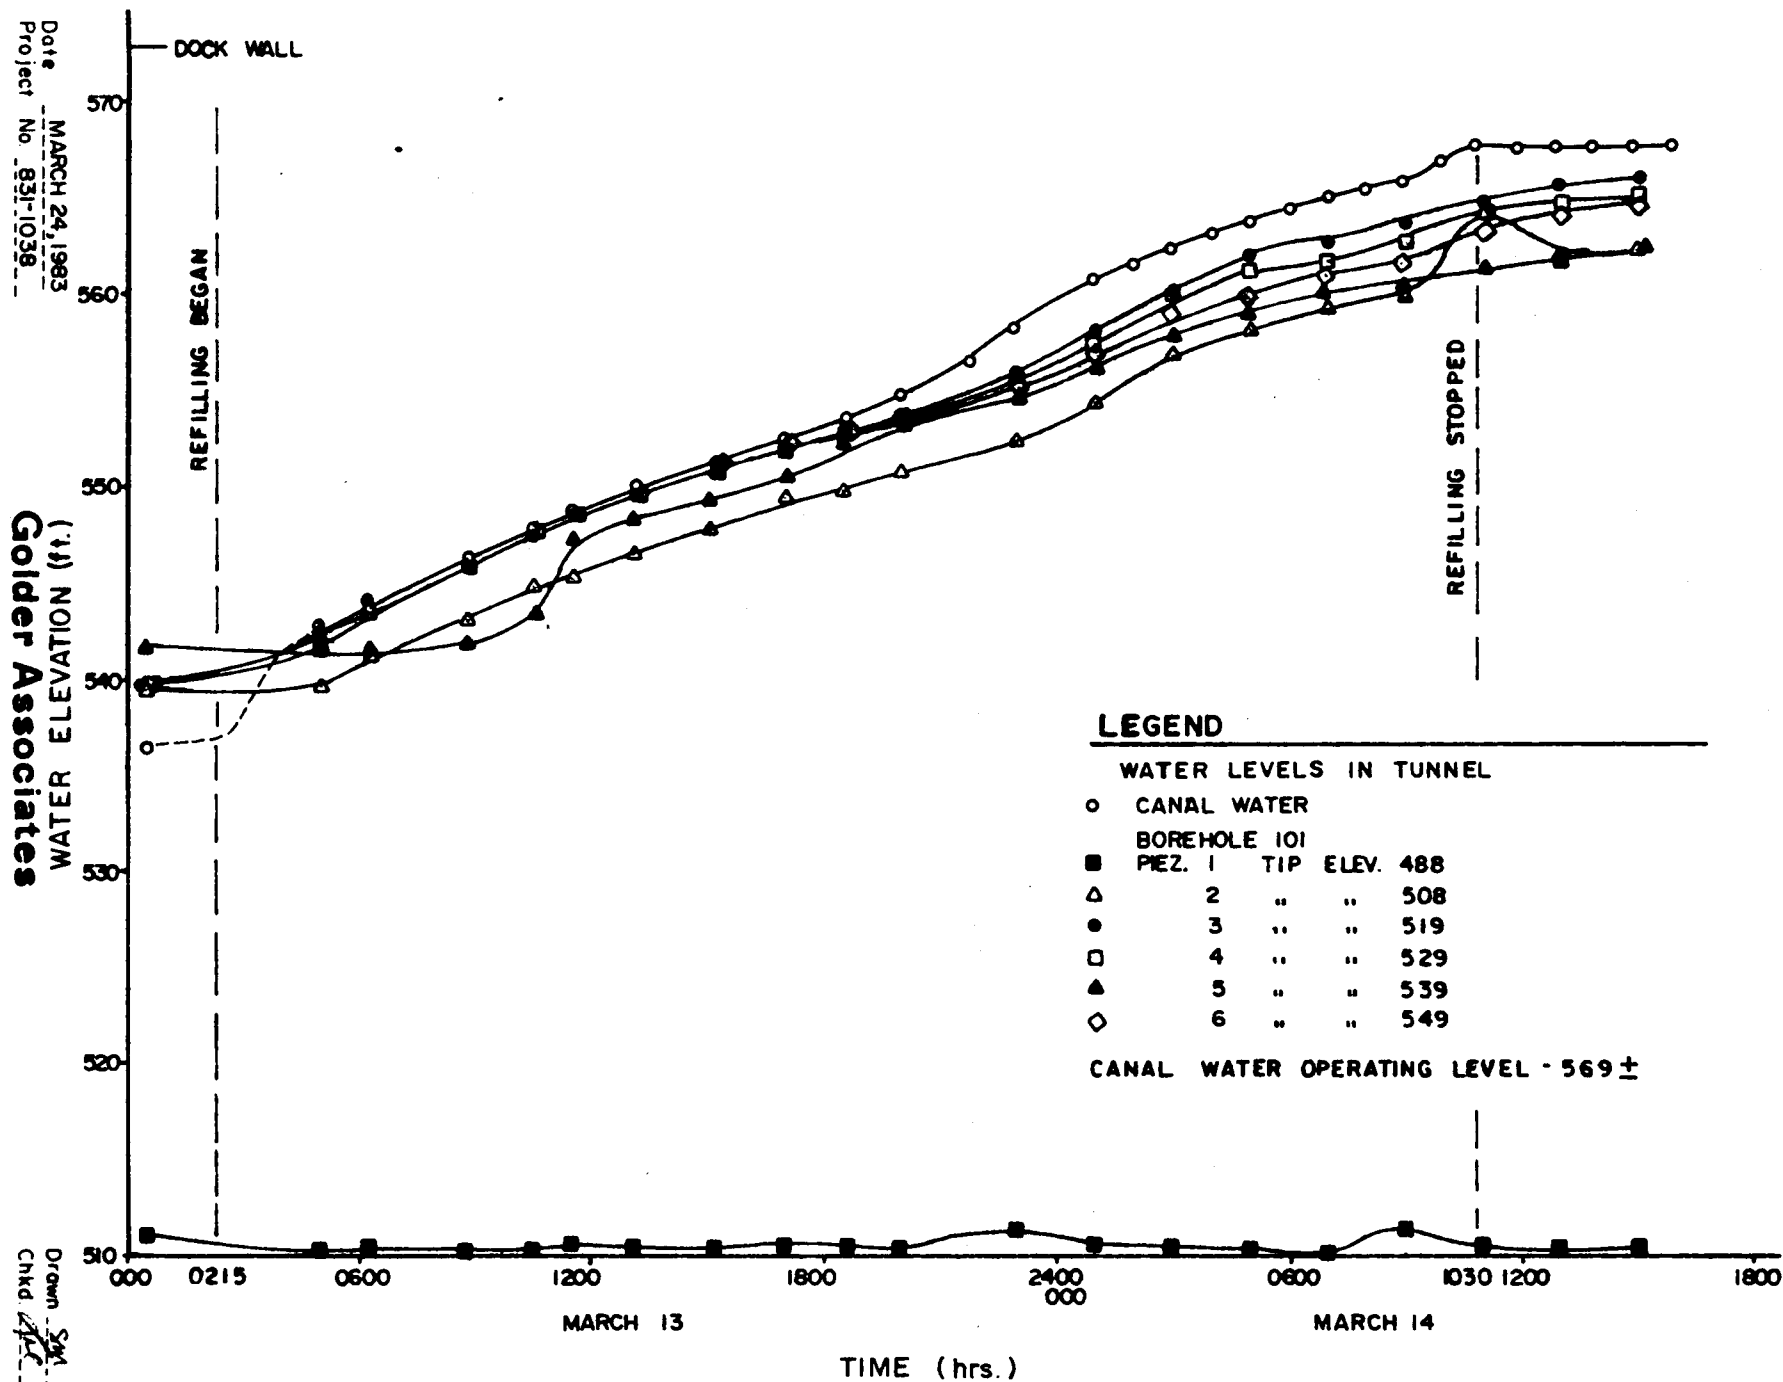
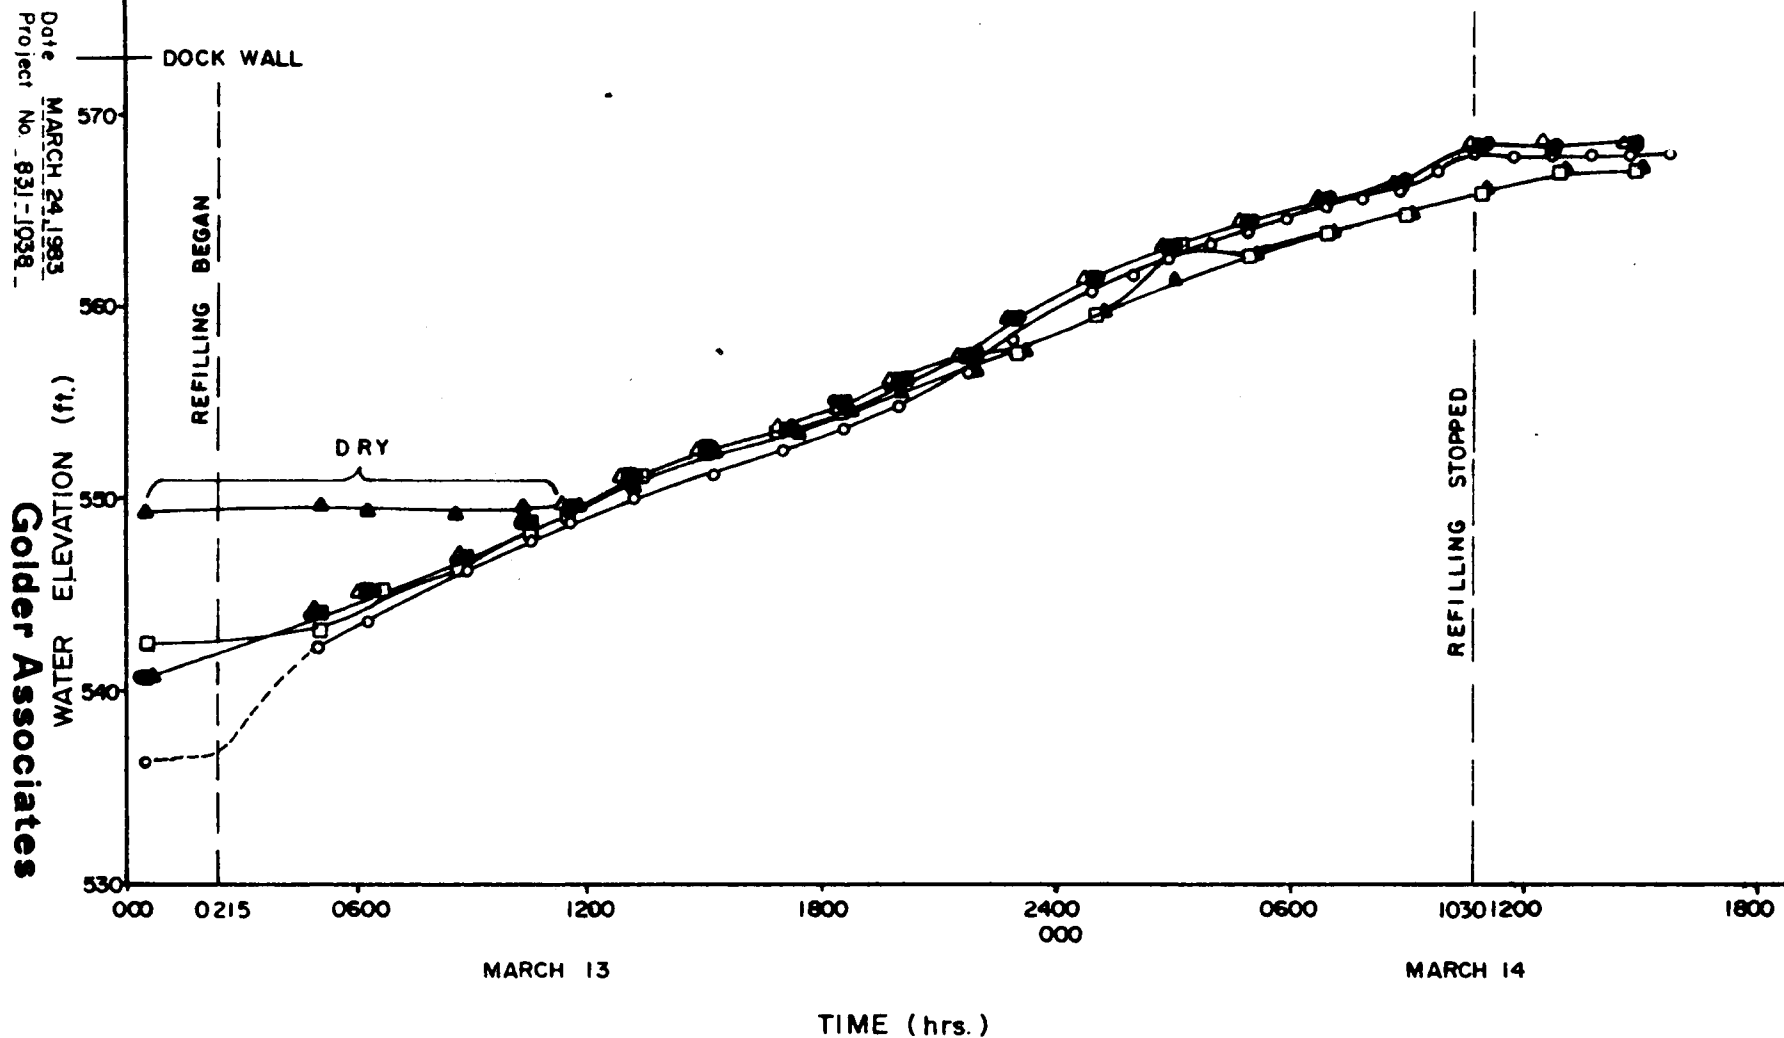
FIGURE 9

As shown on Figures 9 and 10, the piezometers within the dolostone formations (above elevation 504 ft.) responded very rapidly to changes in the canal water level. The response times for the piezometers in Borehole 102 were more rapid than for the piezometers in Borehole 101; their distances from the west wall of the canal being about 75 ft. and 240 ft., respectively. When refilling of the canal was stopped at 1030 hours on March 14, the dolostone piezometers in Borehole 101 were within 2 ft. of the canal water level, while the maximum differential in Borehole 102 was 6.5 ft.

PLOT OF WATER LEVELS VS. TIME  
PIEZOMETER IOI  
DURING CANAL REFILLING MAR./83
