**FOUNDATION INVESTIGATION AND DESIGN
SLOPE RESTORATION AT STATION 15+718
HIGHWAY 405 W-N/S RAMP AT STANLEY AVENUE
HIGHWAY 405 REHABILITATION FROM QEW TO
QUEENSTON-LEWISTON BORDER CROSSING
G.W.P. 2445-04-00**

January 2007

06-1111-036

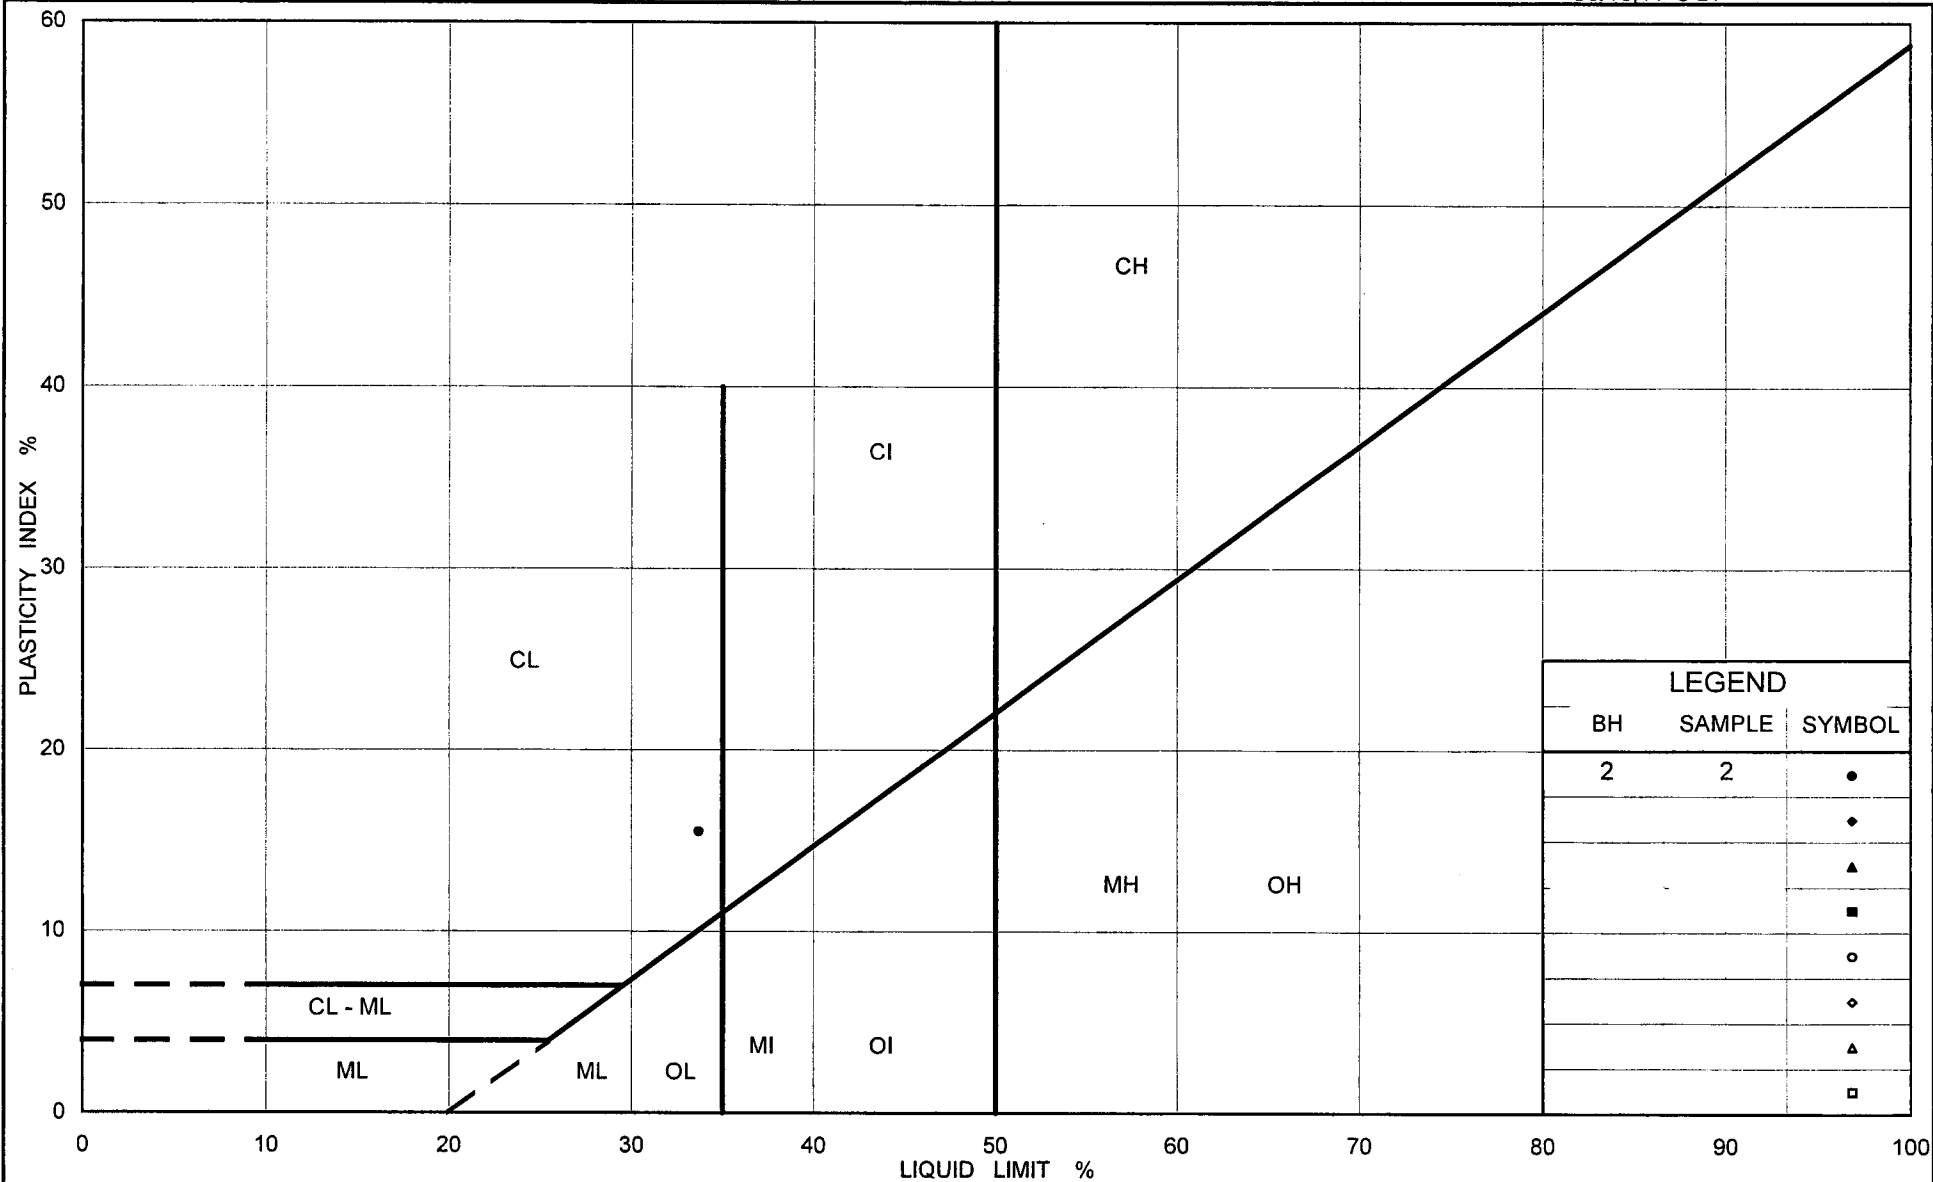
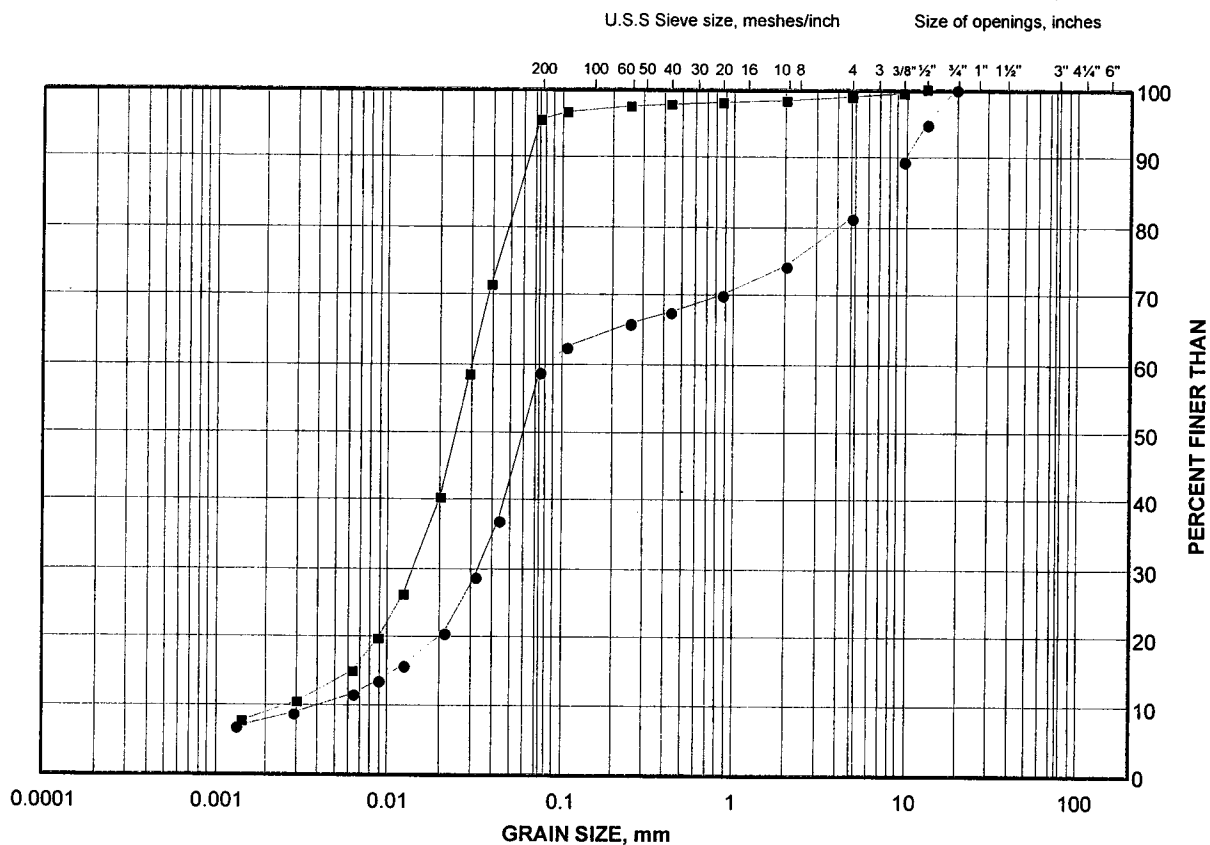
FIGURE 2

The results of two grain size distribution tests carried out on selected samples of this material are provided on Figure 2 and indicate that the deposit is slightly coarser in Borehole 1. Measured SPT "N" values within the sandy silt to silt deposit typically range from 44 to greater than 100 blows per 0.3 m of penetration, with the exception of one SPT "N" value measured at 28 blows per 0.3 m of penetration obtained within the saturated zone just above the bedrock surface in Borehole 2. The SPT "N" results indicate that the sandy silt to silt deposit typically has a dense to very dense relative density.

Sandy Silt to Silt
