THOROLD TUNNEL

INSPECTION OF ROCK SLOT  
SOUTH OF WEST SERVICE BUILDING

September 1982

Acres Consulting Services Limited  
Niagara Falls, Canada

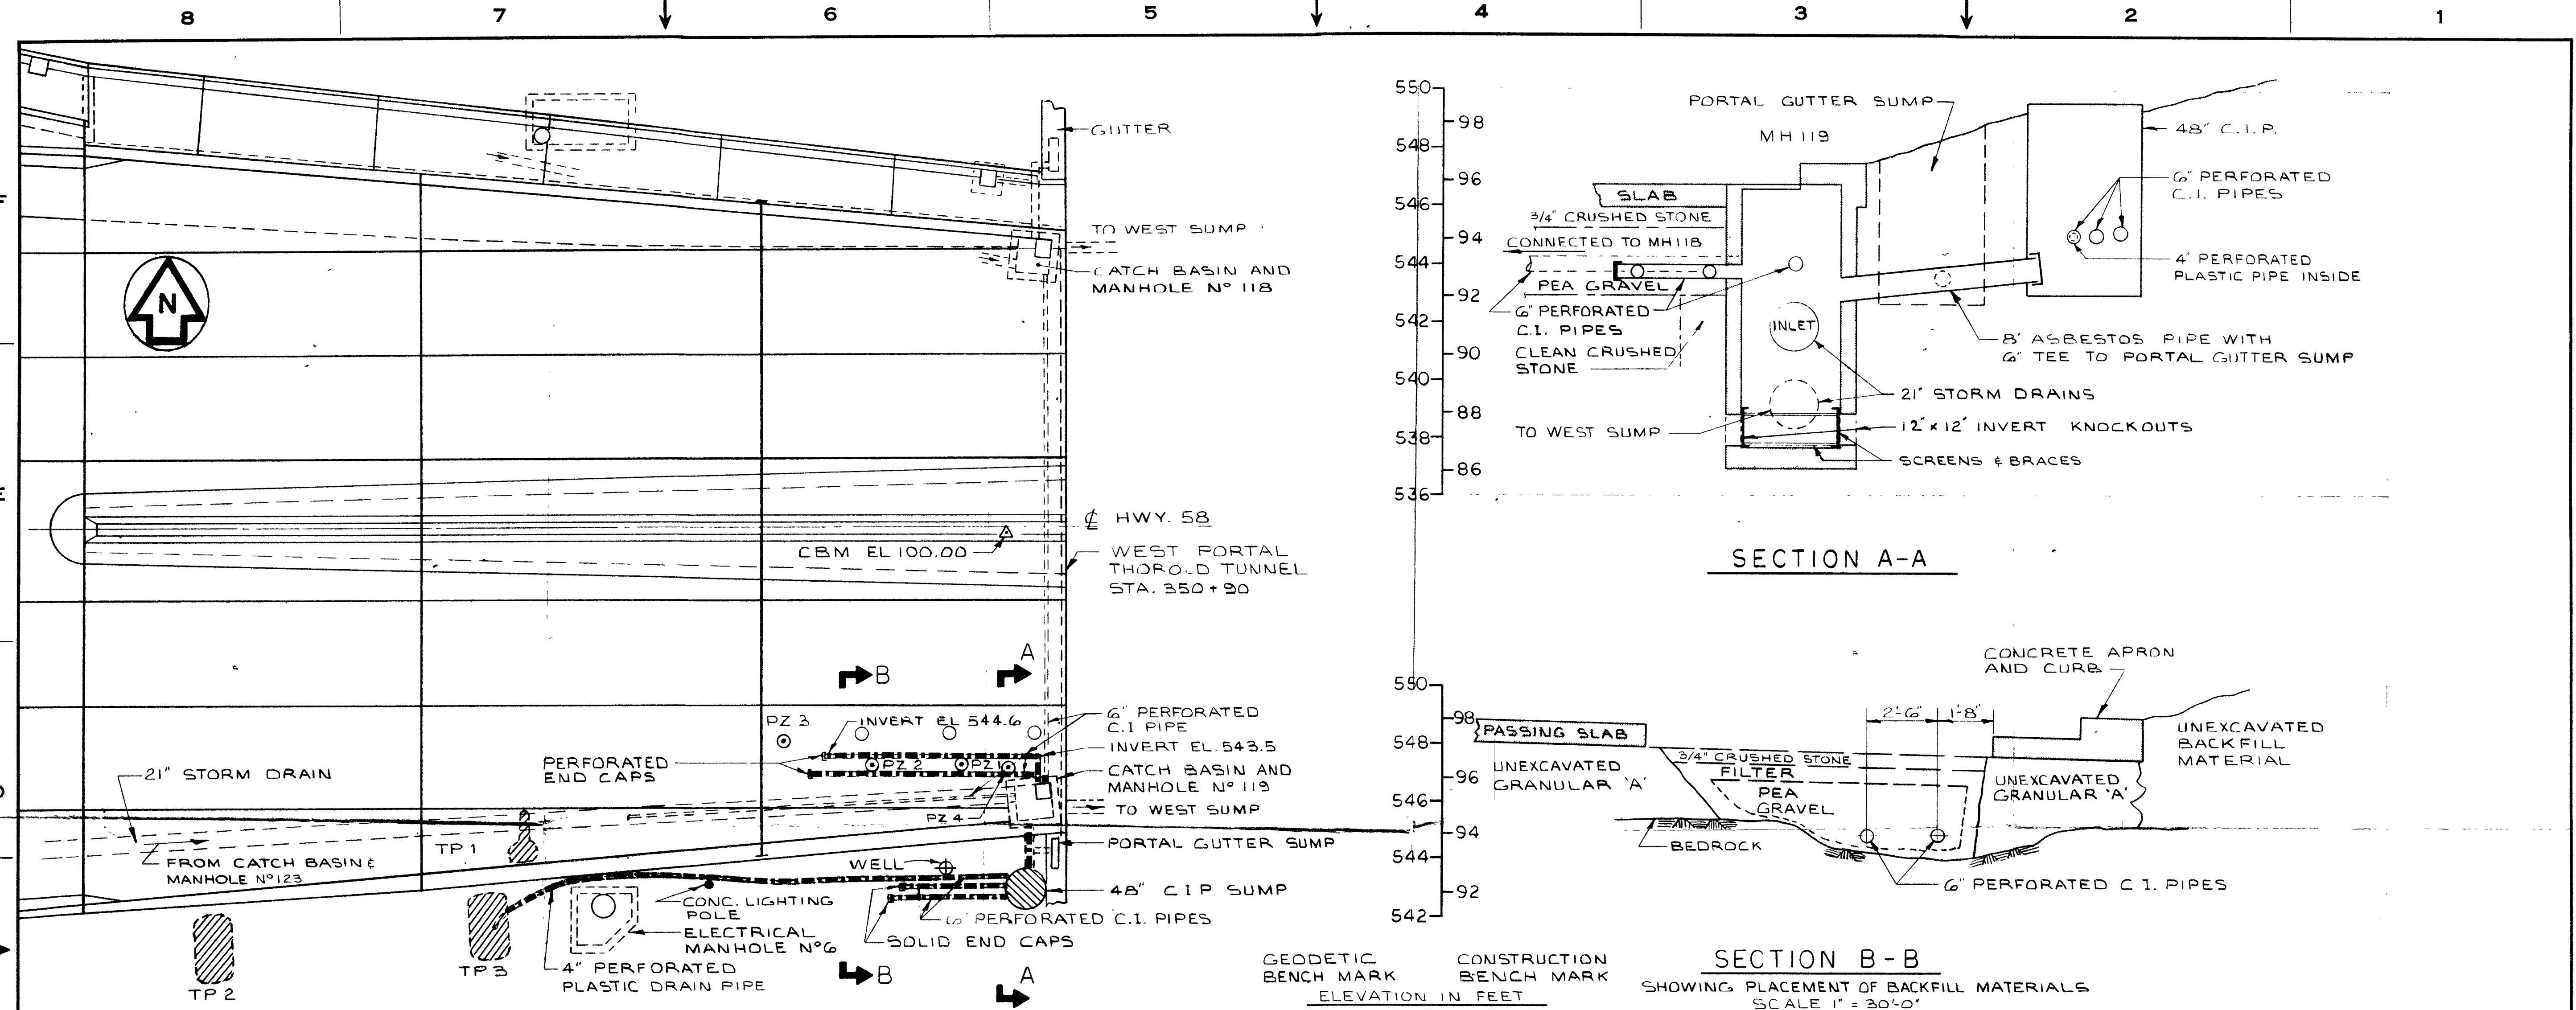
CATCH BASIN AND MANHOLE NO 118  
INFLOW INSPECTION (JUNE 26 1979)

NOTE  
1 THE BOTTOM OF THE CATCH BASIN WAS COVERED WITH 3" OF SAND, GRAVEL AND ROCK RUBBLE.  
2 A STRONG SULFUR/SEWER SMELL WAS NOTED.

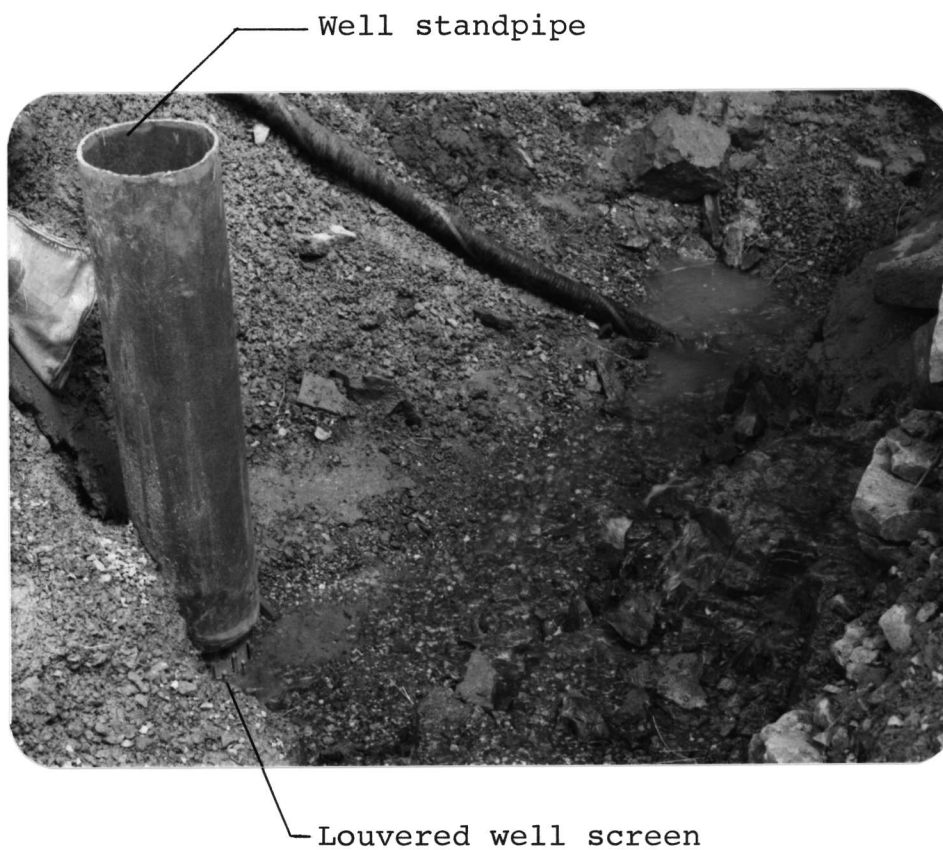
PHOTO NO. 1

60 gal/min. Photo No. 1 shows the exposed well standpipe and screen. The seepage into the excavation, which was mainly at the bedrock surface, can be seen in photo No. 2.

Portal gutter base

Bedrock

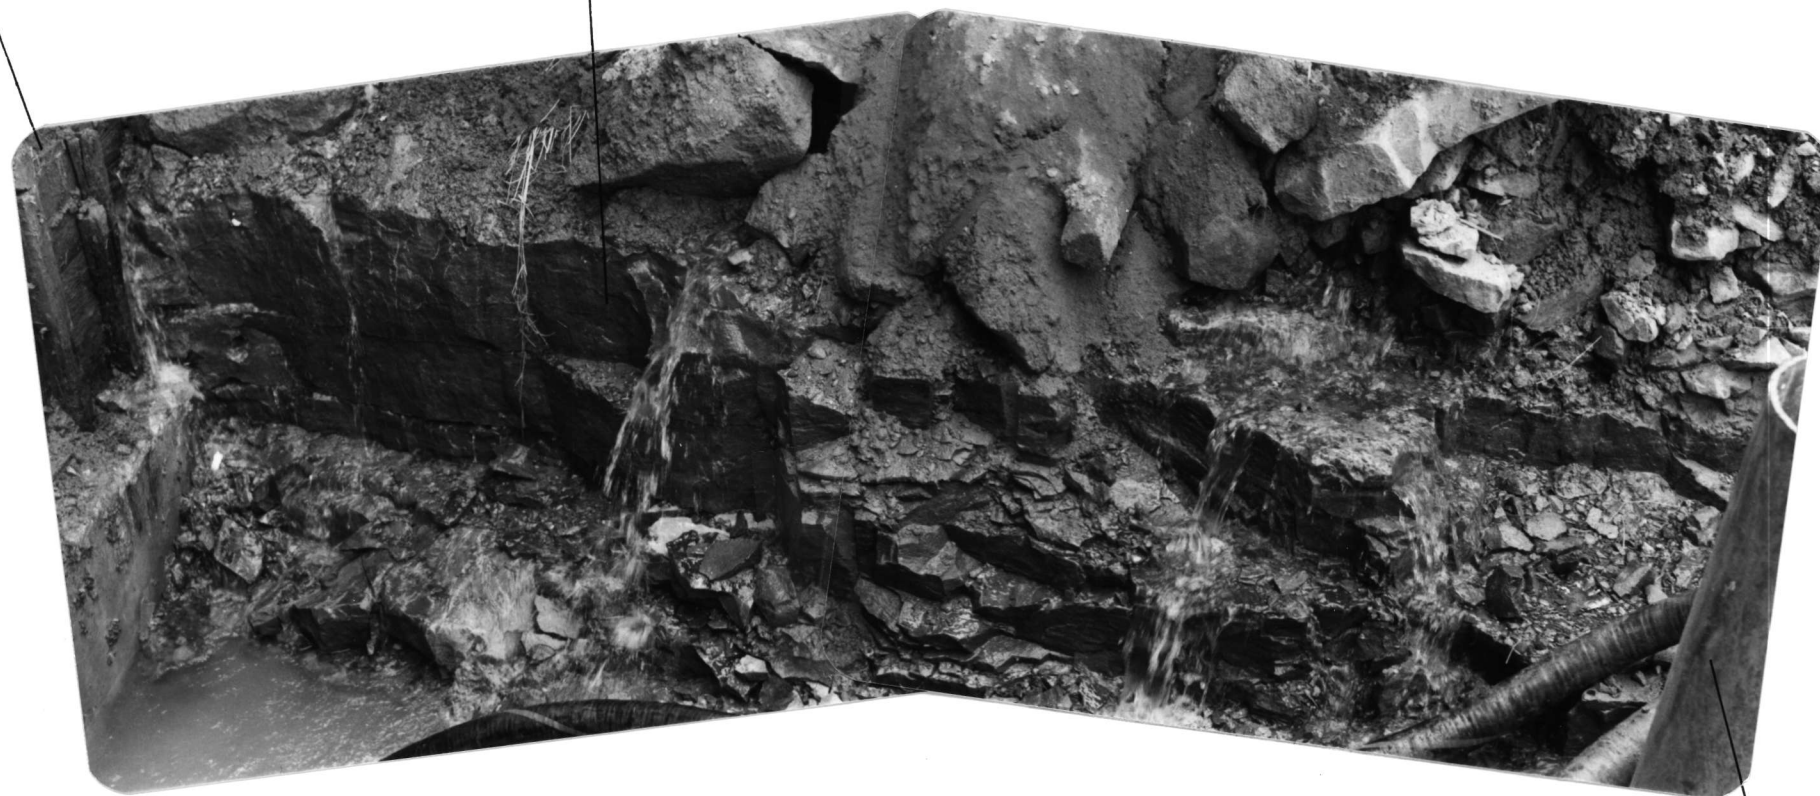
PHOTO NO. 2

Well casing

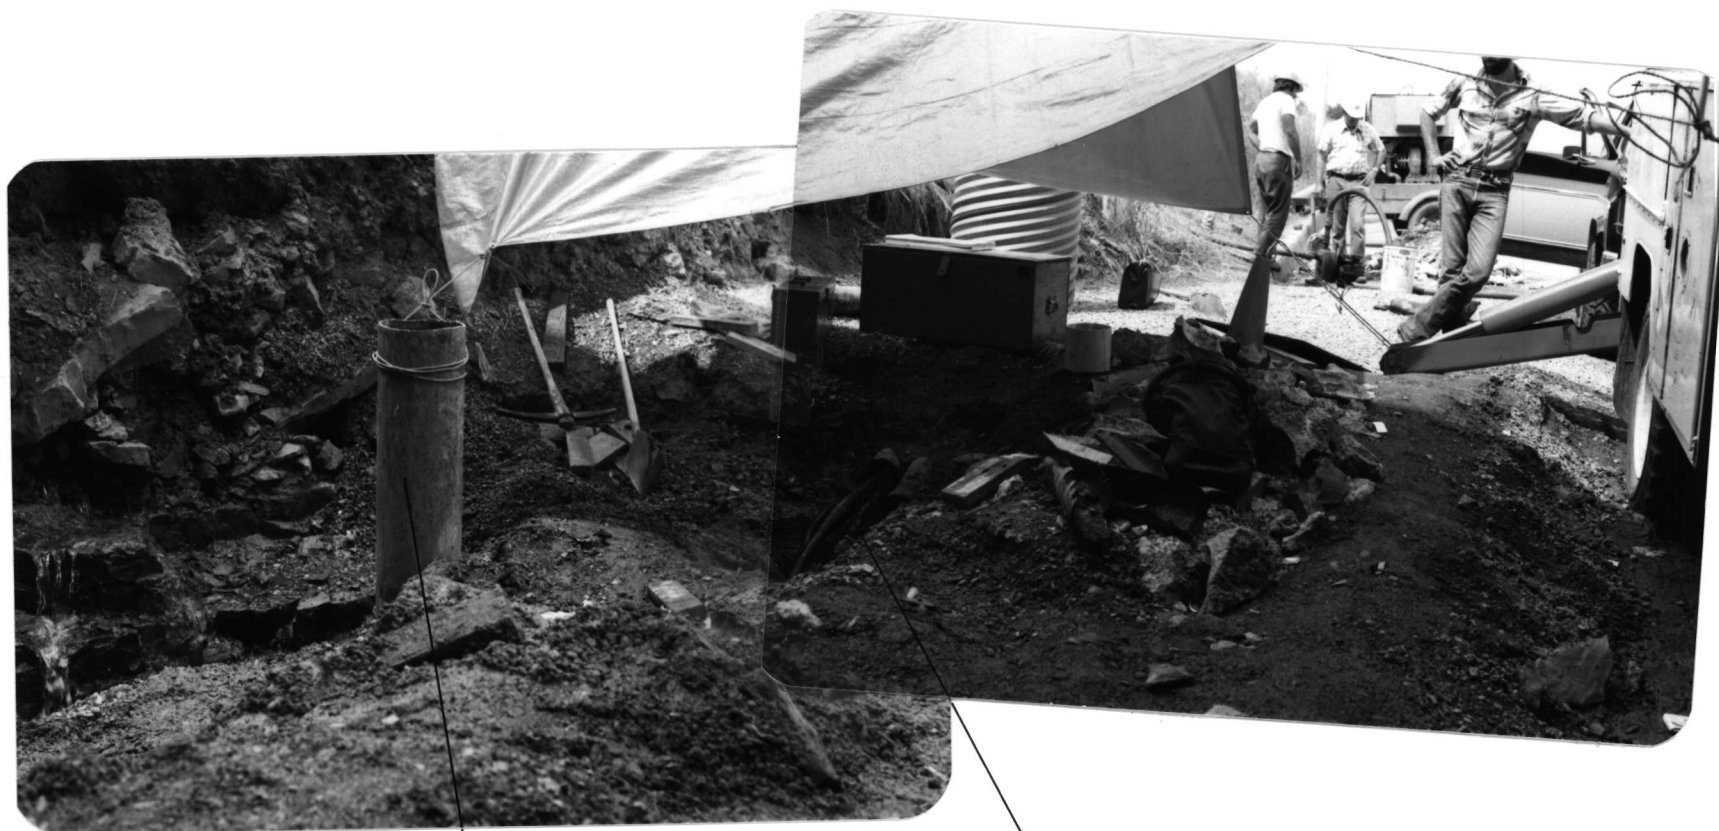
During excavation behind the curb, two 13,800-V power cables were damaged as shown in photos No. 3a and 3d. Three cable ducts were exposed during the repair work. They extend from electrical manhole No. 6 to the curb near the portal. One of the ducts carried three power cables and the other two were empty as can be seen in photo No. 3e. The two empty conduits acted as drains for the manhole. Electrical repairs were conducted on July 11 and 12 by G.A.M.S. Ltd. who spliced the two cables (photo No. 3e). Photo No. 4 shows the complete excavation and the relative positions of the portal (to the left), well standpipe and the repaired electrical cables.

Well casing

Repaired power cables

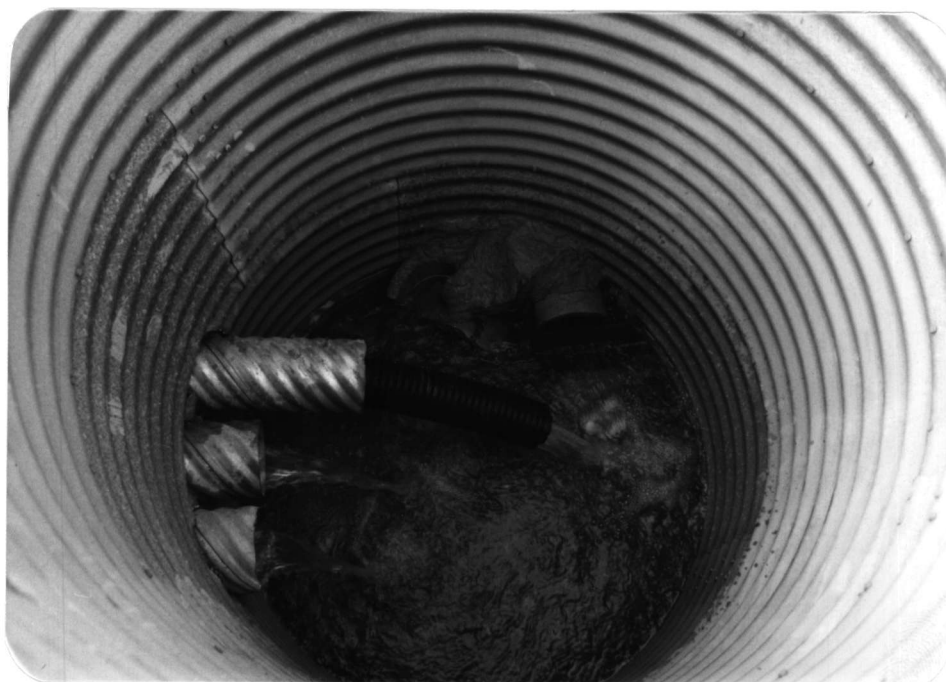
PHOTO NO. 5b

Test pit 3 was excavated to a depth of about 3 ft below curb level on July 16 and intercepted a flow of 50 to 60 gal/min. Photo No. 7a shows the pit location with respect to the portal and electrical manhole No. 6. Upon pumping from the test pit, flow in the 6-in. pipe leading into the west side of manhole No. 119 was reduced to about half its original volume. A trench was dug south of the curb leading from the end of the pipes connected to the sump to the test pit. A 4-in. perforated plastic pipe was laid through one of the 6-in. perforated steel pipes (photo No. 5b) along the trench and into TP3 to collect the flow (photo No. 7b).

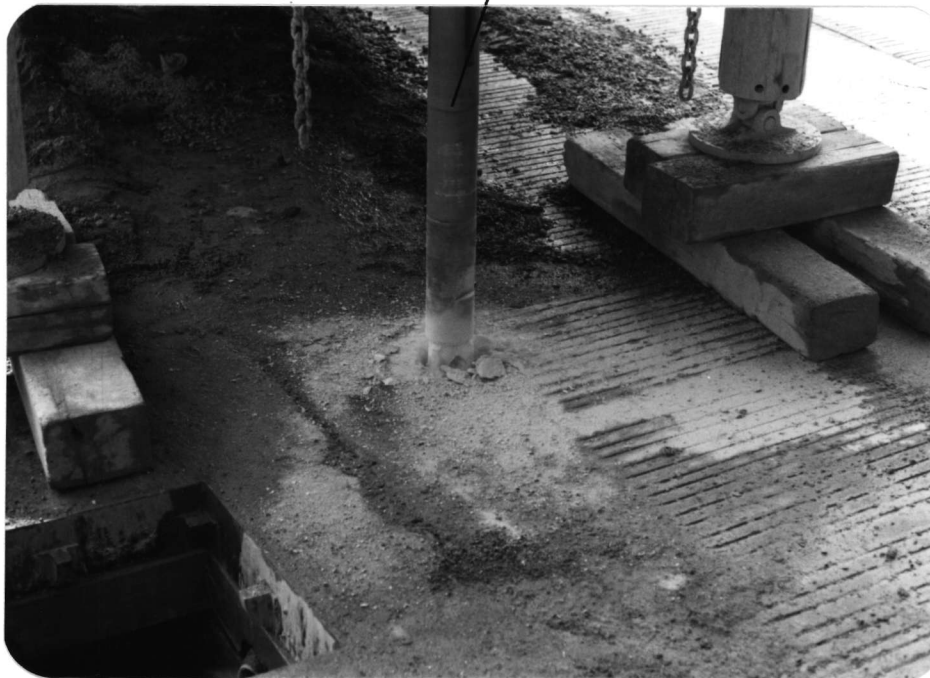
PHOTO NO. 6

Four piezometers (PZ-1 to PZ-4) were placed on July 13 at locations shown on Plate 1. Piezometer 4 was later removed as it interfered with the excavation operations. Drilling of this piezometer is shown on photo No. 6 (manhole No. 119 is in the lower left corner). Piezometer installation details and water levels are presented in Table 1.

Drilling hole for PZ-4

Manhole No. 119

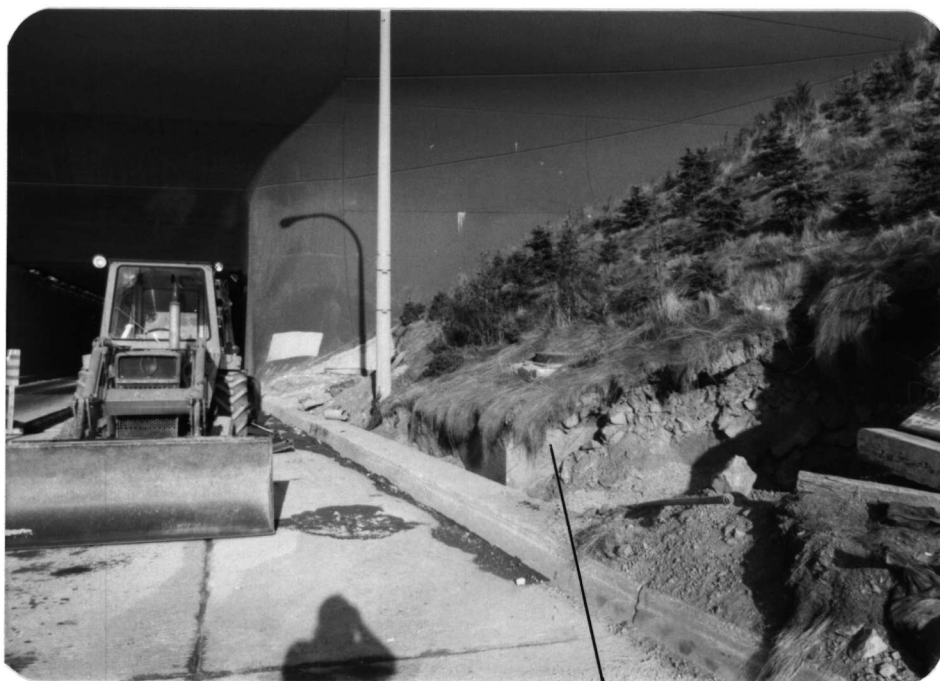
PHOTO NO. 7a

TP-3

Electrical manhole No. 6

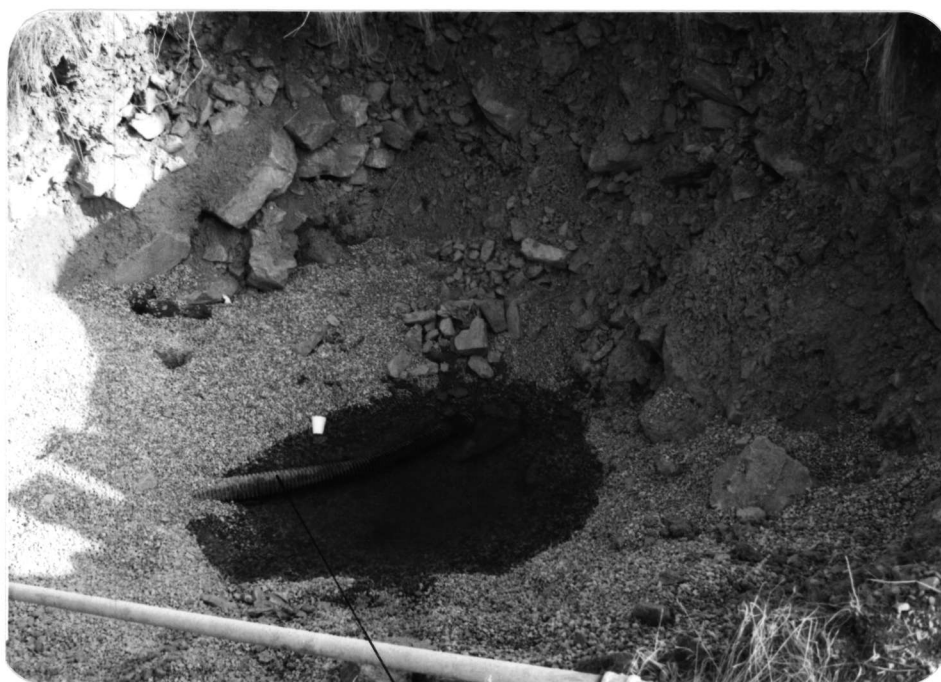
PHOTO NO. 7b

Perforated plastic pipe in TP-3

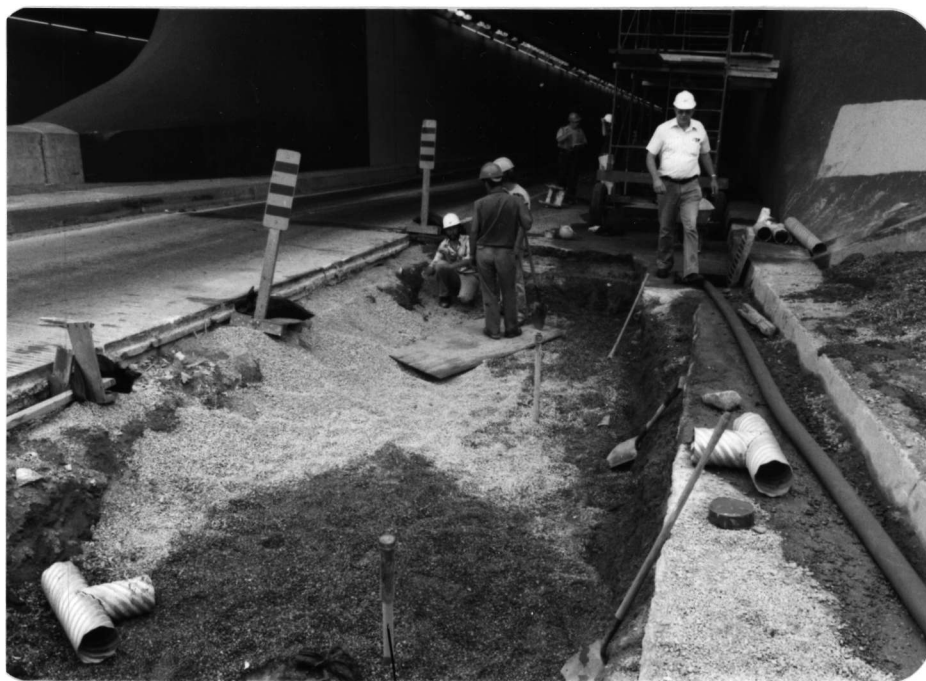
PHOTO NO. 11

Piezometer PZ-2

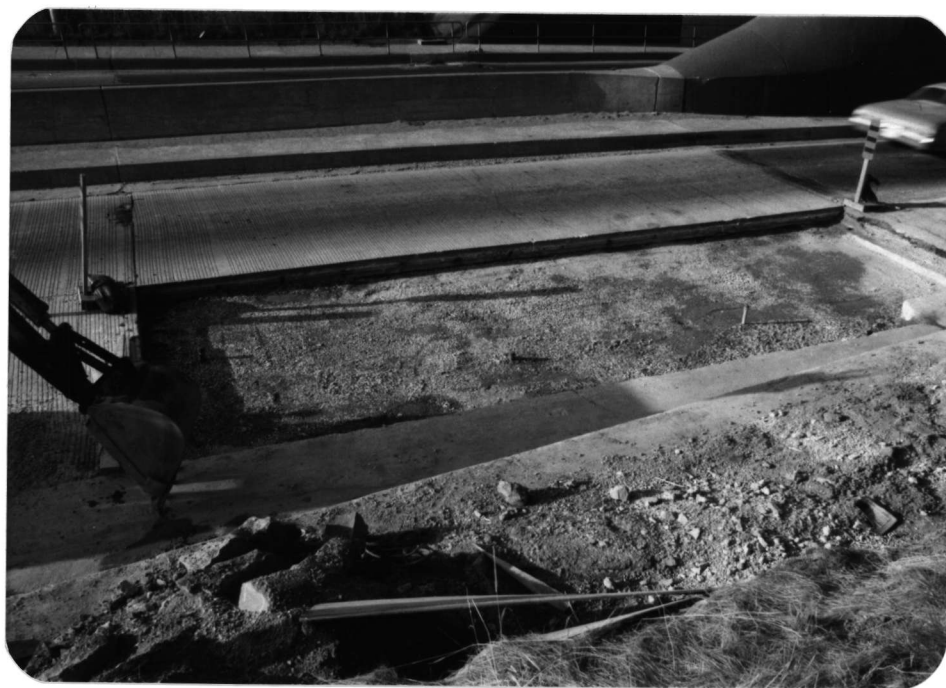
PHOTO NO. 13a

Final backfilling to proper grade and compaction was completed on July 25. Photo No. 13a shows the entire area just before the final crushed stone was placed and compacted. Note the piezometer pipes extending above the grade. These were left in place to permit an ongoing monitoring of the water levels below the slab. Compaction tests using a nuclear densometer were performed by the Ministry of Transportation and Communications. Photo No. 13b shows the western edge of the backfilled area with load transfer bars extending from the adjacent slab.
