THOROLD TUNNEL

INSPECTION OF ROCK SLOT
SOUTH OF WEST SERVICE BUILDING

September 1982

Acres Consulting Services Limited
Niagara Falls, Canada

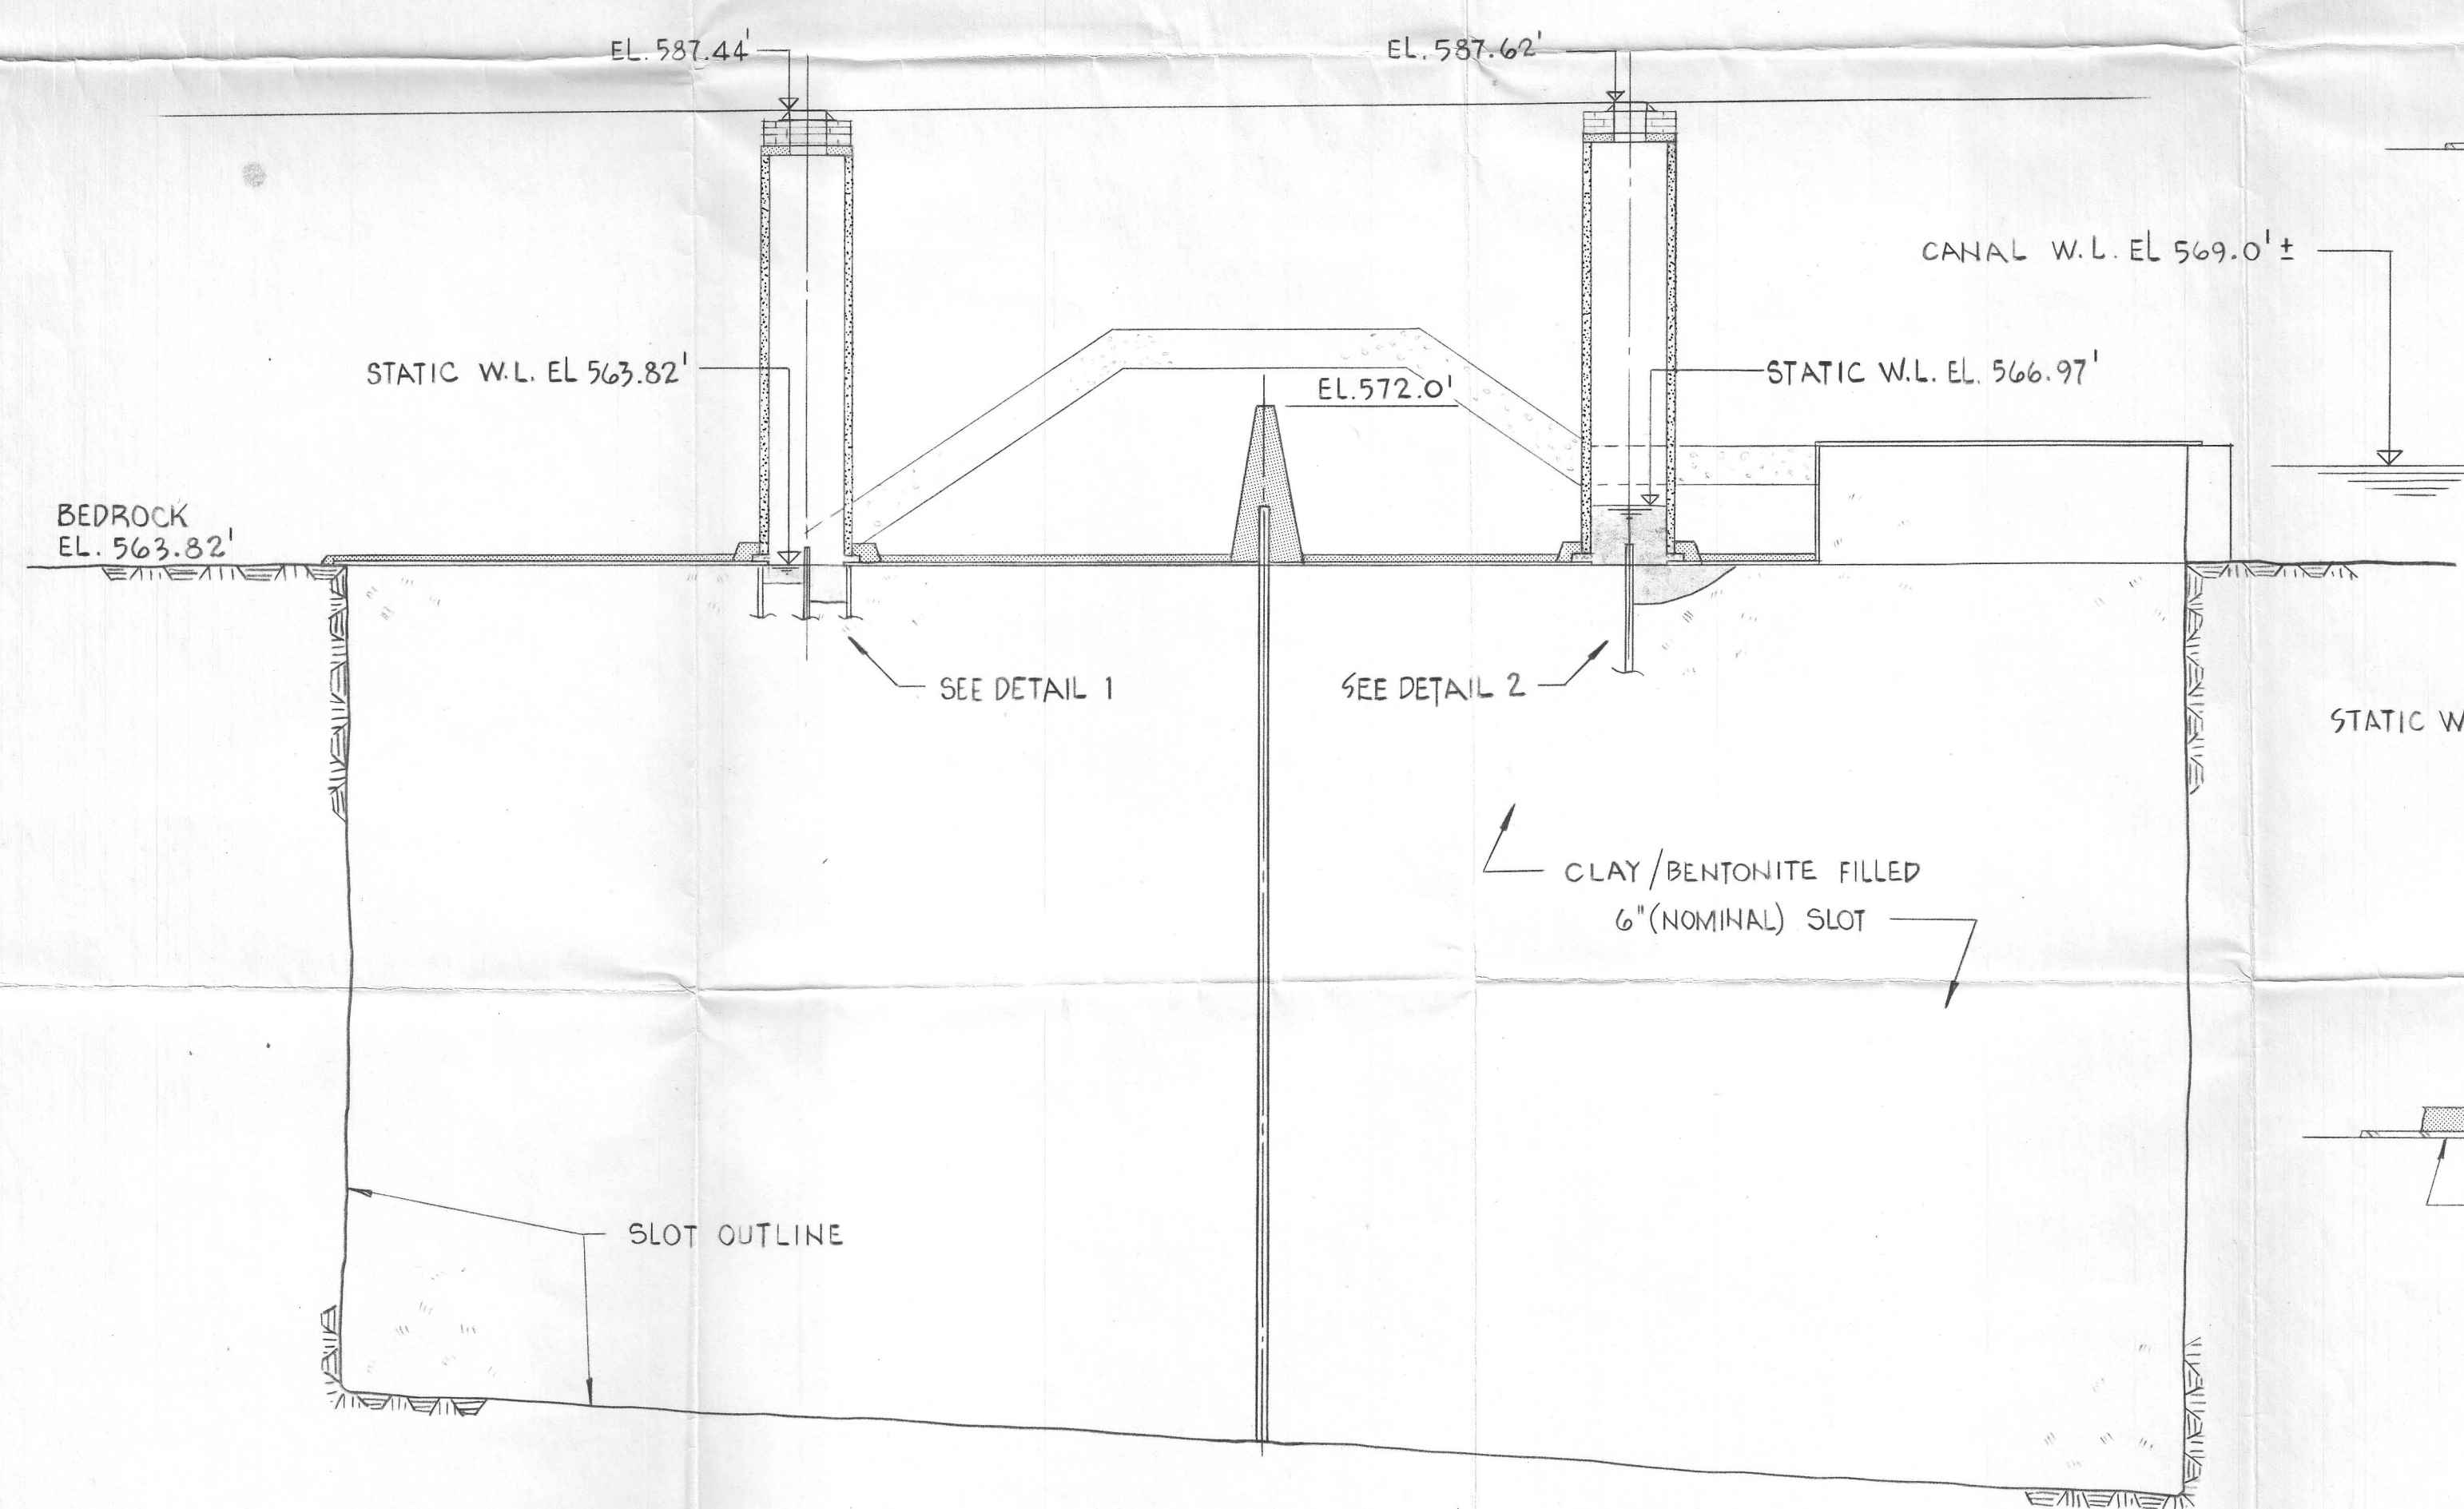
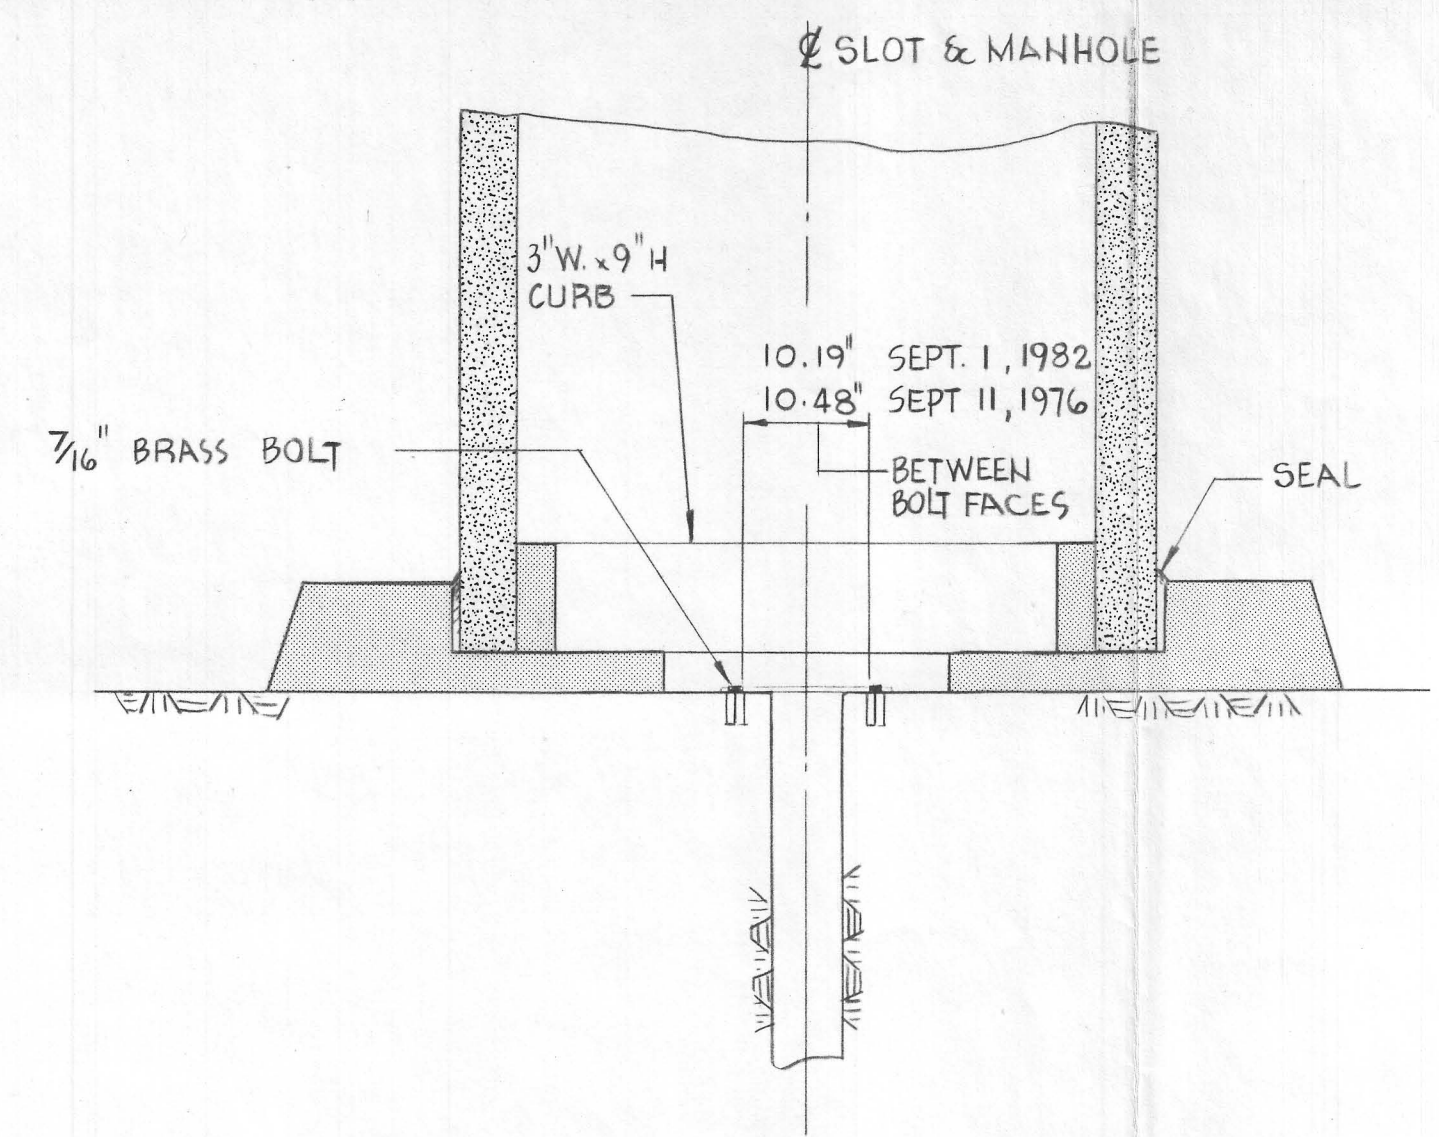
ACRS	MINISTRY OF TRANSPORTATION & COMMUNICATIONS		
	THOROLD TUNNEL - ROCK SLOT INSPECTION		
DETAILS OF SLOT FILL AND MANHOLES		DATE SEPT. 24, 1982	SCALE AS NOTED
PROJECT		DEPARTMENT HEM	DRAWING No.
PROJECT		PROJECT	PLATE 1
PROJECT		PROJECT	SHEET OF

The probing within the slot was carried out using a metal fish wire which was pushed along the slot until an obstruction was encountered. Details of what was found in each manhole area are shown on Plate 1, Detail 1 representing the west manhole and Detail 2 the east manhole.

In the eastern manhole, only one wooden bulkhead was found near the manhole centre and it also had instrumentation tubes attached to it. The slot is full of clay/bentonite on the west side of the bulkhead, while a triangular-shaped void about 2 ft deep and 5 ft long exists on the east side (see Detail 2, Plate 1).

Since the portion of the slot without fill material is relatively small and no flow appears to be occurring along the slot, it is not considered necessary to proceed with filling the voids at this time. It is recommended that the slot be inspected in the future, say 5 years from now, to assess whether any changes have occurred.
