THOROLD TUNNEL

Investigations to Determine the  
Cause of Cracking in the Structure

Supplementary Report No. 3  
West Service Building  
Review of Observed Structural  
Behavior 1971 to 1972

December 1972

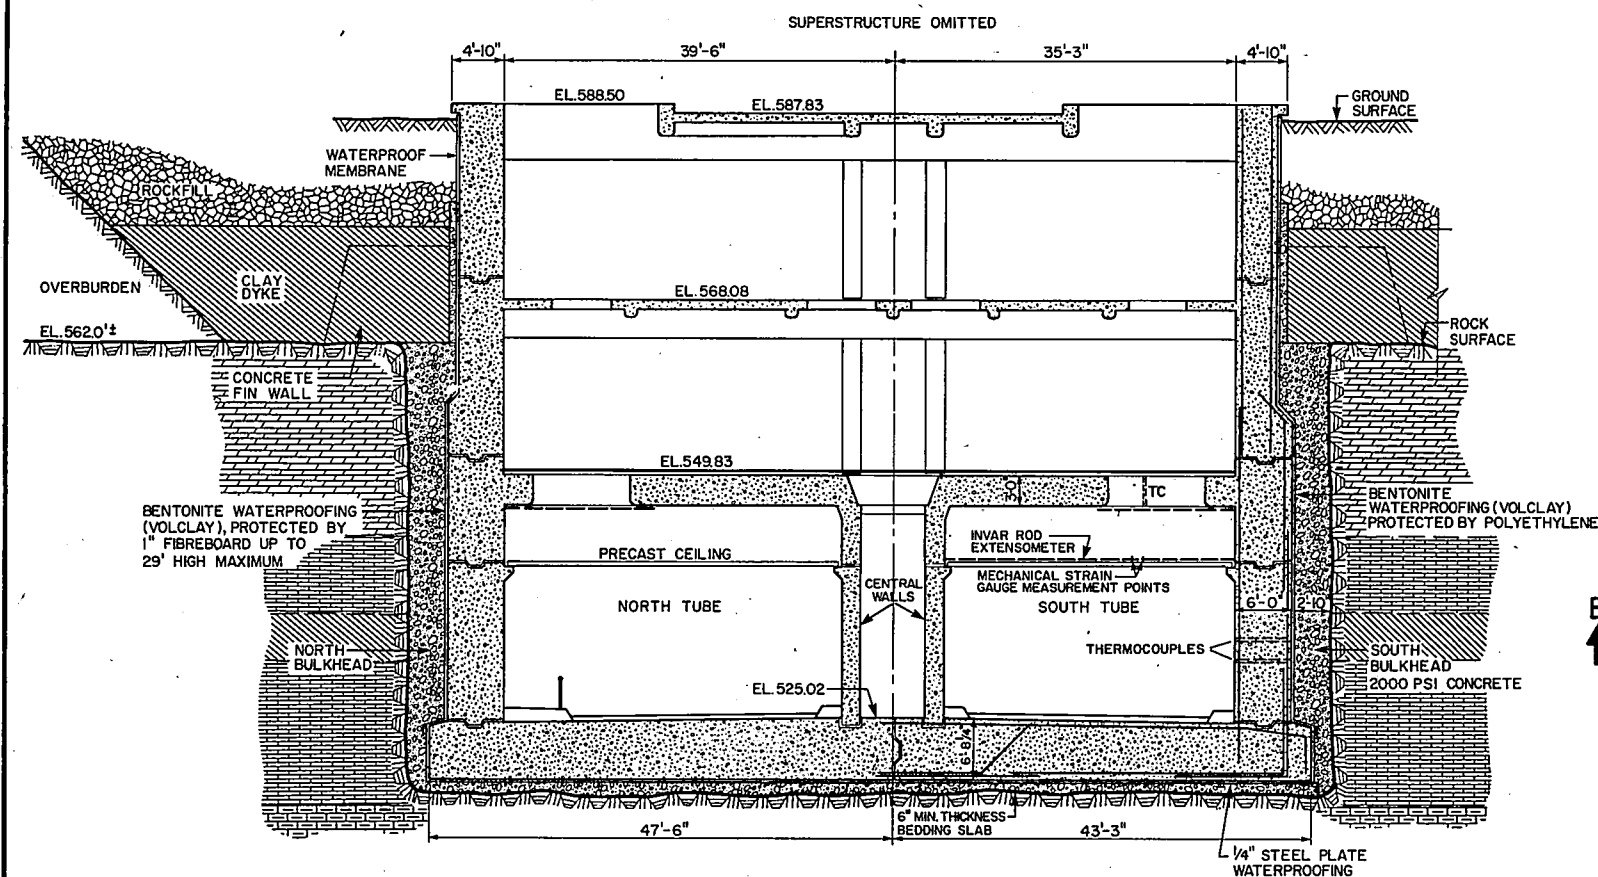
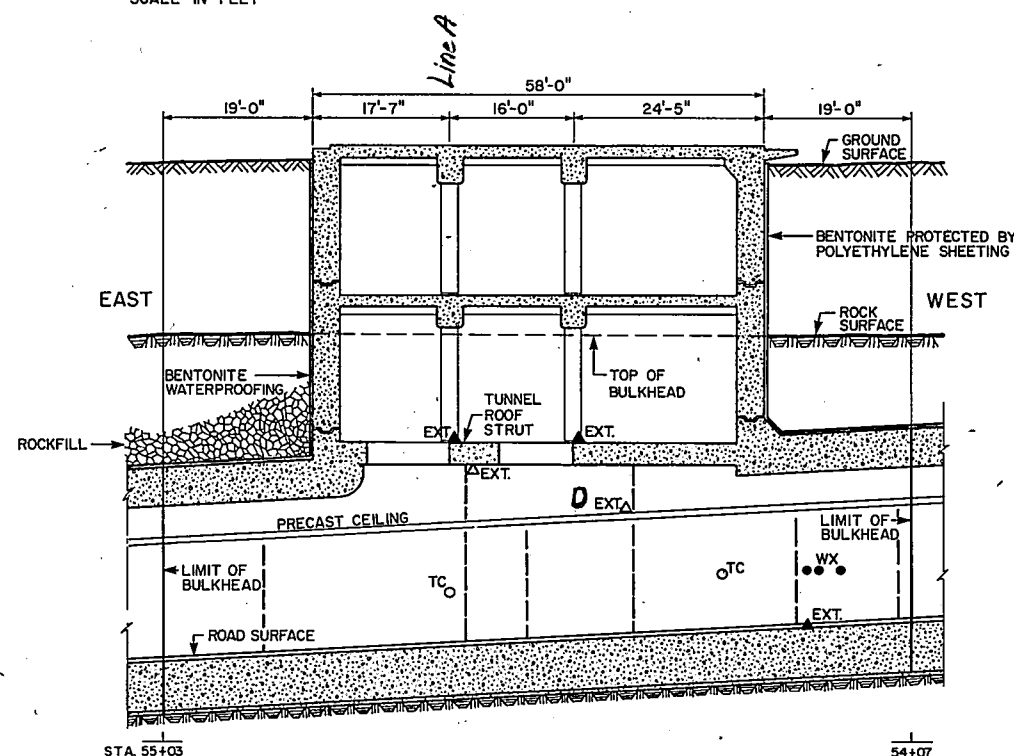
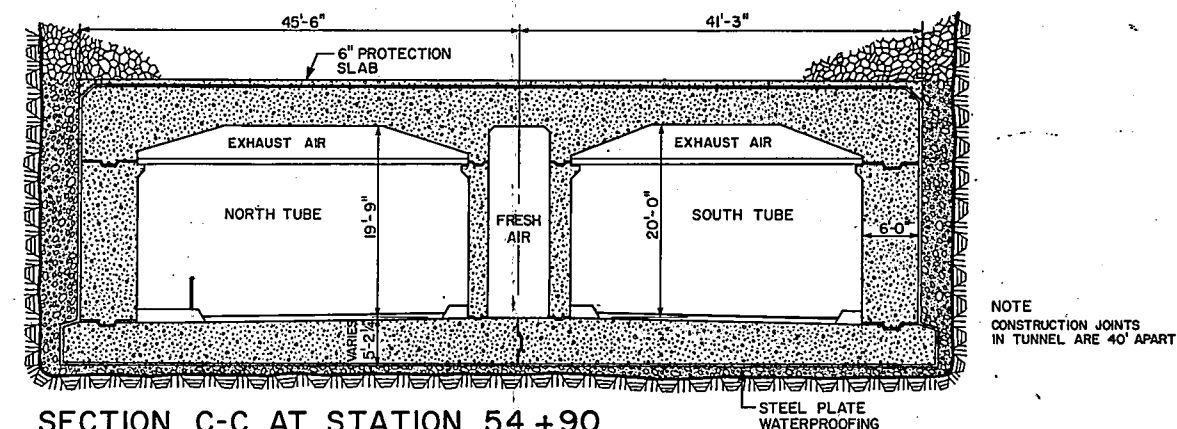
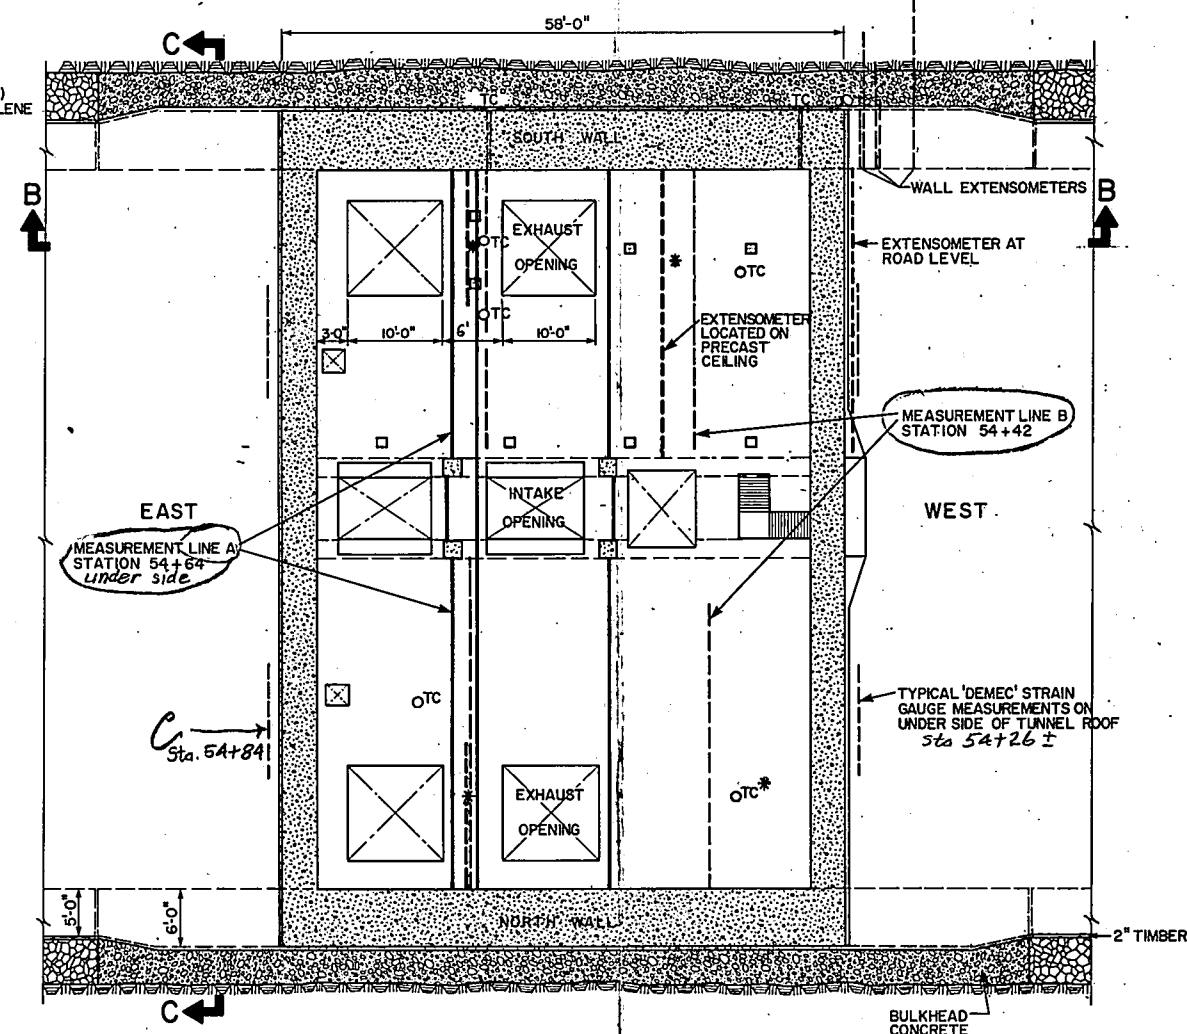
The methods used to determine stresses and strains in concrete and reinforcing steel were described in Supplementary Report No. 1 of May 1972. Monitoring observations since May 1972 have utilized instrumentation as follows, see Plate 1:

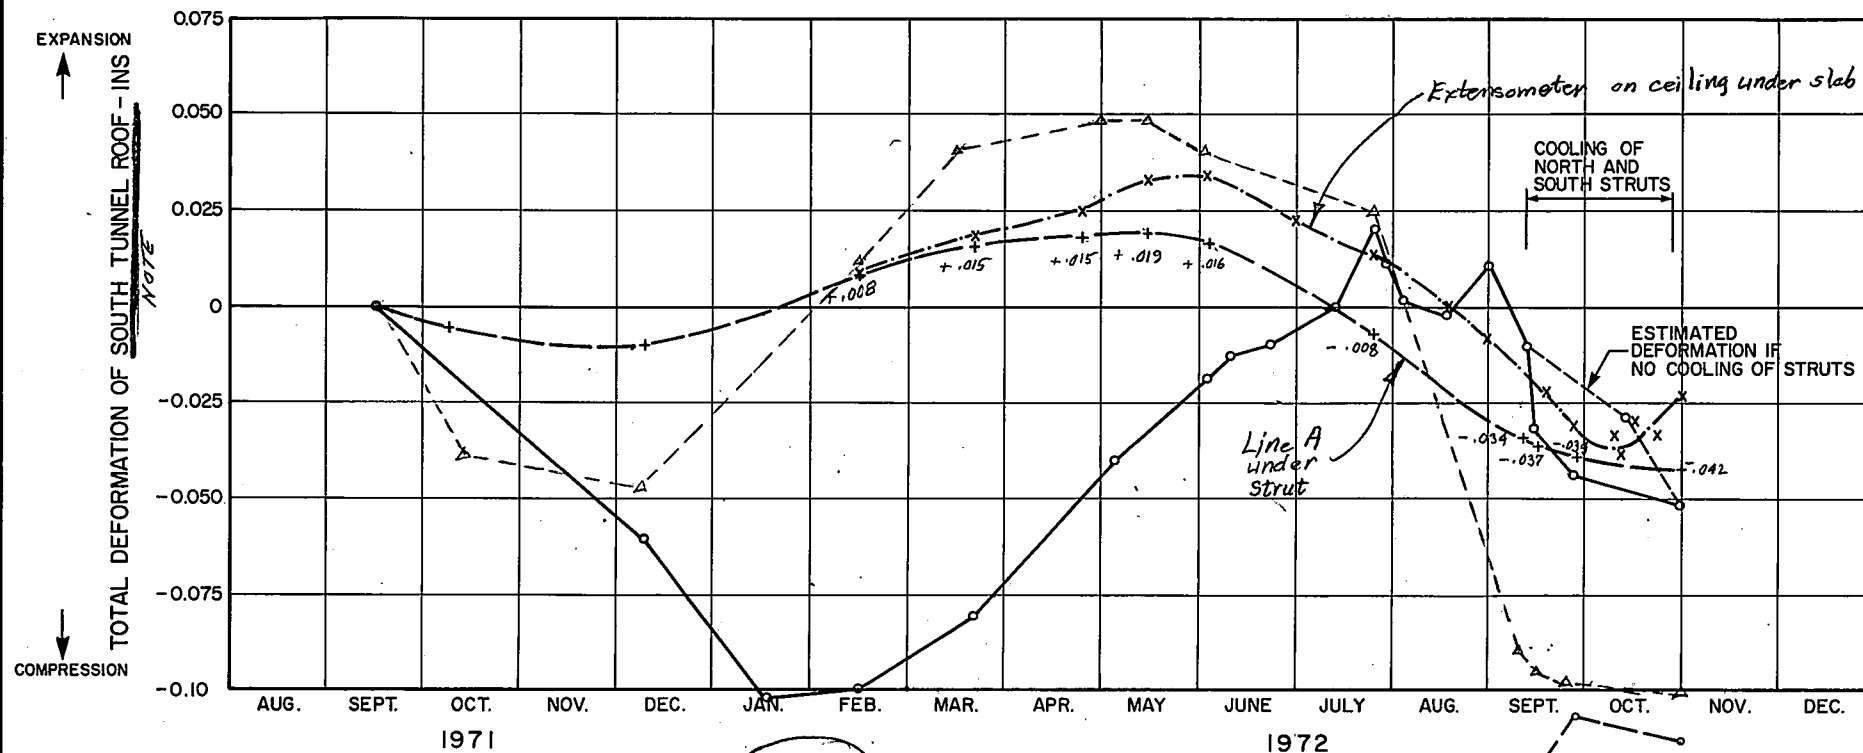
TUNNEL ROOF DEFORMATION (LINE A) - CENTER LINE OF ROOF STRUTS STATION 54+64

- (c) In addition to increasing progressively the imposed deformation due to rock squeeze has been observed to have an annually fluctuating component, as shown on Plates 3 and 11. This component has a peak to peak magnitude of the order of 0.14 inch, with the maximum compressive effect occurring in October-November of 1971 and 1972.

1. FOR LOCATION OF MEASUREMENTS REFER TO PLATE 1
2. TUNNEL ROOF DEFORMATION IS CALCULATED FROM STRAINS MEASURED BY EXTENSOMETERS SHOWN IN PLATE 1
3. CRACK WIDTH MEASUREMENTS PRESENTED TYPICAL OF SIMILAR OBSERVATIONS

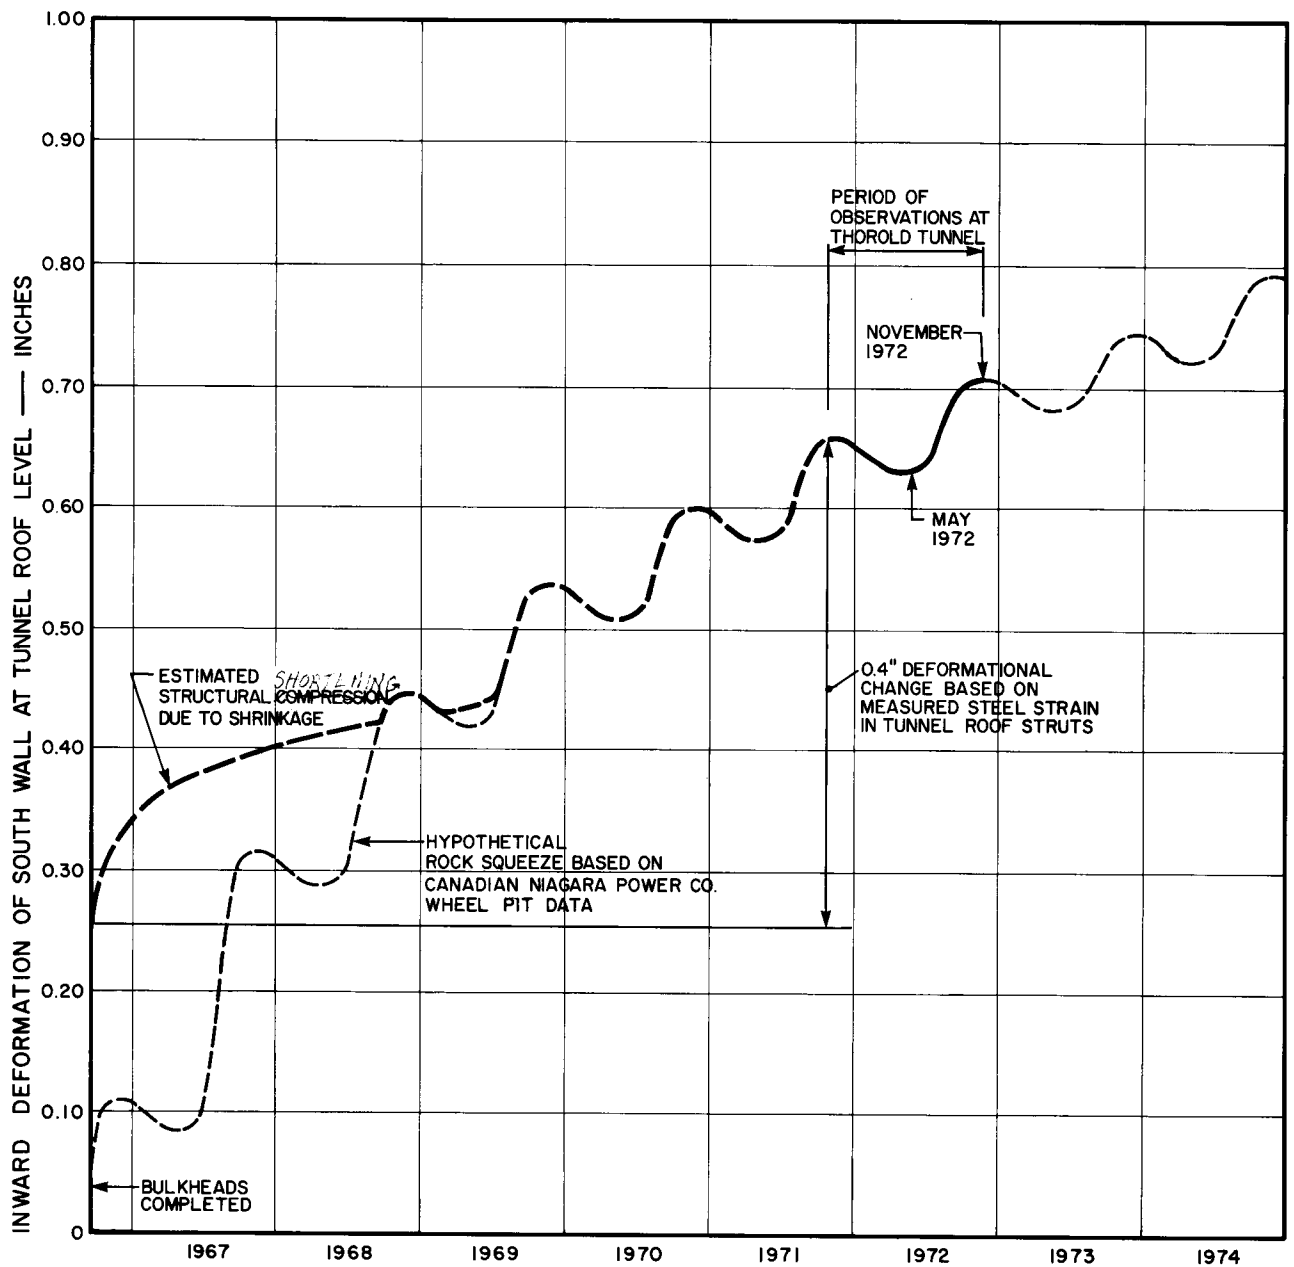
- (j) Observed tunnel deformations attributable to rock squeeze for 1971 to 1972 show good correlation with similar observations in the Canadian Niagara Power Company's wheel pit in Niagara Falls. The latter has continued to have a progressive movement with the superimposed annual fluctuation for 70 years, and based on this precedent, there is no reason to believe that the progressive compression of the tunnel will cease in the foreseeable future.

HYPOTHETICAL CURVE OF DEFORMATIONS DEVELOPED FROM MEASUREMENTS OF WHEEL PIT MOVEMENTS MADE BY ONTARIO HYDRO AND ON 1971-72 FIELD OBSERVATIONS AT THOROLD
