THOROLD TUNNEL

Investigations to Determine the
Cause of Cracking in the Structure

Supplementary Report No.2
East Service Building

December 1972

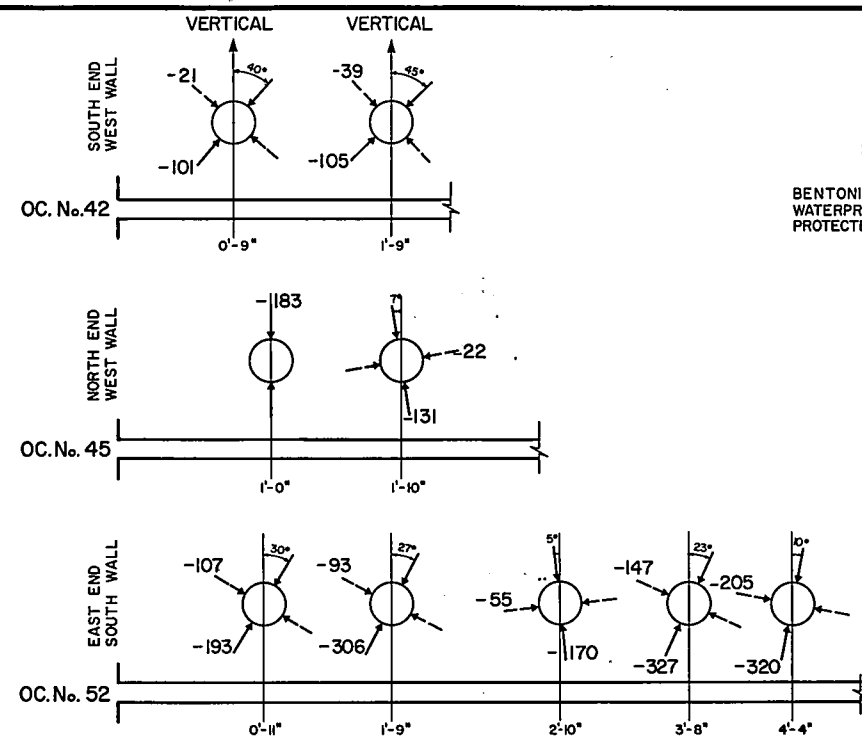
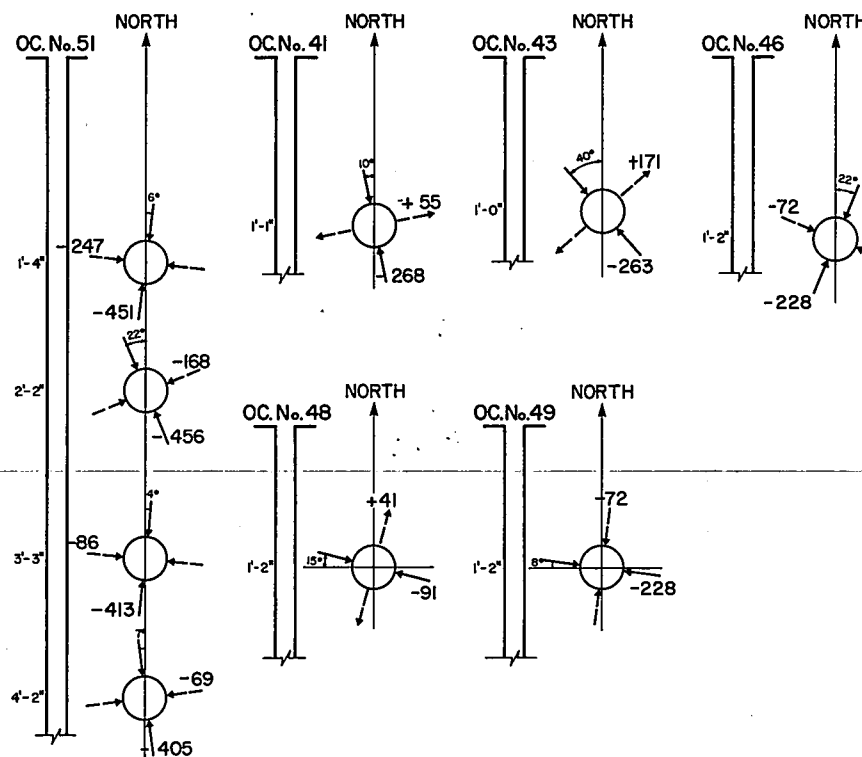
The steel stress determined in the top of the tunnel floor slab in the fresh air duct, as shown on Plate 2, was lower than that in the roof beam. Subsequent strain observations in this area have indicated that restraint by the adjacent internal walls has a significant effect on the observed strains, so that due to unreliability of the in situ steel strain measurements, a meaningful comparison with the concrete stress measurements (OC-50 and OC-51) is not possible.
