## THOROLD TUNNEL

Investigations to Determine the  
Cause of Cracking in the Structure

Supplementary Report No.1  
West Service Building

May 1972

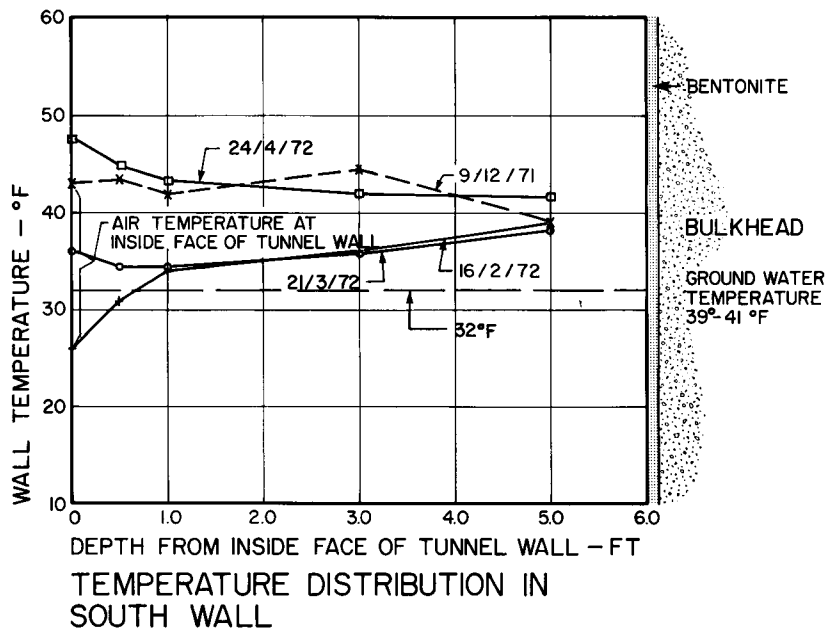
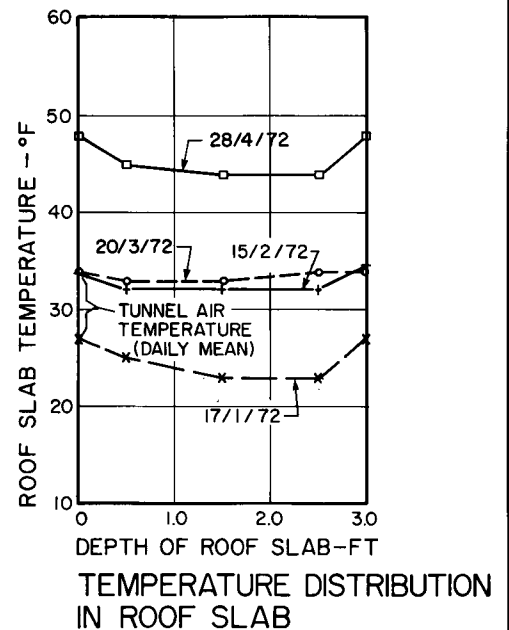
PLATE  
2

The results of additional stress measurements carried out in April 1972 are shown on Plate 1. Stress measurements made in October 1971 are shown on Plate 2. Continuing observations on deformations of the west service building and temperature are given on Plates 3 and 4.
