WP #174-61

OVERPASS

W.A. TROW & ASSOC. LTD.			
FOUNDATION INVESTIGATION			
PROPOSED CROSSING AT HIGHWAY NO 401 E.B.L. LINE 'G' AND ROCKPORT RD. LINE 'A'			
PROJECT NO 1967	W.P. NO 174-61	DATE NOV. 1962.	DWG. 1.

Re: Foundation Conditions - Rockport Road Overpass  
Hwy. 401, W.P. 174-61 - 1

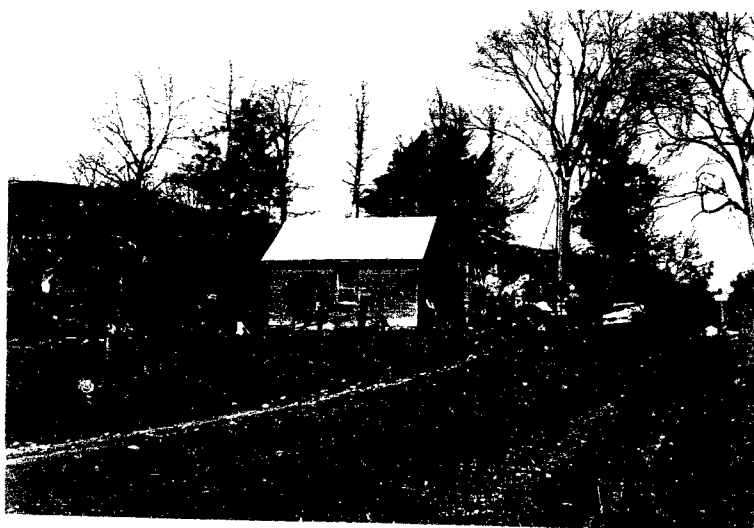
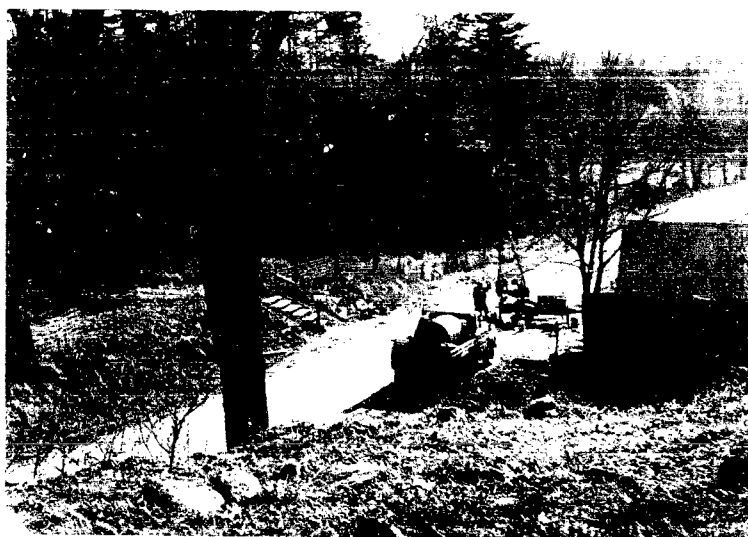
View From the Northwest  
Drill on Hole 2

Bedrock was proven in hole 2 for a depth of 10 feet. Extremely hard granite to granite gneiss was encountered. It contained many weathered seams and joints. Poor recovery was obtained in the second drill run from 20 to 25 feet, despite the fact that the machine was on pressure at all times and full water return was noted. The core in this run was badly broken.
