COLLINS BAY

FAILURE AREA

Re: Collins Bay Failure Area,
Hwy. #33, near Kingston,
Cont. 60-129 - Dist. #8.

COLLINS BAY FAILURE AREA
HWY. #33, NEAR KINGSTON,
CONT. 60-129, DISTRICT #8.

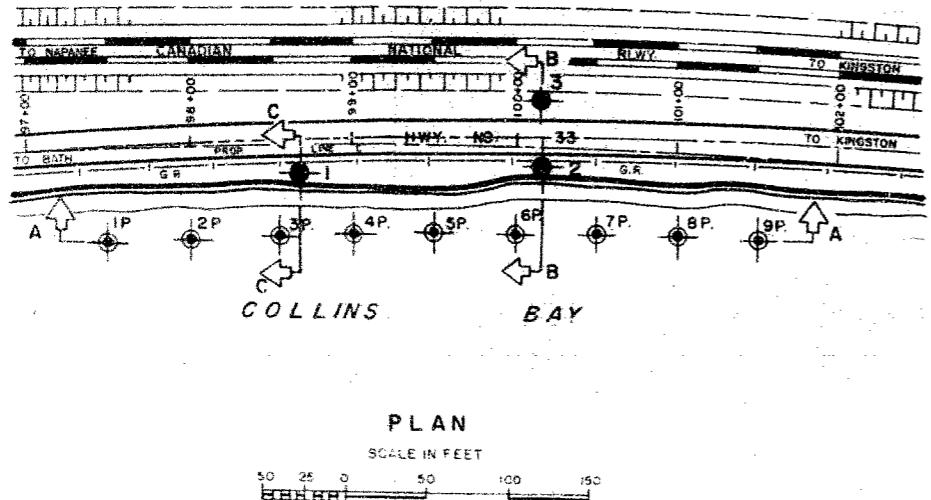
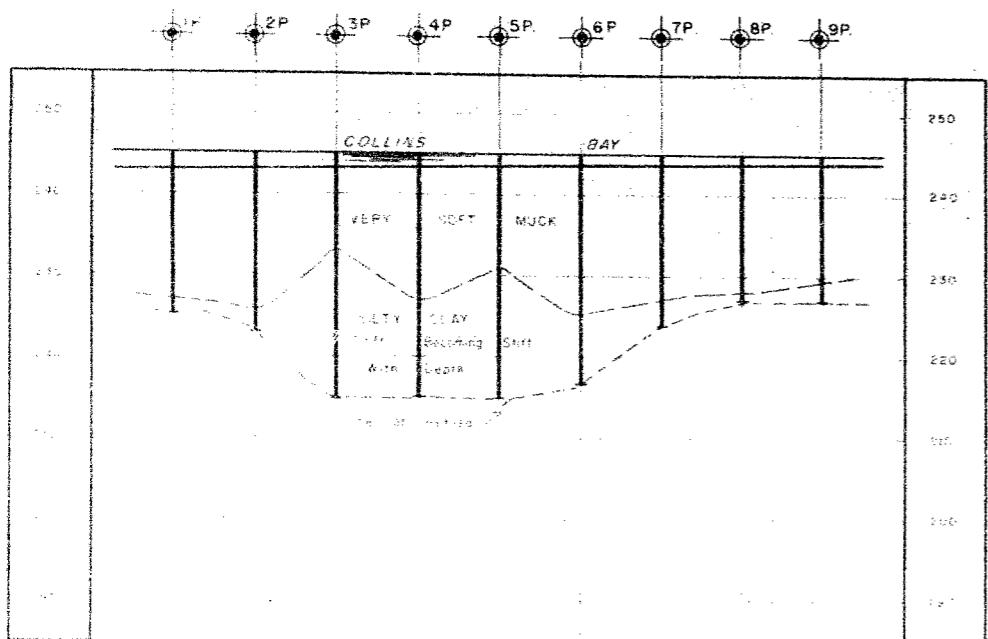
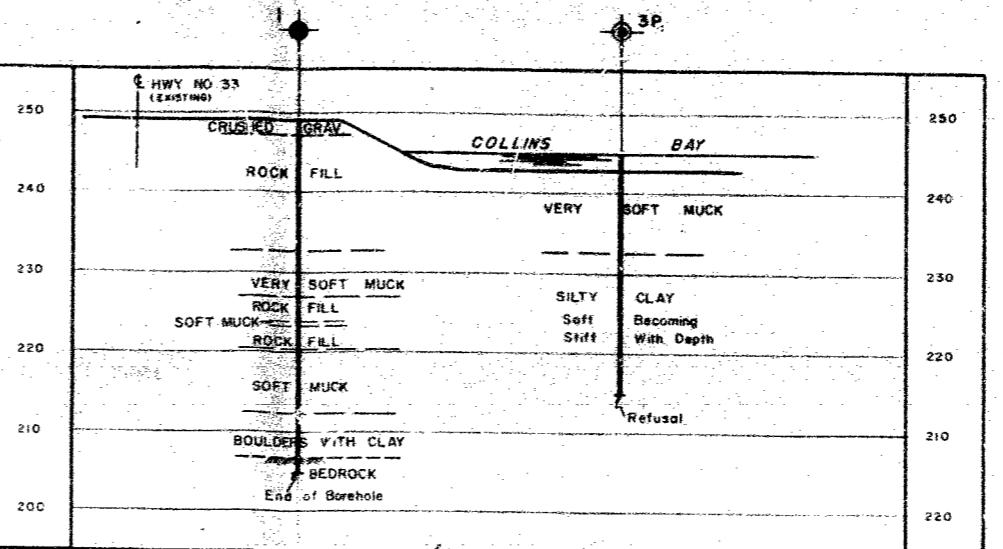
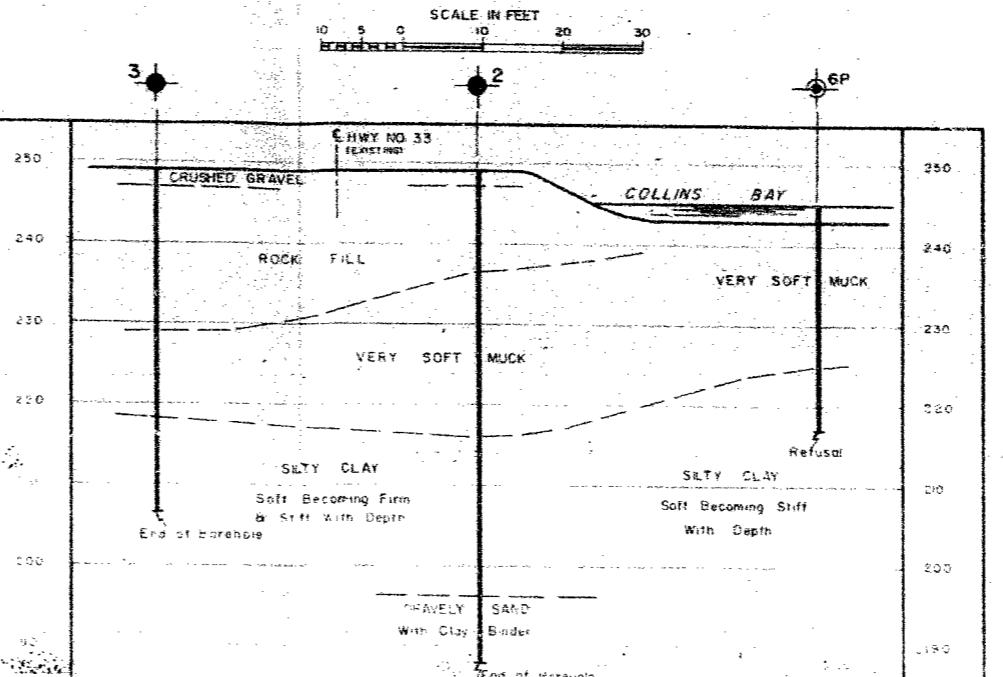
COLLINS BAY FAILURE AREA HWY. NO. 33

Cross section B-B is perpendicular to the road's centre line and encompasses two diamond drill boreholes - No. 3 and 2) and one power auger borehole (No. 6P). There the difference in thickness of rock fill and very soft compressible muck is obvious. A more equalized condition is to be expected under the area of borehole 3 than 2. Apart from that, the very soft muck in the area of borehole 6P provides only little lateral support and therefore, movements in this direction are explainable.

Cross section C-C, being also at right angle to the road's centre line, encompasses one diamond drill borehole - (No. 1) and one power auger hole (No. 3P). No borehole was put down on the north side of the road which is performing satisfactorily. The diamond drill borehole has revealed a very irregular stratification which resulted from only a partial displacement of the soft muck by the rock fill. Here again, due to the presence of trapped muck and small lateral support, the appearance of cracks can be explained.
