Technical Memorandum

Subject: Permanent Remediation of Cut Slope Instabilities on Highway 89 near 5th Line, Essa Township.
W.O. 2012-11010
GEOCRES No. 31D-537

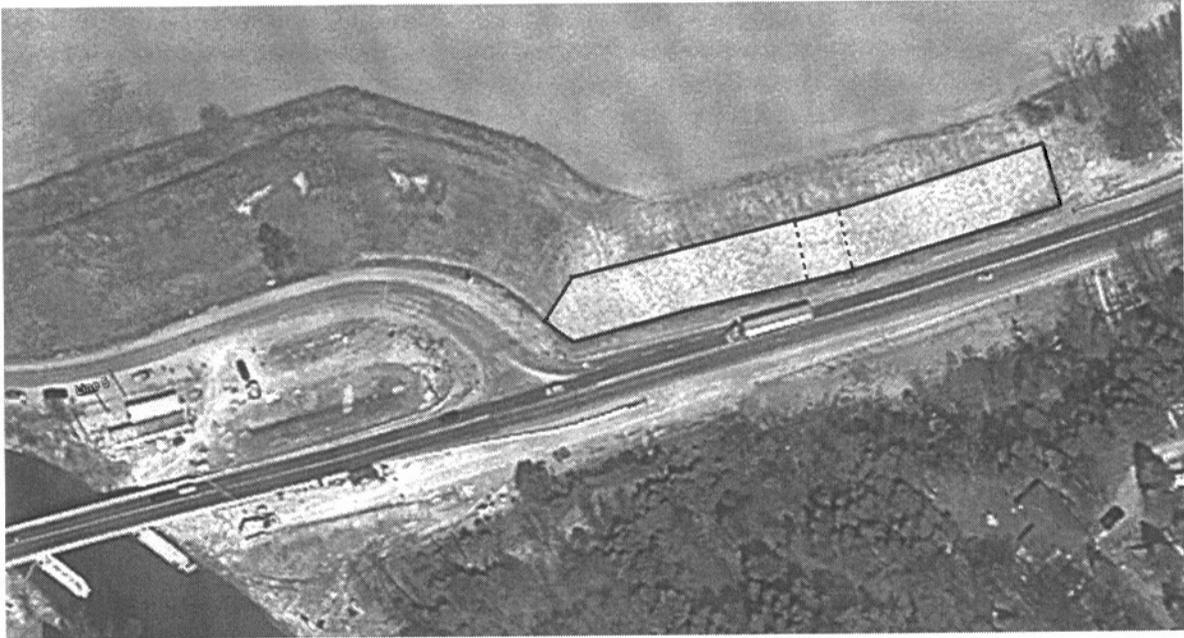
Figure 1: Location of Cut Slope Instability

perspective. The slope instability was observed to be approximately 75 m east of the intersection of Highway 89 and 5th line, which coincides with the middle of the portion where riprap is present. The location of instability is approximately shown with dotted lines in Figure 1. Figures 2 to 4 show some views from the slope instability. Sand bags had been placed to control the run-off from the slope by the contractor after the incidence took place. However, they were not observed to efficiently control the run off (see Figure 5).
