CONTRACT 68-123

H.W.Y. #516 (FAILURE)

MEMORANDUM

Failure of Hwy. 516 at Utterson Lake
Contract 68-123 -- W.J. 69-F-69

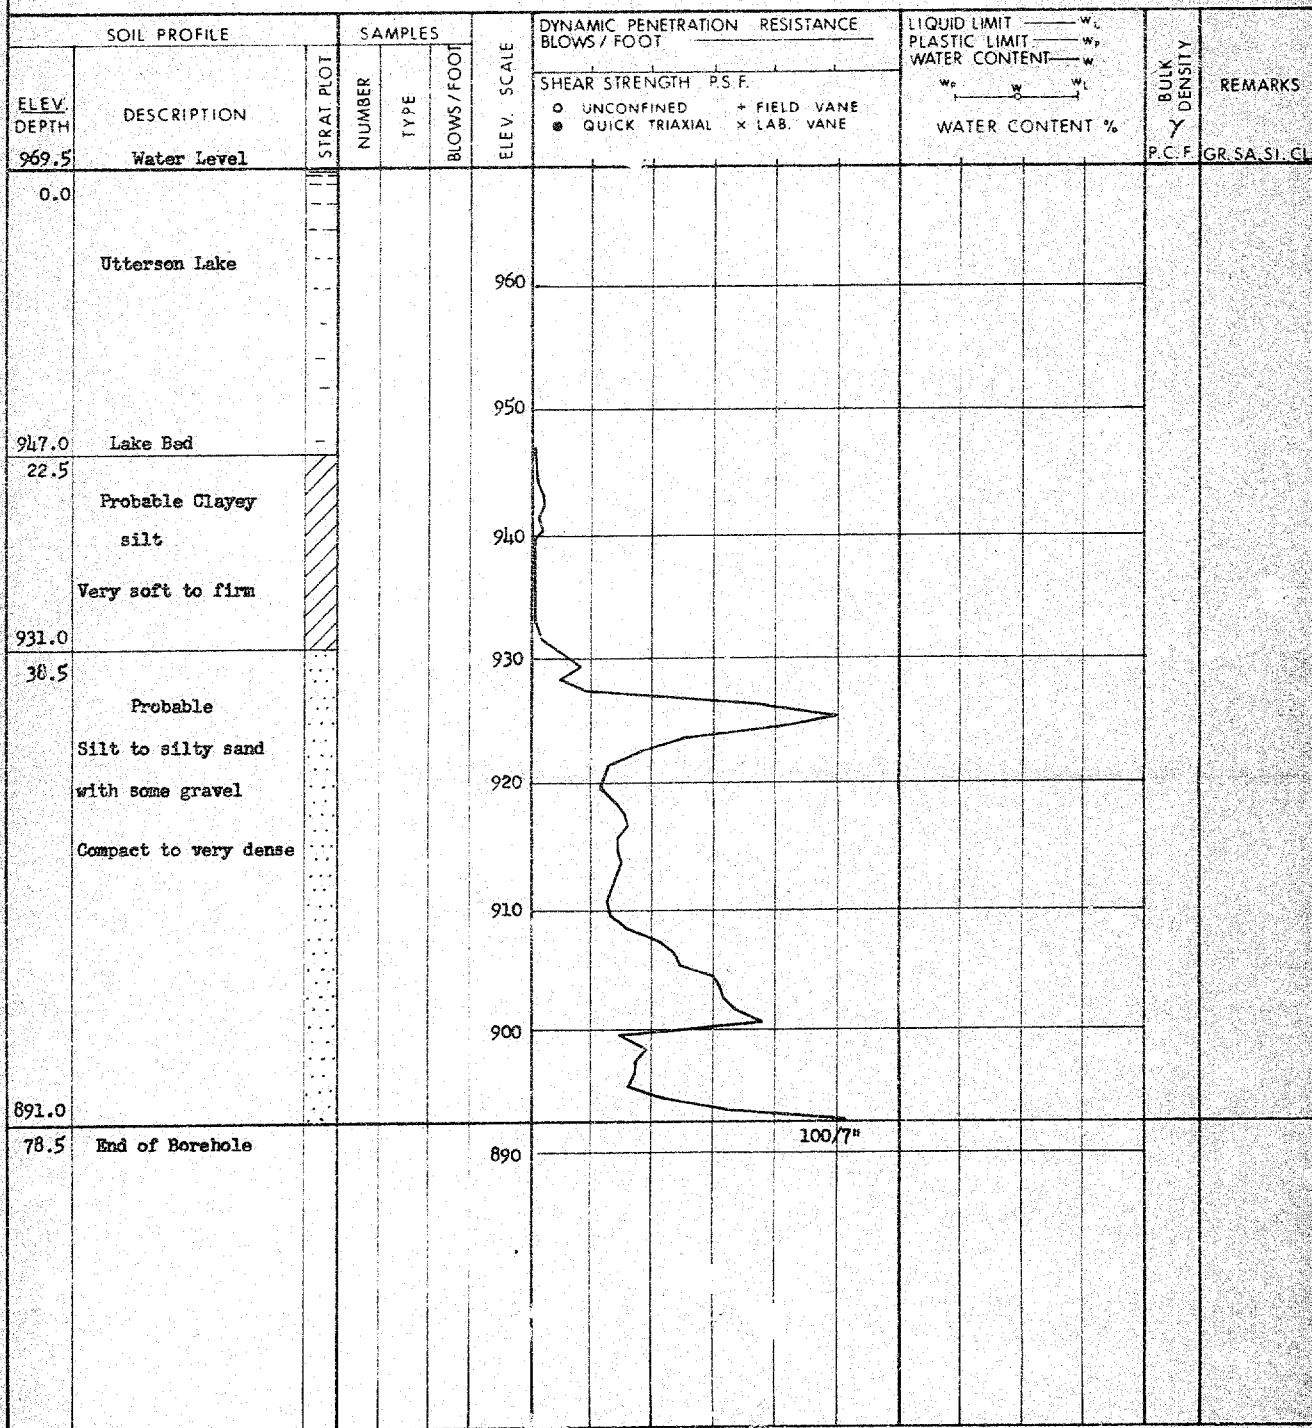
JOB 69-P-69 LOCATION Sta. 123 + 50 o/s 92' Lt. 6 ORIGINATED BY GA
 W.P. BORING DATE August 15, 1969 COMPILED BY GA
 DATUM Geodetic BOREHOLE TYPE Dynamic Cone Penetration CHECKED BY AK

Subsoil was found to consist of from 7 to 15 feet of very soft to soft clayey silt followed by 20 to about 40 feet of loose to very dense silt followed by granite bedrock. The thicknesses of the subsoil layers increase with increasing distance into the lake from the edge. Along the boundary of the failed zone a rock ledge was observed to extend from the east end of the zone to about Station 123+15. At this point B.H. #1 revealed that the rock was about 10 ft. deep, indicating that the projecting ledge was sloping steeply downwards from a point just east of Station 123+15.
