SPECIAL REPORT NO. 81

TITLE Failure of the Approach to the Assatika Creek Bridge

DATE OF REPORT March 23, 1959.

This report presents the test results from three Shelby tube samples and from two field vane borings at the site of a bridge abutment failure on Assatika Creek, 5 miles west of 1st Orignal, Ontario. Based on these tests the stability of the approach fill has been analysed and certain recommendations concerning reconstruction are made.

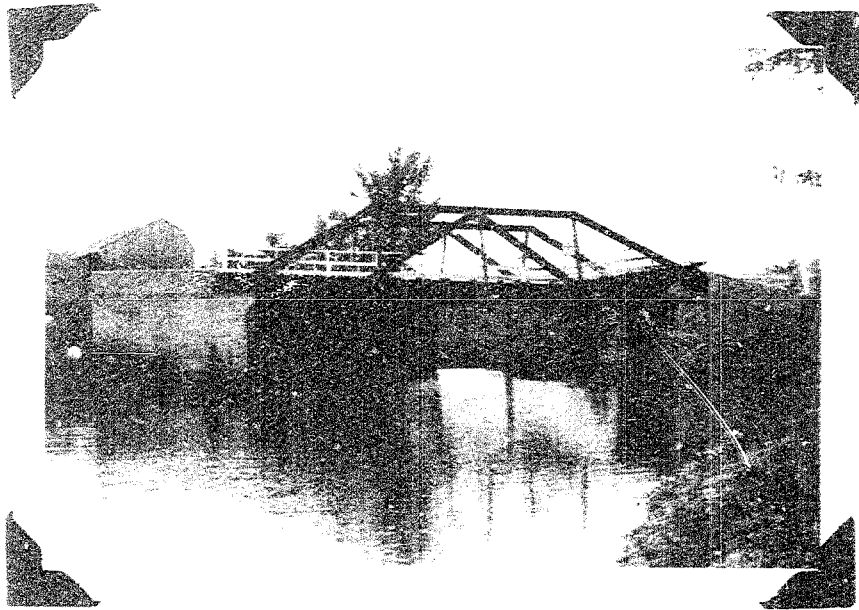
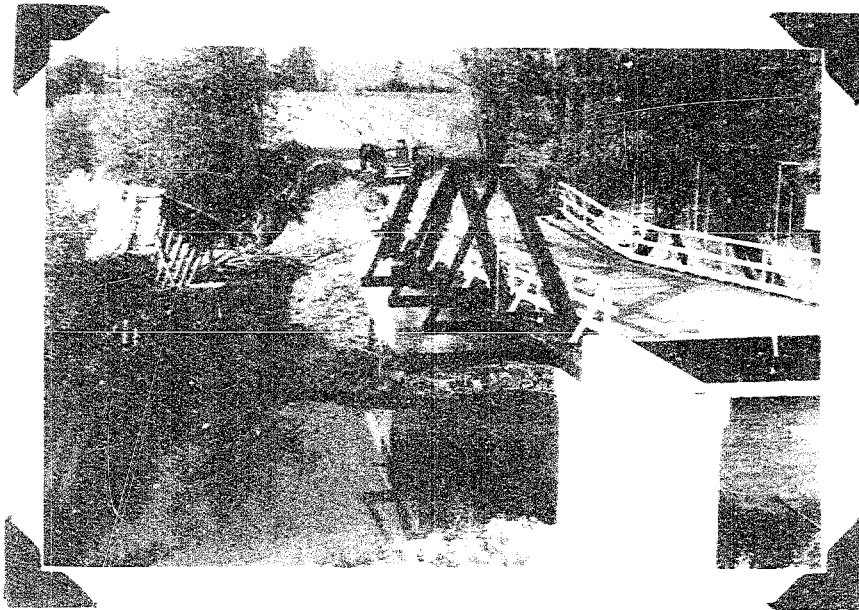
Fig. 1(b) Distortion of old bridge

The abutment failure is shown in Fig. 1(a). The distortion of the old bridge is shown in Fig. 1(b). Figure 2, a contour plan of the north abutment, shows the shift of
