LOCATION Slope Instability
South Bank of Ottawa River

DATE: November 22, 1973.

FOUNDATION INVESTIGATION REPORT
For
Slope Instability, South Bank of
Ottawa River
(Hwy. 17 Between Station 262 and Station 380)
Township of Cumberland
Regional Municipality of Ottawa-Carleton
W.O. 73-11053(X) - W.P. 159-73-01

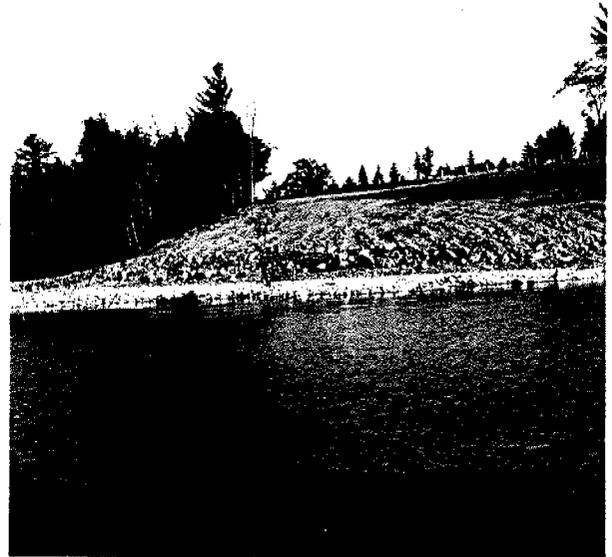
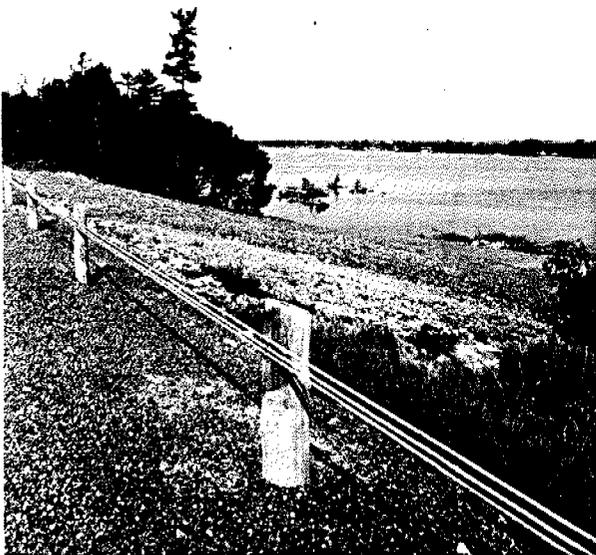
Observations made during August 1973 after the completion of the remedial work, revealed that the slopes were generally satisfactory (Refer Plate No. 5 and No. 6).

PLATE No. 5
STATION 367 TO STATION 370

PLATE No 6
STATION 370 TO STATION 373

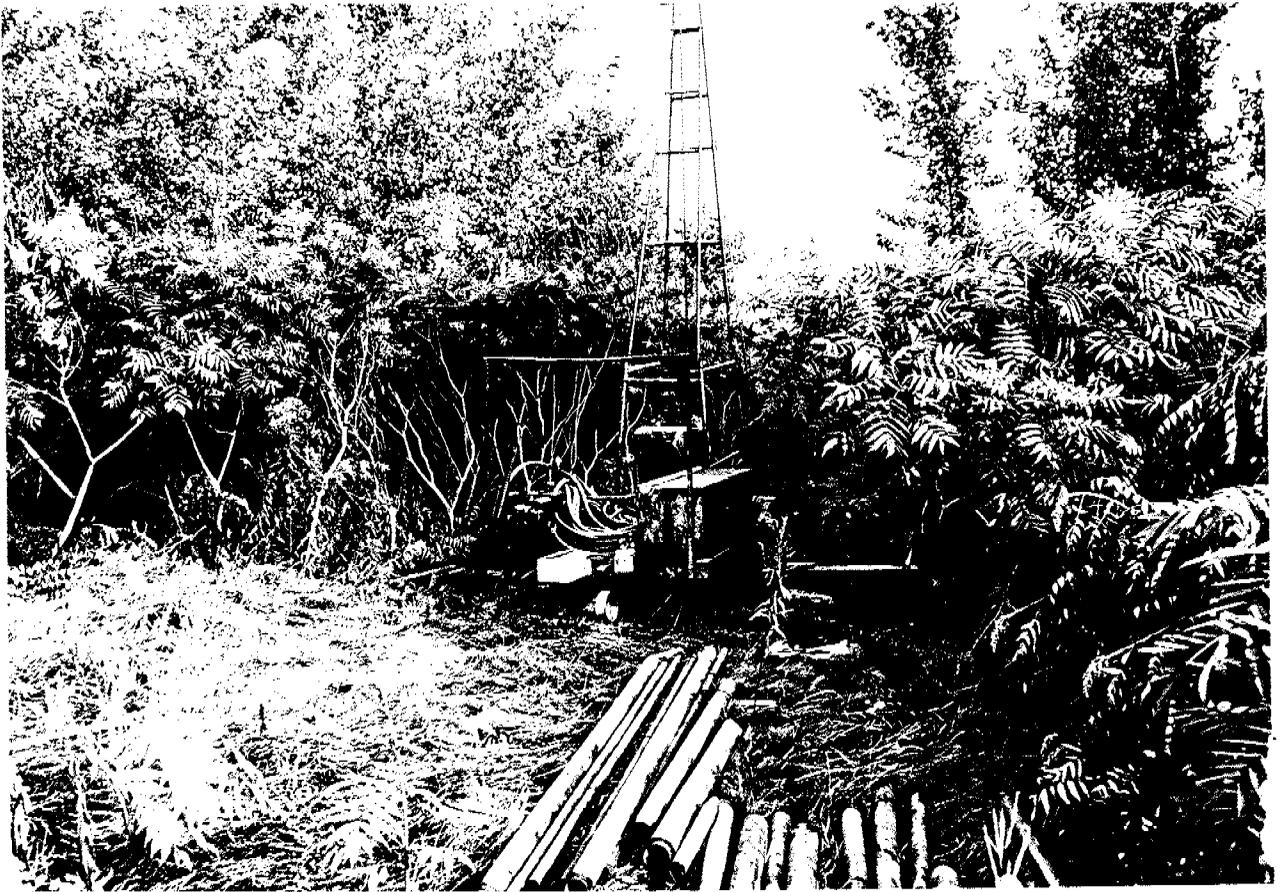
PLATE No. 10 SET UP OF DRILL AT STATION 305

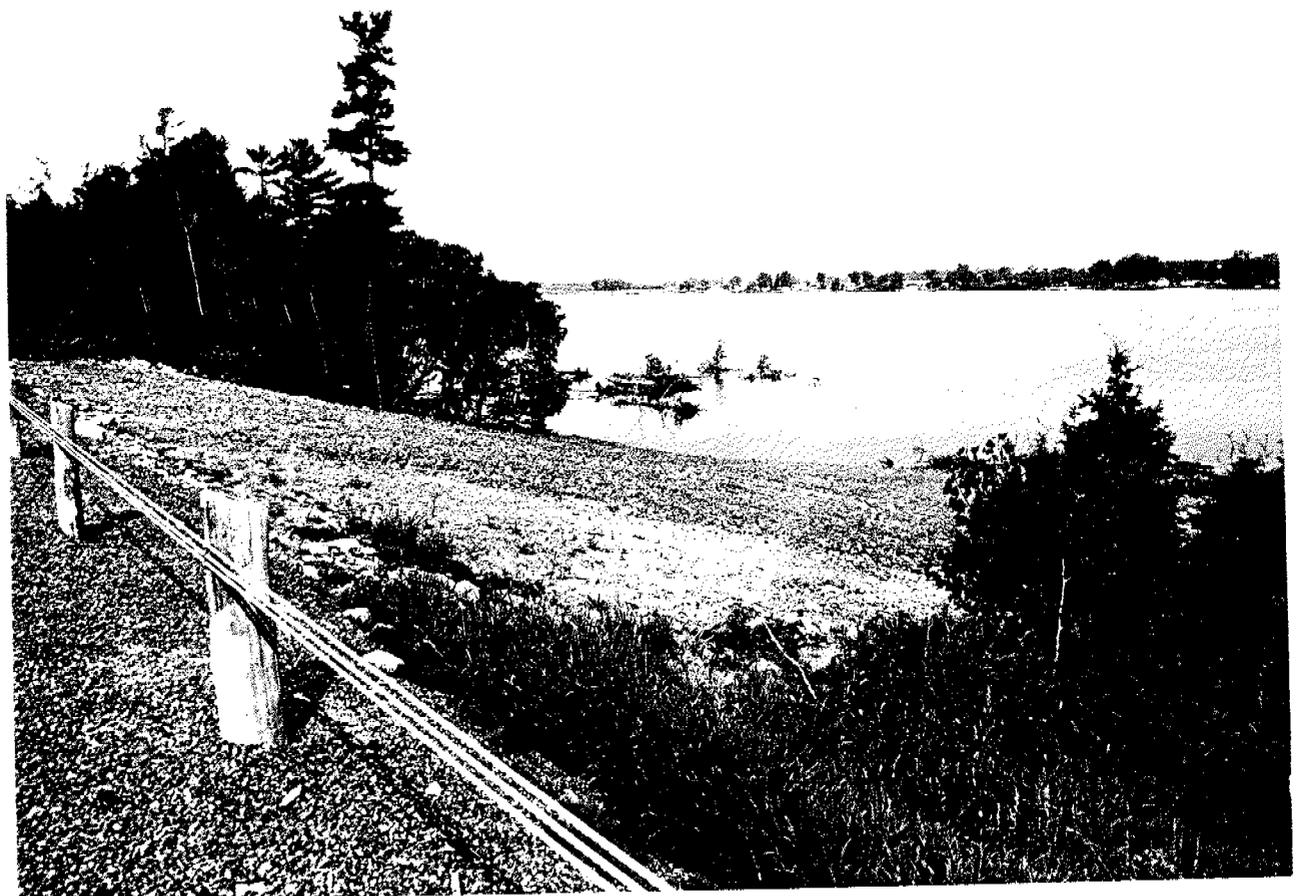
PLATE No. 13 STATION 370 TO STATION 373

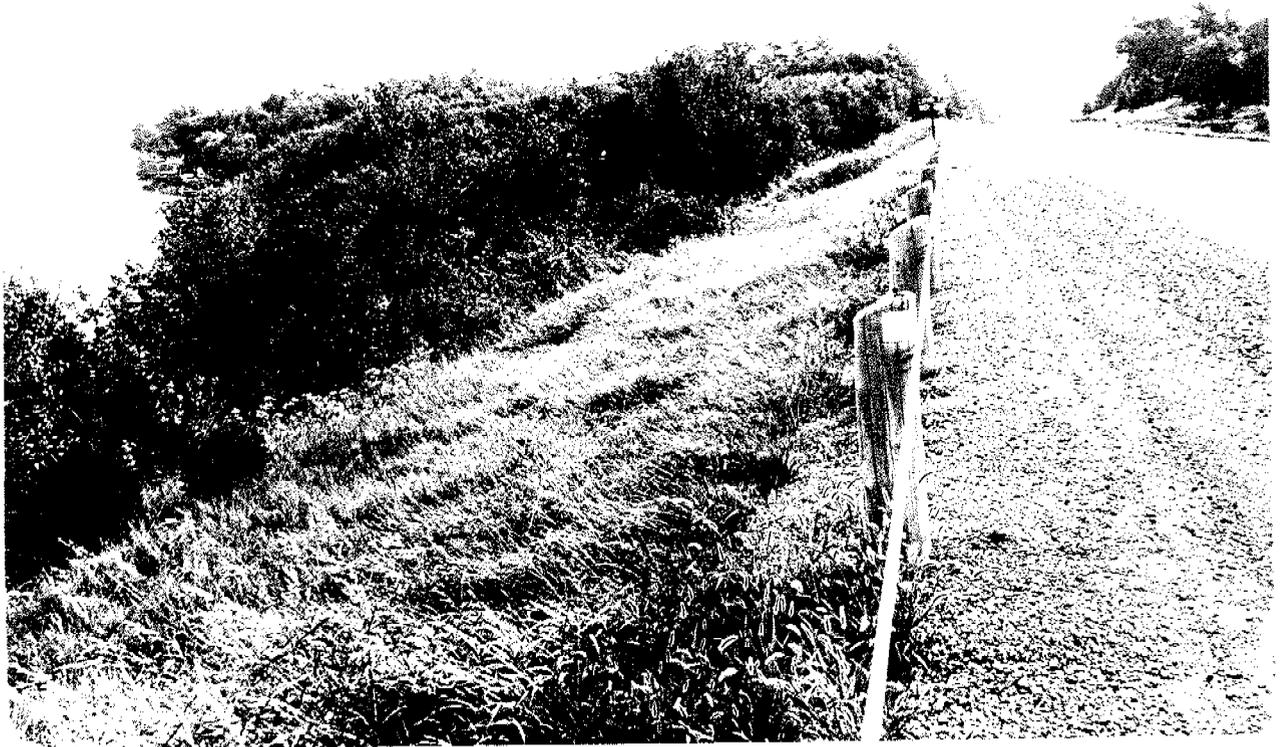
PLATE No.14 GENERAL VIEW BETWEEN STATION 370 & STATION 380

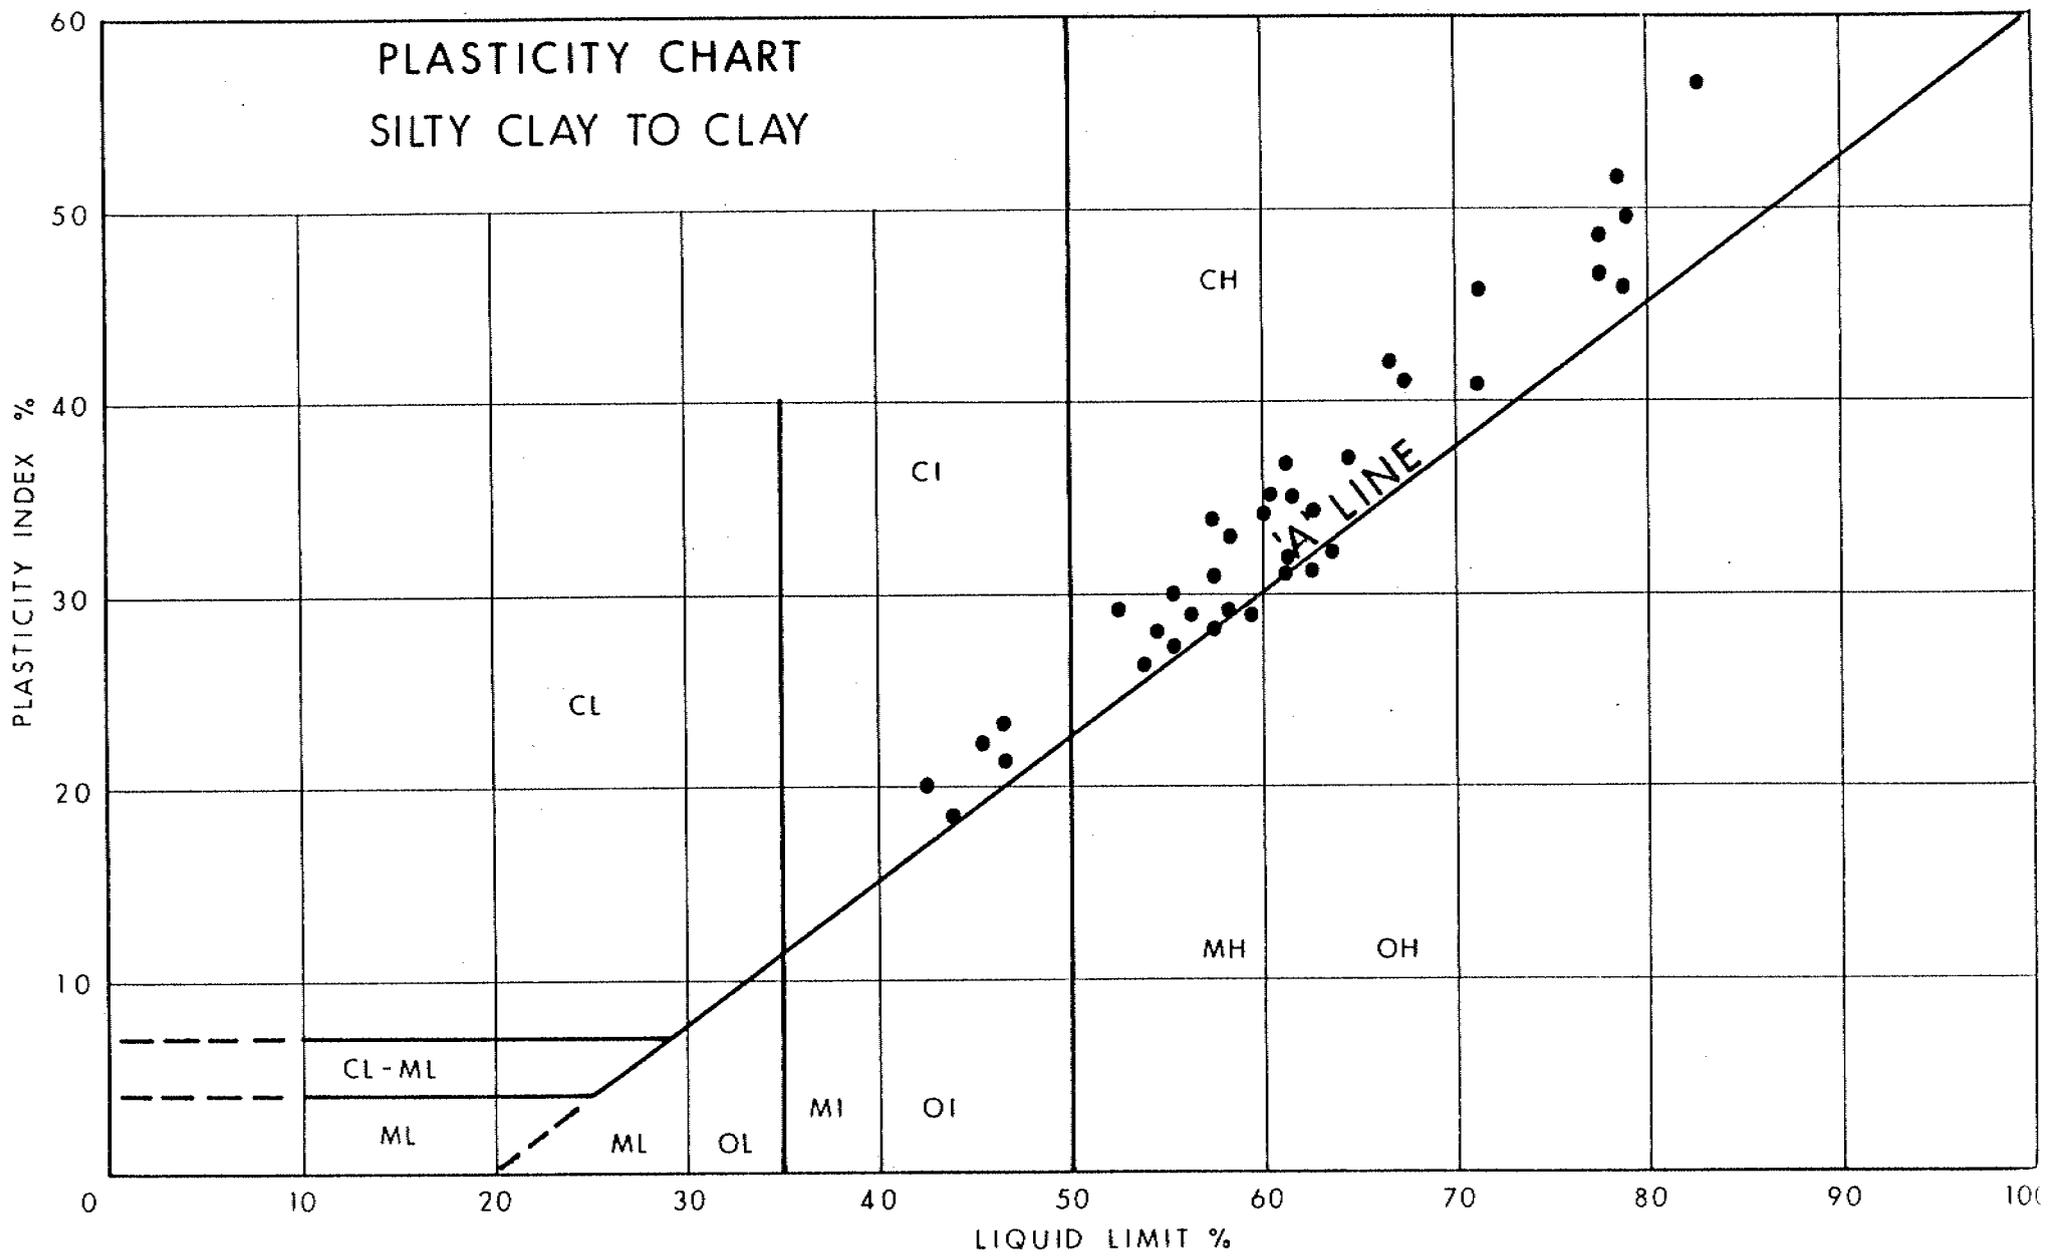
FIG. 4

Atterberg limit tests were carried out on samples of this deposit. The results, which were plotted on the Plasticity Chart (Figure No. 4), indicate that, in general, the clay is inorganic and of intermediate to high plasticity. The natural water content is generally at or higher than the Liquid Limit.

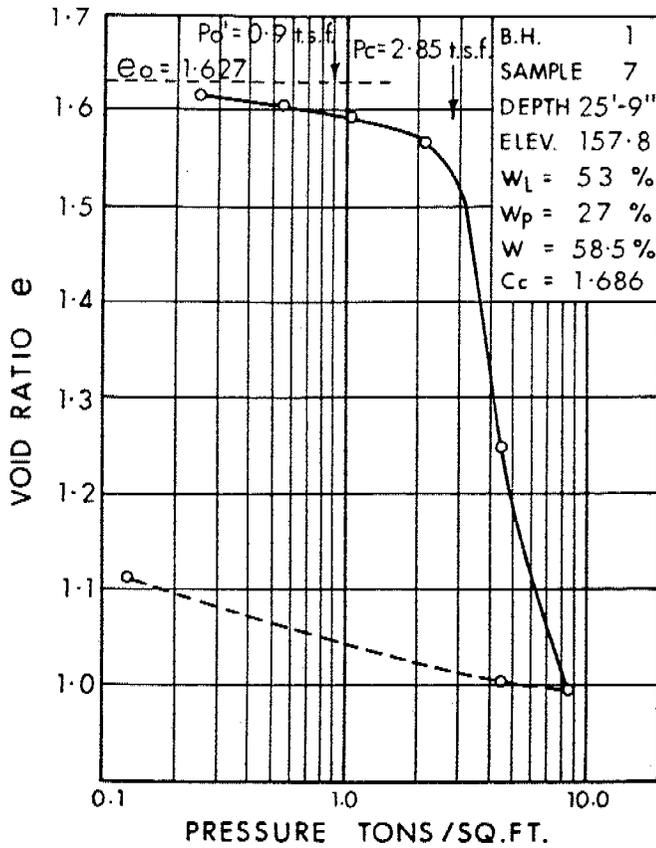
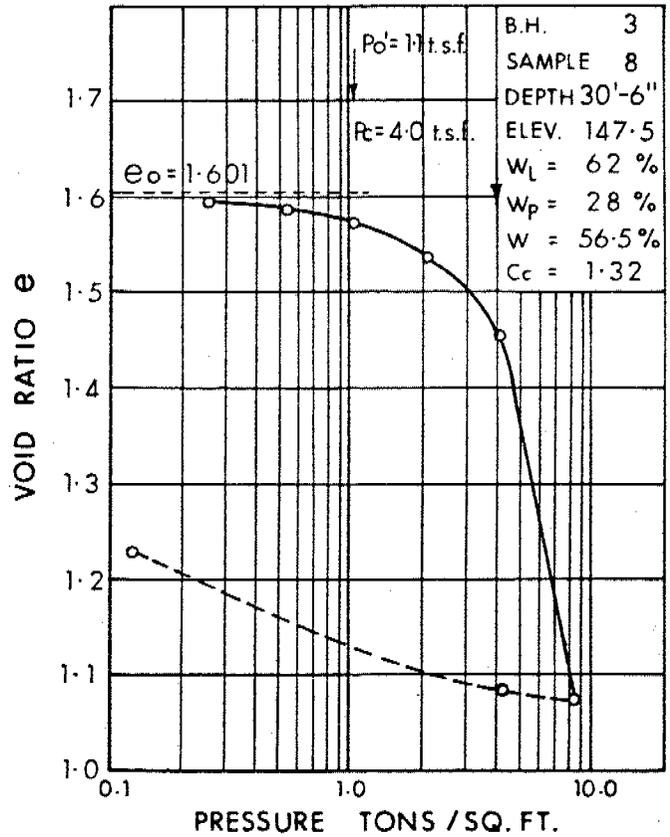
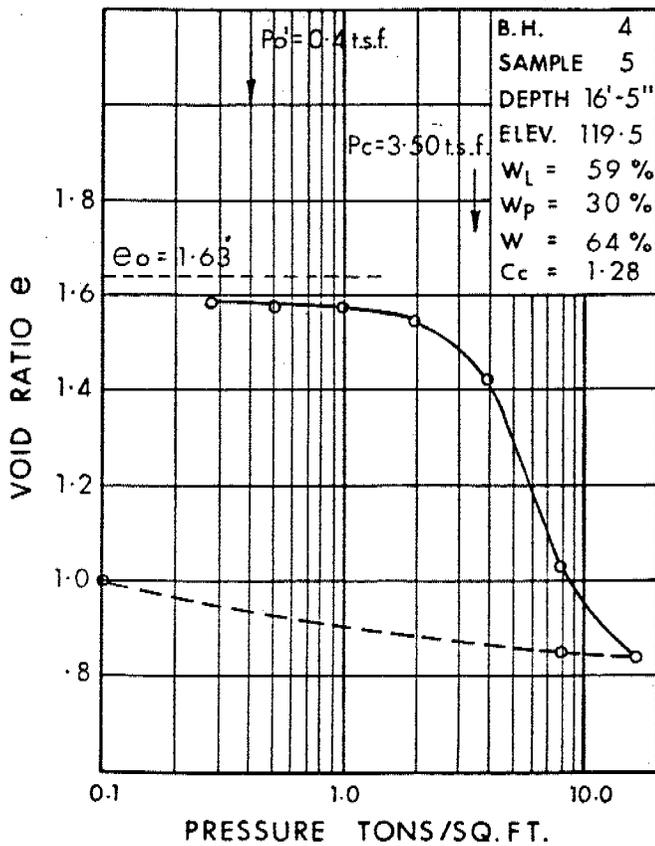
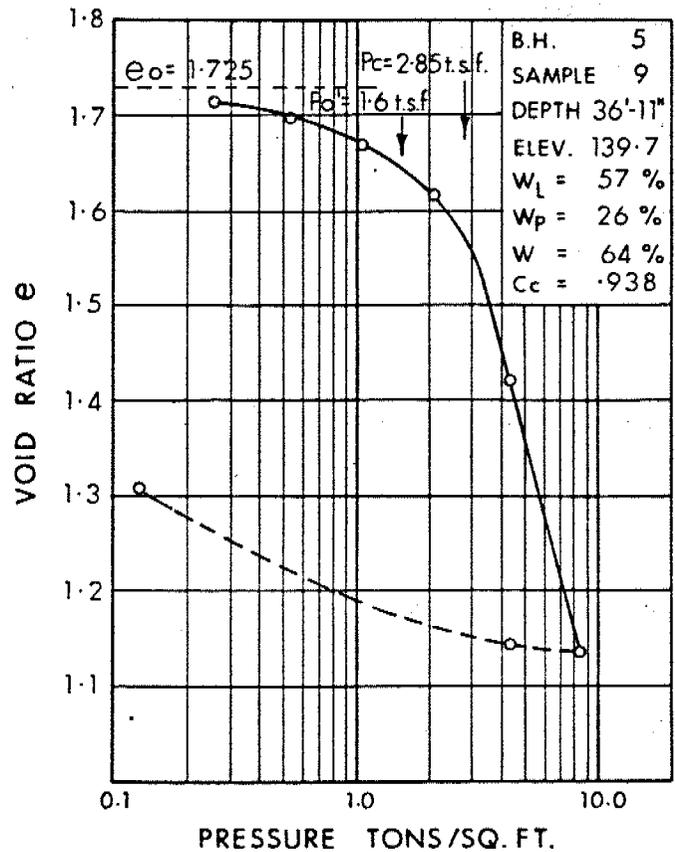
FIG. 5

The consolidation characteristics of the stratum were determined by carrying out four laboratory consolidation tests. The results of this testing, presented on Figure No. 5, indicate that the clay is preconsolidated by about 2,500 to 6,200 p.s.f. in excess of the existing overburden pressure.

VOID RATIO - PRESSURE CURVES

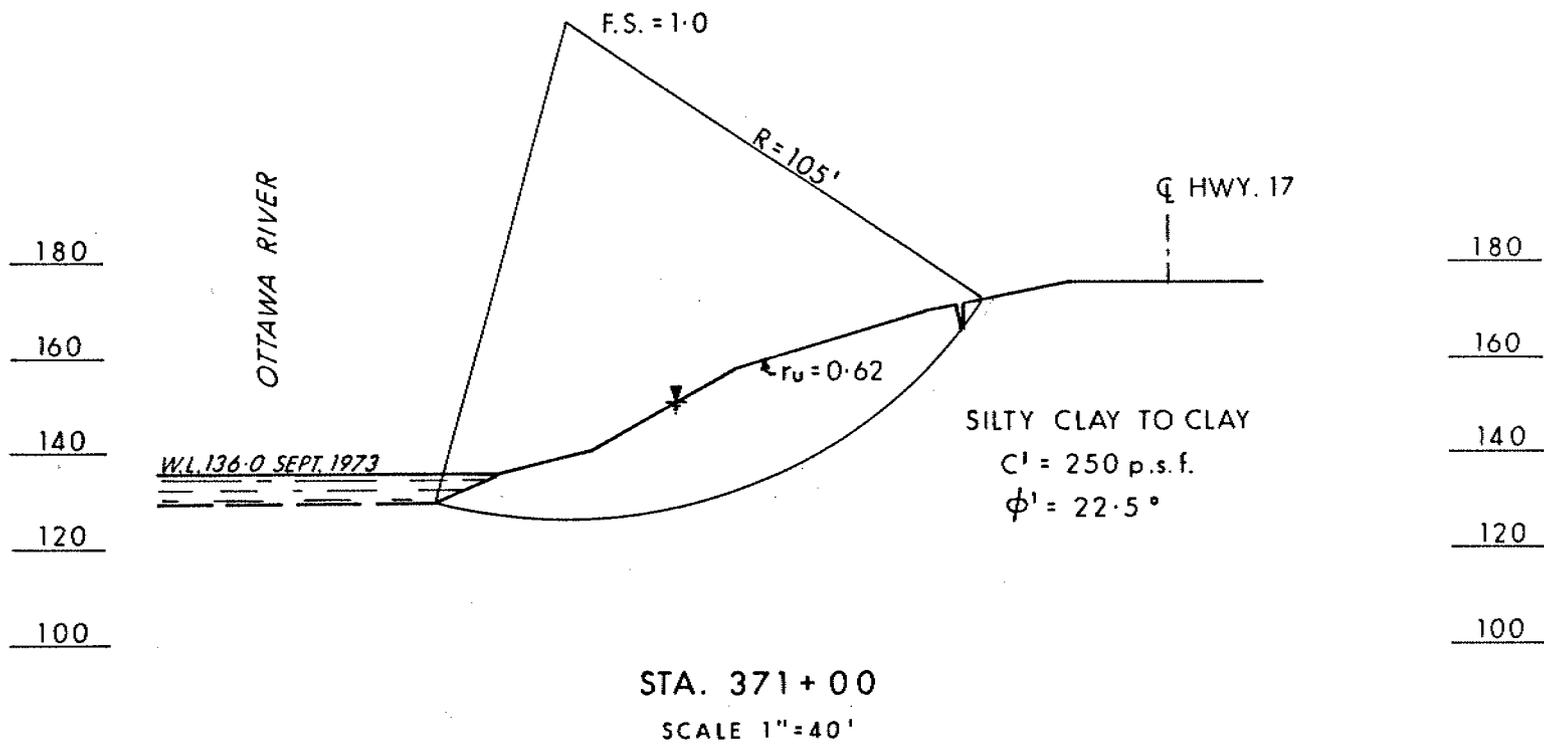
FIG. 16

This portion of the Ottawa River Bank adjacent to Hwy. 17 failed during spring of 1973 after heavy rainfalls. Detailed stability analysis (Figure No. 16 and No. 17) were carried out by this office immediately after the failure and the necessary remedial measures (Figure No. 22 to No. 27) were provided to the Ottawa District. The suggested remedial measures were immediately incorporated. According to our recent field observations, this portion of the river banks appeared to be in a stable condition without any signs of distress.

STABILITY ANALYSIS IN TERMS OF EFFECTIVE STRESS
 (NATURAL SLOPE)

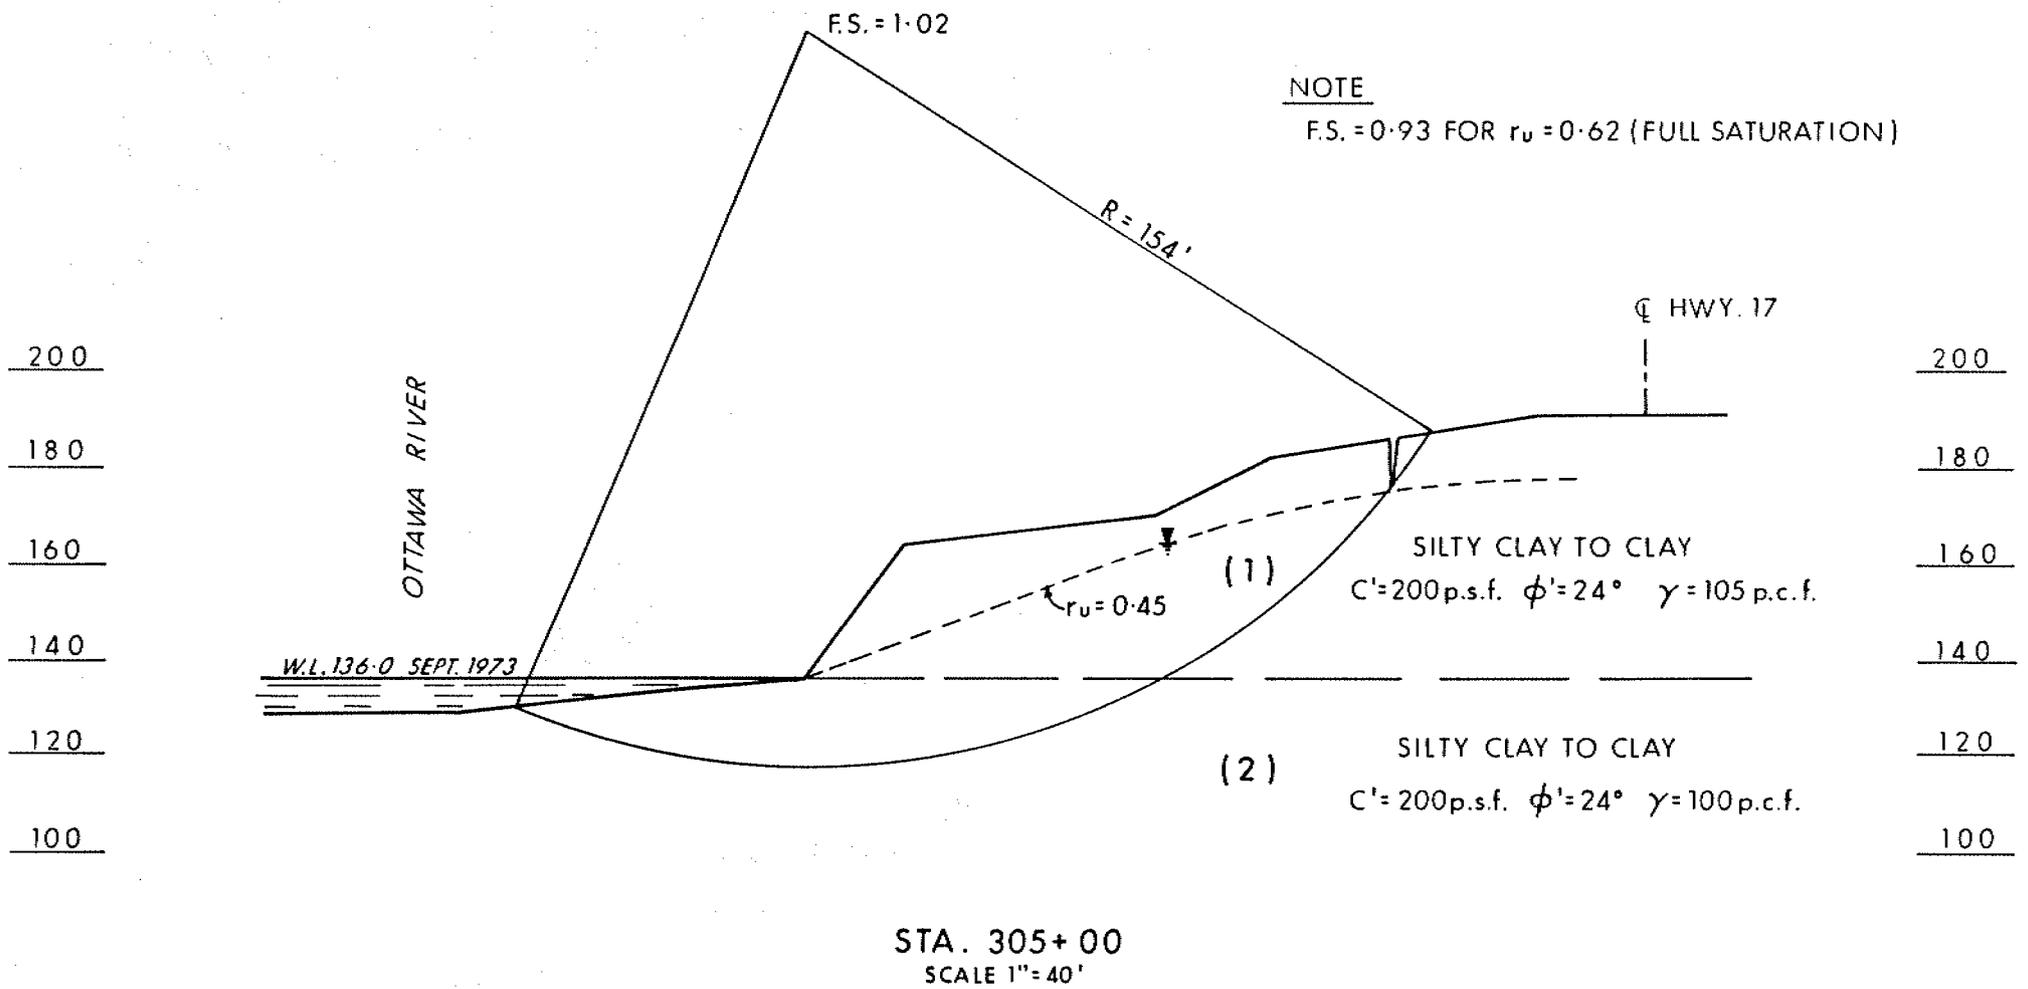
FIG. 18

The results of the stability analysis were shown on Figure No. 18 to 21 inclusive; they are also summarized as follows.

**STABILITY ANALYSIS IN TERMS OF EFFECTIVE STRESS
(NATURAL SLOPE)**

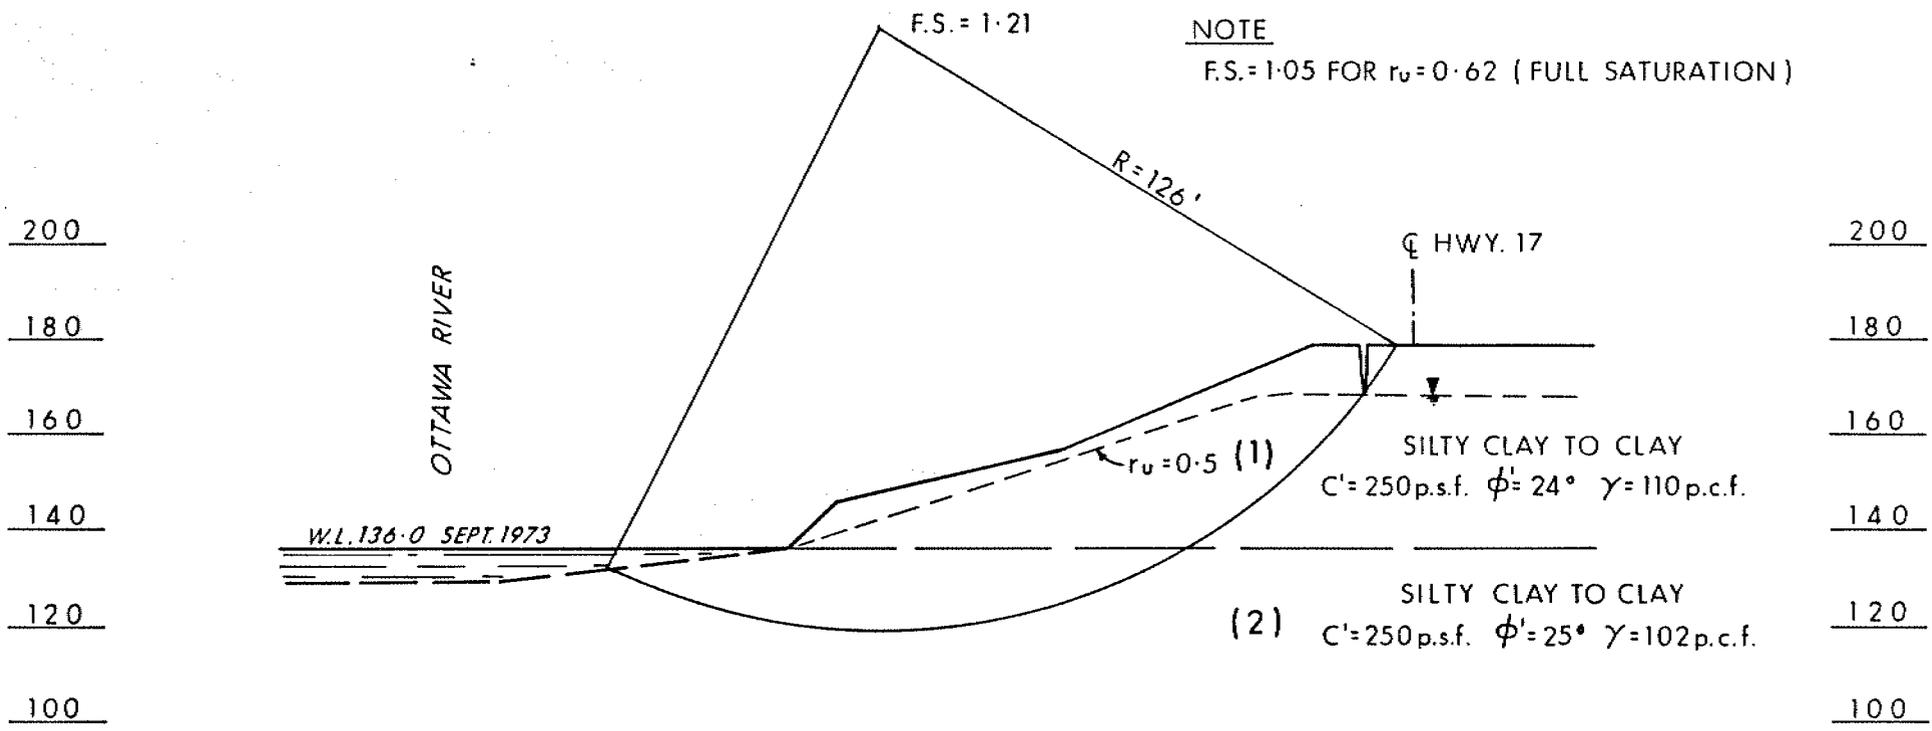
FIG. 19

[✓] Due to the geometry of this section, it is assumed that only the upper slope is fully saturated (Refer to Figure #19)

STABILITY ANALYSIS IN TERMS OF EFFECTIVE STRESS
 (NATURAL SLOPE)

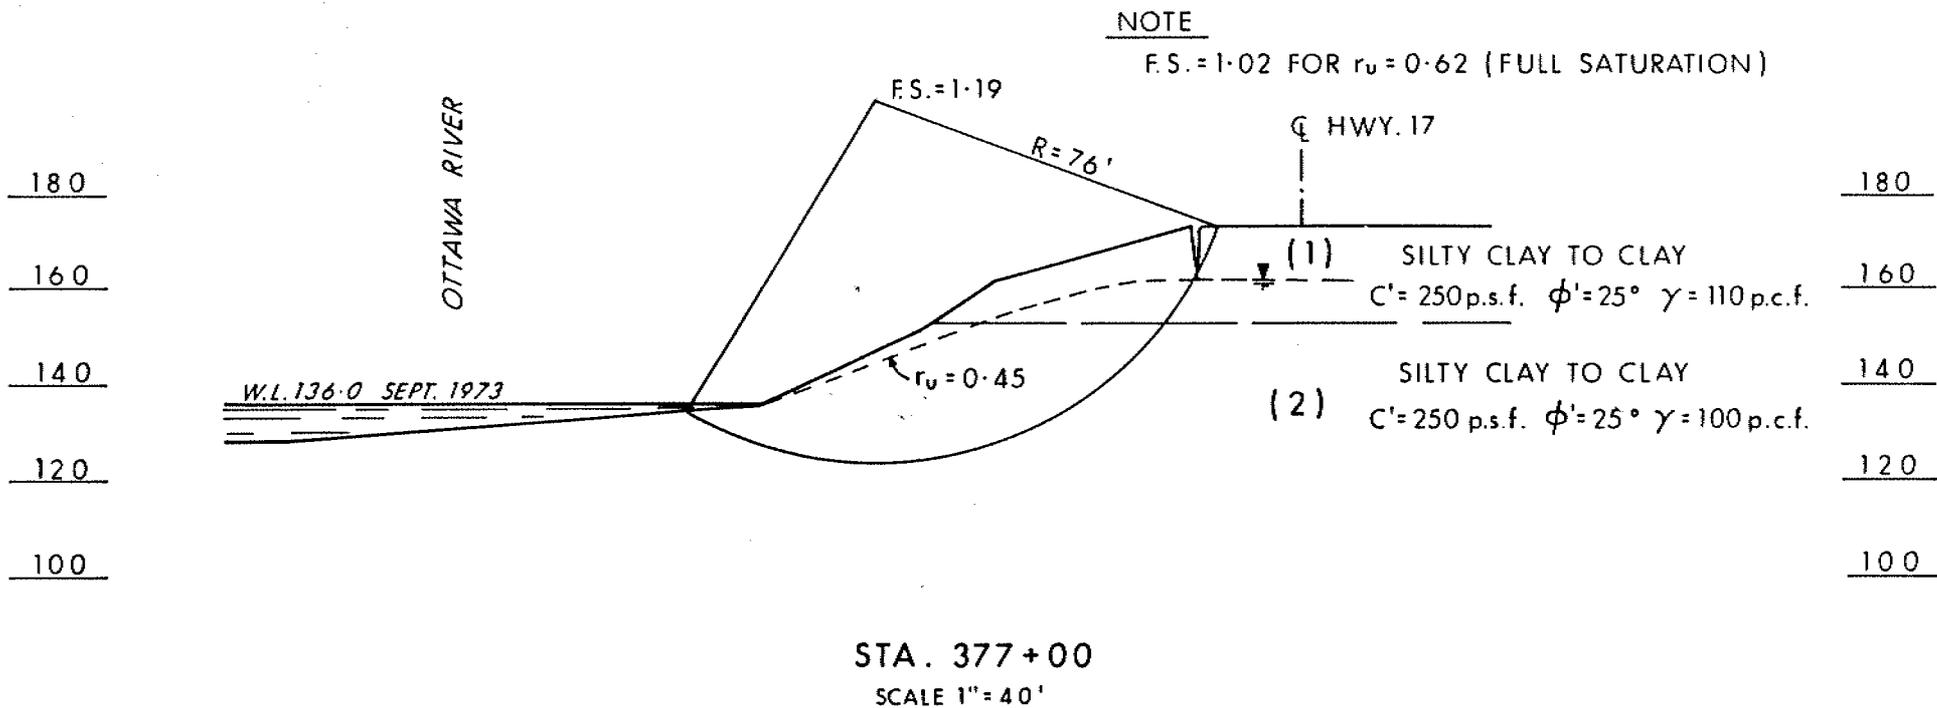
FIG. 20

STABILITY ANALYSIS IN TERMS OF EFFECTIVE STRESS
(NATURAL SLOPE)

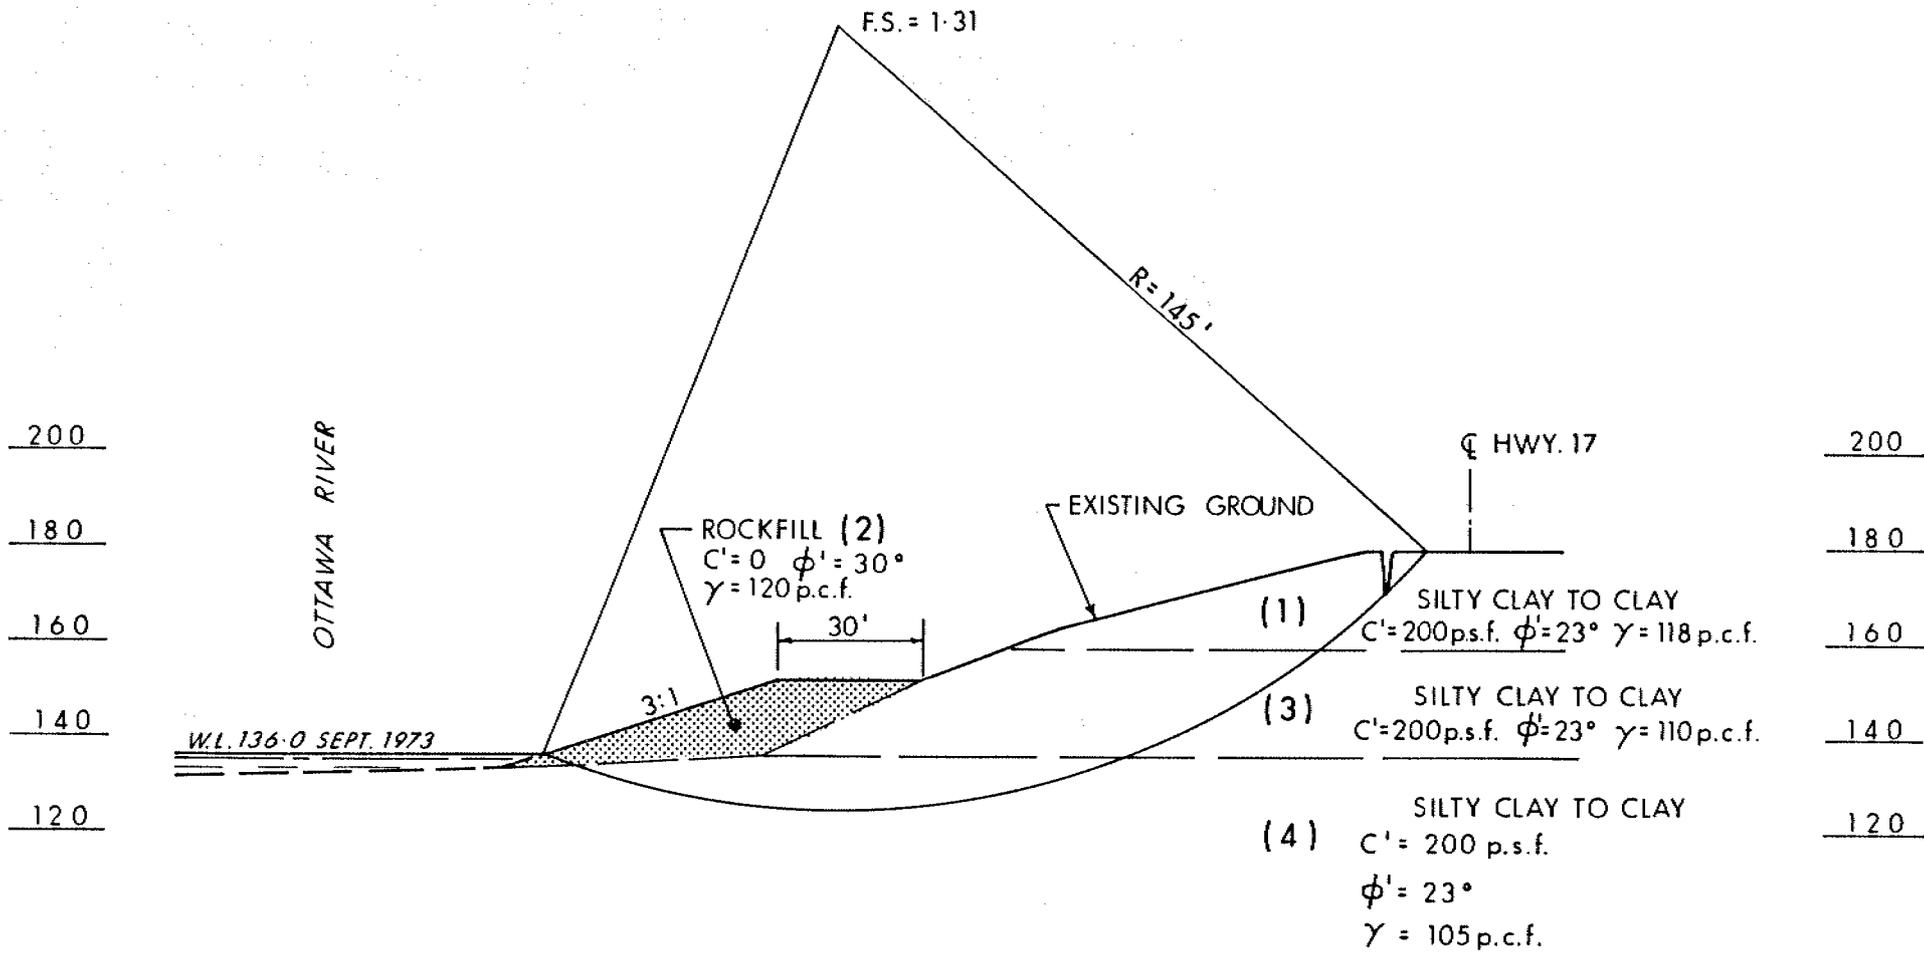
FIG. 28

The stability computations including the soil properties are summarized on Figures No. 28 to No. 31 inclusive and the results are tabulated as follows.

STABILITY ANALYSIS IN TERMS OF EFFECTIVE STRESS
 (REMEDIAL MEASURES)

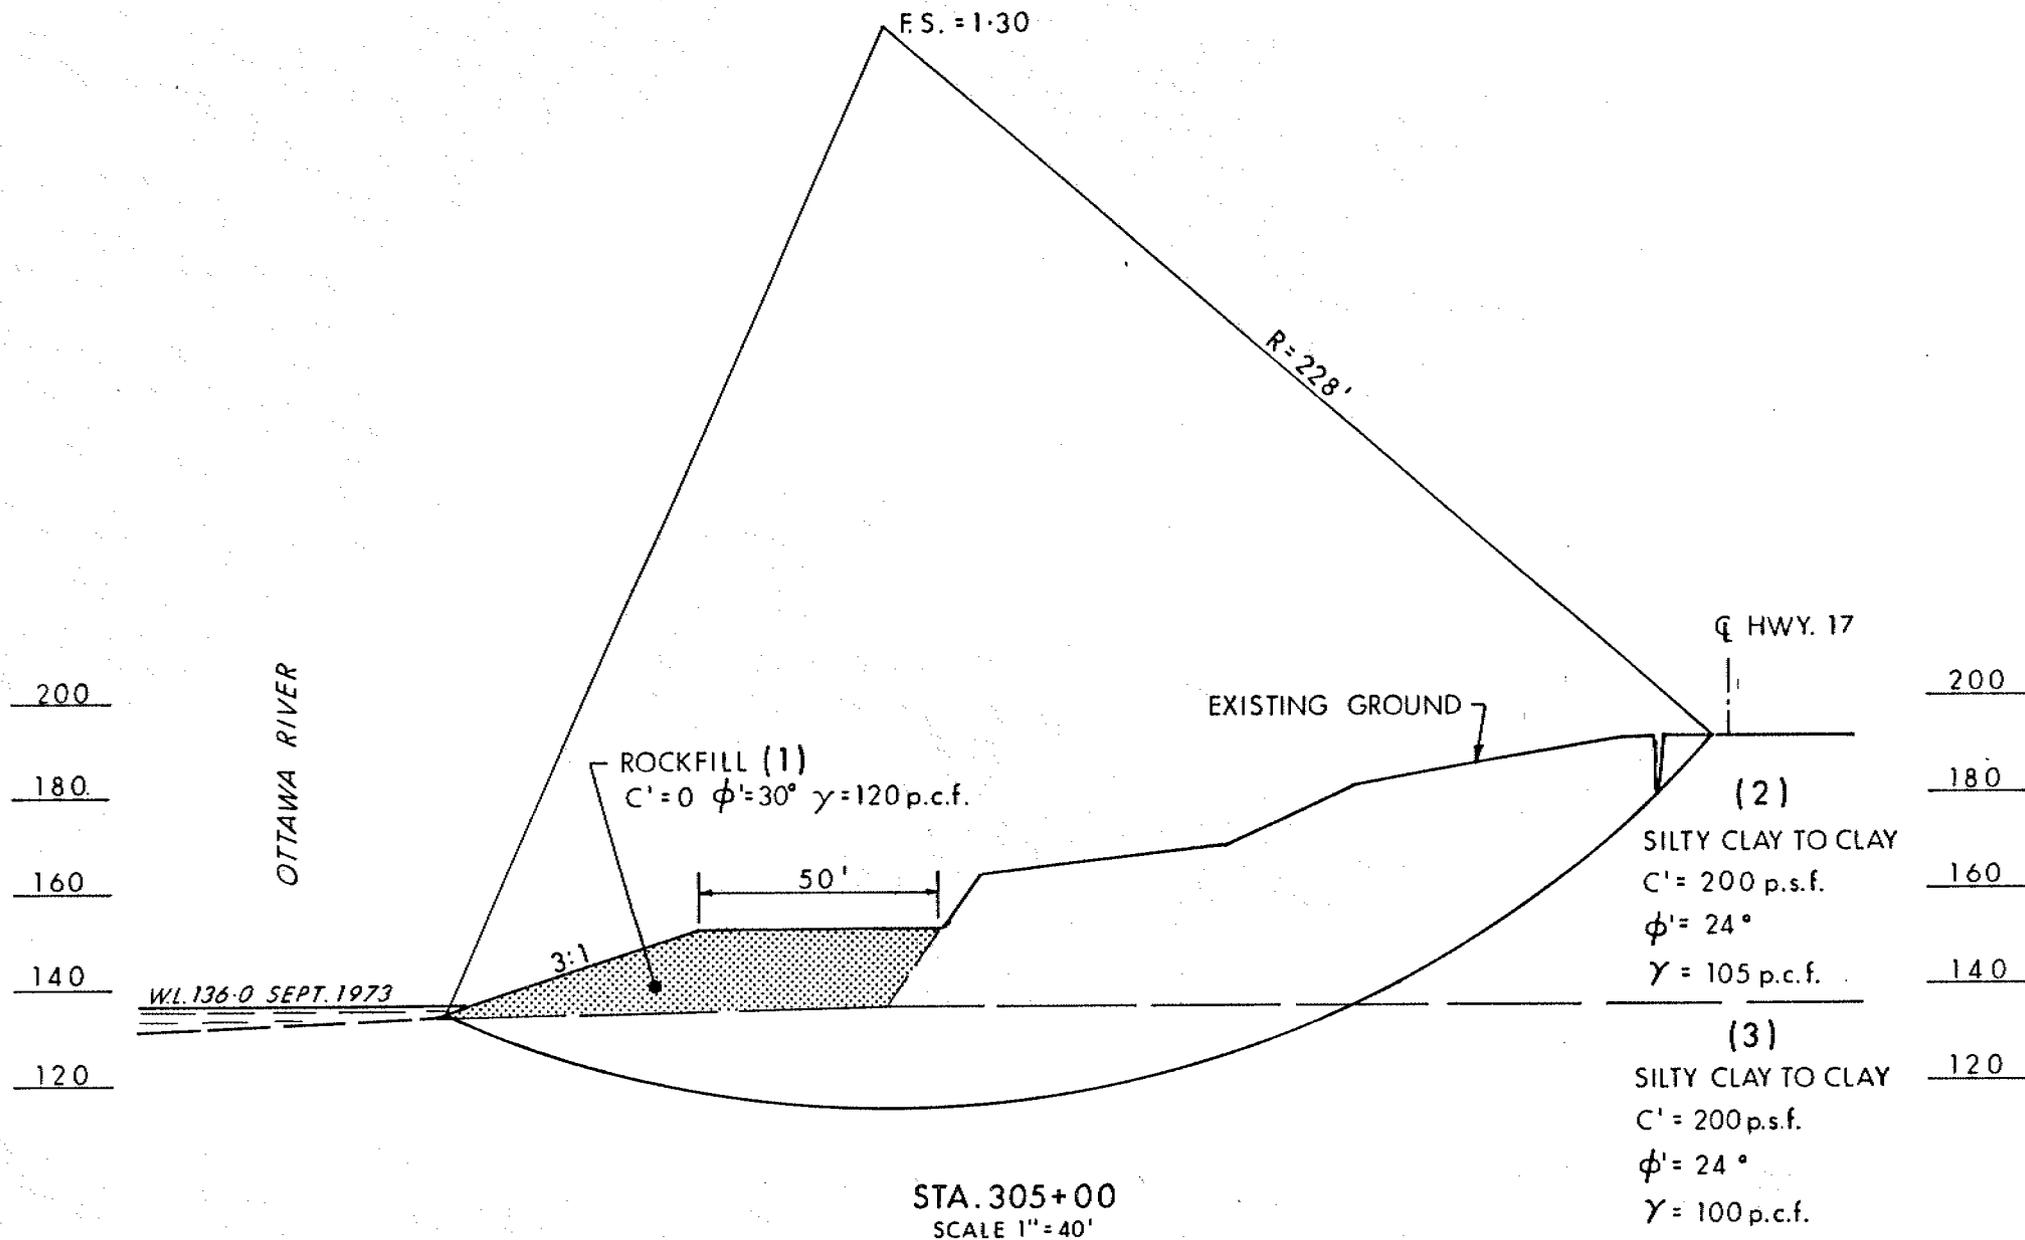
FIG. 29

STABILITY ANALYSIS IN TERMS OF EFFECTIVE STRESS
 (REMEDIAL MEASURES)

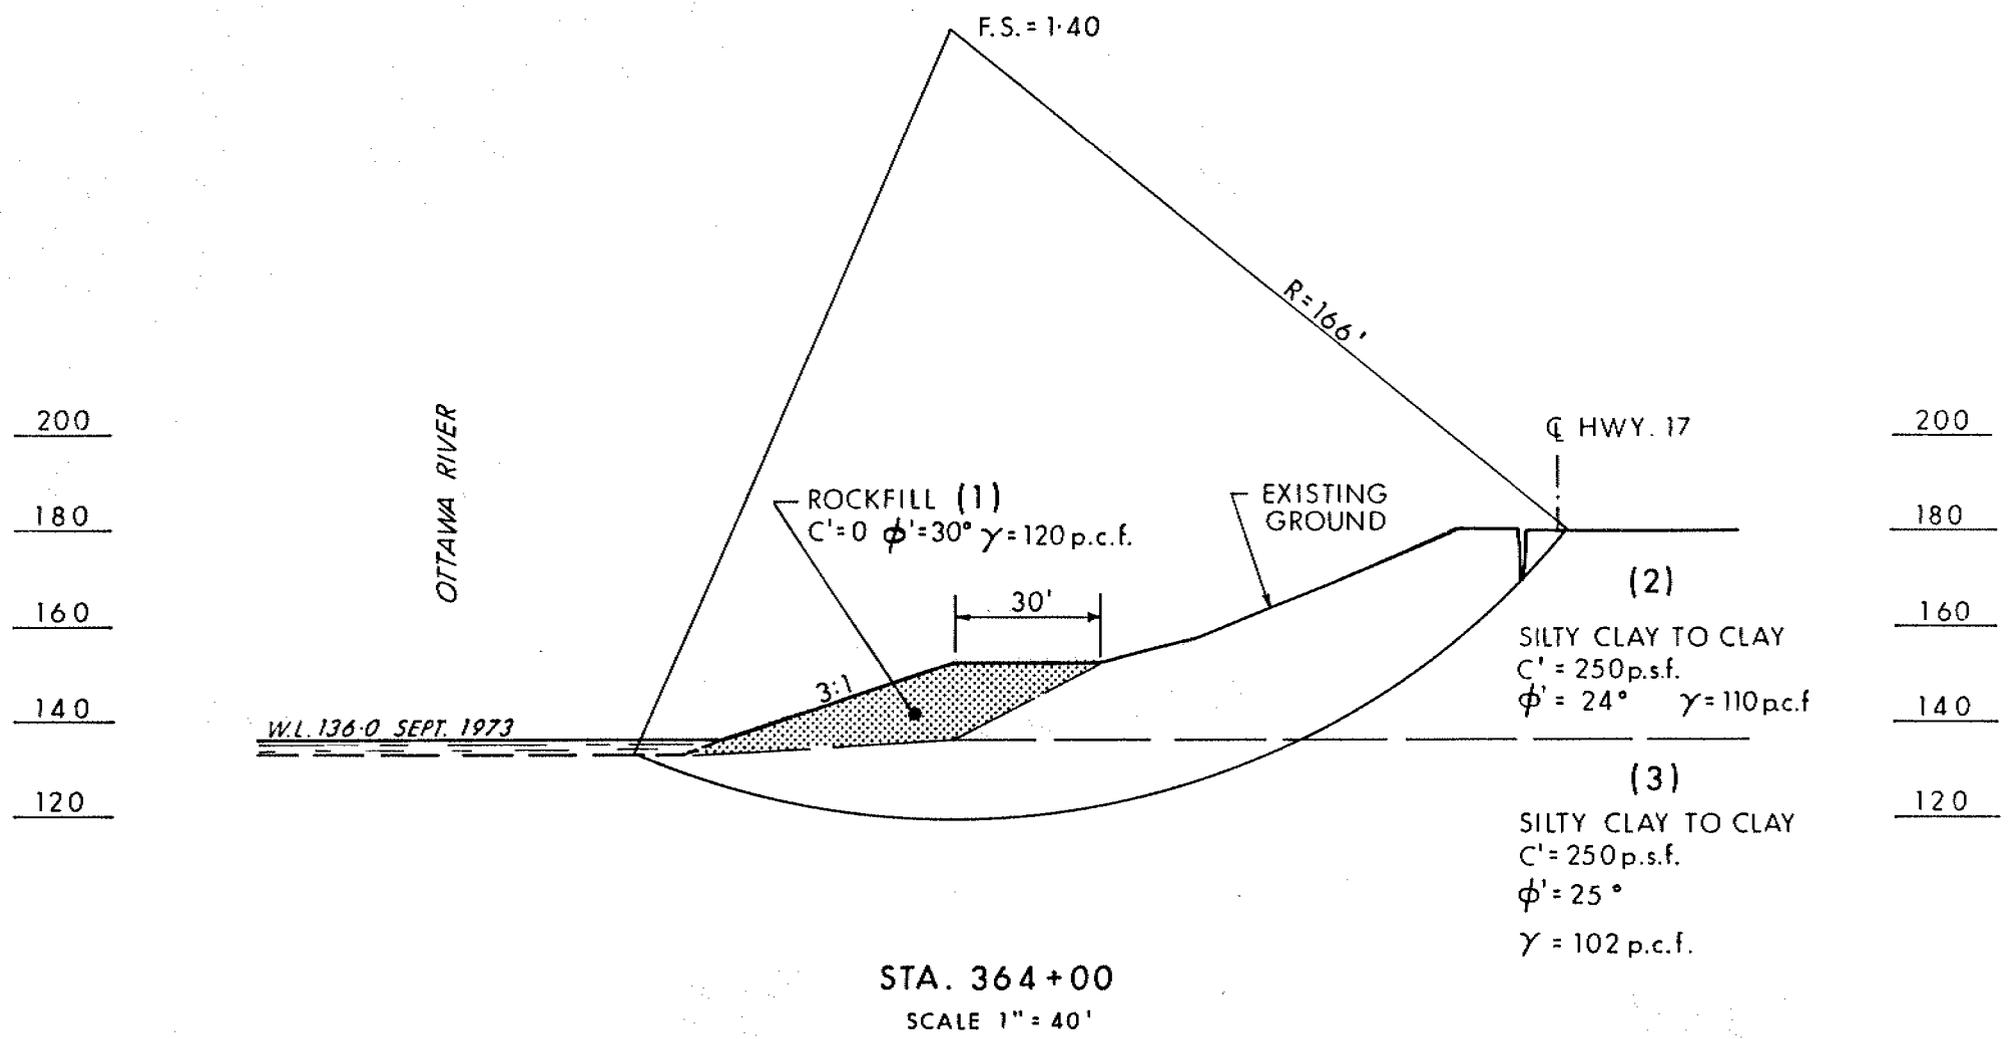
FIG. 30

**STABILITY ANALYSIS IN TERMS OF EFFECTIVE STRESS
 (REMEDIAL MEASURES)**
