LOCATION Slope Instability
South Bank of Ottawa River

DATE: November 22, 1973.

FOUNDATION INVESTIGATION REPORT
For
Slope Instability, South Bank of
Ottawa River
(Hwy. 17 Between Station 262 and Station 380)
Township of Cumberland
Regional Municipality of Ottawa-Carleton
W.O. 73-11053(X) - W.P. 159-73-01

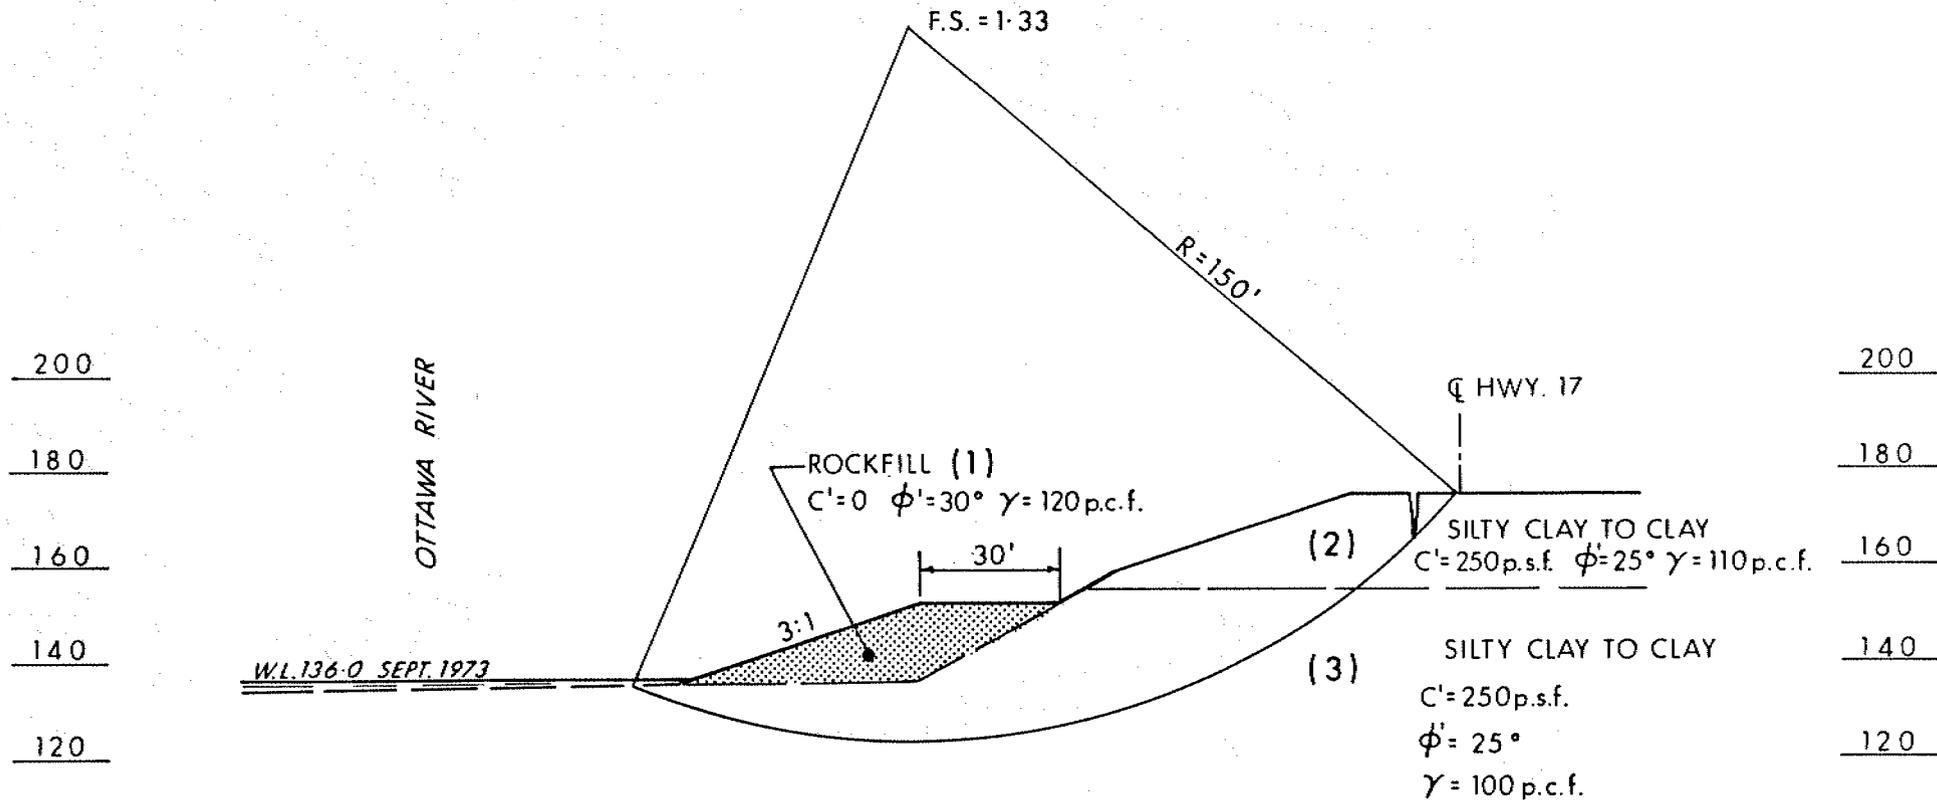
FIG. 31

STABILITY ANALYSIS IN TERMS OF EFFECTIVE STRESS
 (REMEDIAL MEASURES)

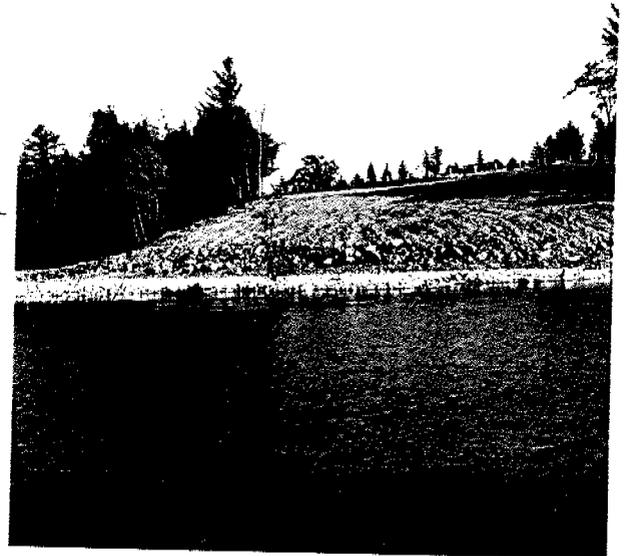
PLATE No 4
TOE EROSION
STATION 262 TO STATION 267

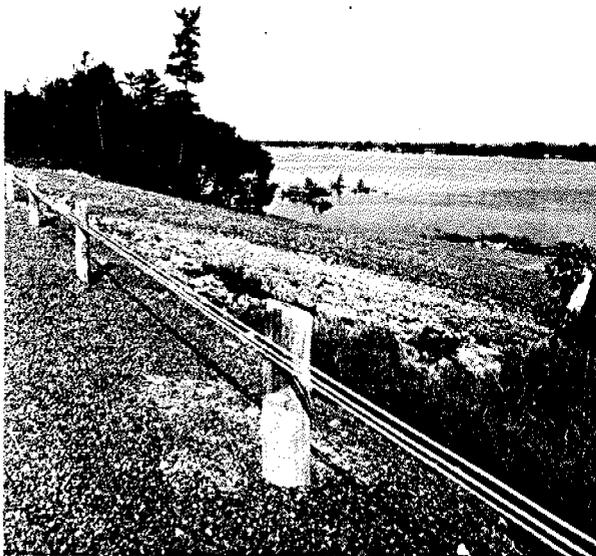
PLATE No. 5
STATION 367 TO STATION 370

Observations made during August 1973 after the completion of the remedial work, revealed that the slopes were generally satisfactory (Refer Plate No. 5 and No. 6).
