FOUNDATION INVESTIGATION
HIGHWAY #17 BY PASS, EARLTON, ONT.

Trow Soderman and Associates

April 22 1958

FOUNDATION INVESTIGATION
ONTARIO NORTHLAND RAILWAY OVERPASS AND EMBANKMENTS
HIGHWAY #17, EARLTON, ONT

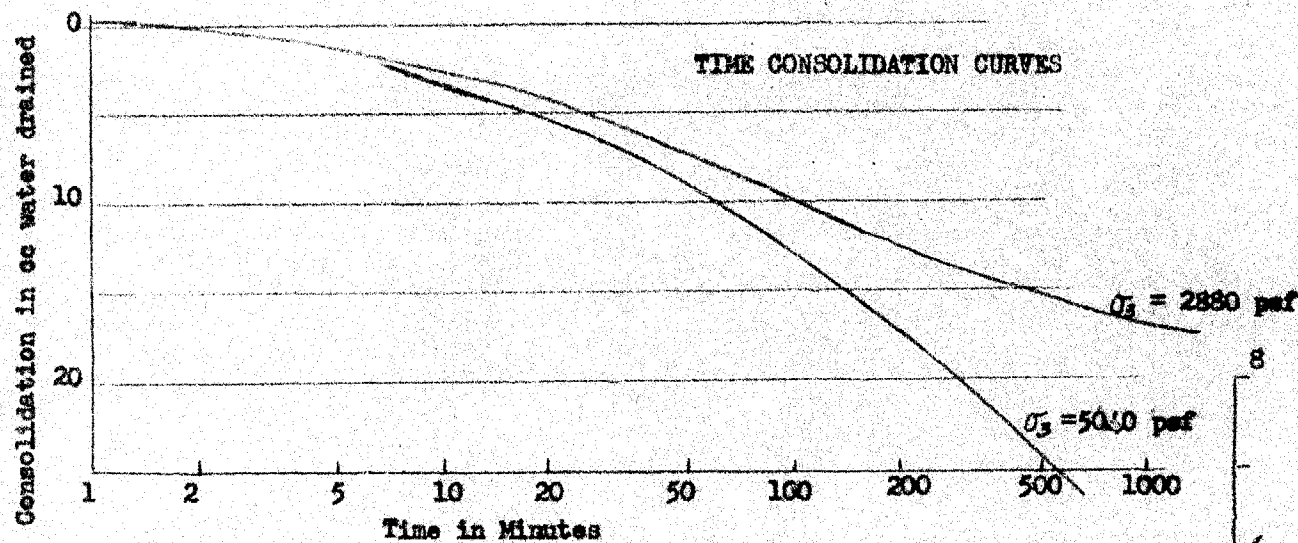
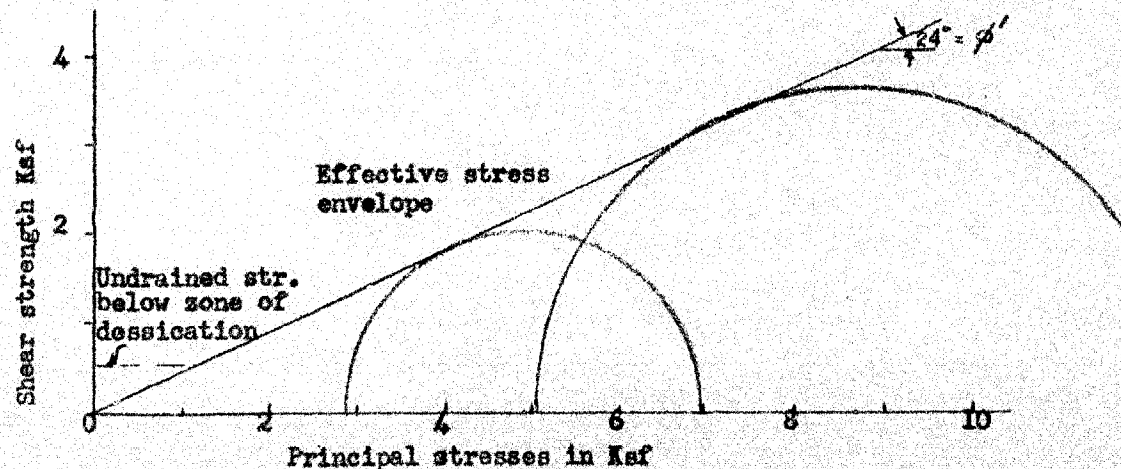
CONSOLIDATION CHARACTERISTICS FOR CLAY PORTION OF A VARVE

Another factor favouring the use of a multispan bridge concerns the compressibility of the underlying varved clay. The two consolidation tests for the clay phases of the varved clay, shown in drawing 11, indicated a compression index ranging from 1.5 to 2.5, values comparable to the very compressible Leda clay of the Ottawa valley. They are not unreasonable considering that the liquid limit of the clay is about 71% and the natural moisture content reaches 90%. No consolidation test was performed on the silt, but experience indicates that it should be greater than about 0.2.

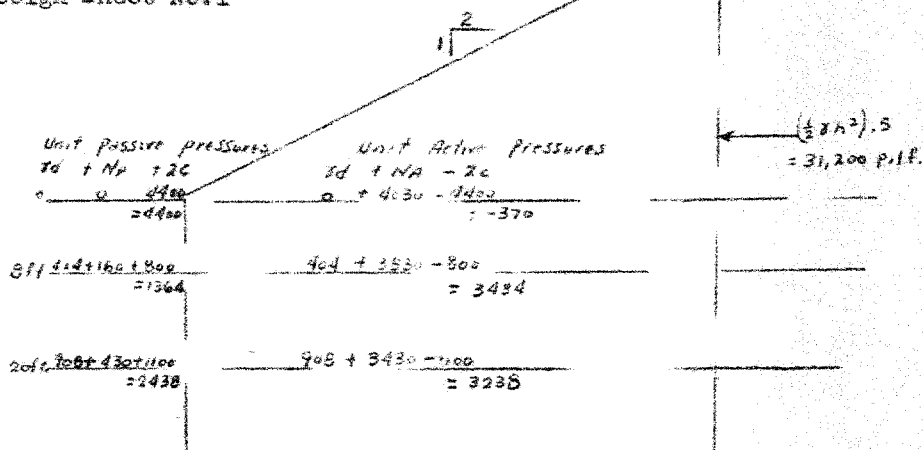
COMPUTATIONS OF PERMISSIBLE SAFE PORE PRESSURES FOR 2:1 EMBANKMENT SLOPE AND H = 31 FEET

$$8 \text{ ft.} = 31,200 + \frac{-370 + 3434}{2} \times 8 = 43,456$$

$$(P_A - P_p) 8 \text{ ft.} = \frac{20400}{62} = 330 \text{ psf}$$

$$(P_A - P_p) 20 \text{ ft.} = \frac{37620}{62} = 607 \text{ psf}$$
