SITE INVESTIGATION

BEAR CREEK BRIDGE

REPORT  
ON  
SITE INVESTIGATION  
FOR  
PROPOSED BRIDGE  
OVER  
BEAR CREEK  
HARLEY-DYMOND TOWNSHIP LINE, ONTARIO

OUR REFERENCE NO: 6-12-3

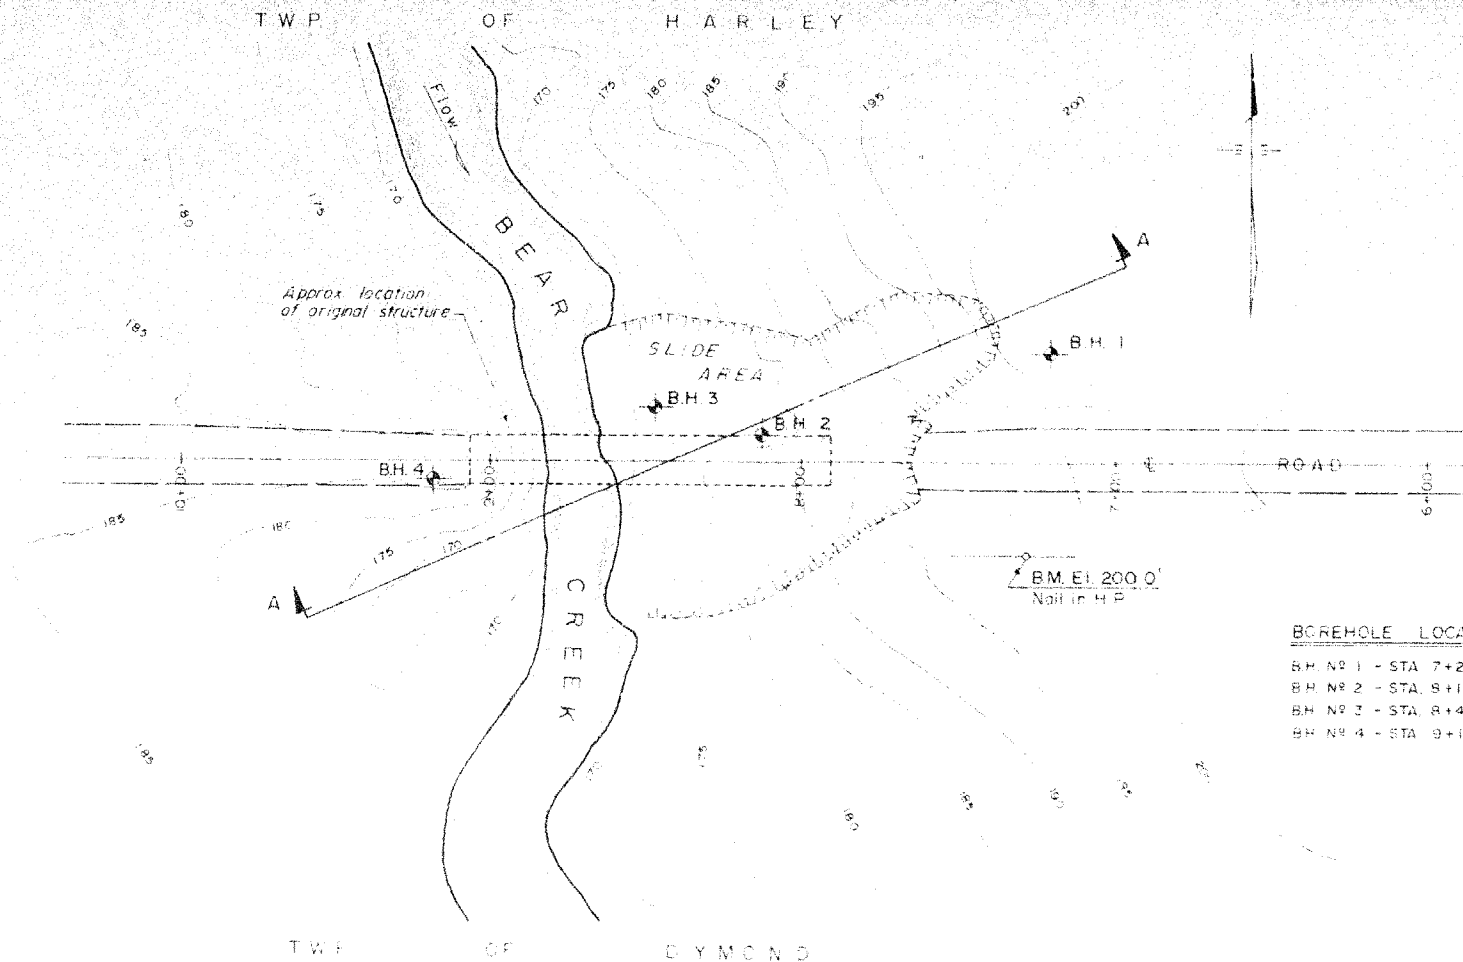
### BOREHOLE LOCATION PLAN

- BH No 1 - STA. 7+20.0, 35' RT. of C
- BH No 2 - STA. 8+10.5, 9' RT. of C
- BH No 3 - STA. 9+16.7, 18' RT. of C
- BH No 4 - STA. 9+16.7, 6' LT. of C

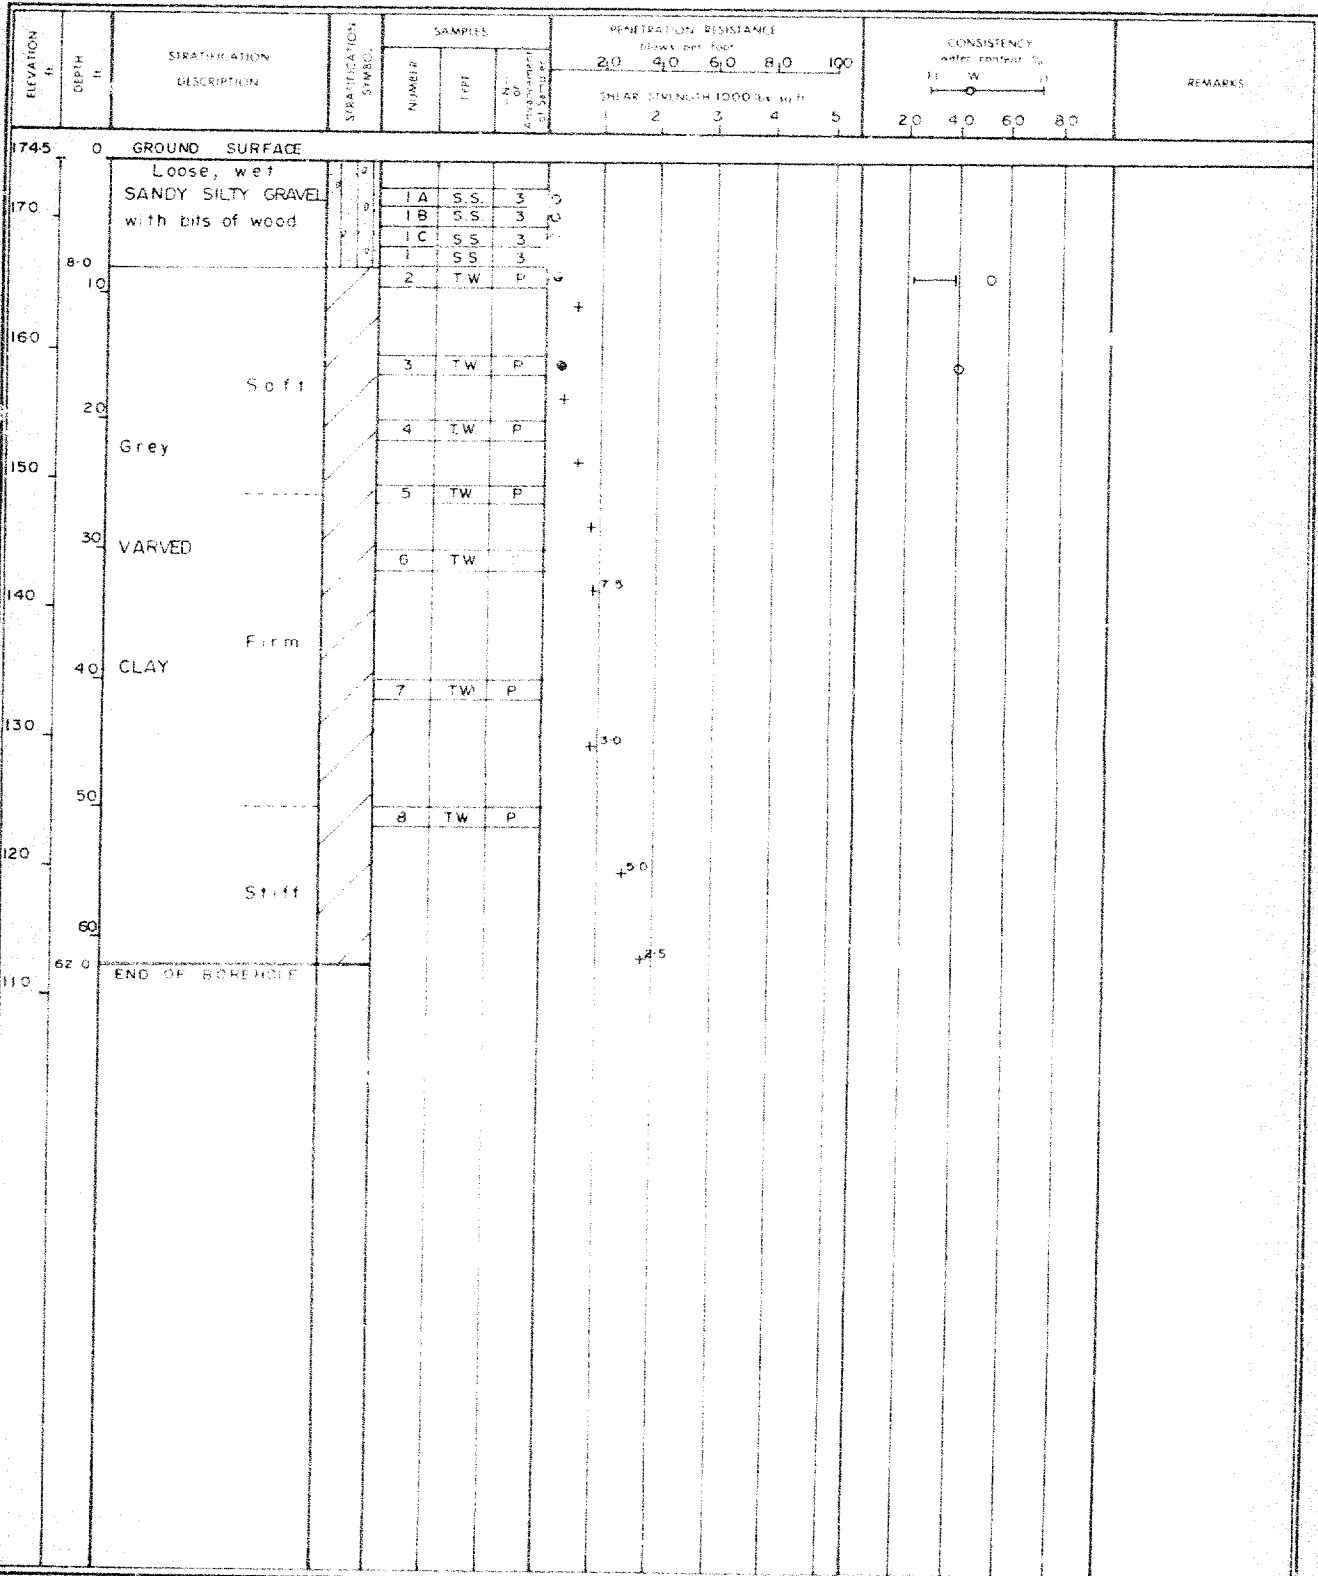
# GEOTECHNICAL DATA SHEET FOR BOREHOLE . . . 3 . .

METHOD OF BORING: WASHBORING  
DIAMETER OF BOREHOLE: 2 7/8"  
DATE: DEC. 14, 1966
