Our Ref. No. 8-11-4.  
February, 1969.

FOUNDATION STUDY  
FOR THE  
PROPOSED RECONSTRUCTION OF  
UNO PARK BRIDGE OVER WABI RIVER  
TOWNSHIP OF HARLEY.

Prepared for:  
THE SUTCLIFFE COMPANY.  
Consulting Engineers,  
NEW LISKEARD.

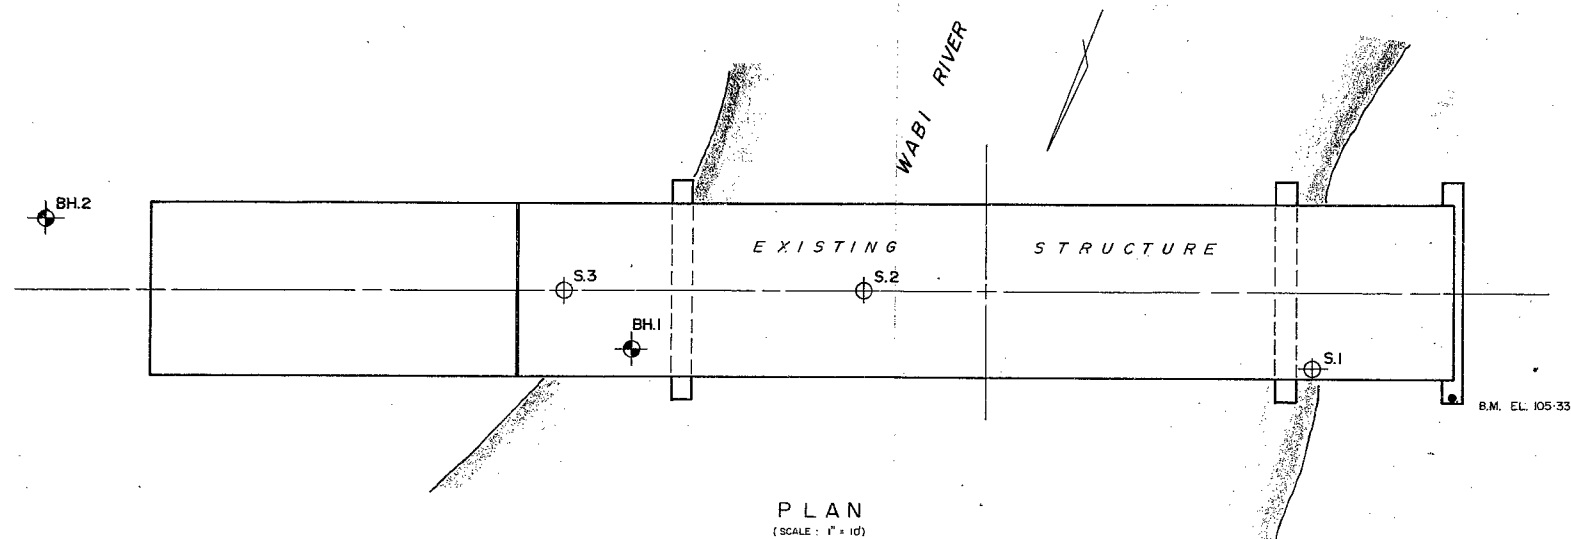
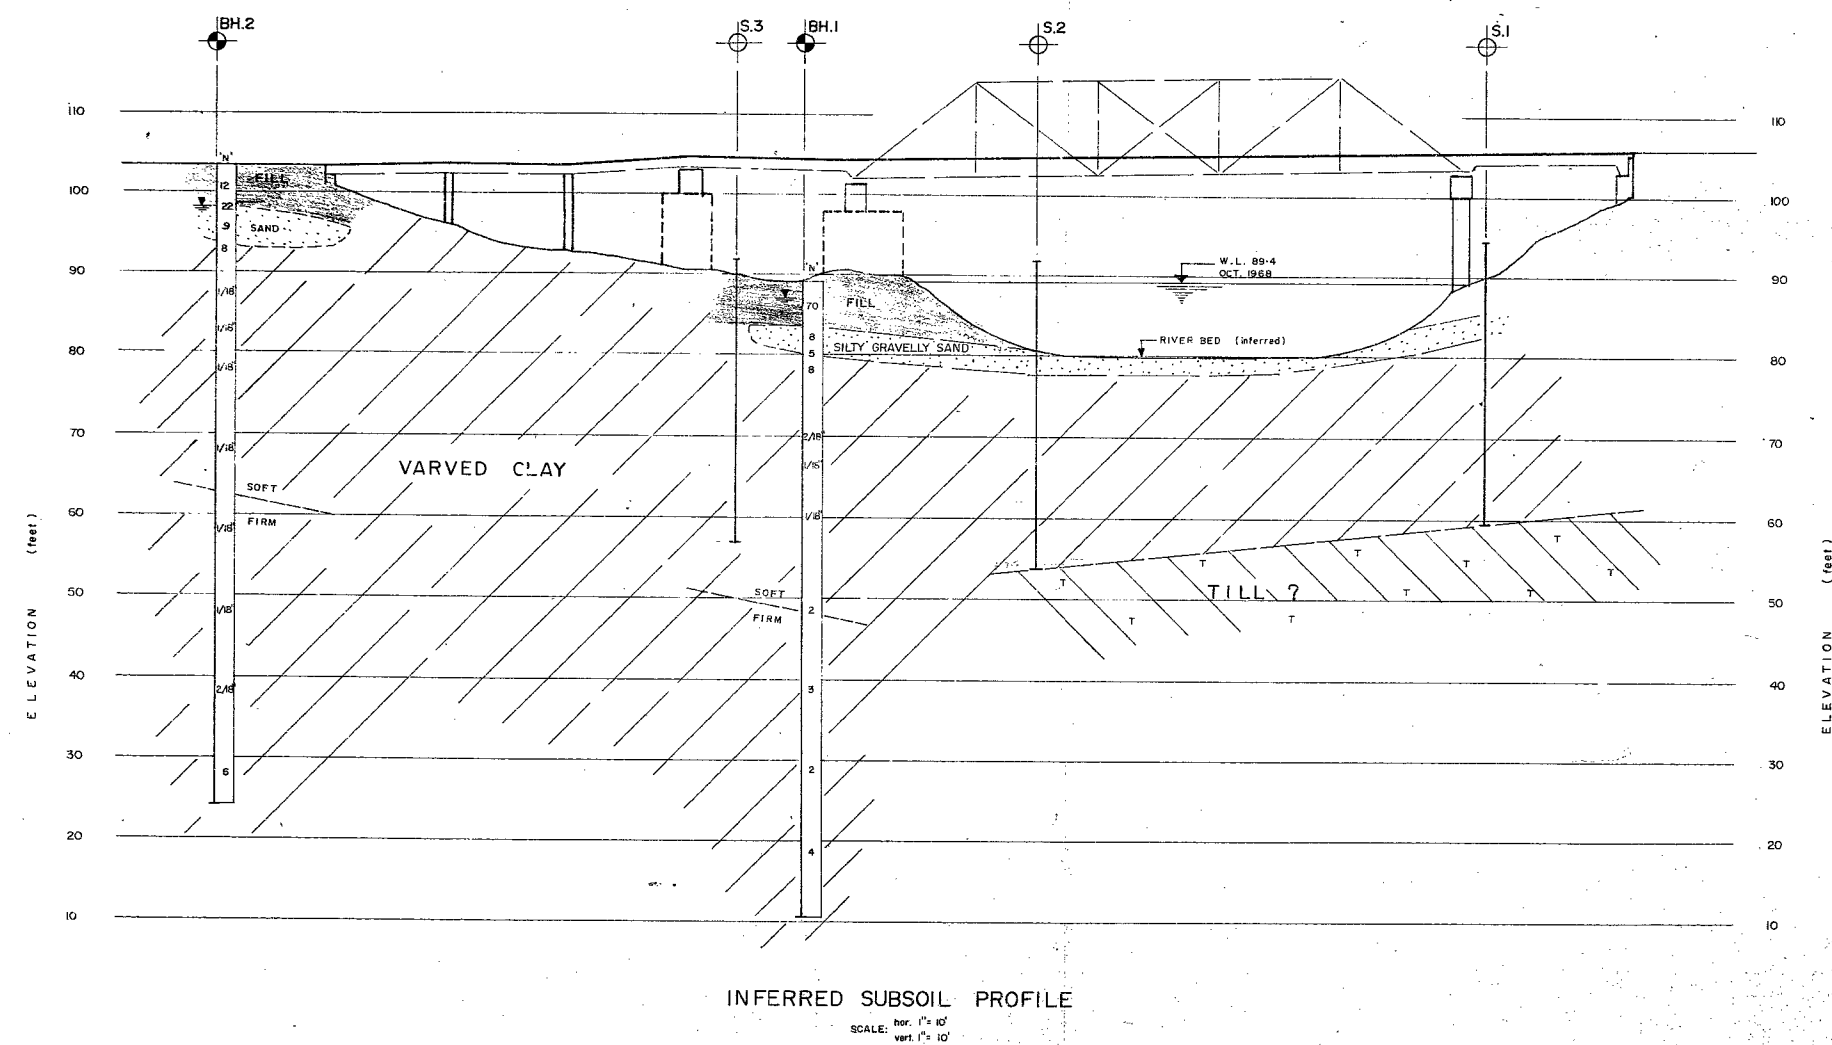
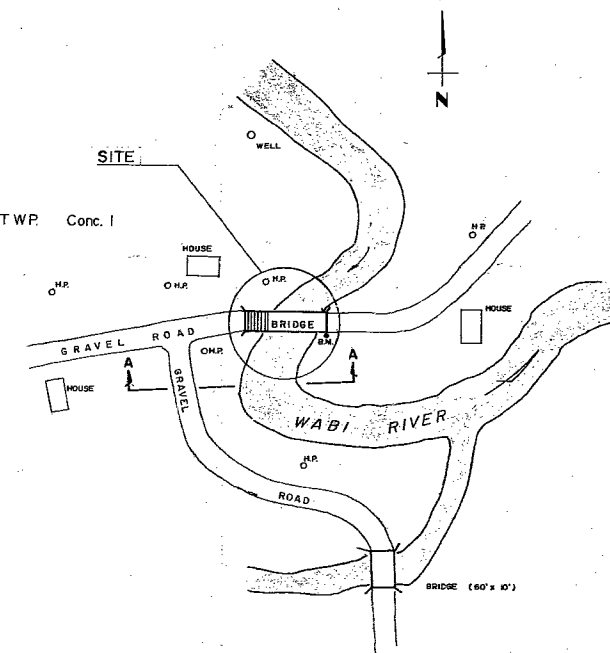
THE SUTCLIFFE CO.				
DOMINION SOIL INVESTIGATION LTD. CONSULTING ENGINEERS, TORONTO				
WABI RIVER BRIDGE AT UNO PARK TWP. OF HARLEY CONC. I				
BOREHOLE LOCATION & SUBSOIL PROFILE				
SCALE AS SHOWN	DRAWN BY C. K.	CHECKED	OUR REF. 8-11-4	DWG. NO. 1

Although a detailed analysis of the failure was not carried out, calculations based on total and effective stresses indicate that the failure of the approach fill was inevitable, as the weak subsoil was unable to support the weight of the embankment. Stability calculations also indicate that with an effective angle of shearing resistance of  $21^{\circ}$  (see enclosure No.5) the west bank of the river is stable at its present 7 to 10 degree slope (see enclosure No.6 and Drawing No.1).
