REPORT TO
KNOX MARTIN KRETCH LTD.
ON

TOWN OF COBALT
MINING HAZARD ASSESSMENT
PHASE IV A
COBALT ONTARIO

March 1988

881-1702

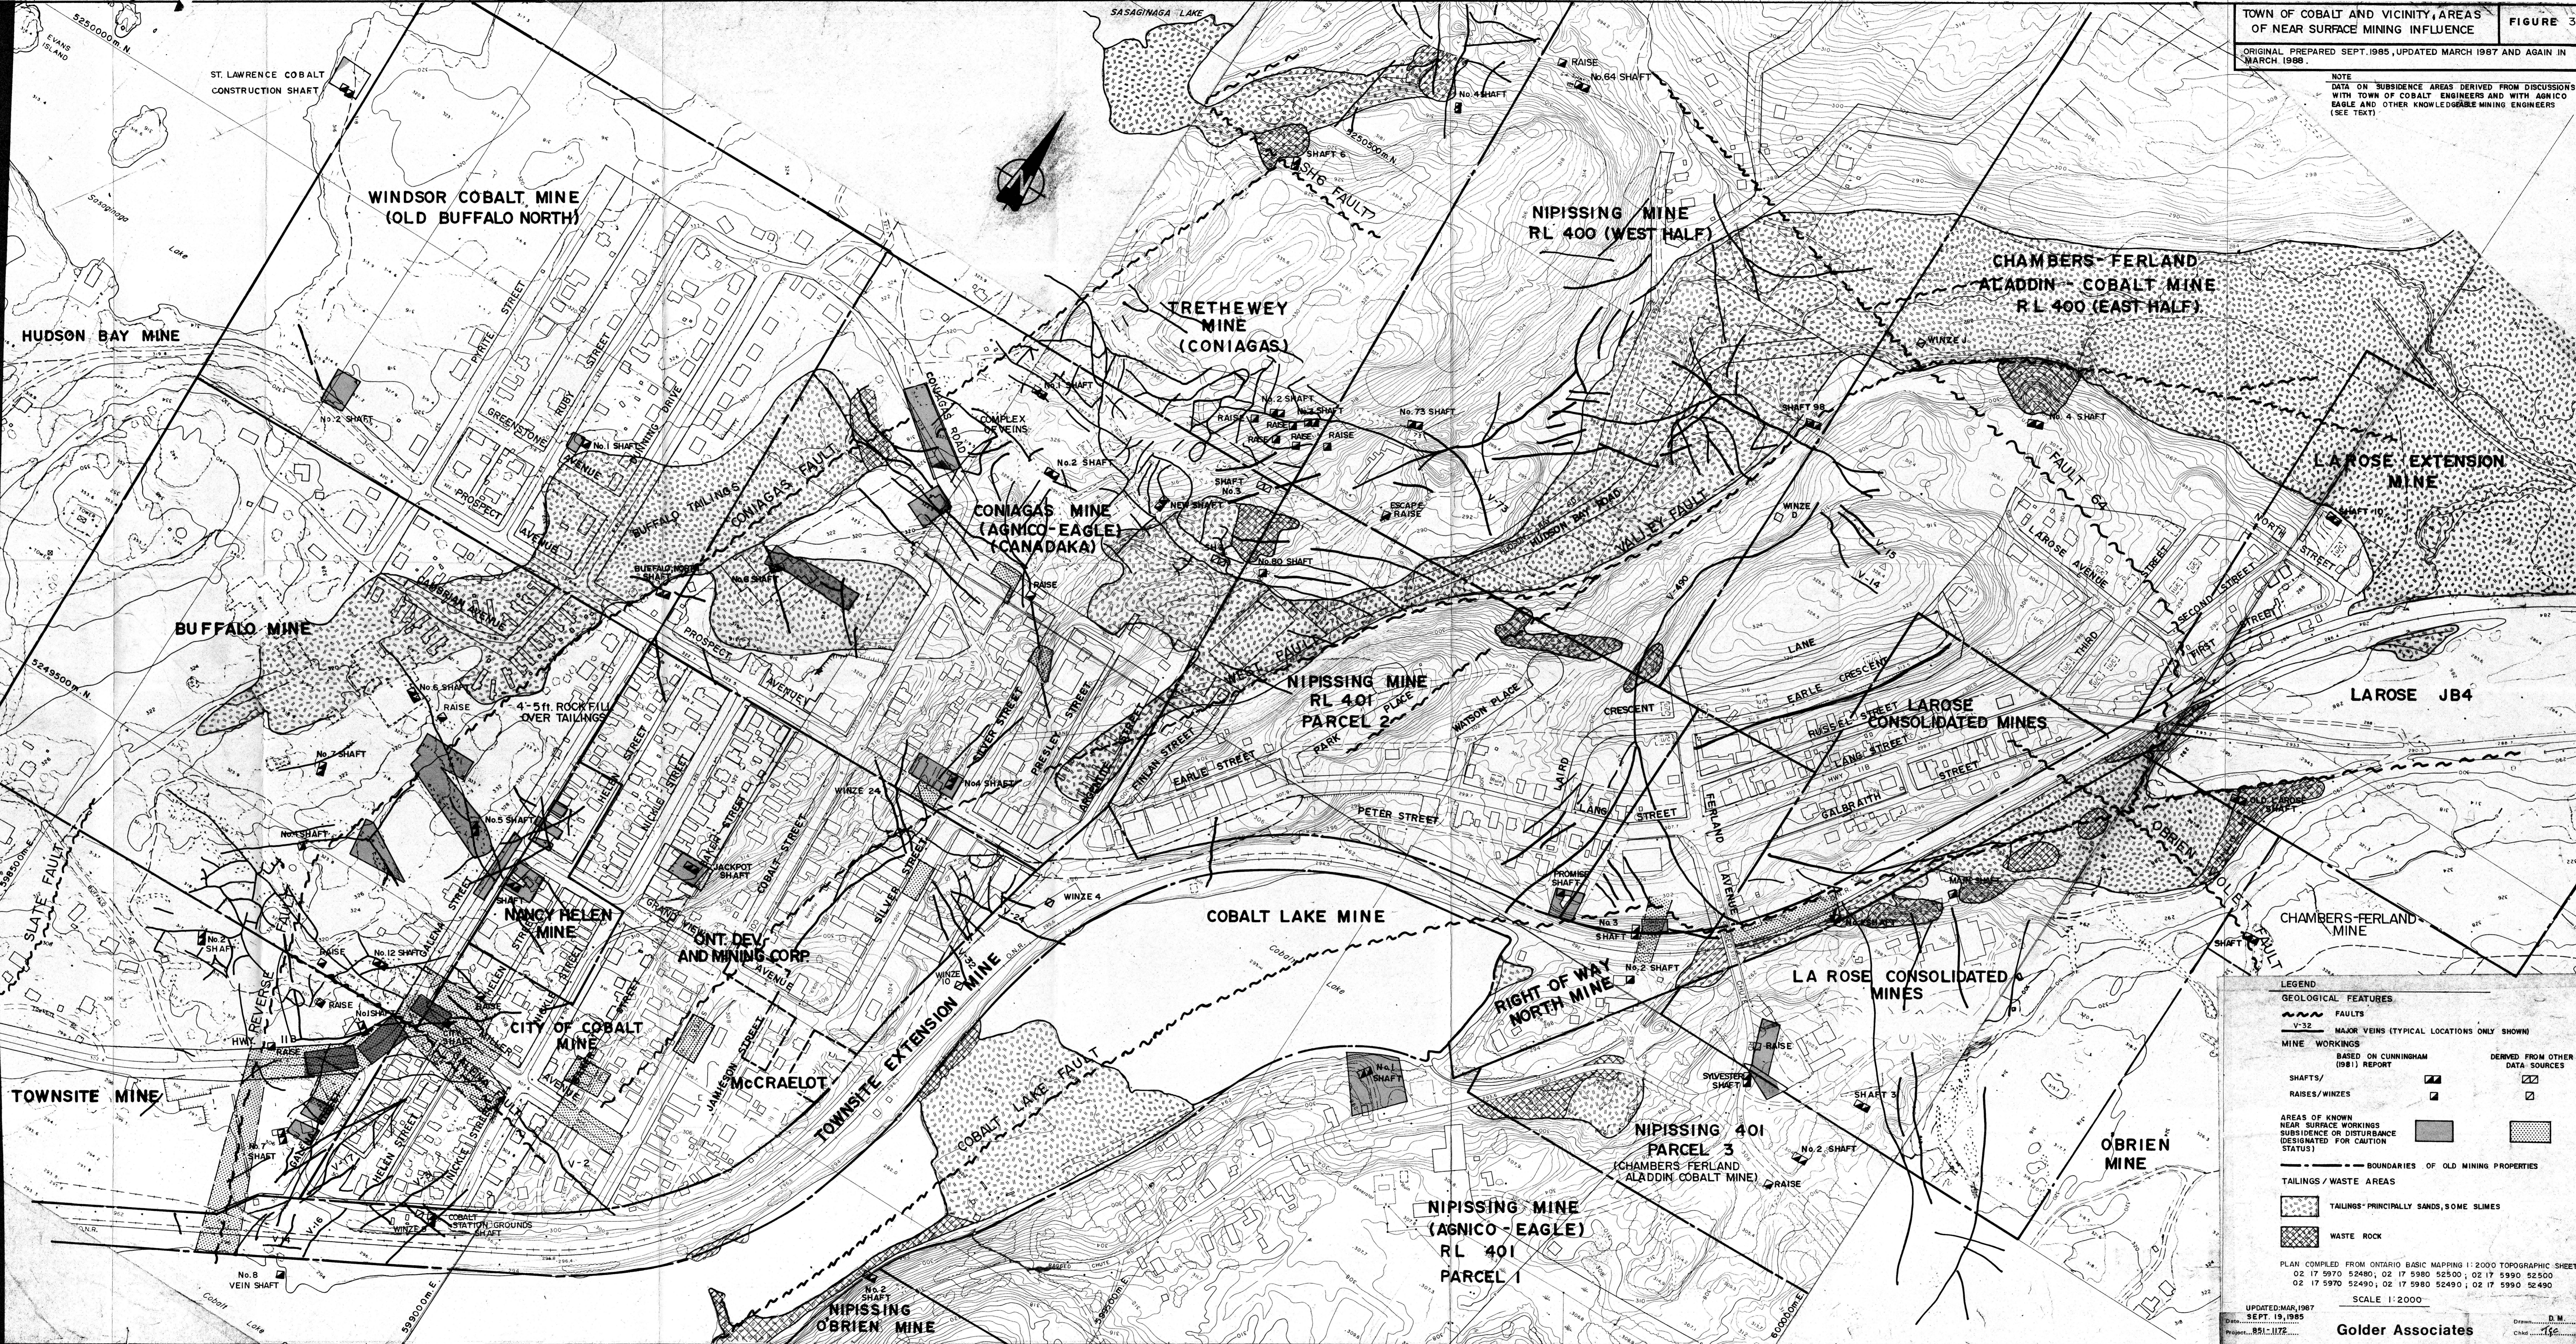
FIGURE 5

Very little information is available on the geometry of the underground workings which currently exist beneath the Street or under the houses in the immediate area. However, as shown on Figure 5, several zones of stoping are known to extend across Galena Street and under some of the adjacent properties. Furthermore, as indicated in the records collected from Agnico Eagle Mines Limited, two areas of the old workings have, in the past, caved through to surface - one directly beneath the roadway and another (related to the old mine shaft) into the back garden of the property at #56 Galena Street. Cunningham in his 1981 report indicates that the section of the roadway in this area was capped in 1980, (see Figure 18 of Golder Associates report #851-1172 for details of capping). The precise date of the capping of the old stoped out shaft area (Figure 17 of report #851-1172) is unknown, but presumed to be in the early 1970's.

As shown on Figure 5, numerous near surface stopes exist with back elevations close to ground surface. In addition, the area adjacent to the Nancy Helen Shaft itself, which was capped by Agnico Eagle Mines Ltd. in the 1970's is situated in the backyard of House #56 Galena Street.

PLAN AND SECTION OF
GALENA STREET IN AREA OF OLD NANCY
HELEN MINE WORKINGS
SHOWING DOCUMENTED INFORMATION
