REPORT TO
THE MAYOR AND COUNCIL
TOWN OF COBALT
ON

PRELIMINARY ENGINEERING ASSESSMENT
AND SUGGESTED REMEDIAL MEASURES
"P-S" STOPE INTERSECTION CROWN PILLAR,
HWY #11B
COBALT, ONTARIO
WO: 2002-11005

August 1987

871-1289

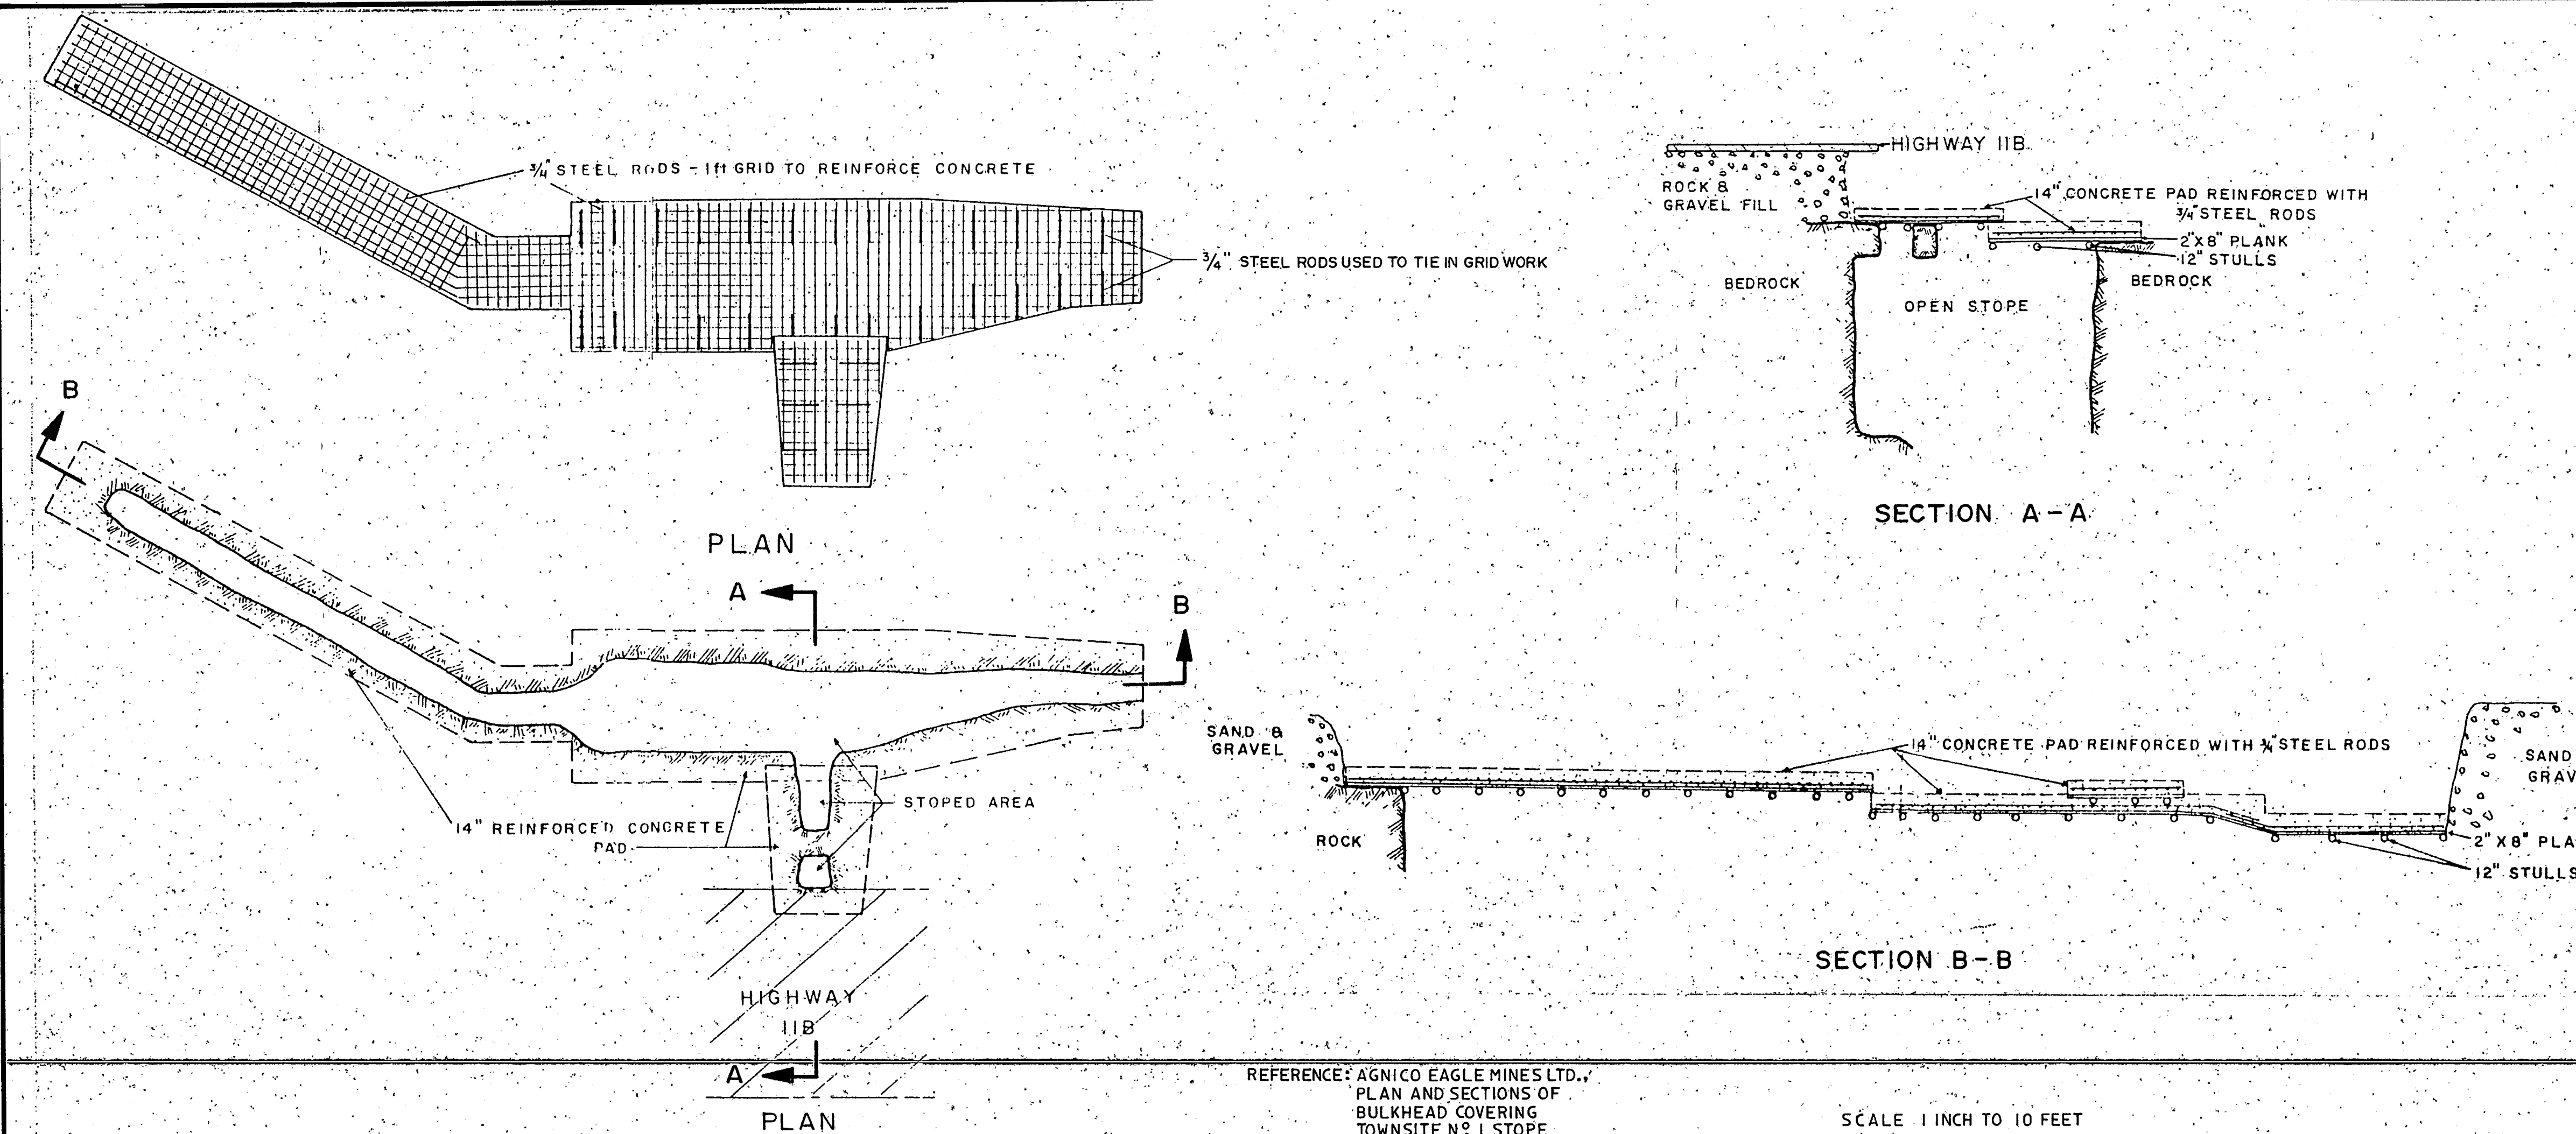
REFERENCE: AGNICO EAGLE MINES LTD.,
PLAN AND SECTIONS OF
BULKHEAD COVERING
TOWNSITE No. 1 STOPE

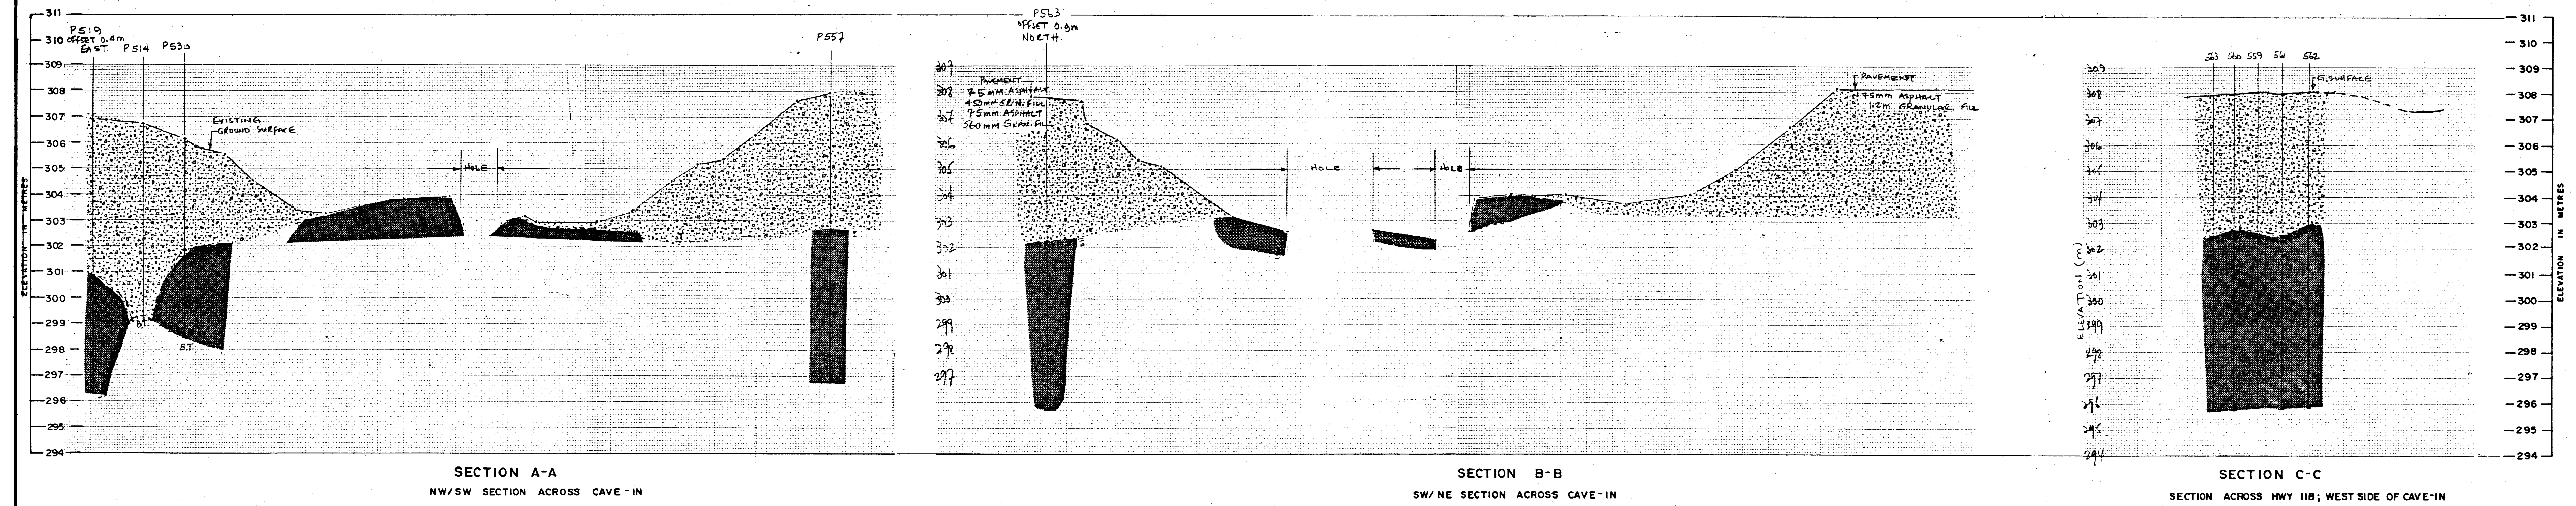
On Figure 8 the areas of known "hole-throughs" (i.e. no rock present in the crown pillar) and of thin crown pillar conditions, have been shaded with dark grey and light grey screens, respectively; the latter has also been coloured in orange on the drawing. The extent of the rock cap around the existing "cave-ins", as shown on Figure 8 is based on interpretation of crown pillar geometry derived from the old 1916 stope sections for the S and P veins (Figures 5 and 6), on data from the ongoing drilling and on information provided by mapping carried out by surveyors from Agnico Eagle Mines Ltd. The condition of the rock mass in the vicinity of the P-S stope intersection as revealed by radar traversing, is illustrated on Figure 13 which indicates that the remaining crown pillar over the orange shaded area on Figure 8 is only of the order of 3 ft. to 5 ft. (1 m to 1.5 m) thick on the sides of the open holes (see plates 1 and 2).

The plan (Figure 8) and the sections (Figures 9 to 12 inclusive) are up-to-date as of August 10, 1987; drilling is still on-going following directions identified either by the geophysics or by review of the mine records. Most of the potential hazard locations identified to August 10, 1987 had already been investigated by that date, by means of airtrack drilling, by diamond coring and/or by overburden augering and bedrock coring; however several areas were still outstanding as indicated in Figure 8.

The alternative to the minimum span solution is to conservatively select the minimum thickness of crown pillar for which collapse would be improbable and to provide a structure to span over the remainder of the crown pillar. Based on the geometry of the stopes and crown pillars investigated so far, this thickness has been established as 10 ft (3 m) and the area involved is coloured orange on Figure 8.

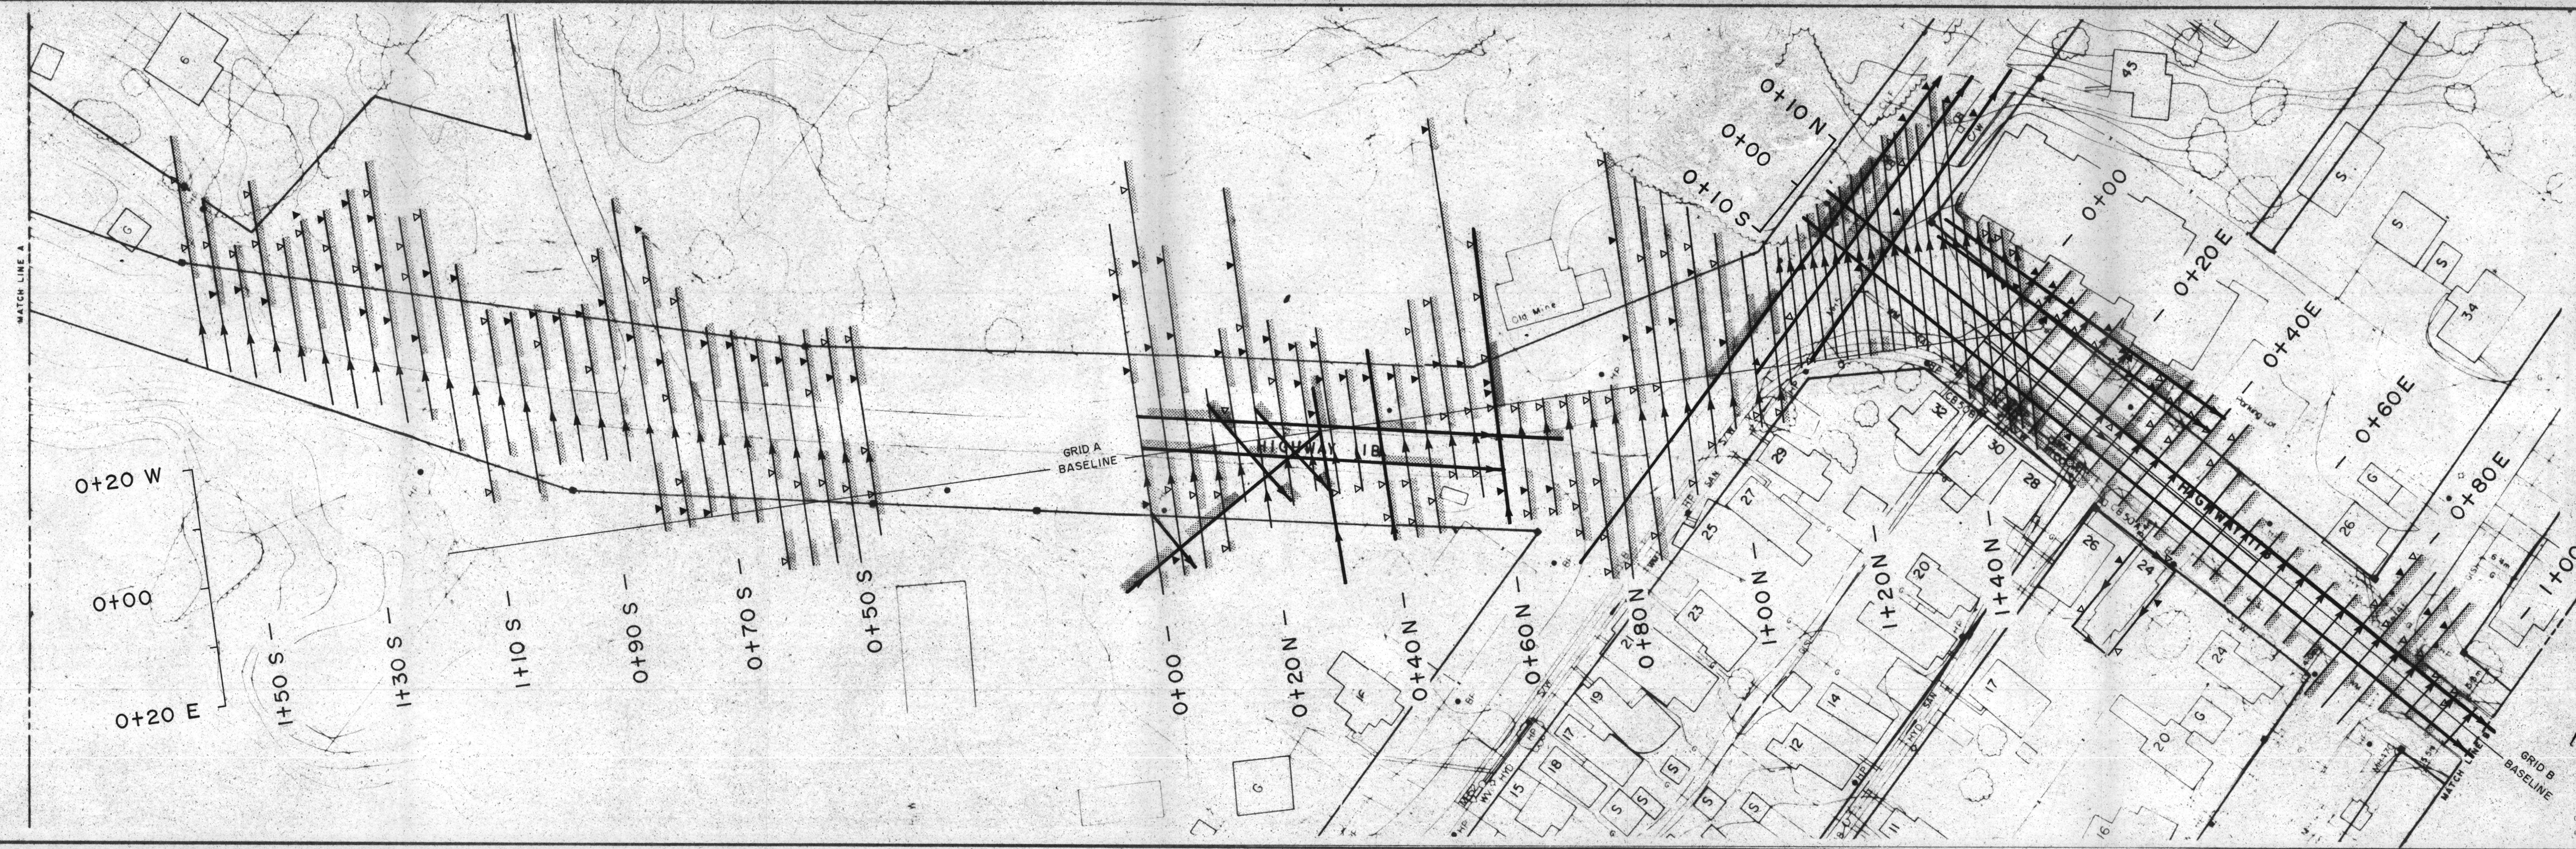
FIELD PROGRAM 2 RADAR SURVEY LINES

Unfortunately, the utilization of geophysical techniques to target drilling is not without complications. Many of the anomalies that show up on the radar, for example, are difficult to interpret because of disturbed overburden ground conditions and overhead power lines; in many cases the anomalies do not represent underground workings; rather they reflect variations in the overburden or reflect random fill containing obstructions. In consequence, only by careful validation using drilling techniques is it possible to establish the precise cause for each of the geophysical anomalies. Figure 14, for instance, shows the locations of all significant radar anomalies and major zones of reflectivity, as currently being used for positioning the drilling. It should be noted that not all of the anomalies shown on this drawing are associated with underground workings. However, some clearly indicate subsurface workings, as for example that shown on Figure 15.

This drawing shows the type of response typical of that now known to reflect an uncharted stope. This stope also occurs under the highway and slightly to the northeast of the area of the original June 22nd "cave-in" (see Figure 8). It should be noted that it does not appear on any of the old mining records (Figure 4), and was therefore probably developed by the lessors in the 1930's. As indicated on Figures 11 and 12, (sections II, JJ, KK and LL) no rock crown pillar was found over much of the central section of the stope. Some timber was however found at the bedrock/overburden interface suggesting that mining had probably been taken right up to a frozen overburden interface and that over the intervening years only the timber supported the overburden.
