HWY. No. 2LOCATION Failure of Embankment4 km W of WardsvilleNo of PAGES - 1

**Re: Inspection of Highway 2 Embankment  
4 km West of Wardsville  
Highway 2, District 32, Chatham**

Re: Restoration of Embankment (Stn. 14 + 567 to Stn. 14 + 625)  
W.P. 300-92-00, Highway 2, District 32, Chatham

Re: Failure of Embankment (Stn. 14+563 to Stn. 14+635)  
4 km West of Wardsville  
W.P. 300-92-00  
Highway 2, District 2, London  
Geocres No: 40I12-24

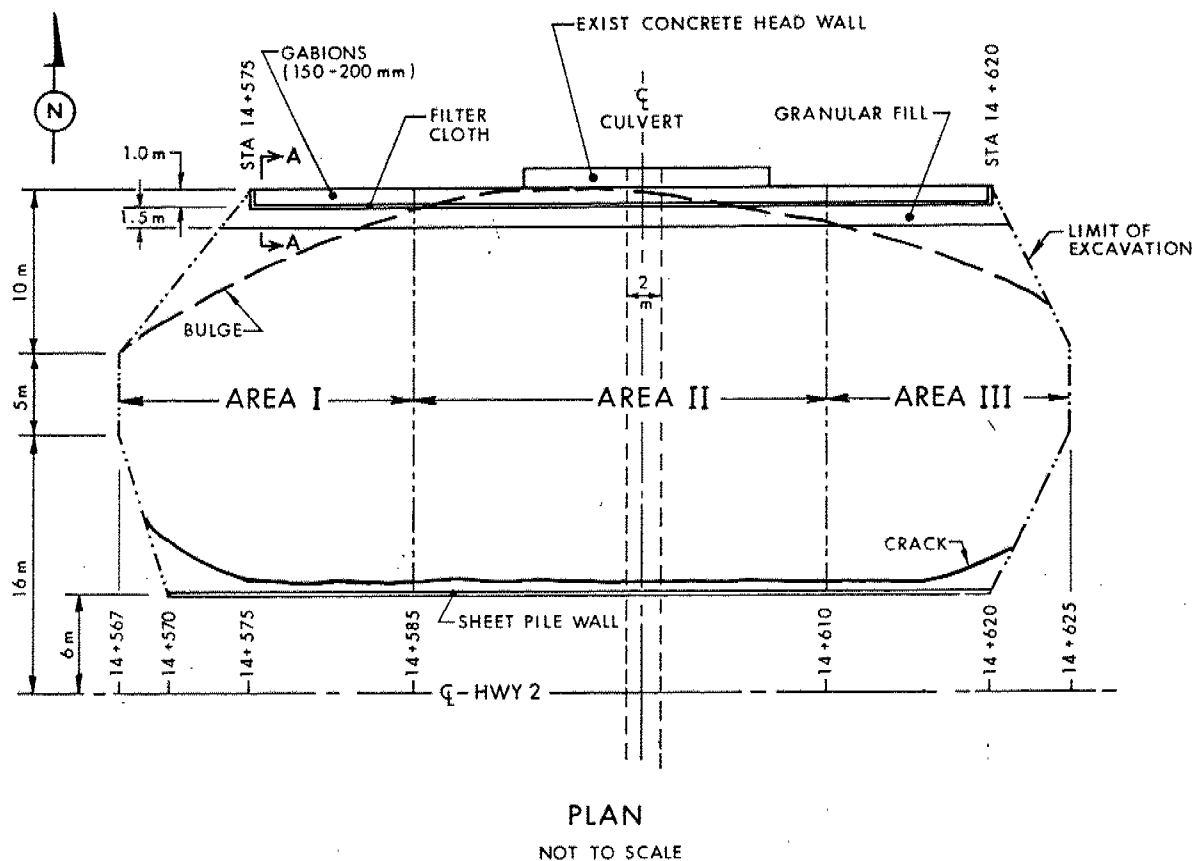
HWY 2 DIST 32  
WP 300 - 92 - 00 Geocres No 40112 - 24  
1995 06 22 FIGURE No 1

#### AREA OF RESTORATION

The surface crack adjacent to the guard rail extends to a distance of about 41 m, however, the failed area gradually spread to a distance of about 72 m near the middle of the embankment and narrows down to about 4.5 m at the toe. Surface cracks varying in width from a few millimetres to a maximum of 600 mm were observed. The failed portion is displaced by approximately 0.9 m to 1.1 m vertically and 0.3 m to 0.6 m horizontally. However, near the toe of the embankment, bulge of soil varying in thickness from a few millimetres to a maximum of about 300 mm was observed. The details of the failure are shown on Figure 1.

Based on the information gathered, it appears that the failure is confined to the fill itself and centred around the culvert location. The probable failure surface is shown on Figure 1 and it is expected to extends to a depth of 2.5 m to 3.0 m below the existing slope at the deepest location.

The area of subexcavation as well as details such as location of gabion and sheet pile wall are shown on Figure 1. Benching arrangements are shown on Figures 2, 3 & 4.

- 1) Drive the sheet pile to El. 203 from Stn. 14 + 570 to Stn. 14 + 620
- 2) Provide benching as shown on Sections 14 + 582 for Area I, 14 + 598.5 for Area II and 14 + 615 for Area III
- 3) Remove any spongy or soft areas observed below the bench level specified and backfill with acceptable fill material.
- 4) Place the gabion and filter cloth as shown on Figures 1, 2, 3 & 4.
- 5) Place the fill in layers and compact.

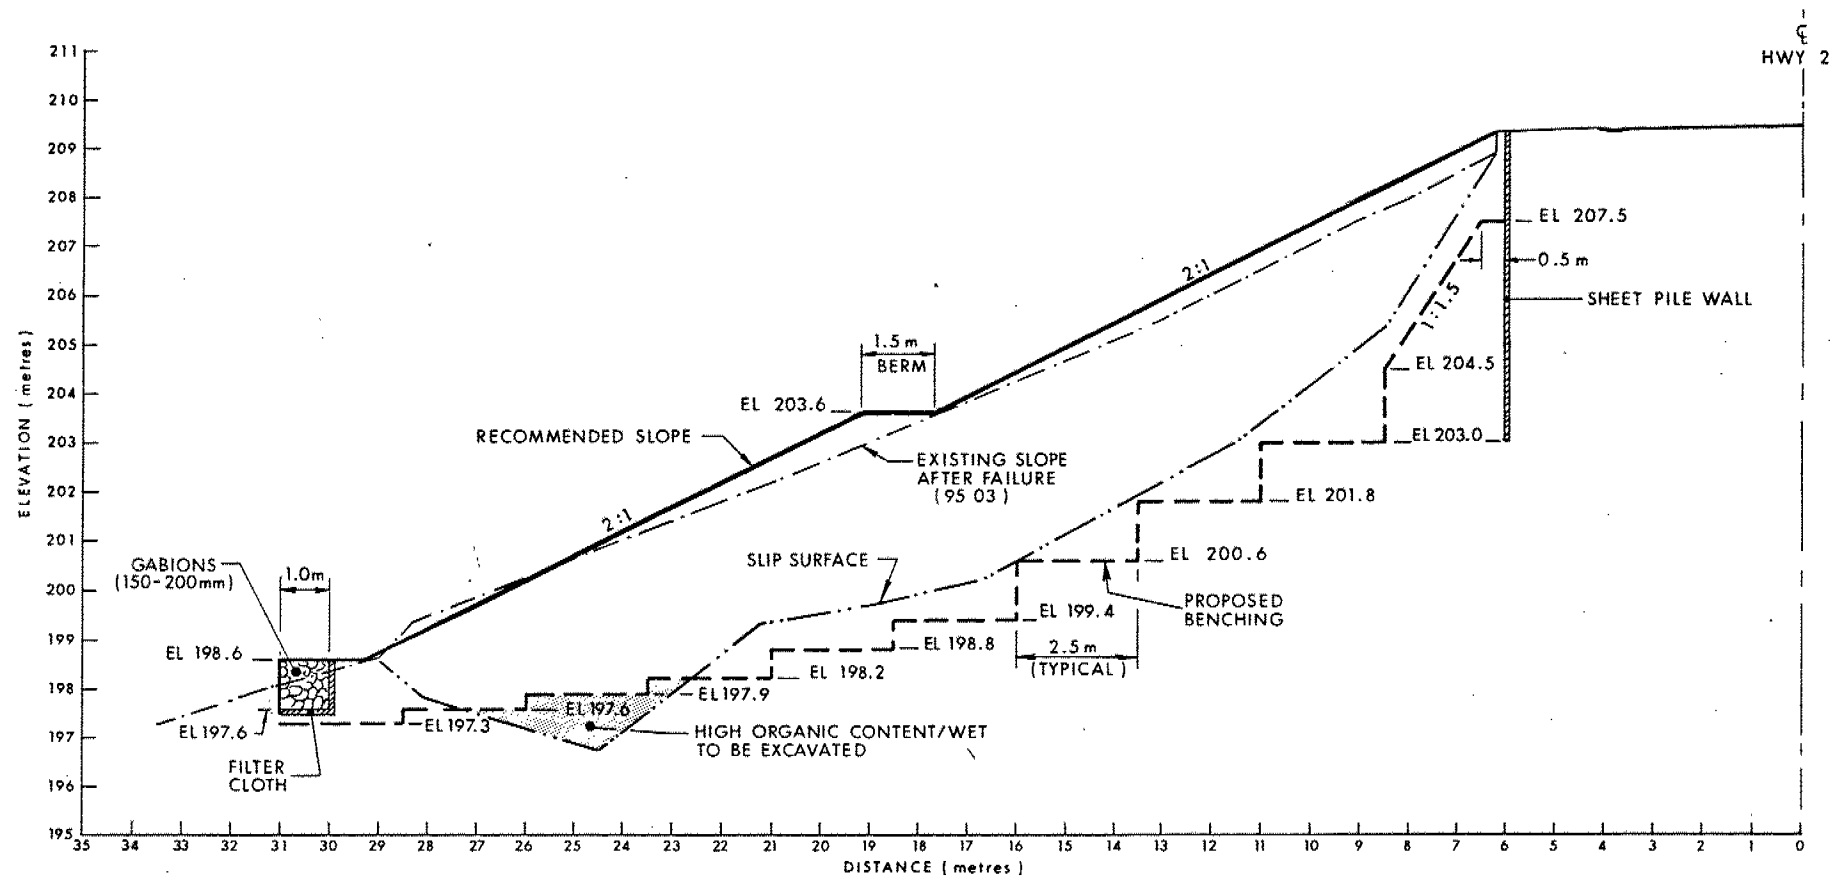
HWY 2 DIST 32  
 WP 300-92-00 Geocres No 40 112-24  
 1995 06 22 FIGURE No 2

SECTION AT STA 14+582

**RECOMMENDED SLOPE & BENCHING  
FOR RESTORATION**

The recommended gabion adjoining the head wall should be placed at least 0.3 m to 0.4 m below ground level and extend to a height of 1.0 m (El. 198.6) above the head wall to accommodate 1.5 m wide berm around El. 203.6 (refer to Figure 2 & 3). However, near the crown of the culvert, depth of 0.3 m to 0.4 m into the ground may not be feasible and this may be reduced according to the availability of space.

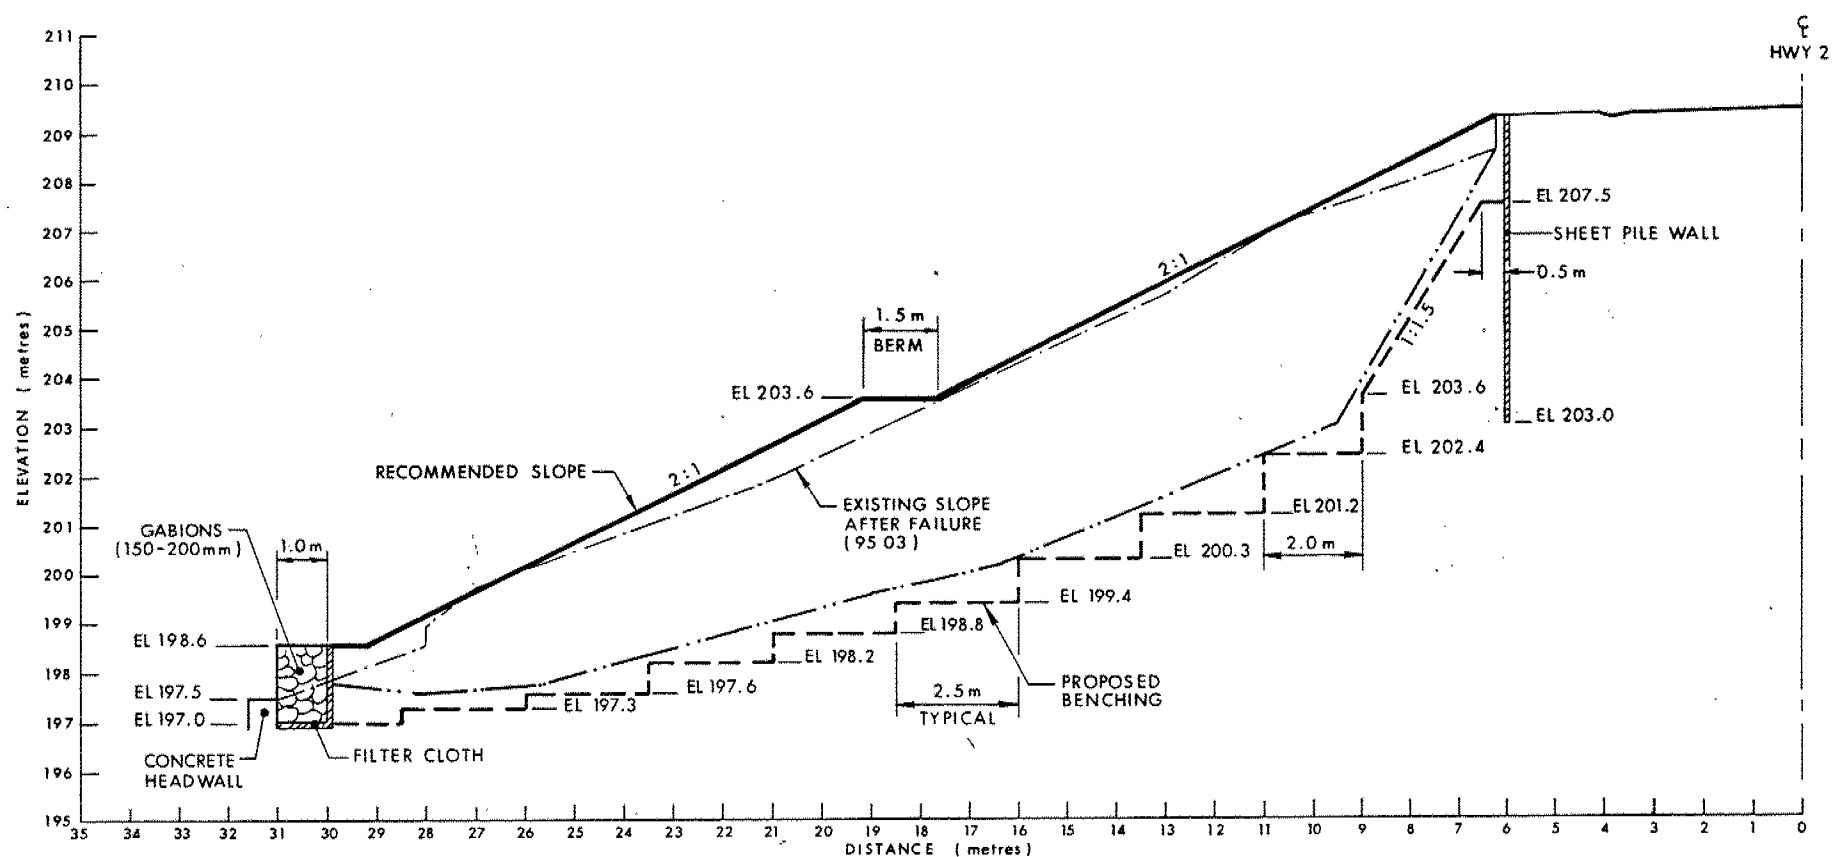
HWY 2 DIST 32  
 WP 300-92-00 Geocres No 40112-24  
 1995 06 22 FIGURE No 3

SECTION AT STA 14+598.5

### RECOMMENDED SLOPE & BENCHING FOR RESTORATION

- 1) Subexcavate in 3 m strips toward the slope as shown on figure 4 to avoid any failure of adjoining area.
- 2) Place the gabion, crushed stone (20 mm to 25 mm) and Granular "A" as per Figure 3.
- 3) On completion of placing crushed stone and Granular "A" and compacting, subexcavate the rest of the strip below the slip surface with the provision for benching and backfill (for sequence of construction refer to figure 4).
- 4) Backfilling of the subexcavated portion should be carried out prior to the commencement of the excavation of a new strip.
