GEOCRES No. 40P1-69

LOCATION PROP. COCKSHUTT
RD. BRIDGE, BRANTFORD

McCORMICK RANKIN & ASSOCIATES LIMITED
PRELIMINARY SUBSURFACE INVESTIGATION
PROPOSED REPLACEMENT STRUCTURE
COUNTY ROAD NO. 4
BRANT COUNTY ONTARIO

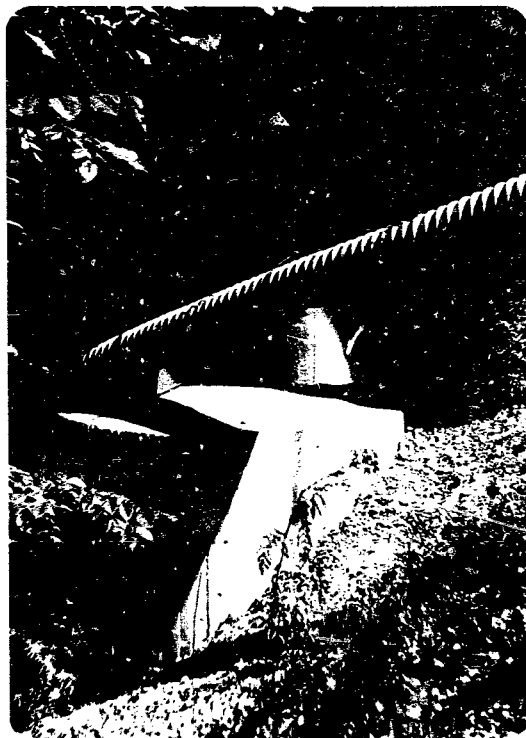
RELATIVE DISPLACEMENT — SOUTH ABUTMENT

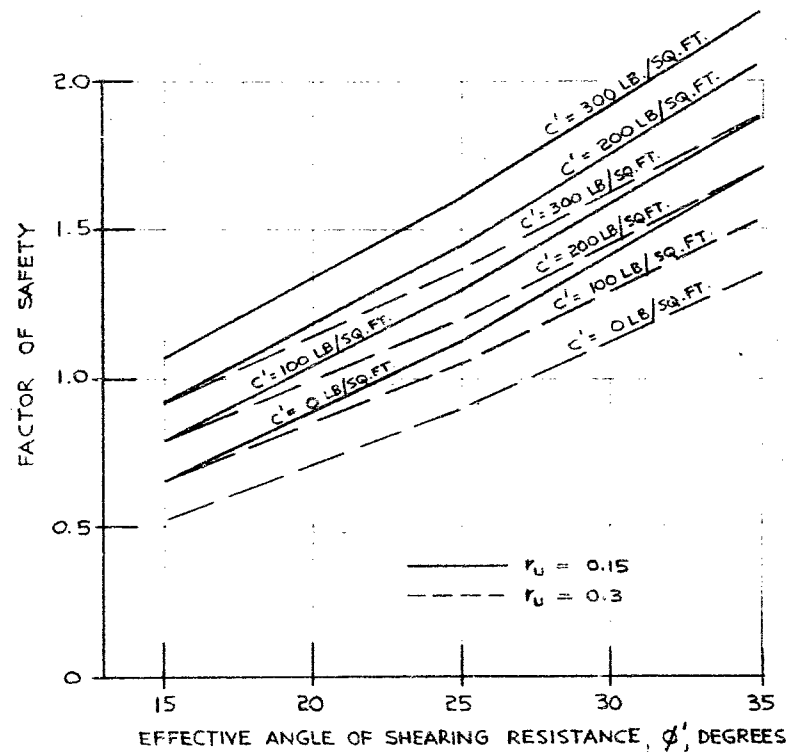
(a)

Based upon the average undrained shear strength of 1,800 lb/sq. ft., an overall slope height of 87 ft., and an average slope angle of 2.9 horizontal to 1 vertical, the results of a total stress stability analysis indicate a factor of safety of about 1.3 against movement. However, the undrained shear strength in the upper portion of Borehole 1 is typically in the range of 1,400 lb/sq. ft., and for this condition, the factor of safety under total stress conditions is about 1.0.

For an $r_u = 0.15$ (which is typical of the present piezometric conditions) a factor of safety of 1.2 would be present for a range of effective stress strength parameters from $c' = 200$ lb/sq. ft. and $\phi' = 20^\circ$, to $c' = 75$ lb/sq. ft. and $\phi' = 25^\circ$. However, for a value of $r_u = 0.30$ (which is probably the condition existing under high spring groundwater conditions), the factor of safety would be about 1.0 (see Fig. 9a).

RESULTS OF PRELIMINARY STABILITY ANALYSIS OF SECTION
ALONG LINE 2 (SEE FIG. 7)

Because of the present marginal slope conditions, it is recommended that overall slopes of about 4 (horizontal) to 1 (vertical) should be used for feasibility design computations and that the south abutment for any proposed bridge structure should be founded on steel H-piles driven to a firm founding strata. Prior to carrying out final design, a detailed geotechnical investigation should be carried out to determine the actual effective stress shear strength parameters and pertinent geotechnical properties of the foundation soils.

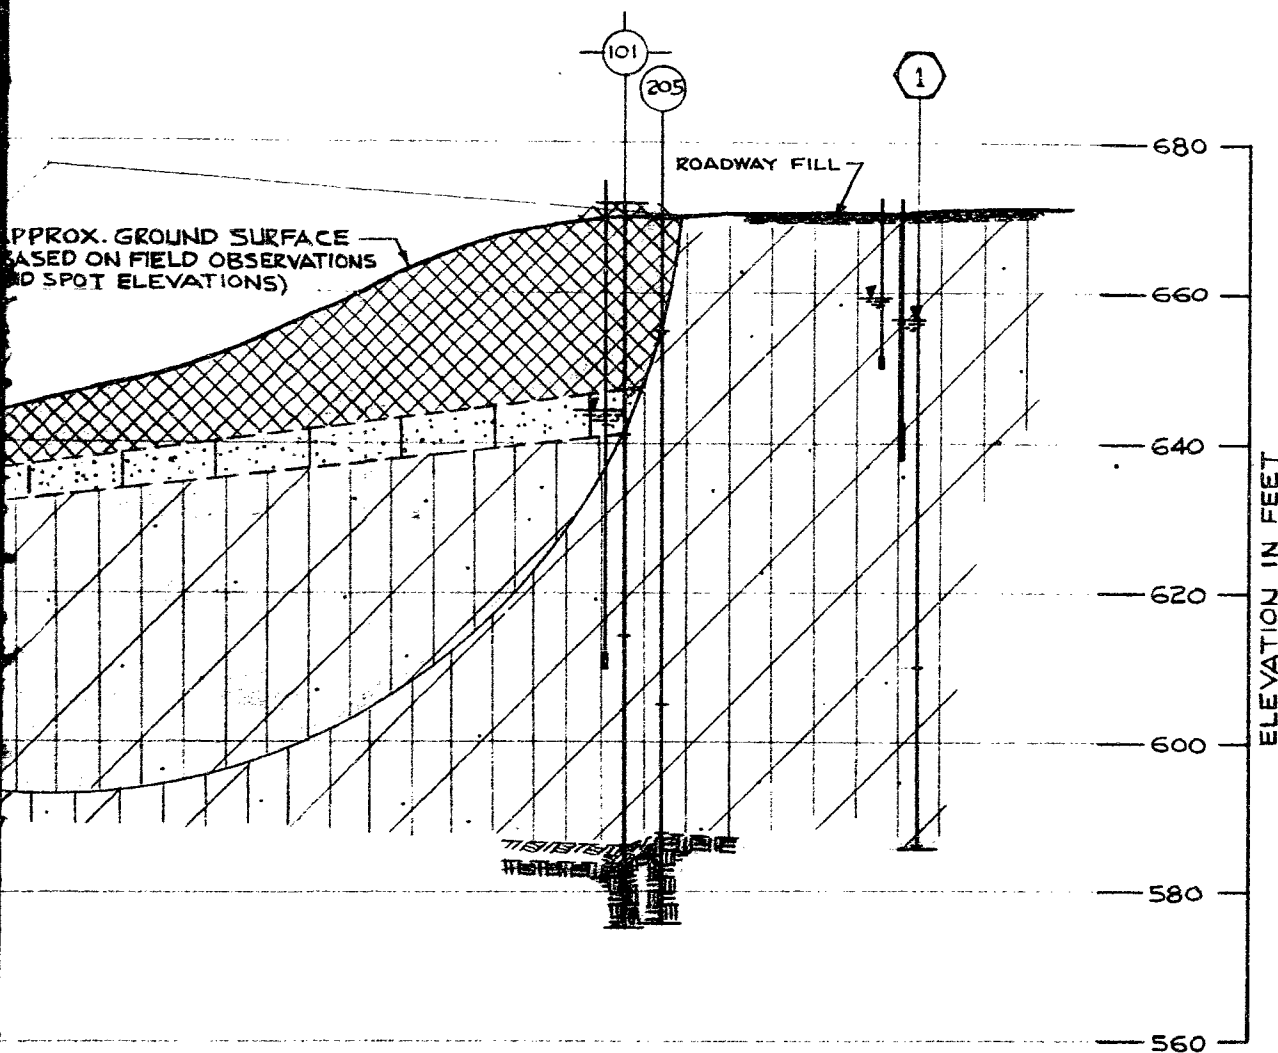
ILLUSTRATIVE SECTION THROUGH "1957" FAILURE

- FILL REPORTEDLY PLACED AFTER "1957" FAILURE
- SANDY SILT ZONES
- ESSENTIALLY HORIZONTALLY BEDDED LACUSTRINE SILTS AND CLAYS.
- ERRATICALLY BEDDED LACUSTRINE SILTS AND CLAYS (SLIDE DEBRIS)
- WEATHERED BEDROCK
- FAIRLY SOUND TO SOUND BEDROCK

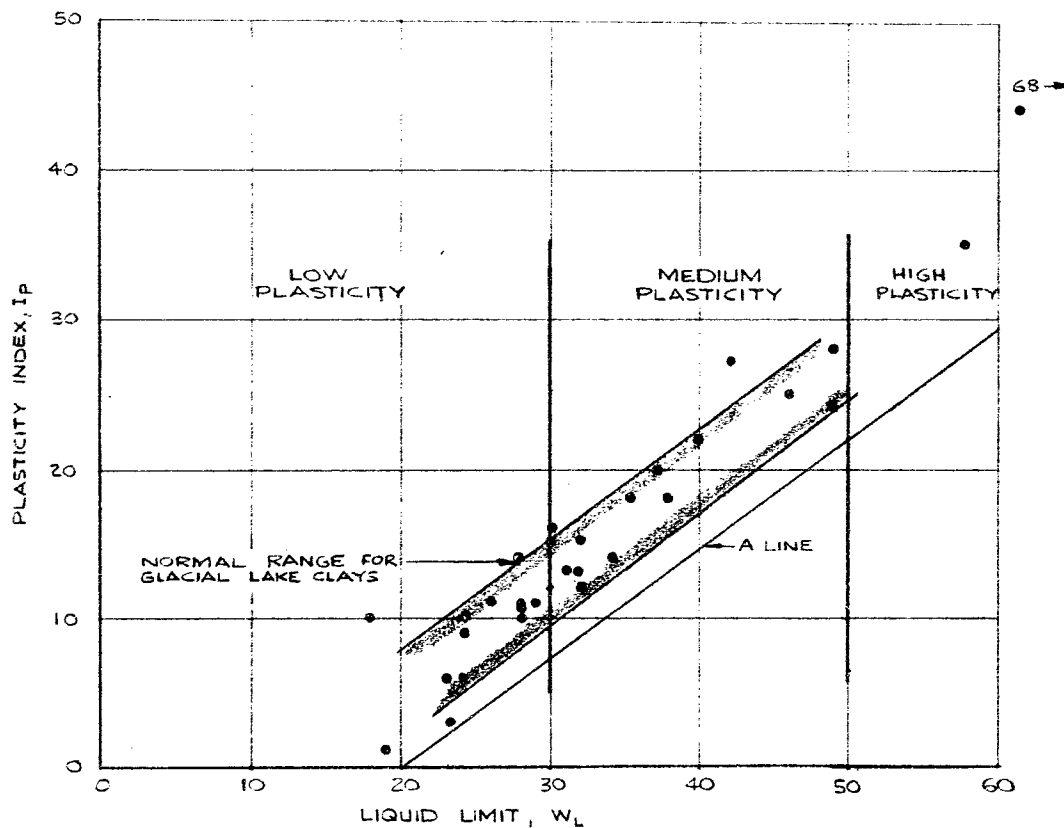
FIGURE 7

As indicated on Figure 7 the plasticity of the material is typical for a glacial lake clay and, excluding cohesionless silt layers, the material in individual layers ranges from a clayey silt of low plasticity to a silty clay of high plasticity. The in situ water content of the layers (see Figure 6) generally ranges between about 20 and 40 per cent and the liquidity index of the materials is generally less than about 0.5. However, in occasional layers a liquidity index of as high as about 1 was determined.

PLASTICITY CHART LAGUSTRINE DEPOSITS

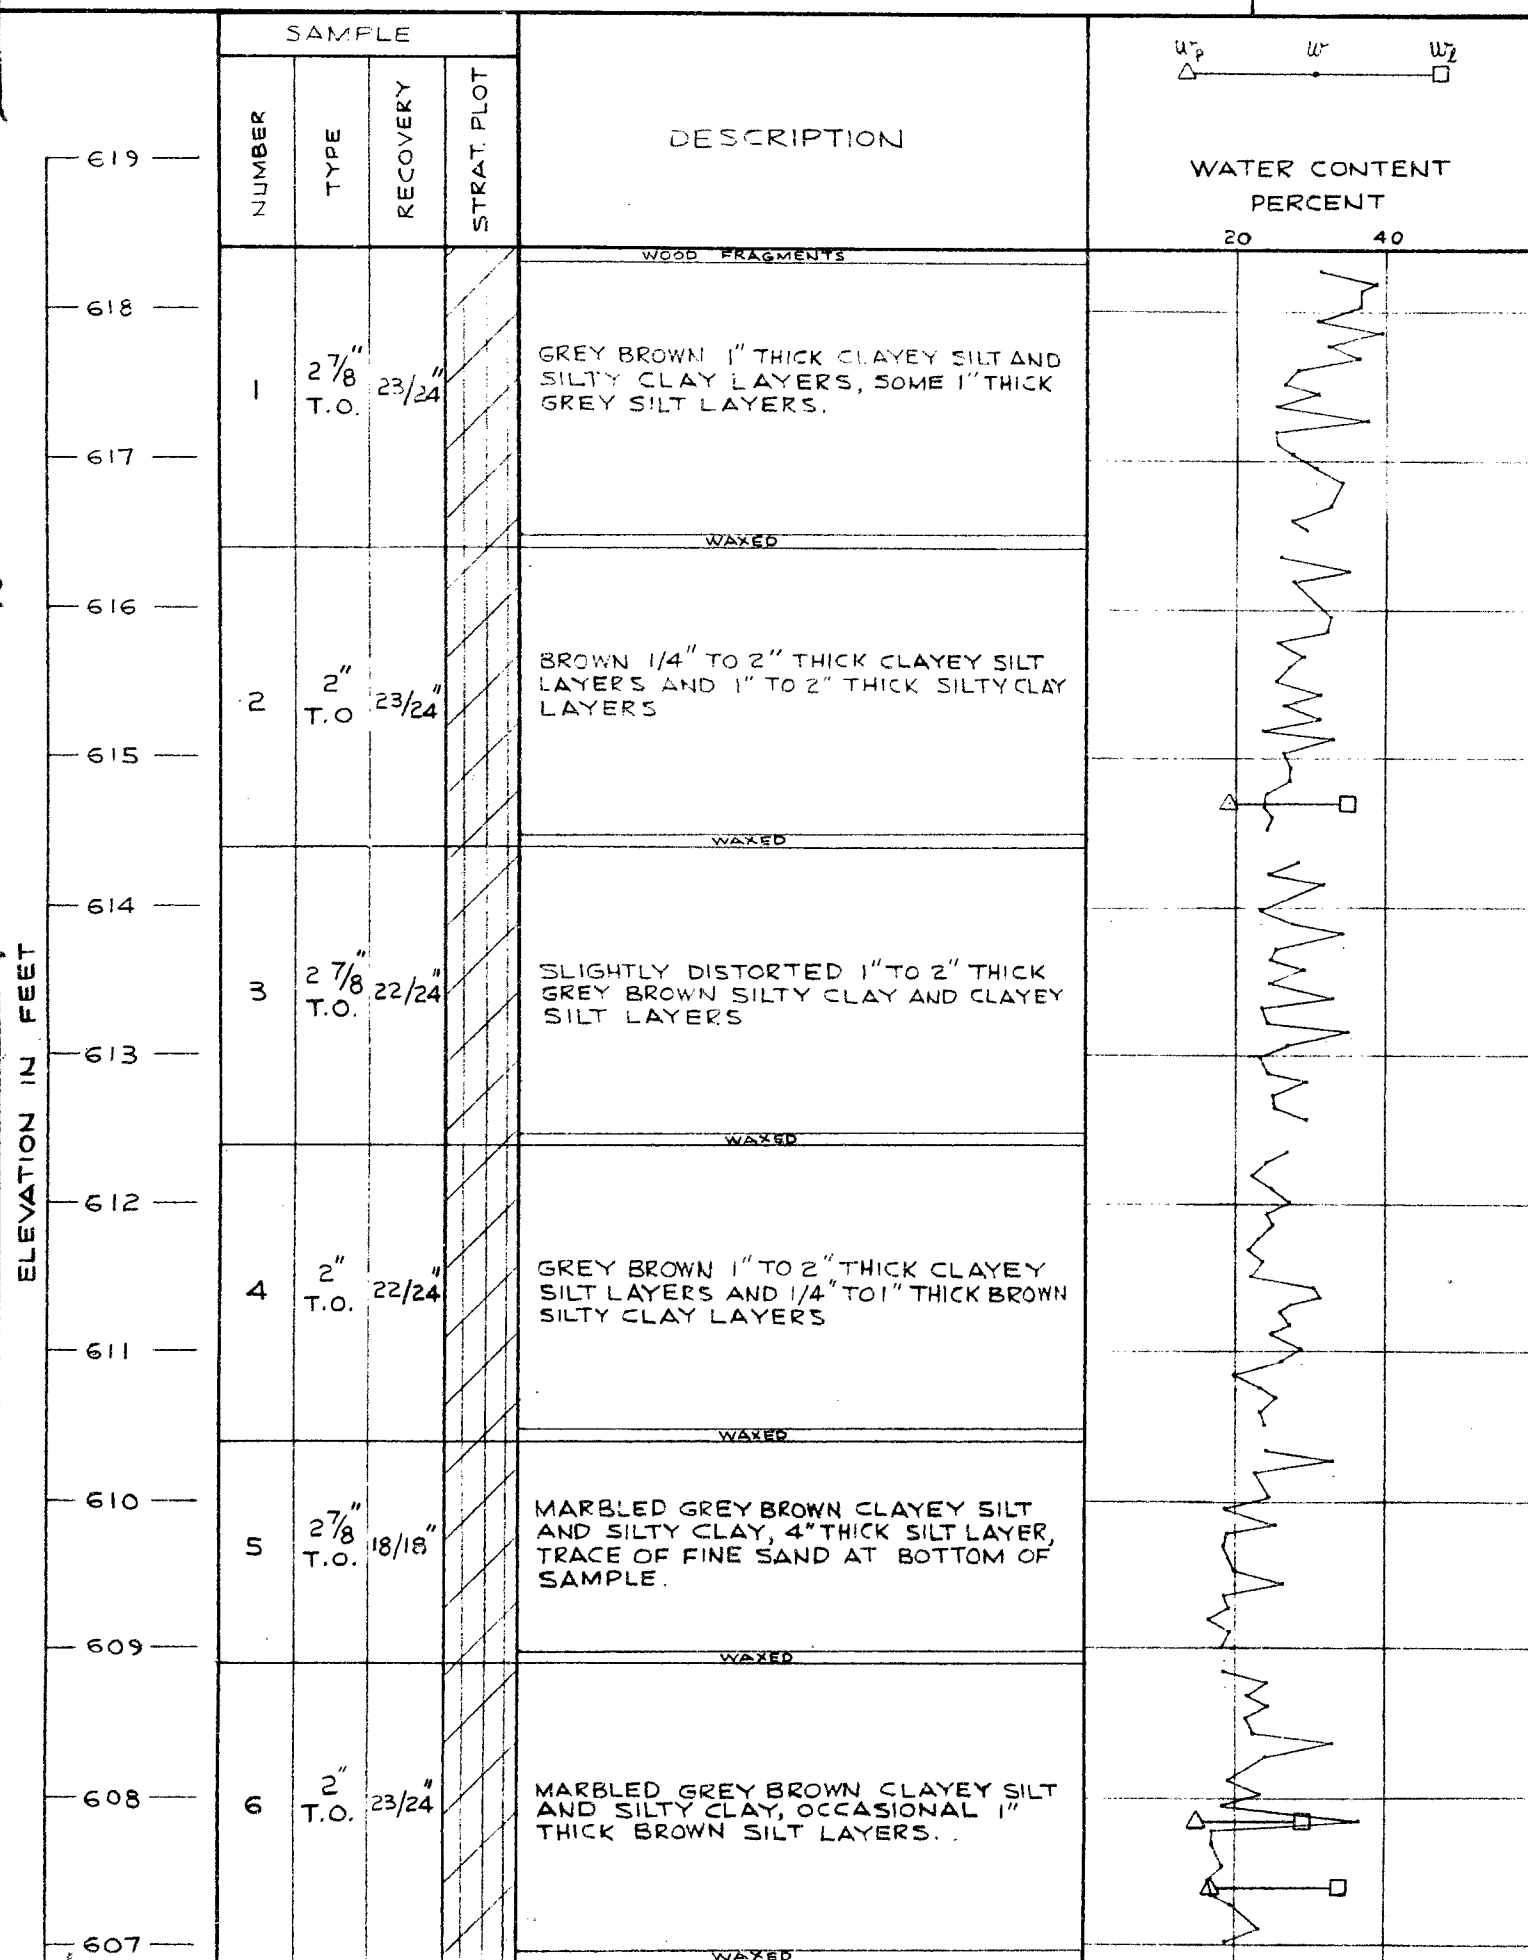
FIGURE 9

A detailed examination of the series of continuous, undisturbed samples which were obtained in borehole 203 between depths of 30 and 41.5 ft. (elevation 618.5 to 607) showed that the layering of these samples was approximately horizontal. Based on these observations we conclude that the soil in borehole 203 has not been disturbed by the adjacent slide movements. It should also be noted that the 11.5 ft. interval which was examined in detail in borehole 203 was chosen to correspond to the depth at which the reported failure of the adjacent south bridge abutment had occurred in 1945. No evidence of a failure plane was noted in the soil samples, and the detailed water content profile which was taken along the samples (as plotted on Figure 9) shows no abnormal trend in water content, which would normally be associated with a major slip surface.

SUMMARY OF WATER CONTENTS - BH. 203 DEPTH 30' TO 41.5'

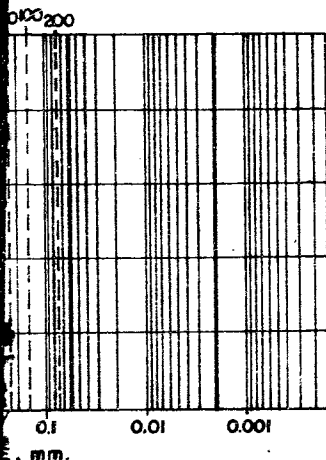
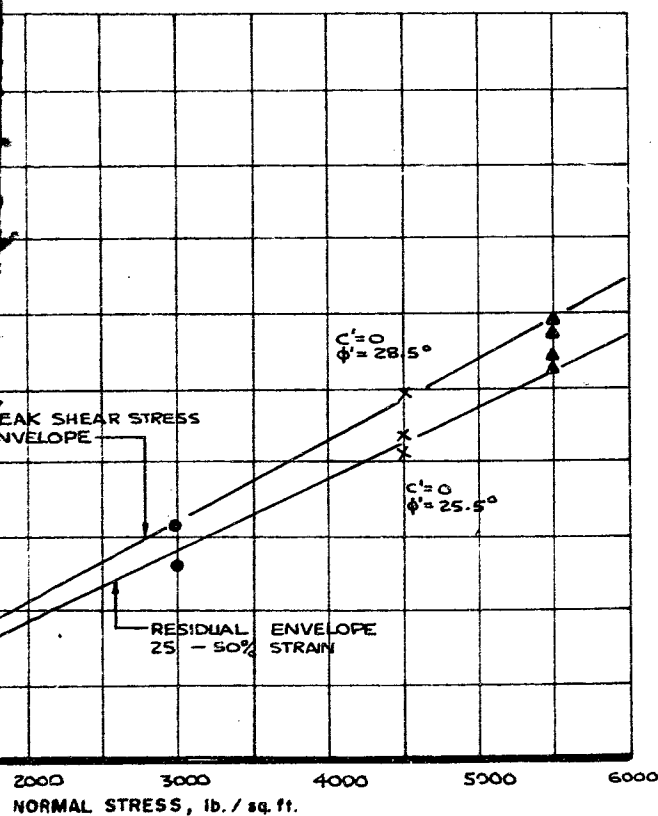
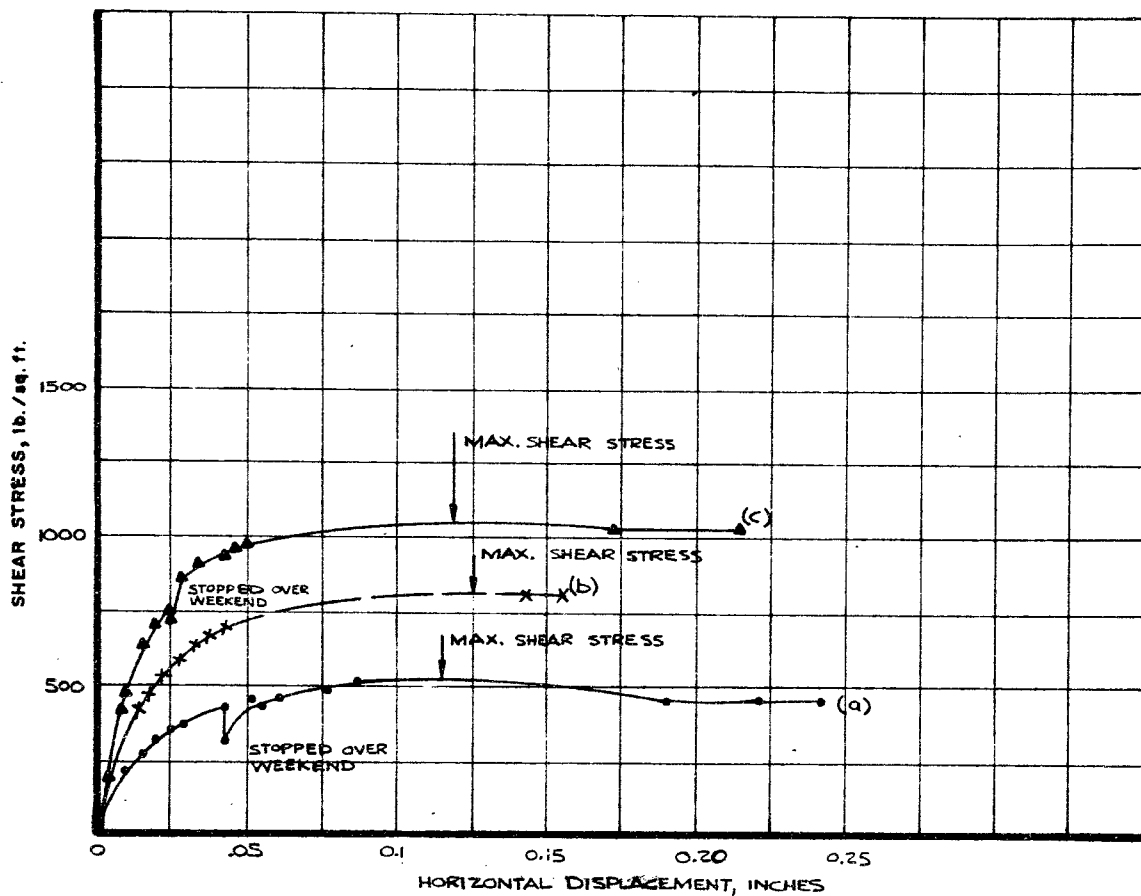
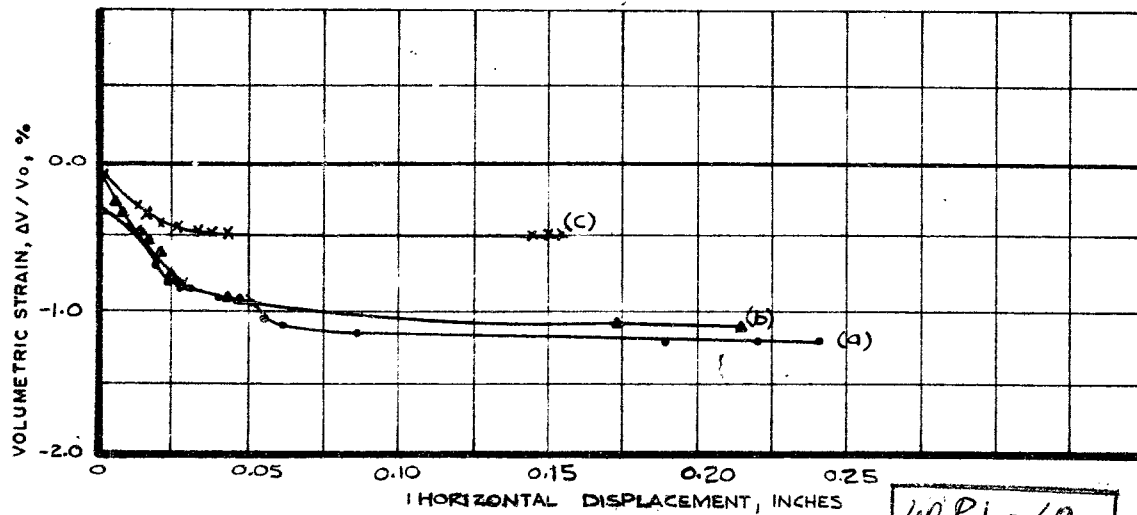
FIGURE 11

The results of residual strength tests carried out on sample 17, borehole 101, (see Figure 11) indicate that the residual shear strength of the material is about 90 per cent of the available peak strength.

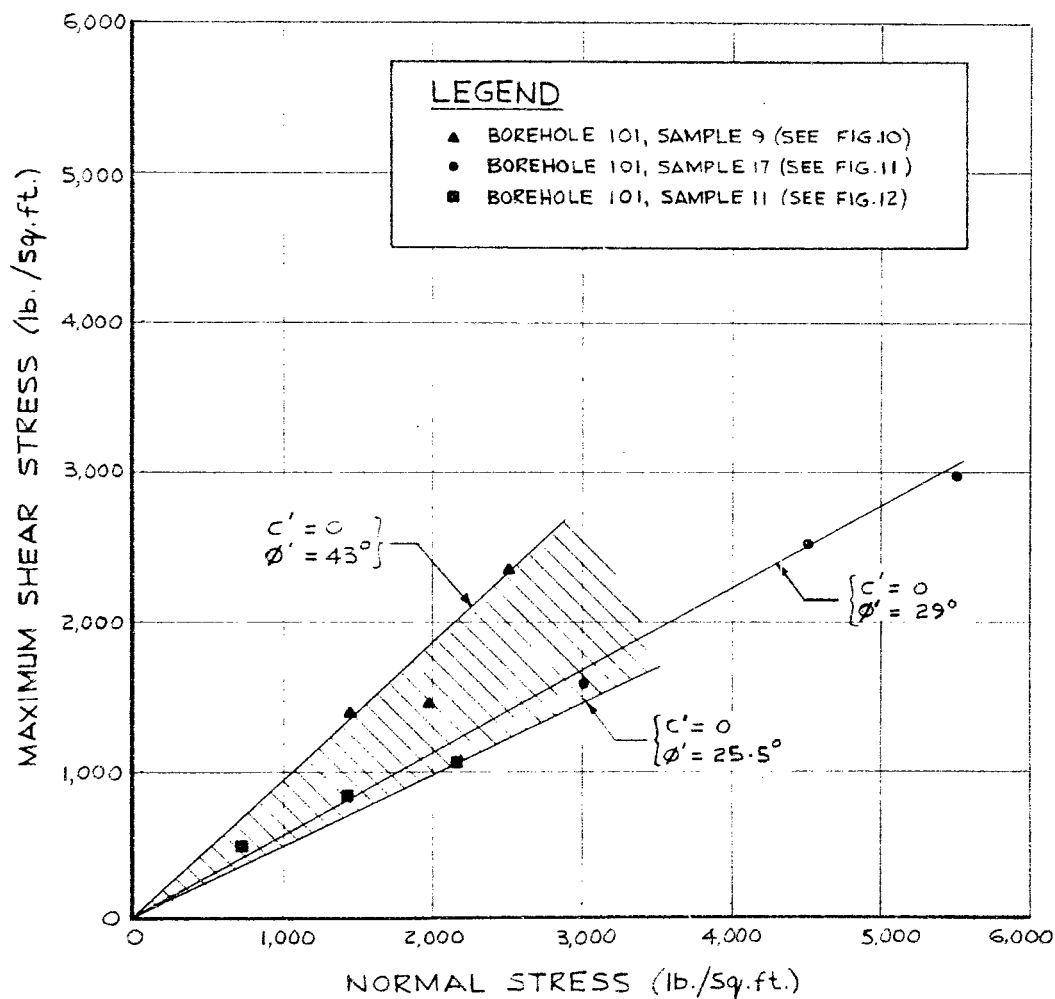
FIGURE 13

Based on a "best guess" groundwater level in the slope and assuming a purely frictional material (i.e. $c' = 0$) the results of the effective stress sliding wedge analysis indicate that the "critical" plane of failure is somewhat higher than for the case of the total stress analysis and that the angle of shear resistance, ϕ , required for stability is about 25 degrees for the case of a 2 horizontal to 1 vertical slope and about 29 degrees for a $1\frac{1}{2}$ horizontal to 1 vertical slope. For the case of the steeper slope, the required, ϕ , agrees closely with the average measured, ϕ , from laboratory tests (see Figure 13).

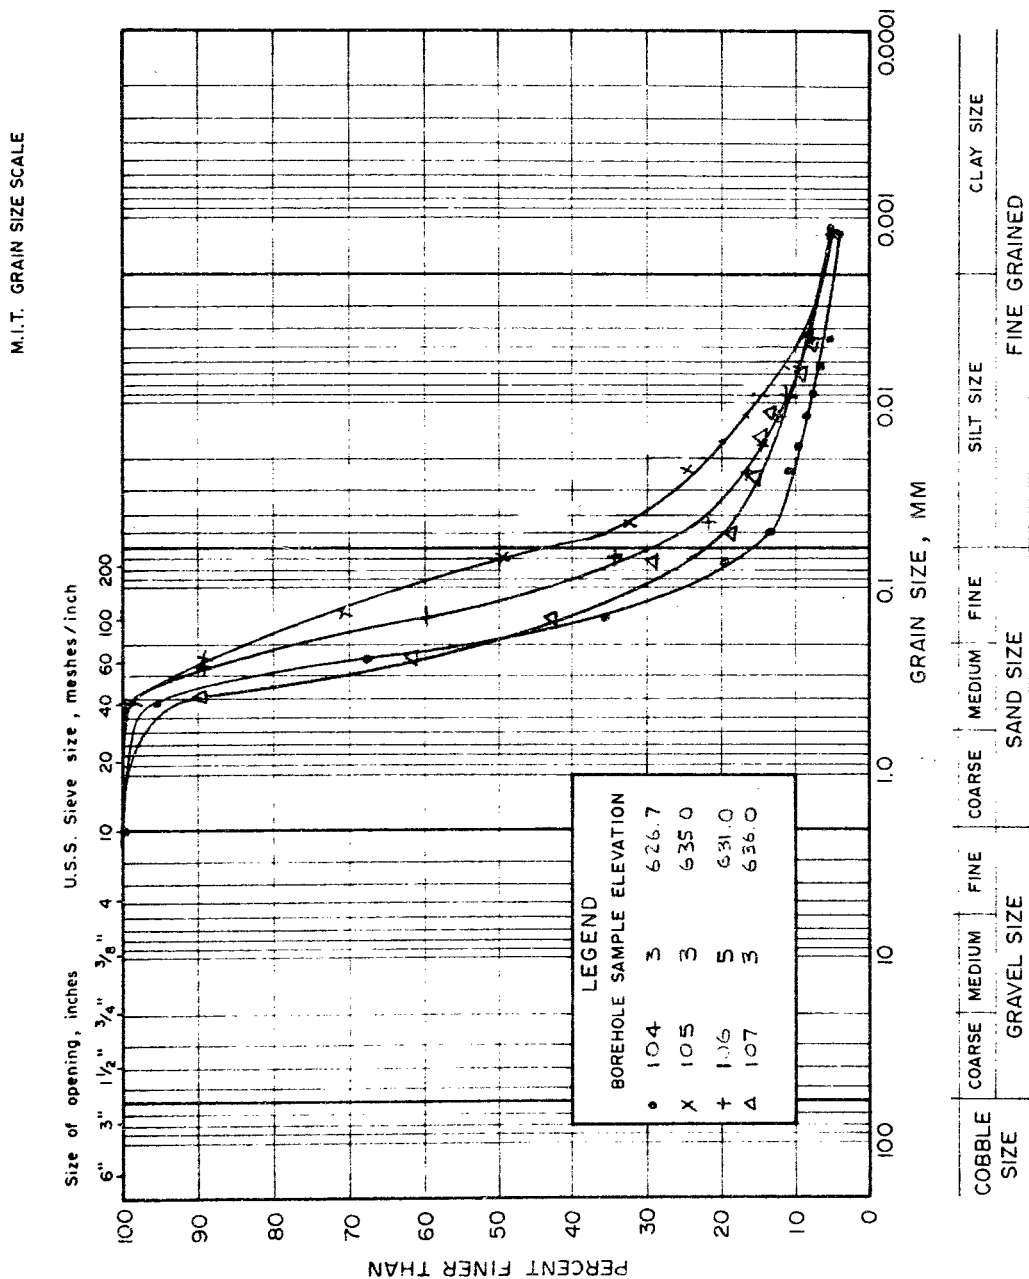
FIGURE 16

Excluding the existing roadway embankment fill and local topsoil deposits, boreholes 104 to 107 inclusive, which were put down across the valley flood plain, encountered a surficial silty sand deposit which is probably of recent alluvial origin. Gradation curves of typical samples of this deposit are given on Figure 16. Based on the results of standard penetration tests which gave 'N' values ranging between 4 and 12 blows/ft. the silty sand is in a generally loose state of packing.

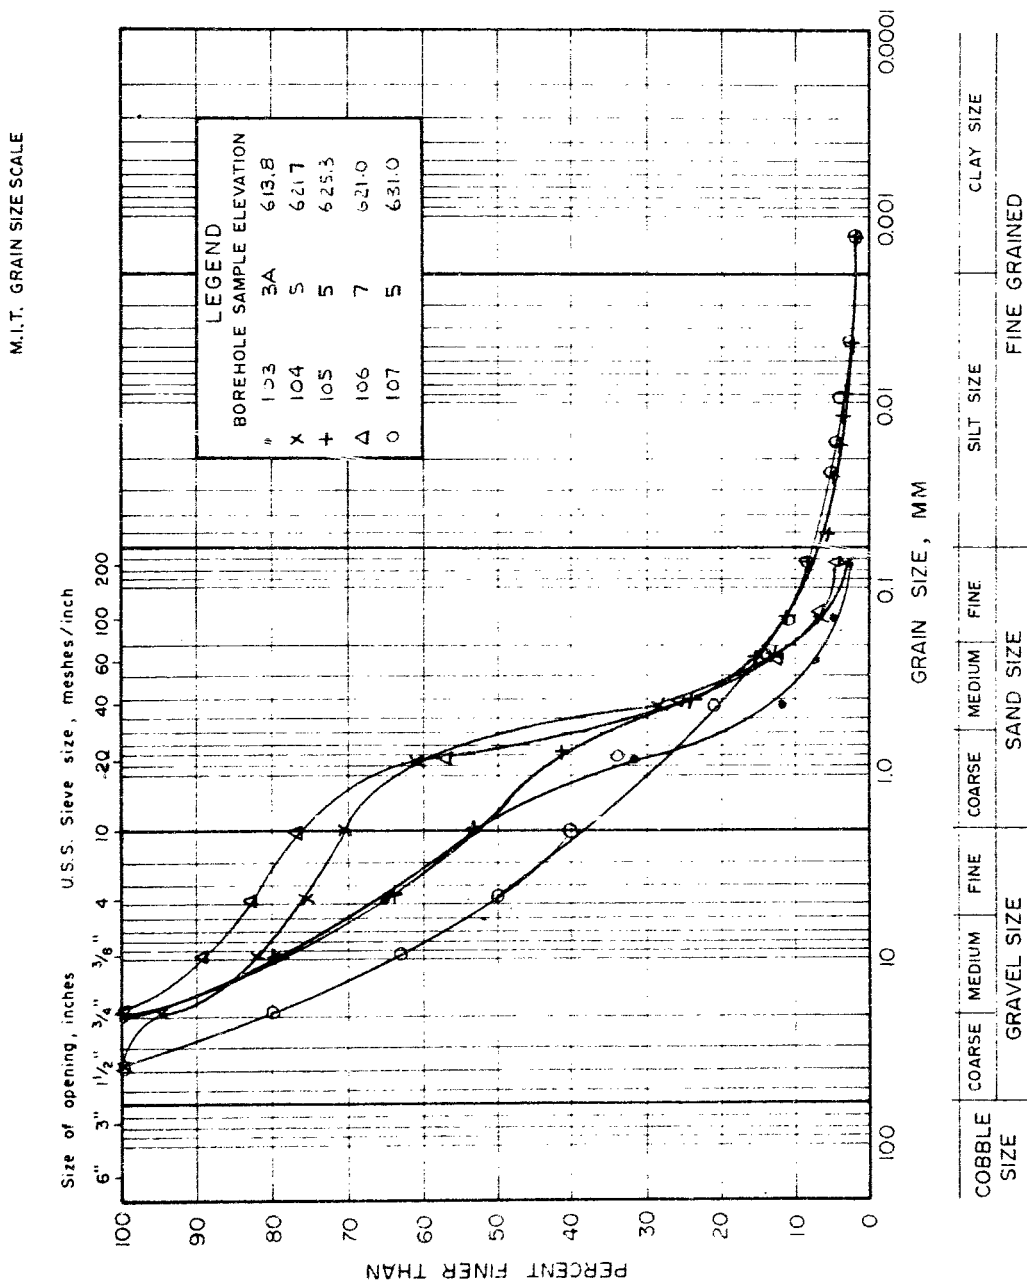
FIGURE 17

Underlying the recent alluvium and the existing river channel (borehole 103), the borings encountered some 5 to 15 feet of sand and gravel. As indicated on Figure 17 (gradation curves) the sand and gravel deposit is relatively clean (silt content of less than about 10 per cent). Based on these gradation curves and field observations, the sand and gravel is relatively pervious with an estimated coefficient

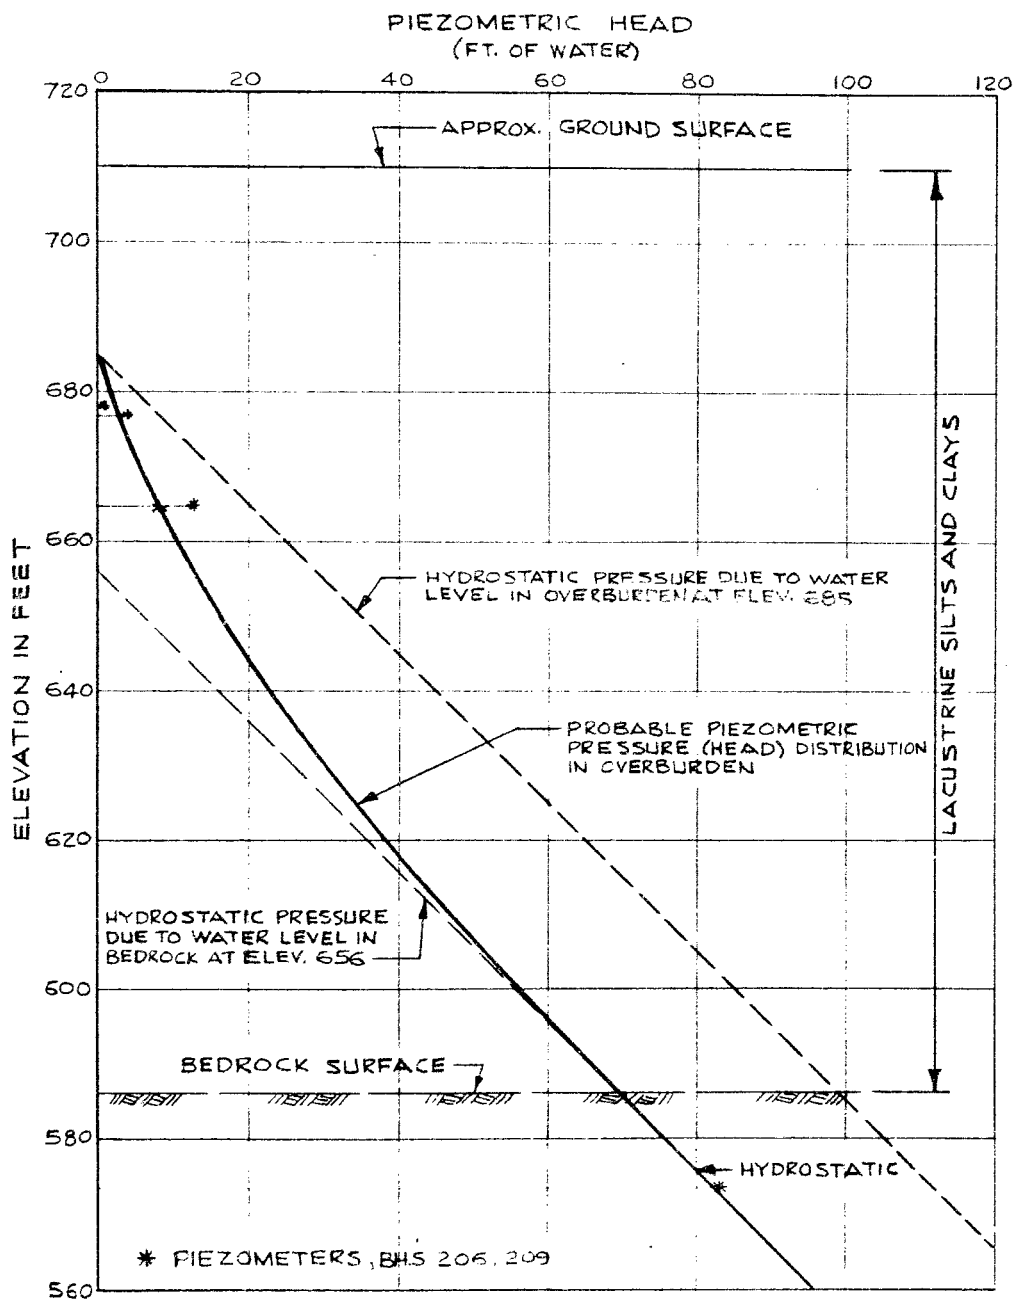
FIGURE 21

Within the undisturbed material behind the 1957 failure, downward seepage of surface water into the bedrock and lateral seepage towards the existing approach cut and the face of the valley bank is occurring. Behind the crest of the existing valley bank (boreholes 206, 207 and 209) the piezometric water level varies with depth from a phreatic surface at about elevation 680 to 685 to a level corresponding to the piezometric pressure in the underlying bedrock (see Figure 21).

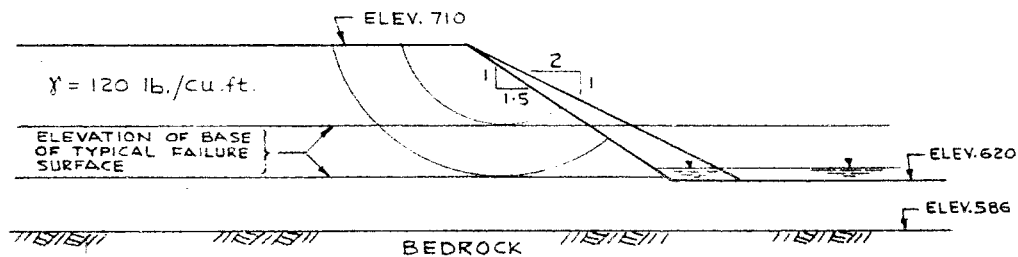
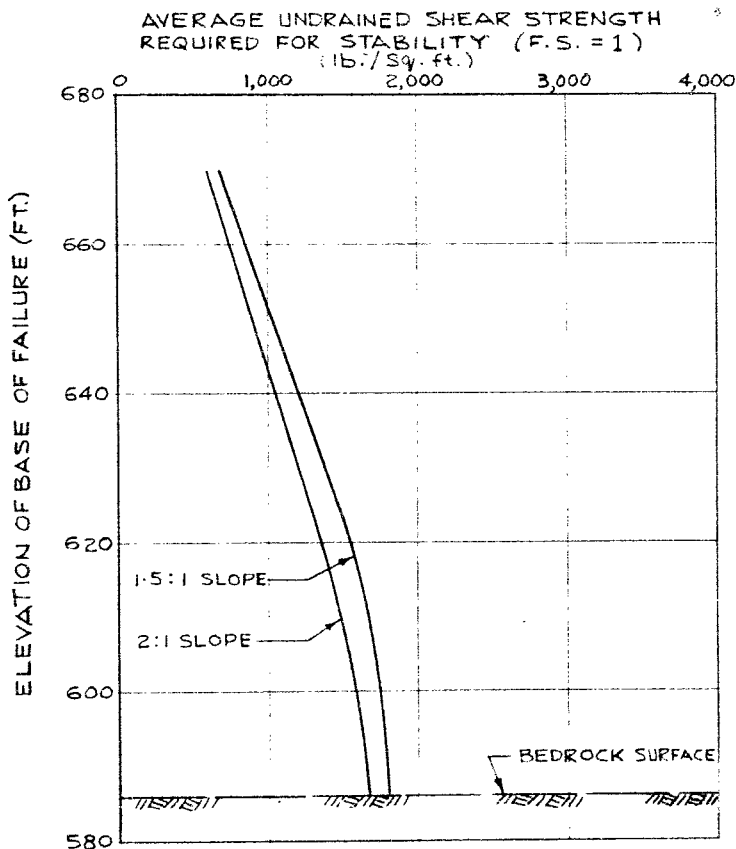
FIGURE 24

The 1957 failure was also "back-analysed" assuming a conventional circular arc failure surface and using published slope stability charts (Terzaghi and Peck, 1948). The results of this analysis (based on total stress conditions) are summarized on Figure 24 and indicate that for a deep-seated failure surface the required average undrained shear strength for stability is about 1,700 to 1,800 lb/sq.ft. ($1\frac{1}{2}$ to 2 horizontal to 1 vertical overall slope). As the average measured undrained shear strength below about elevation 670 (see Figure 6) is only about 1,500 lb/sq.ft. failure could be anticipated for slopes flatter than apparently existed at the time of the actual failure.

It should be noted from Figure 6 that the lowest actual measured undrained shear strengths occur between about elevations 620 and 660 (minimum average shear strength of about 1,200 lb/sq.ft.) However, based on the results of the total stress stability analyses (see Figure 24) and considering the presence of the stiffer overlying crustal material (estimated average undrained shear strength of about 3,000 lb/sq.ft. above elevation 670), a deep-seated failure surface extending to or close to the bedrock will probably be more critical despite the trend for increasing strength with increasing depth (see Figure 6).

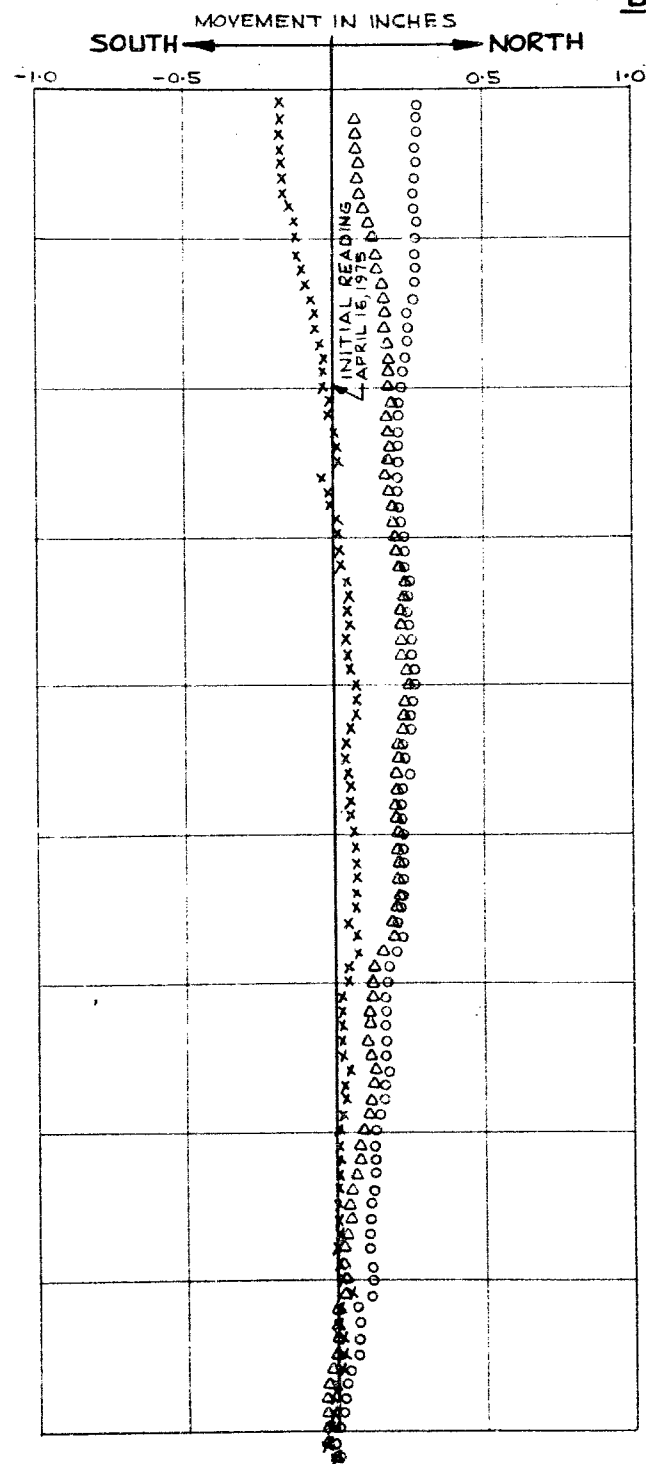
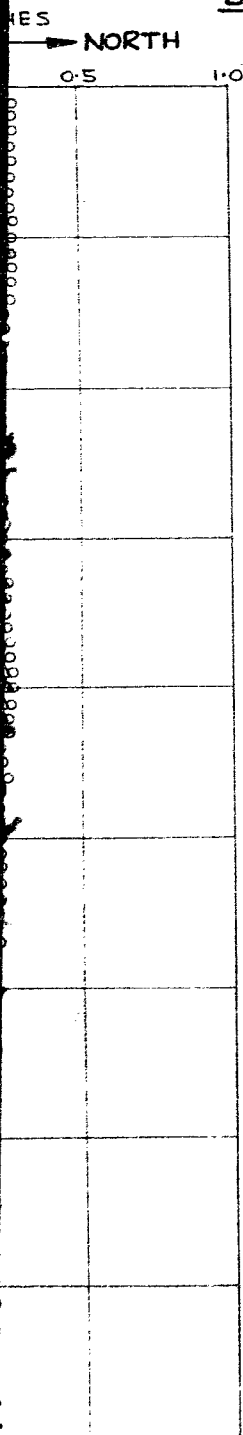
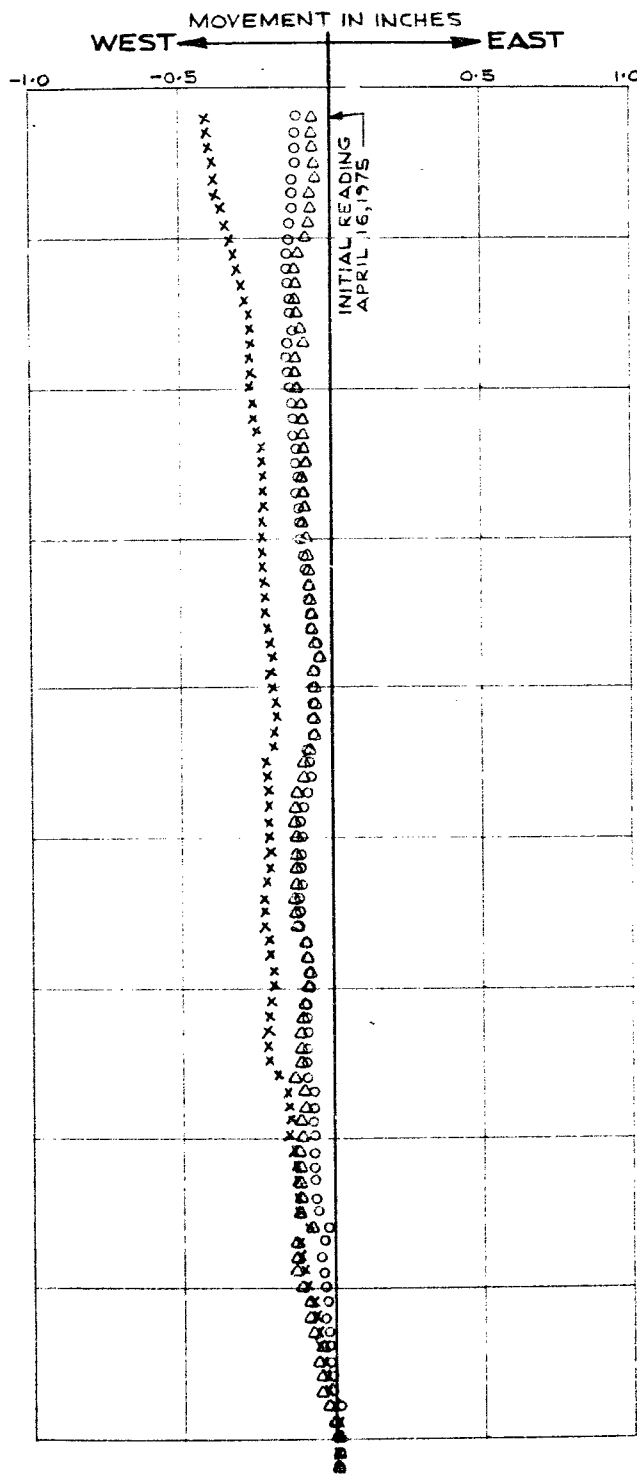
SLOPE INDICATOR No. 2

BOREHOLE 205

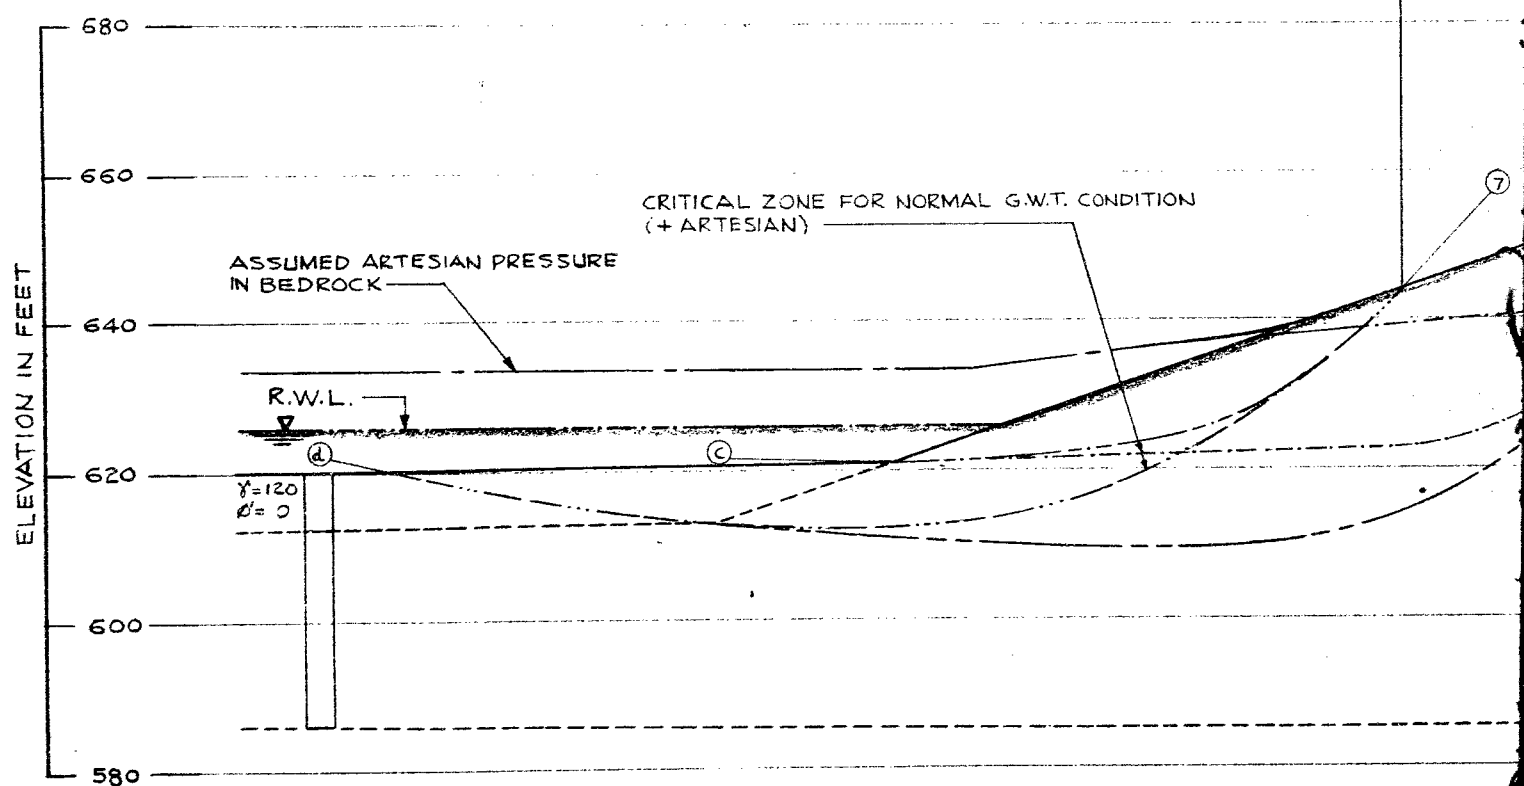
FACTOR OF SAFETY
ASSUMING NORMAL G.W.L.

- TRIAL SURFACES TANGENT TO ELEV. 620-624
CLAYEY SILT $\phi' = 30^\circ$, $C' = 0$, $\gamma = 130$, $\gamma' = 65$
- TRIAL SURFACES TANGENT TO ELEV. 610
CLAYEY SILT $\phi' = 30^\circ$, $C' = 0$, $\gamma = 130$, $\gamma' = 65$
SAND AND GRAVEL $\phi' = 0$, $C' = 0$, $\gamma = 120$, $\gamma' = 57$

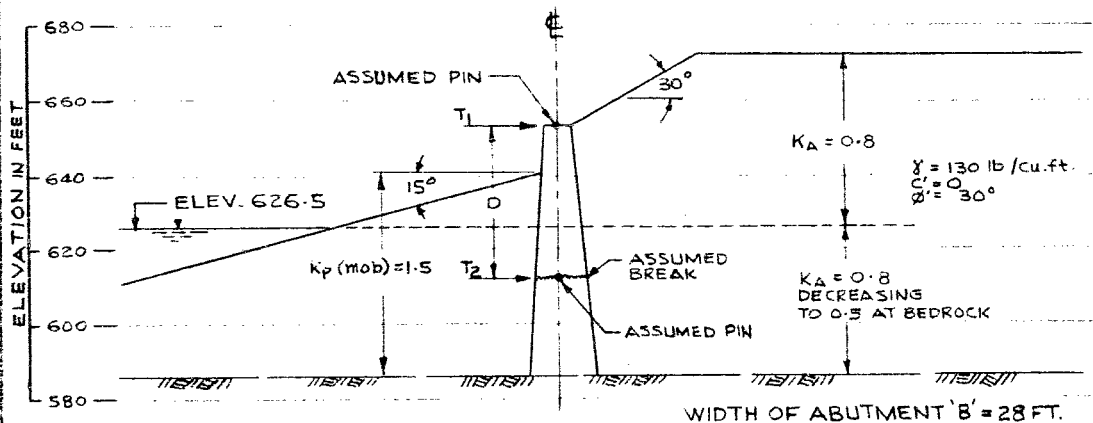
KEY SECTION

T_1 - THRUST AT TOP OF ABUTMENT DUE TO ROTATION AT BREAK.

T_2 - SHEAR FORCE AT BREAK DUE TO ROTATION AT TOP OF ABUTMENT.

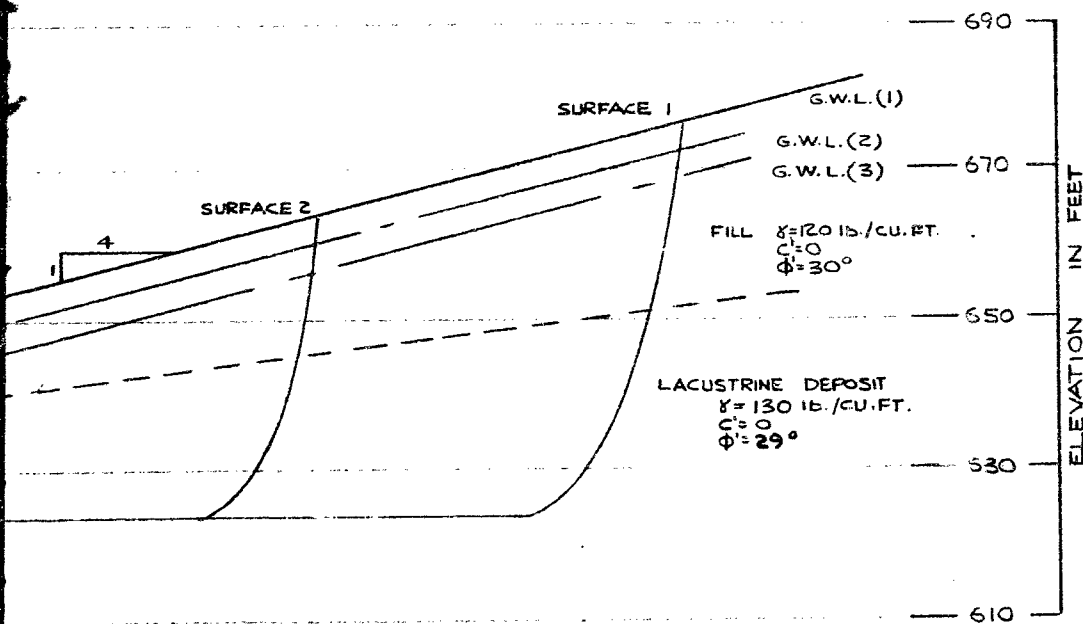
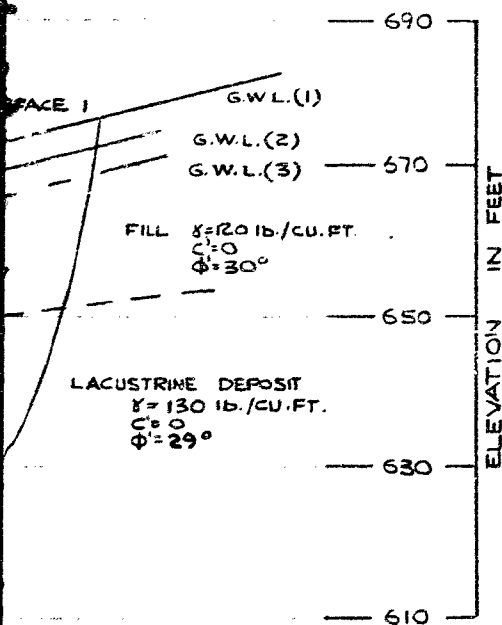
FIGURE 30

SUMMARY OF STABILITY ANALYSIS PROPOSED SLOPE
