HWY # 81

BRIDGE

Memo to Mr. A. M. Toye, **Date** December 11, 1959.
Bridge Engineer. **Subject** SOIL & STABILITY ANALYSIS
From Materials & Research Section. by Geoccon, Limited.

S6636
REPORT
TO
DEPARTMENT OF HIGHWAYS, ONTARIO
ON
ENGINEERING STUDY
HIGHWAY 81 STA. 53+00 - STA. 55+00
AUSABLE RIVER BRIDGE

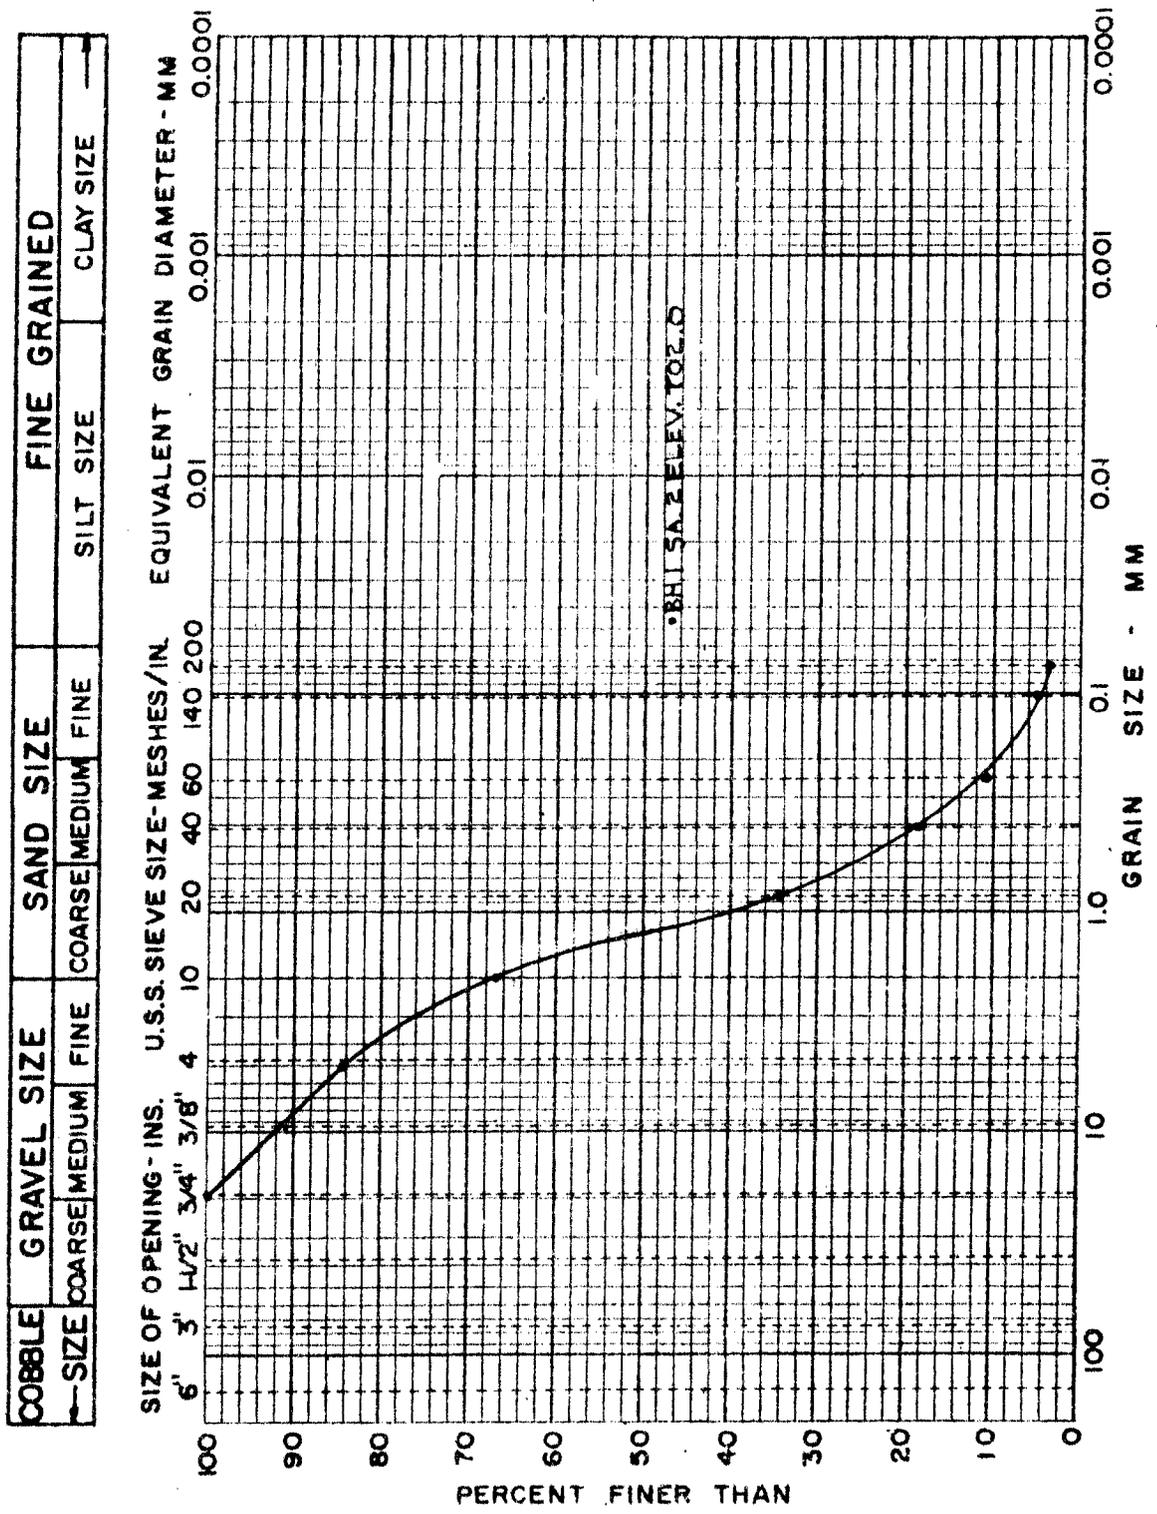
APPENDIX 11
 FIGURE 2
 PROJECT 56636

abutment excavation to grade. The fill consists of fine gravel and sand in all grainsizes. It has a fairly high silt content as indicated by the grainsize distribution curve in Figure 2 of Appendix II.

GRAIN SIZE DISTRIBUTION

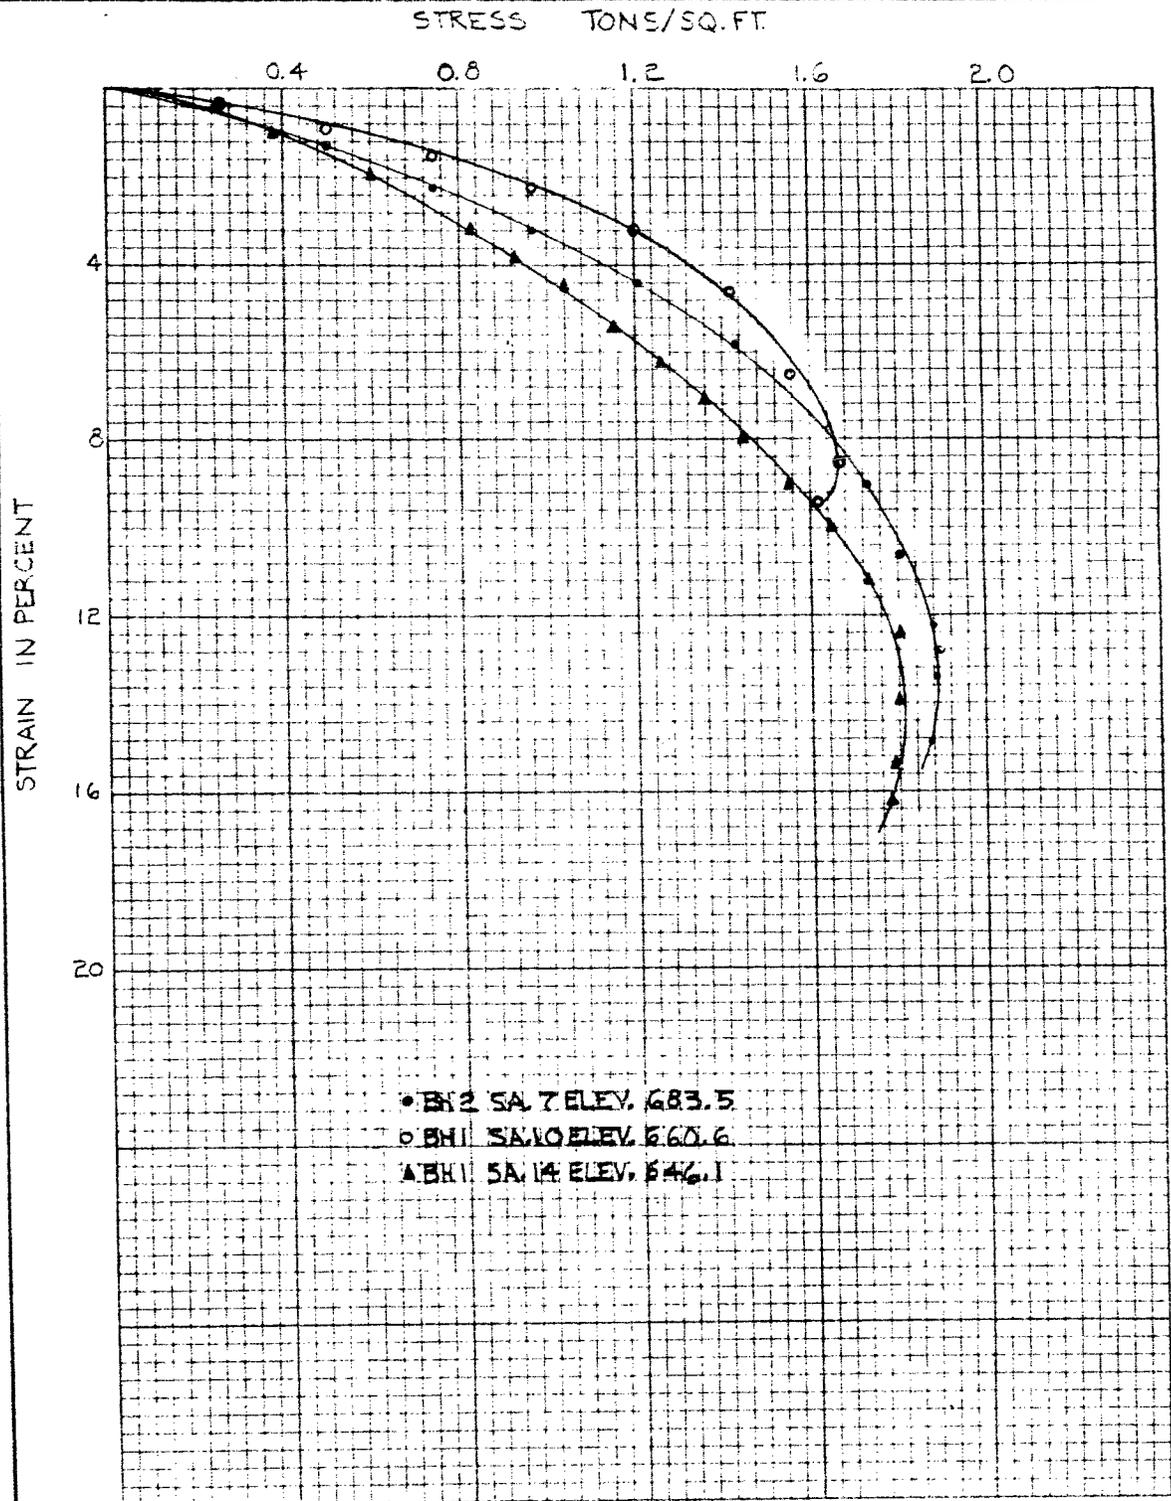
APPENDIX 11
FIGURE 3
PROJECT 56636

Typical stress-strain curves obtained from the unconfined compression tests are given on Figure 3 of Appendix II. The mean strain at failure for the triaxial tests was about 4 per cent.

UNCONFINED COMPRESSION TESTS
VARVED SILTY CLAY
TYPICAL STRESS-STRAIN CURVES

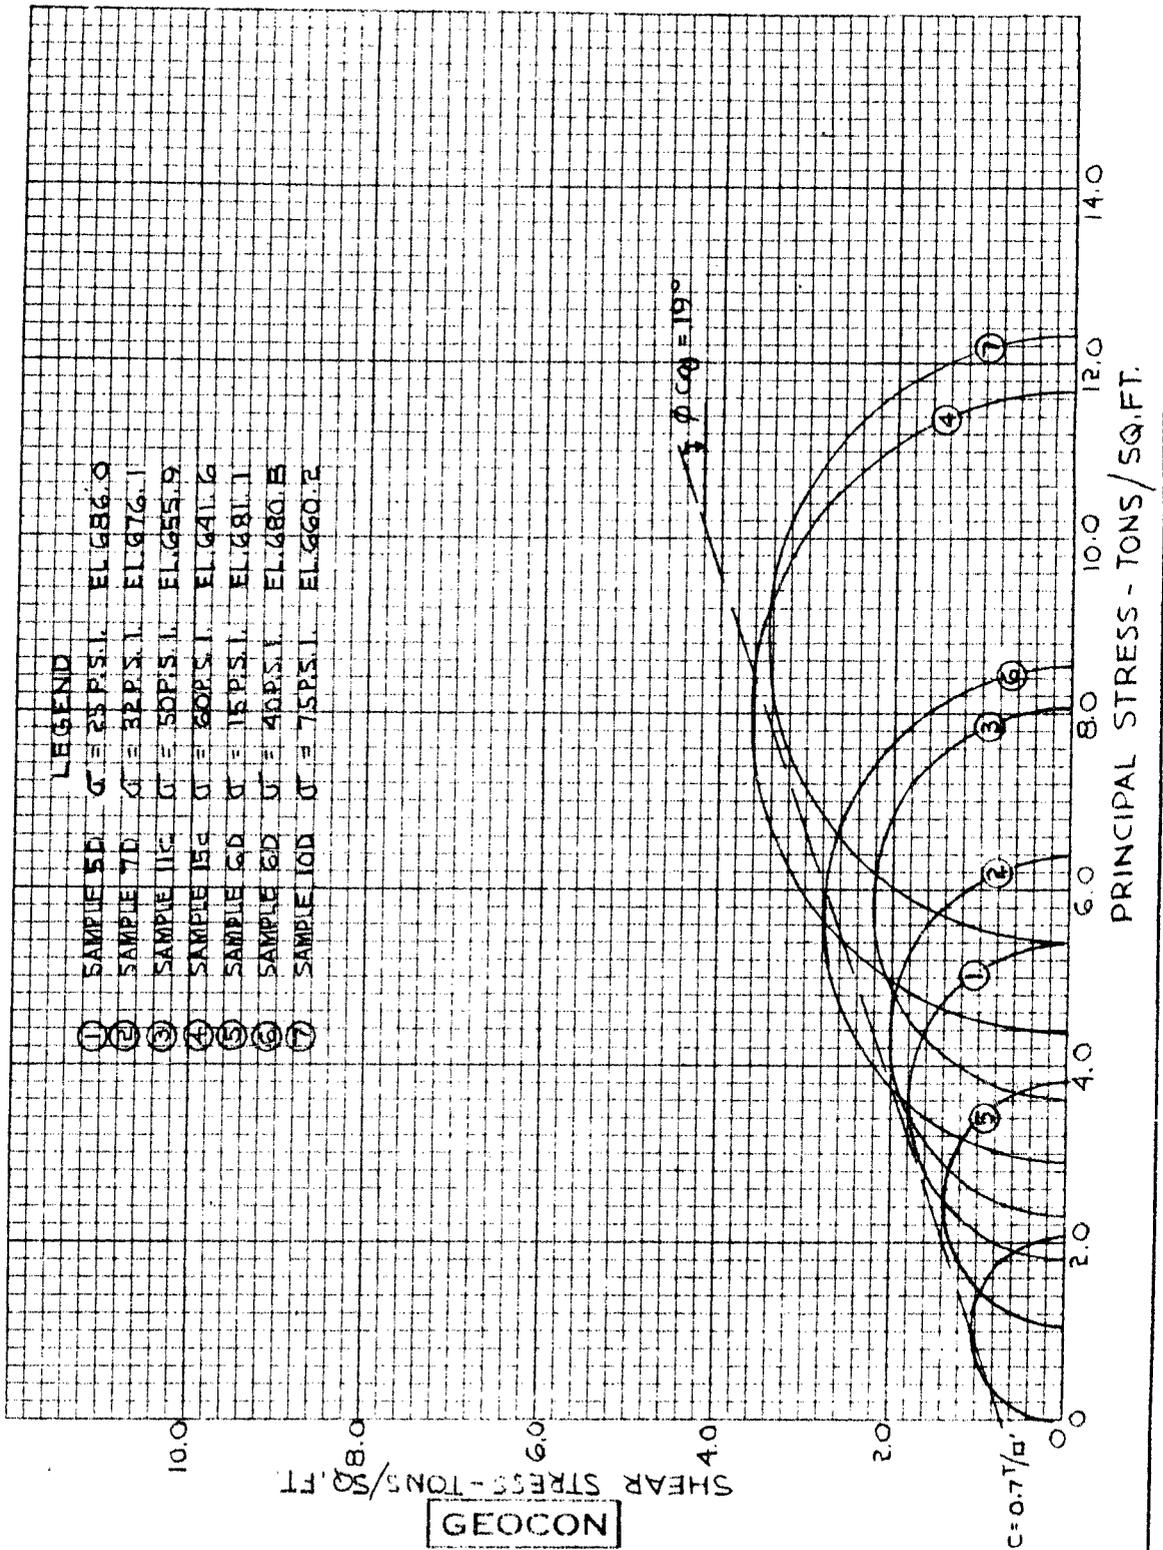
APPENDIX 11
 FIGURE 4
 PROJECT 56636

A number of consolidated quick triaxial tests were carried out and the resulting Mohr stress circles are given on Figure 4. The apparent angle of shearing resistance obtained for the failure envelope is 19 degrees at an apparent cohesion of 1400 pounds per square foot.

MOHR'S CIRCLES
 CONSOLIDATED QUICK TRIAXIAL TESTS
 BOREHOLE 1

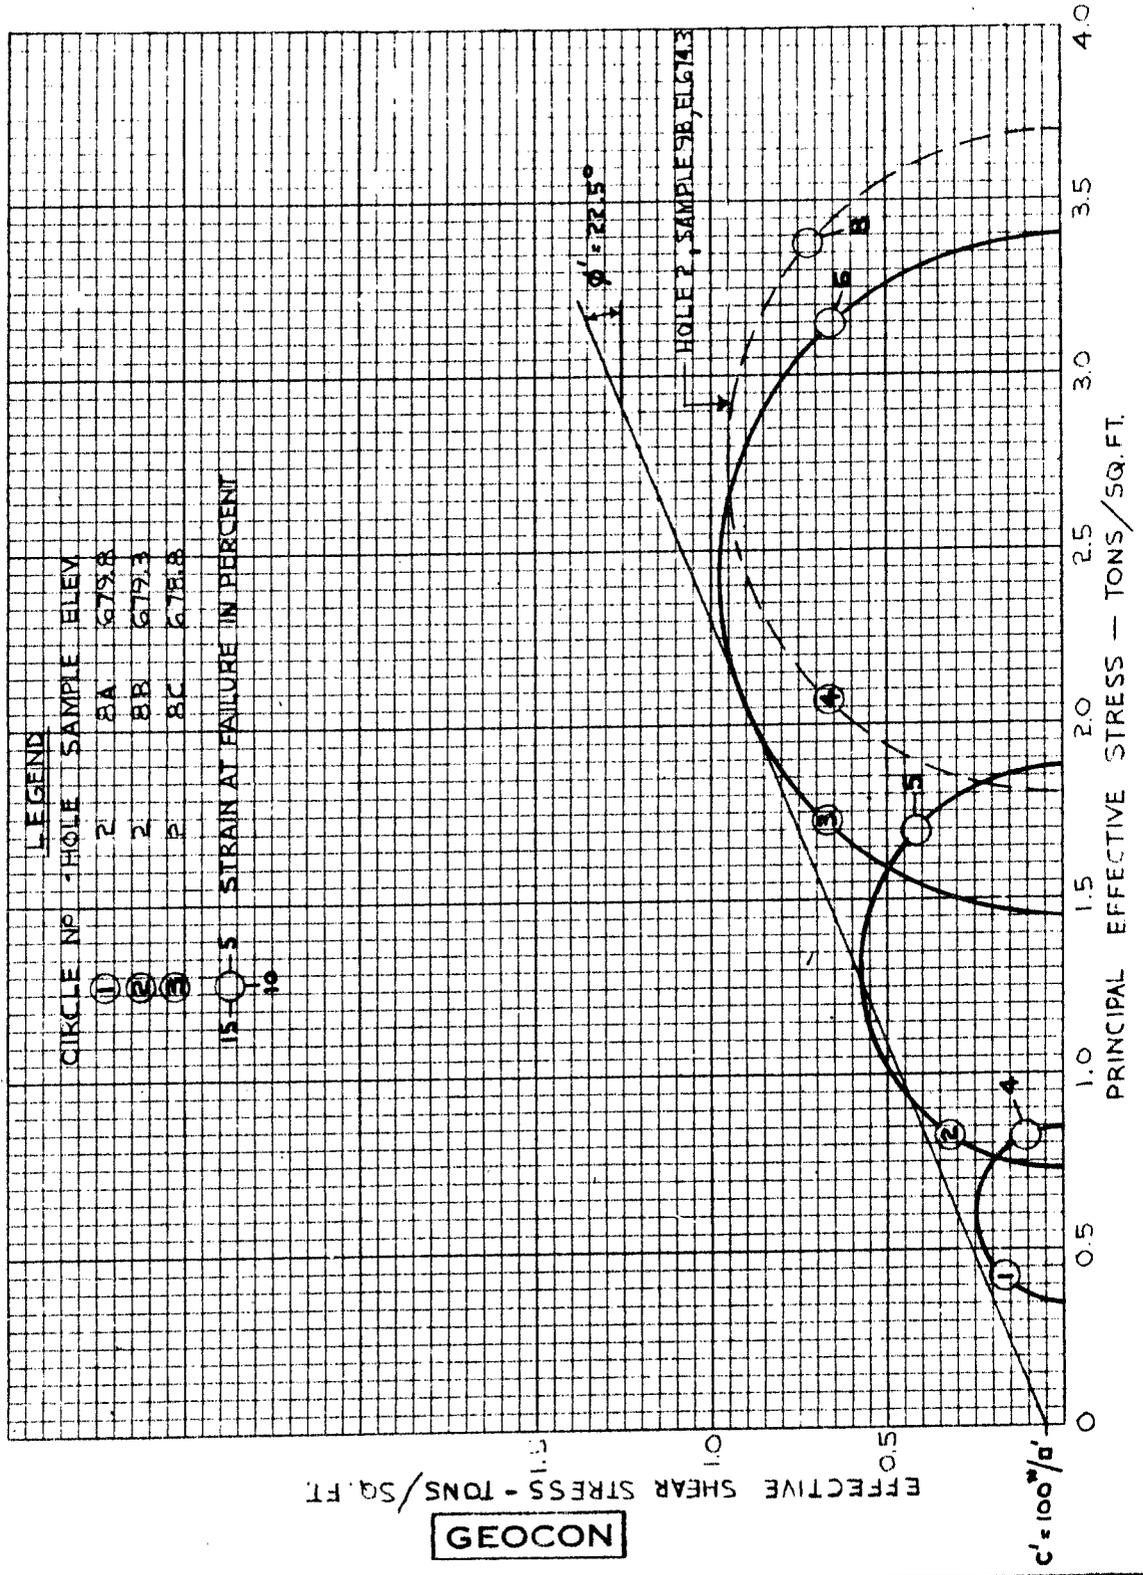
APPENDIX 11
FIGURE 5
PROJECT 56636

Two series of slow drained triaxial tests were carried out. The initial series of tests is plotted on Figure 5, Appendix II. This series is combined with the following series on Figure 6, Appendix II. It is significant to note that an almost constant failure envelope to both series of tests is obtained, giving strength parameters C' of 150 pounds per square foot and ϕ' of 22 degrees. The divergence from this relationship by 2 of the 7 tests is considered due to the radical variation in index properties of these samples. This variation is noted on the Figures.

MOHR'S CIRCLES SLOW DRAINED TRIAXIAL TESTS VARVED SILTY CLAY

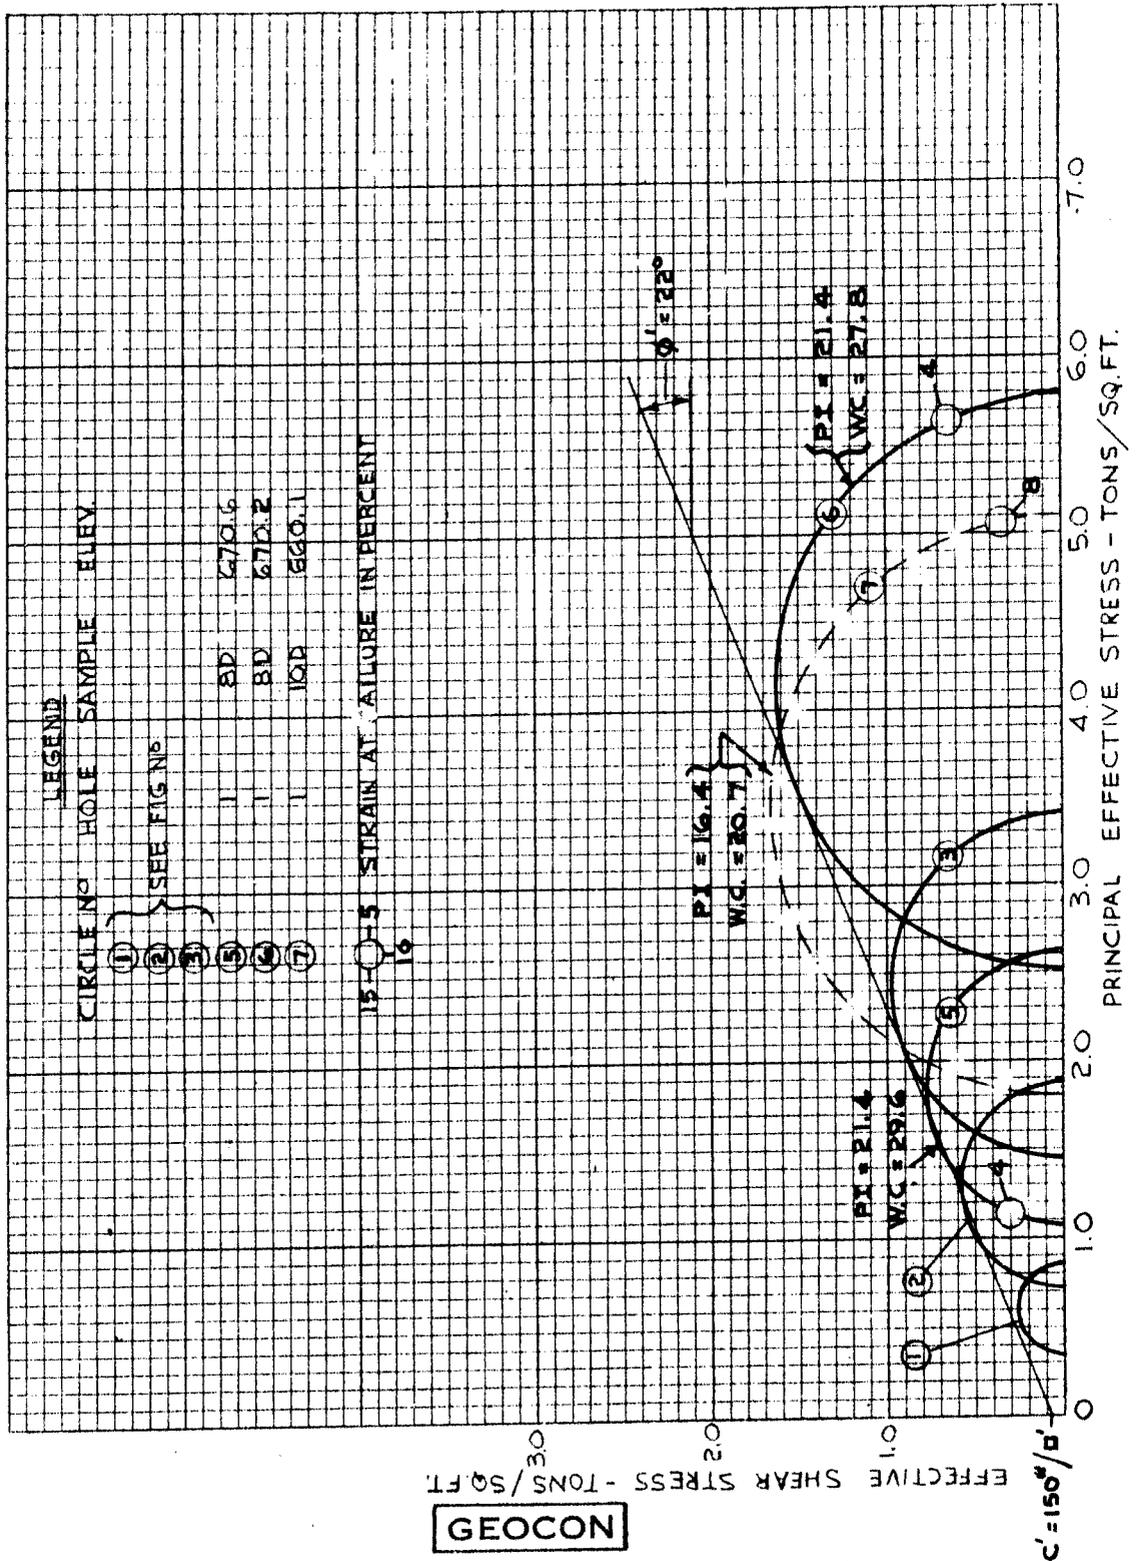
APPENDIX 11
FIGURE 6
PROJECT S6636

Considering assumption (a) and using the average clay strength parameters $c' = 150$ pounds per square foot and $\phi' = 22$ degrees, as shown in Figure 6, Appendix II, effective stress analyses were carried out. These results are summarized on Drawing S6636-5. It may be seen that, provided piezometric surface was about elevation 688, the factor of safety immediately after placing the backfill was less than 1. Increased stability would only take place with a reduction in elevation of the piezometric surface. The variation in factor of safety with piezometric surface for both the excavated and completed slope is shown.

MOHR'S CIRCLES
SLOW DRAINED TRIAXIAL TESTS
VARVED SILTY CLAY

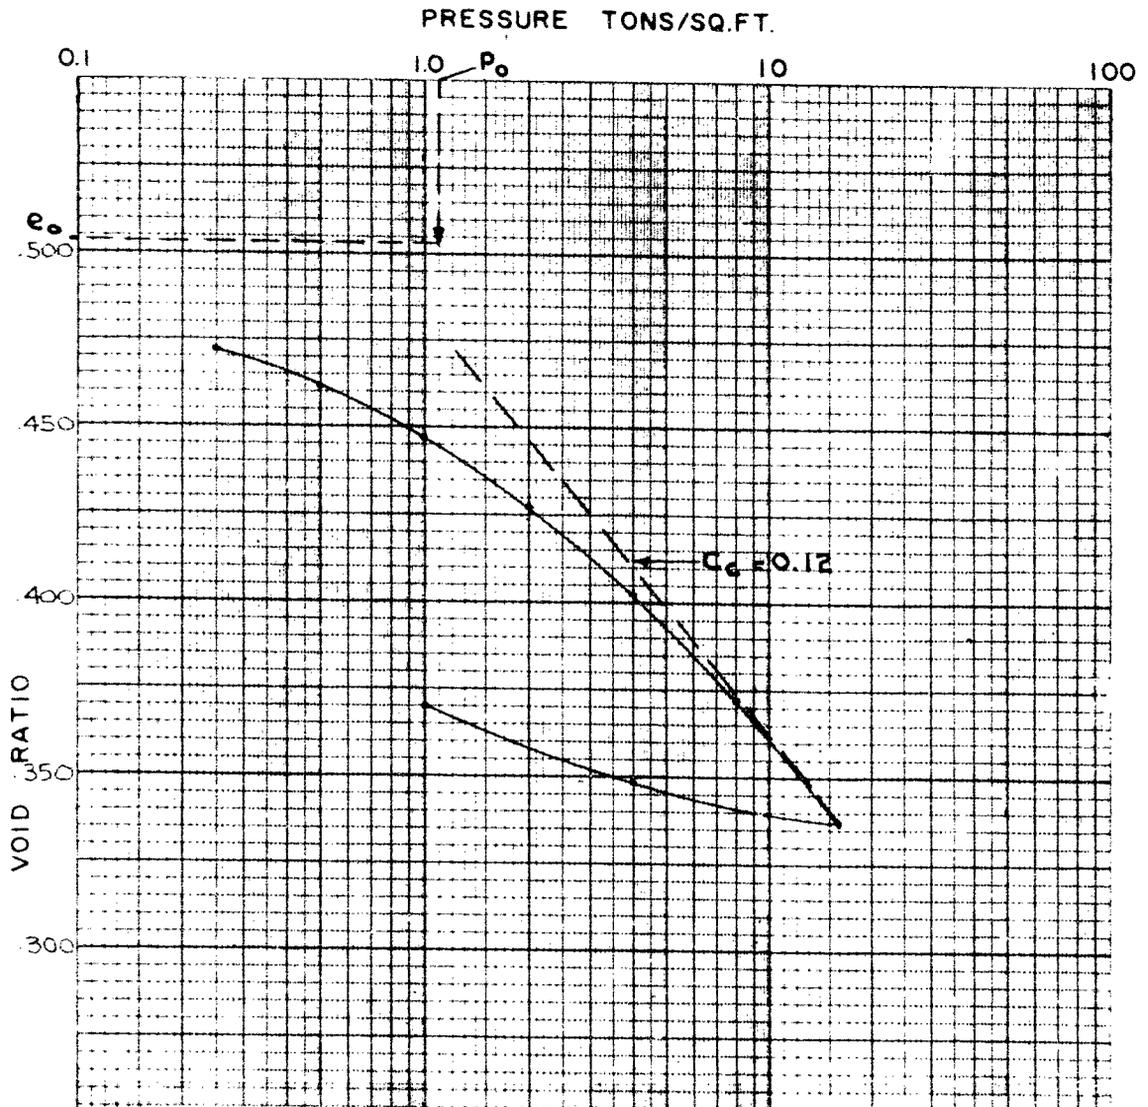
APPENDIX 11
FIGURE 7
PROJECT 56636

Four consolidation tests were carried out on selected samples at regular intervals throughout the depth of the clay stratum. The resulting void ratio-log pressure curves are given on Figures 7 to 10 inclusive.

VOID RATIO-PRESSURE CURVES CONSOLIDATION TEST

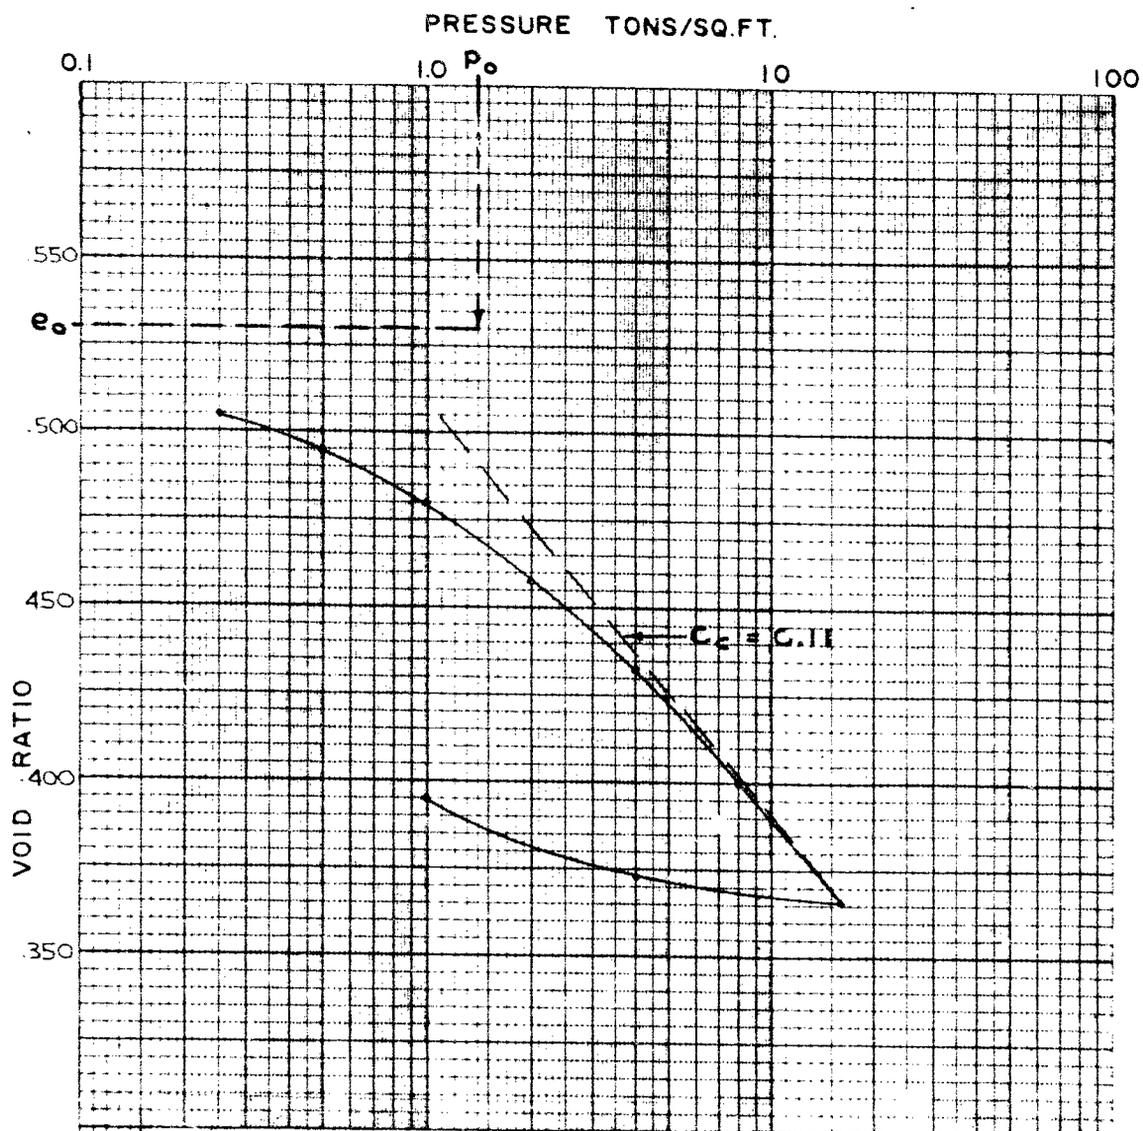
APPENDIX 11
FIGURE 8
PROJECT 56636

VOID RATIO-PRESSURE CURVES CONSOLIDATION TEST

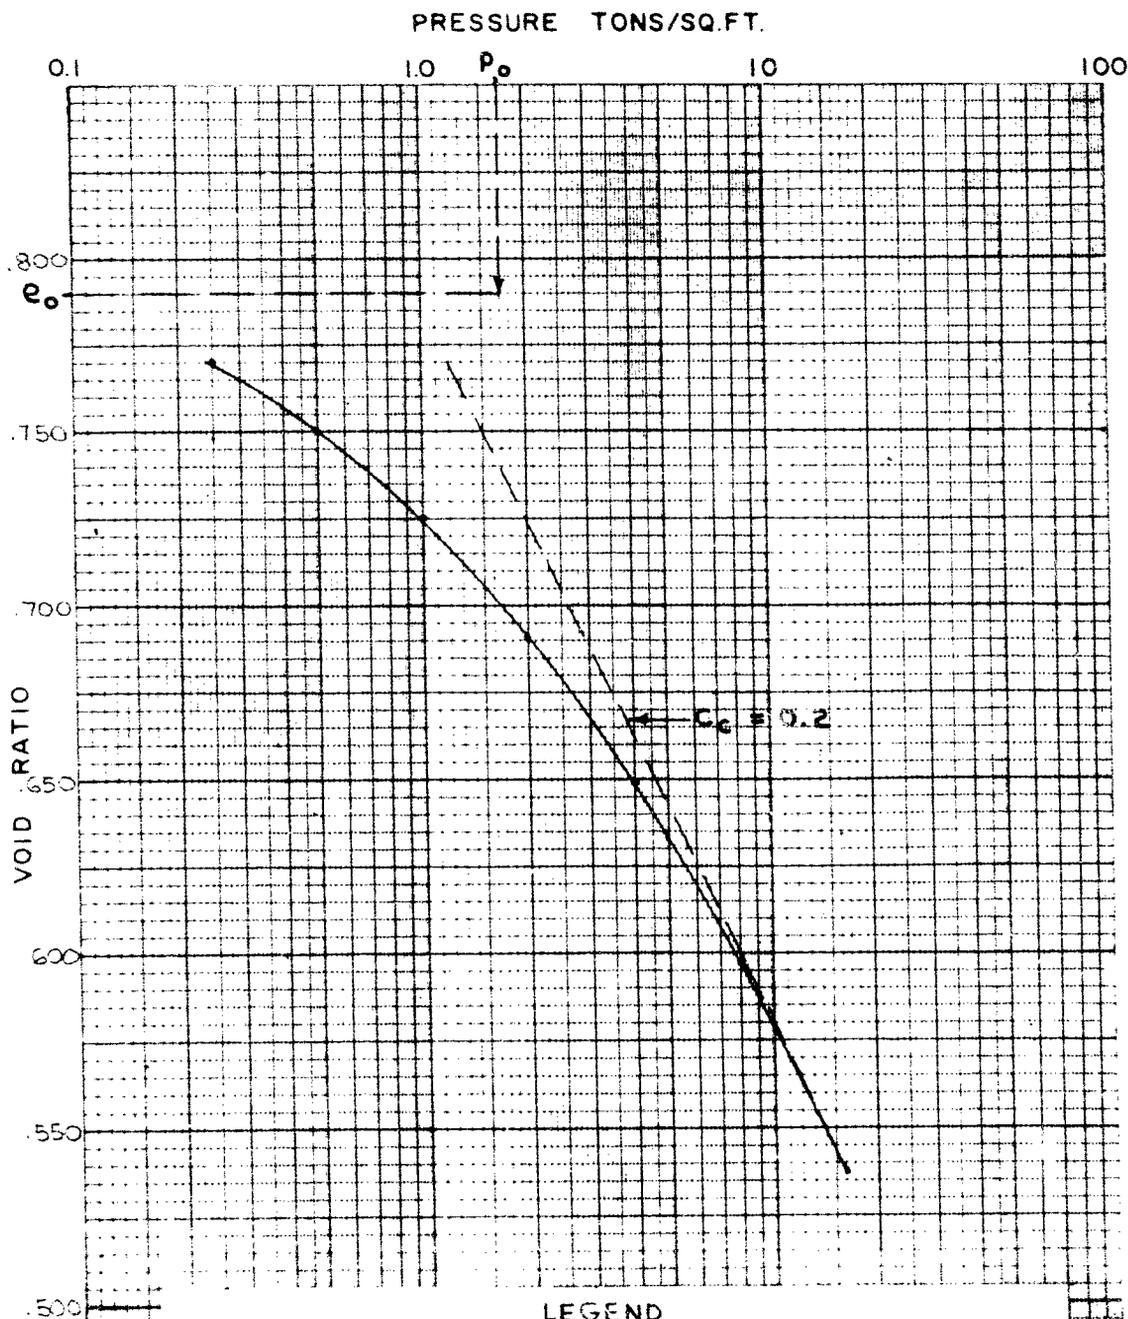
APPENDIX 11
FIGURE 9
PROJECT 56636

VOID RATIO-PRESSURE CURVES CONSOLIDATION TEST

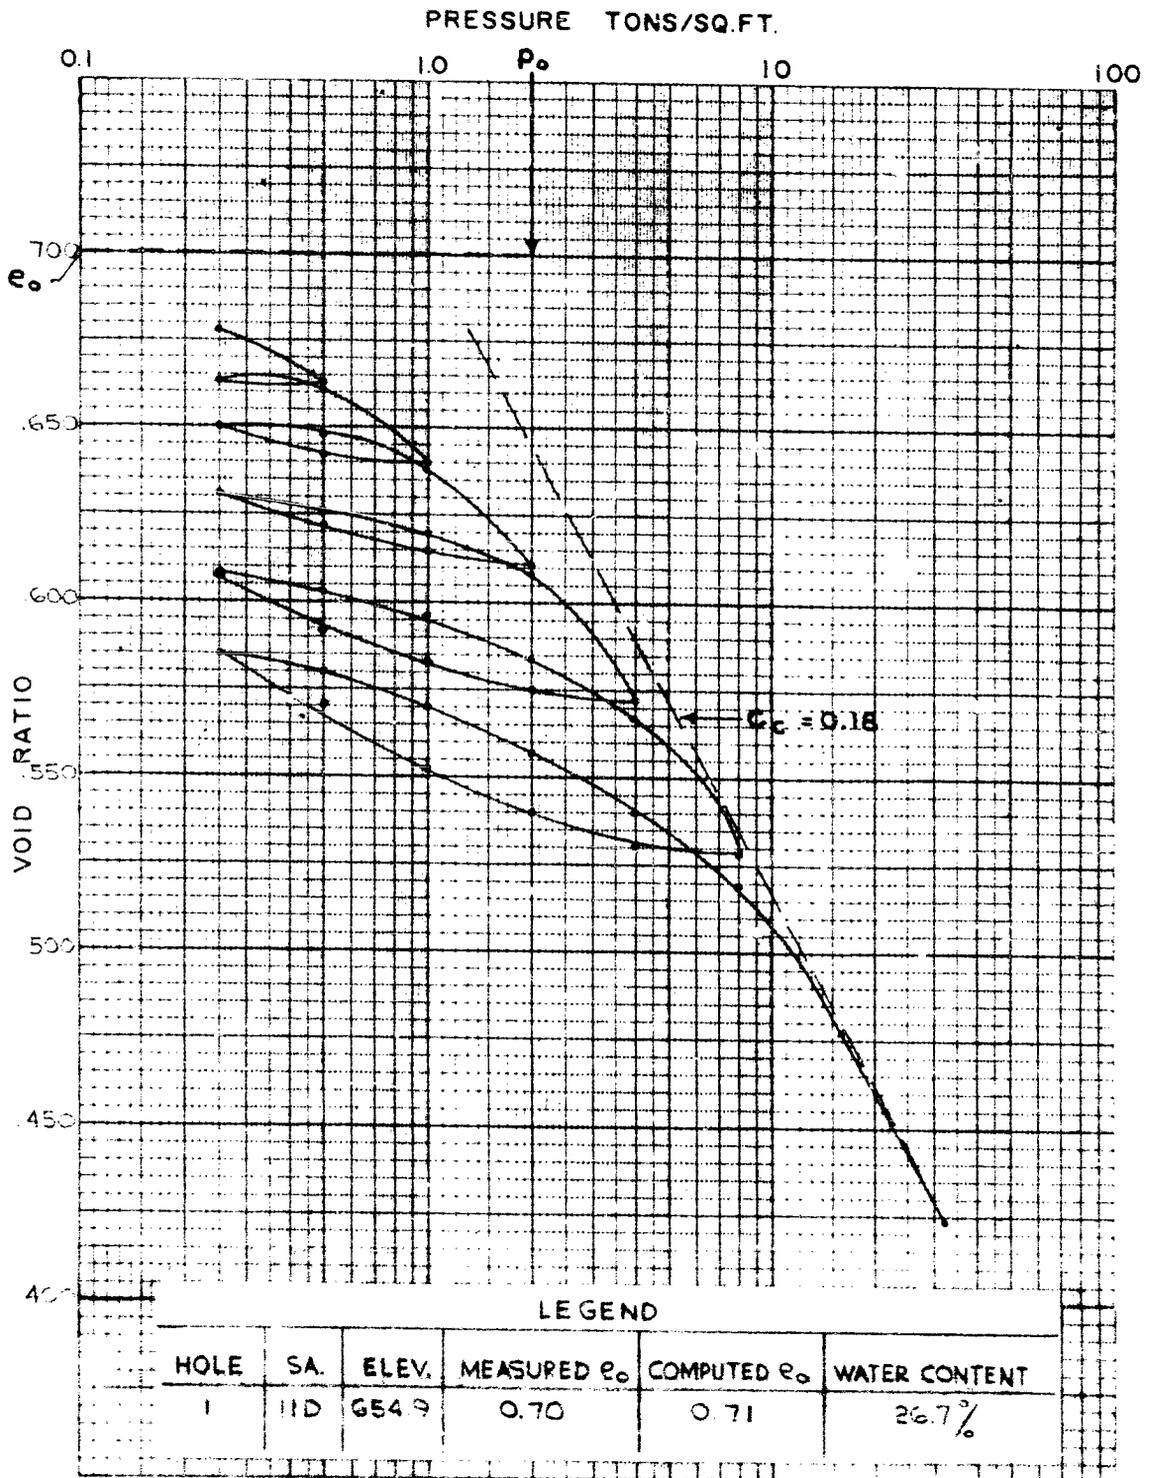
APPENDIX 11
FIGURE 10
PROJECT 56636

VOID RATIO-PRESSURE CURVES CONSOLIDATION TEST
