DEPARTMENT OF HIGHWAYS - ONTARIO			
MATERIALS & TESTING DIVISION - FOUNDATION SECTION			
DEVELOPMENT ROAD 724			
STA. 39 + 00 TO STA. 42 + 00			
KING'S HIGHWAY NO. _____		DIST. NO. 2 _____	
CO. MIDDLESEX			
TWP. W. WILLIAMS & ADELAIDE LOT _____		CON. _____	
BORE HOLE LOCATIONS & SOIL STRATA			
SUBWD. A B	CHECKED <i>19</i>	W.P. NO. _____	M.S.T. DRAWING NO. _____
DRAWN S.O.	CHECKED _____	JOB NO. 67 - F - 95-1	67 - F - 95 B.
DATE 18 JUL 1968	SITE NO. _____	BRIDGE DRAWING NO. _____	
APPROVED <i>A. B. Thomas</i>	CONT. NO. _____

SUPPLEMENTARY REPORT ON THE SOILS  
INVESTIGATION AT THE FAILURE AREA

On Development Road #724  
Sta. 39+00 to Sta. 42+00  
County of Middlesex  
W.J. 67-P-95-1 -- Dist. #2 (London)

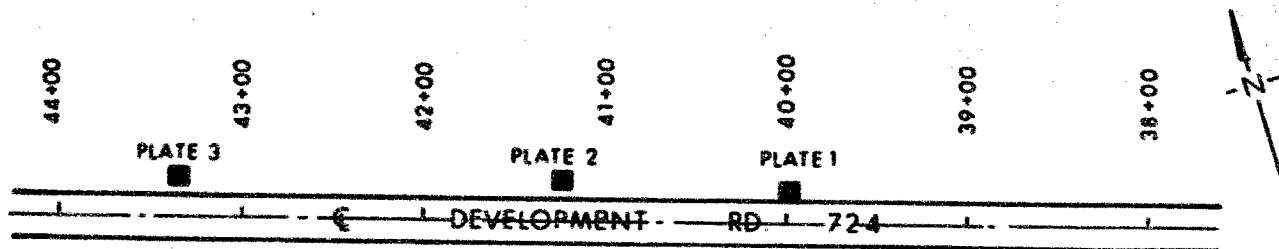
FIG. 1

The settlement plates have been installed and observed now by the District for a period of 14 weeks. The locations of the plates and the observations of settlements are plotted on Figures #1 and #2. By the end of May 1968, it became obvious that the settlements at the approx. centre of the failure area (Plate #1) proceeded at a constant rate, averaging about  $3/16"$  -  $1/4"$  per week. Due to the fast rate of settlement, it was decided that further field investigation and instrumentation be implemented in order to present some remedial measures at an early date.

APPROX DEPTH OF PLATES 5 Ft BELOW GROUND LEVEL

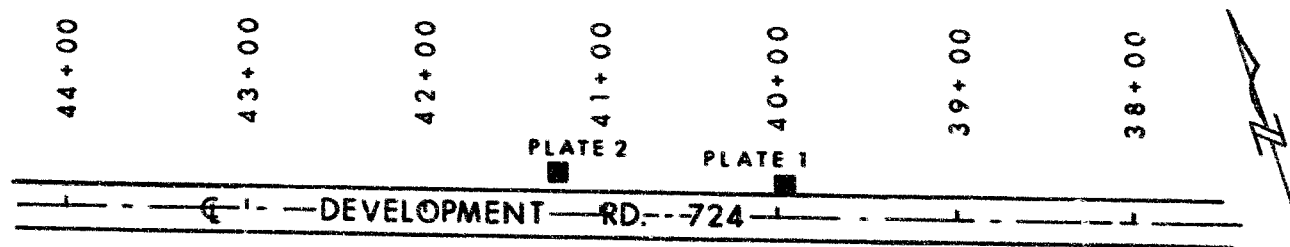
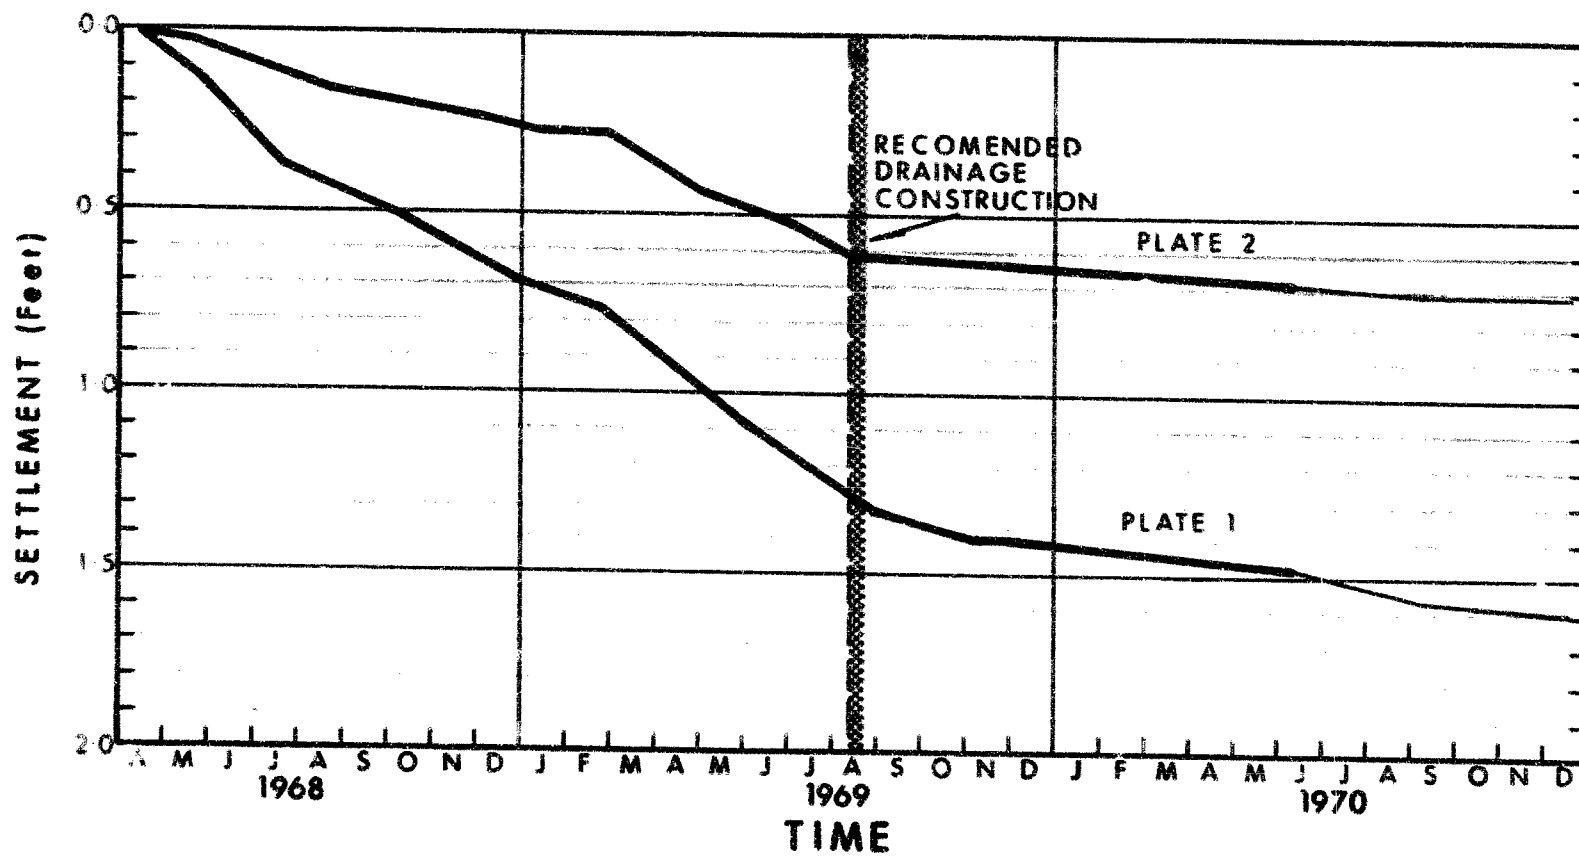
FIG. 1

Plate # 1. It appears 39+90 and not 37+90 as indicated  
 on drawing. This is approx middle of failure and approx 50'  
 east of our bridge!

Small seepage along the length of north slope

38+40 have slope surface failure with seepage  
 intercepting drain works but not adequate. Either deeper  
 intercepting drain or counterfoot drains should be necessary.  
 Depth of granular no more than 3' at middle of  
 failure!
