**GEOTECHNICAL INVESTIGATION
EAST EMBANKMENT BETWEEN
STATION 11+600 AND 11+700
HIGHWAY 10/24 IMPROVEMENT
ORANGEVILLE, ONTARIO**

PROJECT NO. 10183

September 17, 1998

**Re: Geotechnical Investigation
East Embankment Between Station 11+600 to 11+700
Highway 10/24 Improvement
Orangeville, Ontario**

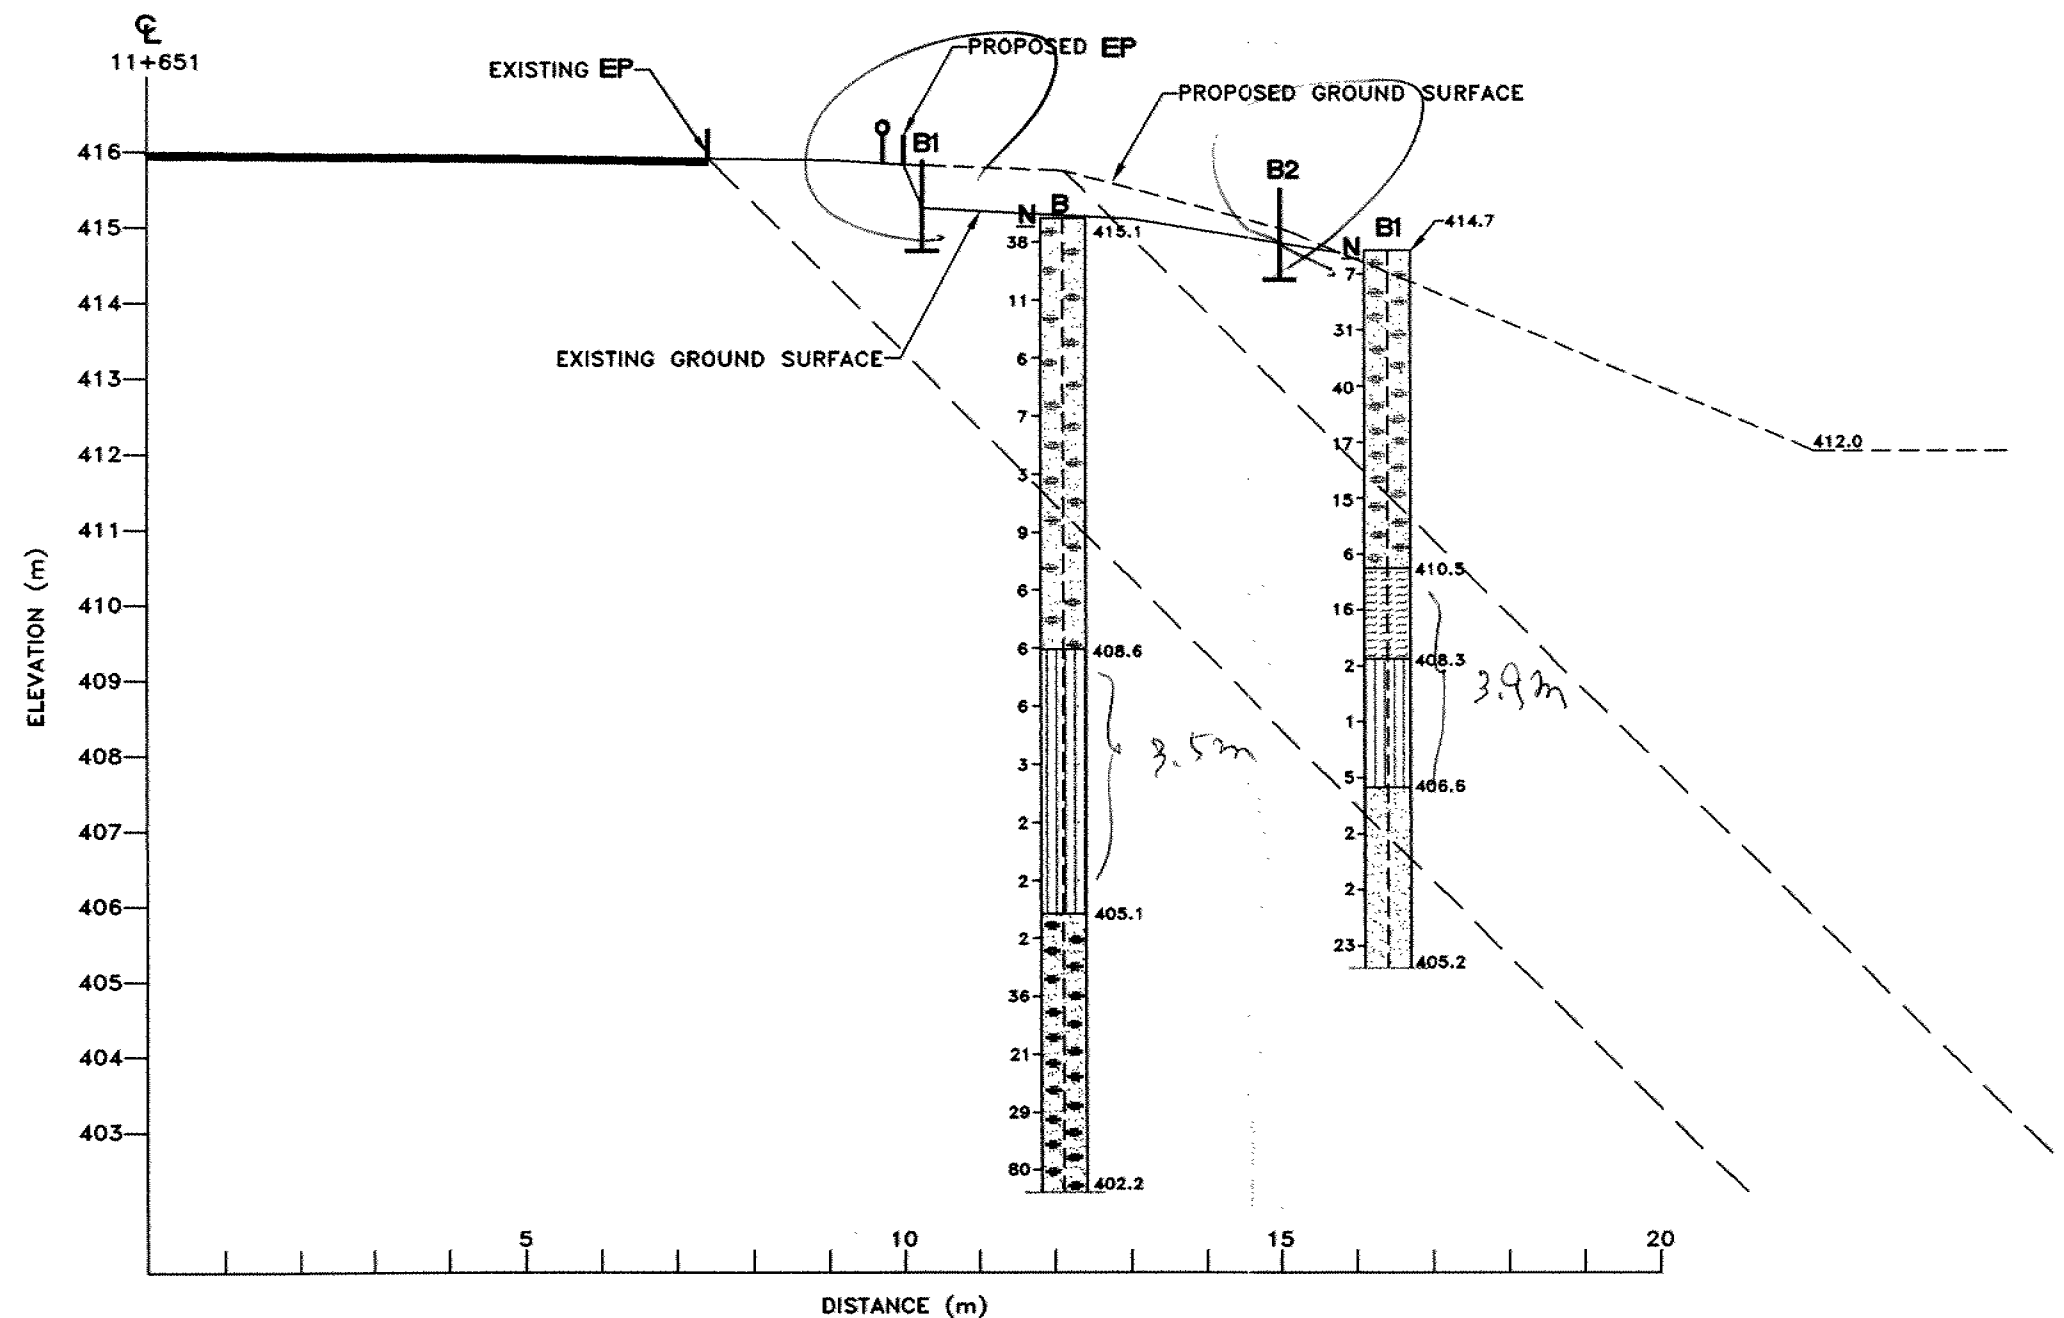
Job No:	10183	Dwg. No:	2
Date:	98/09/15	Dwn. by:	PC
		Appd:	DW

CROSS SECTION SHOWING BOREHOLE B AND B1 LOCATION AND SUBSOIL STRATIGRAPHY
STATION No. 11 + 651
HIGHWAY 10/24, ORANGEVILLE, ONTARIO
