FOUNDATION INVESTIGATION REPORT

Slope Failures of Cut Sections
Between Eugenia and Kimberley
Development Road #783-1

Artemesia Twp. -- Grey County
District No. 5 (Owen Sound)

W.J. 68-F-35(R)

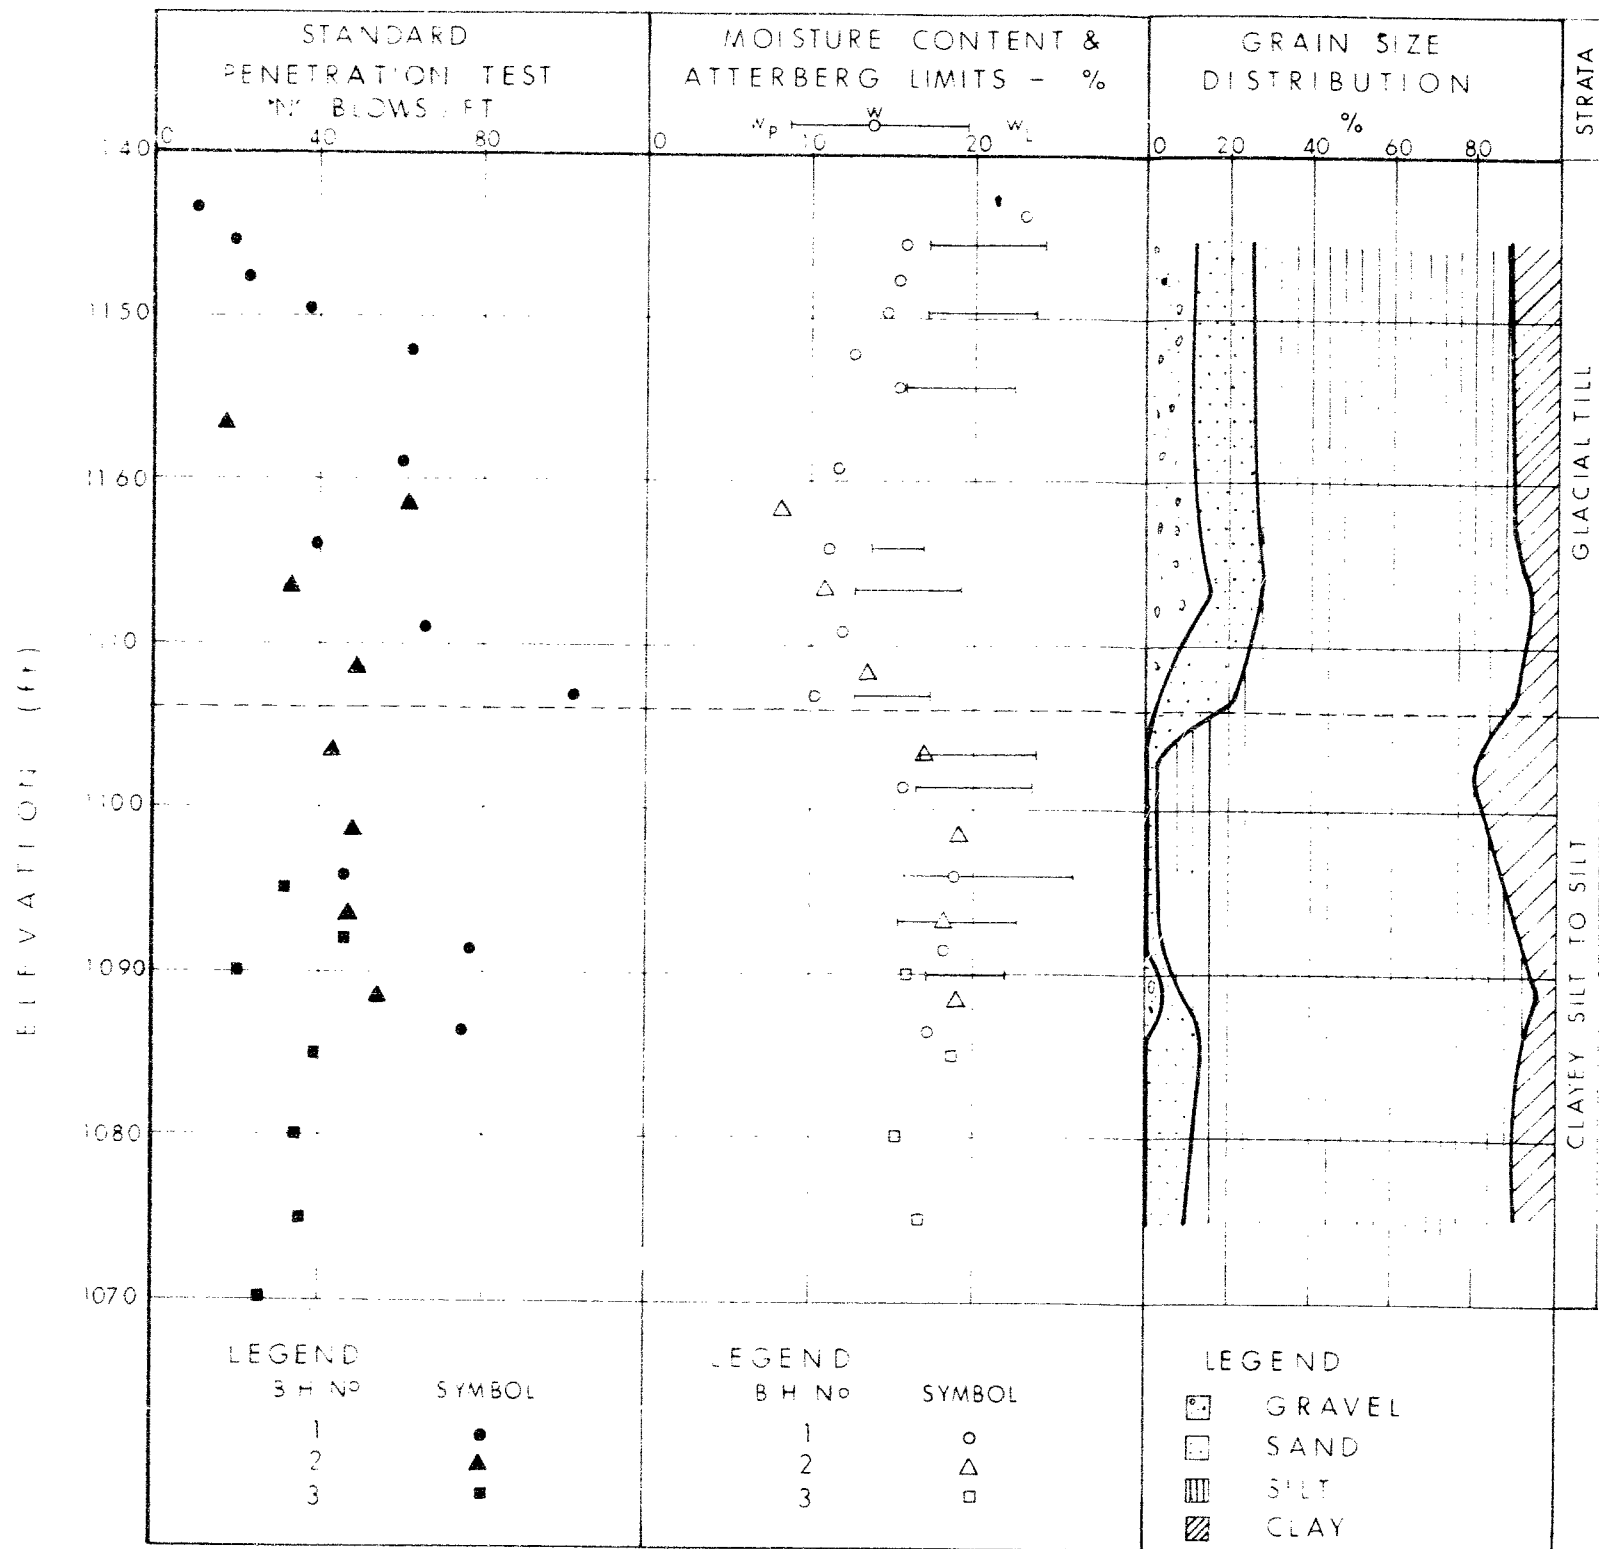
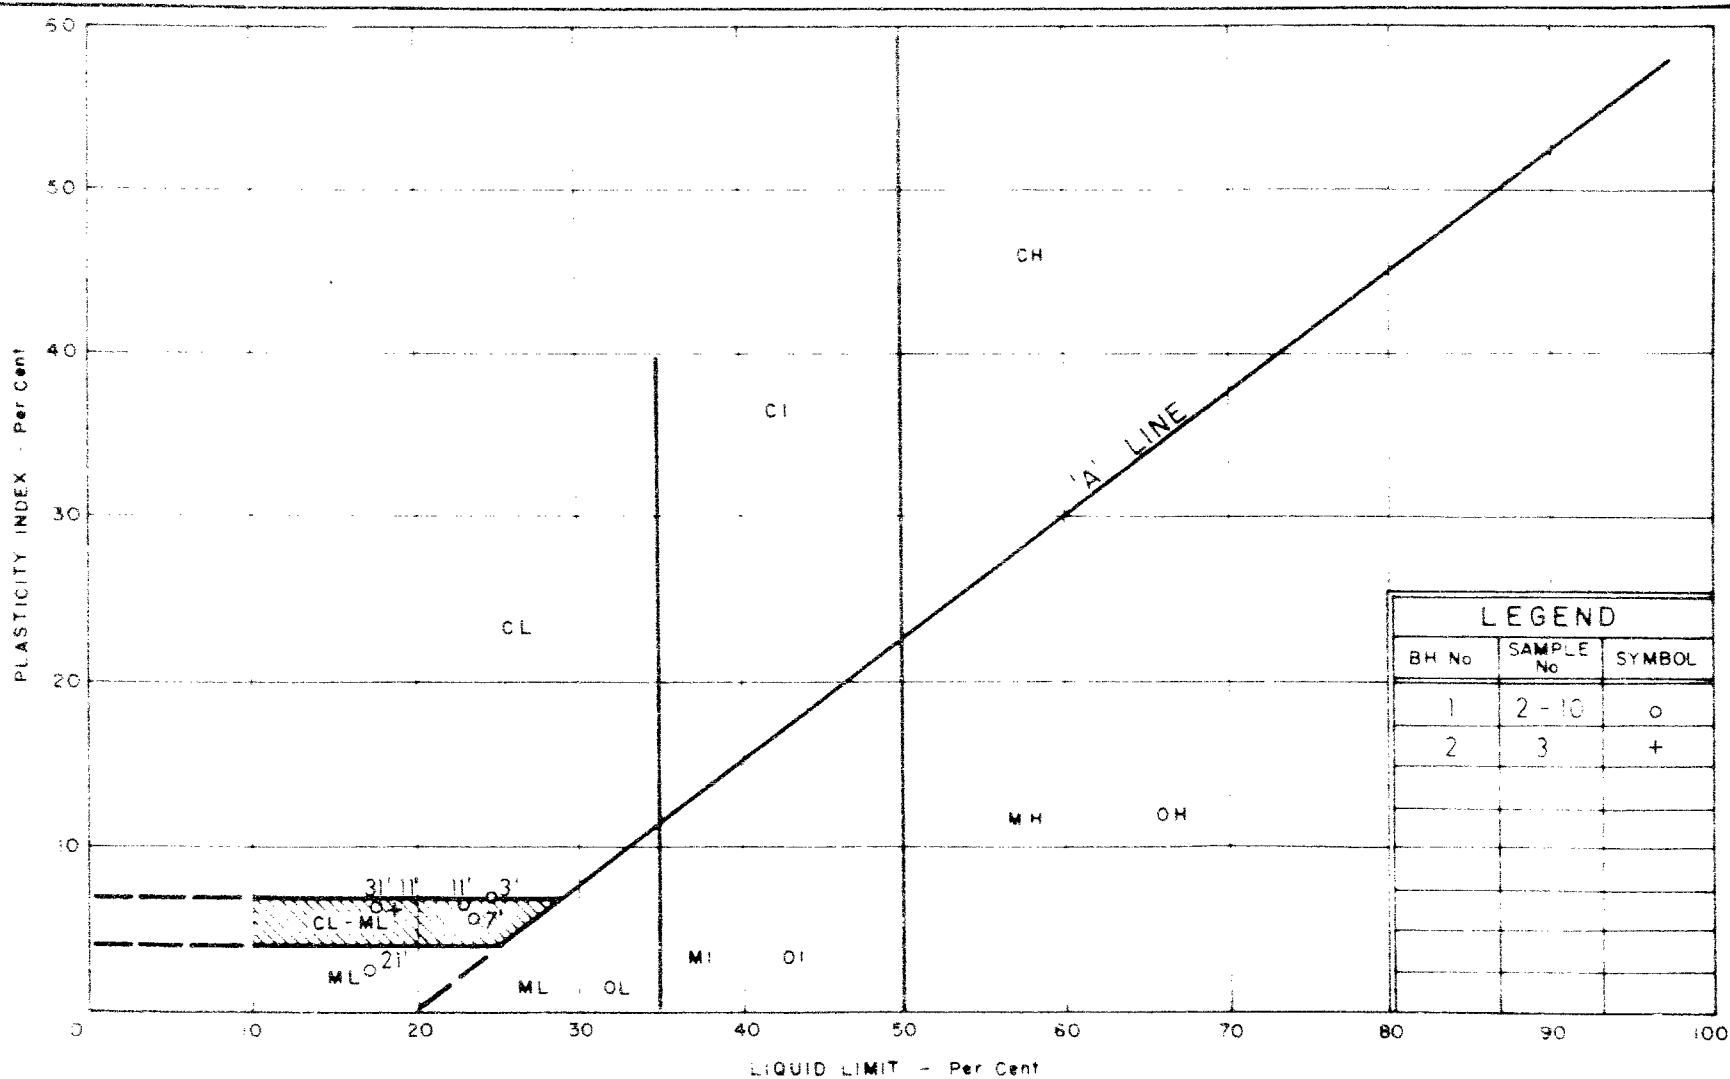
SUMMARY of FIELD & LAB. RESULTS

A summary of the physical properties of the stratum, as determined in the field and the laboratory, is given on Figure 1 in Appendix I. The moisture content decreases with depth from an average value of about 15% at elevation 1135 to 12% at elevation 1110. The same trend is noticeable in respect of the Atterberg Limits; the liquid limit decreases from 25% at elevation 1135 to about 18% at elevation 1110, whereas the plastic limit ranges between 17% and 13%. It should be pointed out that without exception, the natural moisture content of the deposit is below the plastic limit indicating that the deposit has been subjected to very high pressures in the past. This would also explain the presence of fissures in the deposit. The Atterberg limits are also plotted on the Plasticity Chart, Figure 2, which indicates the soil to be a clayey silt of low

The physical properties of the clayey silt and silt strata are summarized on Figure 1. The moisture content is nearly constant or decreases very slightly with depth, averaging about 18%. The liquid limit ranges between 22% and 26%, averaging 24%, and the plastic limit averages about 16%. The Atterberg limits shown on the Plasticity Chart, Figure 3, indicate the soil to be a clayey silt or silt (CL-ML or ML in the Unified Soil Classification System, October 1963). Grain-size distribution curves for representative samples are shown on Figure 5 and the results are summarized on Figure 1.
