EMBANKMENT FAILURE
APPROX. 1.5 MILE WEST OF DESBARATS
(STA. 360+00 TO STA. 370+00)

BORE HOLE LOCATIONS & SOIL STRATA

FOUNDATION INVESTIGATION REPORT
For
Failures of Embankment Between
Station 363+00 and Sta. 369+00
Trans-Canada Highway #17
Contract 67-85
District #18 (Sault Ste. Marie)
W.J. 68-F-34 -- W.P. 904-62

FOUNDATION INVESTIGATION REPORT
For
Failures of Embankment between
Station 363+00 and Sta. 369+00
Trans-Canada Highway #17
Contract 67-85
District #18 (Sault Ste. Marie)
W.J. 68-F-34 -- W.P. 904-62

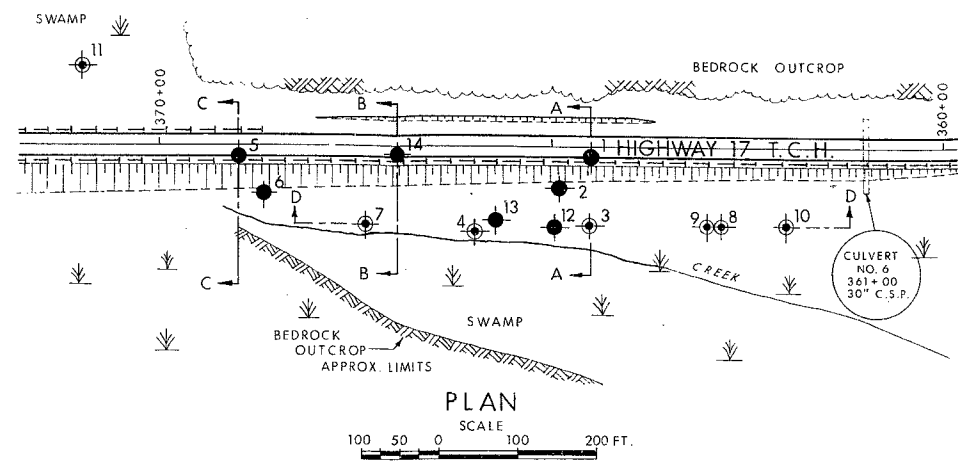
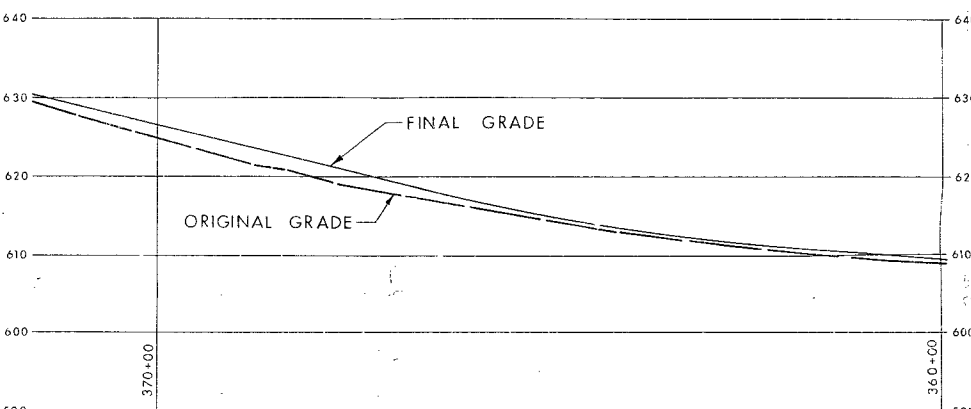
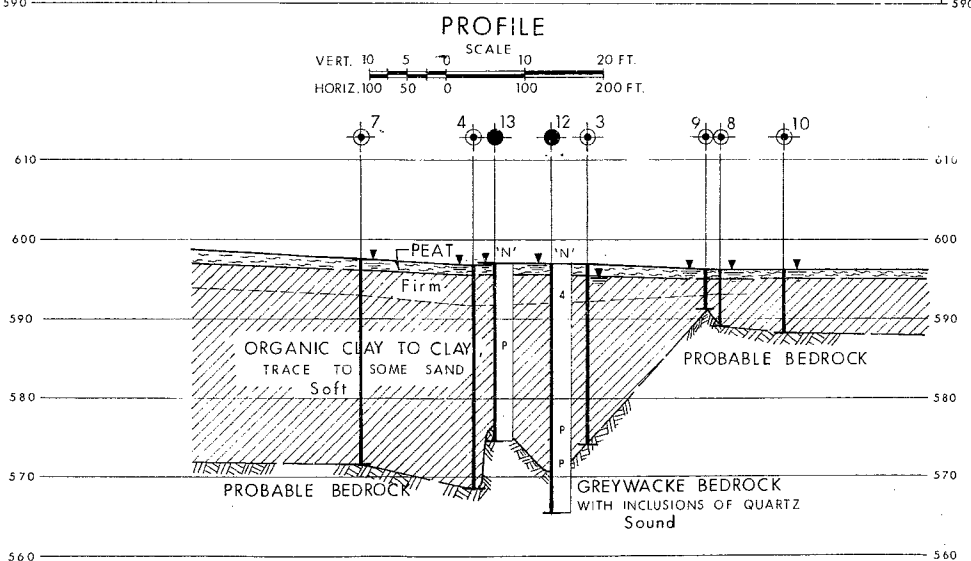
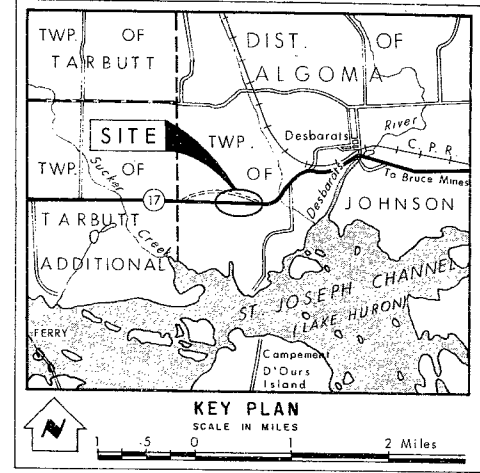
1. Field Investigation carried out between April 17-24 1968.
2. Soil Conditions shown are those existing following Failure but prior to construction of Berm to final dimensions.

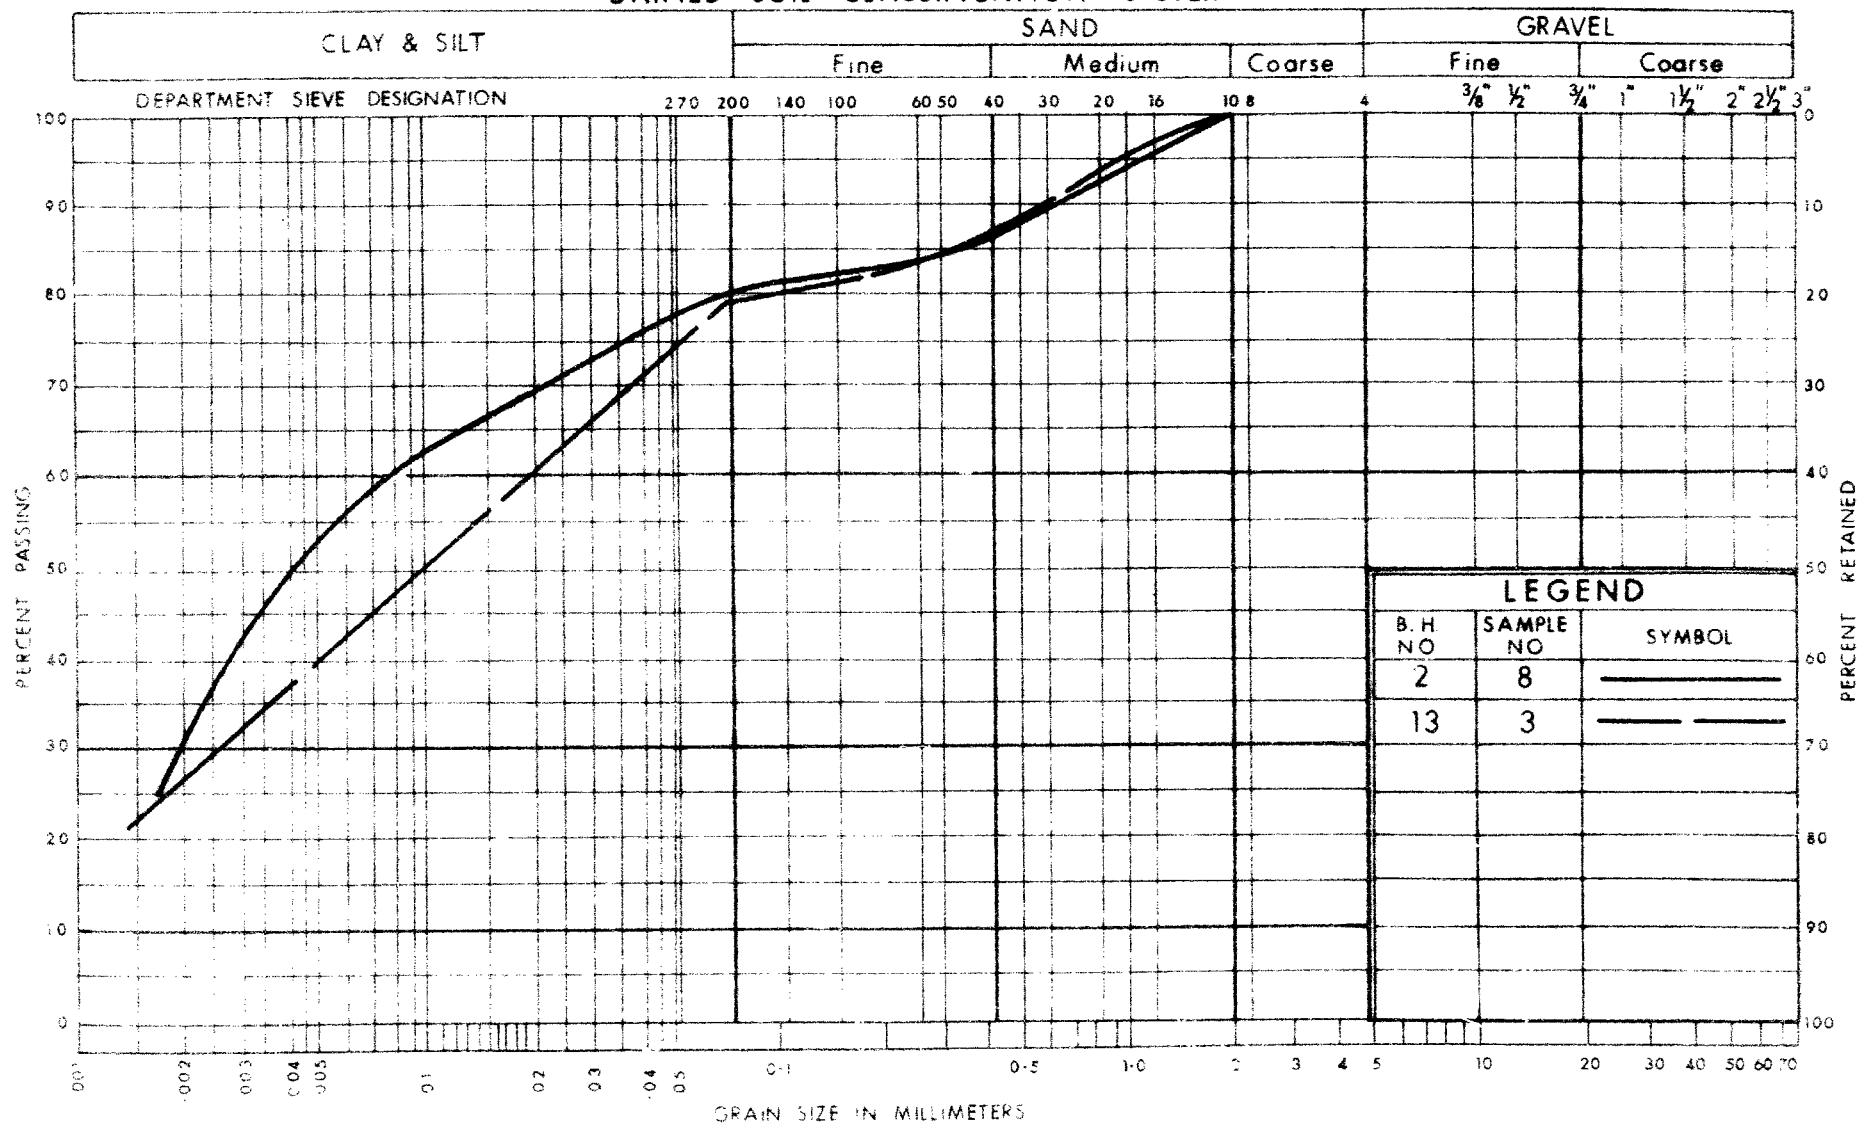
FIG. NO. 1

GRAIN SIZE DISTRIBUTION ORGANIC CLAY TO CLAY STRATUM

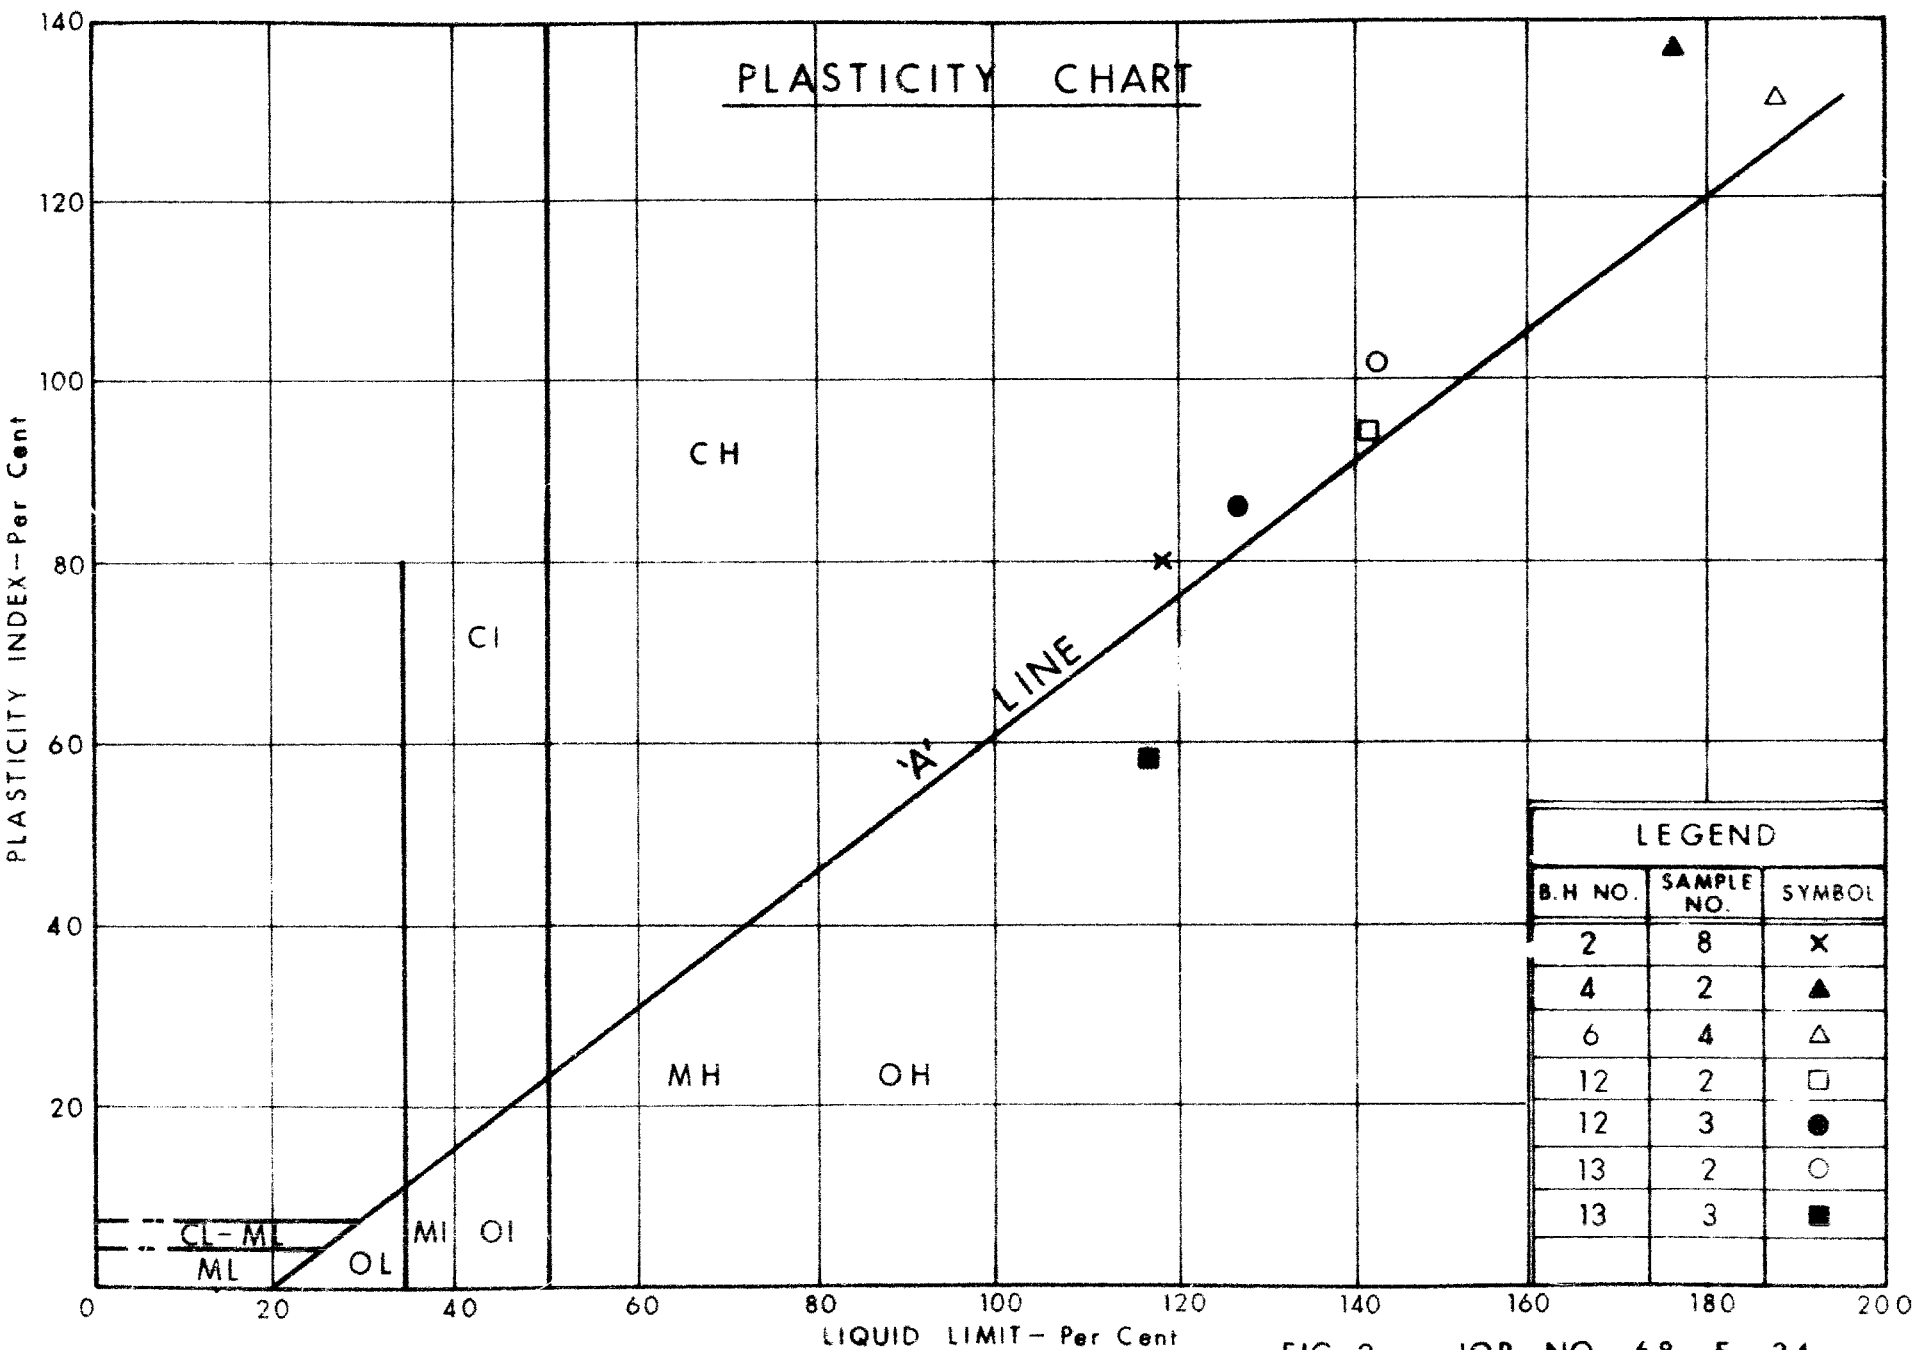
FIG. 2 JOB NO. 68-F-34

Seven Atterberg limit tests, carried out on samples of the organic clay to clay stratum, gave values for the liquid and plastic limits ranging from 119 to 176 and 38 to 55, respectively. The natural water content is between the liquid and plastic limits as represented by liquidity indices varying between 0.58 and 0.88, being typically about 0.7. These limit values are summarized on the Plasticity Chart, Figure 2.

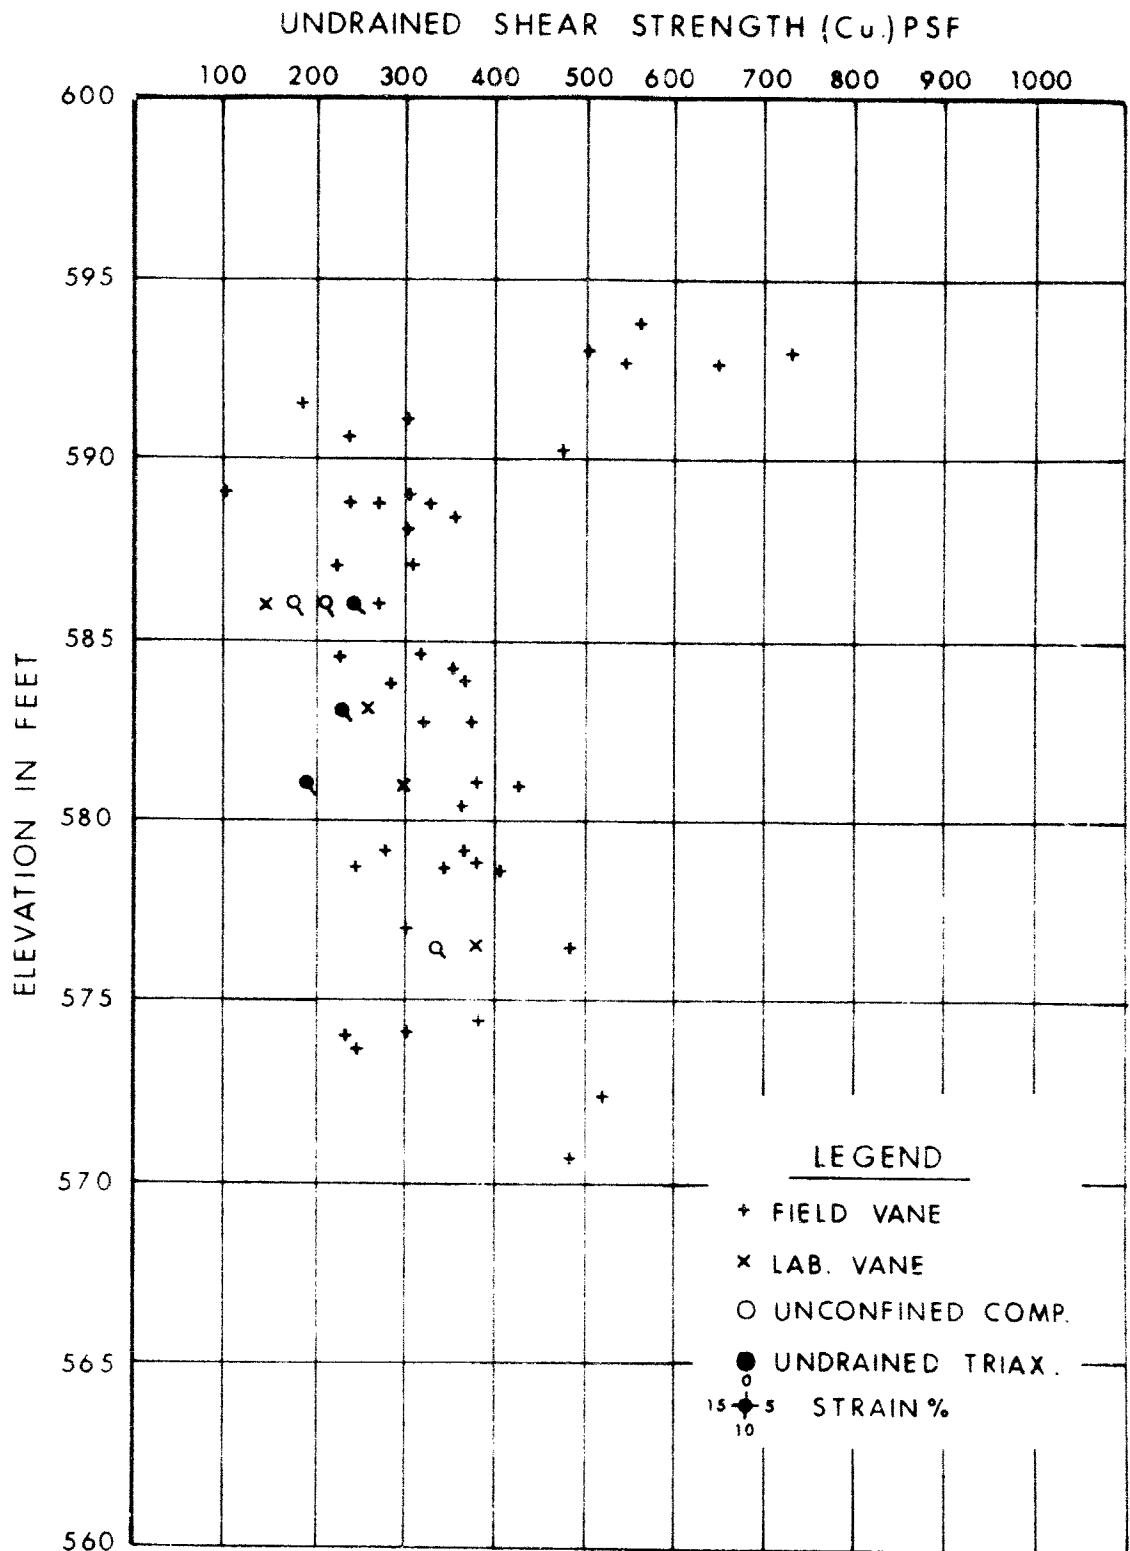
FIG. 3

soft with depth. A summary of the results is plotted on the Undrained Shear Strength versus Elevation profile plotted on Figure 3.

UNDRAINED SHEAR STRENGTH vs ELEVATION
