## **Golder Associates**

MINISTRY OF TRANSPORTATION AND  
COMMUNICATIONS

REVIEW OF RIVER BANK INSTABILITY  
MISSISSAGI RIVER  
IRON BRIDGE TO MISSISSAGI CHUTES  
WP 153-83-00                      DISTRICT 18  
PHASE II

November, 1985

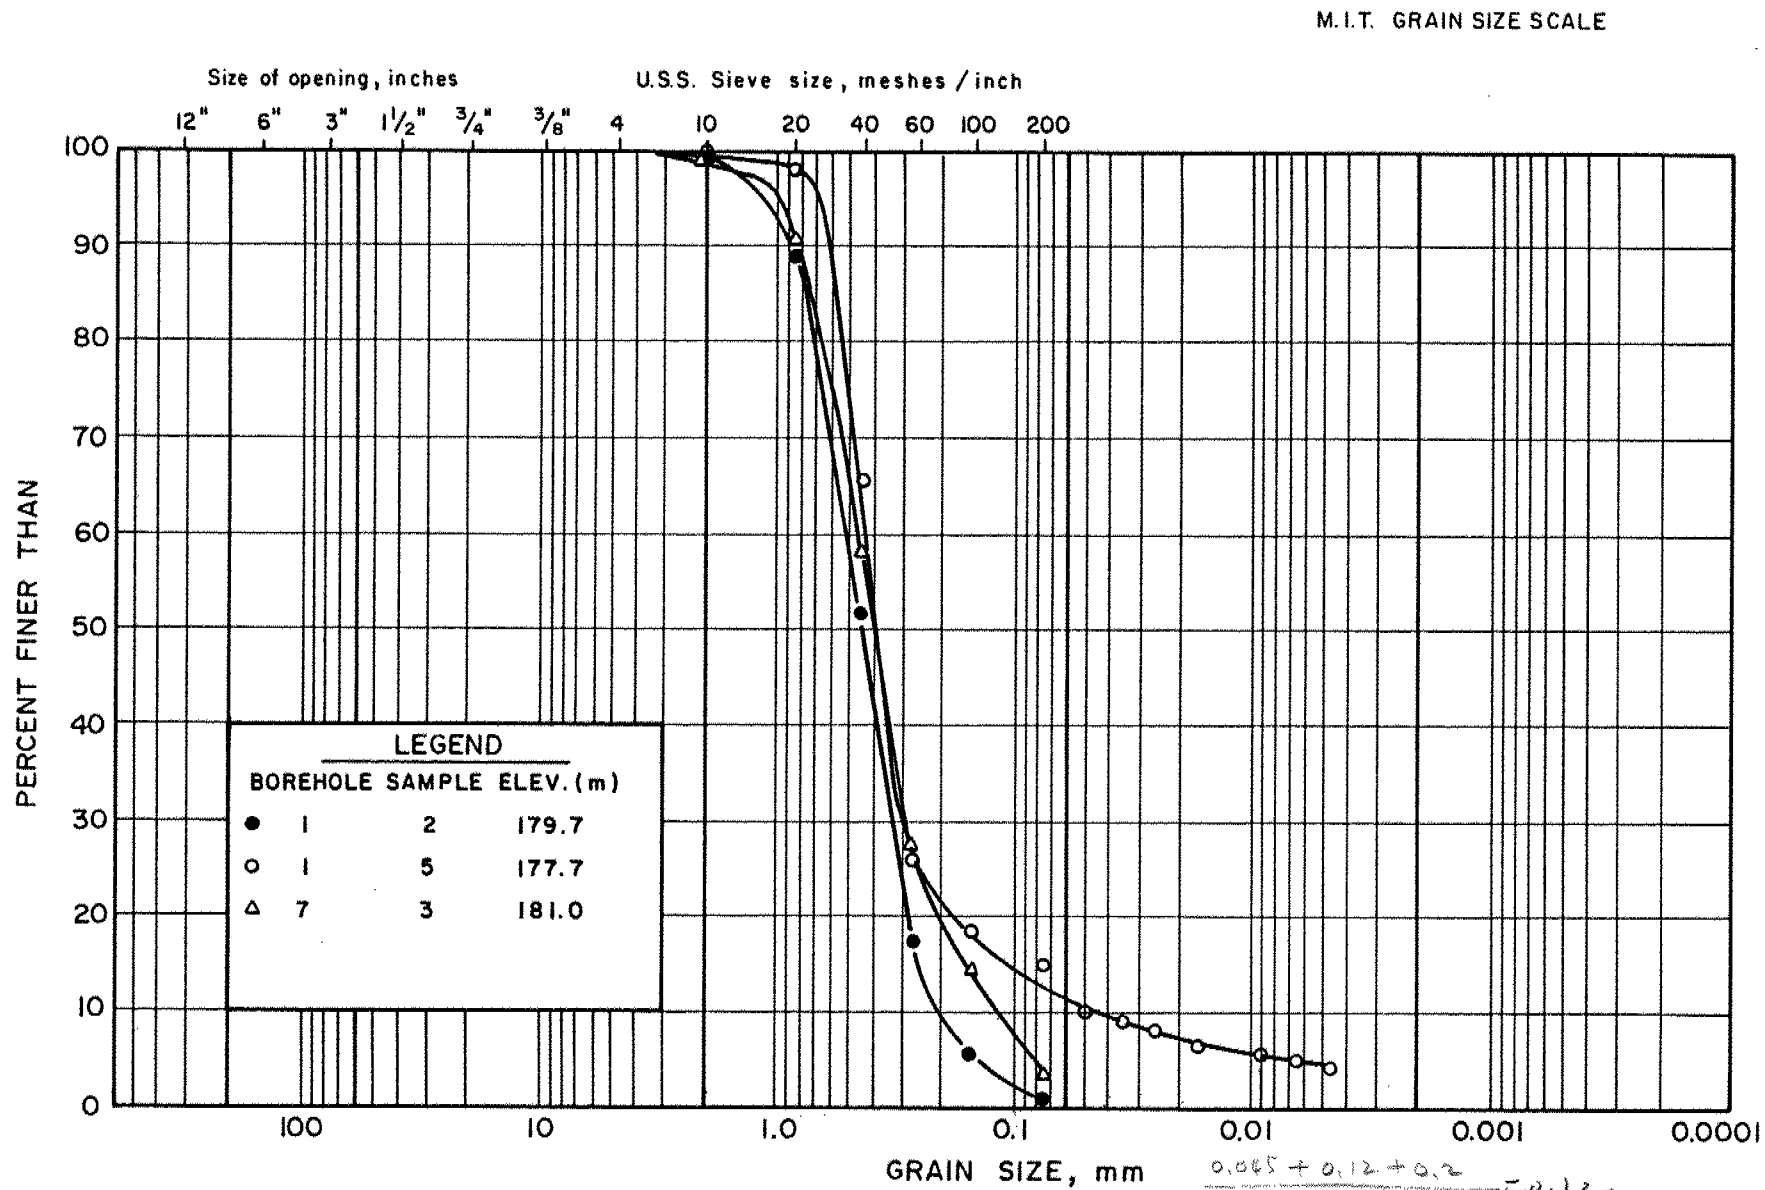
FIGURE 6

In general, the soils comprising the river banks consist of layered/interlayered sands, silts, organic silts and clayey silts. Grain size distribution curves for these strata are shown on Figures 6 to 8, inclusive.

GRAIN SIZE DISTRIBUTION  
SAND

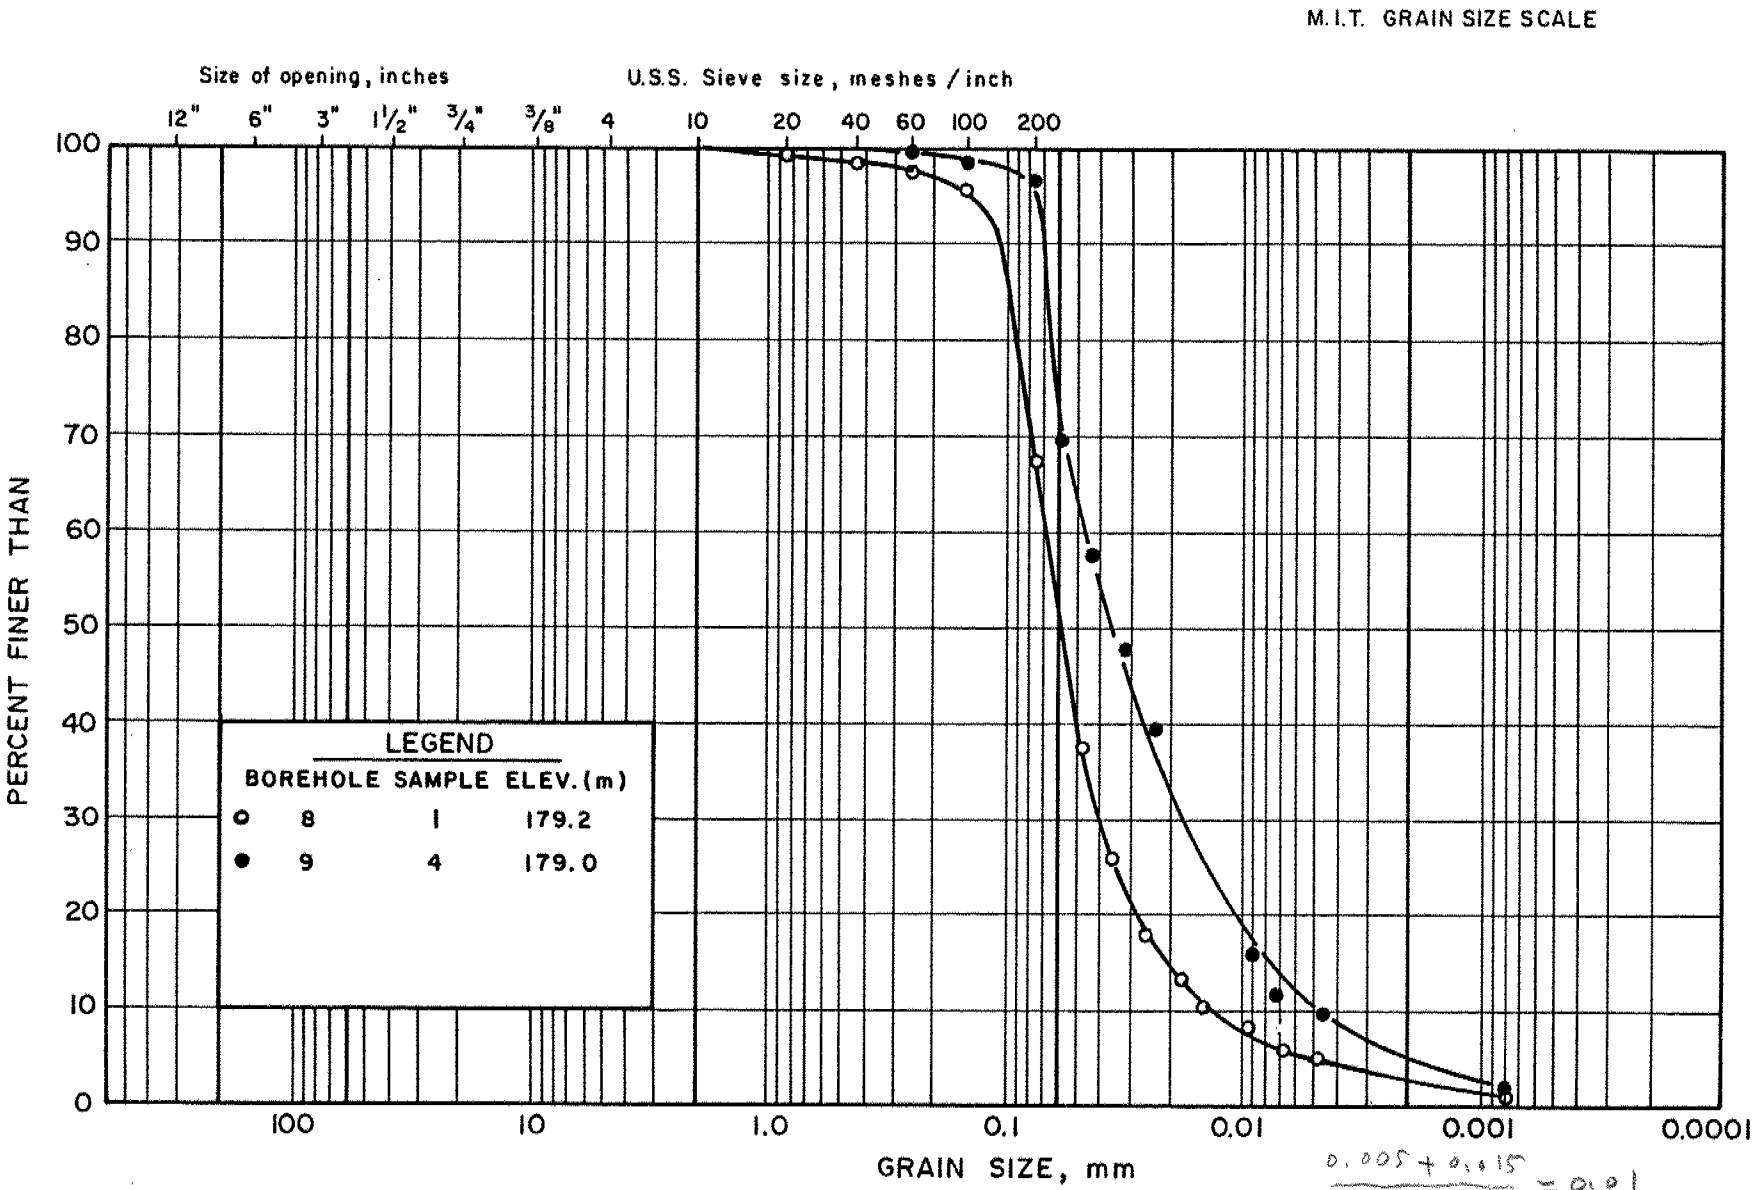
FIGURE 7

GRAIN SIZE DISTRIBUTION  
SILT TO FINE SANDY SILT

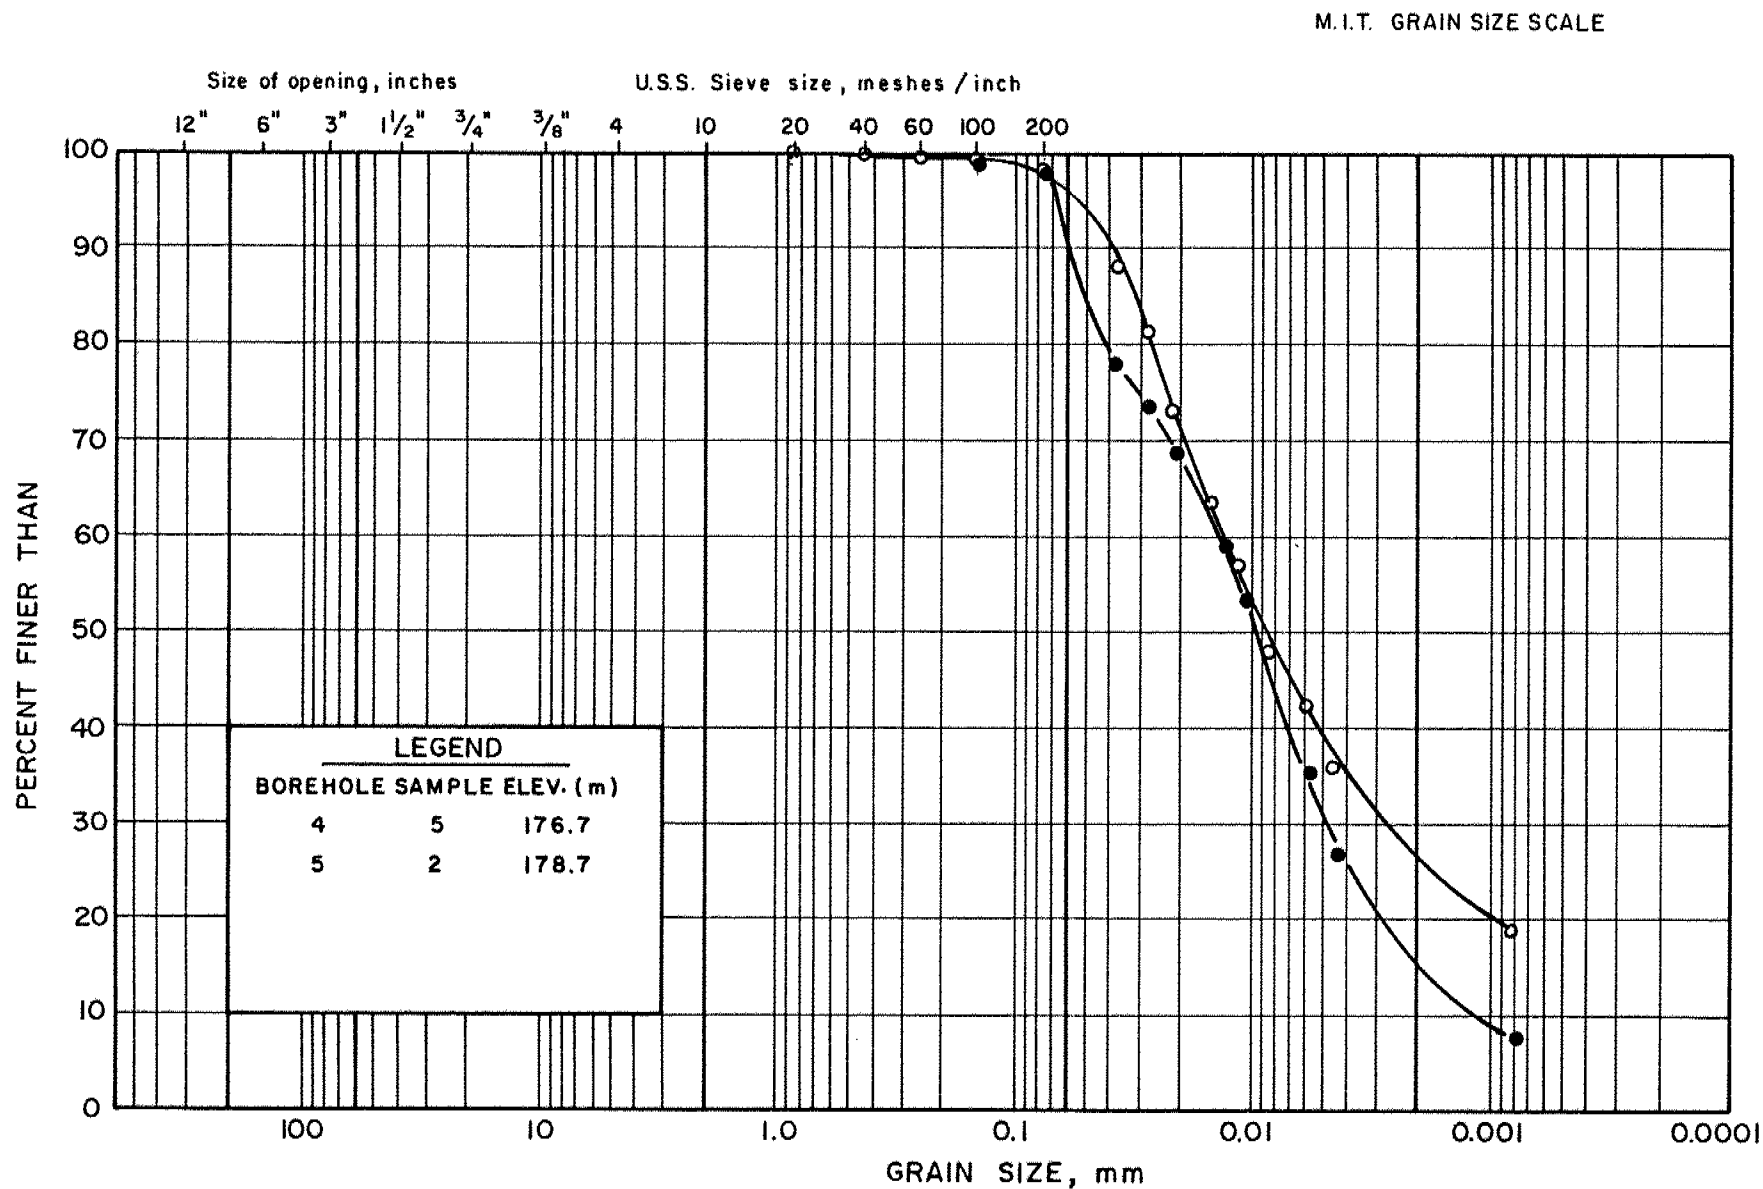
GRAIN SIZE DISTRIBUTION  
CLAYEY SILT

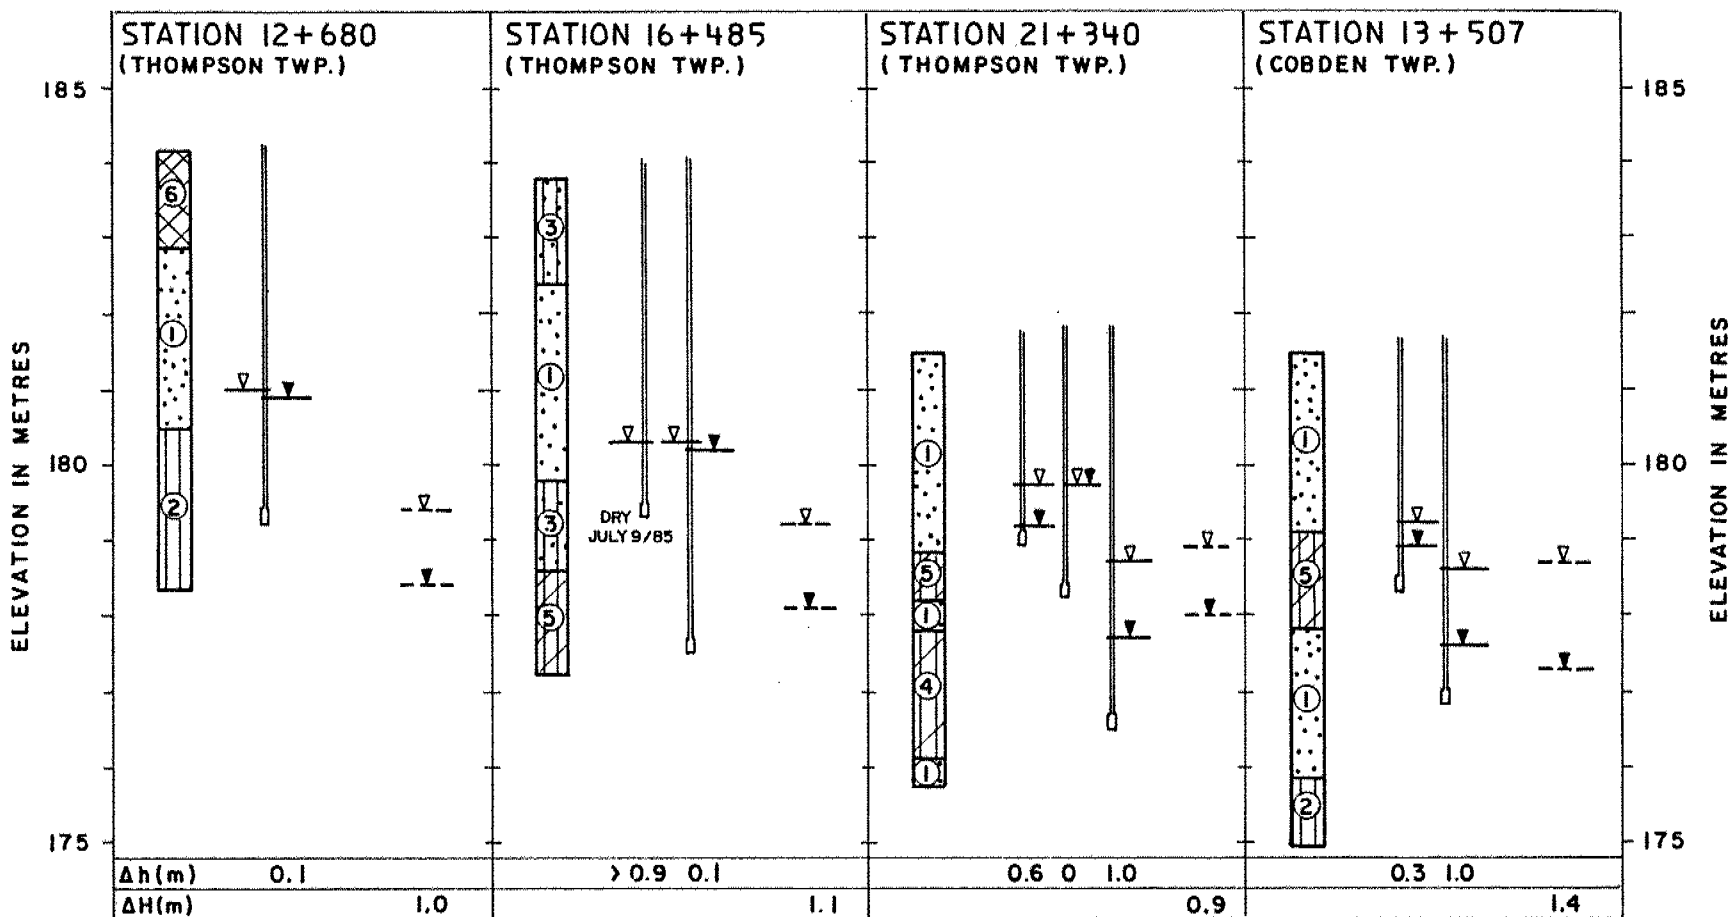
FIGURE 9

At the time of a site visit in July, 1985, the river water level was at about elevation 178 m (about 1 m lower than in May) as shown on Figure 9, and a corresponding drop was measured in the piezometric level in the sands and silts. Where piezometers were sealed into the clayey silt stratum, the decrease in piezometric level ranged from 0 to 0.3 m. [Although the piezometer in Borehole 9, Station 12+680, was installed within silts, due to the distance from the river edge (about 14 m), the water level in the piezometer decreased by only 0.1 m.]

# SUMMARY OF PIEZOMETER INSTALLATIONS AND WATER LEVEL MEASUREMENTS

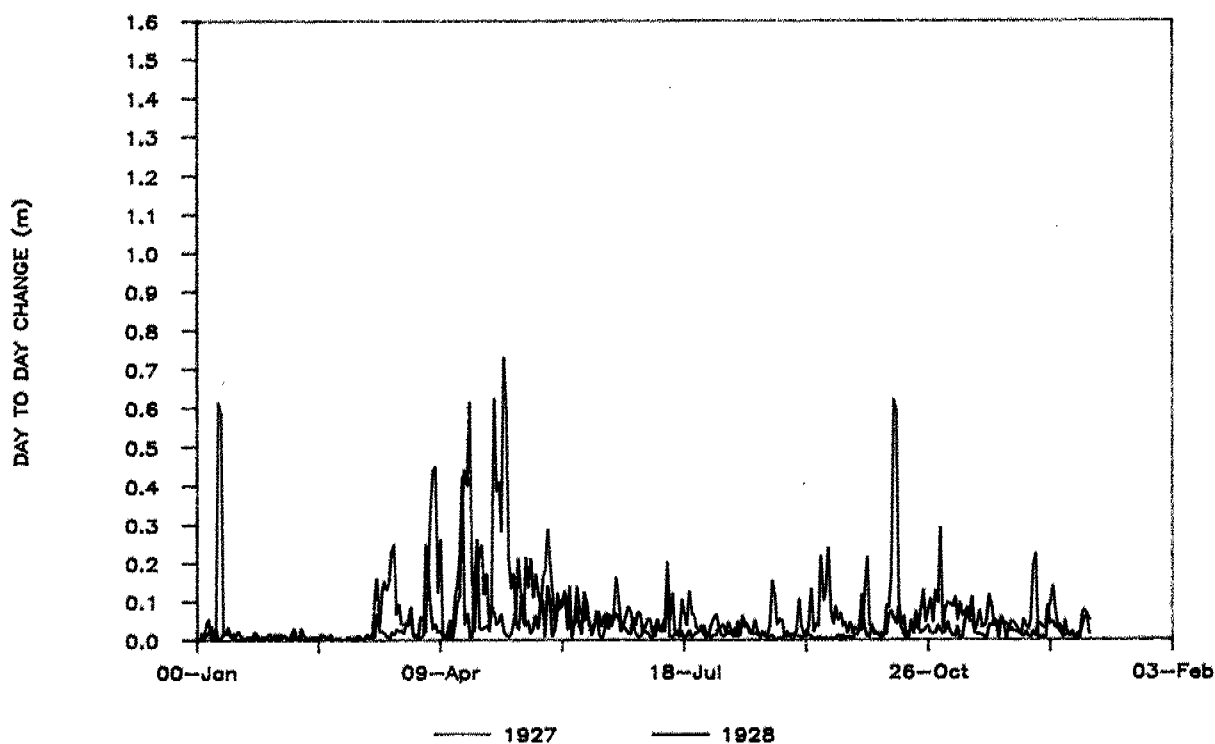
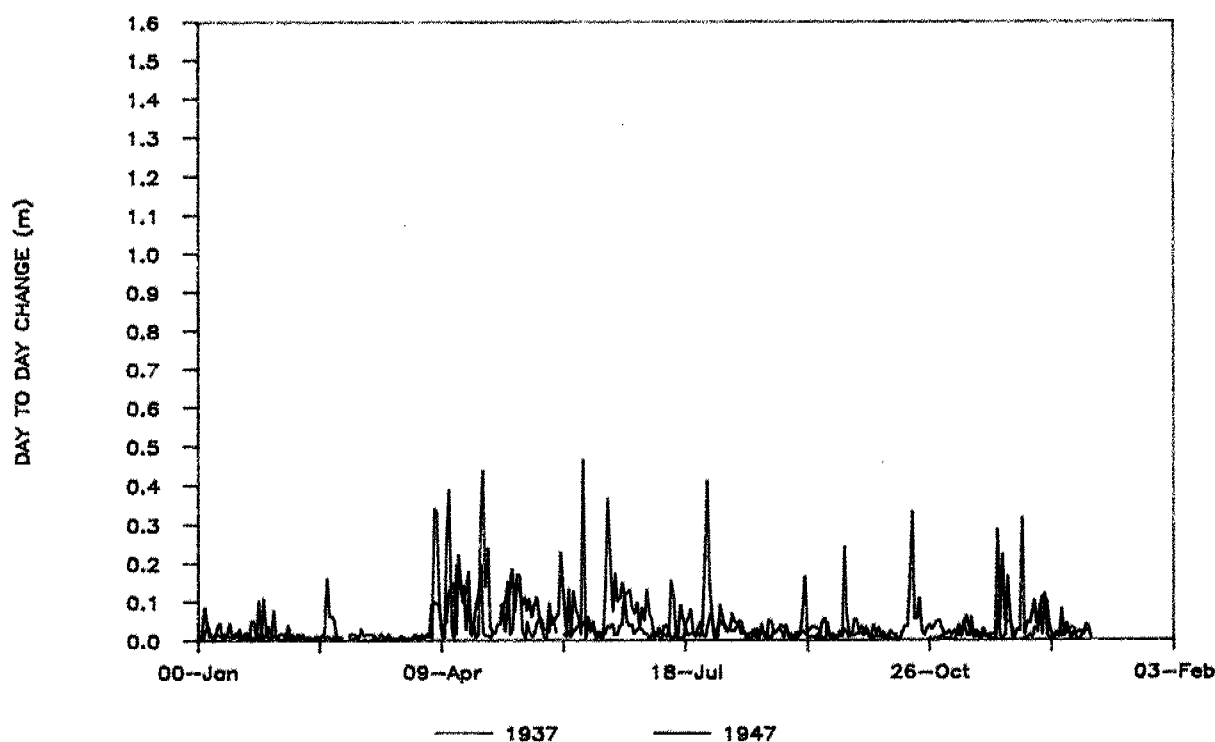
FIGURE 19

In the unregulated river regime, as is typified by years PRIOR to the dam and as shown in Figure 10a, day to day changes of more than 0.2 m are relatively infrequent (see Figure 19). In contrast, in the regulated river, (AFTER dam construction), water level changes within a 24 hour period of up to 0.5 m are commonplace. It should be noted, as shown in Figures 20 and 21, that the largest and most frequent changes in 1970 and 1979 occurred in the winter months where, prior to regulation (as in 1927, 1928, 1937, 1947) the least variation in river water level took place.

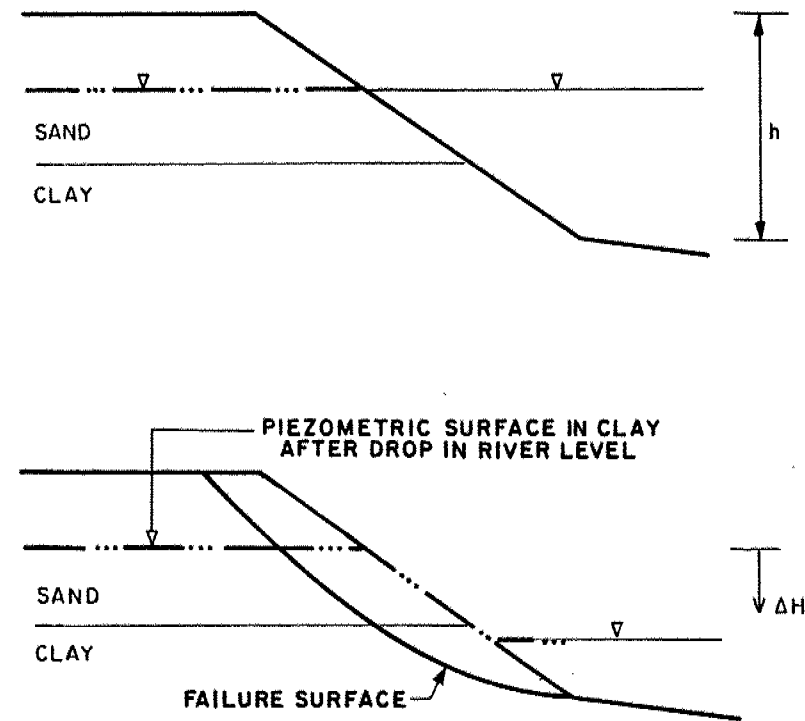
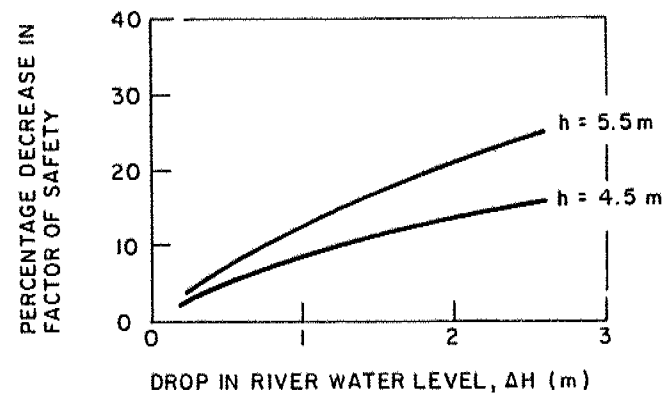
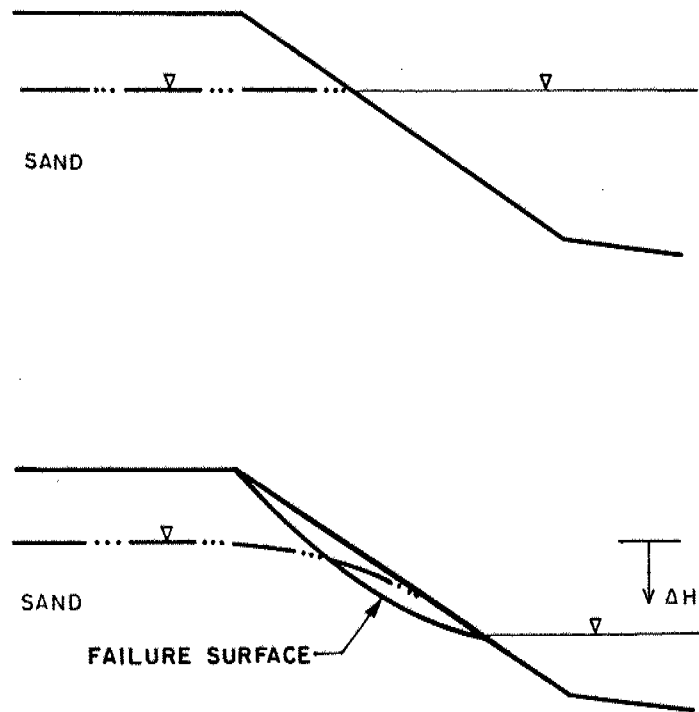
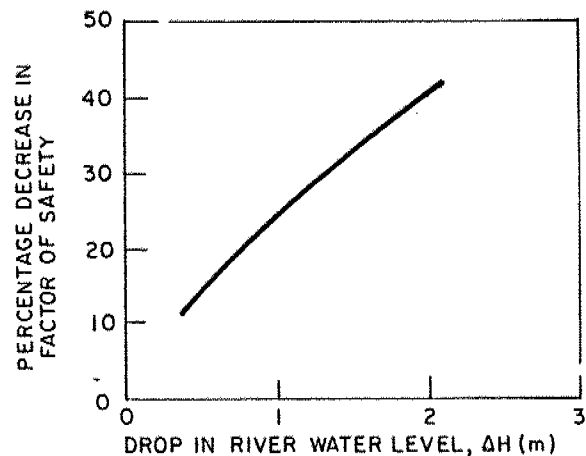
**FIGURE 26**

Fluctuations in river levels produce corresponding changes in the piezometric levels in the river banks. The time required for the piezometric level to stabilize with respect to the river level change is dependent on the permeability of the soil. For the river banks in the study area, where granular materials exist, permeabilities vary between about  $10^{-5}$  m/s for clean fine to medium sands and  $10^{-7}$  m/s or less for the layered sands and silts. Rapid decreases in river water level tend to induce "sudden" drawdown failures or in the less pervious deposits of layered sands and silts. Stability analyses carried out for these slopes indicate that a 1 m drop in river water level decreases the factor of safety against failure for the slope by about 25 per cent (Figure 26).

Stability analyses (Sarma method) were carried out for typical slope profiles where sands overlie clayey silts at the toe of the slope. The piezometric level in the clayey silts assumed in the analysis is shown on Figure 26 and for this condition, the results indicate that a 1 m lowering of the river water level could decrease the factor of safety by about 12 per cent.

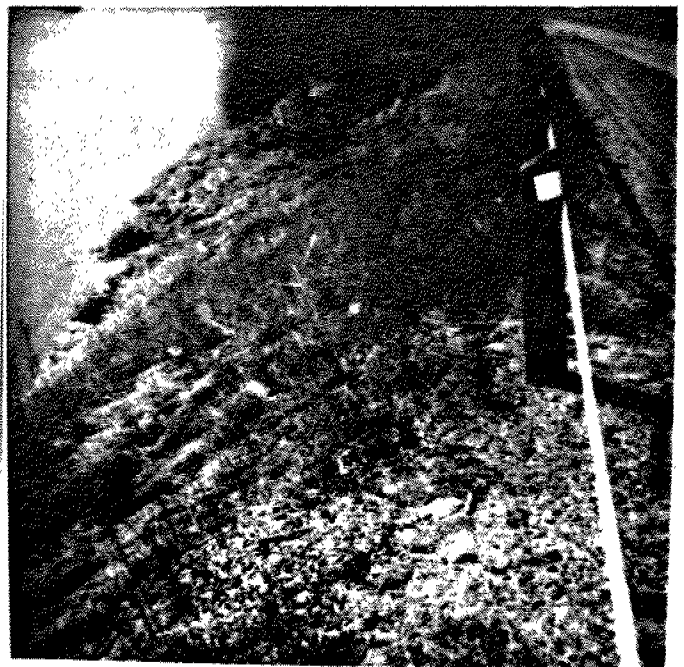
FIGURE 3

1. erosion of soil along the toe of the bank (Figure 1) followed by undercutting of the bank with subsequent slope failure (Figure 2).
2. Sloughing of saturated banks due to rapid changes in the groundwater level (Figure 3).
3. erosion by seepage forces (Figure 4)

1. loss of trees and other vegetation due to slippage into the river (Figure 5)
2. loss of support for guiderail causing potential traffic hazard (Figure 3 and Figure 6)
3. potential danger of complete undermining of Highway 17 (Figure 6 and Figure 7).

In most cases the M.T.C. ratings did agree with Ontario Hydro but in a few locations there were extreme differences. Note in Figure 3 at Station 20+500 that there was severe sloughing in 1984. This area was stabilized in 1984 although Ontario Hydro stated that this location had minor erosion potential.

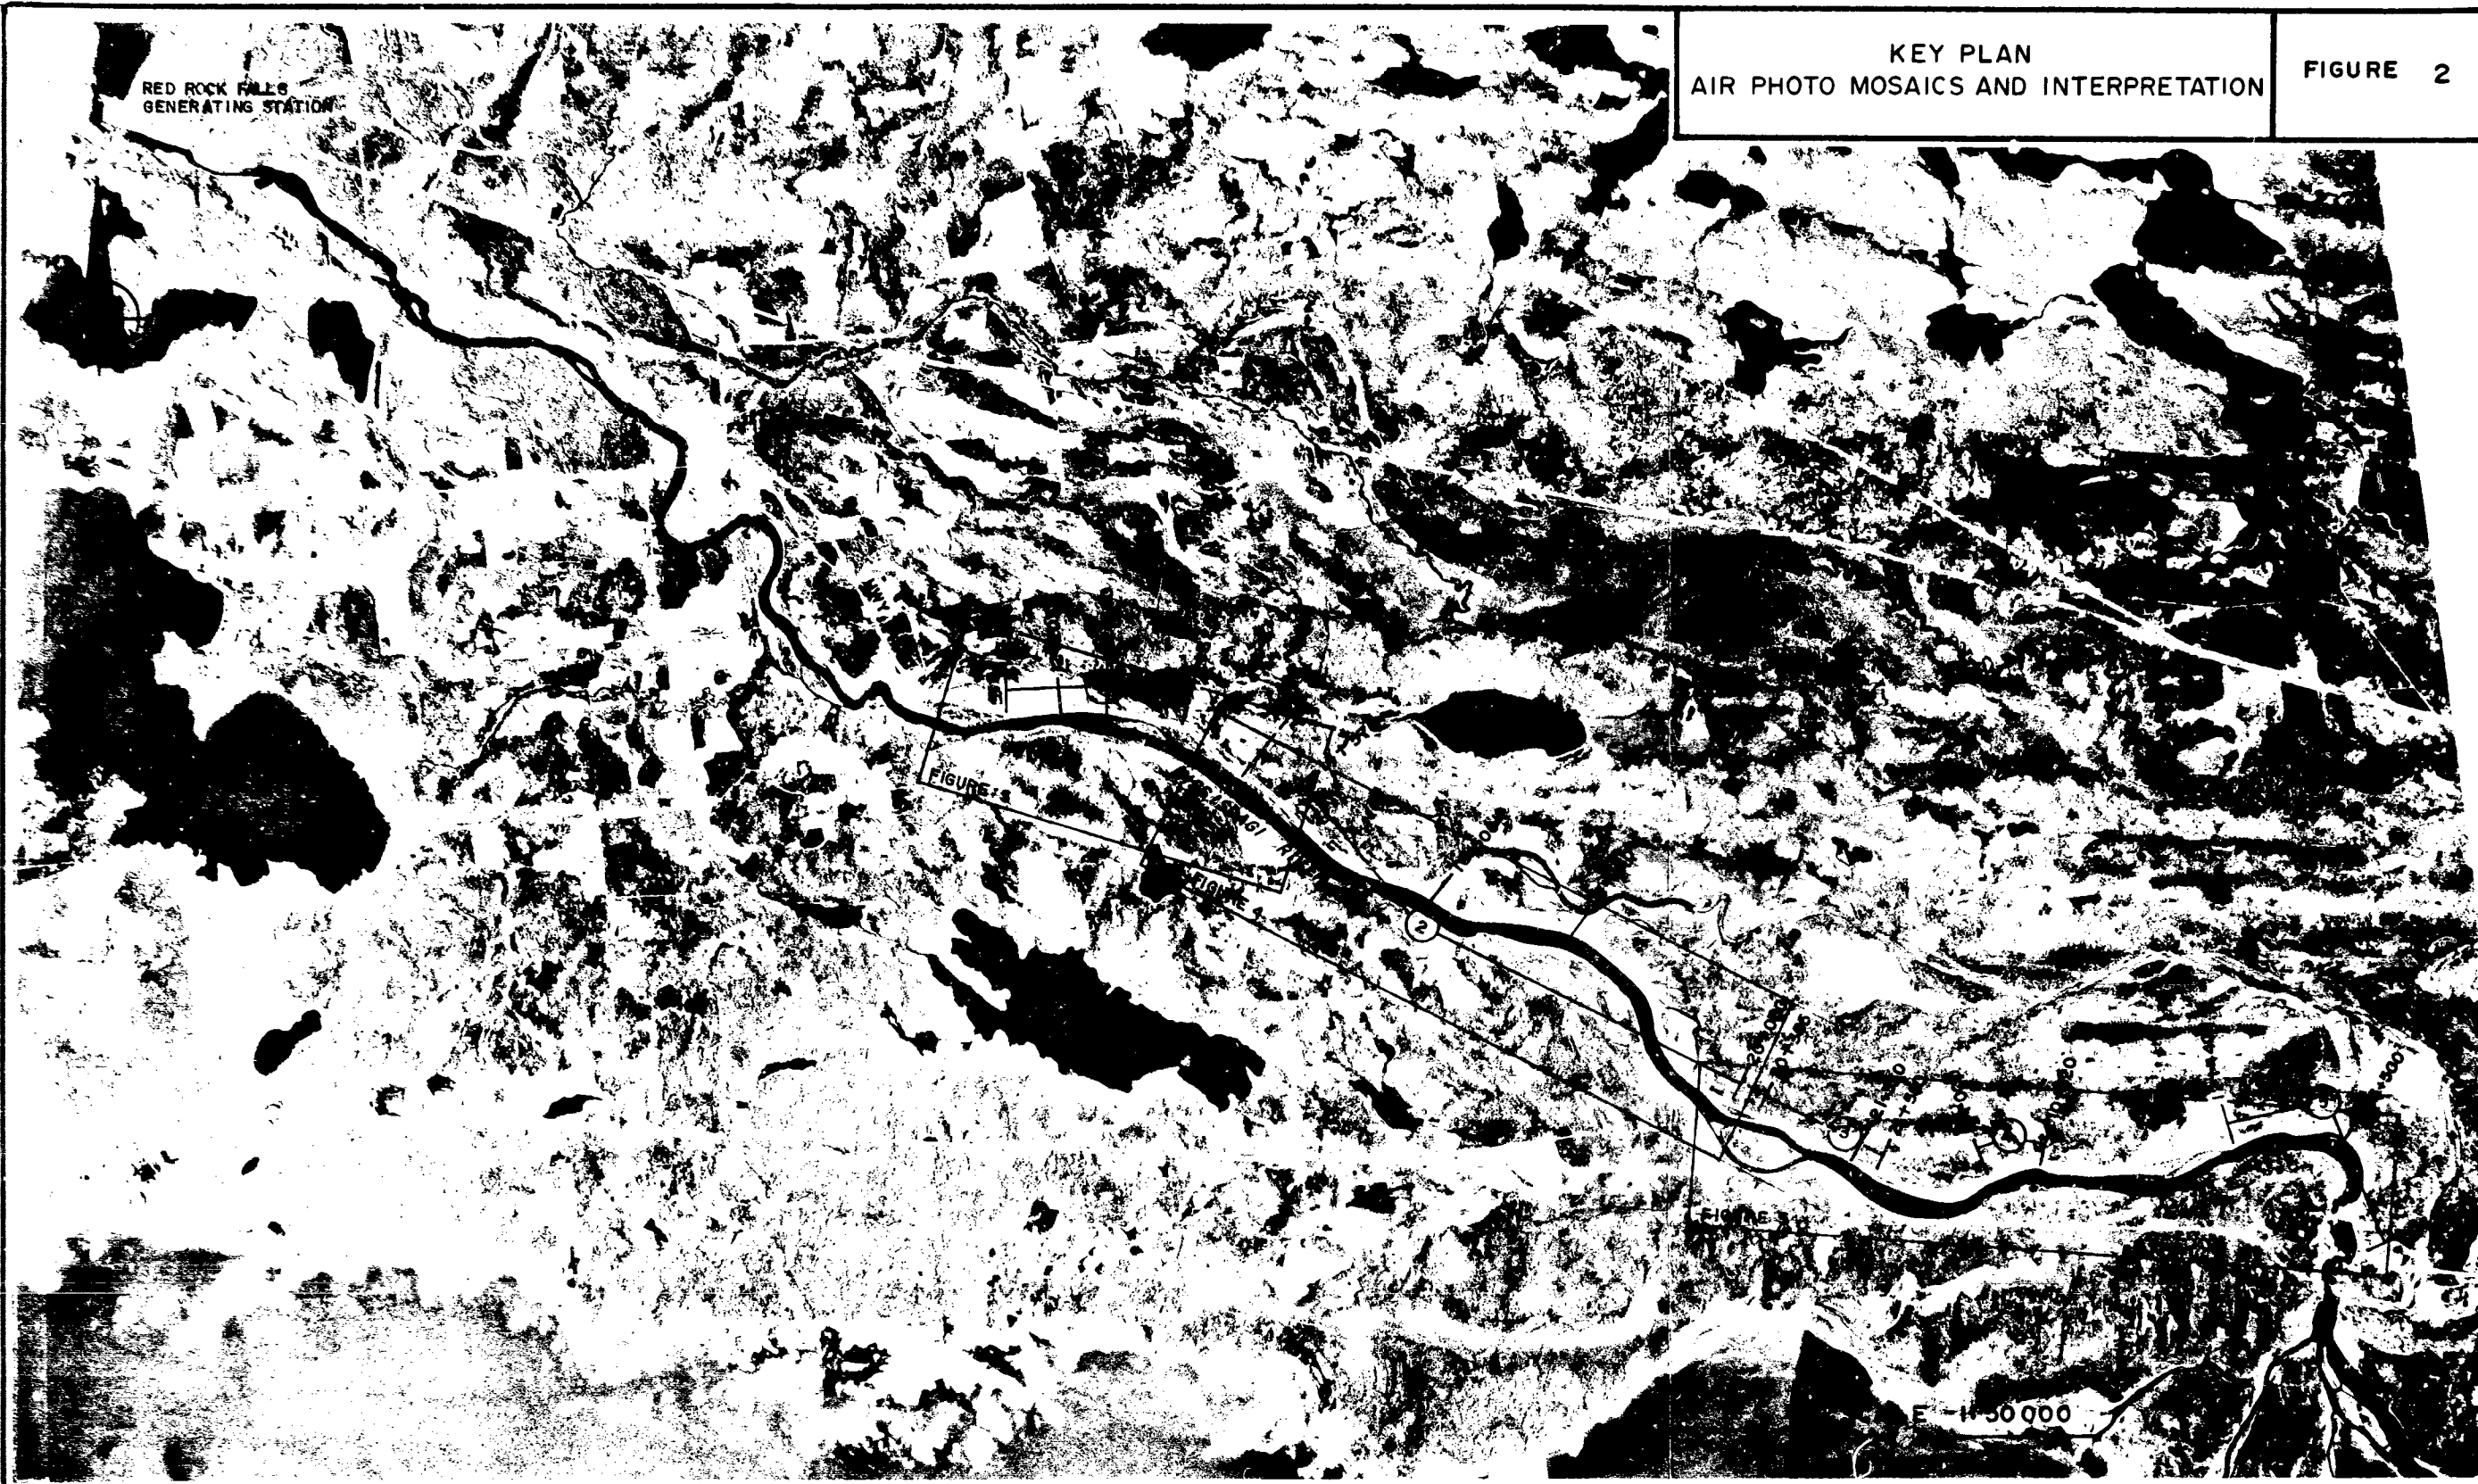
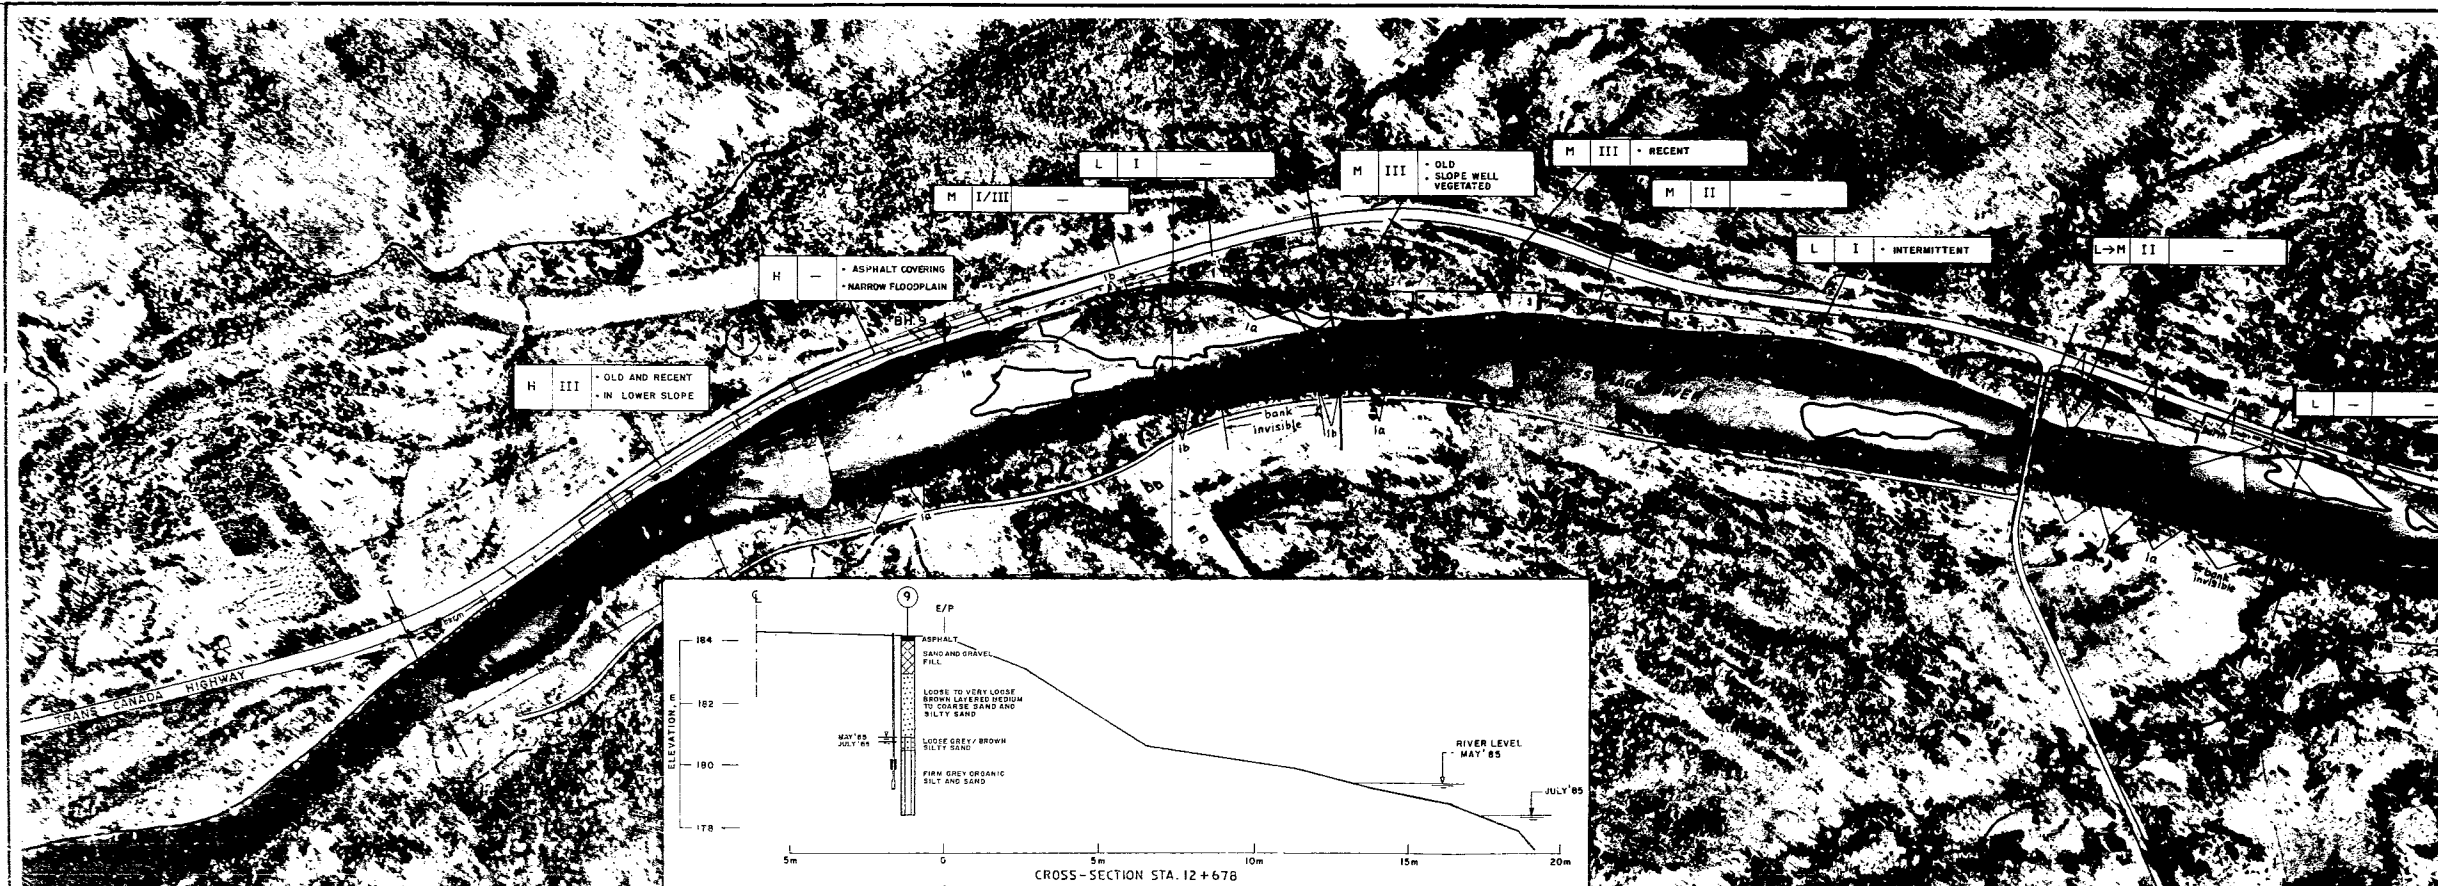
FIGURE 2

KEY PLAN  
AIR PHOTO MOSAICS AND INTERPRETATION

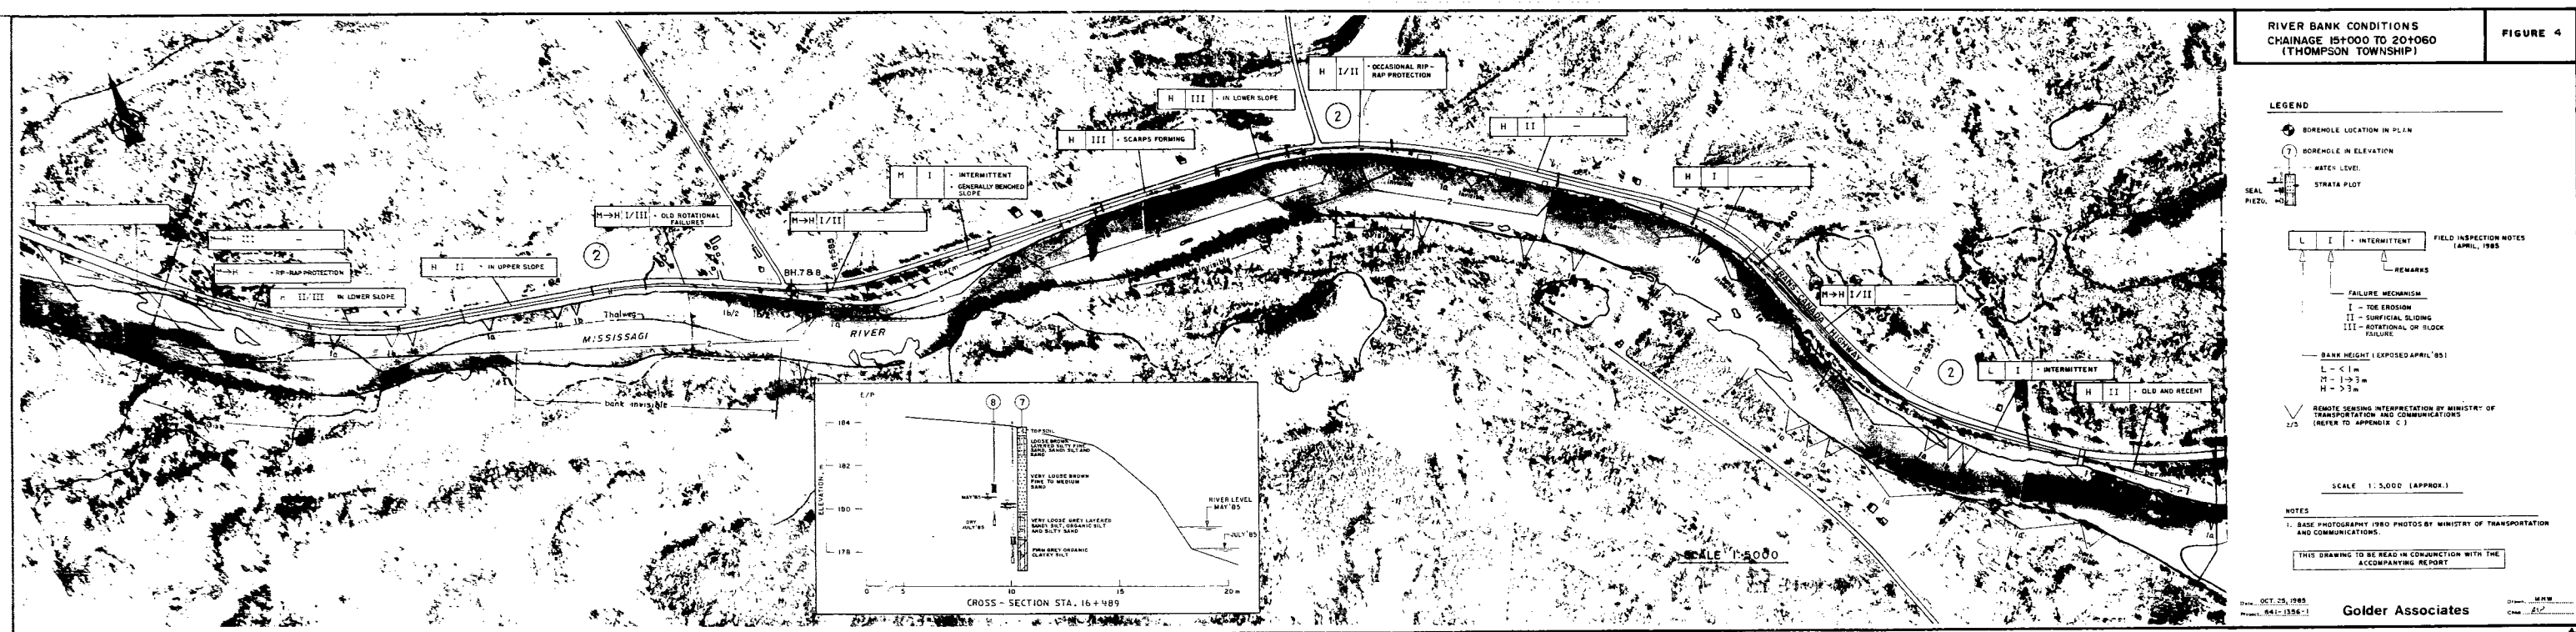
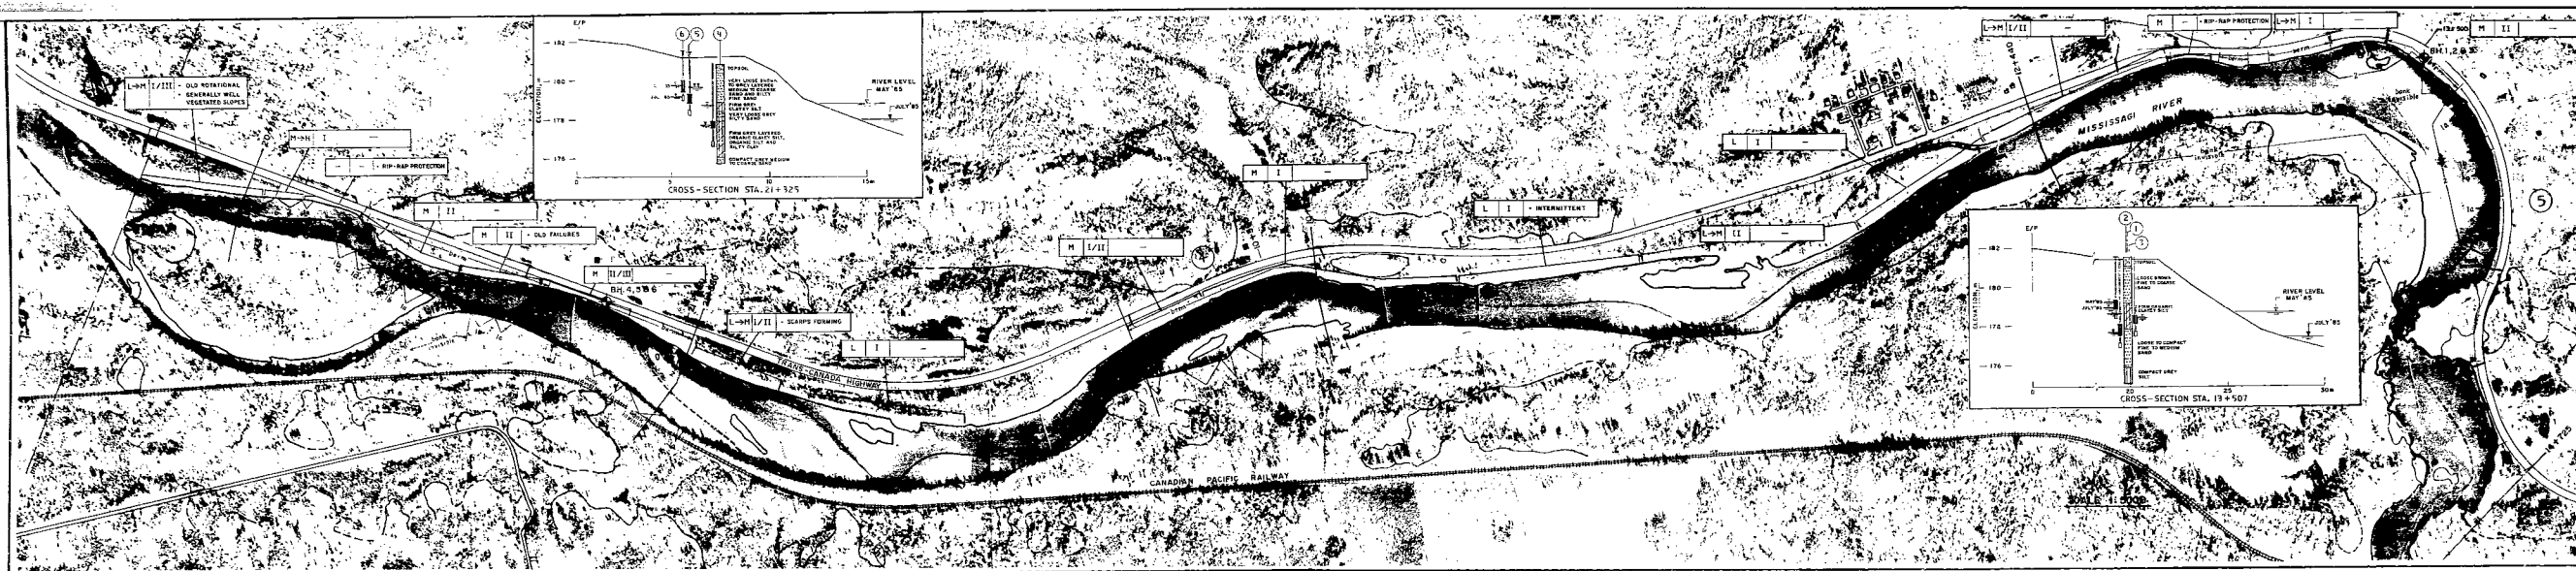
FIGURE 5

RIVER BANK CONDITIONS  
CH. 20+060 TO 22+788 (THOMPSON TWP.)  
CH. 10+000 TO 14+725 (COBLEN TWP.)
