## **Golder Associates**

MINISTRY OF TRANSPORTATION AND  
COMMUNICATIONS

REVIEW OF RIVER BANK INSTABILITY  
MISSISSAGI RIVER  
IRON BRIDGE TO MISSISSAGI CHUTES  
WP 153-83-00                      DISTRICT 18  
PHASE II

November, 1985

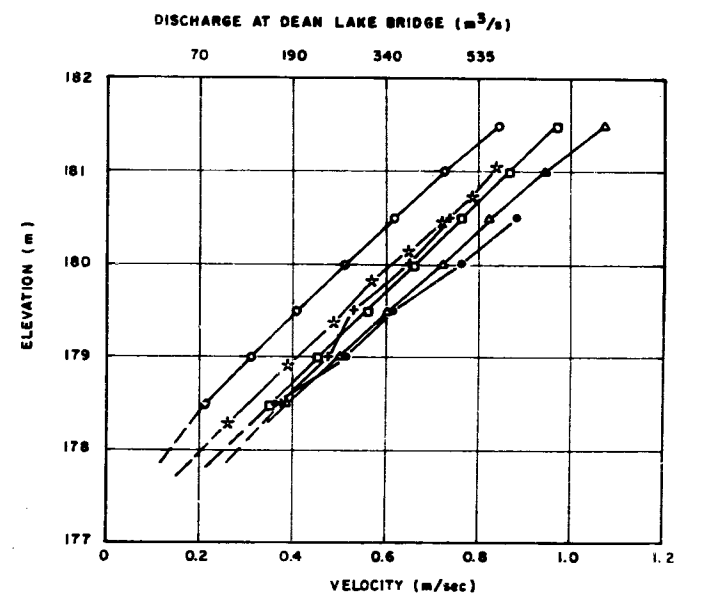
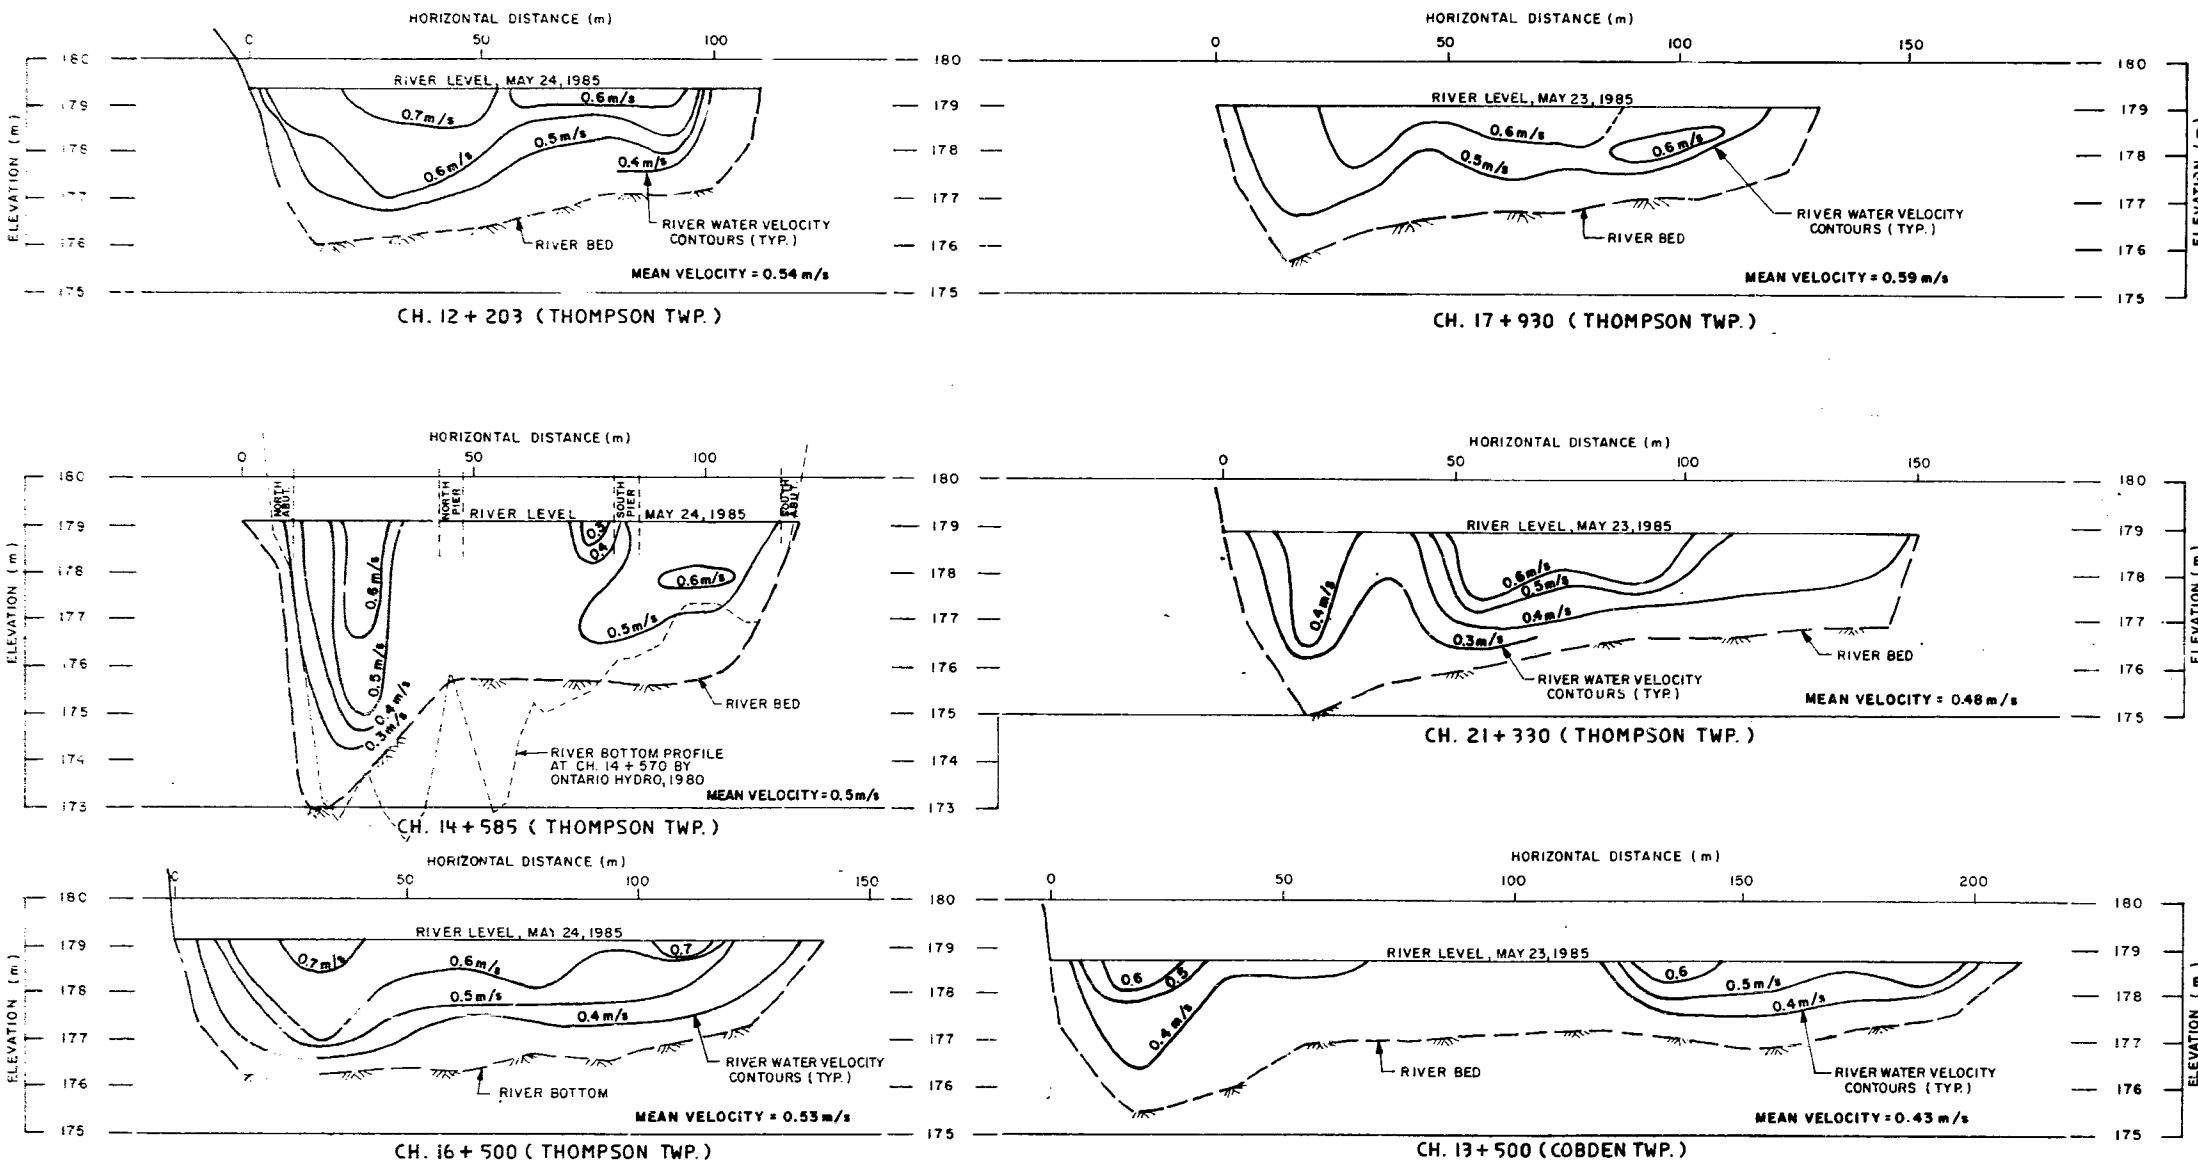
FIGURE 23

The cross-sections and velocity measurements were incorporated in the computer program HEC-2 which was used to simulate the hydraulic conditions of the river. The model was calibrated using both the calculated total channel flows and using the stage-discharge relationships obtained from Water Survey of Canada for Mississagi Chutes and Dean Lake Bridge at the downstream end and near the upstream end of the study reach, respectively. The analysis confirmed that the river geometry is such that changes in flow produce corresponding changes in river water level along the full reach of the study area. It was also possible to establish a relationship of river velocity with respect to river water elevation at each of the profile sites. The relationships are shown on Figure 23 and show that relatively small changes in river level greatly affect the river water velocity.

MISSISSAGI RIVER PROFILES  
CHAINAGE 12+203 (THOMPSON TWP.) TO  
CHAINAGE 13+500 (COBDEN TWP.)

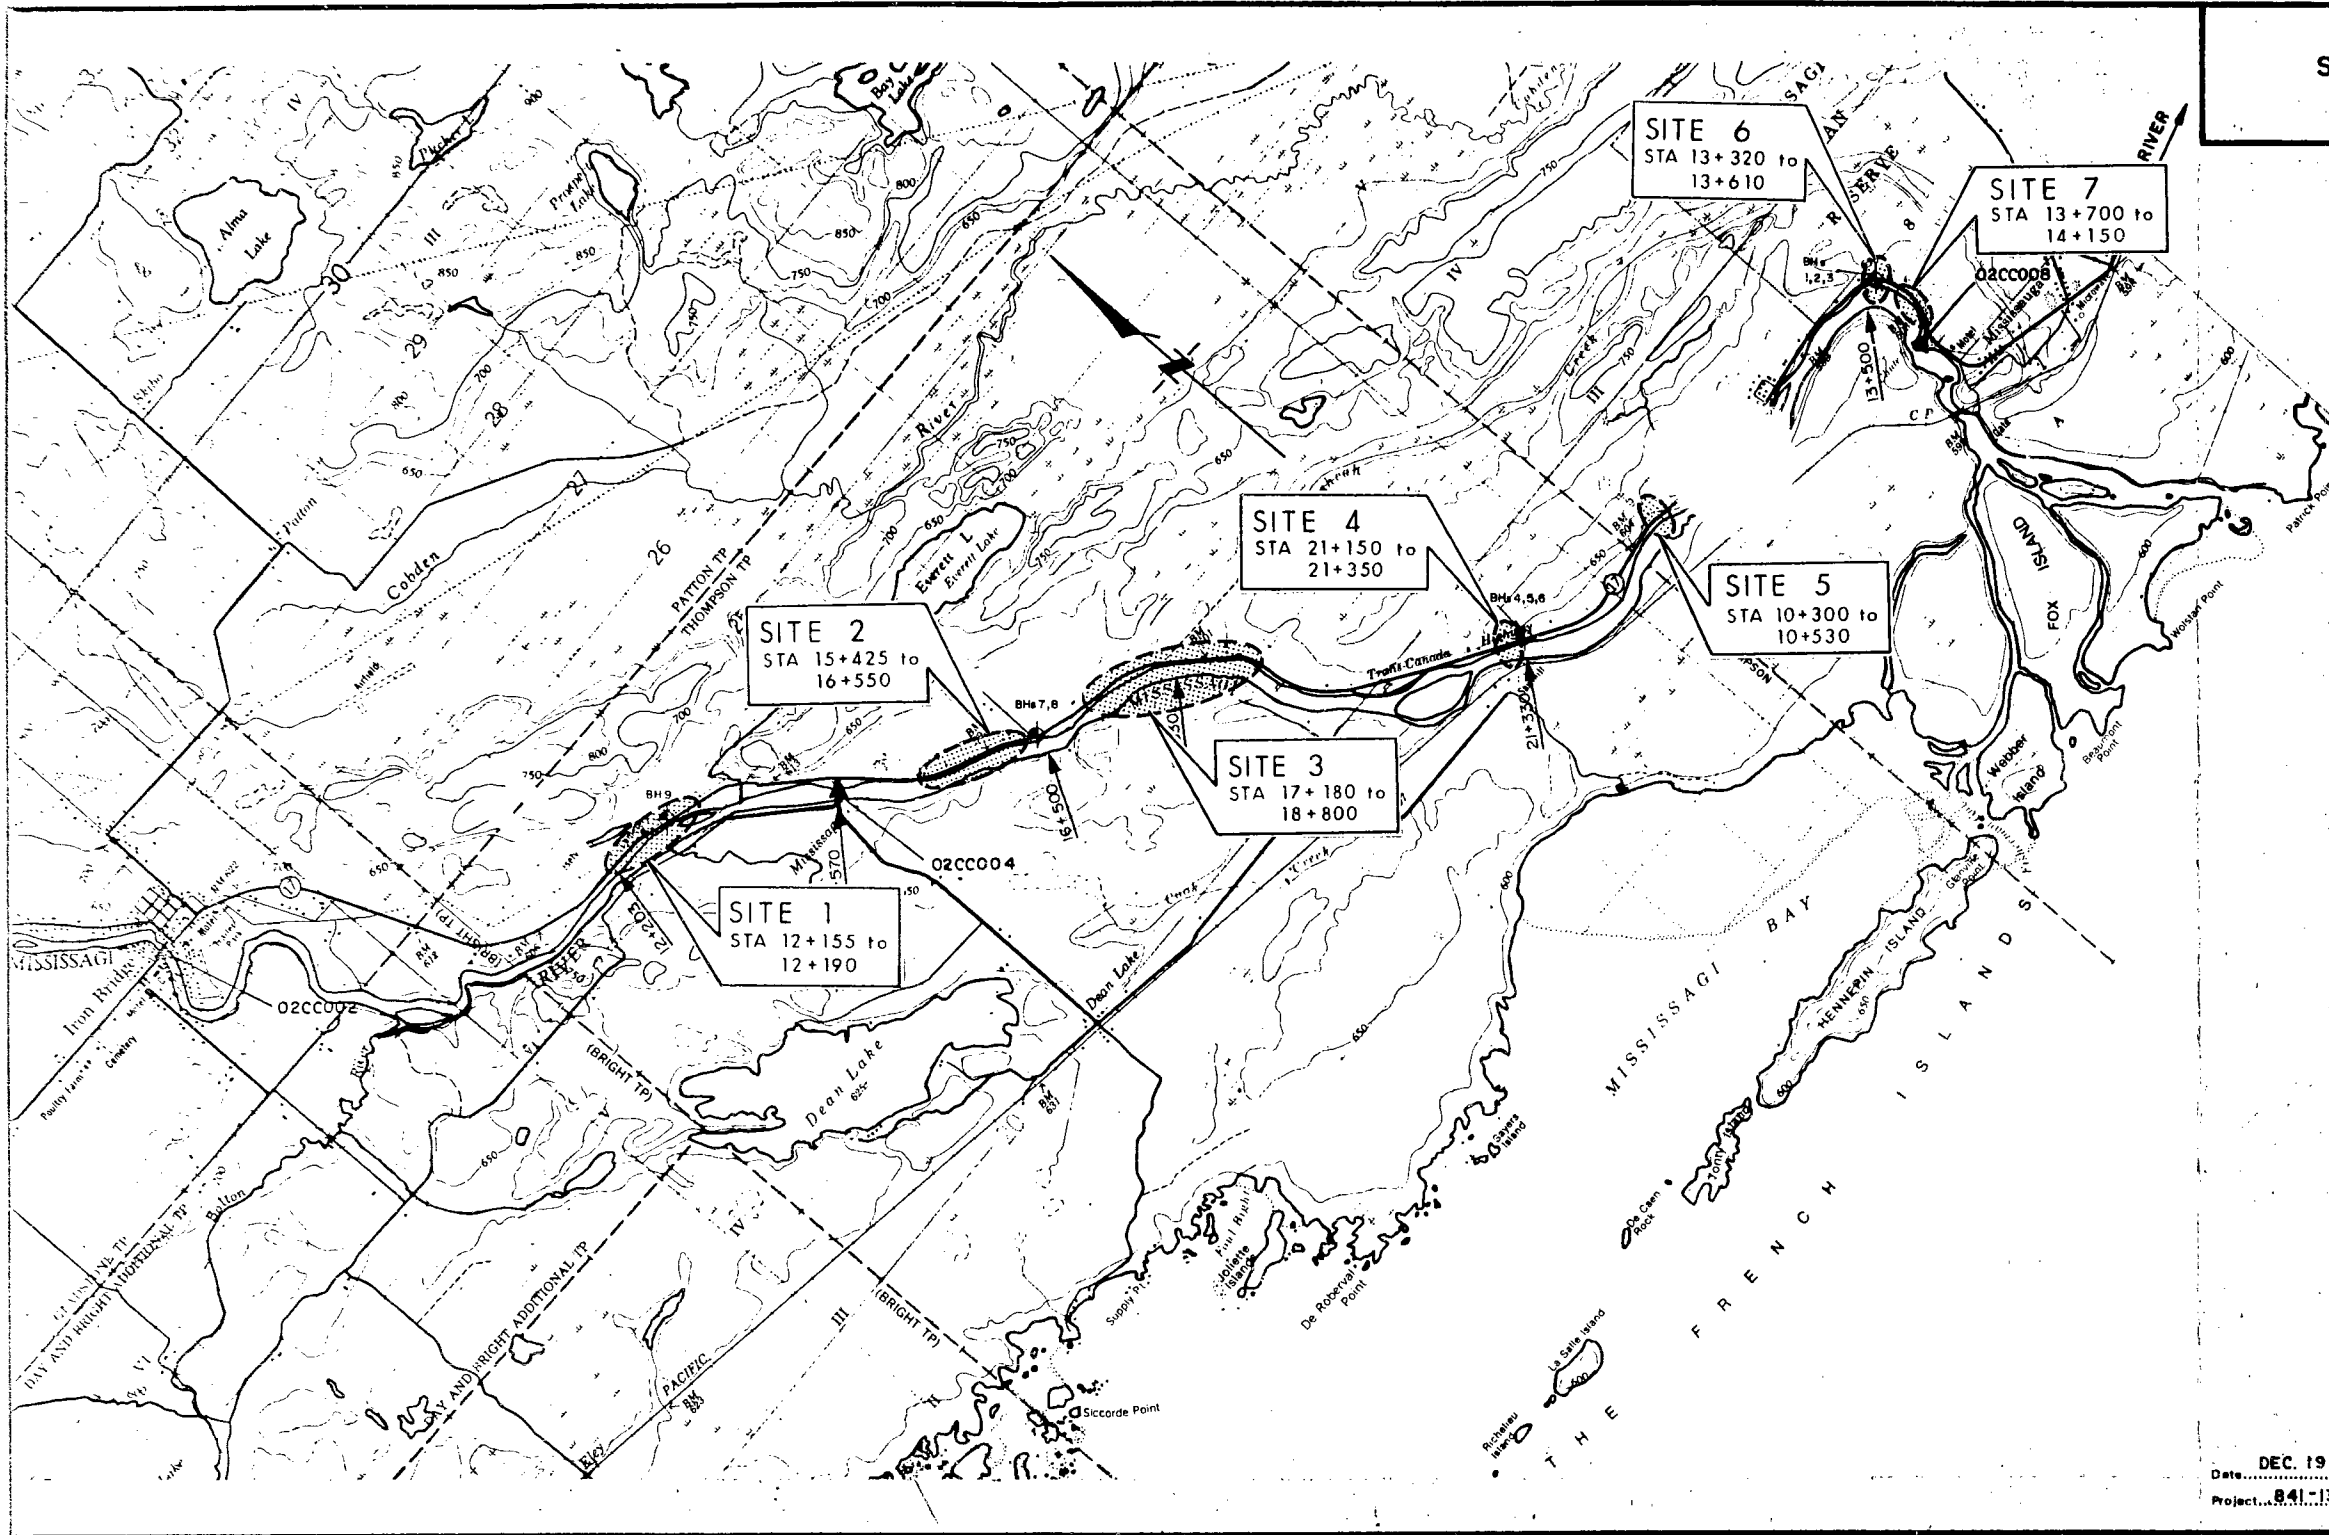
FIGURE 1

A total of 7 site (5080 m) that require remedial treatments have been identified. Approximate locations of these sites are illustrated on Figure 1. Specific details of these sites, including;
