LOCATION Munroe Island Bridge

Foundation Investigation Report
For
Munroe Island Bridge at Highway 548
W.P. 29-88-01, Site 38 S-177
District 18, Sault Ste. Marie

Re Highway 11, Noden Causeway
 Site 45W-75, District 20
 Kenora District, Ontario
 Underwater Inspection Report

This report covers the underwater inspection of the **Highway 548, Munroe Island Bridge, MTO Site 38S-177**, including visual examination of the underwater components of the foundation, underwater videotape recordings of the foundations, determination of scouring conditions, and recommendations for remedial work. The Munroe Island Bridge was inspected previously by our Chief Engineering Diver in 1984.

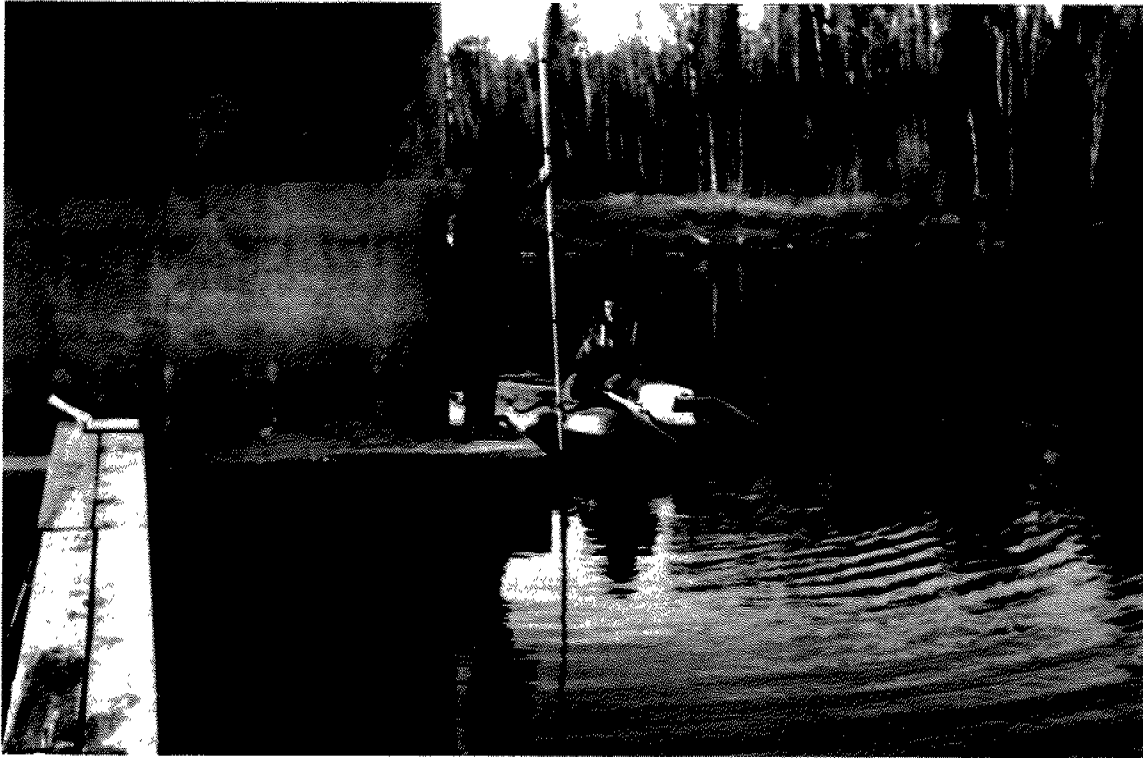
PHOTOGRAPH 3 Obtaining water depth soundings around bridge pier.

The condition of concrete components was evaluated by visual inspection and hammering of the concrete surface. The surficial soil type and relative density in the vicinity of the foundations was evaluated by visual examination and probing of the river bottom with a hand-held 15 mm diameter by 800 mm long steel rod. Water depth soundings were obtained with a sounding rod and an electronic depth sounder around the bridge piers in order to accurately record riverbed depths. Photograph 3 shows the inspection team obtaining water depth soundings around a bridge pier.

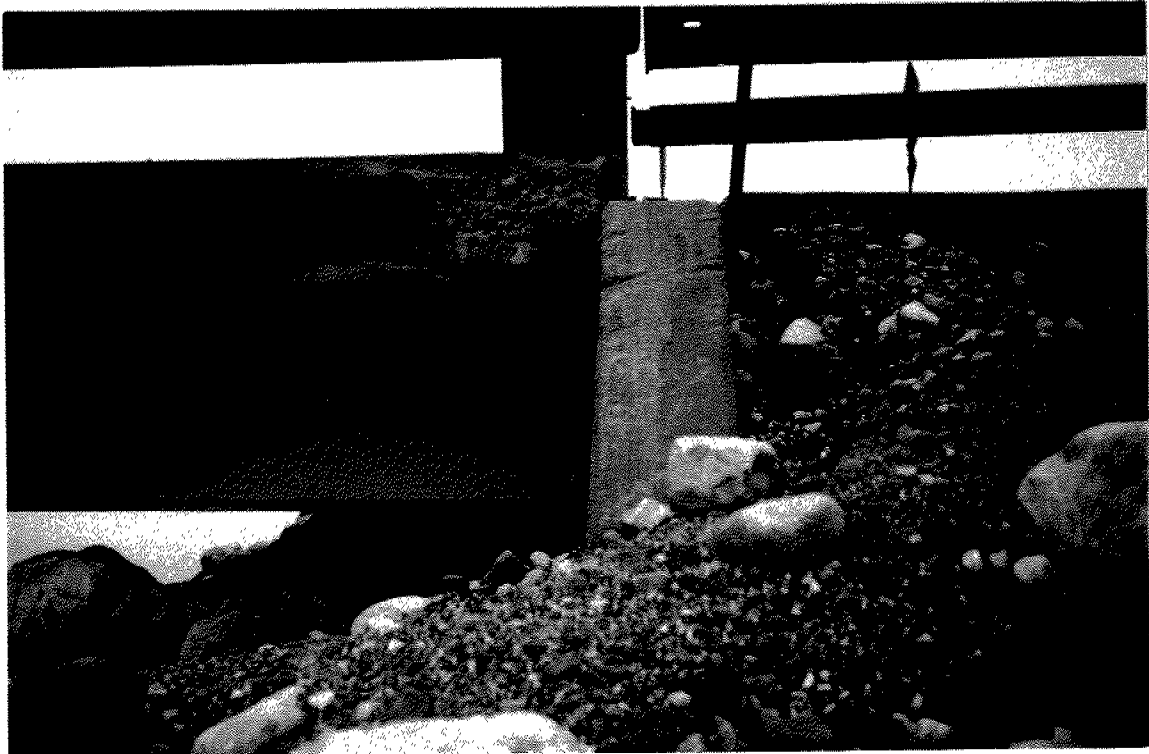
PHOTOGRAPH 12 General arrangement of bridge abutment.

At the bridge location, the St. Marys River flows from west to east. At the time of inspection, the footings of both Piers 1 and 2 were in the water. The abutments were surrounded by dry ground, well above water level. Photographs 1 & 2 show the general view of the bridge and piers. Photographs 5 to 9 show the general layout of the piers, and Photograph 12 shows the general layout of the abutments.

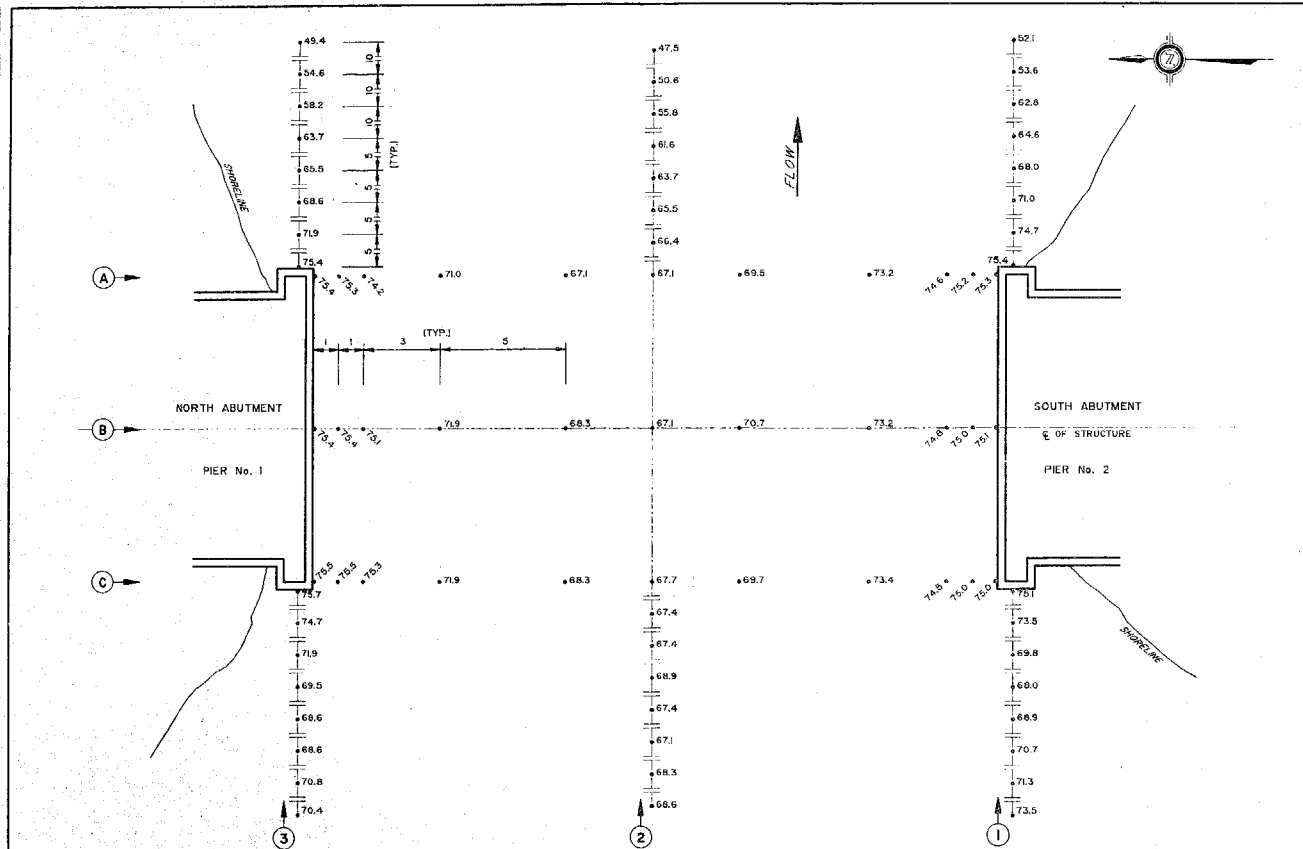
The results of the underwater soundings are presented in Figure 2 which shows a plan of the riverbed elevations. Cross sections of the riverbed are given in Figure 3 and profiles of the riverbed along Piers 1 and 2 and the river centreline are given in Figure 4. In general, the stream bed was found to consist of loose rock material, concrete sacks and concrete rubble material with occasional sandy areas as shown in Photographs 13 through 17. The river bottom could not be probed due to the coarse nature of the material.
