WP 263-90-01 DIST 62
HWY 17 STR SITE 48E-46C

Embankment Failure - 0.9 km West Hopper Road
4 Km West of Thessalon (Lake Street)

DATE NOV 15 1995

FOUNDATION INVESTIGATION REPORT
FOR
Sta. 13+900 to Sta. 14+000
Embankment Failure - 0.9 Km West Hopper Road
4 Km West of Thessalon (Lake Street)
WP 263-90-01, Twp. of Lefroy
District 62, Sault. Ste. Marie

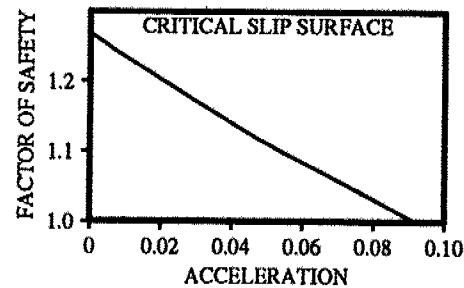
CRITICAL ACCELERATIONS

0.173	0.139	0.116	0.110
0.162	0.125	0.101	0.108
0.153	0.111	0.092	0.114
0.147	0.102	0.095	0.102

FACTORS OF SAFETY

1.598	1.455	1.350	1.352
1.536	1.388	1.294	1.361
1.482	1.325	1.266	1.398
1.444	1.285	1.282	1.284
