Observations and Recommendations regarding the Goulais River Bank Slump of October 13, 2003

**MNR Northeast Region Engineering Unit
Field Service Division,
Ministry Of Natural Resources**

October 27, 2003

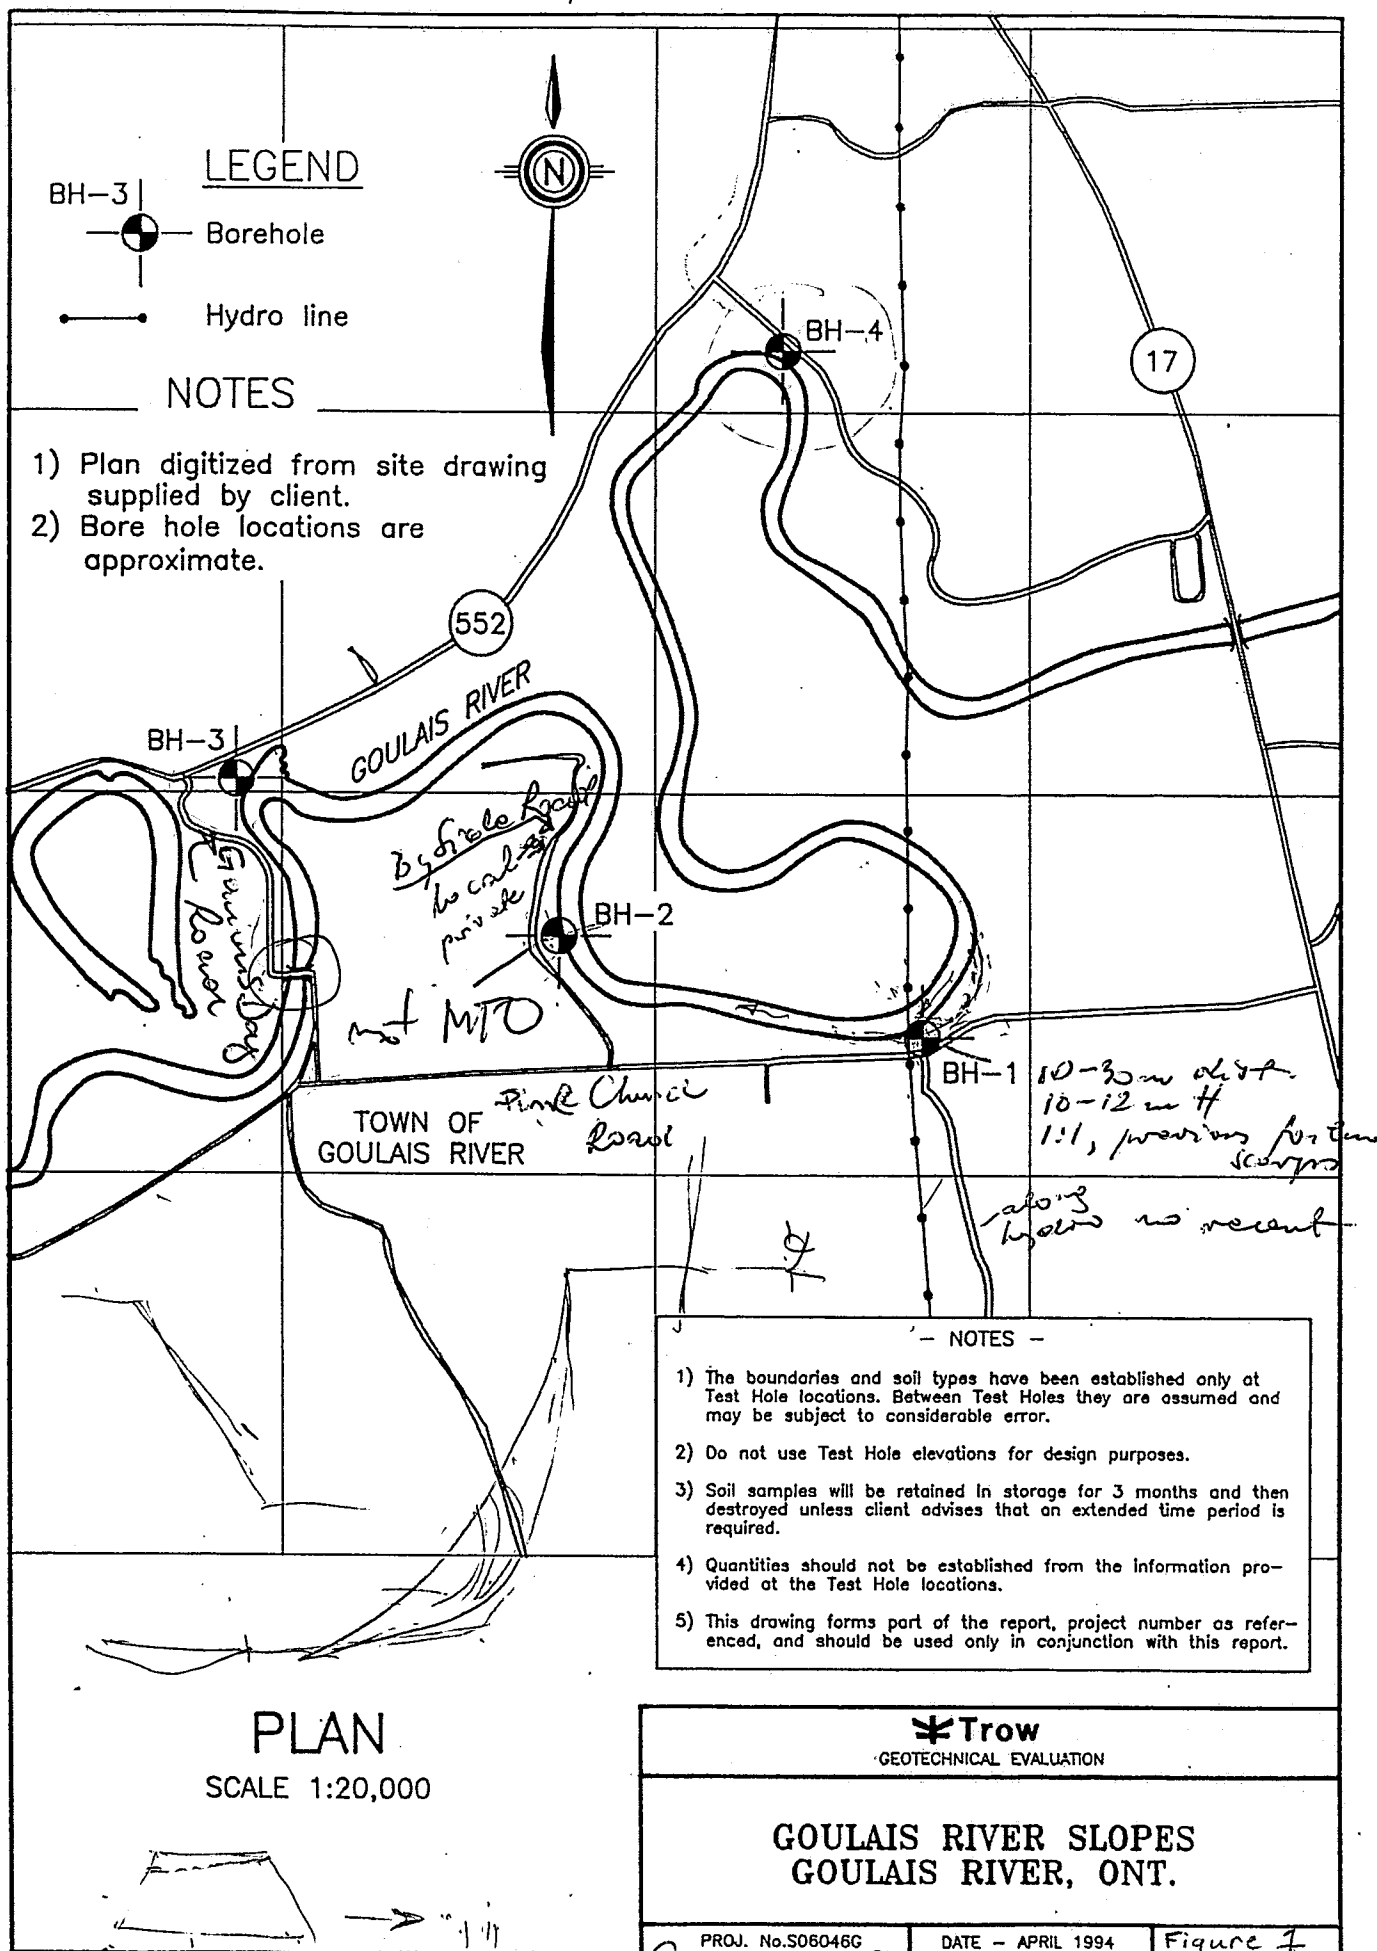
Figure 1: Trow Goulais River Geotechnical Investigation – Location of Boreholes.

Willing Road along - West South of 552
approx 1 km and rip-rope at base move north as far as possible, remove old trees
