HWY. No. 65LOCATION Slope Failure - 17 km N of
Elr. Lake at Hwy 65No of PAGES -

Re: Embankment failure at Hwy. 65
approximately 18 km south of the Junction of Hwy. 65/66
W.O. 96-11002, Hwy. 65, District 53, New Liskeard

Re: Embankment failure at Hwy. 65, approximately 18 km south of the Jct. of Hwy. 66/65.

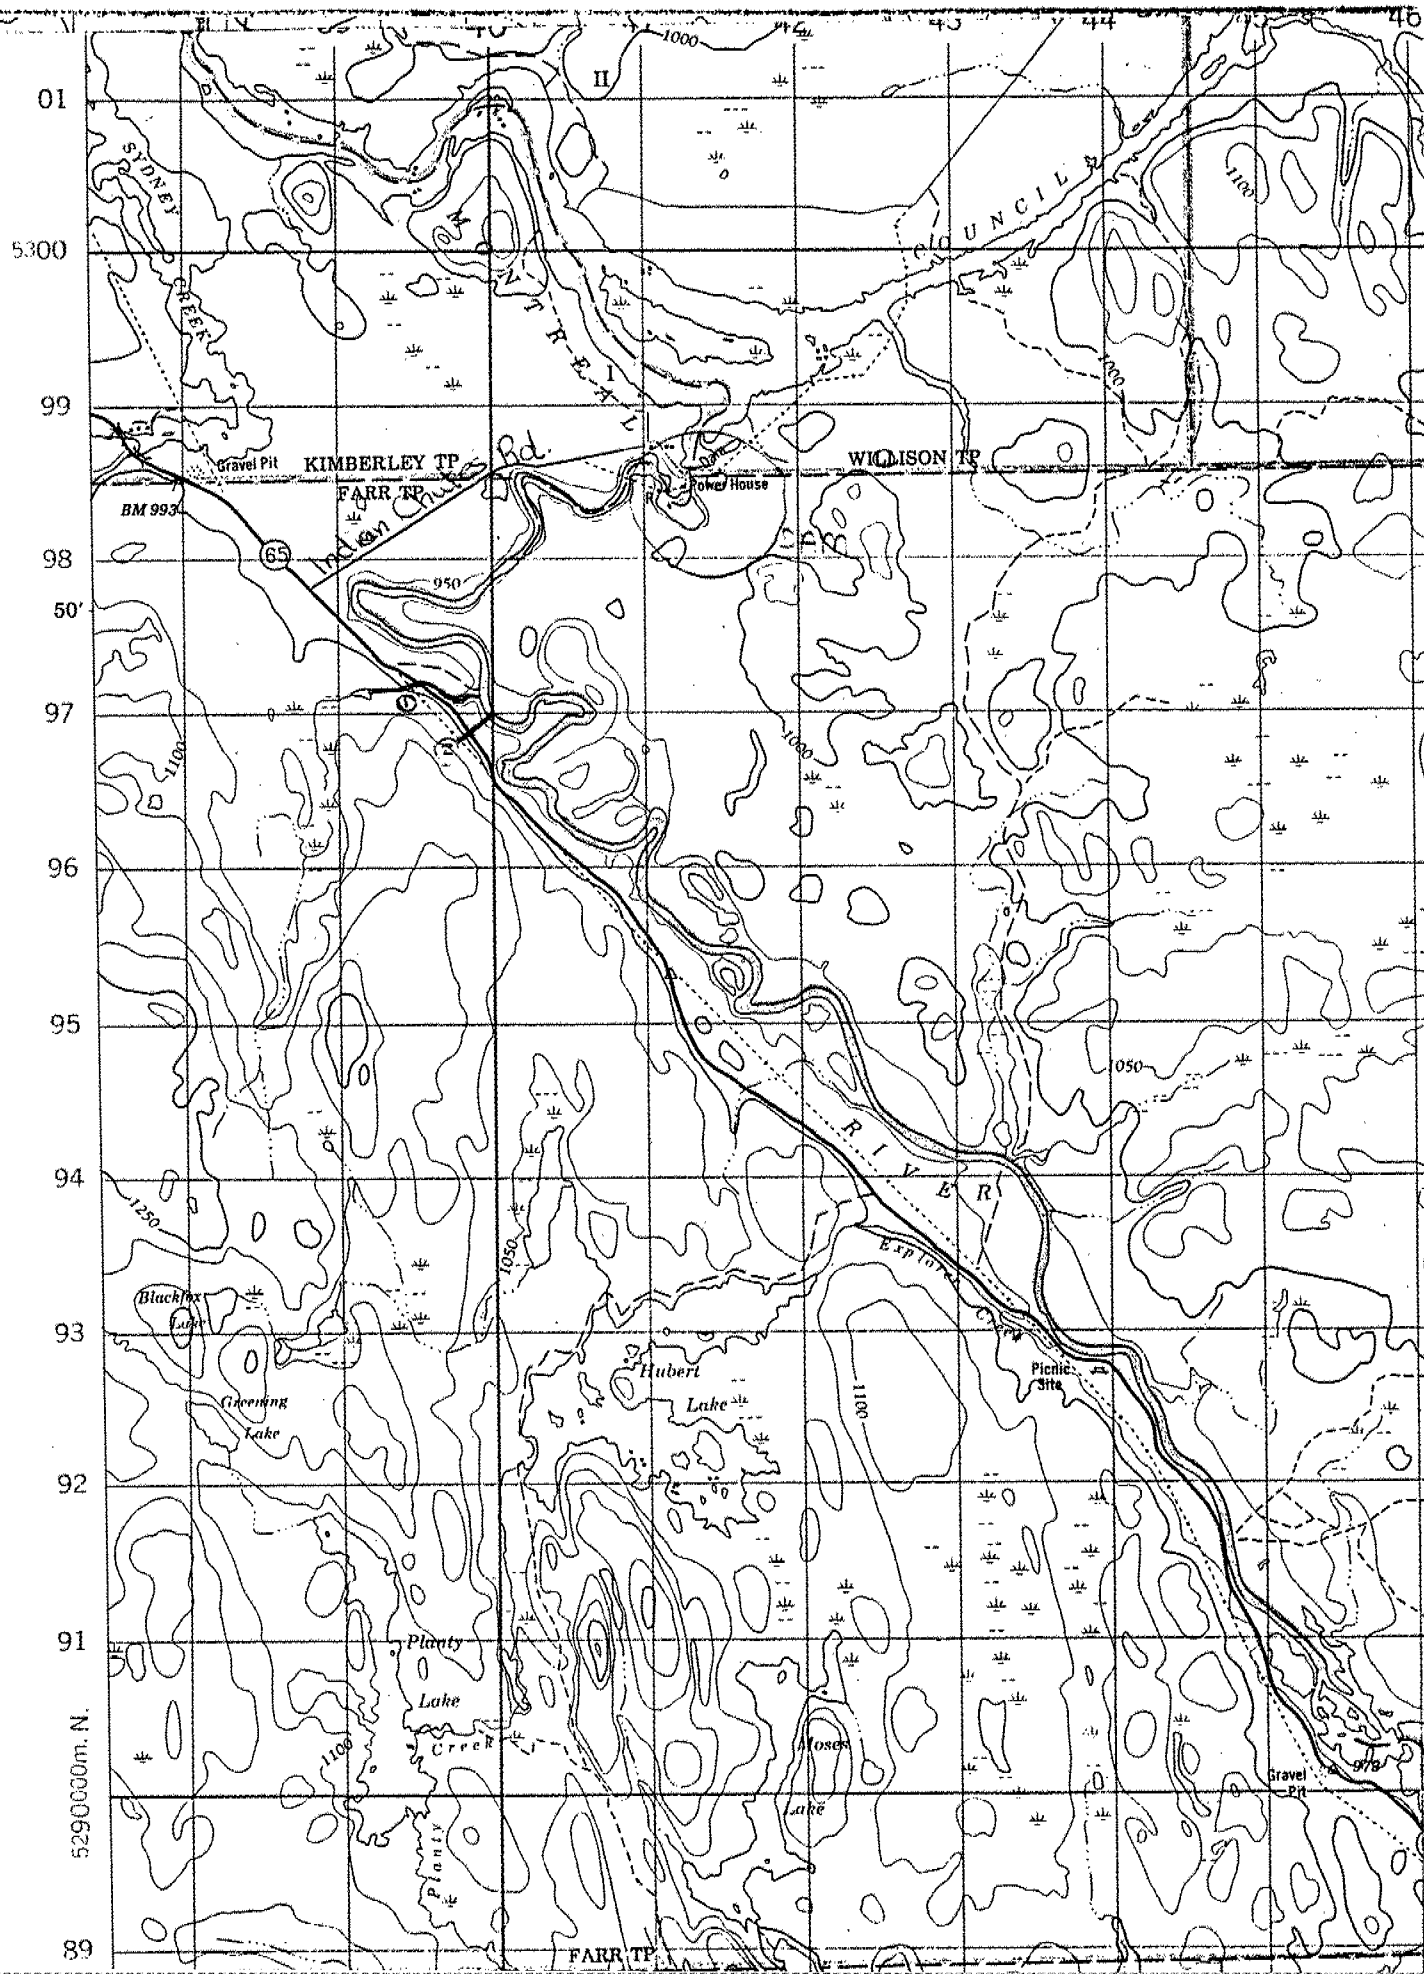
SHEET
11

- Approximate distance from \mathbb{C} of highway to the river is 200m.
- Width of failure at highway was 15m widening to about 50m at river.
- Depth of failure at highway was 6m deepening to about 25m at river.
- Size of CSPA north of failure site was 8' by 6'.
- Size of CSP at failure site was 36".
- Failure took place at sta 186+00 from contract 78-29 ETR sheets, approximately 18 km south of the Junction of Hwy. 66/65.

① 8'x6'
CSPA
② 36" csp
site of
failure
