FOUNDATION INVESTIGATION REPORT

Distress of Embankment
Constructed Over An Organic Terrain
From 8.4 Miles to 11.0 Miles West of Raith
W.P. 910-75-01
Hwy. 17 (T.C.H.) District 19, Thunder Bay

FOUNDATION INVESTIGATION REPORT
for
Distress of Embankment
Constructed Over An Organic Terrain
From 8.5 Miles to 11.0 Miles West of Raith
W.P. 910-75-01
Hwy. 17 (T.C.H.) District 19, Thunder Bay

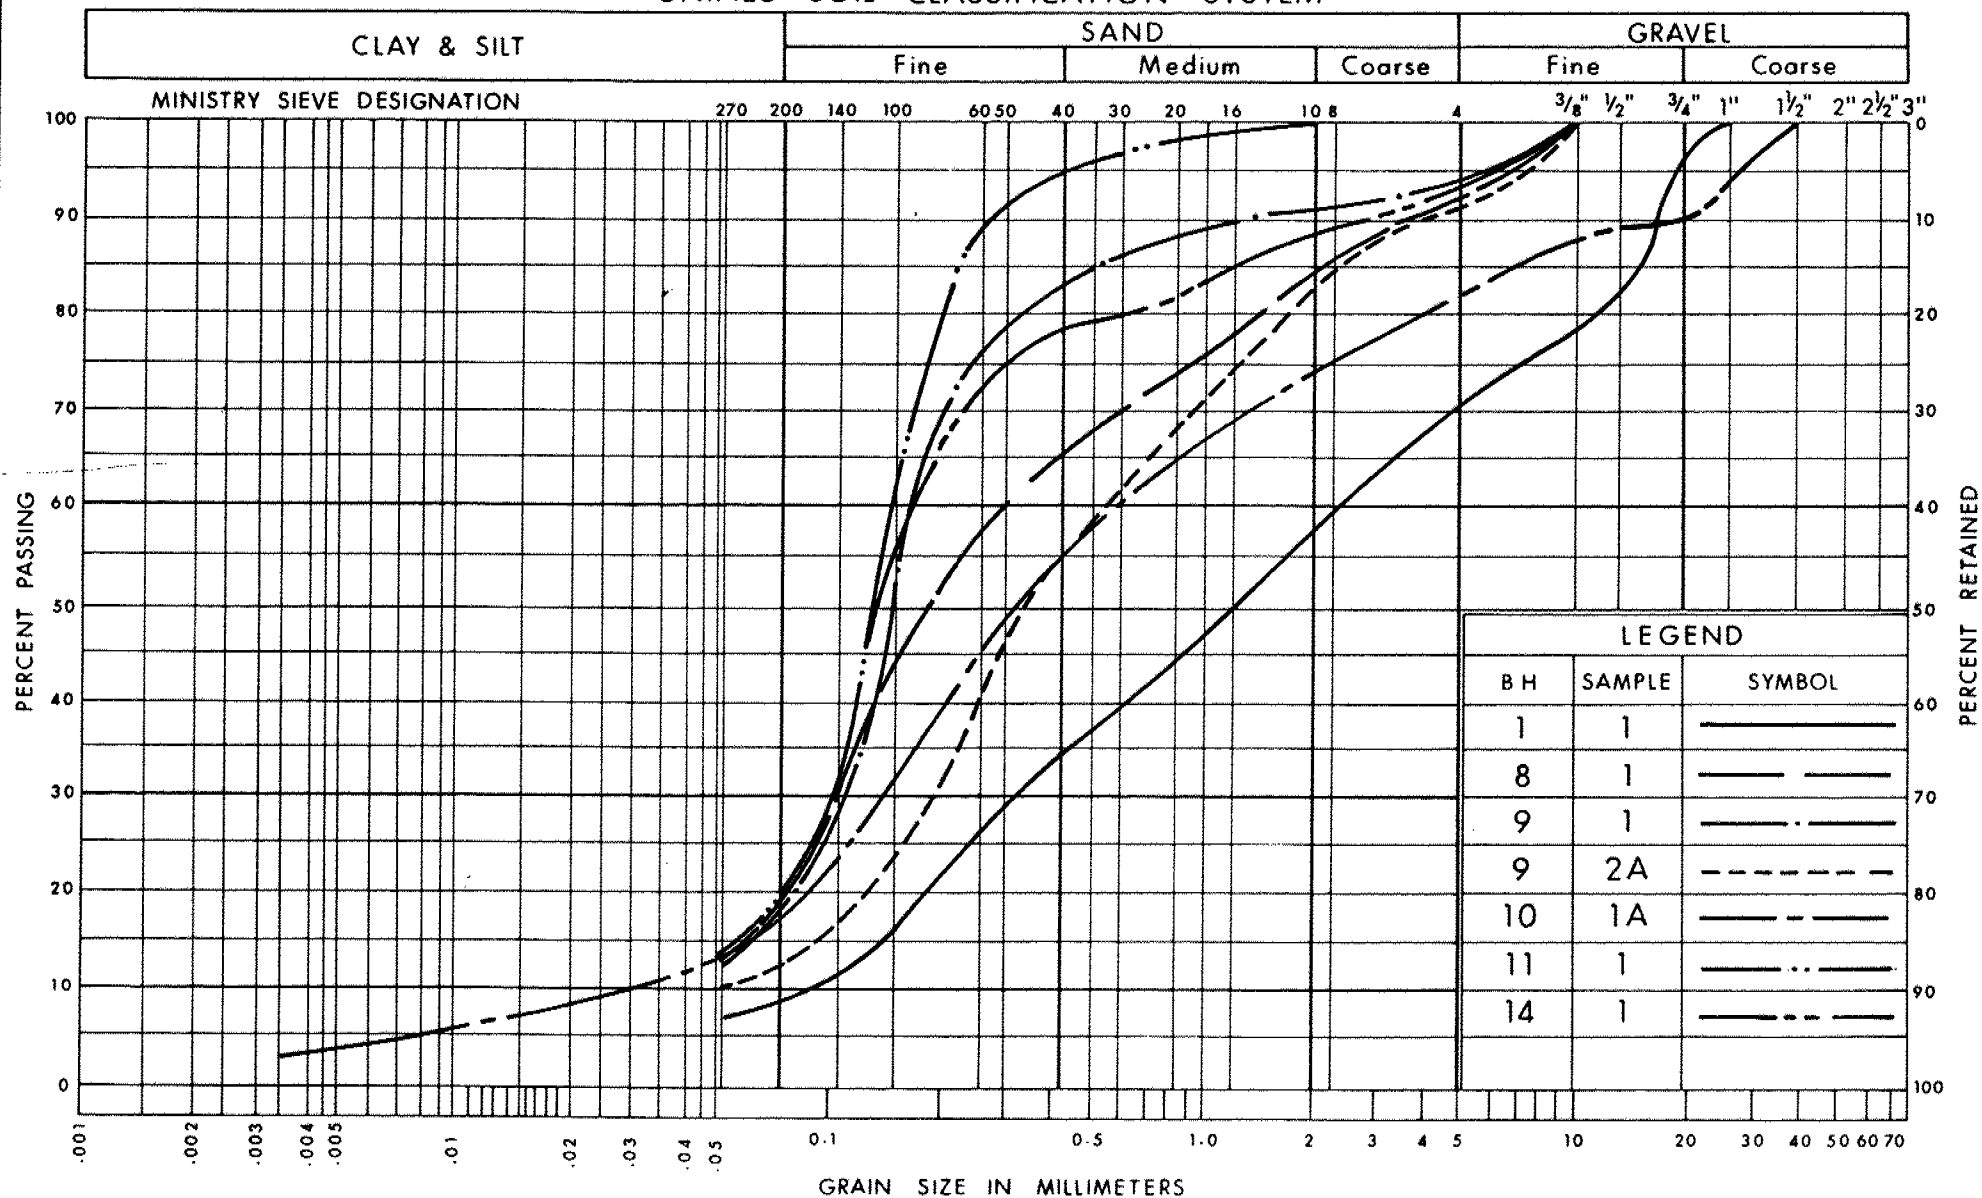
FIG No 5
W P 910-75-01

GRAIN SIZE DISTRIBUTION FILL MATERIAL ON SHOULDER (FILL MAT'L)

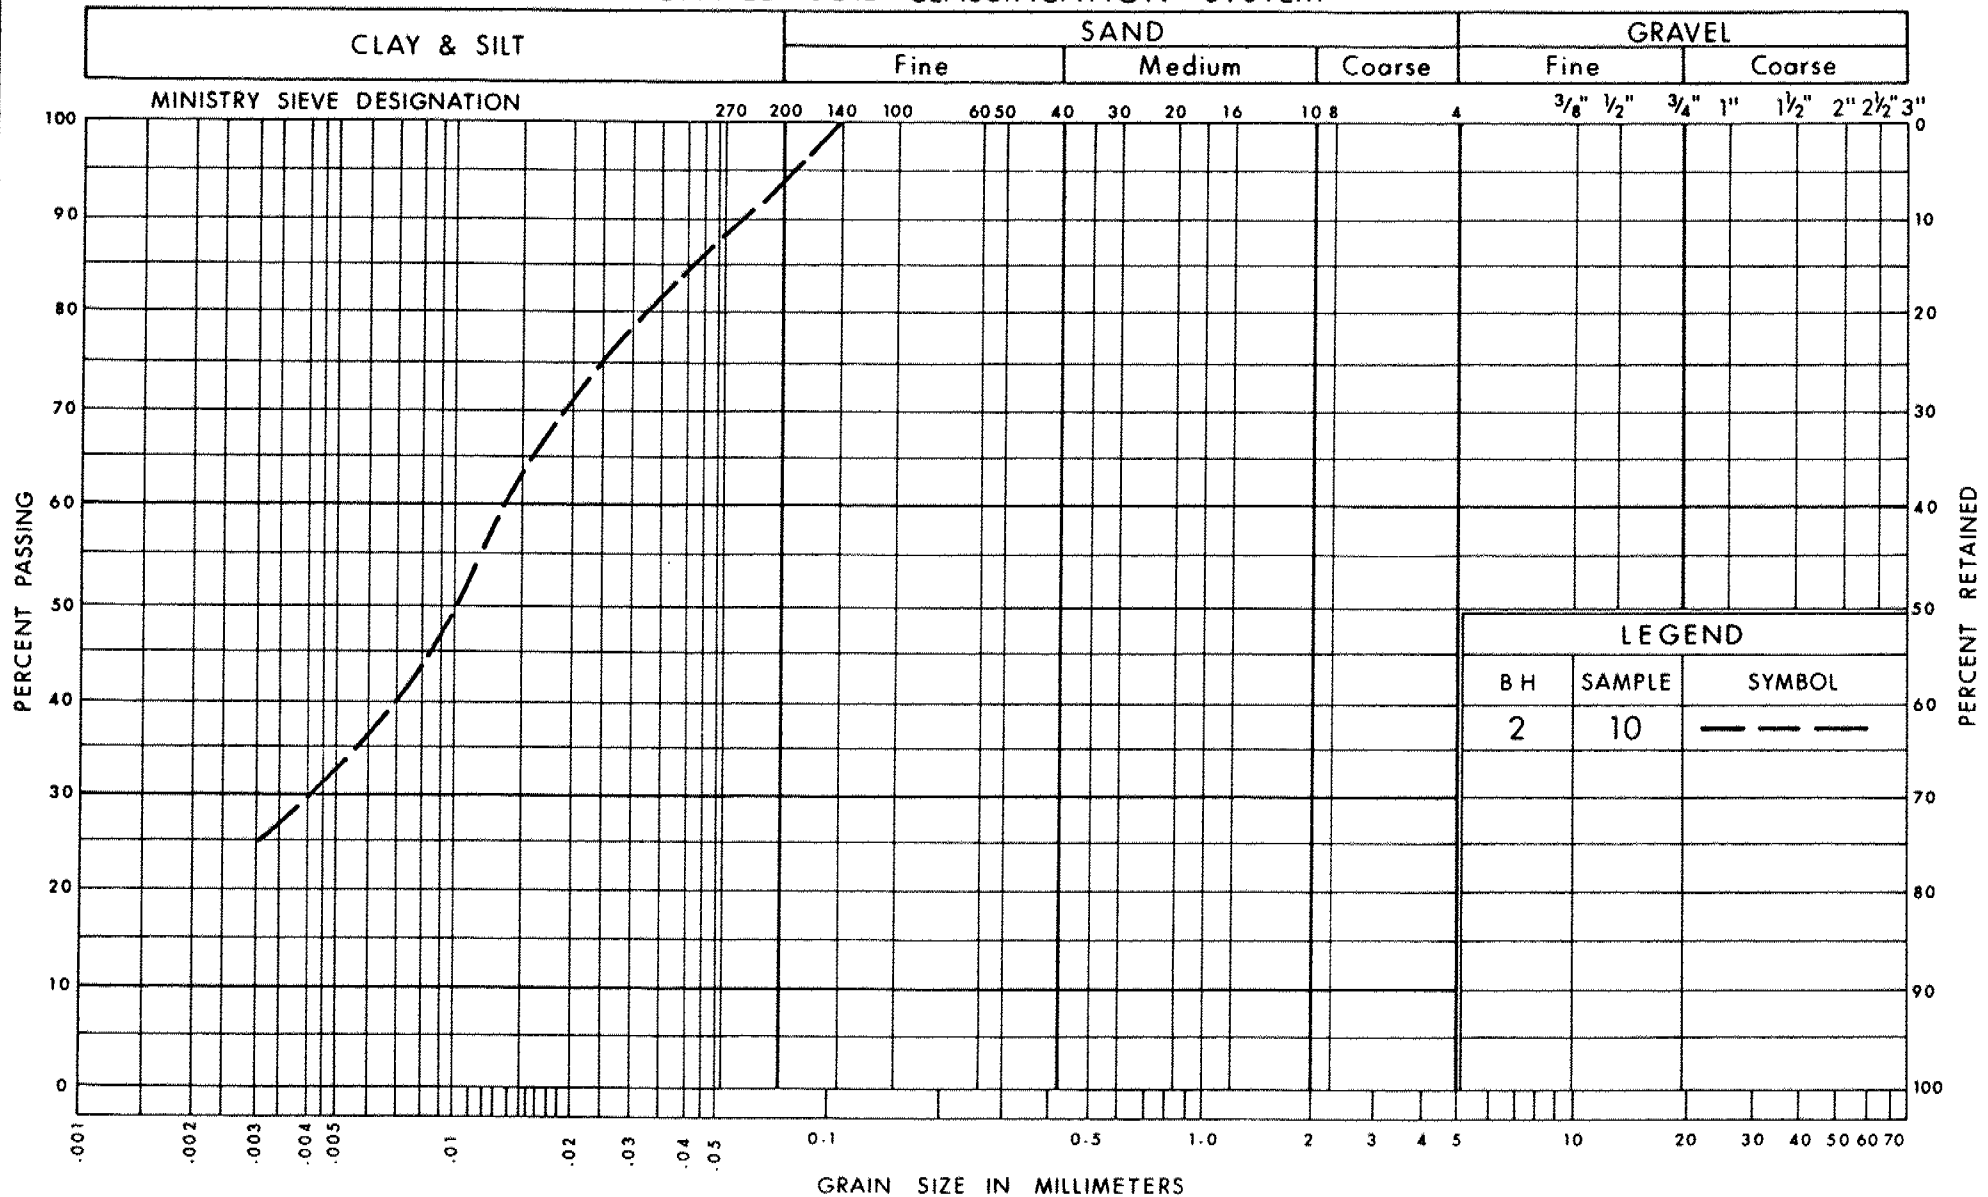
FIG No 6

Grain Size Distribution (Fig. 6)

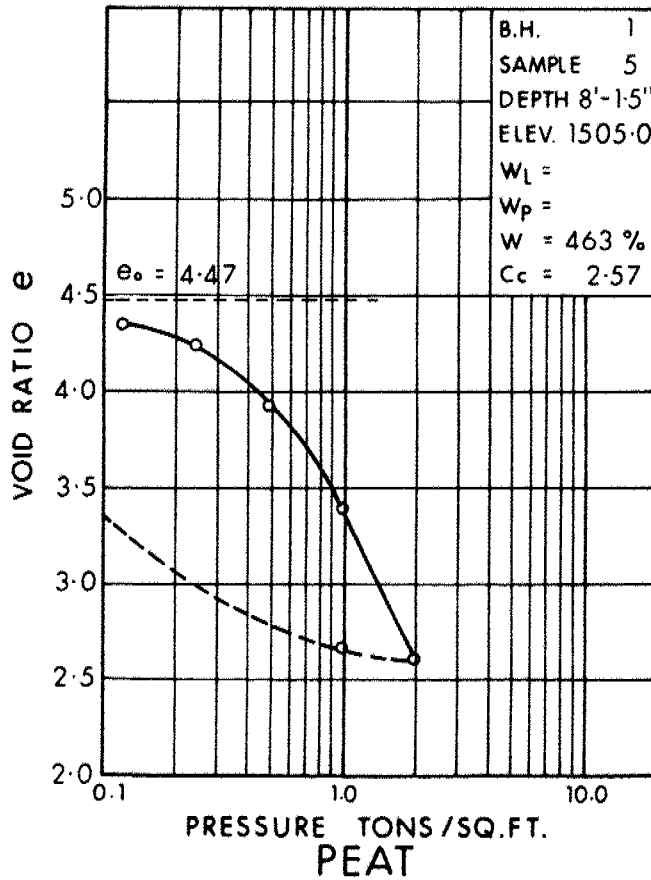
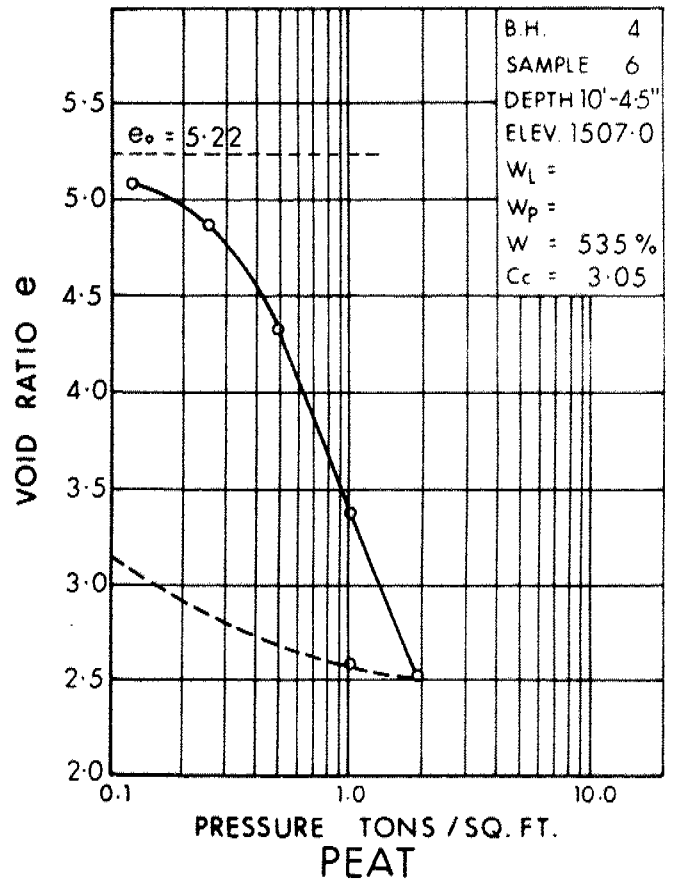
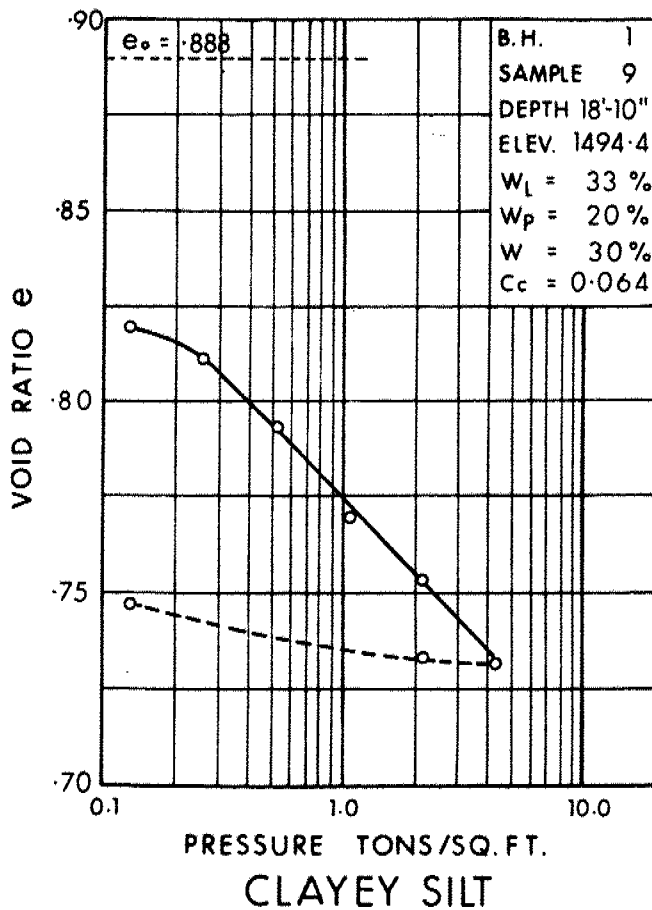
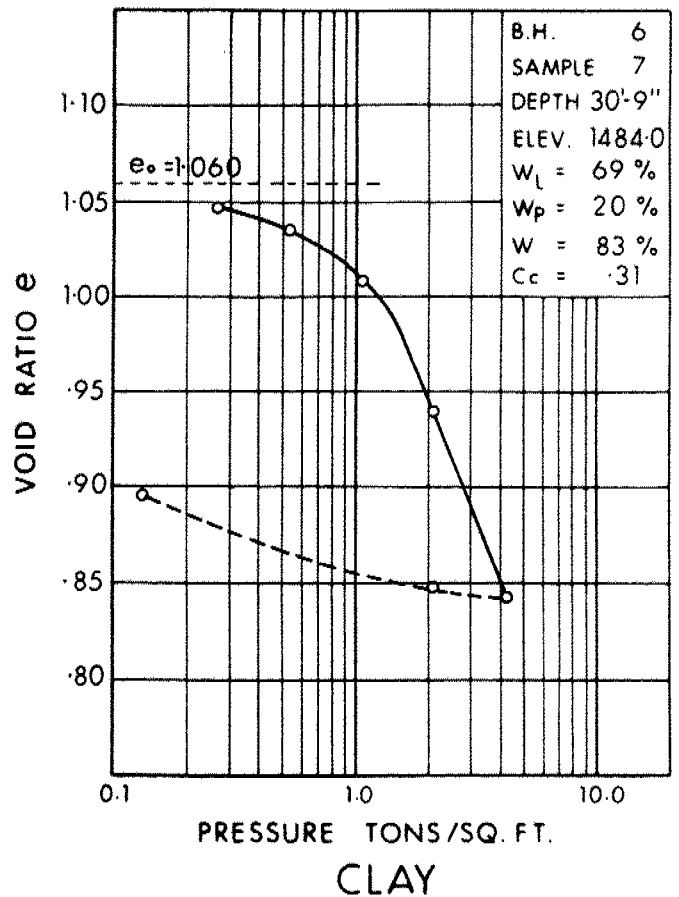
FIG. 8

Under the Roadbed	Outside the Roadbed
Moisture content	192-537 %	586-757%
In situ vane shear strength	800-1680 psf.	200-600 psf.
Compressibility characteristics (Fig. 8)		
initial void ratio (e_0)	4.47-5.22 (B.H.'s 1 & 4)	
Compression index (C_c)	2.57-3.05 (B.H.'s 1 & 4)

One-dimensional consolidation tests were carried out on samples from the cohesive deposit. One sample from the clay portion gave the following results: (Fig. 8)

The other consolidation test was carried out on a stiff clayey silt sample. It was found to be less compressible as is evident from the following results. (Fig. 8)

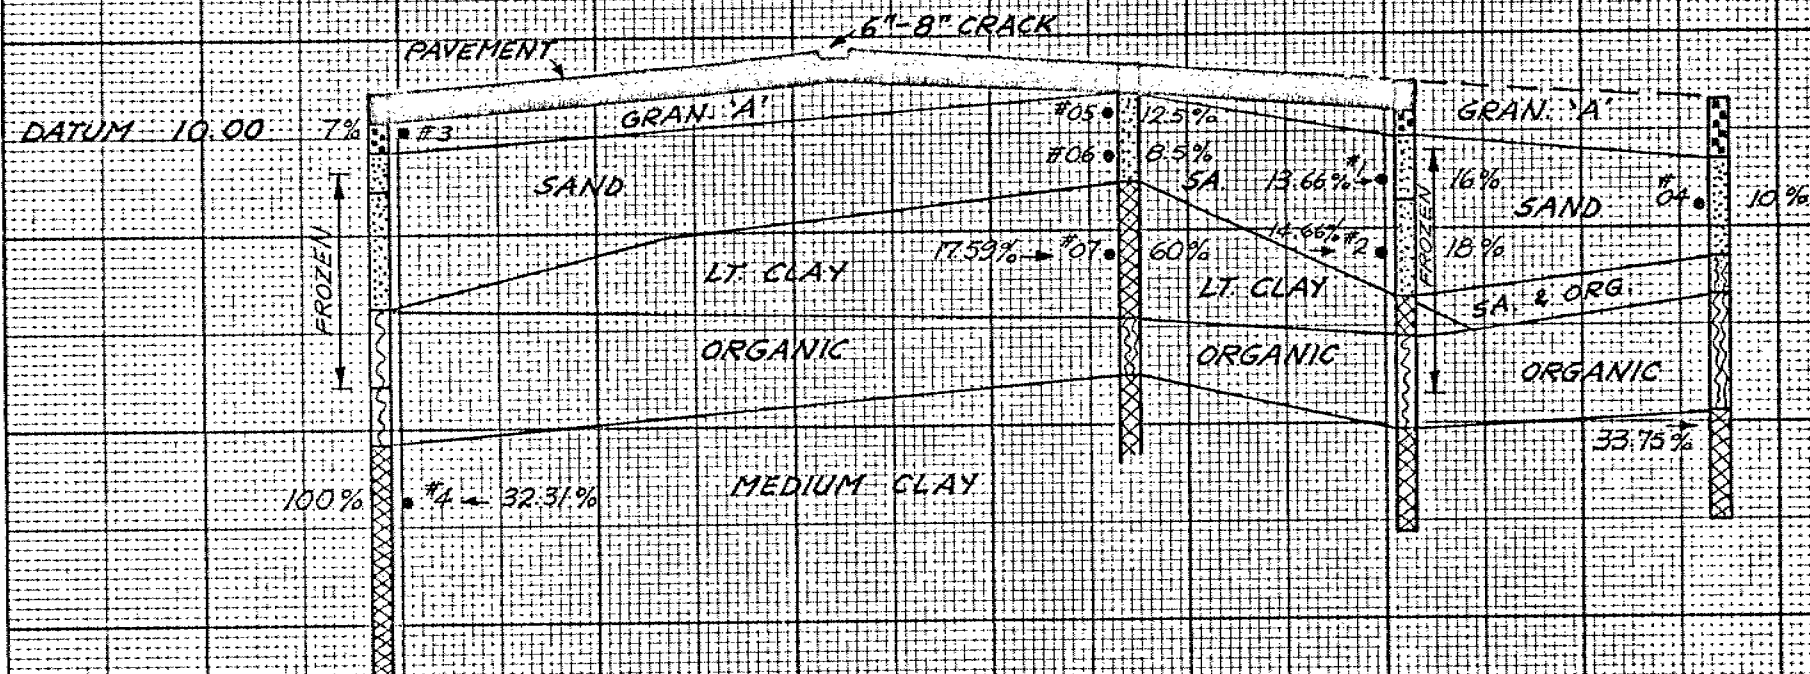
SAMPLES: 74-RN-1 (24"-36") RT. & : SAND 16% PASS #200
74-RN-2 (48"-60") RT. & : SAND 18% " "
74-RN-3 (6"-16") LT. & : SAND 7% " "
74-RN-4 (120"-132") LT. & : MEDIUM CLAY 100% "

MOISTURES: @ 30" RT. & : 13.66 %
@ 54" RT. & : 14.66 %
@ 126" LT. & : 32.31 %

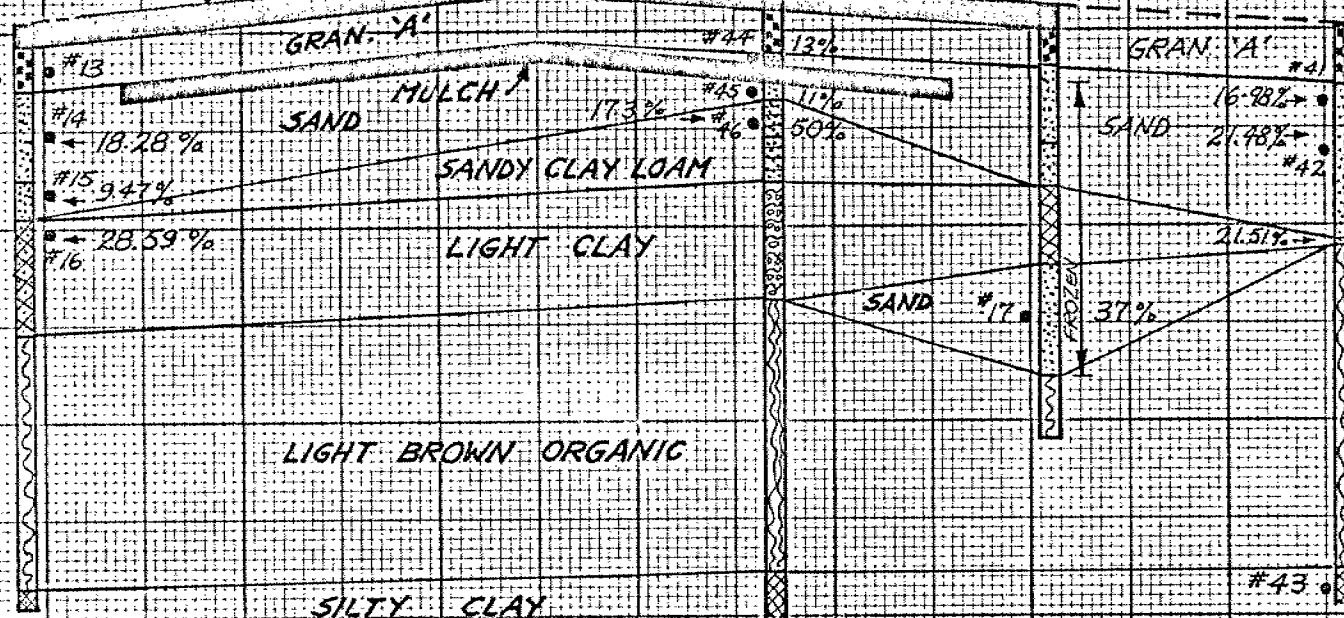
SAMPLES: 74-RN-13 (8"-13") LT. & : SAND 5% PASS # 200
74-RN-14 (30"-42") LT. & : SAND 9% " "
74-RN-15 (48"-60") LT. & : SAND 8% " "
74-RN-16 (60"-72") LT. & : LT. CL. 62% " "
74-RN-17 (90"-102") RT. & : SAND 37% " "

MOISTURES: @ 36" LT. & : 18.28 %
@ 54" LT. & : 9.47 %
@ 66" LT. & : 28.59 %
