## Foundation Investigation and Design Report

*Embankment Instability on Highway 658, Township of Redditt*

Agreement No. 6021-E-0019

December 20, 2022

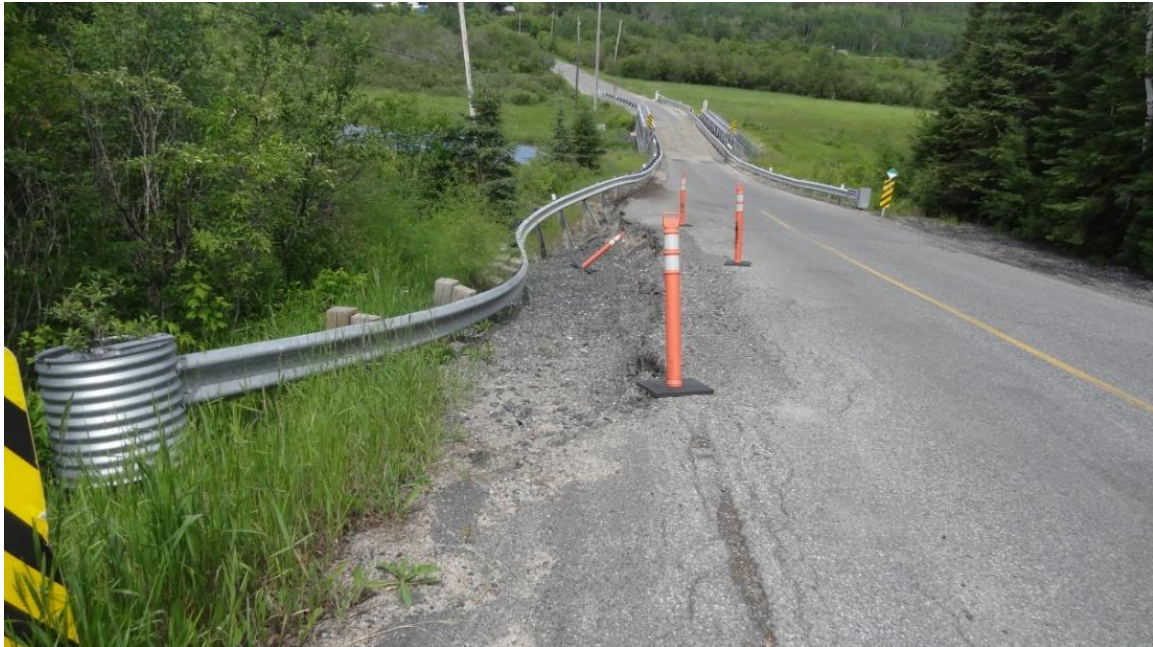
Photograph 1. 2022 Slope instability on Highway 658, facing north, July 7, 2022

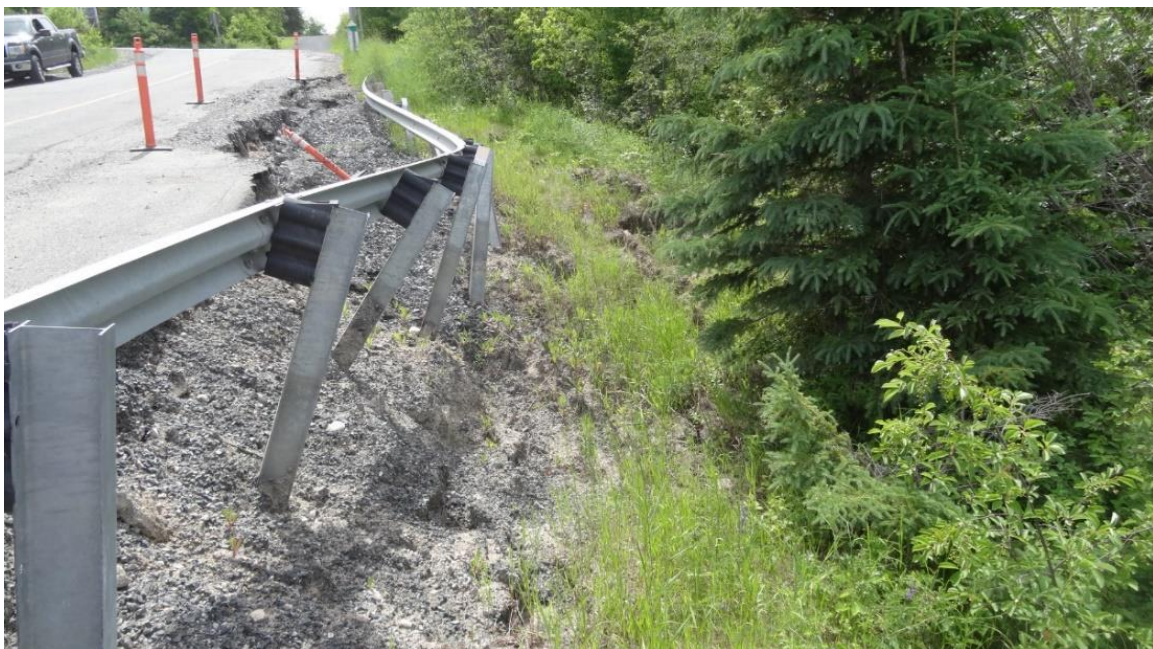
Photograph 2. 2022 Slope instability on Highway 658, facing south, July 7, 2022

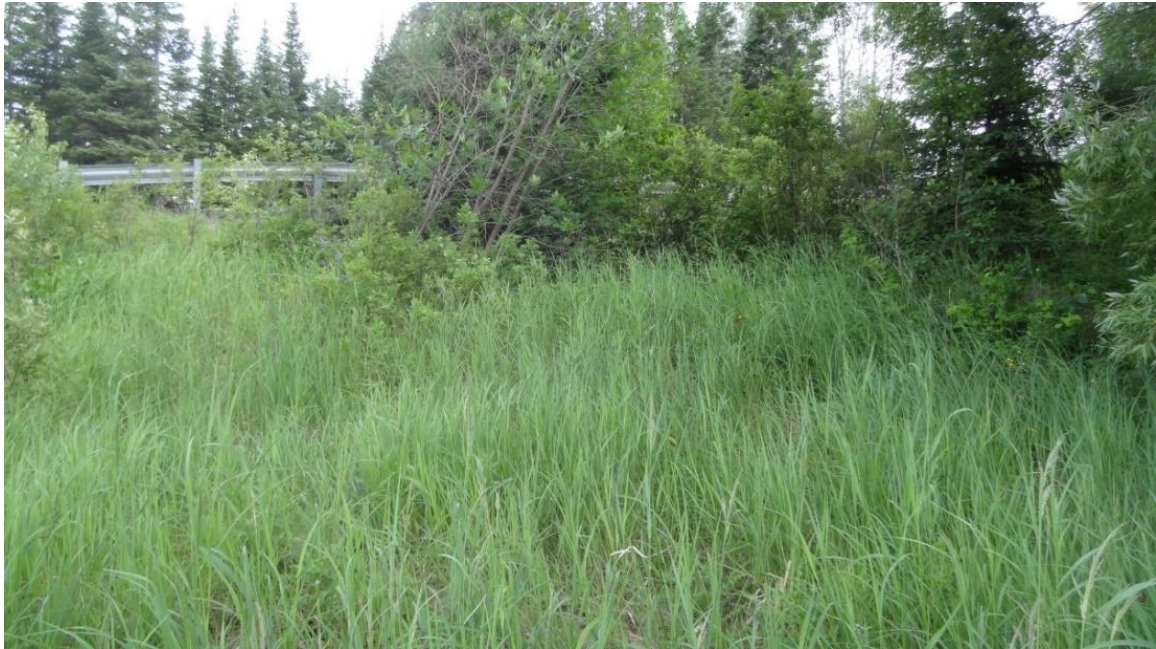
Photograph 3. Highway 658 leaning trees at slope instability, facing southeast, July 7, 2022

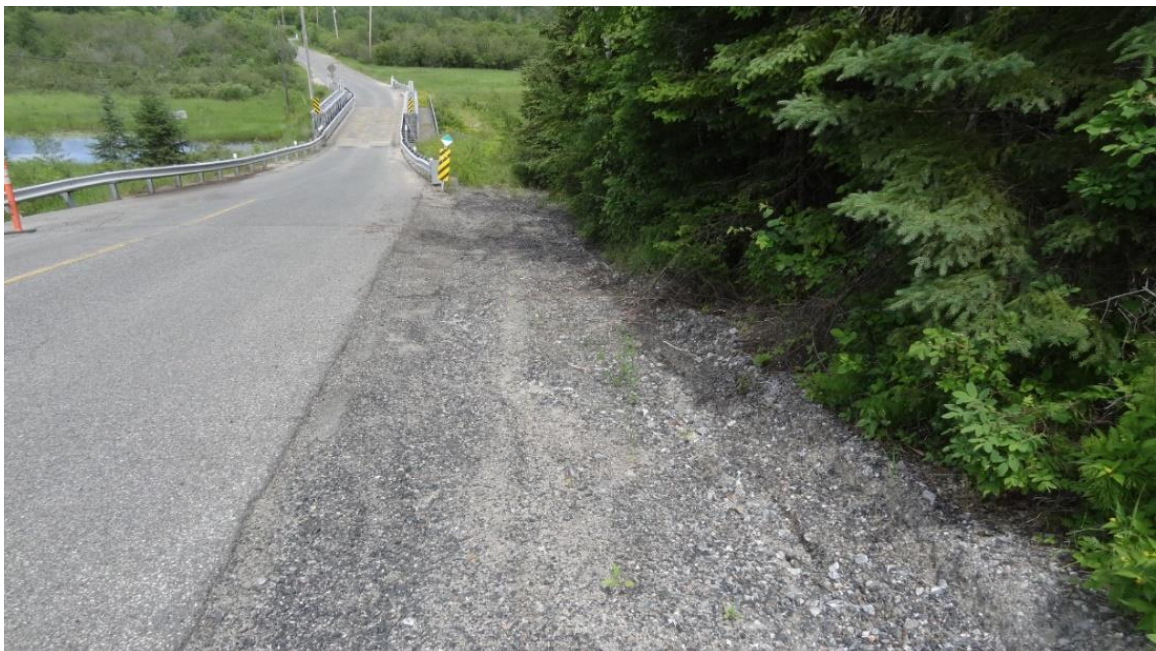
Photograph 4. Highway 658 east shoulder surficial drainage erosion, facing north, July 7, 2022

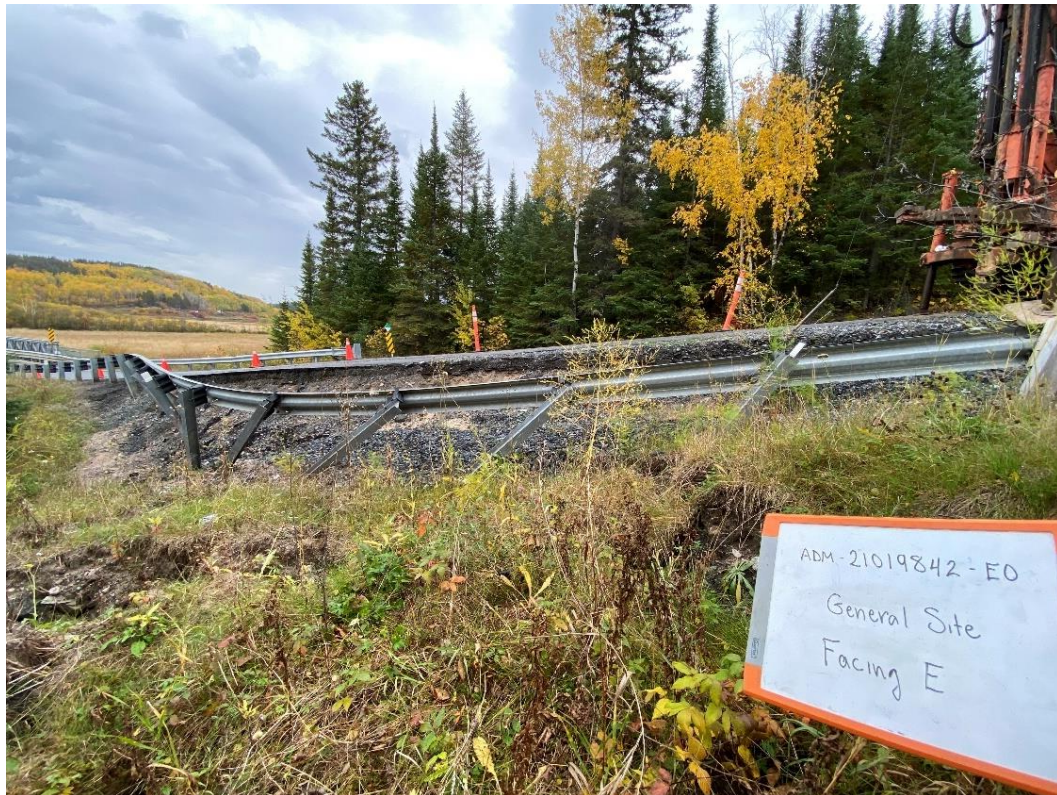
Photograph 5. 2022 Slope instability on Highway 658, facing east, October 2022

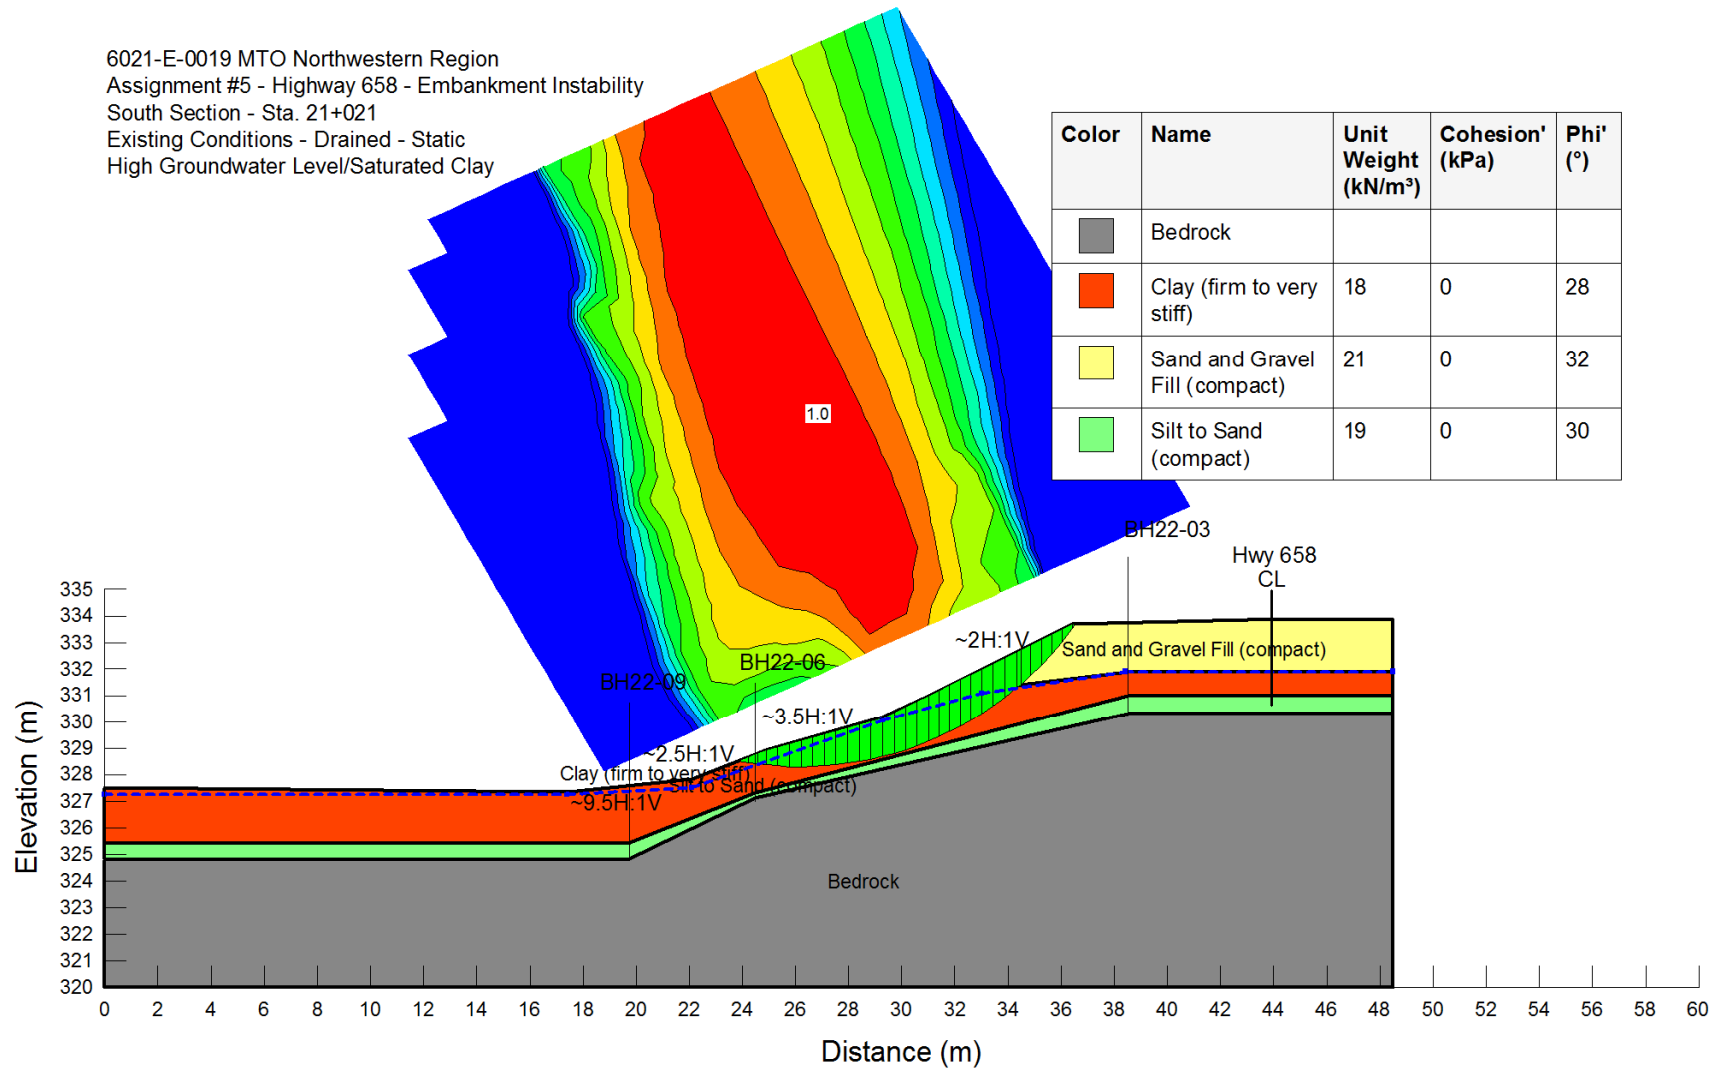
Figure G1. South Section B-B' (Sta. 21+021) – Back Analysis for Clay Friction Angle, High GWL – Drained Static Conditions

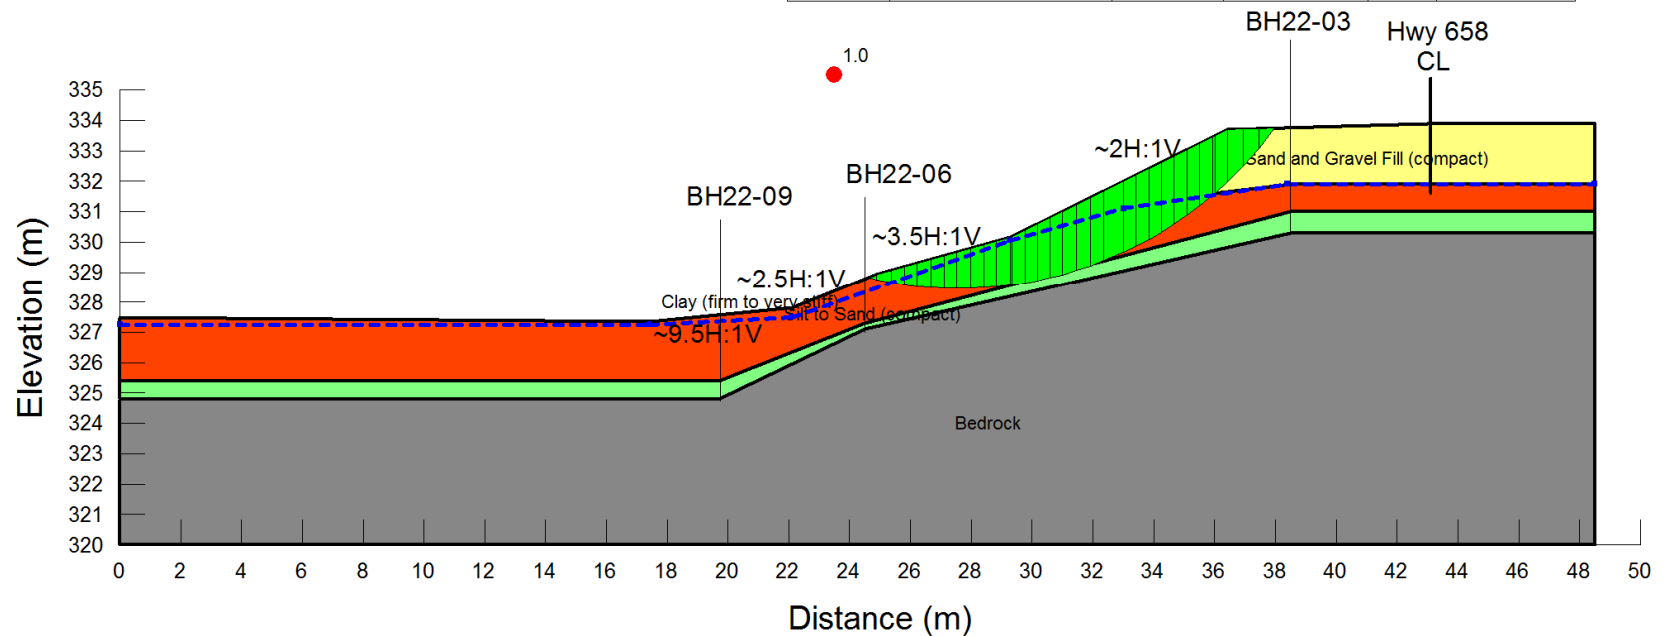
Figure G2. South Section B-B' (Sta. 21+021) – Back Analysis for Clay Undrained Shear Strength, High GWL – Undrained Static Conditions

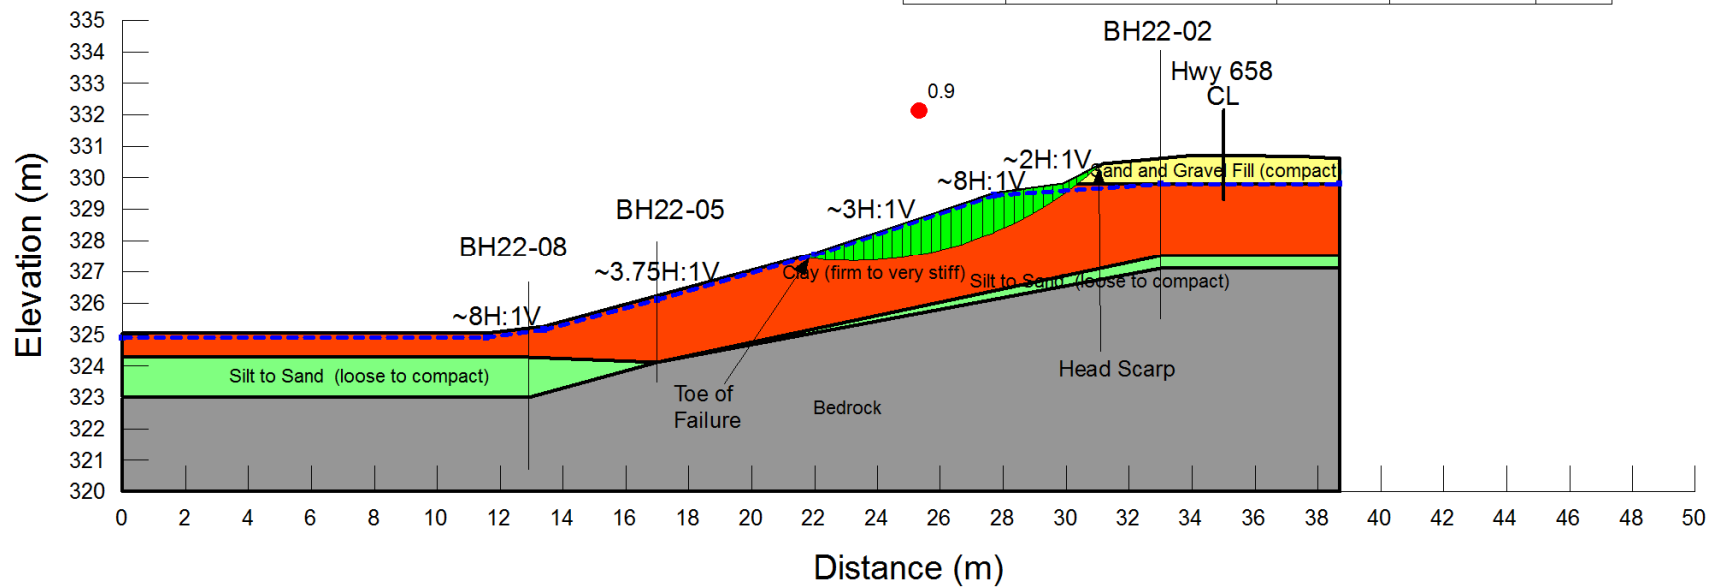
Figure G3. Central Section C-C' (Sta. 21+043) – Back Analysis for Clay Friction Angle Using Assumed Original Slope Profile, High GWL – Drained Static Conditions

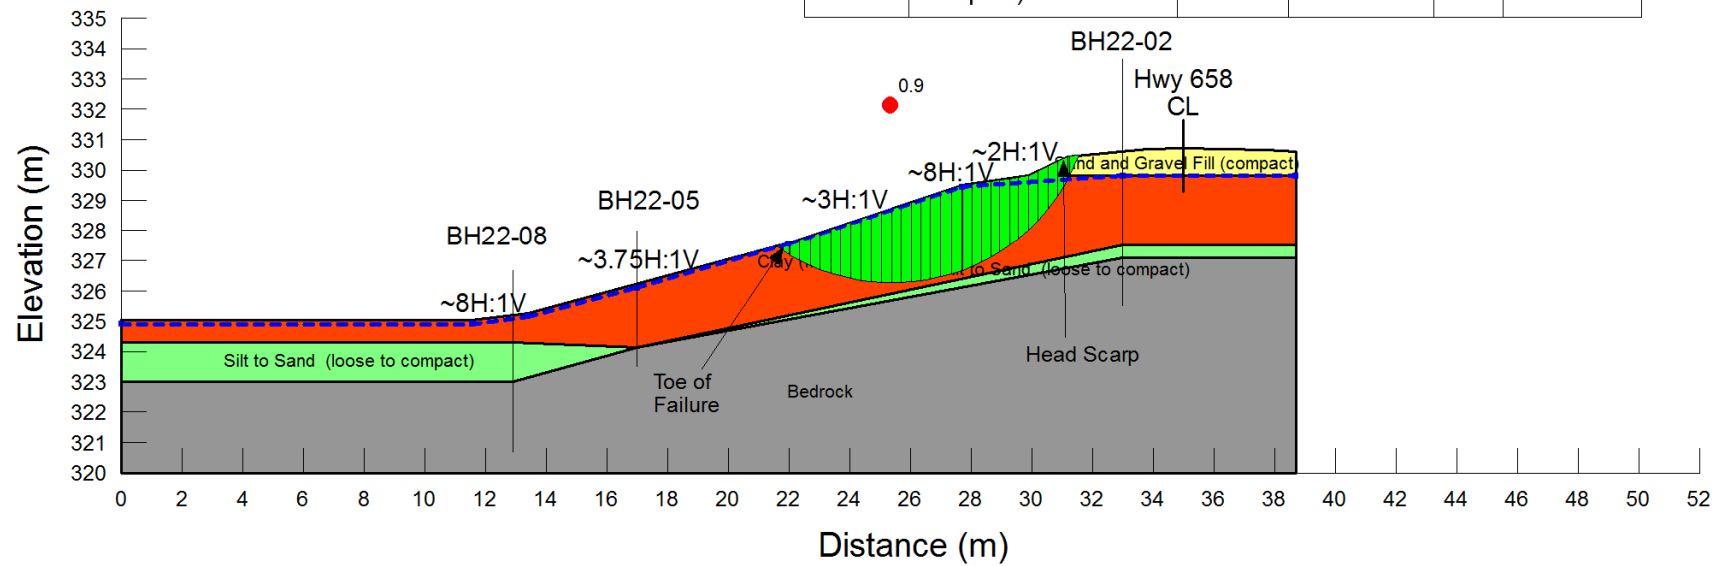
Figure G4. Central Section C-C' (Sta. 21+043) – Back Analysis for Clay Undrained Shear Strength Using Assumed Original Slope Profile, High GWL – Undrained Static Conditions

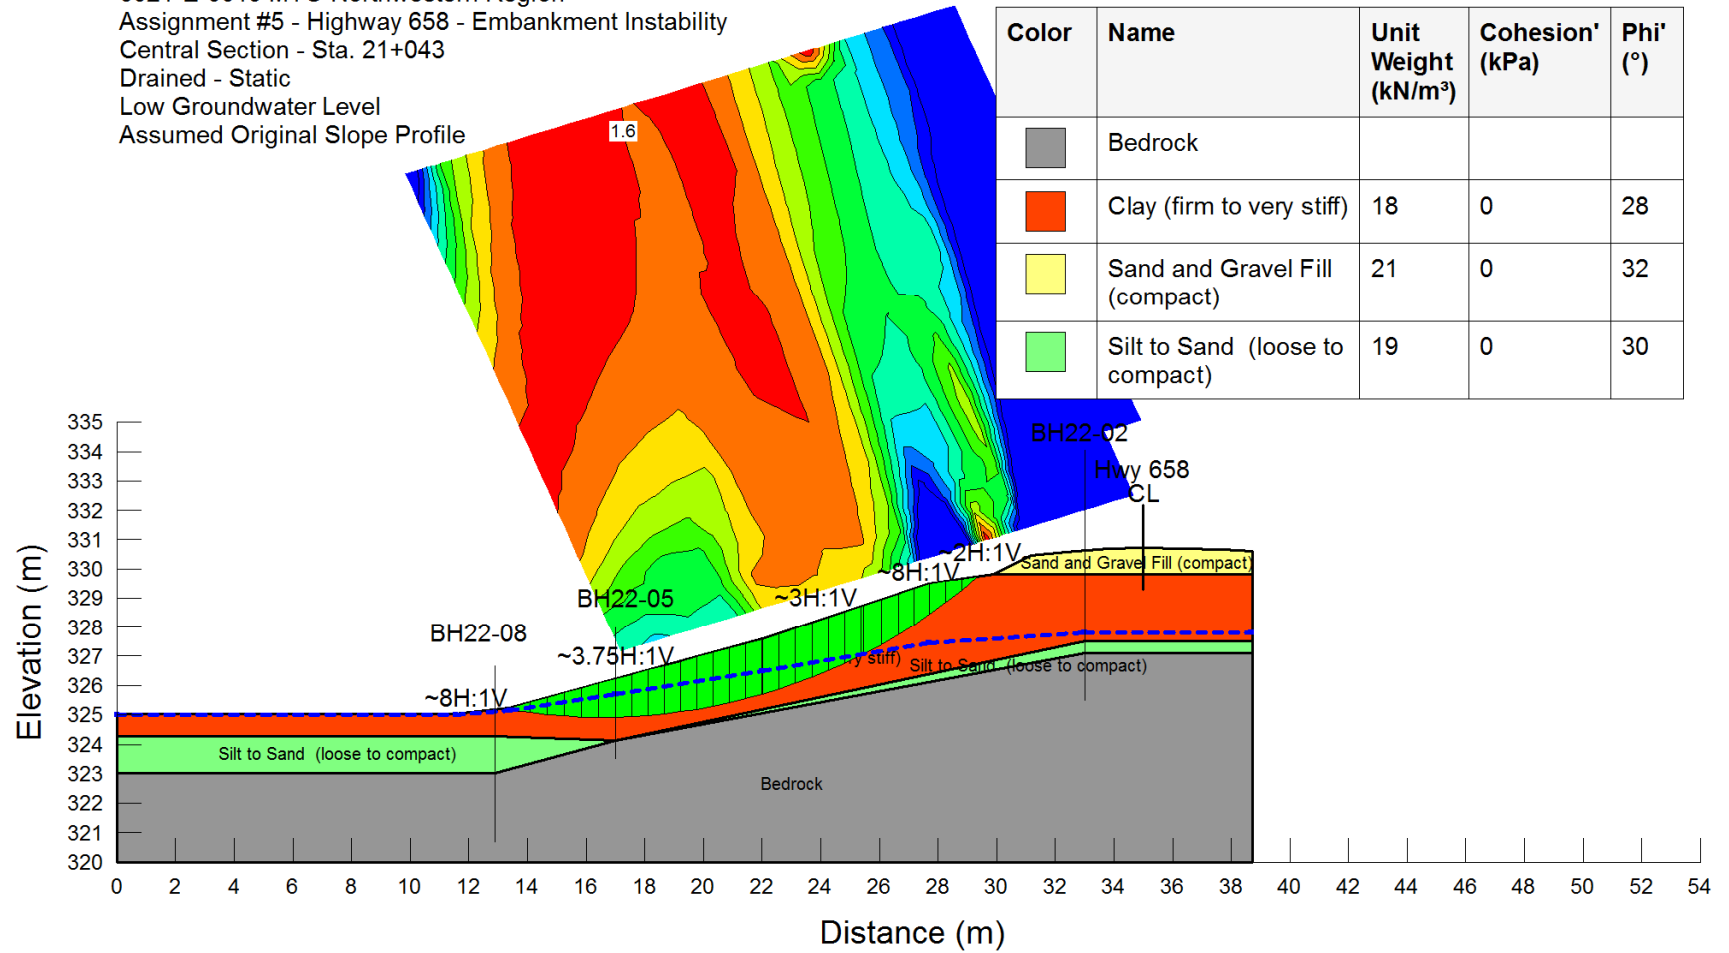
Figure G5. Central Section C-C' (Sta. 21+043) – Slope Prior to 2022 Failure, Assumed Original Slope Profile, Low GWL – Drained Static Conditions

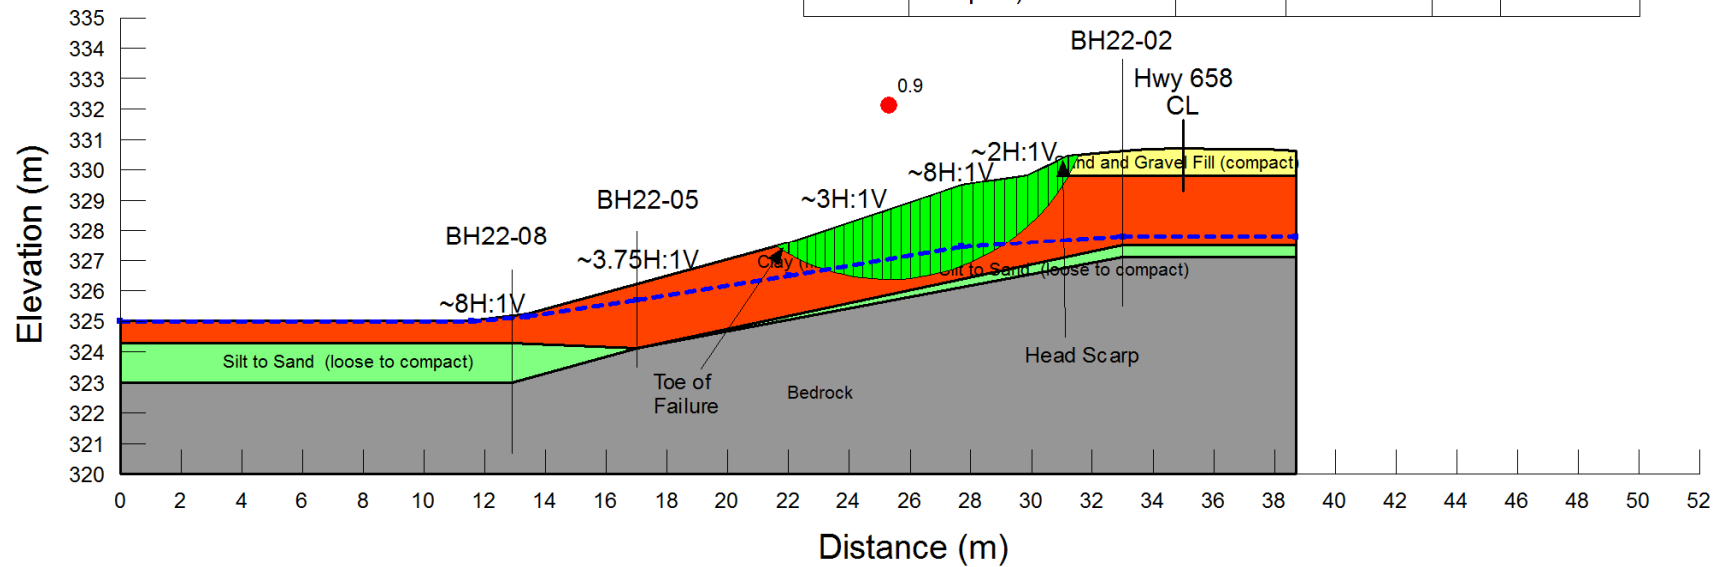
Figure G6. Central Section C-C' (Sta. 21+043) – Slope Prior to 2022 Failure, Assumed Original Slope Profile, Low GWL – Undrained Static Conditions

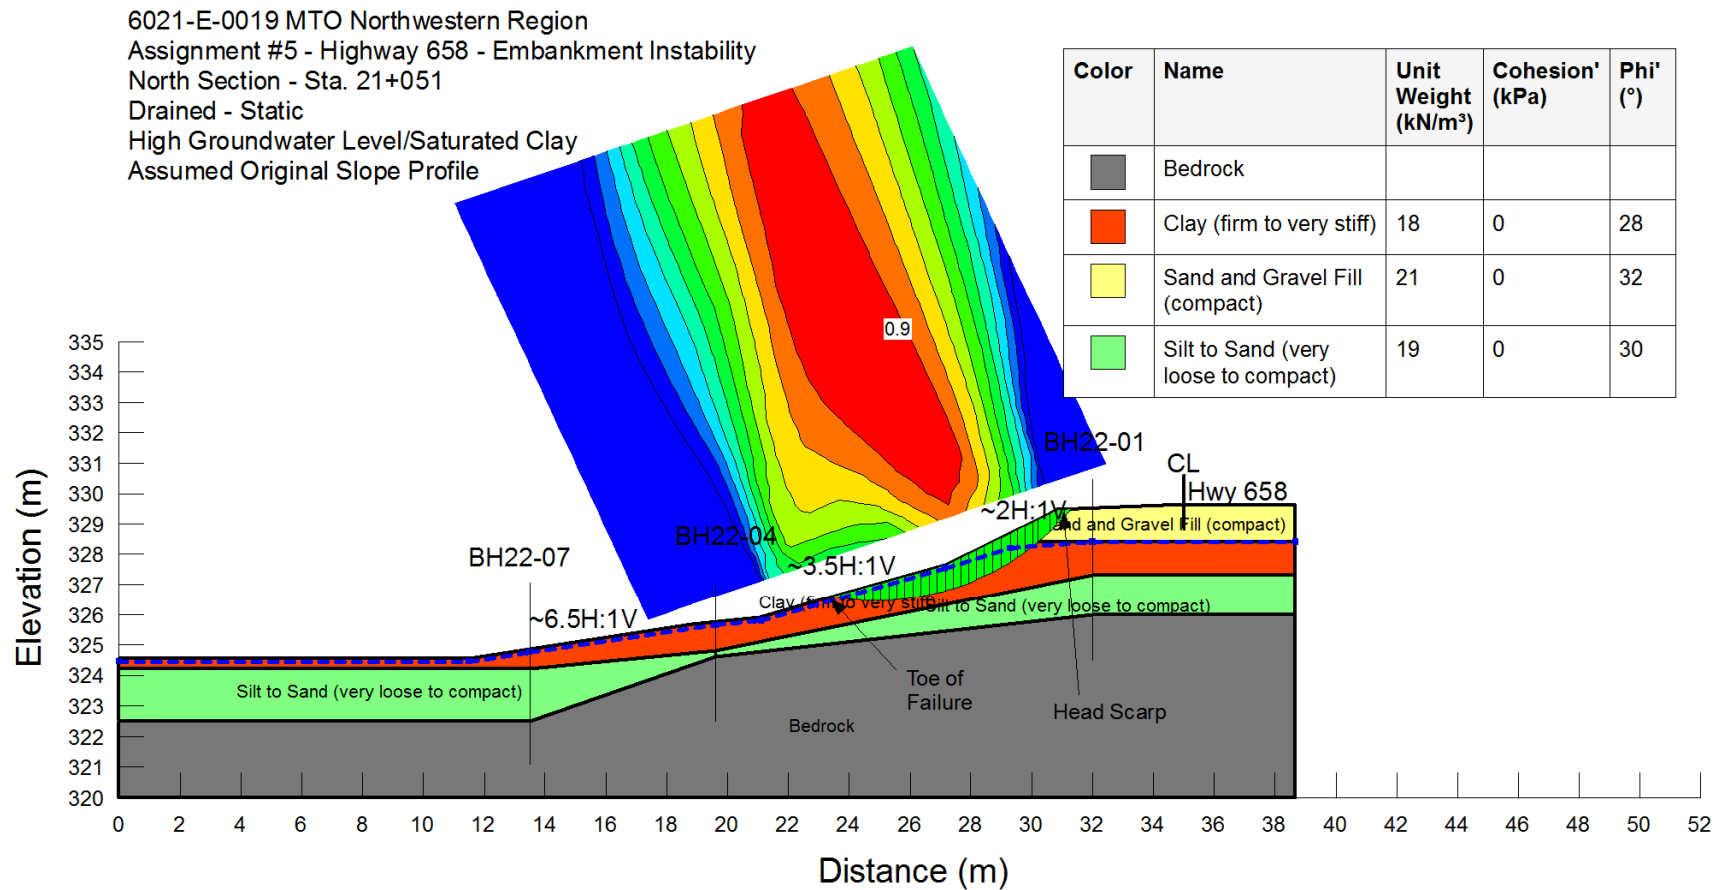
Figure G7. North Section D-D' (Sta. 21+051) – Back Analysis for Clay Friction Angle Using Assumed Original Slope Profile, High GWL – Drained Static Conditions

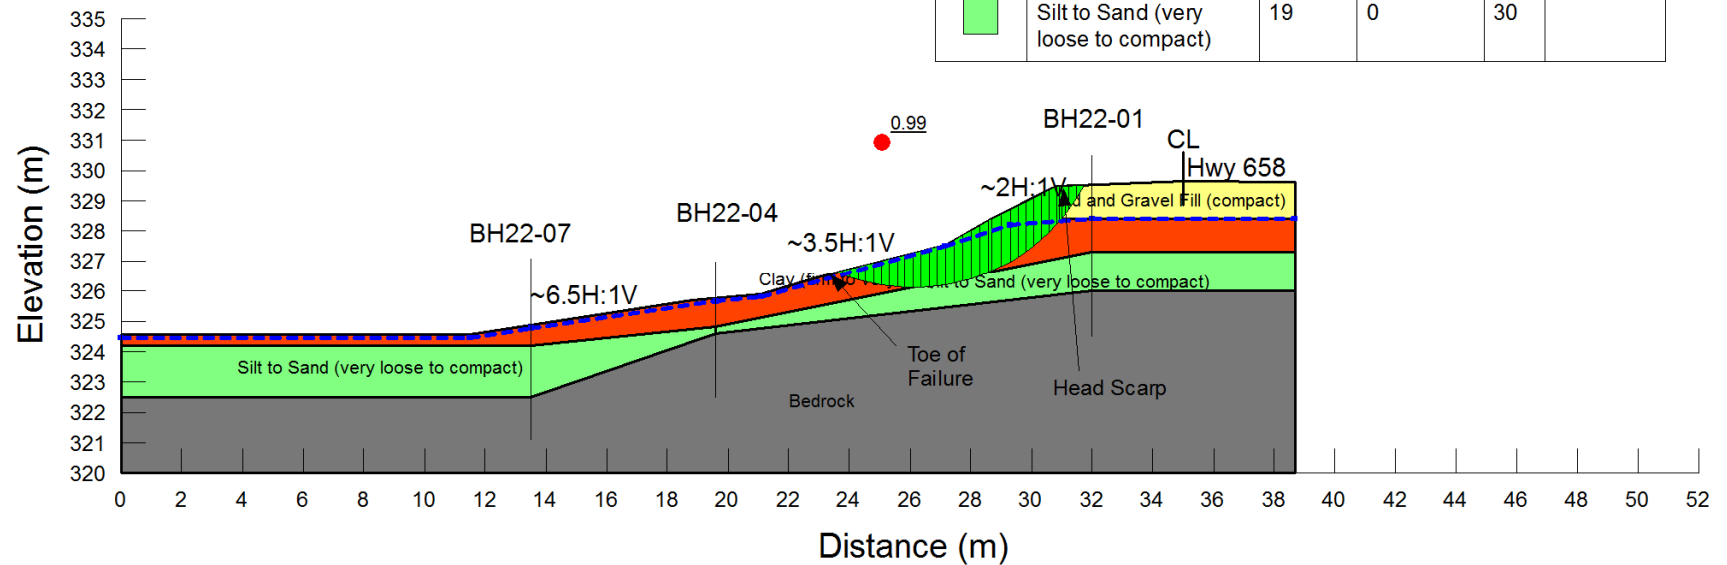
Figure G8. North Section D-D' (Sta. 21+051) – Back Analysis for Clay Undrained Shear Strength Using Assumed Original Slope Profile, High GWL – Undrained Static Conditions

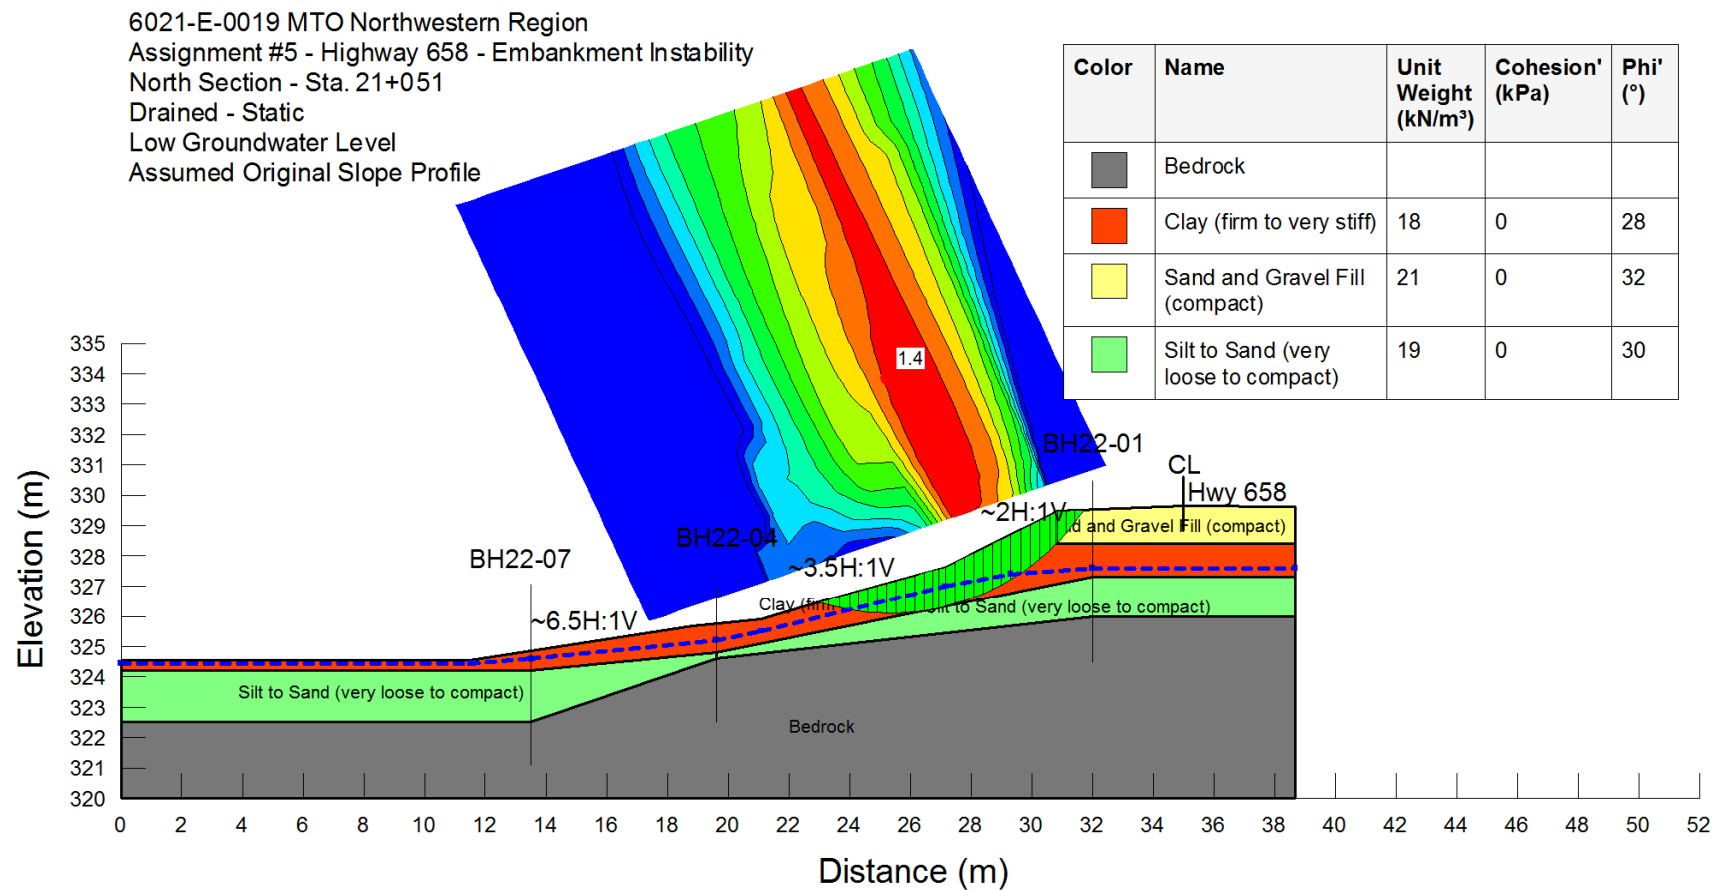
Figure G9. North Section D-D' (Sta. 21+051) – Slope Prior to 2022 Failure, Assumed Original Slope Profile, Low GWL – Drained Static Conditions

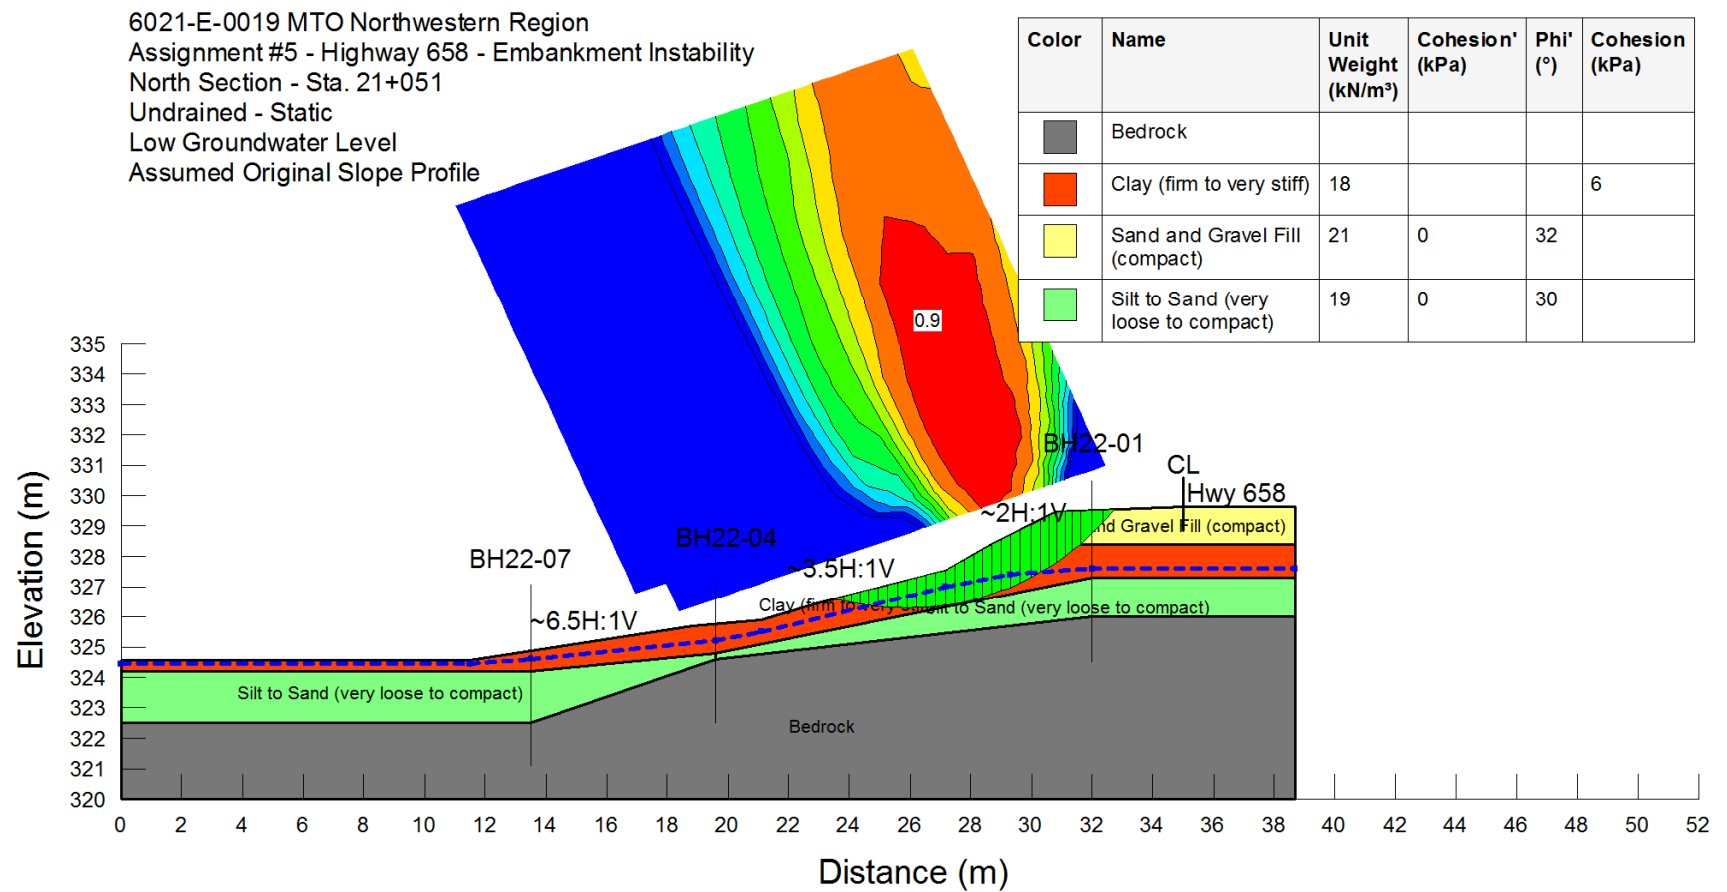
Figure G10. North Section D-D' (Sta. 21+051) – Slope Prior to 2022 Failure, Assumed Original Slope Profile, Low GWL – Undrained Static Conditions

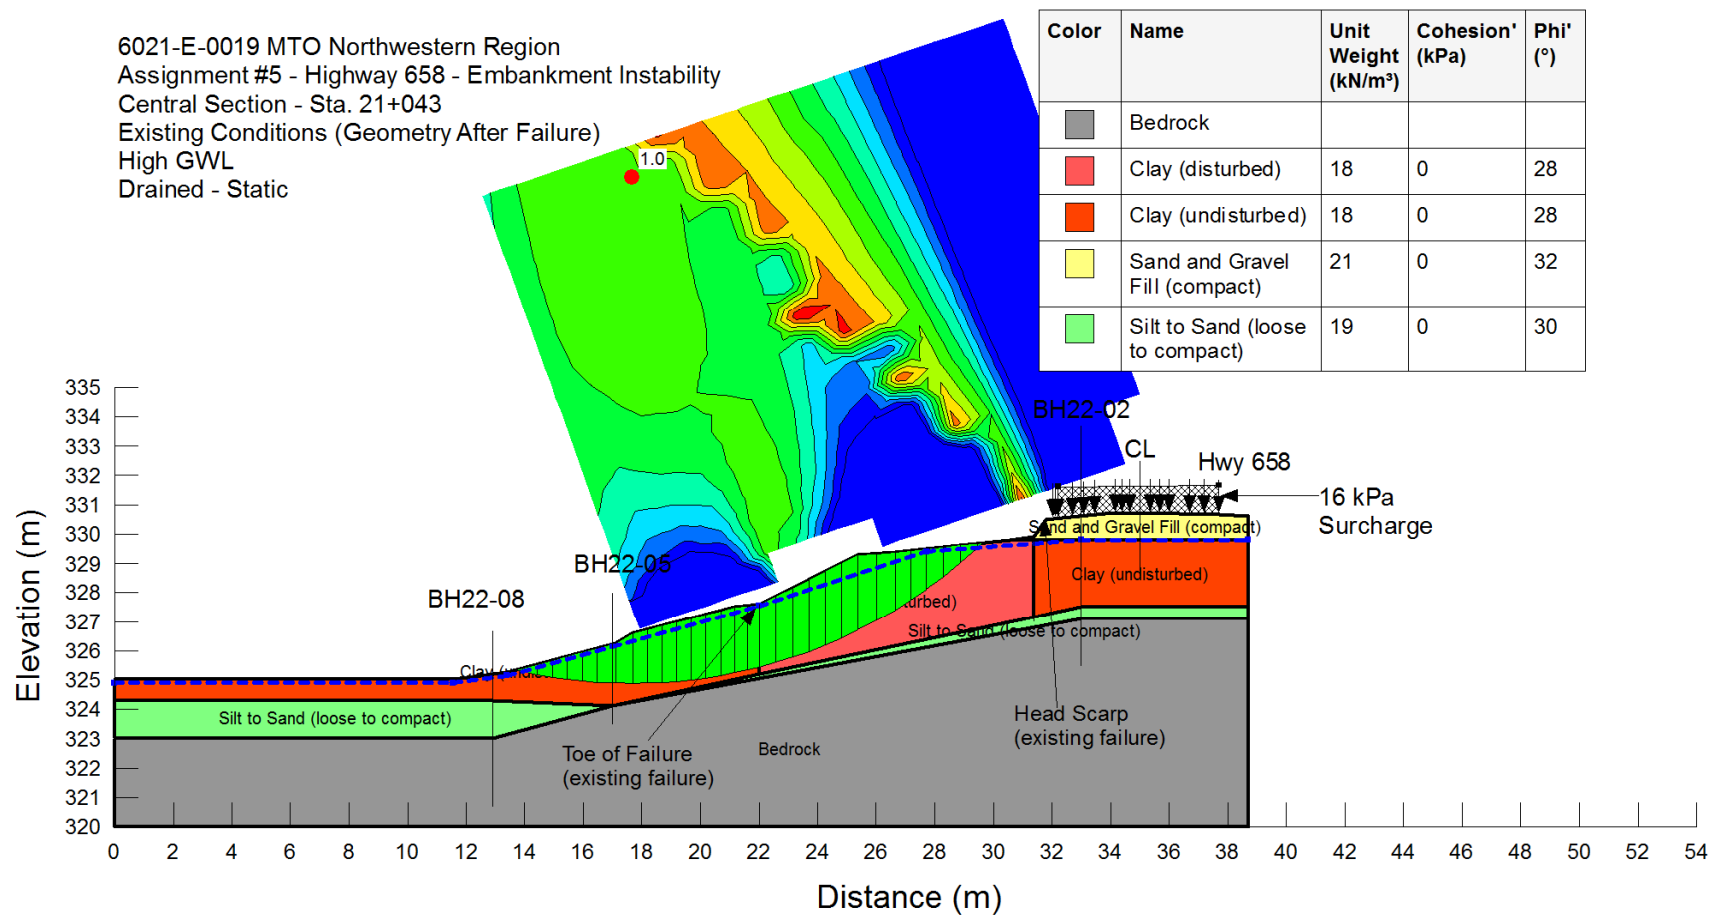
Figure G11. Central Section C-C' (Sta. 21+043) – Stability of Slope After 2022 Failure (Current Slope Geometry), High GWL – Drained Static Conditions

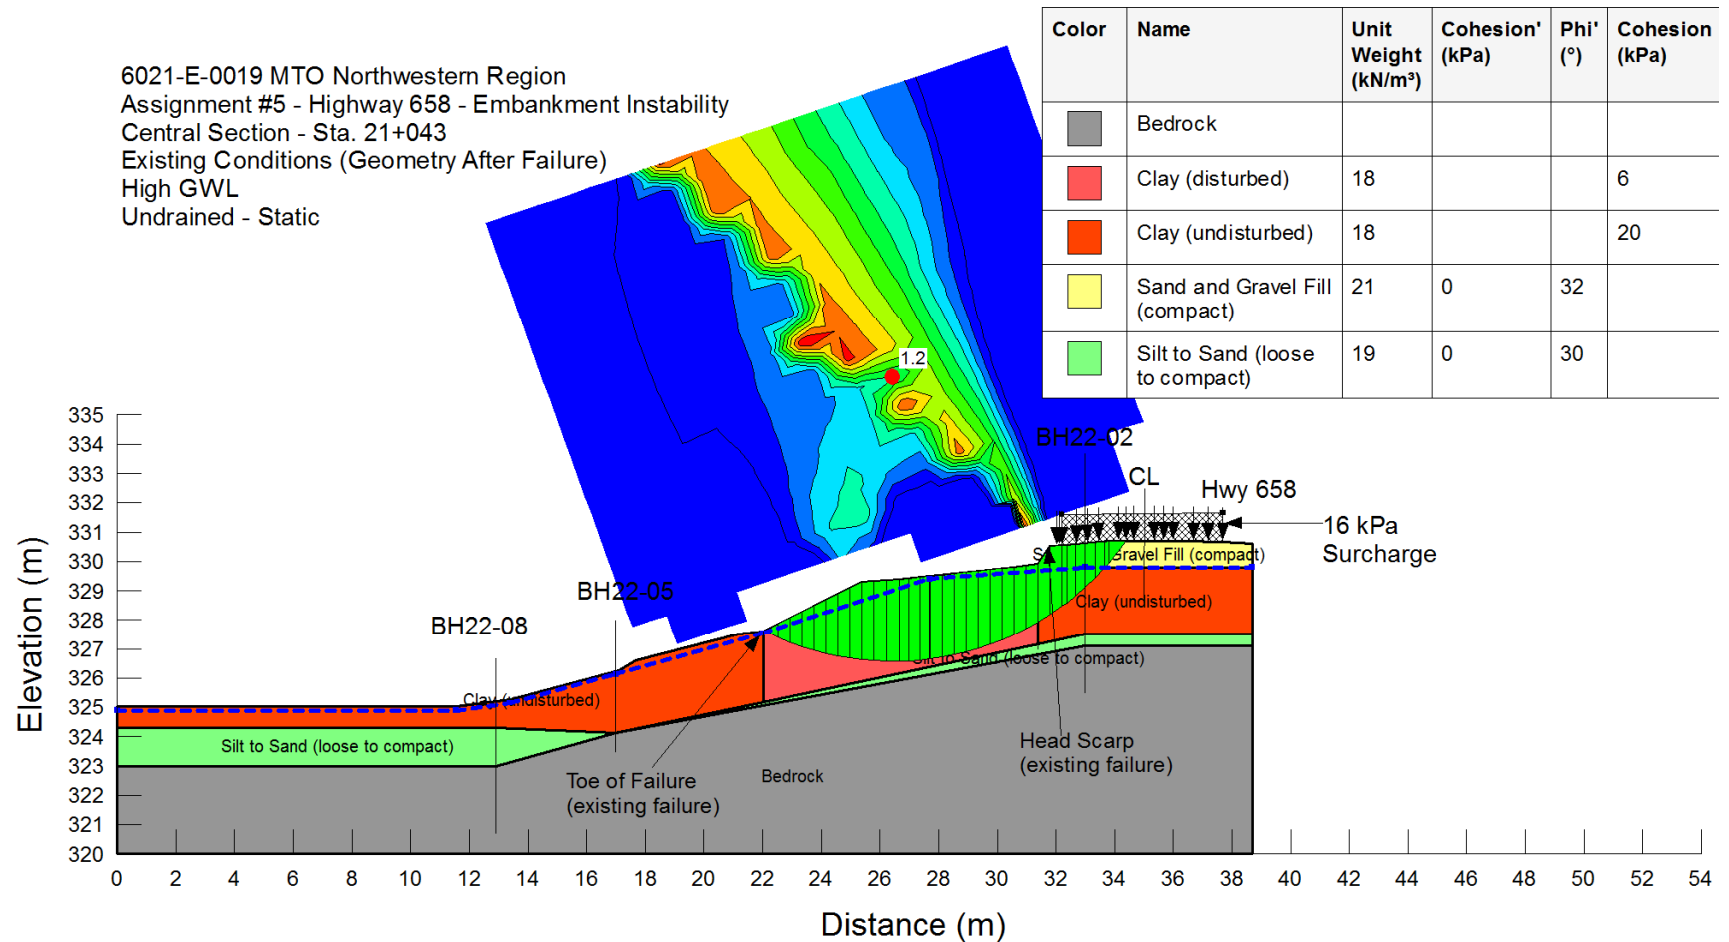
Figure G12. Central Section C-C' (Sta. 21+043) – Stability of Slope After 2022 Failure (Current Slope Geometry), High GWL – Undrained Static Conditions

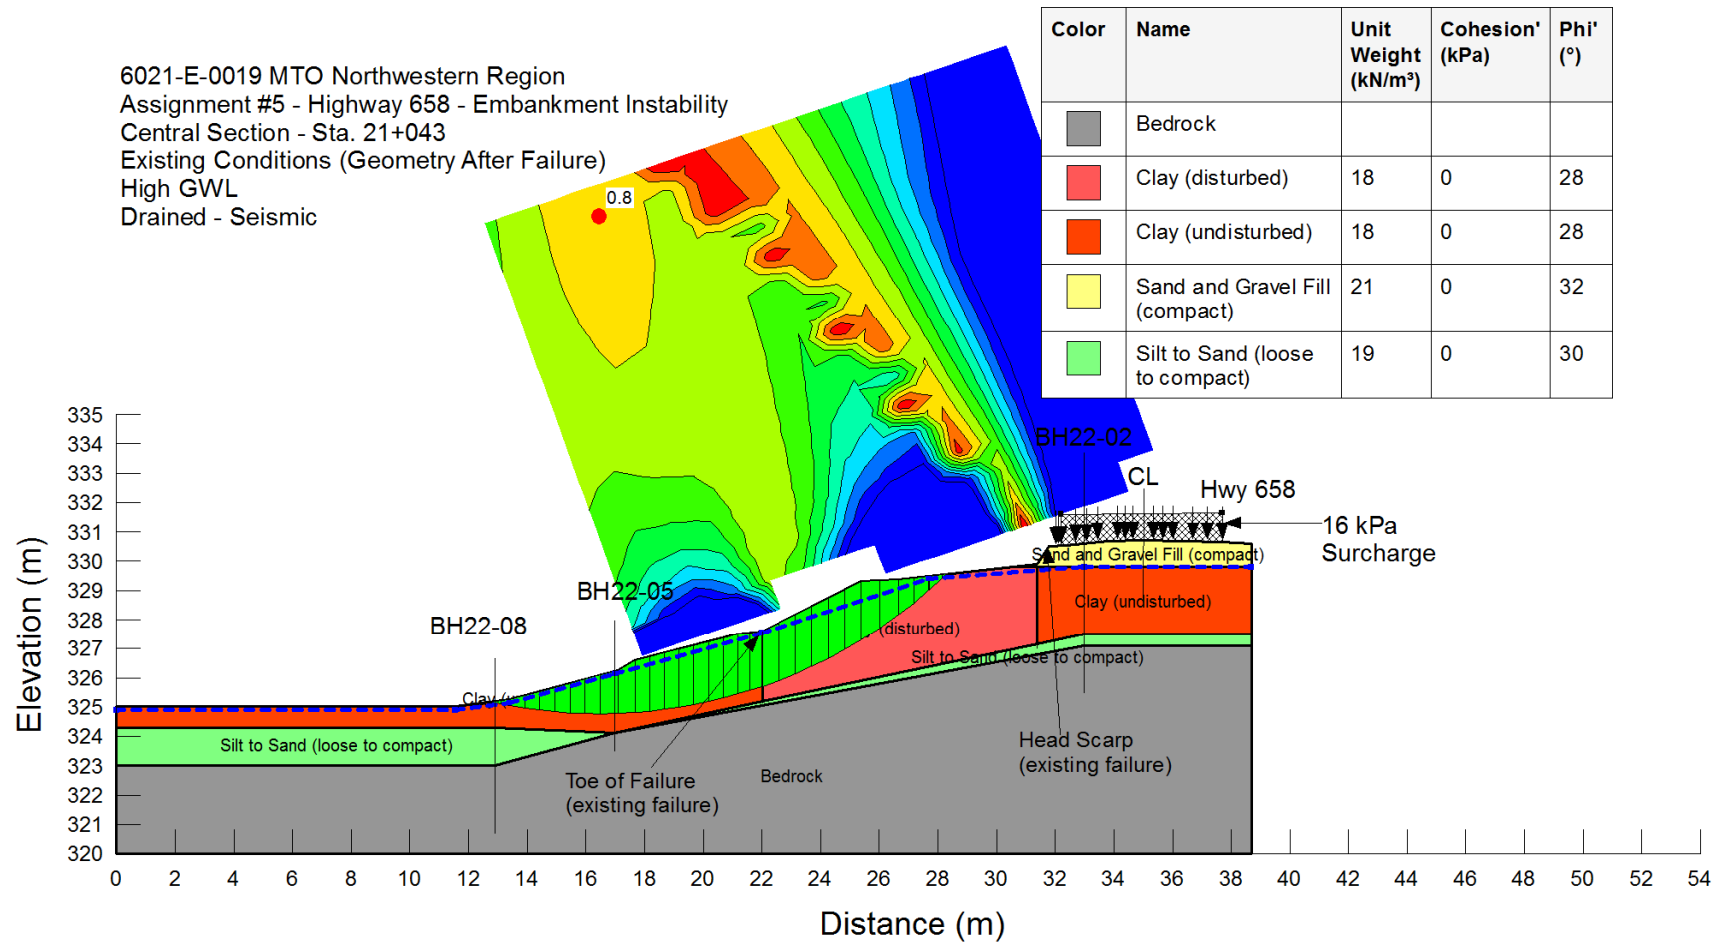
Figure G13. Central Section C-C' (Sta. 21+043) – Stability of Slope After 2022 Failure (Current Slope Geometry), High GWL – Drained Seismic Conditions
