## Foundation Investigation and Design Report

*Embankment Instability on Highway 658, Township of Redditt*

Agreement No. 6021-E-0019

December 20, 2022

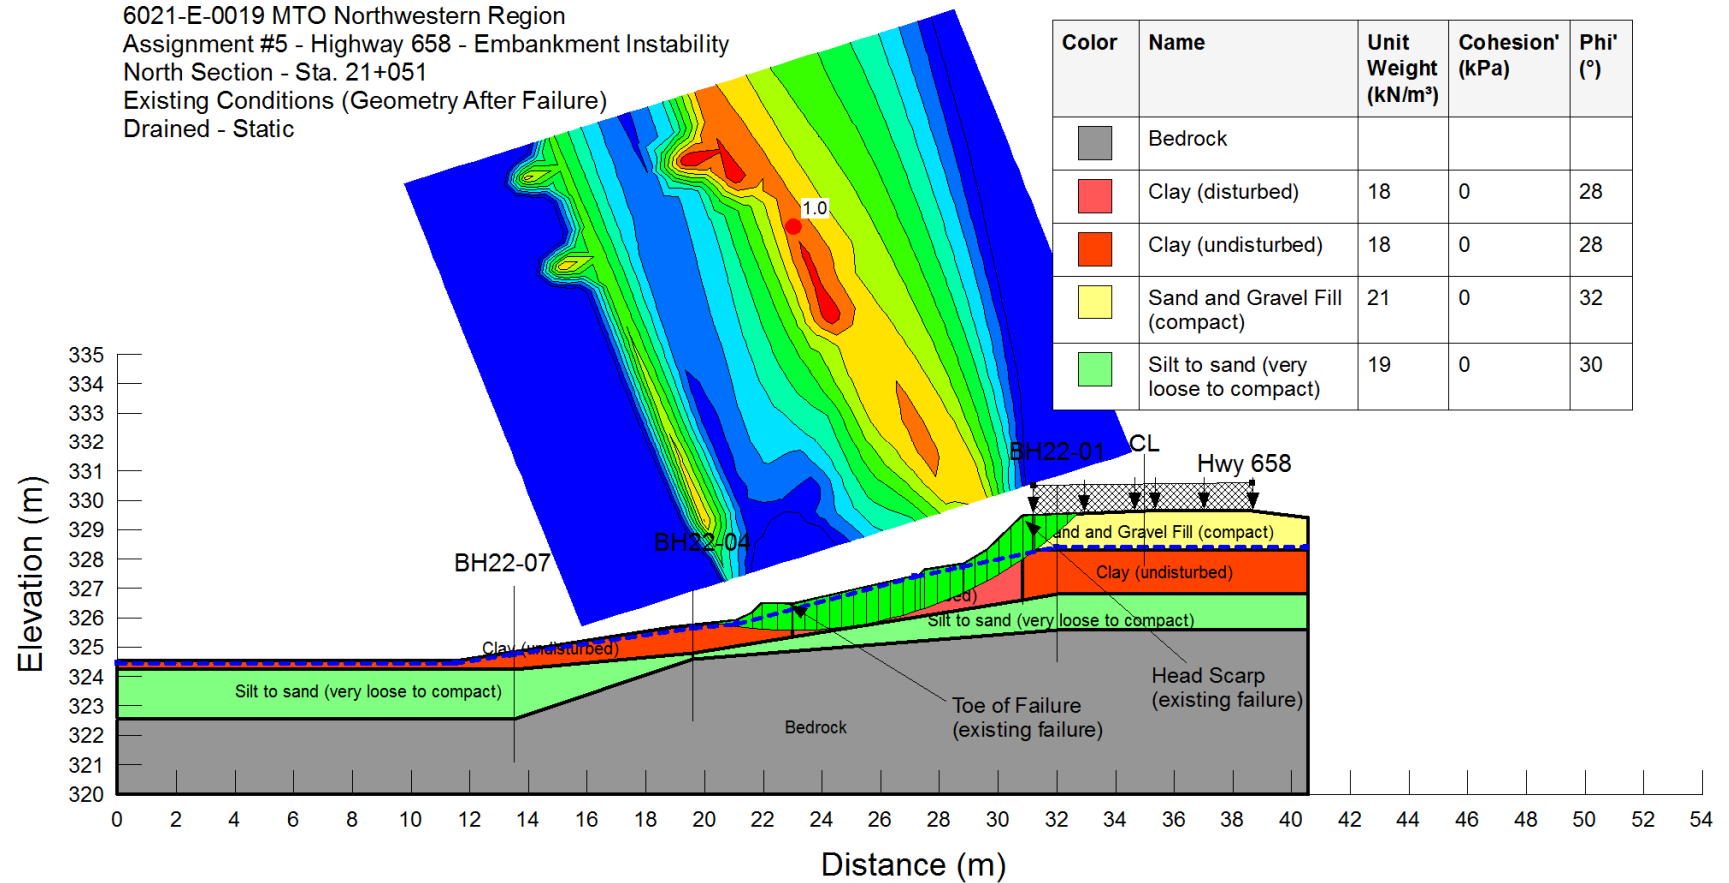
Figure G15. North Section D-D' (Sta. 21+051) – Stability of Slope After 2022 Failure (Current Slope Geometry), High GWL – Drained Static Conditions

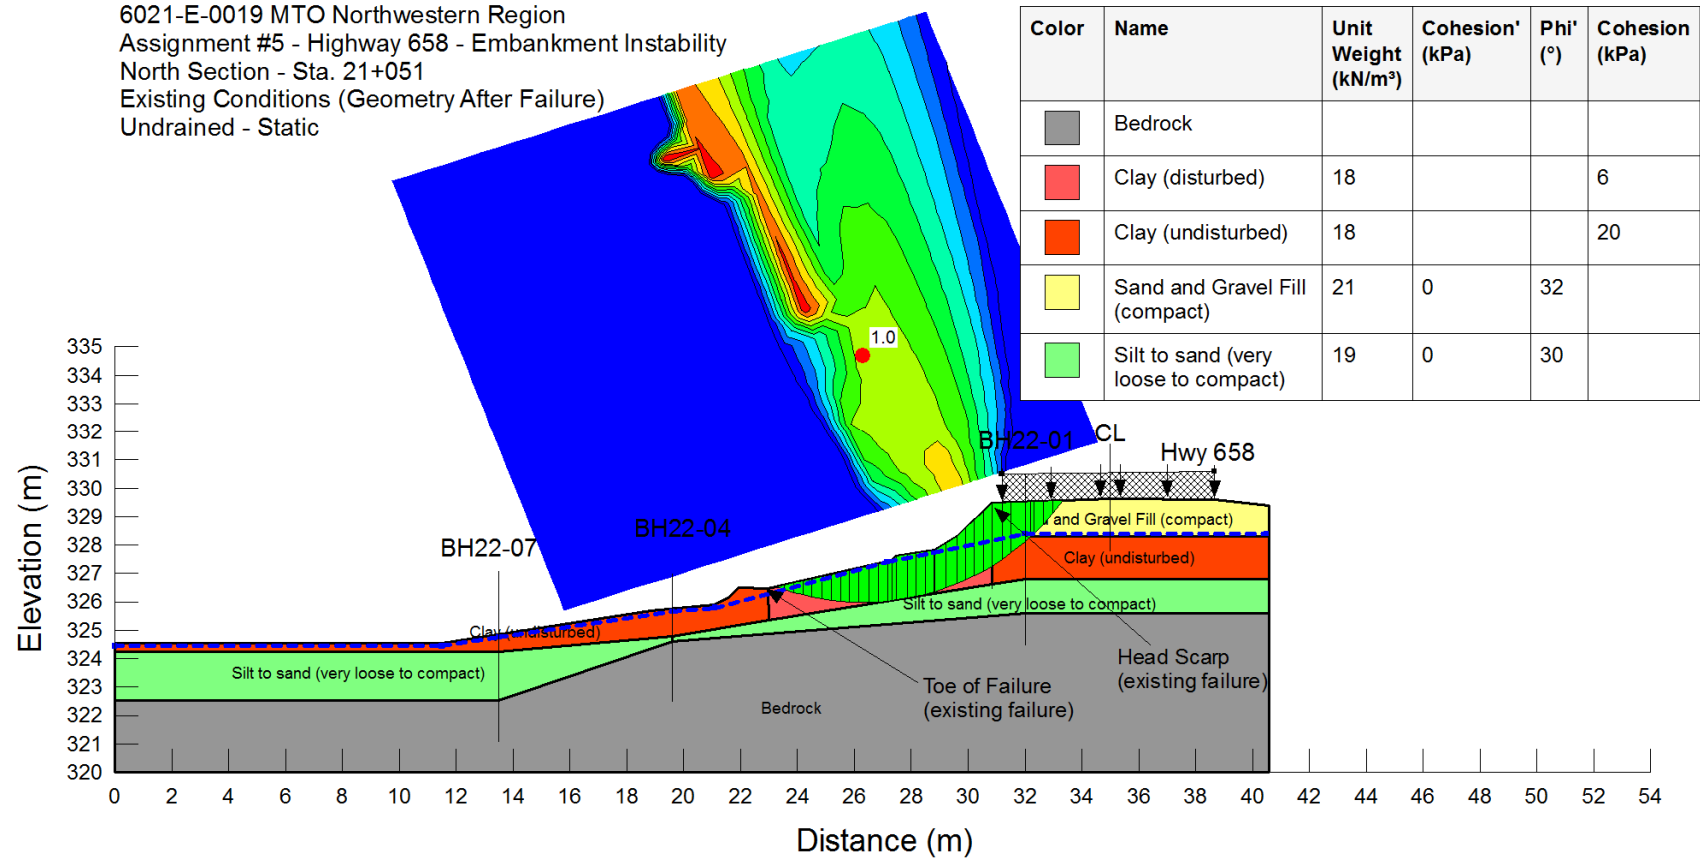
Figure G16. North Section D-D' (Sta. 21+051) – Stability of Slope After 2022 Failure (Current Slope Geometry), High GWL – Undrained Static Conditions

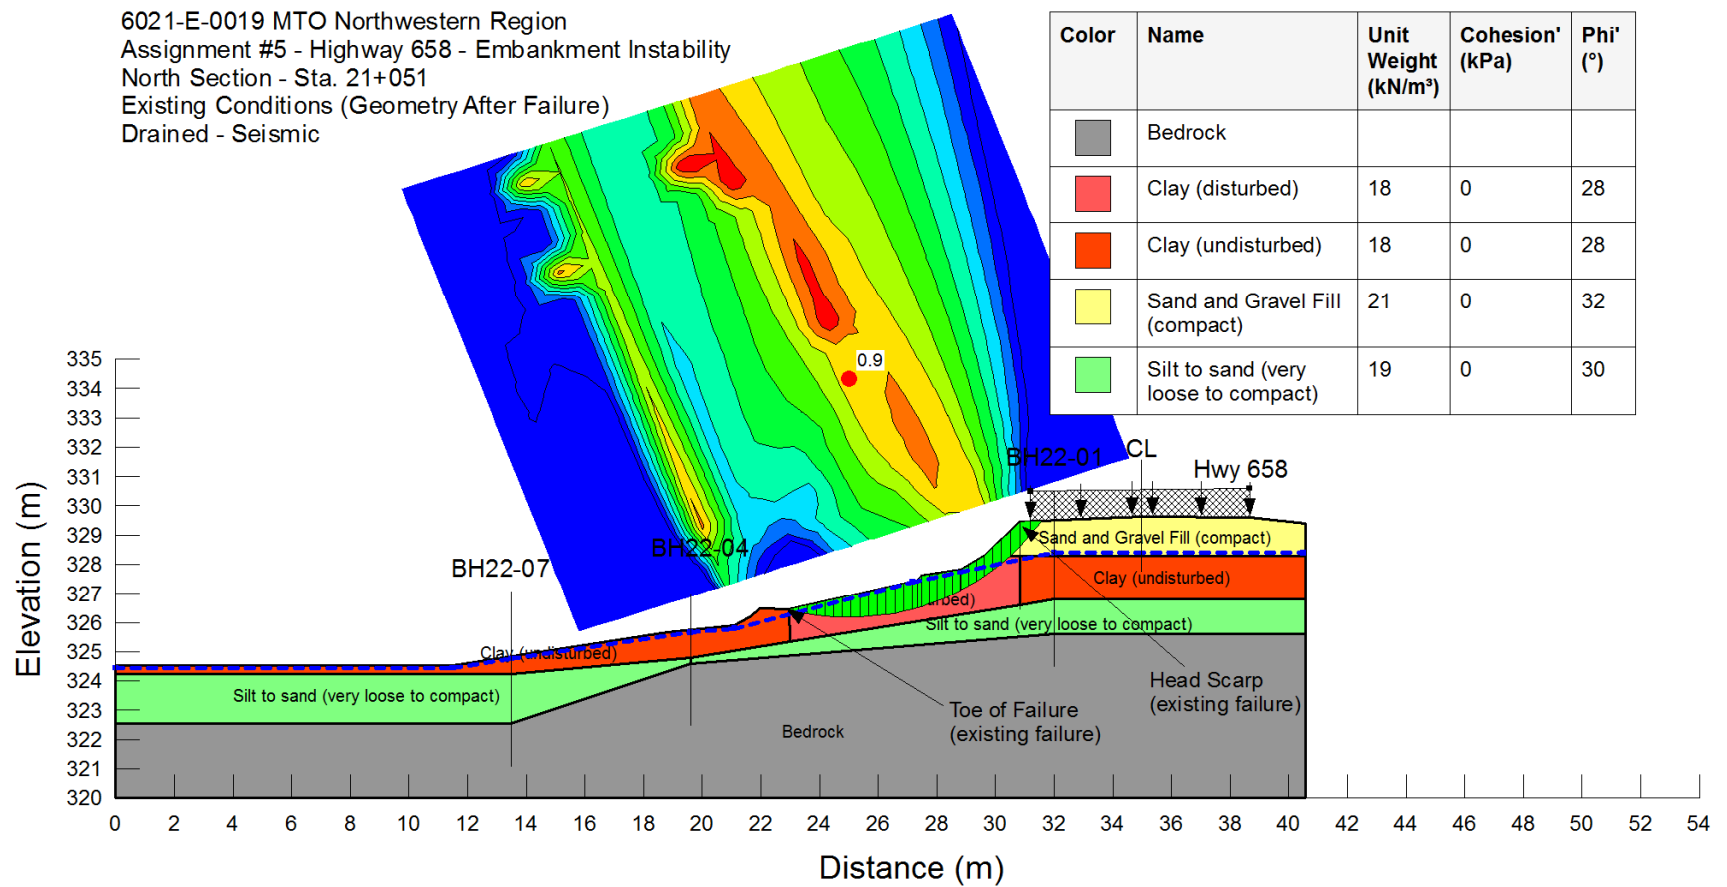
Figure G17. North Section D-D' (Sta. 21+051) – Stability of Slope After 2022 Failure (Current Slope Geometry), High GWL – Drained Seismic Conditions

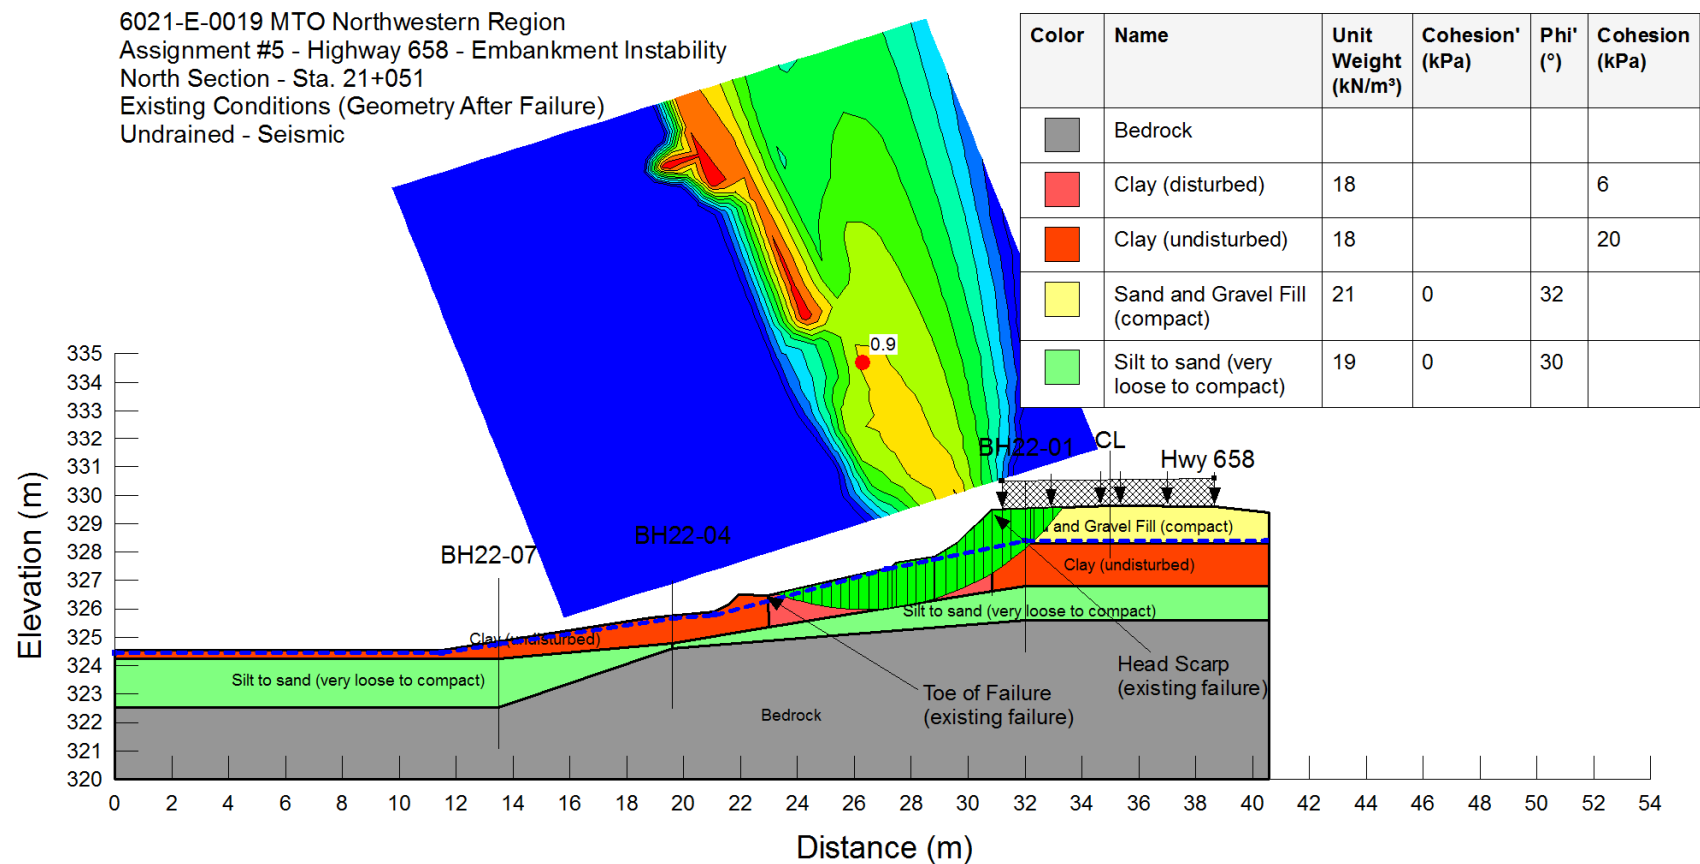
Figure G18. North Section D-D' (Sta. 21+051) – Stability of Slope After 2022 Failure (Current Slope Geometry), High GWL – Undrained Seismic Conditions

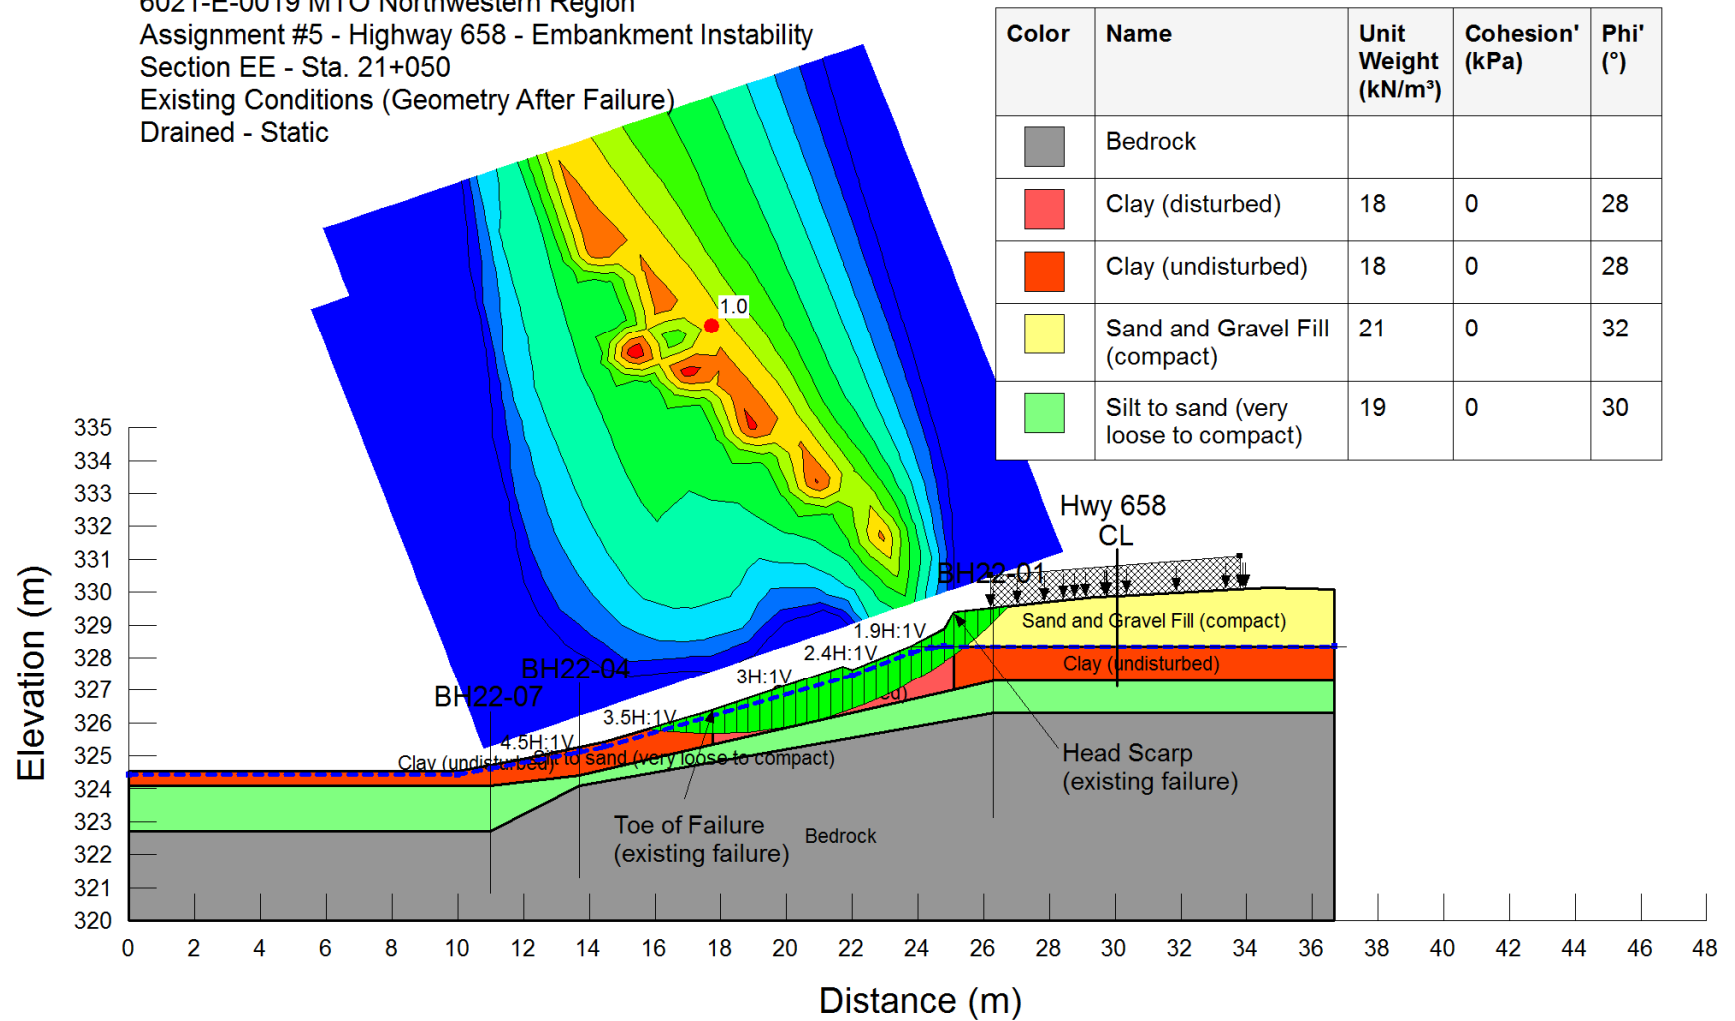
Figure G19. North Section E-E' (Sta. 21+050) – Stability of Slope After 2022 Failure (Current Slope Geometry), High GWL – Drained Static Conditions

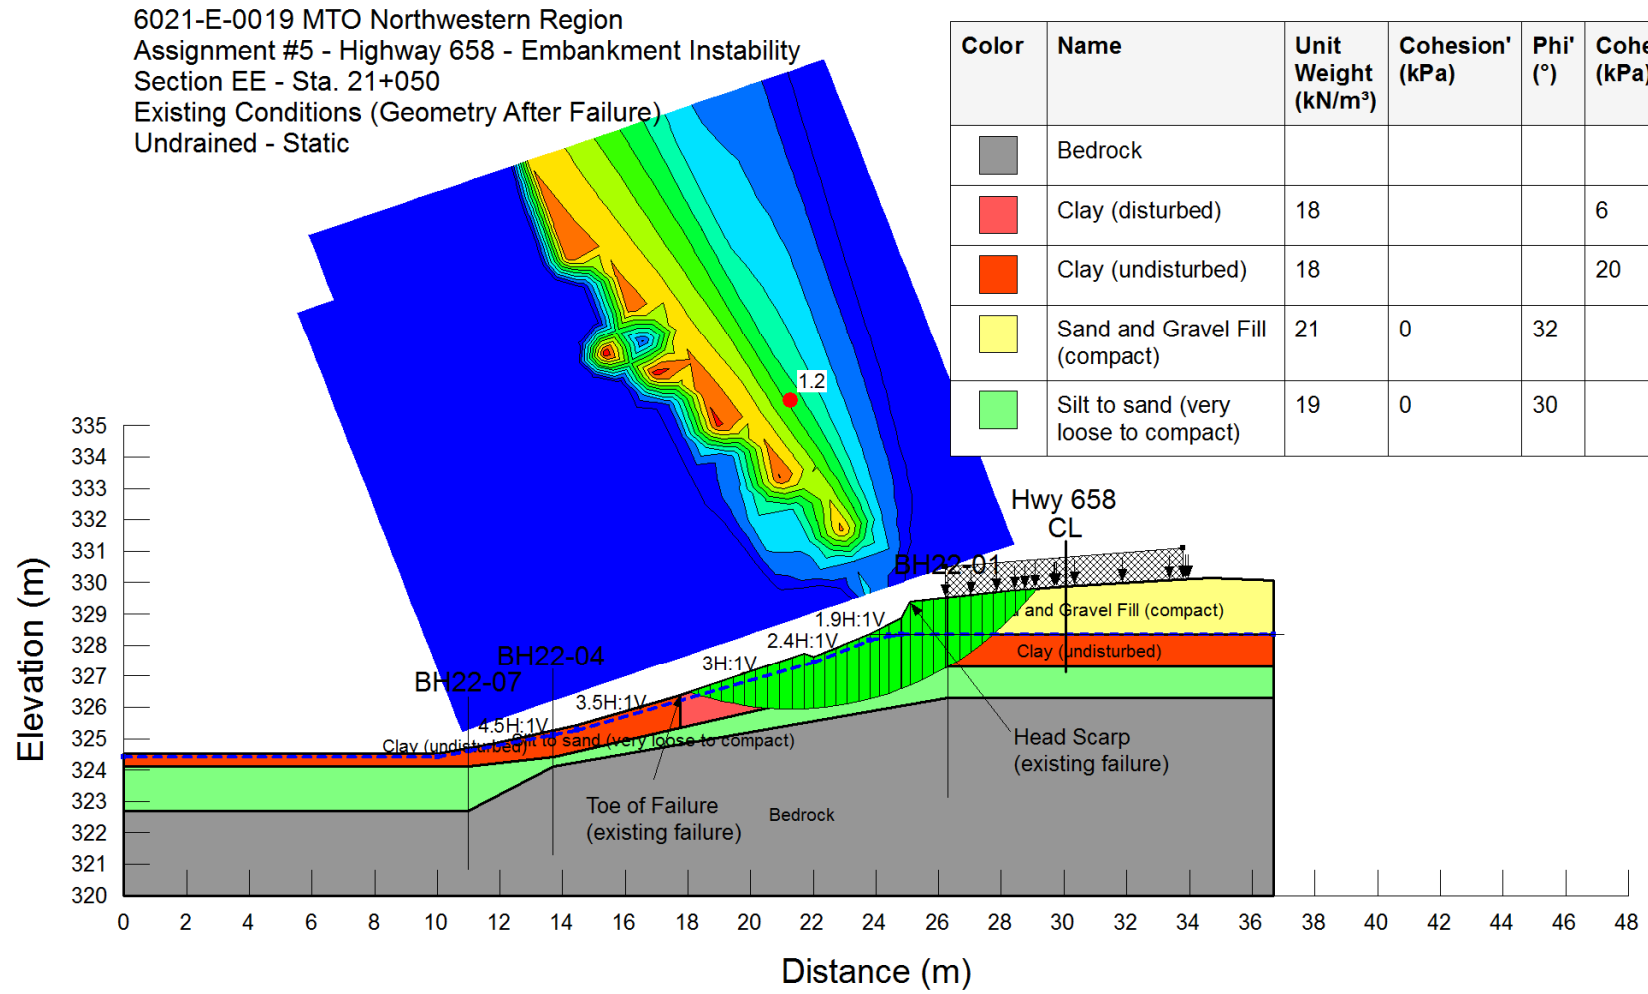
Figure G20. North Section E-E' (Sta. 21+050) – Stability of Slope After 2022 Failure (Current Slope Geometry), High GWL – Undrained Static Conditions

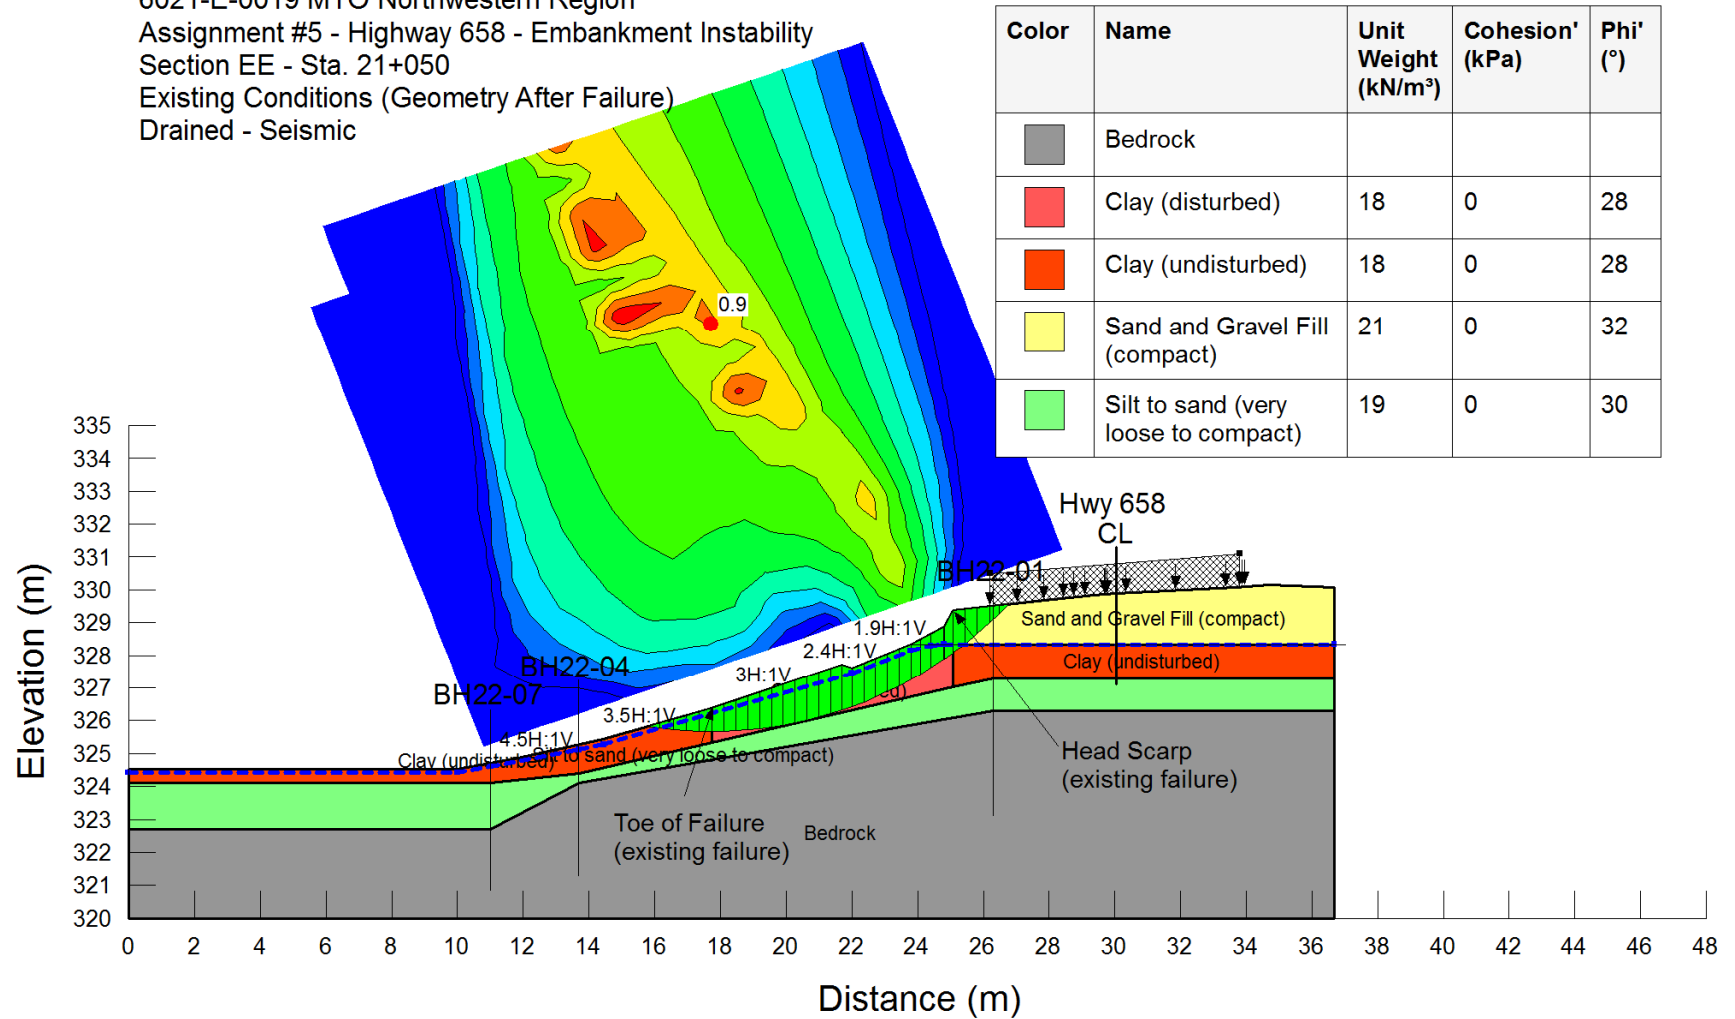
Figure G21. North Section E-E' (Sta. 21+050) – Stability of Slope After 2022 Failure (Current Slope Geometry), High GWL – Drained Seismic Conditions

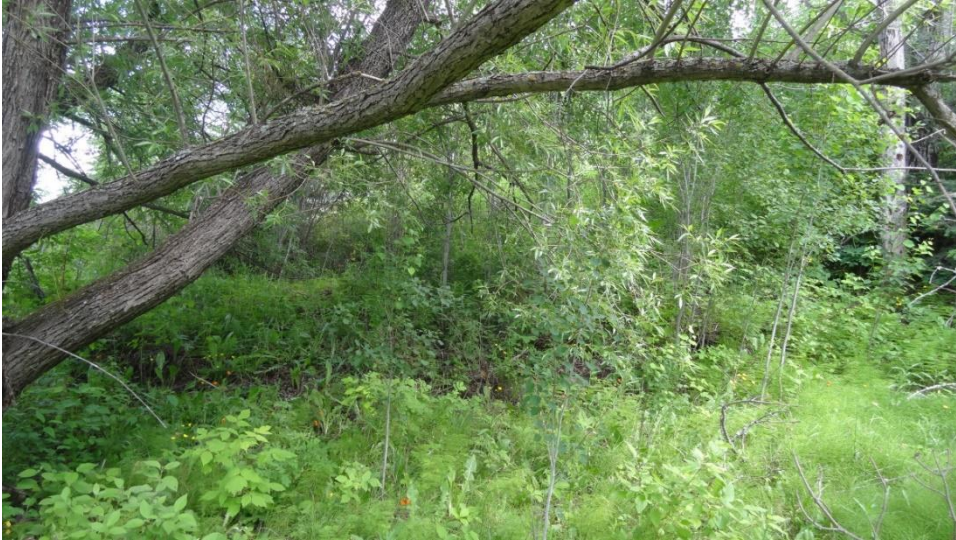
- Slope Instability Length  $\approx 26.0$  m, Aligned North-South Parallel to HWY 658 (Photo 1);
- Slope Height  $\approx 3.5$  m to  $\approx 5.0$  m (Photo 2);
- Slope Instability  $\approx 0.3$  m to  $\approx 1.2$  m into Highway 658 Shoulder and Southbound Lane (Photo 1);
- Head Scarp Depth  $\approx 0.2$  m to  $\approx 1.2$  m, Increasing in Depth from South to North (Photo 3);
- Existing Guardrail and Supports Bent and Twisted with Down Slope Movement (Photo 1);

*Photo 2 (Looking East): July 7, 2022 – Highway 658 Slope Instability Toe to Roadway*

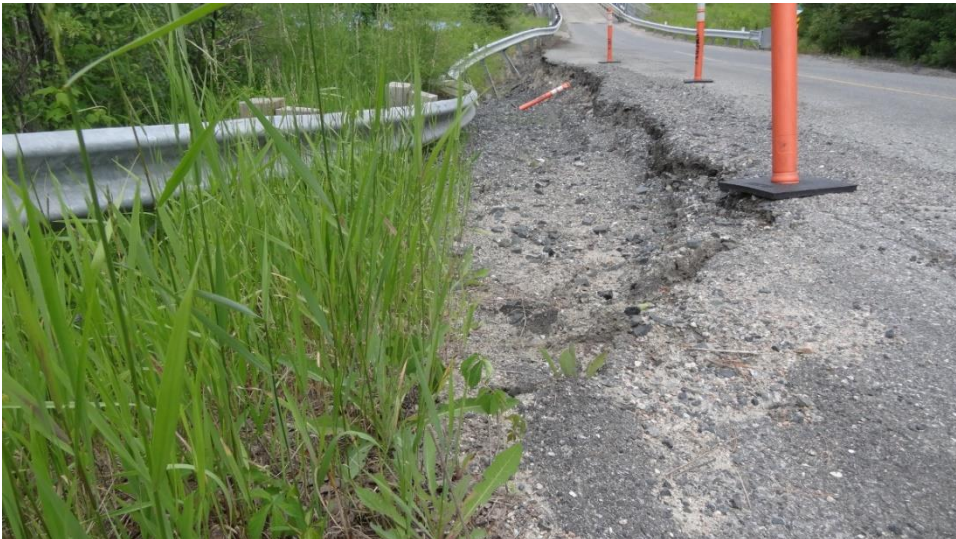
*Photo 3 (Looking North): July 7, 2022 – Slope Instability Head Scarp Parallel to Highway 658*

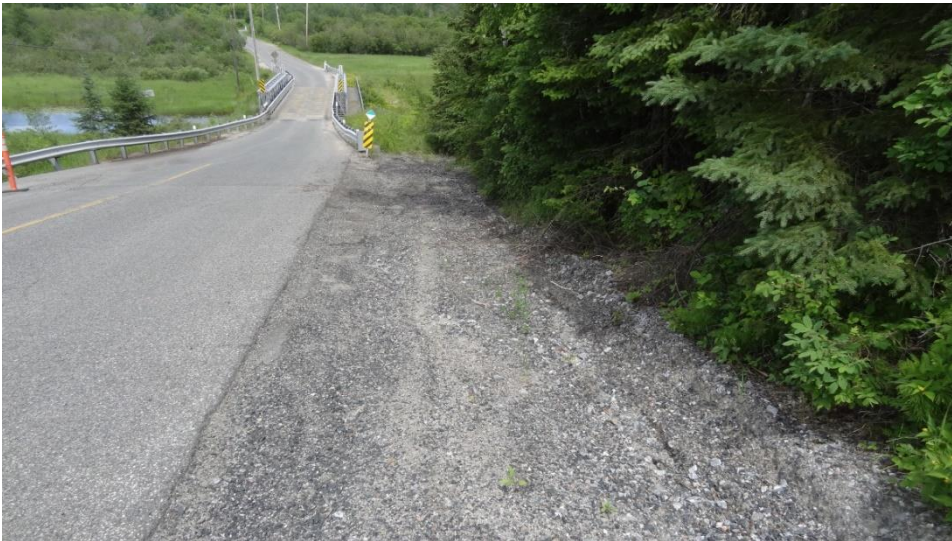
There were no signs of instability observed along the east shoulder or ditch line of Highway 658 across from the recent slope instability, only ditch erosion east of asphalt edge from surficial drainage flow downward from south to north towards the Black River floodplain (Photo 11).

*Photo 11 (Looking North): July 7, 2022 – Highway 658 East Shoulder Surficial Drainage Erosion*

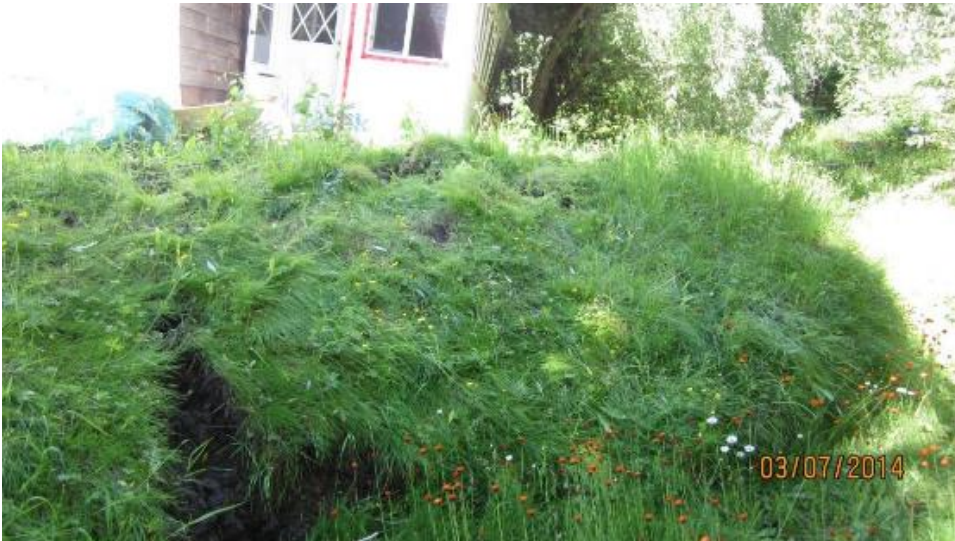
The previous slope instability immediate south of the recent 2022 slope instability was not the focal point of EXP's site reconnaissance. However, EXP did briefly look at the existing condition of the previous 2014 slope instability area, as it was directly south of the 2022 instability area. The 2014 slope instability area appears to have been remediated and/or stabilized by rough grading/placement of fill soils, coupled with the removal of the previous residential development (i.e., existing house, landscaping and any out-building structures – Photo 14), since the 2014 documentation of this slope instability event (MTO 2014).

*Photo 14 (Looking South): July 3, 2014 – Existing House within 2014 Instability Area*

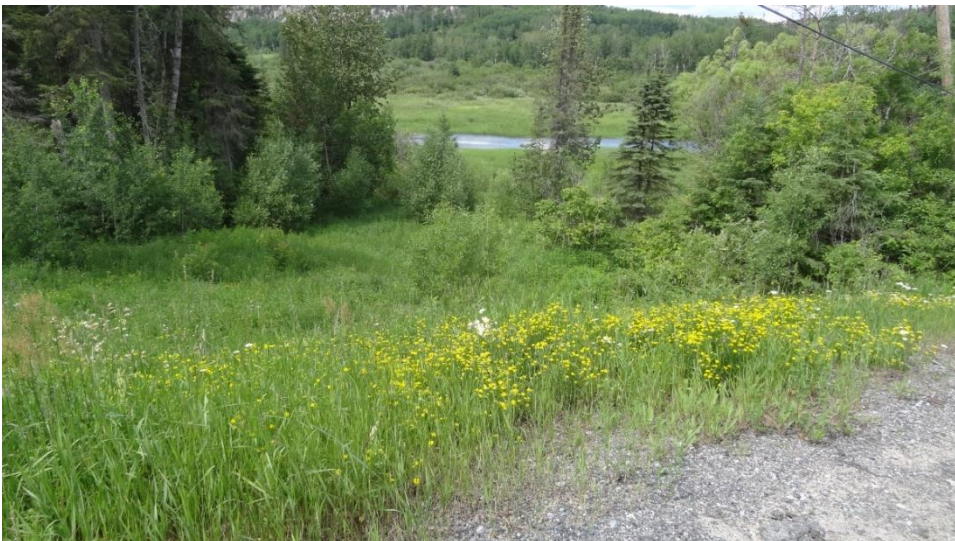
The overall 2014 slope instability area was covered with mature vegetation, inclusive of tall grasses/weeds, shrubs and small seedling trees. The 2014 slope instability area consisted of variable

grades (as steep as 1H:1V with short vertical drops of less than 0.3 m to as flat as 3H:1V near the existing slope toe), sloping down with short drops from the Highway 658 roadway surface down to what is assumed to be the toe of the slope instability or toe of previous fill soil placement (Photo 15). Rock fill placement as a slope armoring mechanism was observed at the leading edge of the 2014 slope instability after remedial grading was assumed to be undertaken (Photo 16). No recent signs of slope movement were observed within the overall 2014 slope instability area; however, EXP was not provided any remediation photos after the 2014 slope instability as a comparison to its existing condition as of July 7, 2022.

*Photo 15 (Looking West Down Slope): July 7, 2022 – 2014 Instability Area*

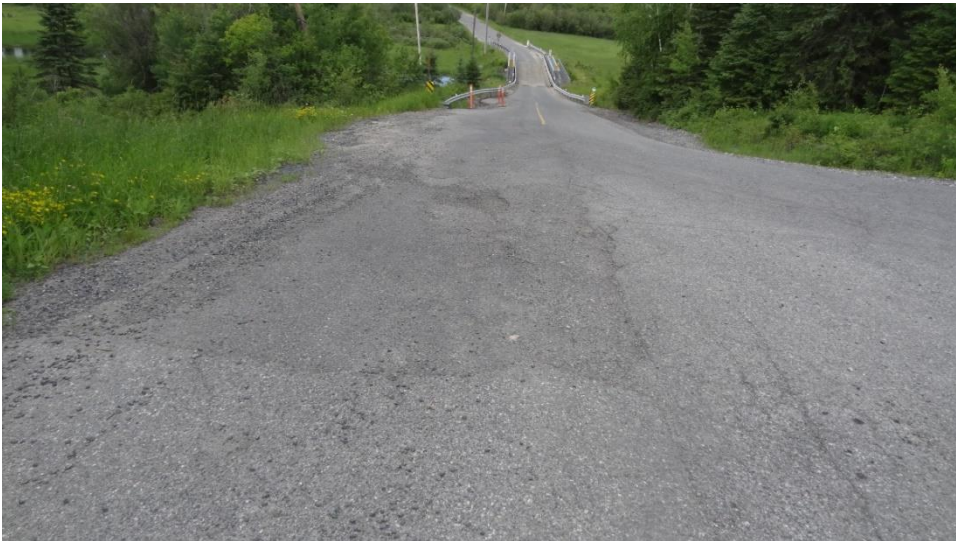
Pavement stress cracks were observed within an area of previous asphalt repair along Highway 658 directly adjacent to the known area of the 2014 slope instability (Photo 17). These stress cracks did not appear to be fresh and are not necessarily indicative of any slope movement since 2014, as they may only be associated with the previous roadway repairs (base/subbase gravel and asphalt patching).

*Photo 17 (Looking North): July 7, 2022 – Asphalt Repair Patch Adjacent to 2014 Instability Area*
