FOUNDATION EVALUATION REPORT

PROPOSED DREDGING OF HOLLAND MARSH NORTH CANAL BRIDGE 1, MTO STRUCTURE NOS. 37-32 1 AND 2

March 5, 2012

11-9-IEG1A

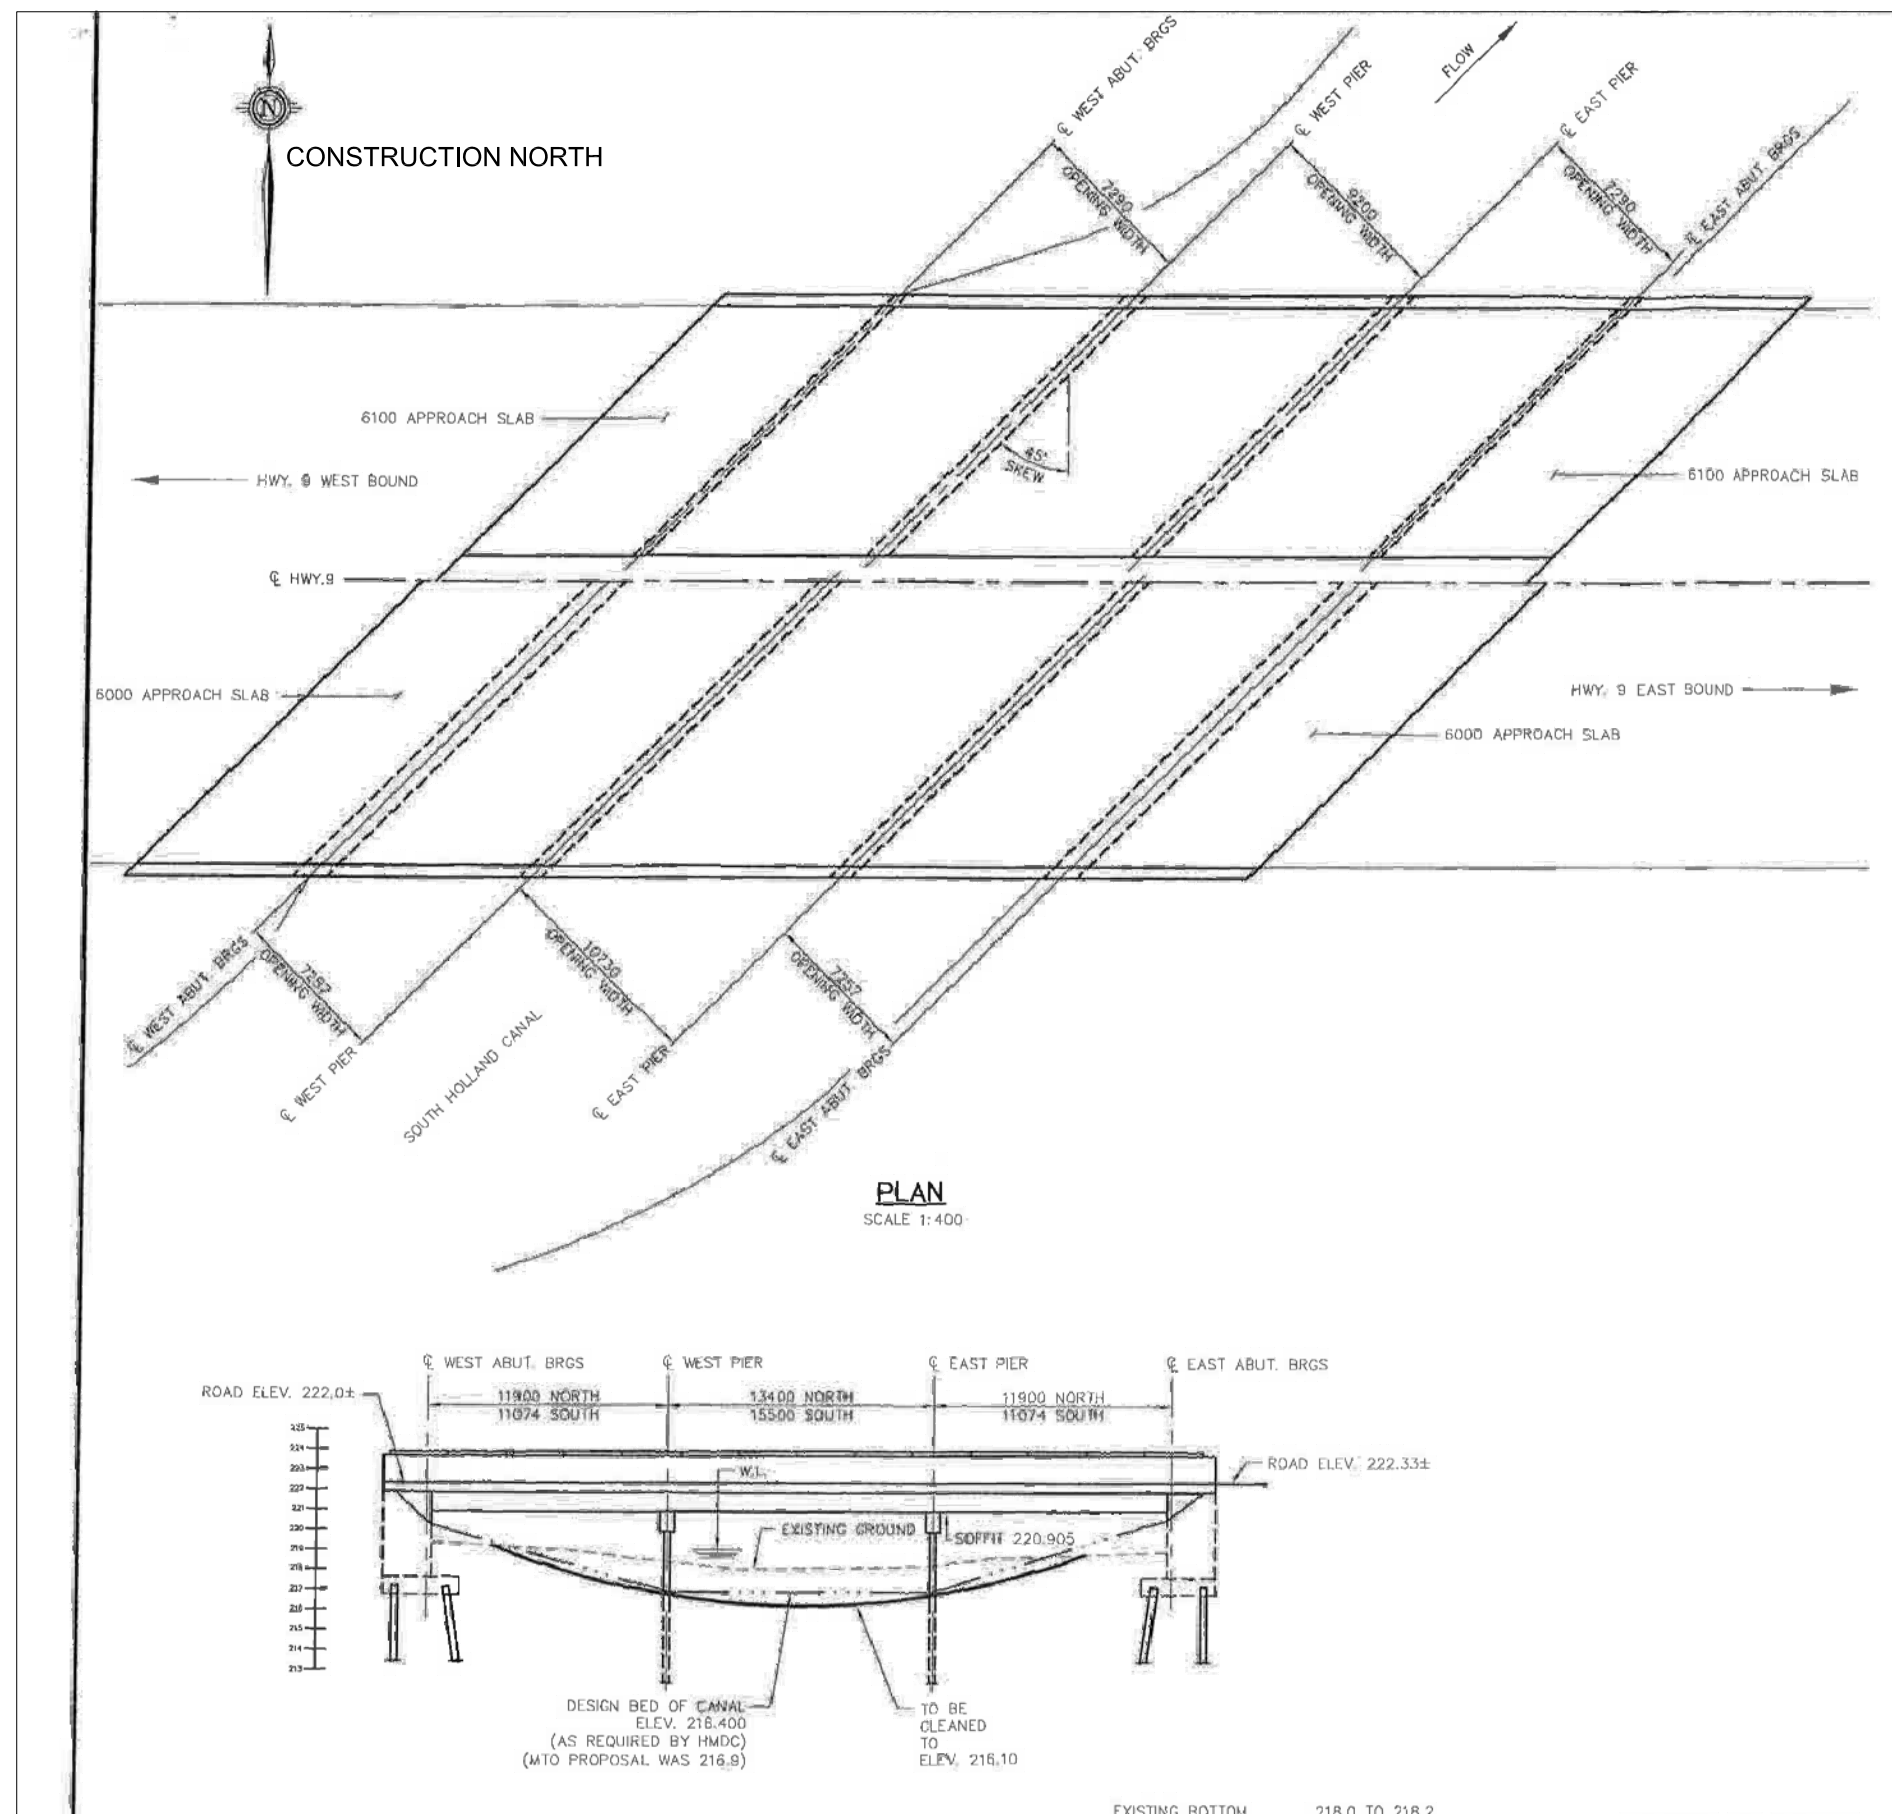
DRAWING 1
SITE PLAN AND PROFILE

The east and west earth embankments generally have a 3H:1V gradient with no revetments. No signs of embankment slope instability were observed at the time of this foundation evaluation. A copy of the site plan and profile is presented on Drawing 1.
