**PHASE II
GEOTECHNICAL INVESTIGATION
AND SLOPE STABILITY
ANALYSIS REPORT
HIGHWAY 602, 0.2 KM SOUTH
OF BONE ROAD
TOWNSHIP OF CROZIER
AGREEMENT No.: 6009-E-0007
GWP: 6093-10-00
GEOCRES NO.: 52C-23**

September 2011

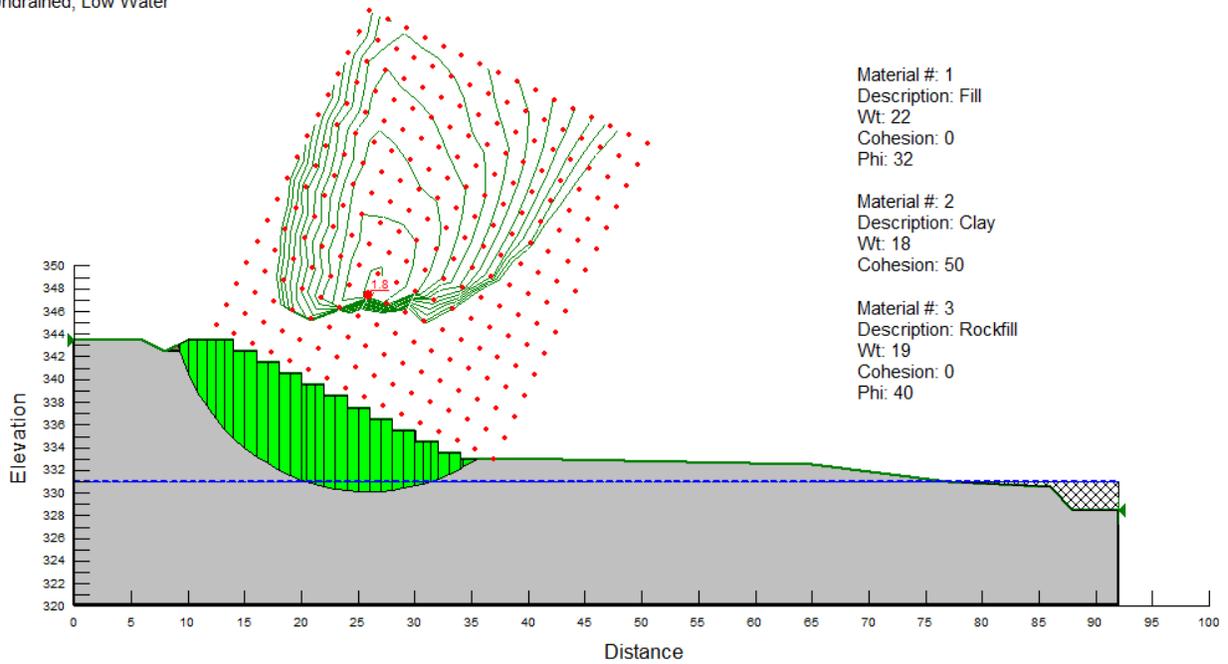
The following table shows factors of safety of the selected cases under undrained conditions for the temporary embankment configuration. Example slope stability analysis outputs can be found in Appendix E, Figures 3 and 4.

Figure 3 Temporary clay embankment 2H:1V, undrained condition with low water

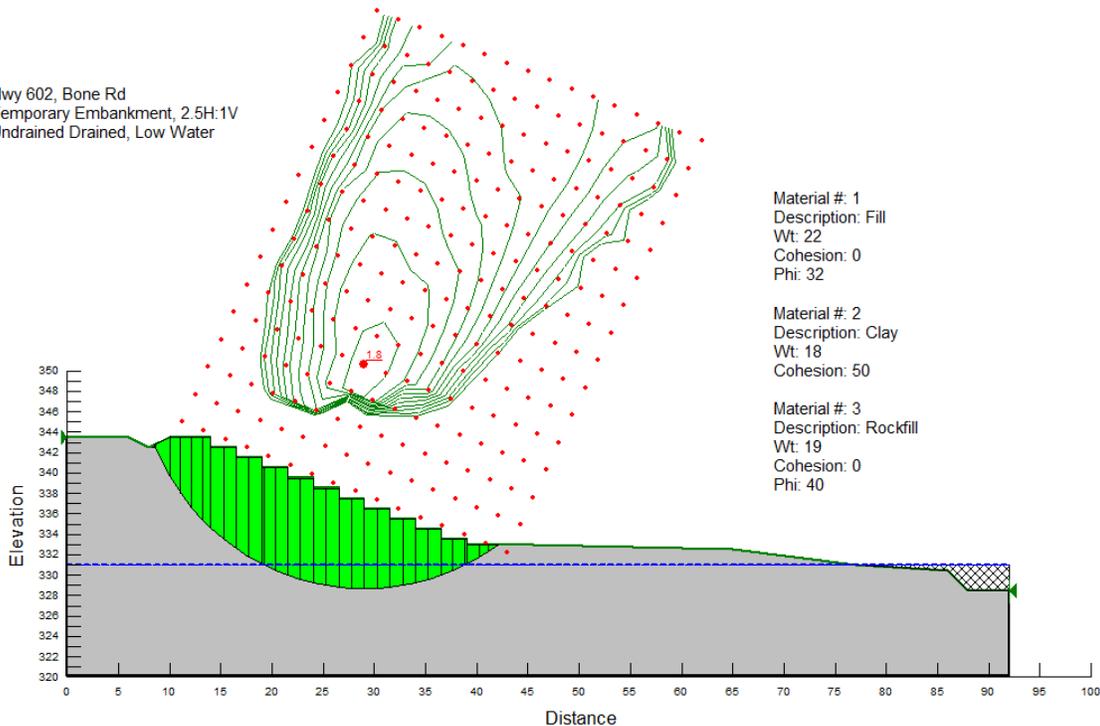
Figure 4 Temporary clay embankment 2.5H:1V, undrained condition with low water

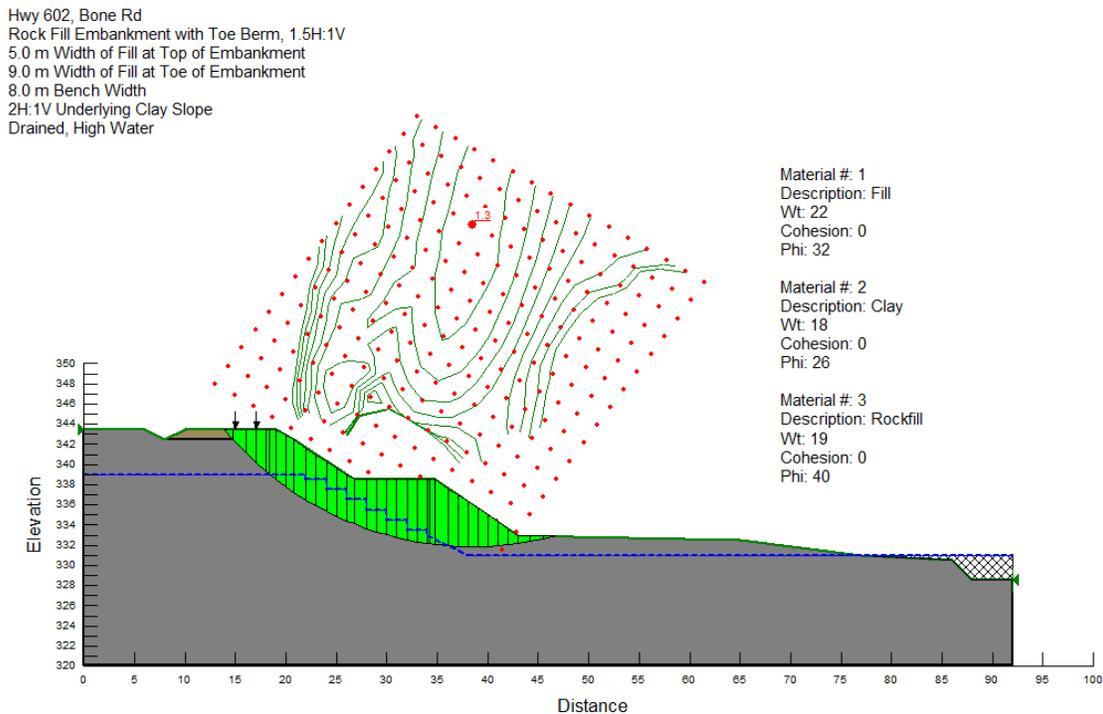
The following tables show factors of safety of the selected cases under undrained and drained conditions for the various rock fill embankment configurations. Example slope stability analysis outputs can be found in Appendix E, Figures 5 and 6. Plan view and cross sections of the proposed remedial methods are shown in Drawings 3 through 8.

Figure 5 Rock fill embankment with toe berm, 2H:1V underlying clay slope, drained condition with high water

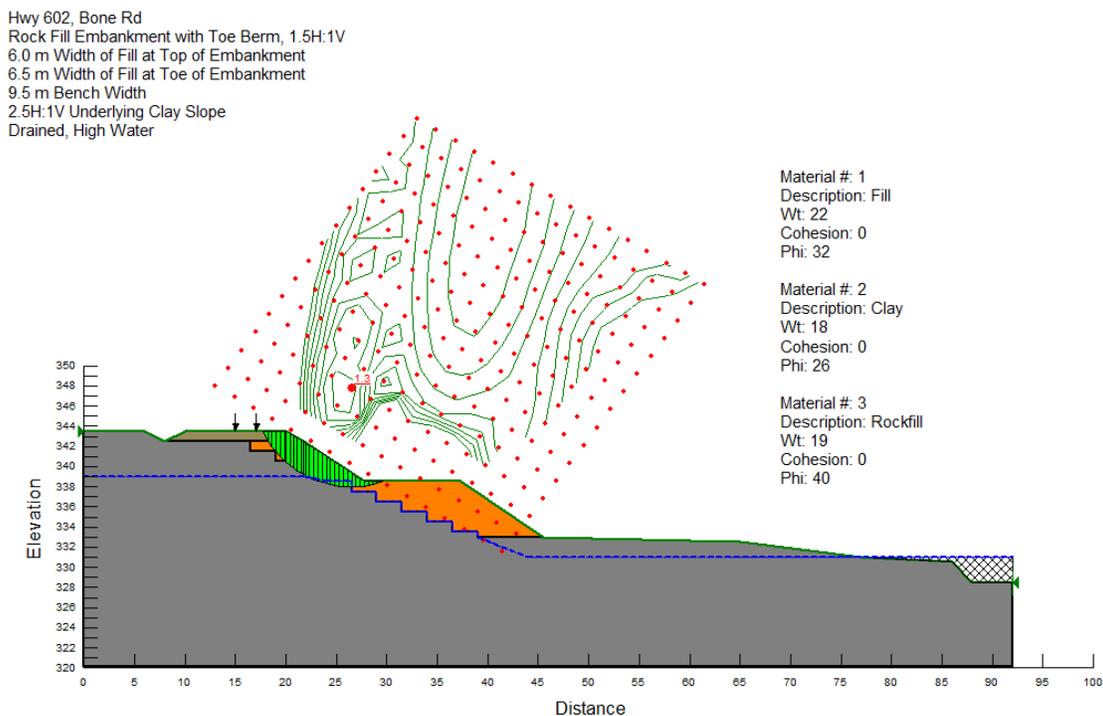
Figure 6 Rock fill embankment with toe berm, 2.5H:1V underlying clay slope, drained condition with low water

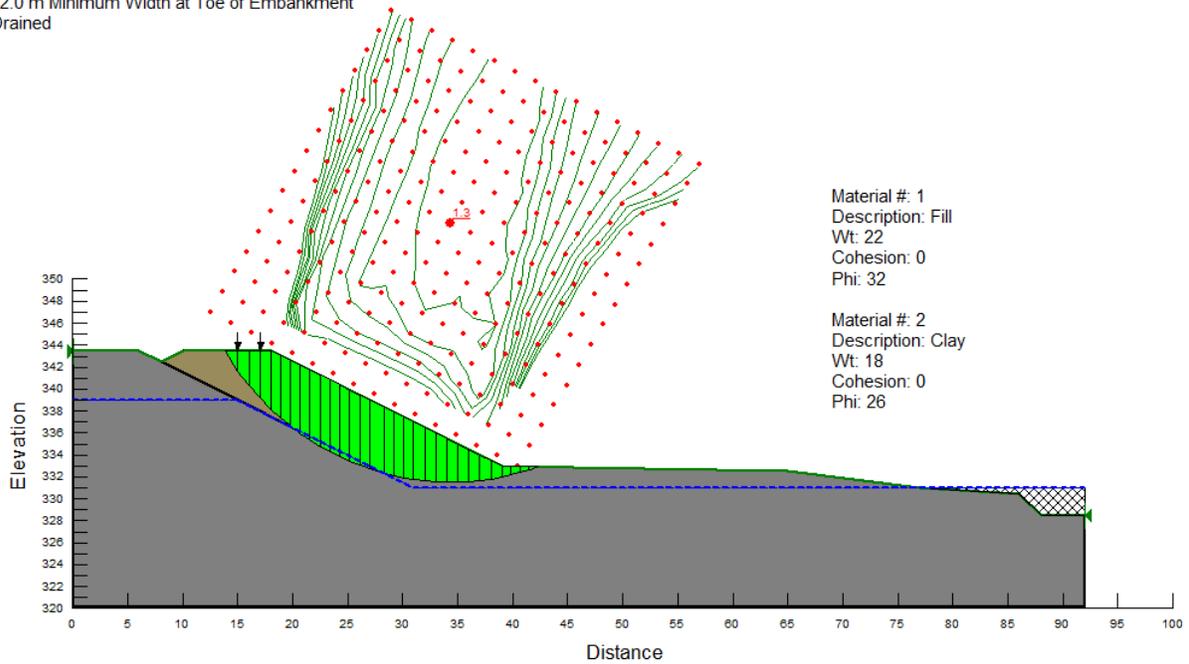
The following table shows factors of safety of the selected cases under undrained and drained conditions for the granular fill embankment configurations. Example slope stability analysis outputs can be found in Appendix E, Figures 7 through 9. Plan view and cross section of the proposed remedial method with a 3H:1V embankment slope is shown in Drawing 9.

Figure 7 2H:1V Granular embankment, 2H:1V underlying clay slope, drained condition with high water

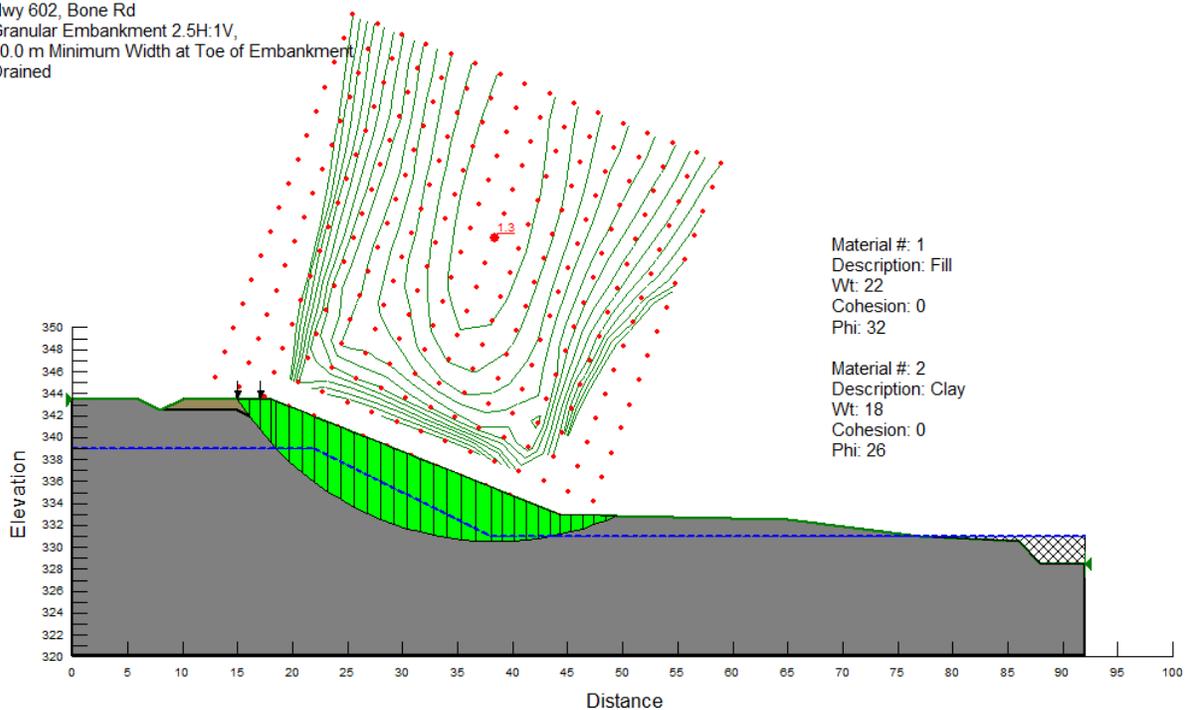
Figure 8 2.5H:1V granular embankment, 2H:1V underlying clay slope, drained condition with high water

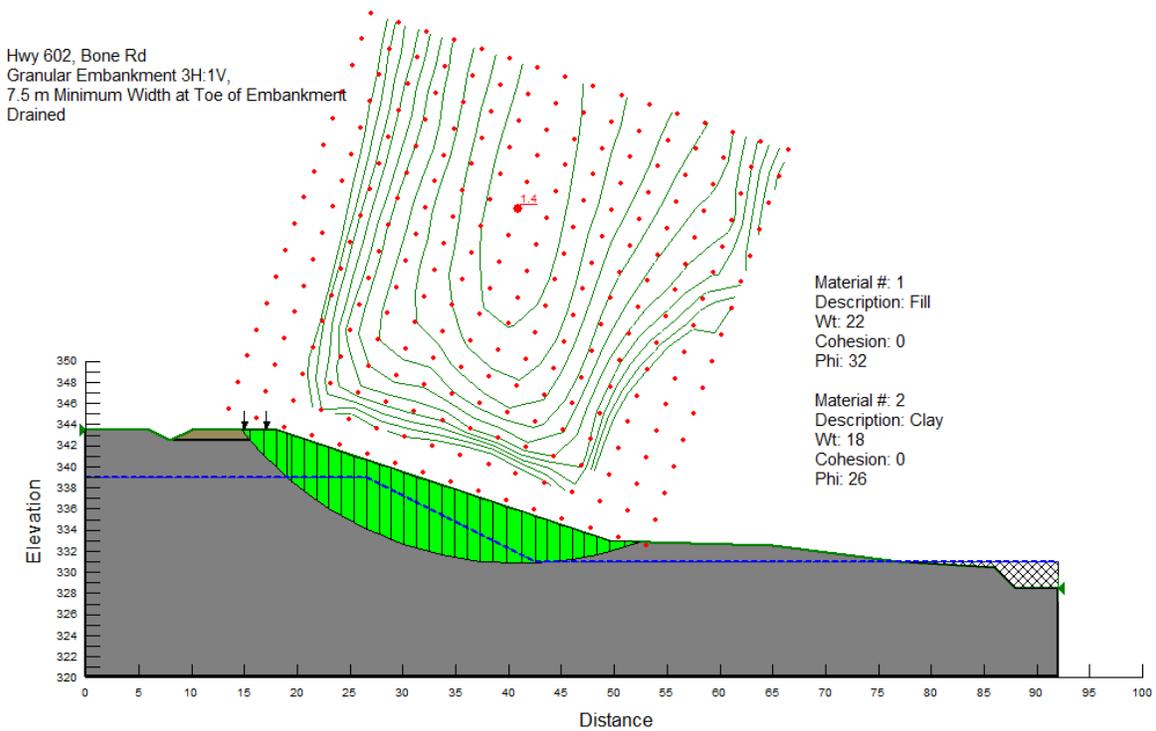
Figure 9 3H:1V granular embankment, 2H:1V underlying clay slope, drained condition with high water

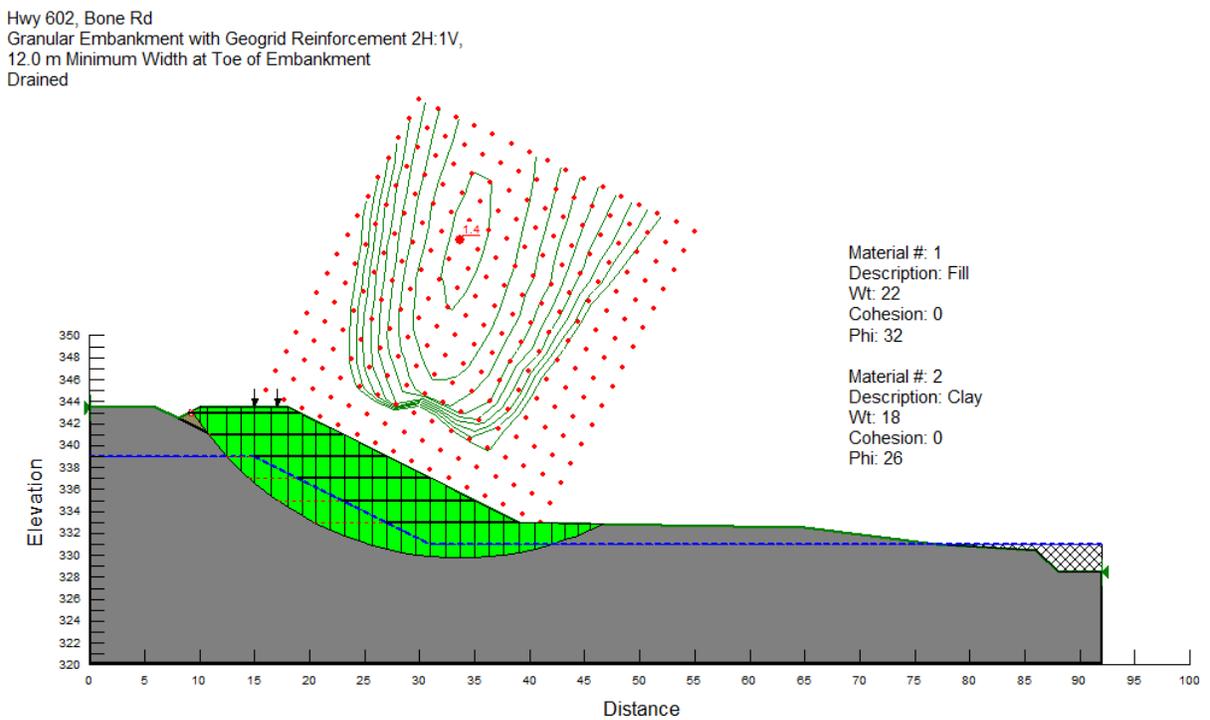
The following table shows factors of safety of the selected cases under undrained and drained conditions for the granular fill embankment with geogrid reinforcing configuration. Example slope stability analysis outputs can be found in Appendix E, Figures 10 and 11. Plan view and cross sections of the proposed remedial methods are shown in Drawings 10 and 11.

Figure 10 2H:1V granular embankment with geogrid reinforcement, 2H:1V underlying clay slope, drained condition with high water

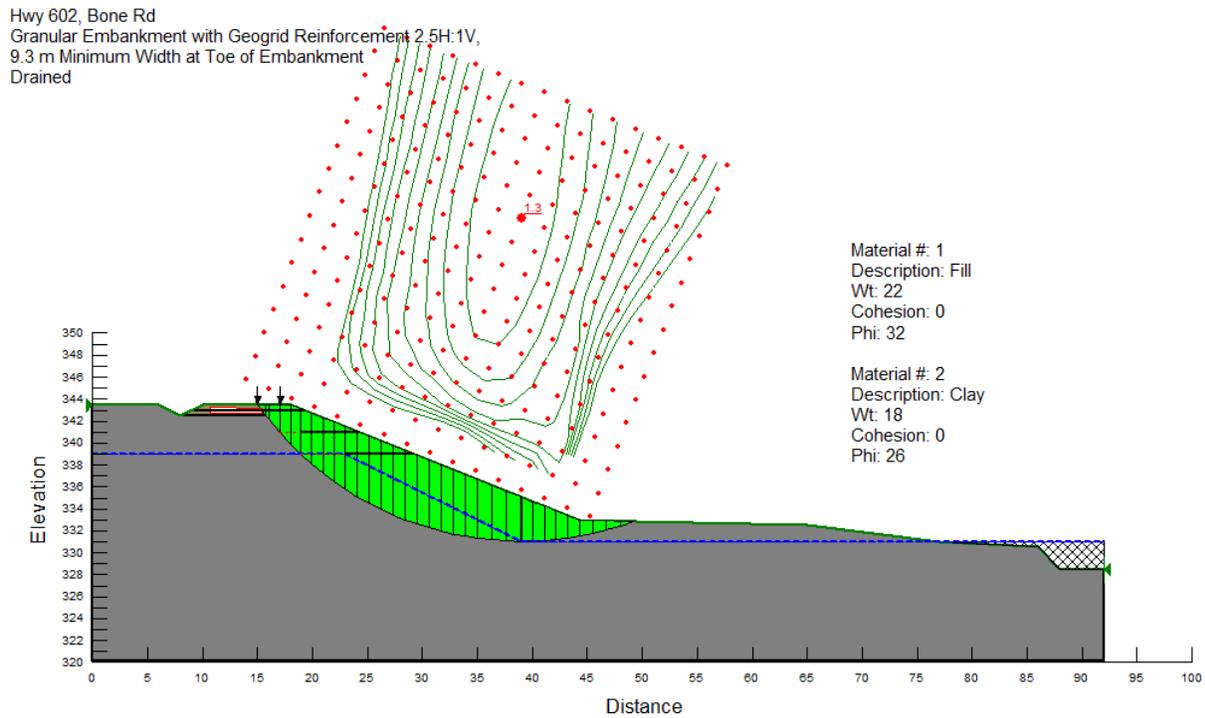
Figure 11 2.5H:1V granular embankment with geogrid reinforcement, 2H:1V underlying clay slope, drained condition with high water

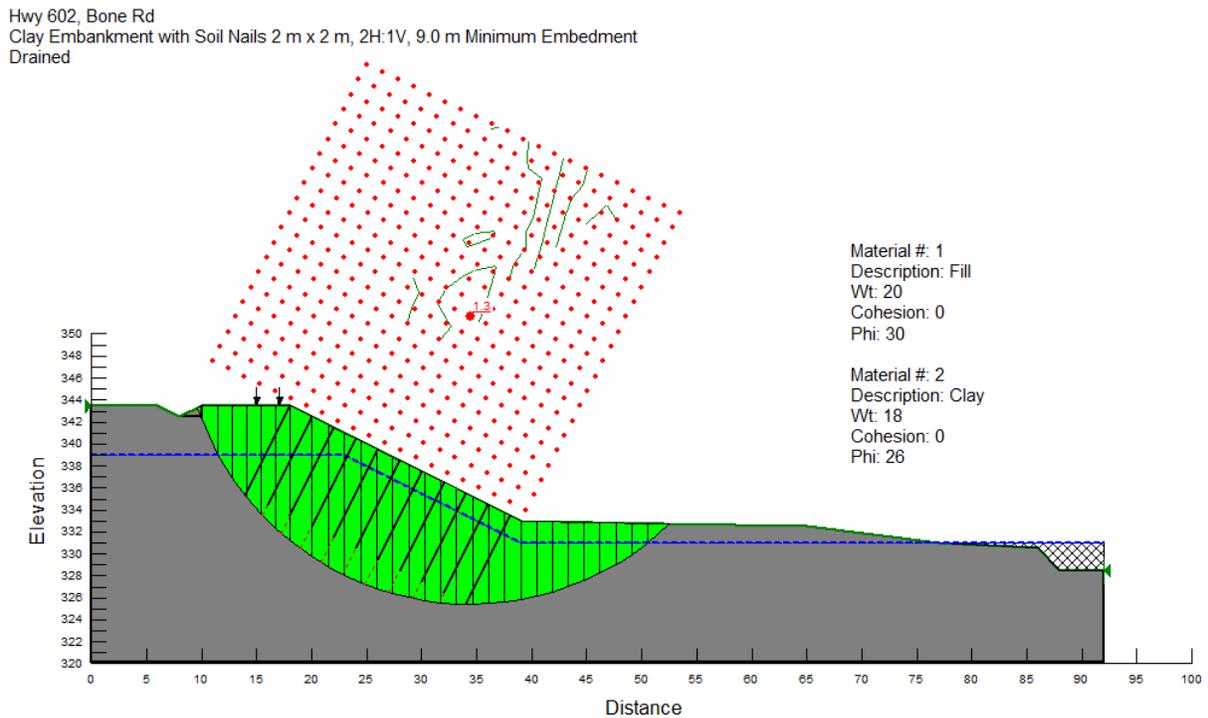
The following table shows the factor of safety of the selected case under undrained and drained conditions for embankment with soil nail reinforcing configuration. Example slope stability analysis output can be found in Appendix E, Figure 12. Plan view and cross sections of the proposed remedial method is shown in Drawing 12.

Figure 12 2H:1V clay embankment with soil nails, 9.0 m embedment, drained condition with high water
