Final Foundation Investigation Report (FIR)

Highway 61 Culvert Replacement

Station 19+250, Township of Blake

GWP 6176-15-00

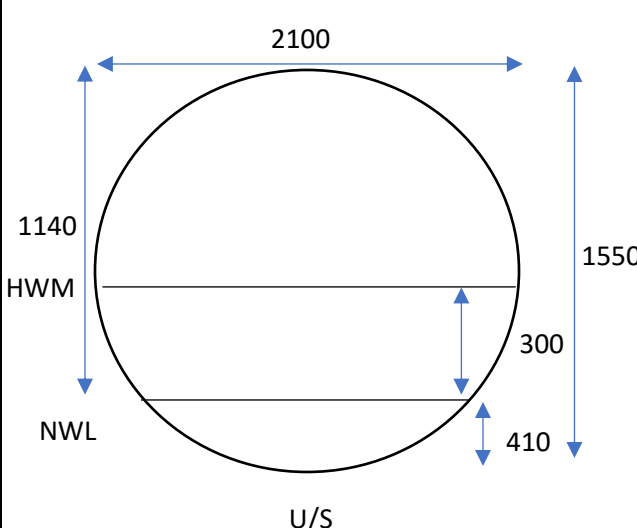
<p>U/S</p> </div> <div style="text-align: center;">

E. SITE CONDITIONS			
Road Condition (sag, settlement, etc.) – OK			
Physical Culvert Condition (rust, damage, etc.) – Poor			
Culvert Appearance (general comments) – Replace			
Site Sketch – <div style="display: flex; justify-content: space-around; align-items: flex-end; margin-top: 20px;"> <div style="text-align: center;">
