**THURBER** ENGINEERING LTD.

## MEMORANDUM

Date: March 9, 2017

### PRELIMINARY FOUNDATION ASSESSMENT SAWERS CREEK BRIDGE (SITE 26-040) GEOCRES NO. 31D-650

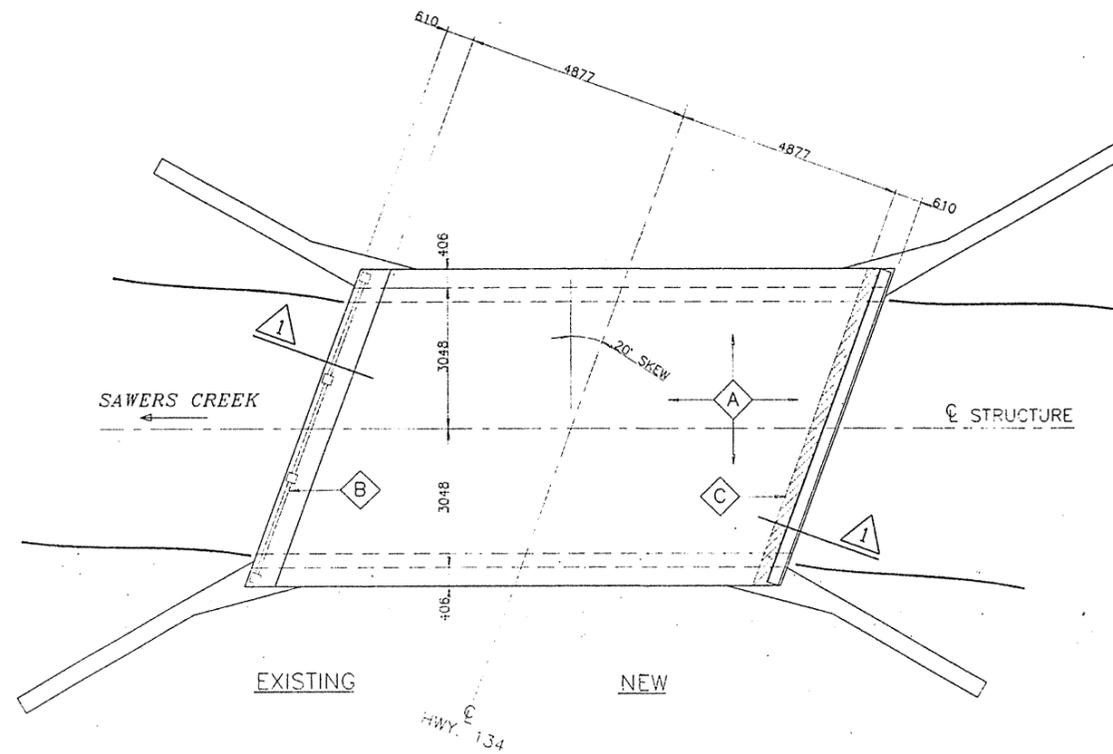
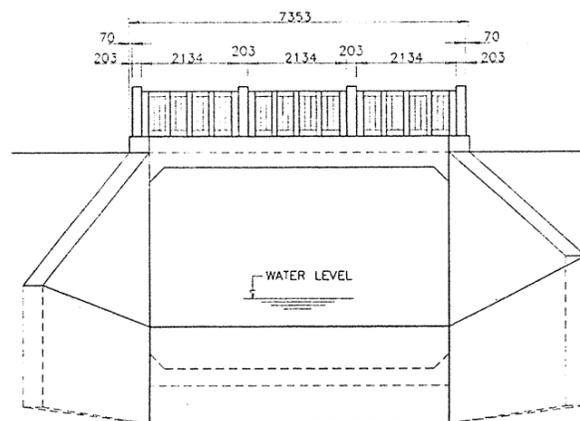
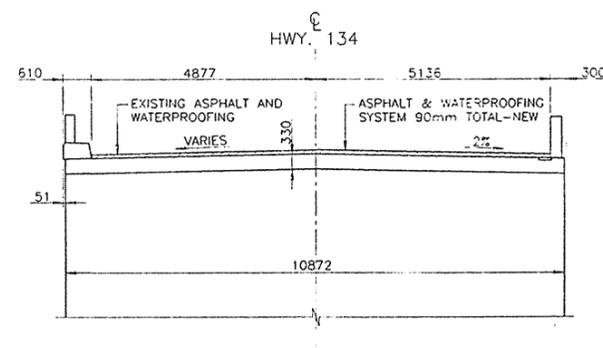
SHEET  
116

- A** REMOVE ASPHALT PAVEMENT AND WATERPROOFING FROM DECK. REMOVE DETERIORATED AND DELAMINATED CONCRETE FROM DECK PATCH, WATERPROOF AND REPAVE.
- B** REPLACE EXISTING CONCRETE POSTS, STEEL RAILINGS AND CURBS WITH CONCRETE PARAPET WALLS AND RAIL.
- C** PATCH REMOVAL AREA WITH CONCRETE
