**FOUNDATION INVESTIGATION AND DESIGN REPORT
STONE CREEK CULVERT FOOTING REHABILITATION
NEW LISKEARD DISTRICT, ONTARIO
GWP 5407-15-00 – HWY 112**

Geocres Number: 41P-66

March 10, 2016
File: 10098

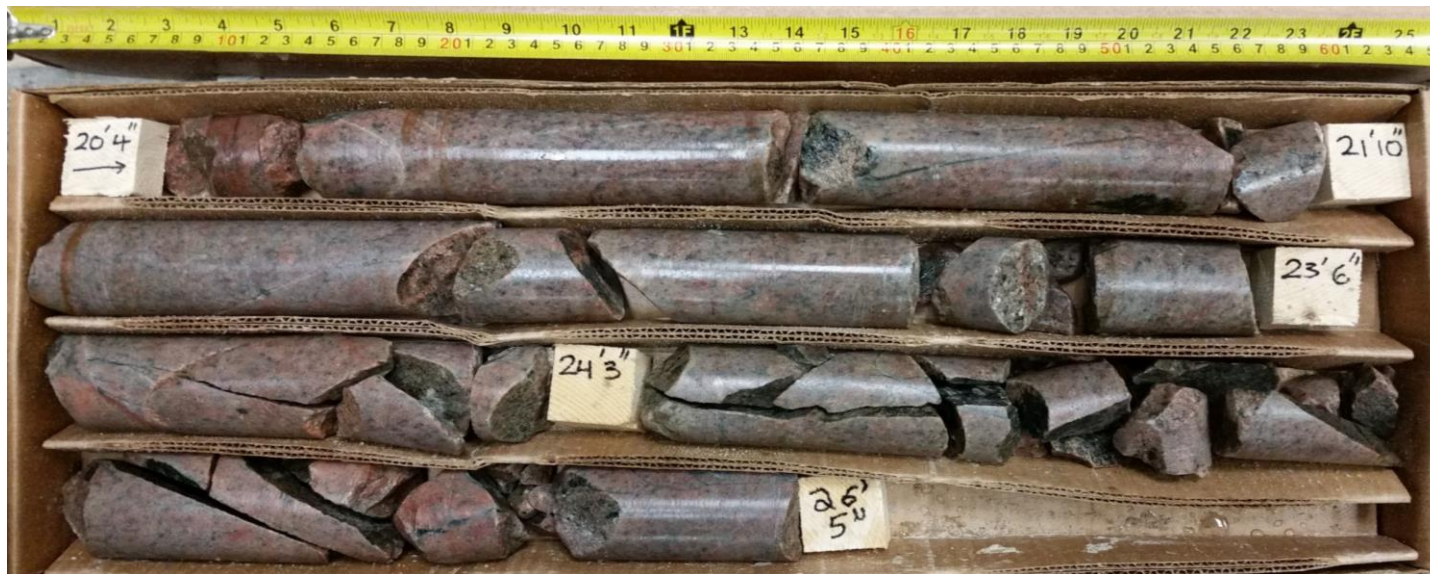
FIGURE B3

BOREHOLE: **BH 15-04**
CORE RUN #1: 20' 4" – 21' 10"
CORE RUN #2: 21' 10" – 23' 6"
CORE RUN #3: 23' 6" – 24' 3"
CORE RUN #4: 24' 3" – 26' 5"

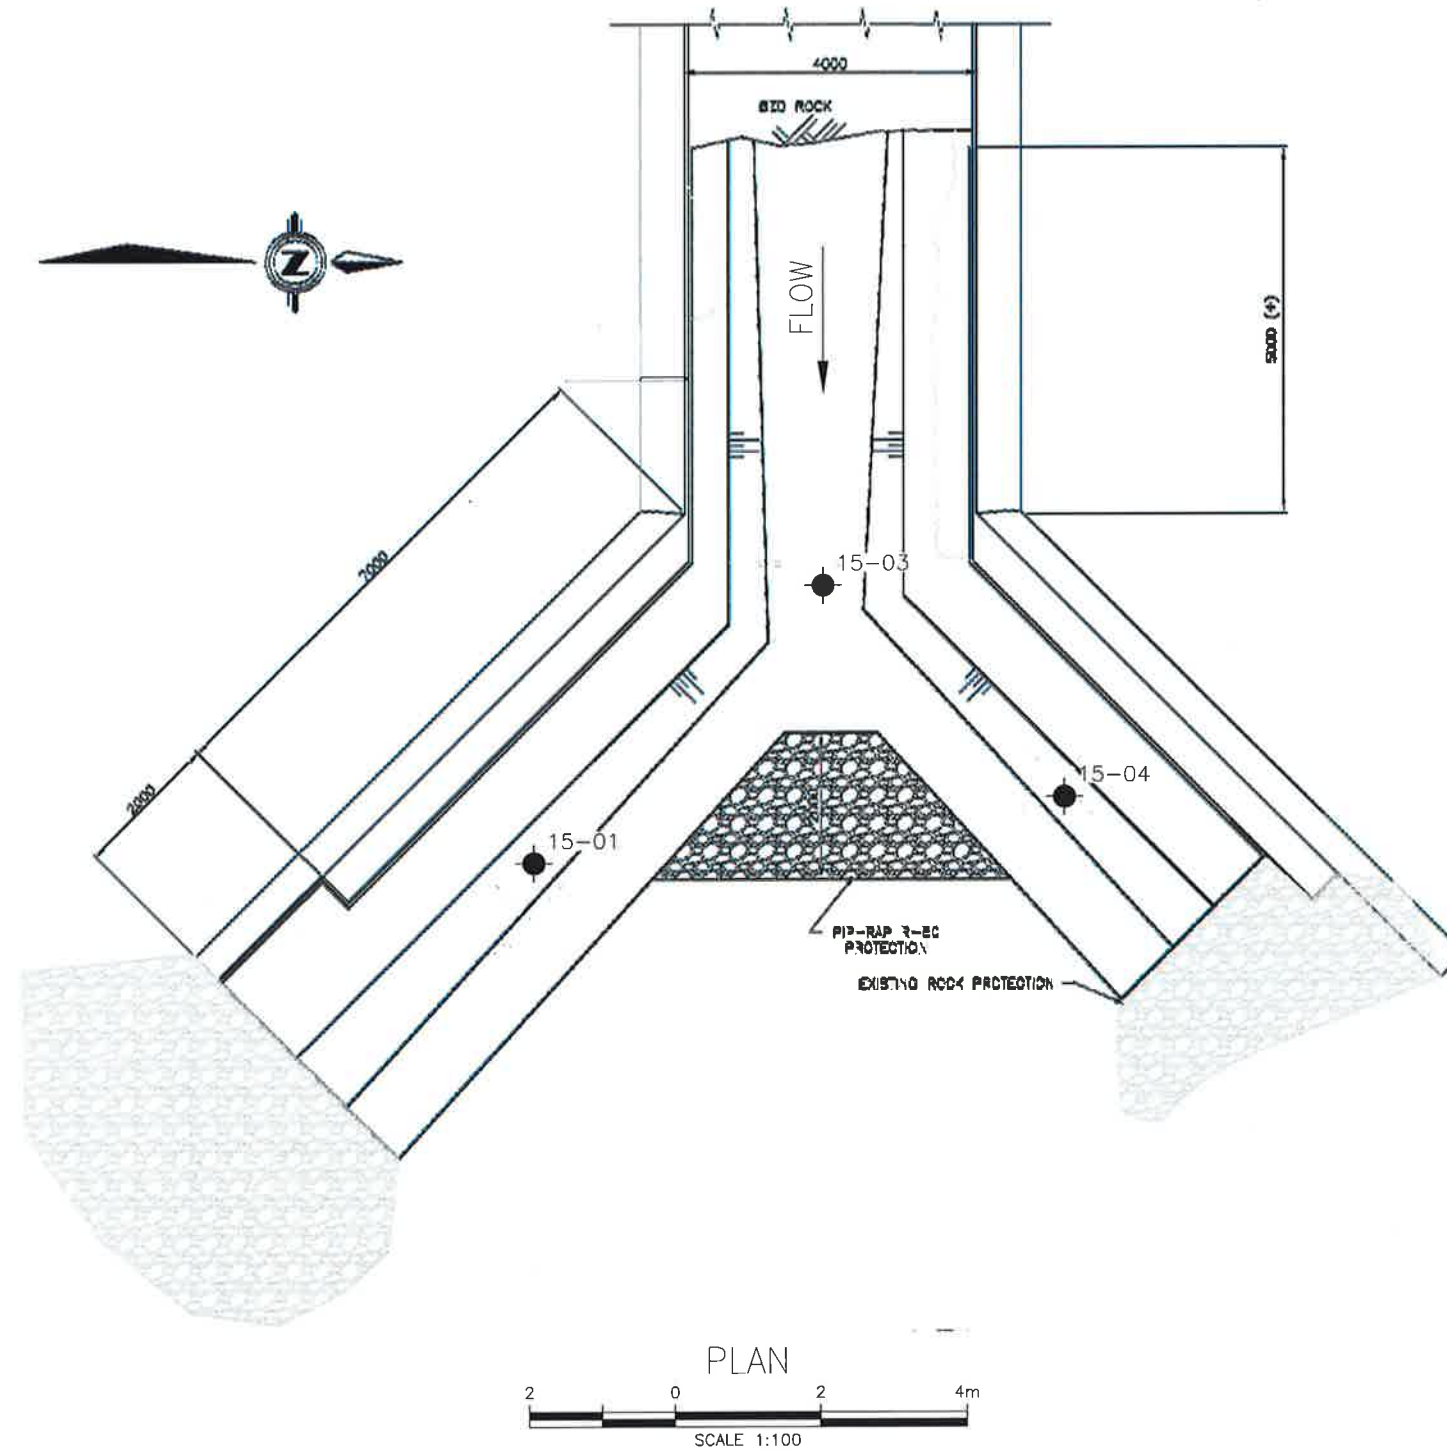
SHEET
4

STONEY CREEK CULVERT
HIGHWAY 112
FOOTING REHABILITATION
BOREHOLE LOCATIONS PLAN
