# Memorandum Report

**Subject:** Remedial Measures for Embankment Instabilities  
Hwy 406 Northbound Approaching Westchester Avenue  
W.O. 2012-11003  
GWP 2364-09-00  
GEOCREs No. 30M3-274

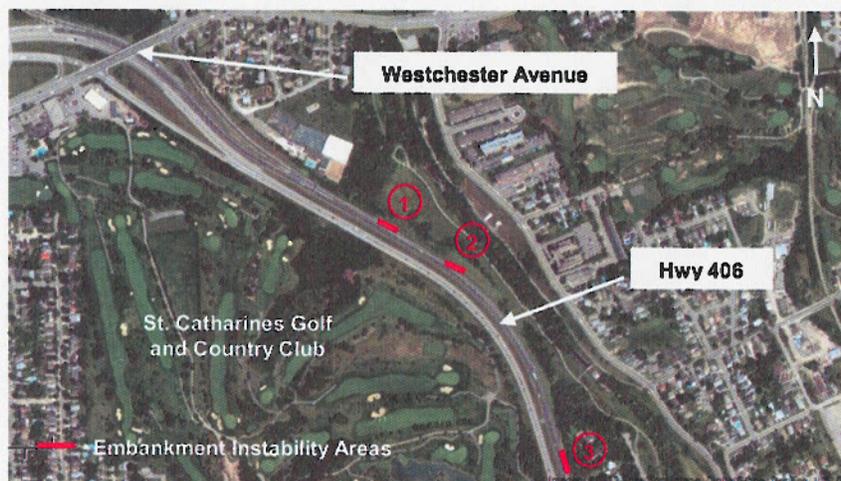
**Figure 1: Location of Embankment Instability Areas**

In response to the CR request, Project Foundations Engineer Fiona Leung, Foundation Design Technician Danny Tari and Foundations Co-op Student Diana Gomez Rodriguez visited the problem site with CR Contract Office Niagara Area Maintenance Coordinator Tymen Evink on February 28, 2012. Tymen Evink identified that there are three separate embankment instability areas (See Figure 1).

1. from Station 28+715 to Station 28+760, approximate 45 m long
2. from Station 28+630 to Station 28+680, approximate 50 m long
3. from Station 28+280 to Station 28+305, approximate 25 m long
