**Foundation Investigation and  
Design Report**

Mariposa Brook Culvert Replacement  
Site No. 32-161/C  
Highway 7  
Station 13+322 Township of Mariposa

G.W.P. 4066-10-00

March 2012

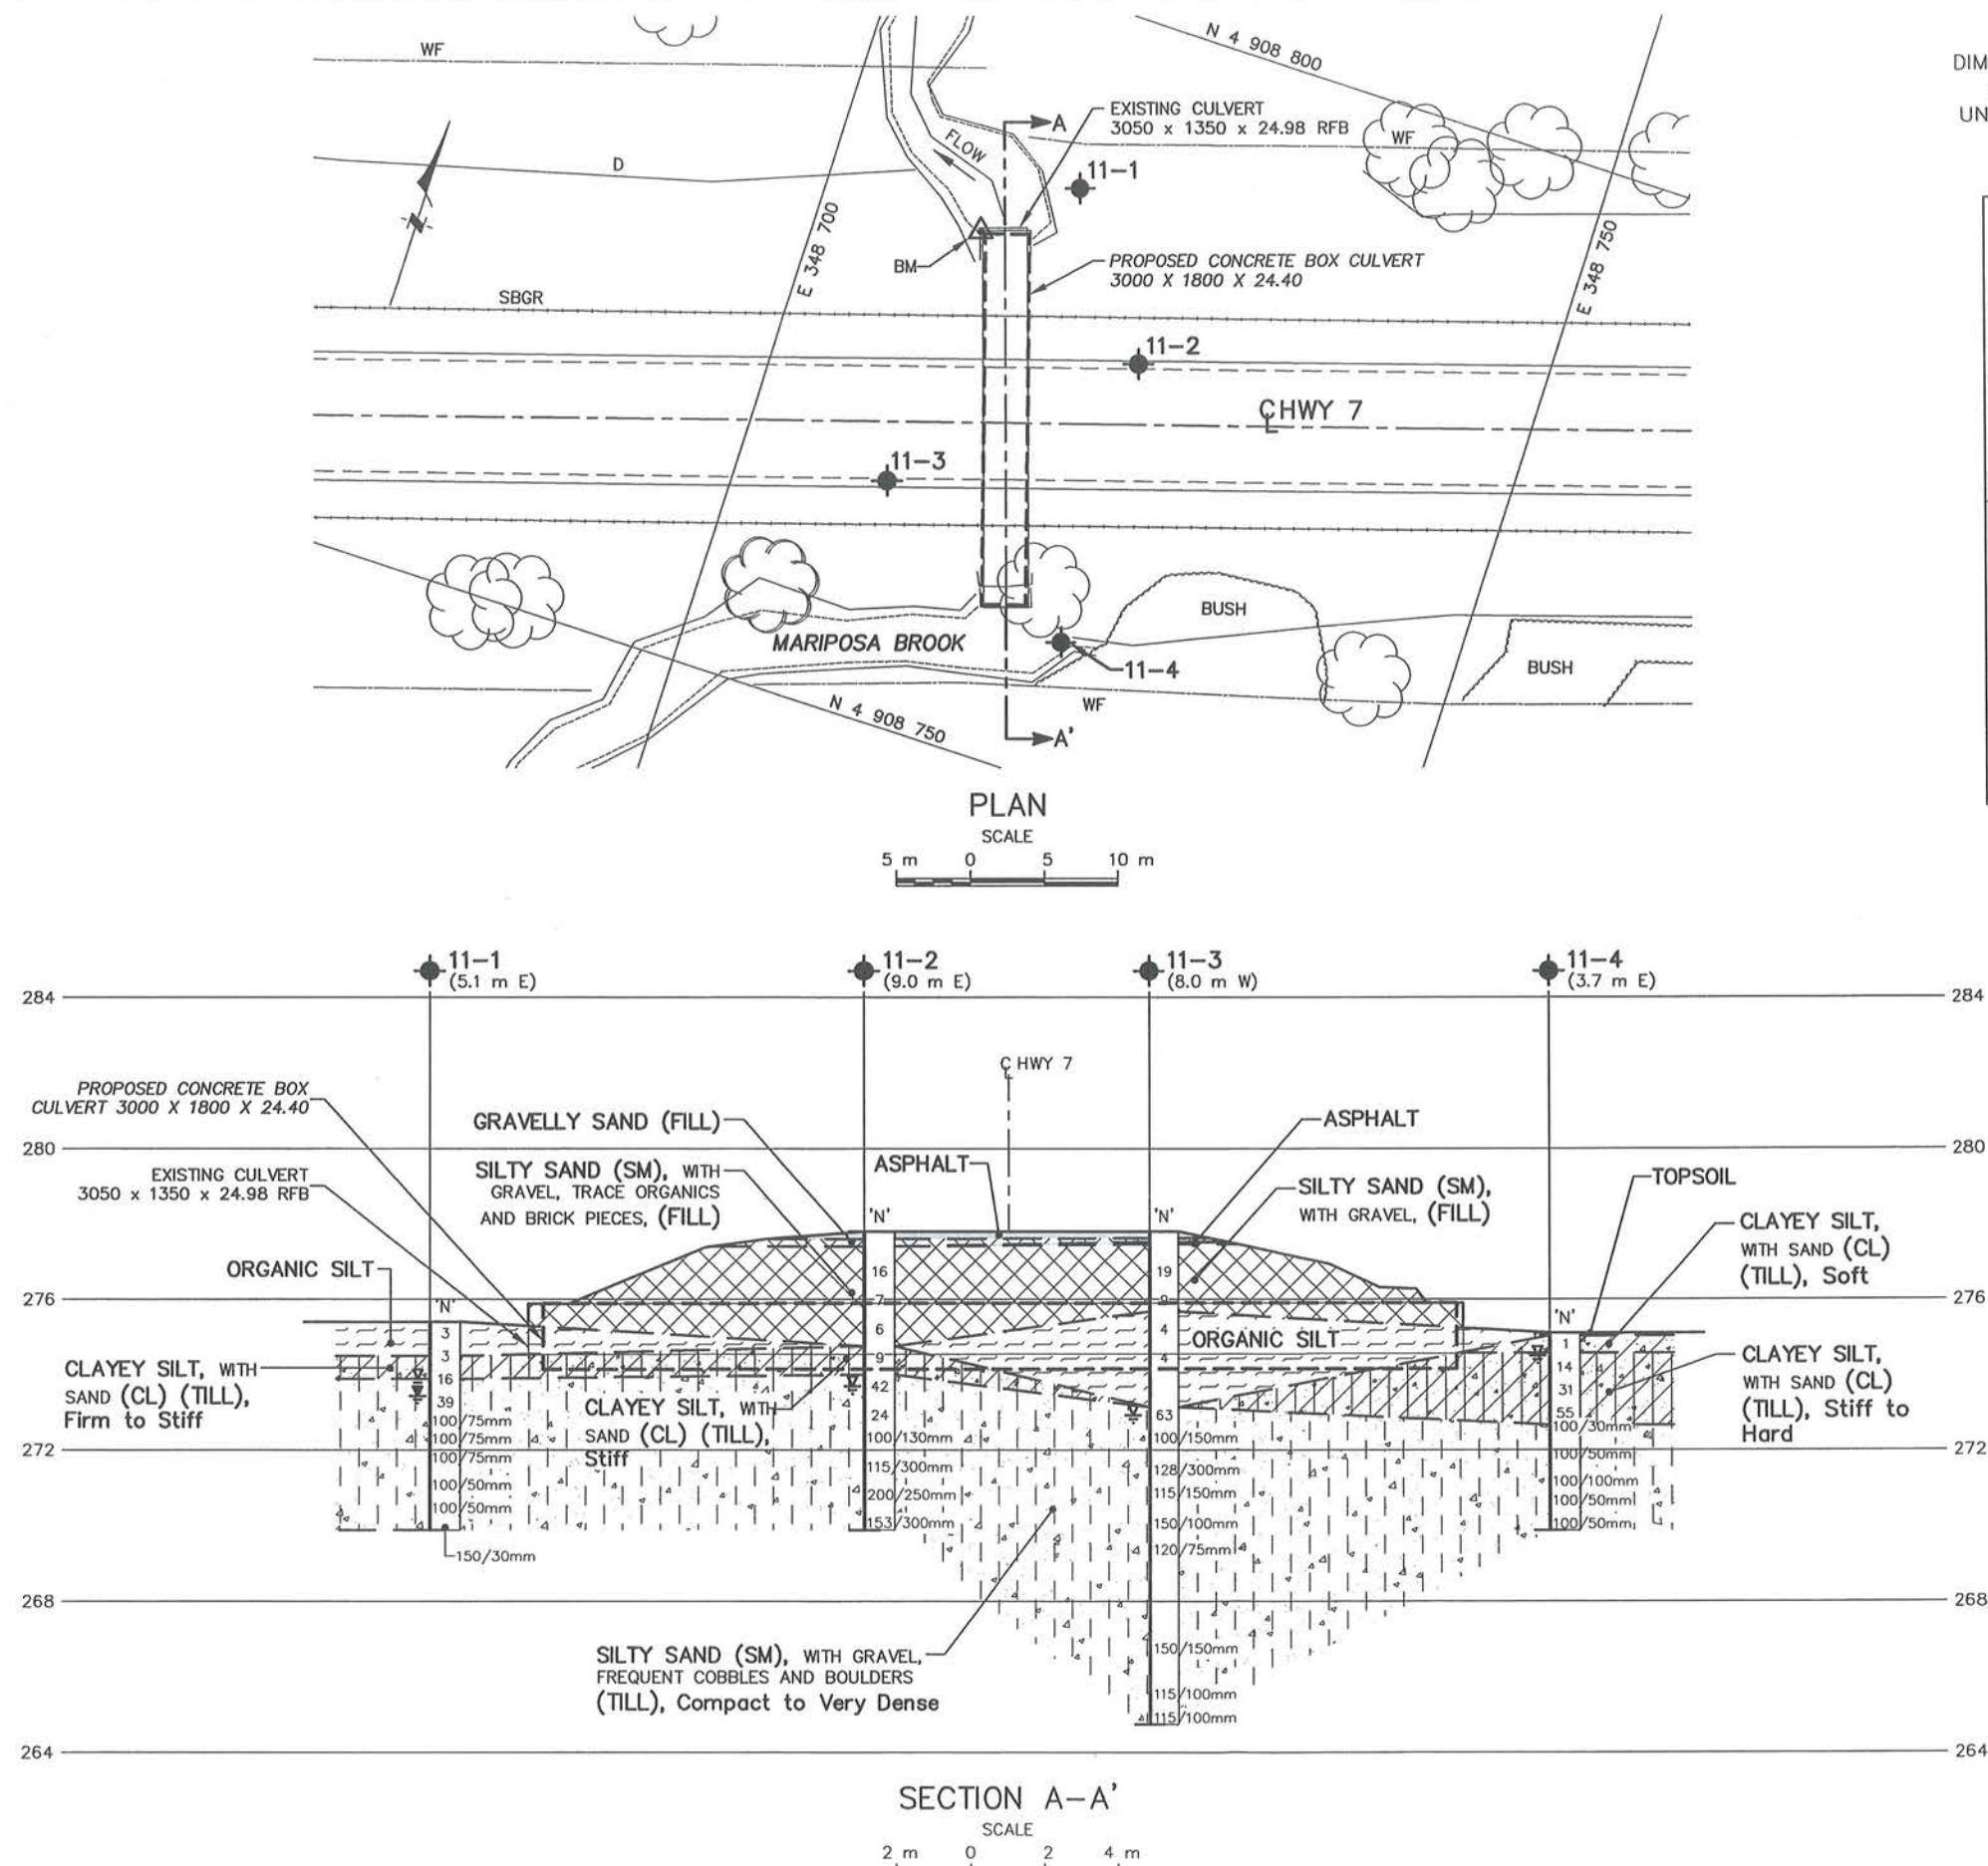
Drawing No. 1 – Borehole Location Plan and Soil Strata

MARIPOSA BROOK CULVERT  
HIGHWAY 7  
BOREHOLE LOCATIONS & SOIL STRATA
