FOUNDATION INVESTIGATION REPORT

Unstable Slope Conditions

Hwy. No. 3 at Canboro

W.J. 67-F-69 -- W.P. 803-66

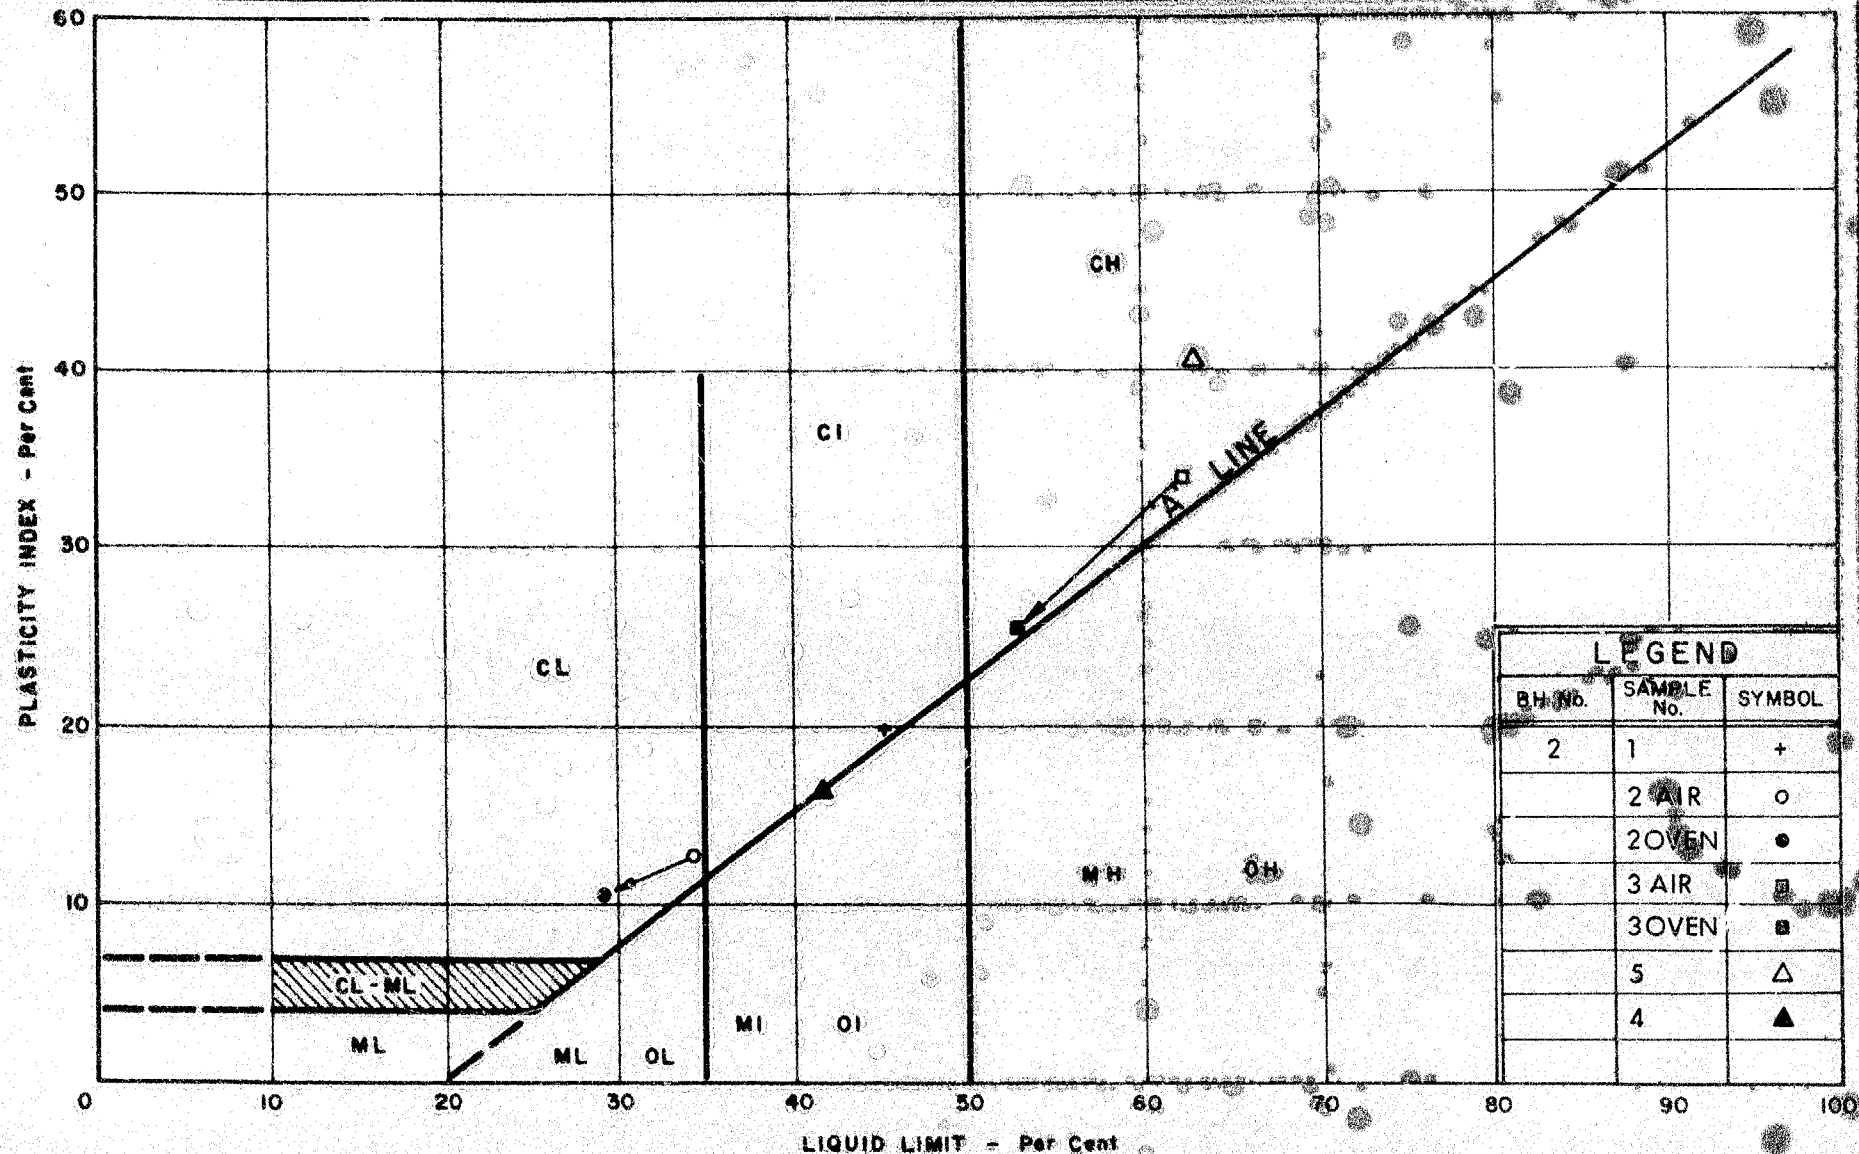
PLASTICITY CHART

LEGEND		
BH No.	SAMPLE No.	SYMBOL
2	1	+
	2 AIR	o
	2 OVEN	•
	3 AIR	□
	3 OVEN	■
	5	△
	4	▲

This layer consists of soft to firm organic silt and is approximately $1\frac{1}{2}$ to 2 feet thick. The layer follows the natural slope line, deepening towards the bottom of the slope. Its natural moisture content is about 27%, its liquid limit about 35%, and its plastic limit about 22%. After oven drying the organic material, the liquid limit is about 29% and the plastic limit about 19%. The colour of this material is black.

This deposit consists of very stiff to firm silty clay to clay. The upper 2 to 4 feet contains organic material. As well, the top 10 to 15 feet contains varved layers of silt. This tendency persists deeper but to a lesser degree. The natural moisture content of the layer ranges from 27% at the top to 40%, 25 ft. into the layer. The liquid limit ranges from 40% to 63%, and the plastic limit from 22% to 32%. If the organic matter in the top 2 to 4 feet is removed by oven drying, the plastic limit falls about 9%.
