## **WINDSOR-ESSEX PARKWAY**

# **Subsurface Conditions Interpretation Report**

**Report Number:** 07-1130-207-0-R02 / 05-1140-003

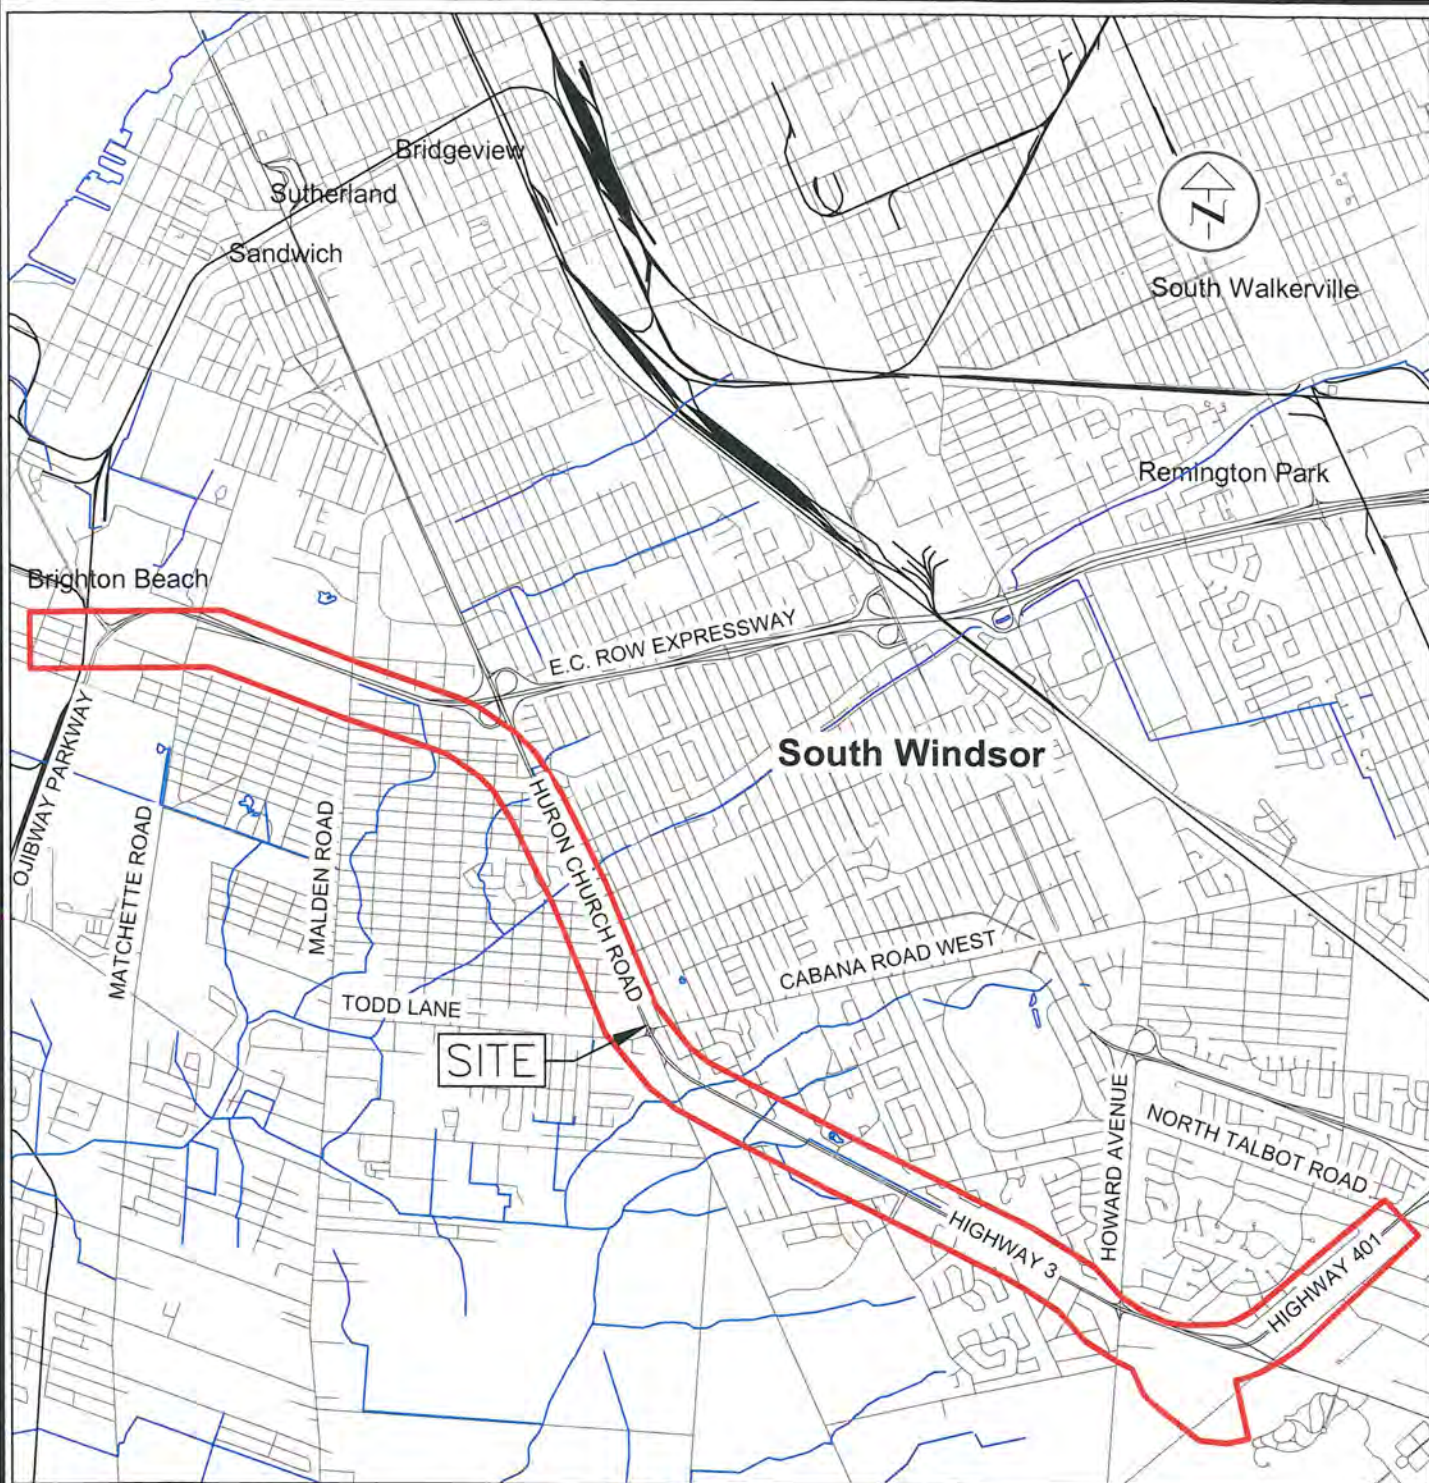
**FIGURE 1.1**

## PROJECT SUBSURFACE CONDITIONS INTERPRETATION REPORT WINDSOR-ESSEX PARKWAY WINDSOR, ONTARIO

This report presents an updated revision to and supersedes the June 2009 Subsurface Conditions Baseline Report for the Windsor-Essex Parkway from North Talbot Road to Ojibway Parkway in Windsor, Ontario. The area of the site is illustrated on Figure 1.1. This report consolidates and summarizes the results of geotechnical explorations and testing carried out on behalf of the Ministry of Transportation, Ontario.

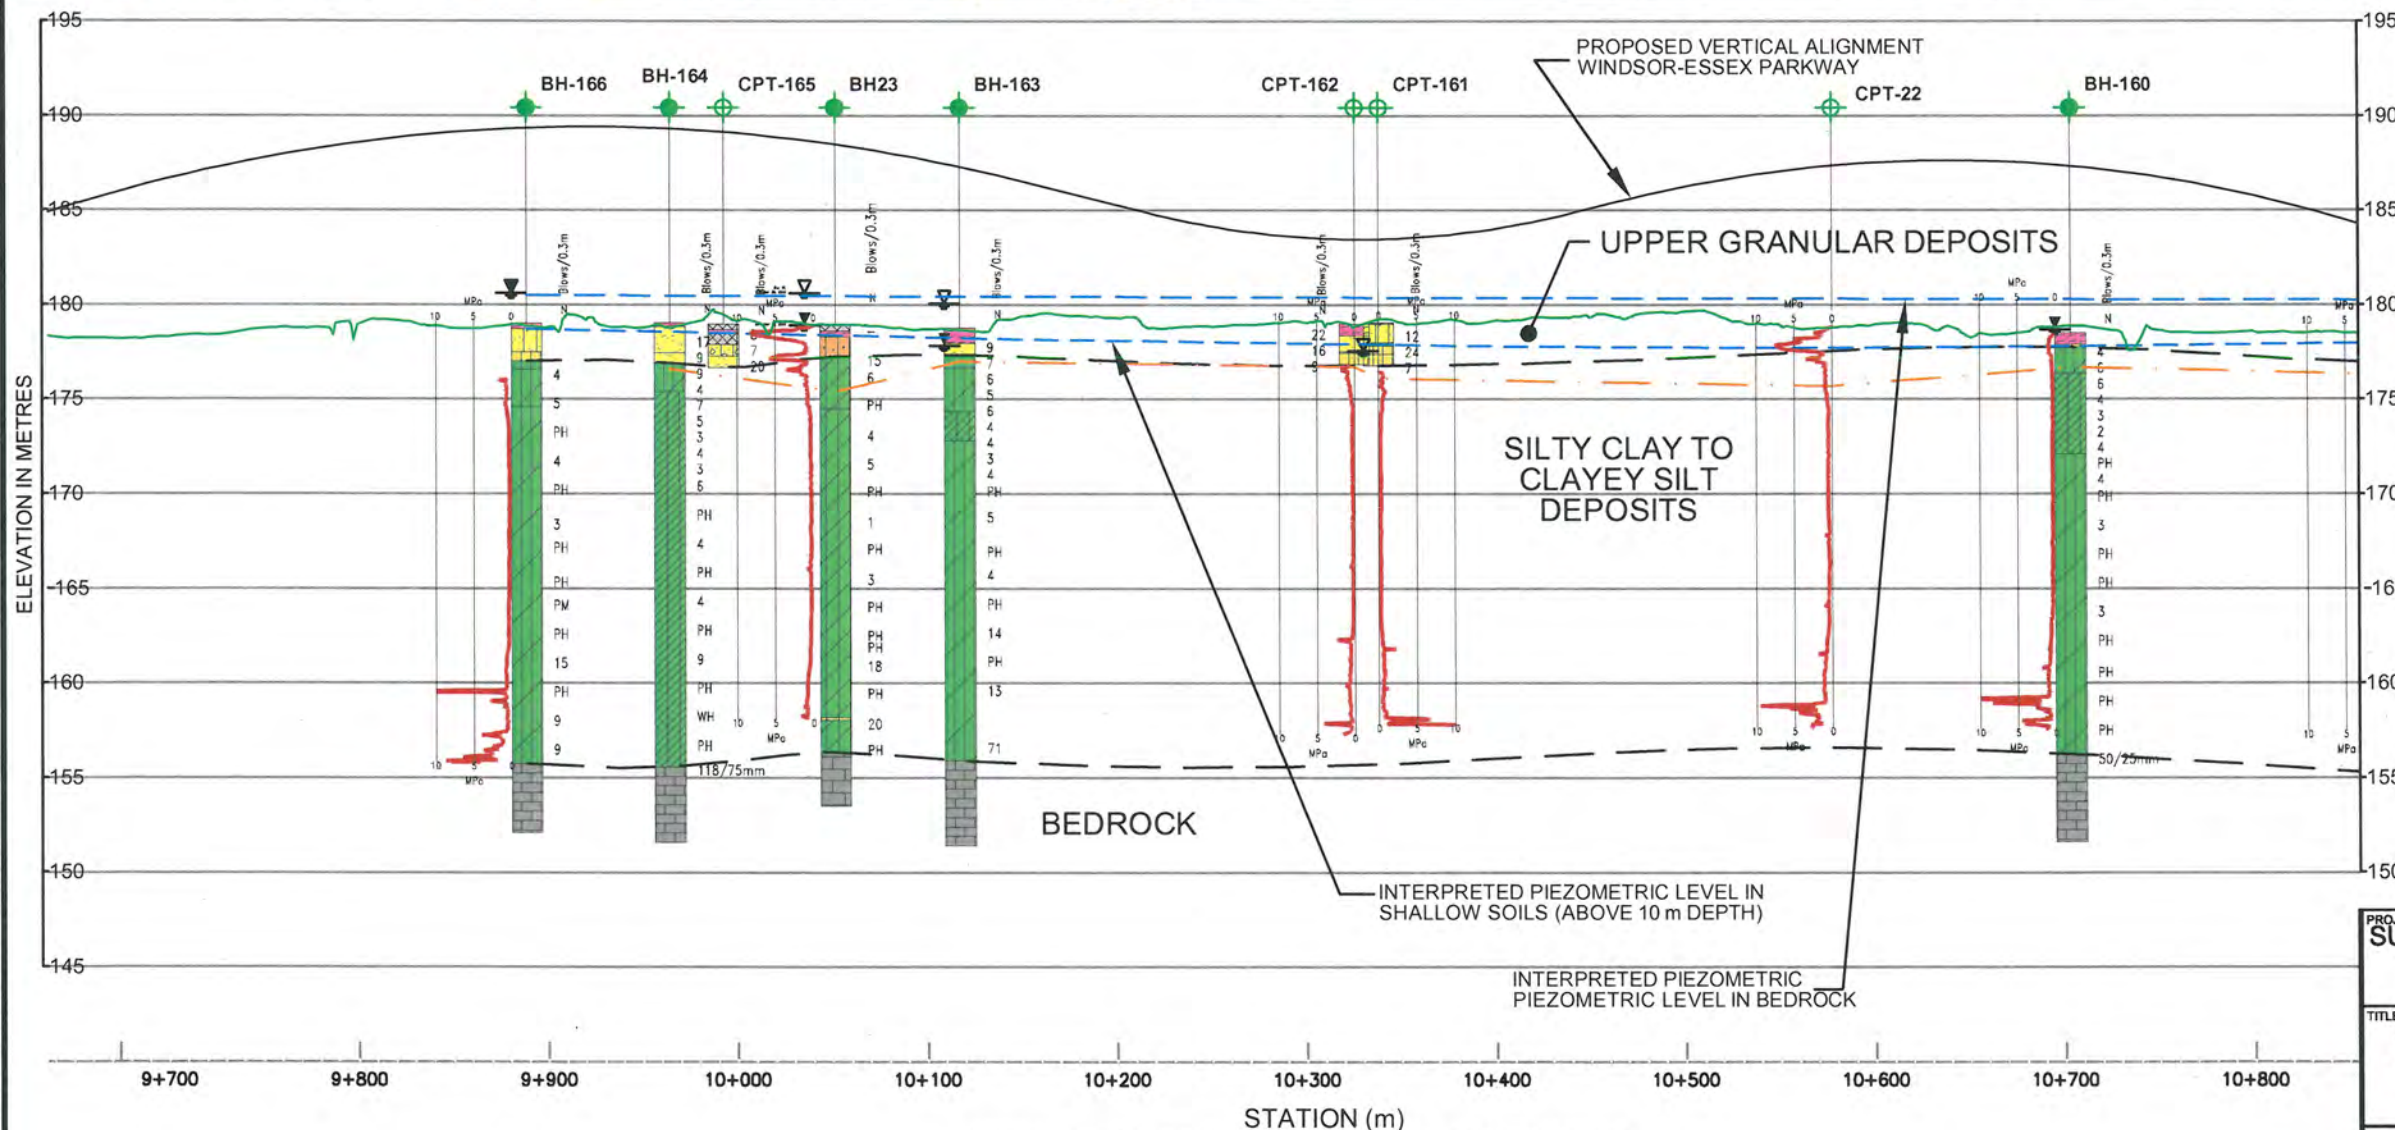
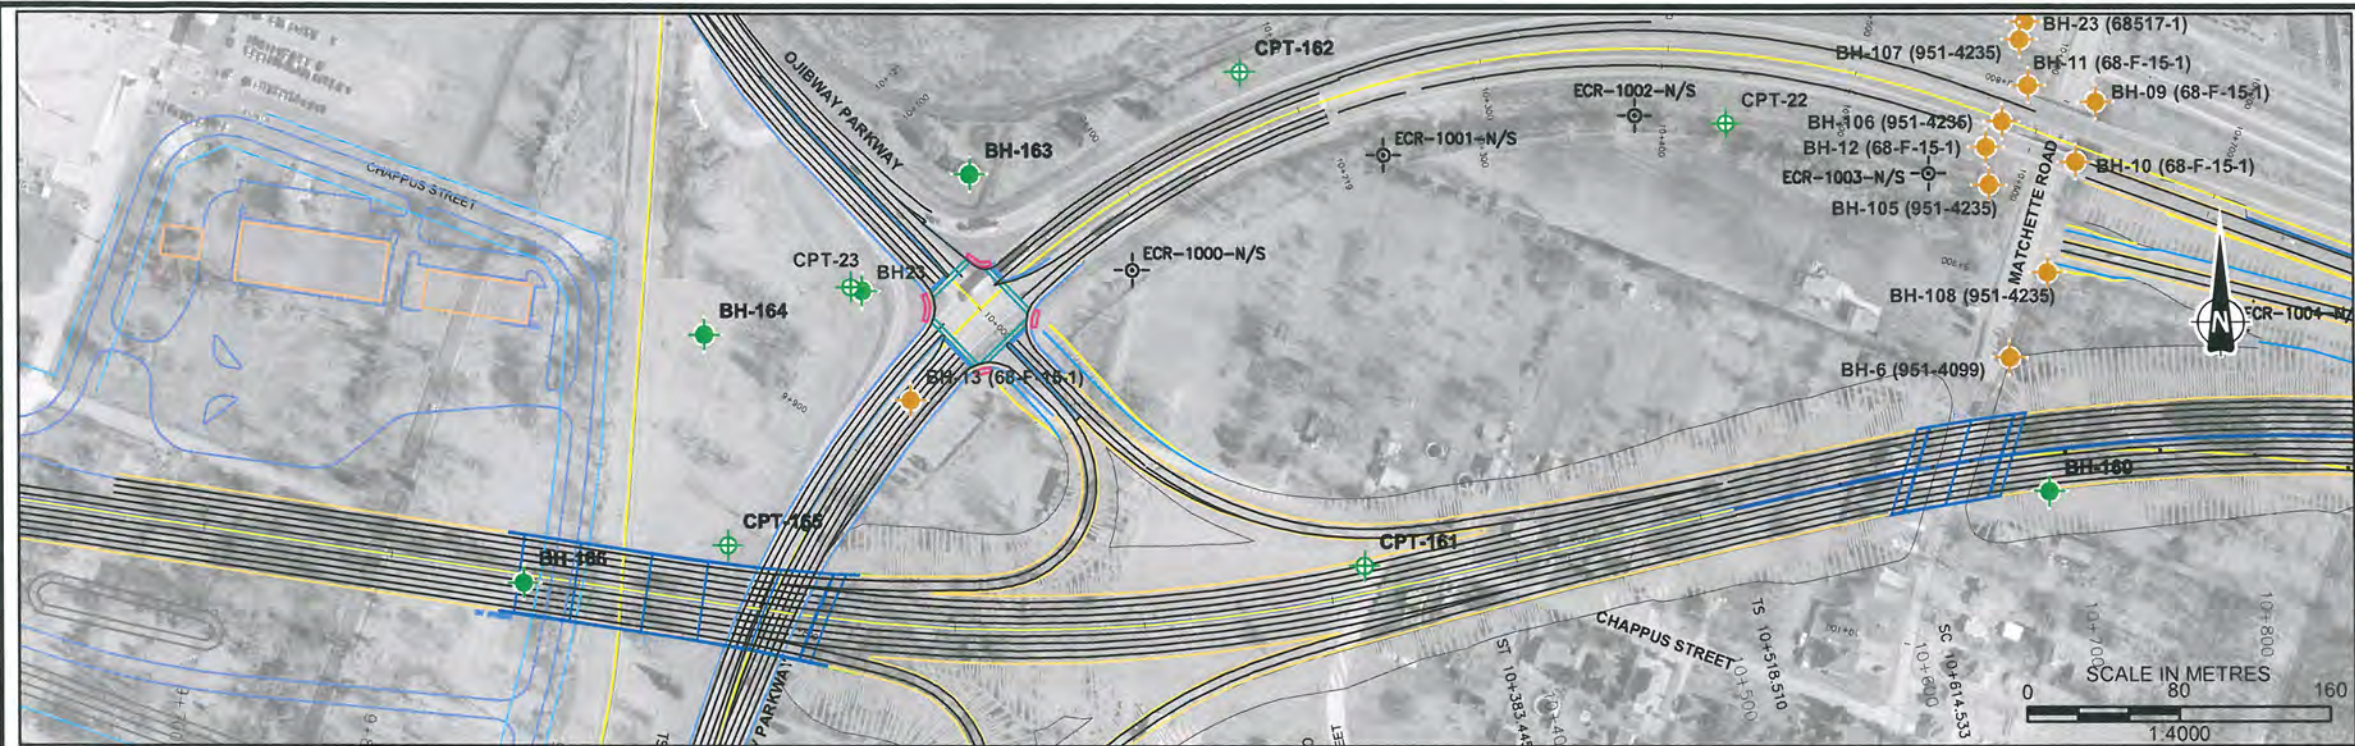
PROJECT No.			FILE No.		
07-1130207-0			0711302070-R02051		
CADD	JDR/WDF	Dec. 02/09	SCALE	AS SHOWN	REV. 1
CHECK	SSS	Dec/09	5.1A

## TITLE INTERPRETED STRATIGRAPHIC PROFILE STN 9+800 TO 10+800

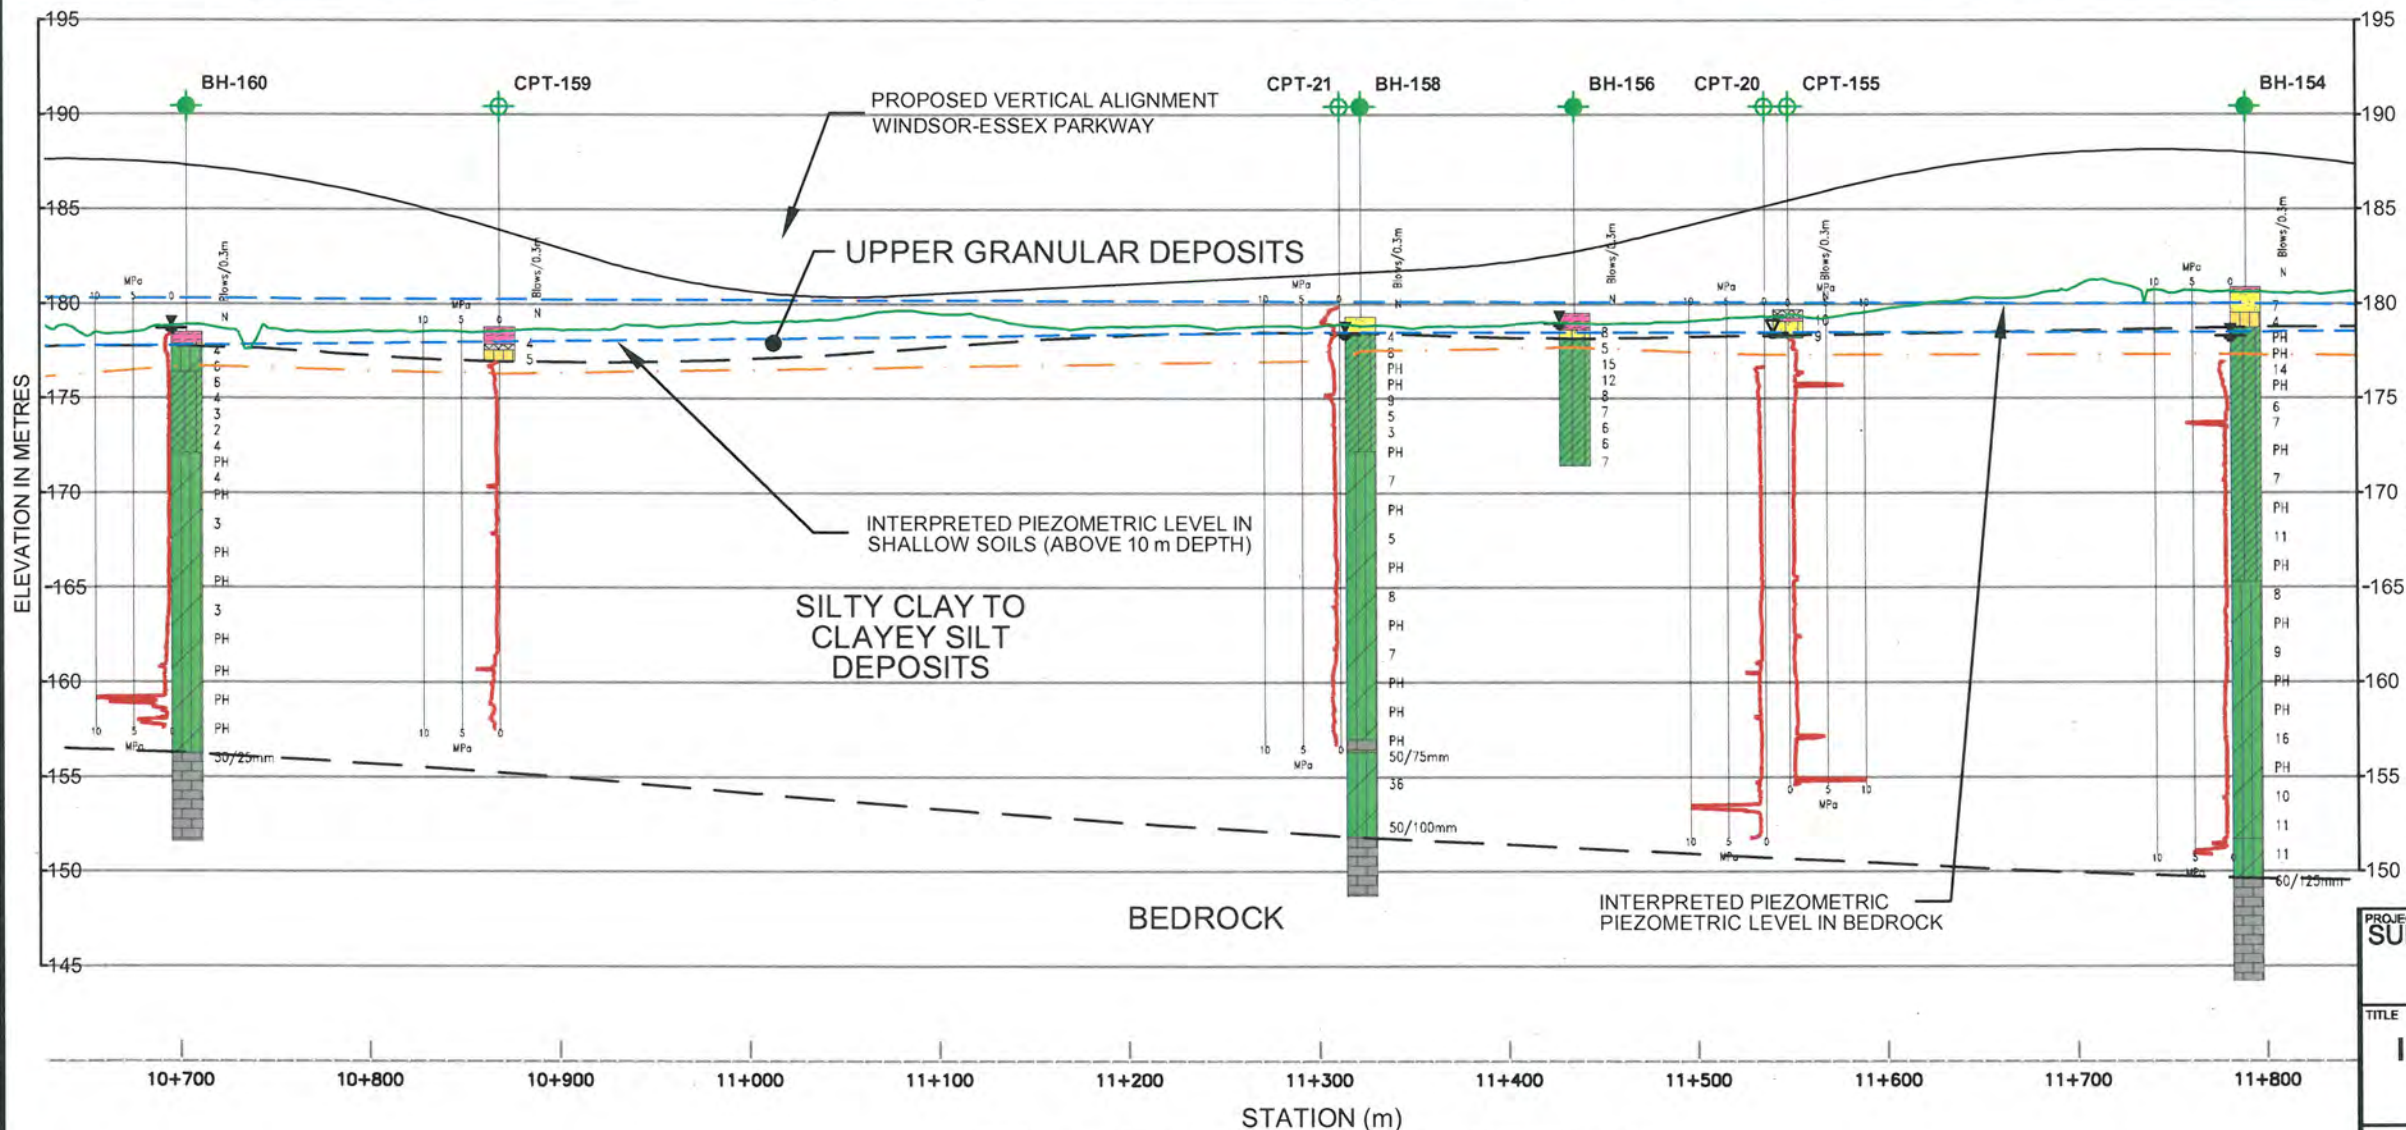
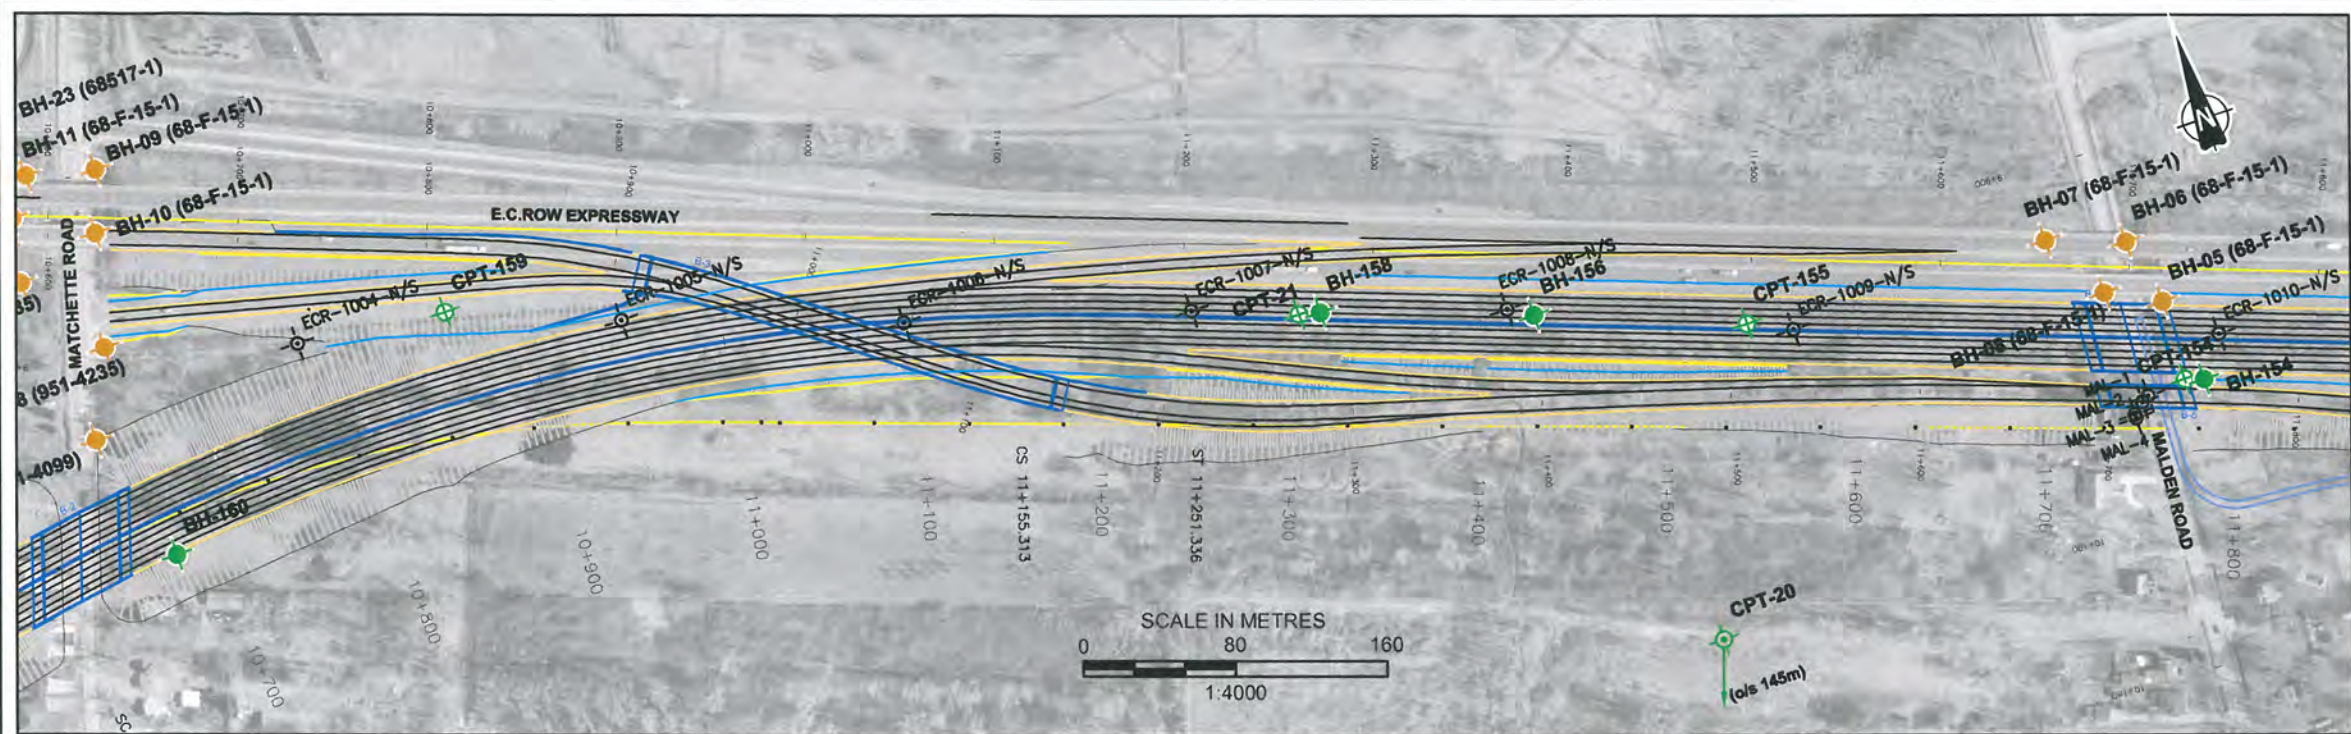
<b>PROJECT</b> SUBSURFACE CONDITIONS INTERPRETATION REPORT WINDSOR - ESSEX PARKWAY WINDSOR, ONTARIO			
<b>TITLE</b> INTERPRETED STRATIGRAPHIC PROFILE STN 10+800 TO 11+800			
<b>PROJECT No.</b> 07-1130-207-0		<b>FILE No.</b> 0711302070-R02051	
<b>CADD</b> JDR/WDF	<b>Dec. 02/09</b>	<b>SCALE</b> AS SHOWN	<b>REV.</b> 1
<b>CHECK</b> S.J.E. R.L.P.		<b>5.1B</b>	
<b>Goldier Associates</b> LONDON, ONTARIO

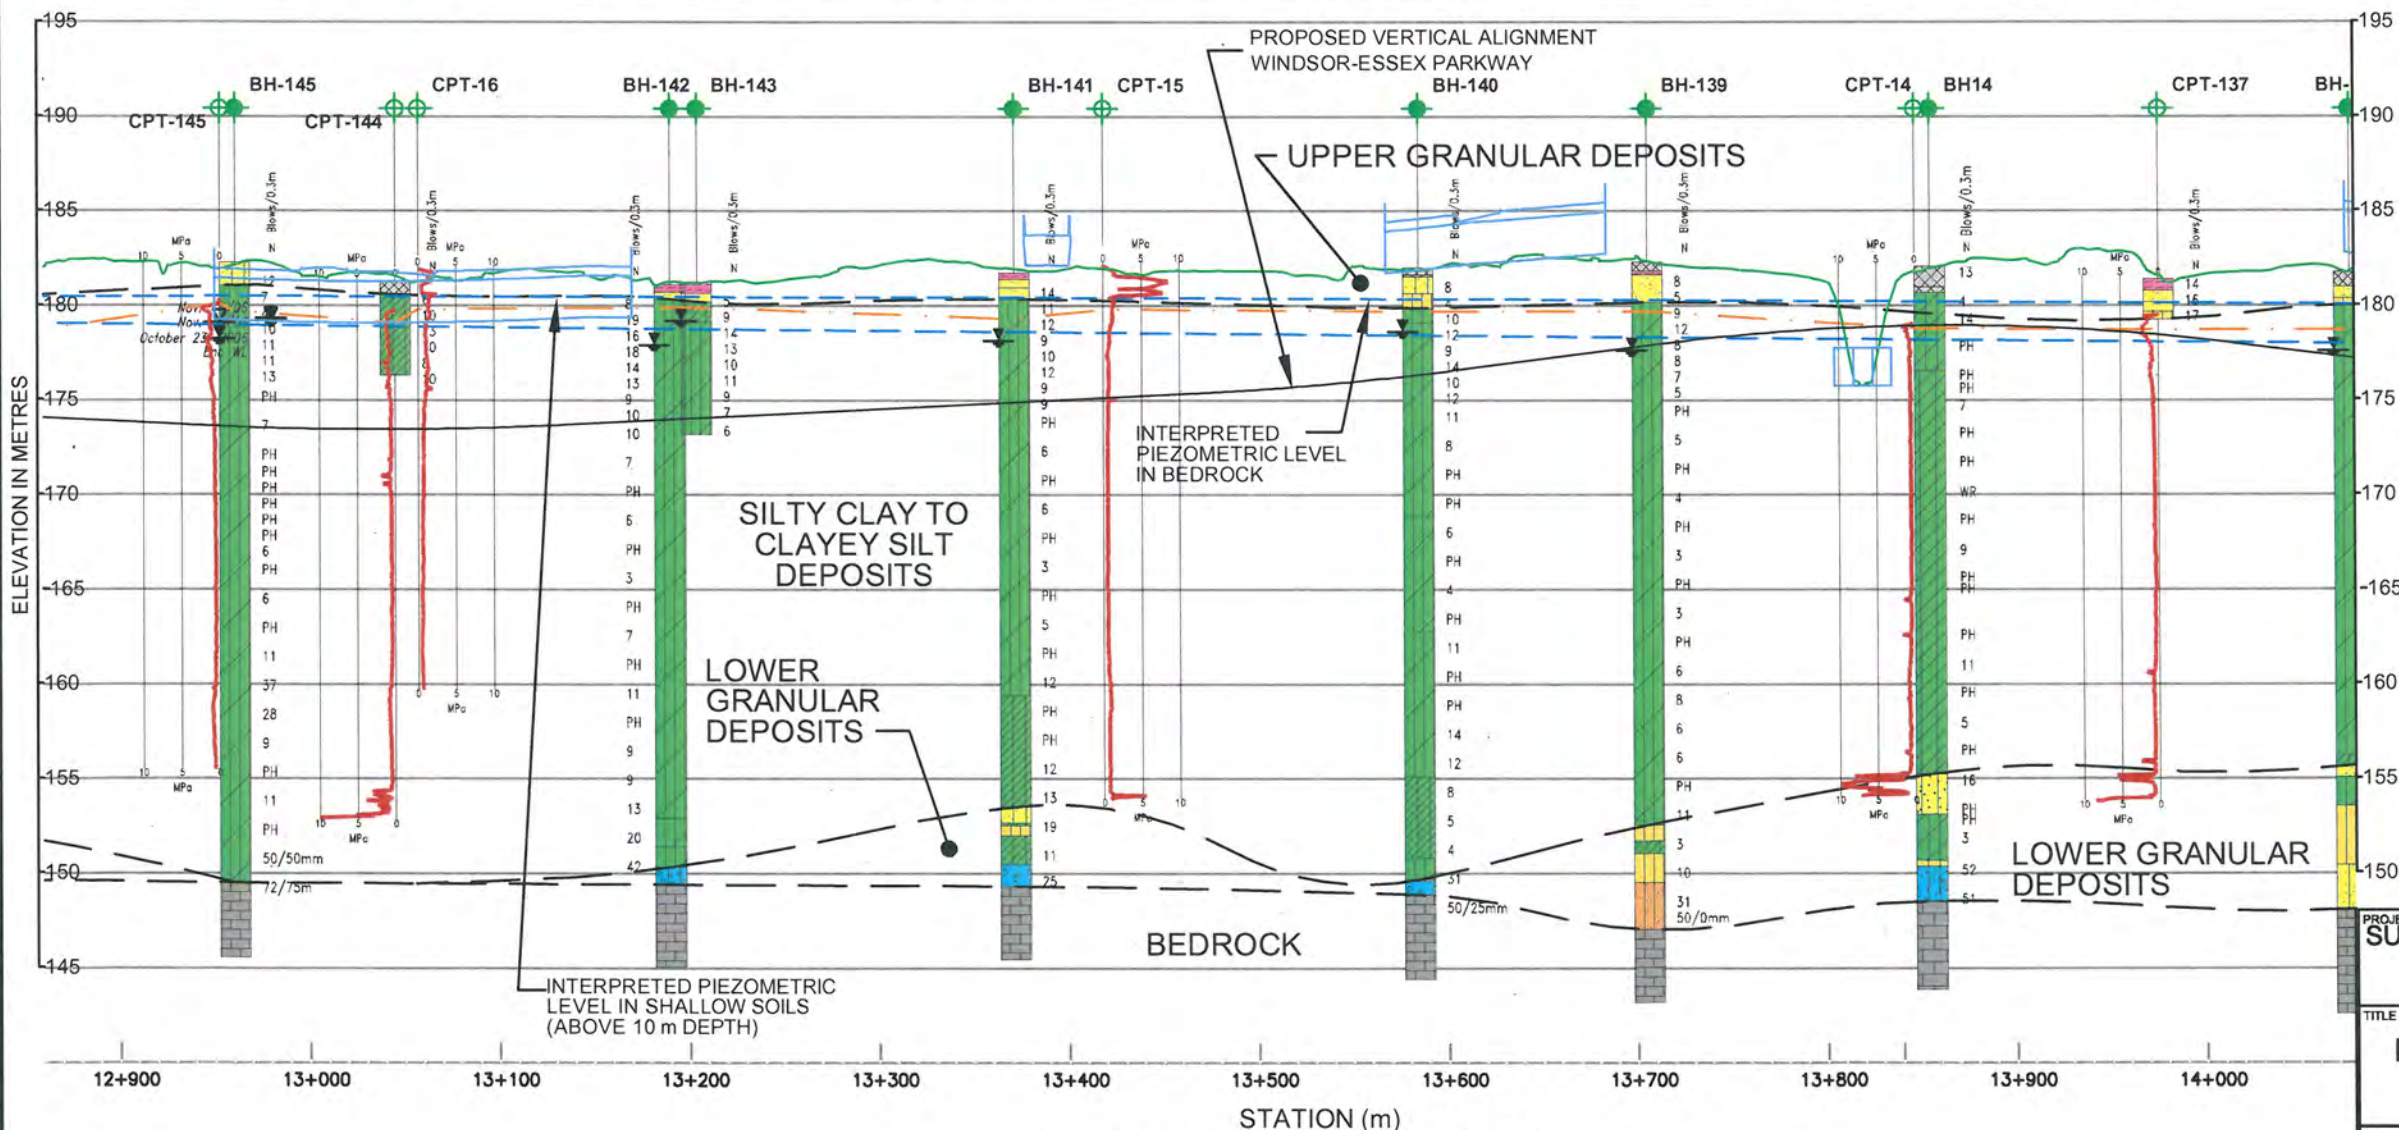
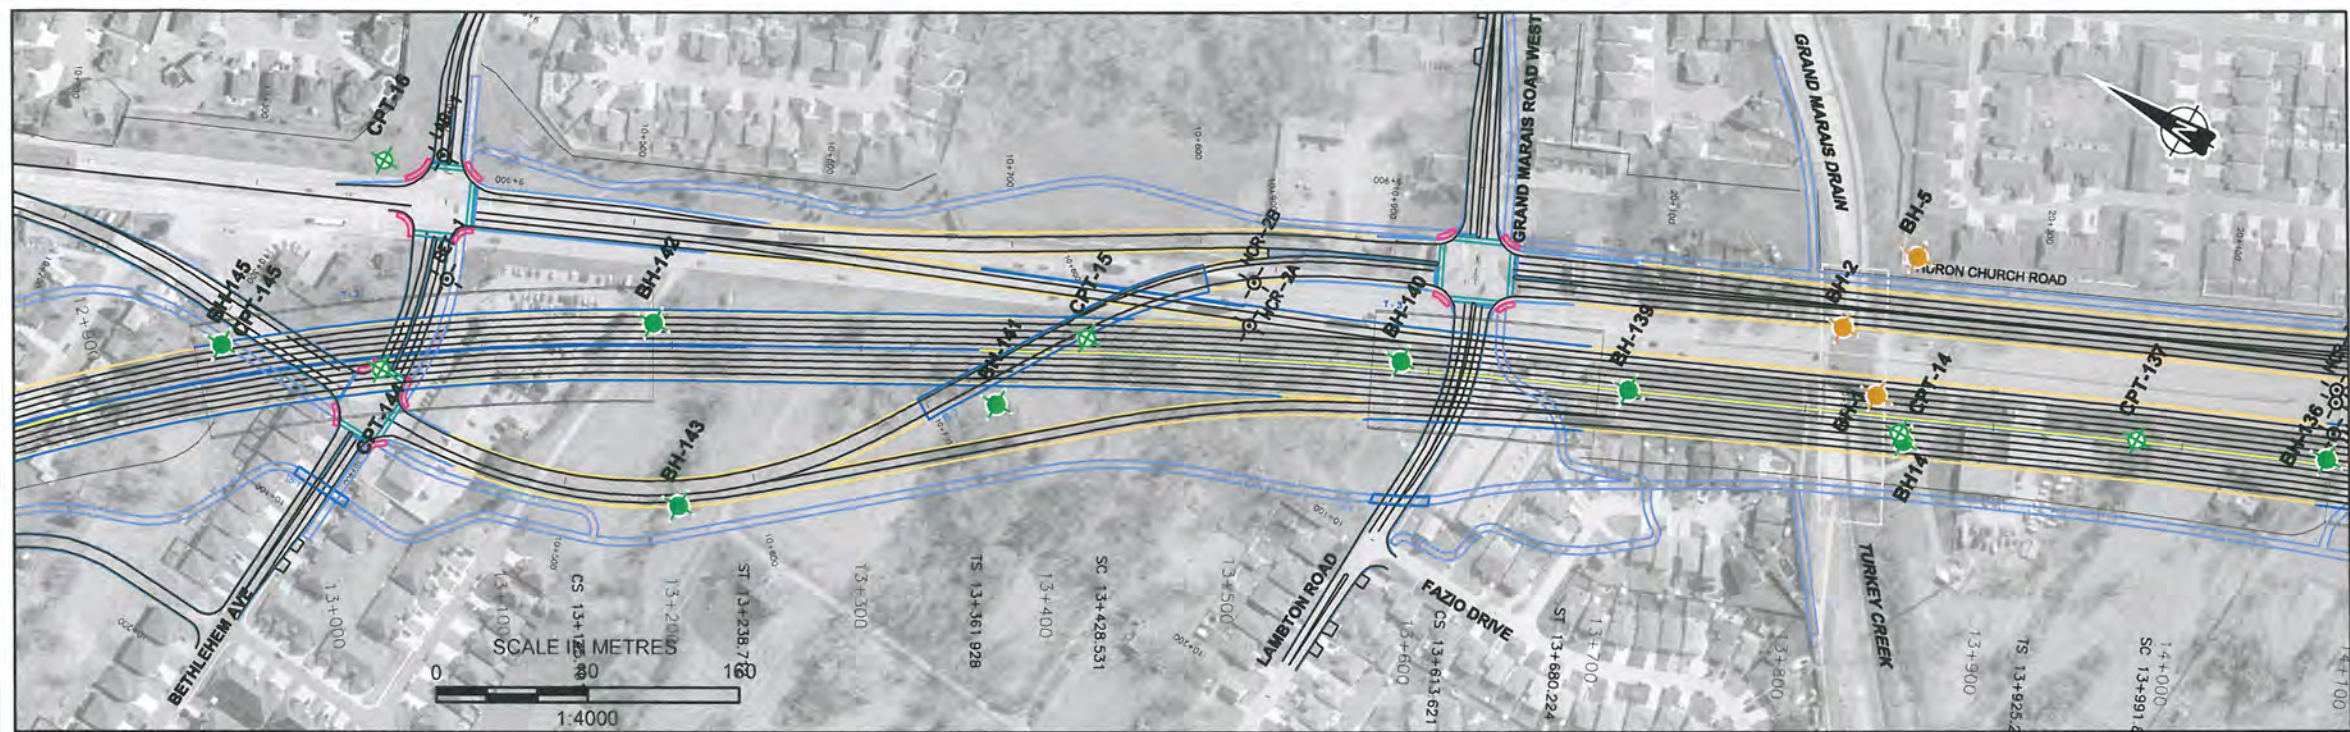
PROJECT No. 07-1130-207-0		FILE No. 0711302070-R02051	
CADD	JDR/WDF	Dec. 02/99	SCALE AS SHOWN
CHECK	SSB	TRC/ky	REV. 1
Golder Associates LONDON, ONTARIO		5.1D

# INTERPRETED STRATIGRAPHIC PROFILE STN 12+900 TO 14+000

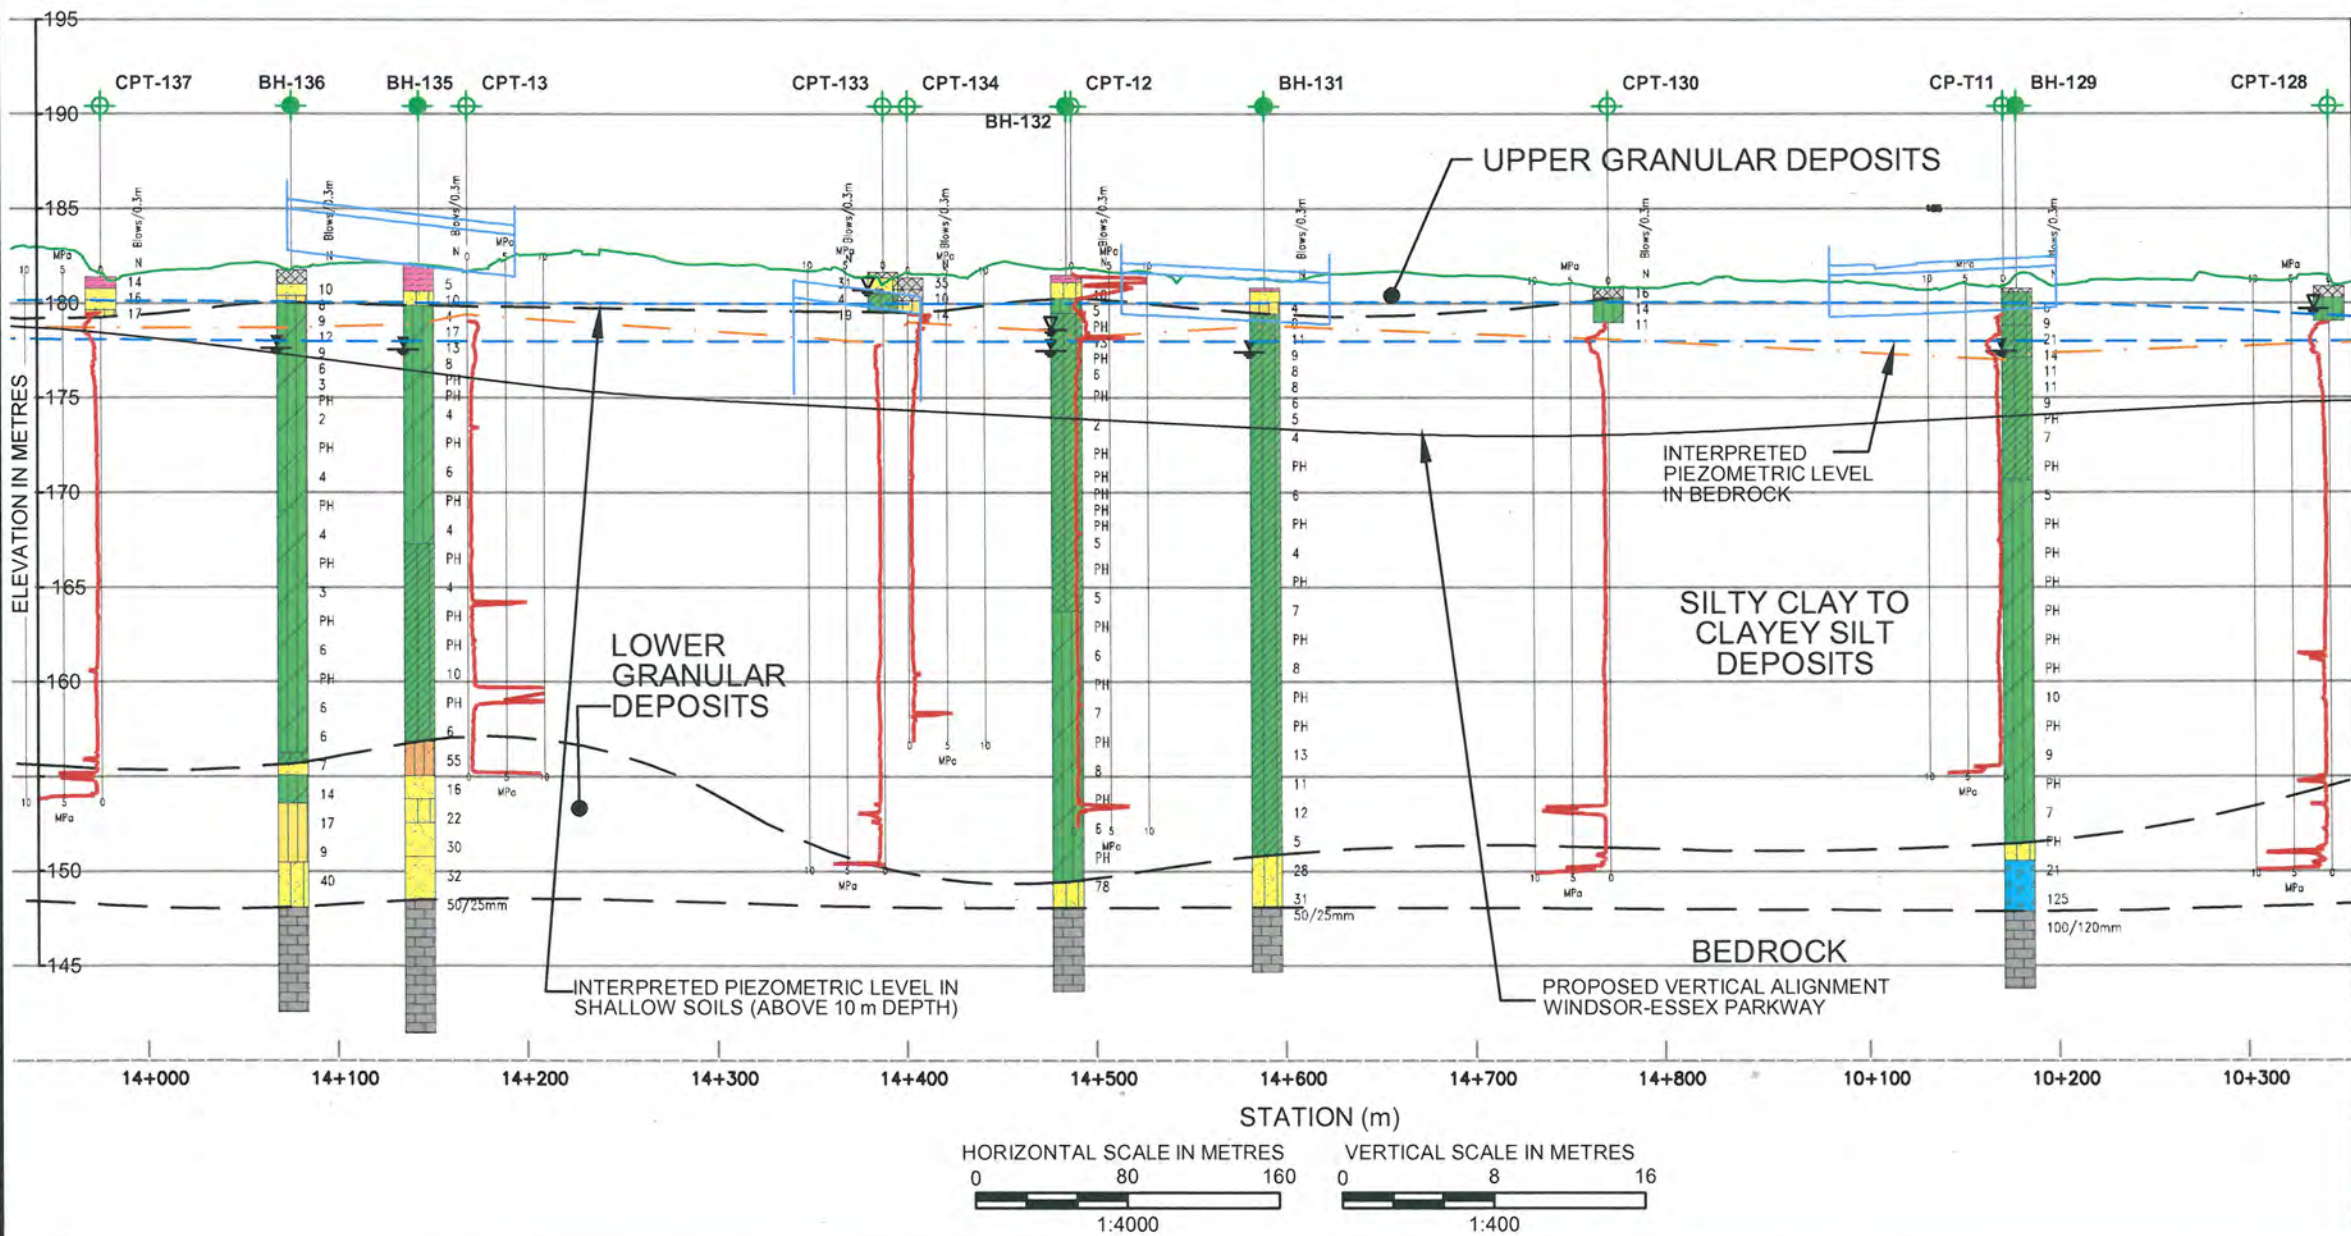
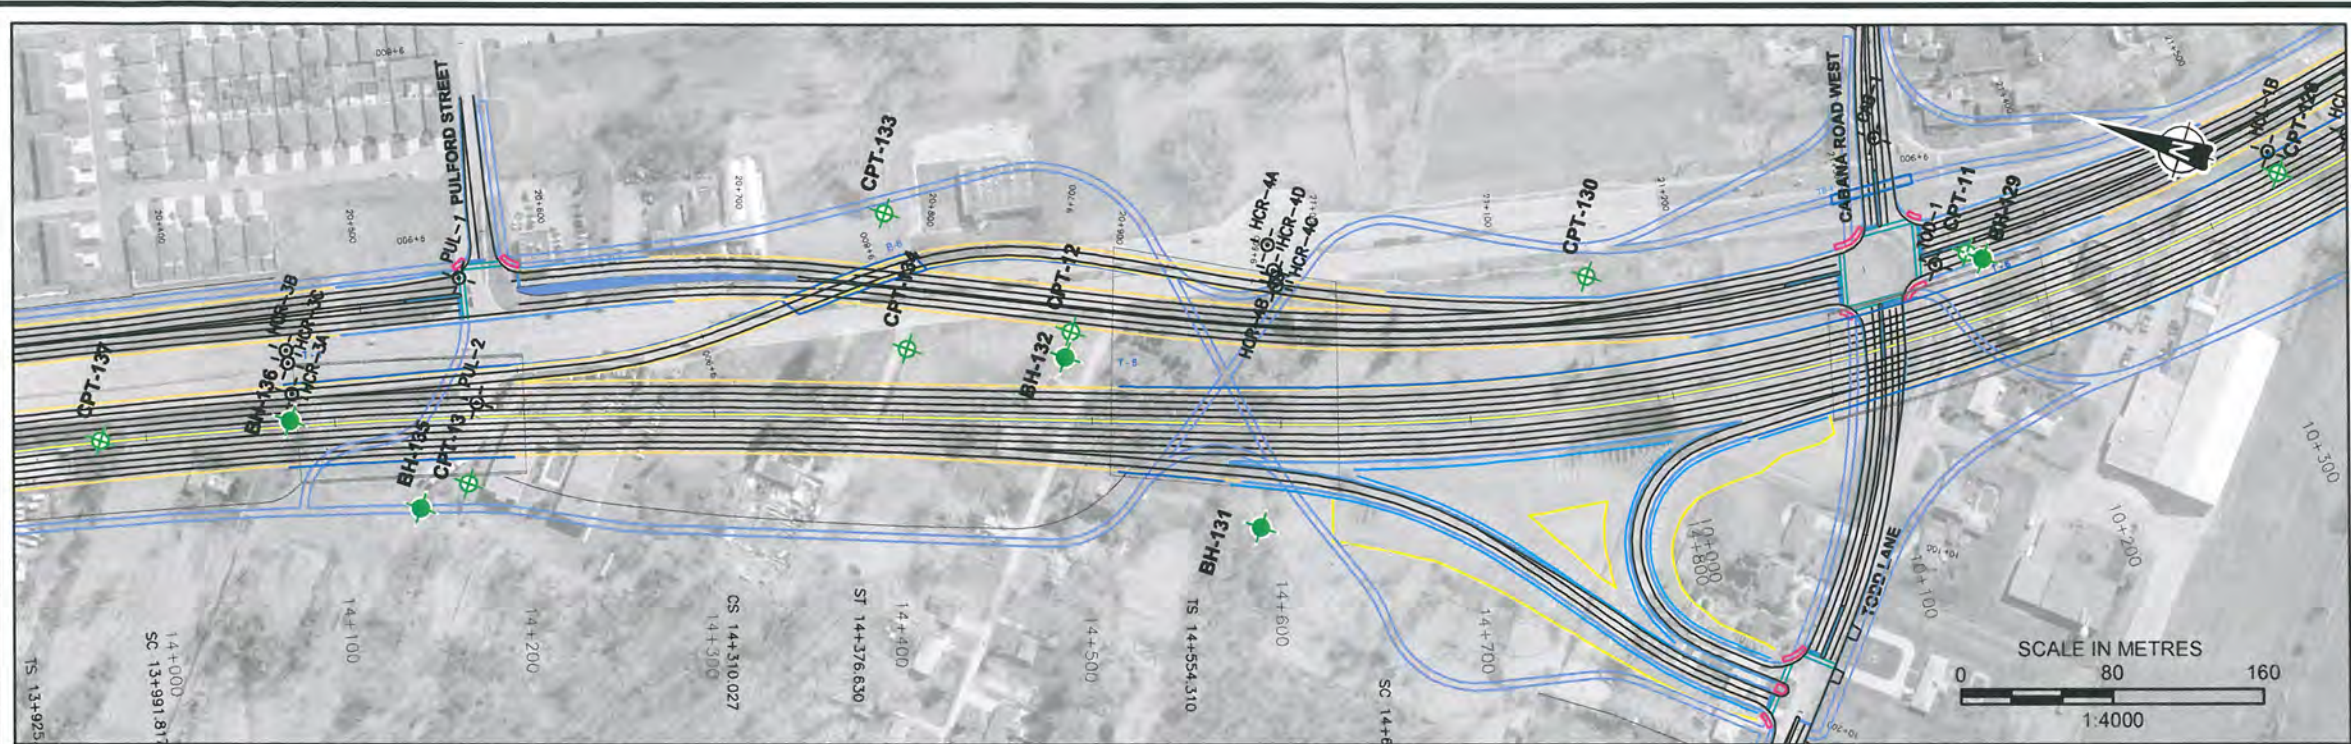
PROJECT No.	07-1130-207-0	FILE No.	0711302070-R02051
CADD	JDR/WDF	Dec. 02/09	SCALE AS SHOWN
CHECK	SJS	REV. 1	5.1E

**TITLE**  
INTERPRETED STRATIGRAPHIC PROFILE  
STN 14+000 TO 14+800  
STN 10+000 TO 10+300
