## **WINDSOR-ESSEX PARKWAY**

# **Subsurface Conditions Interpretation Report**

**Report Number:** 07-1130-207-0-R02 / 05-1140-003

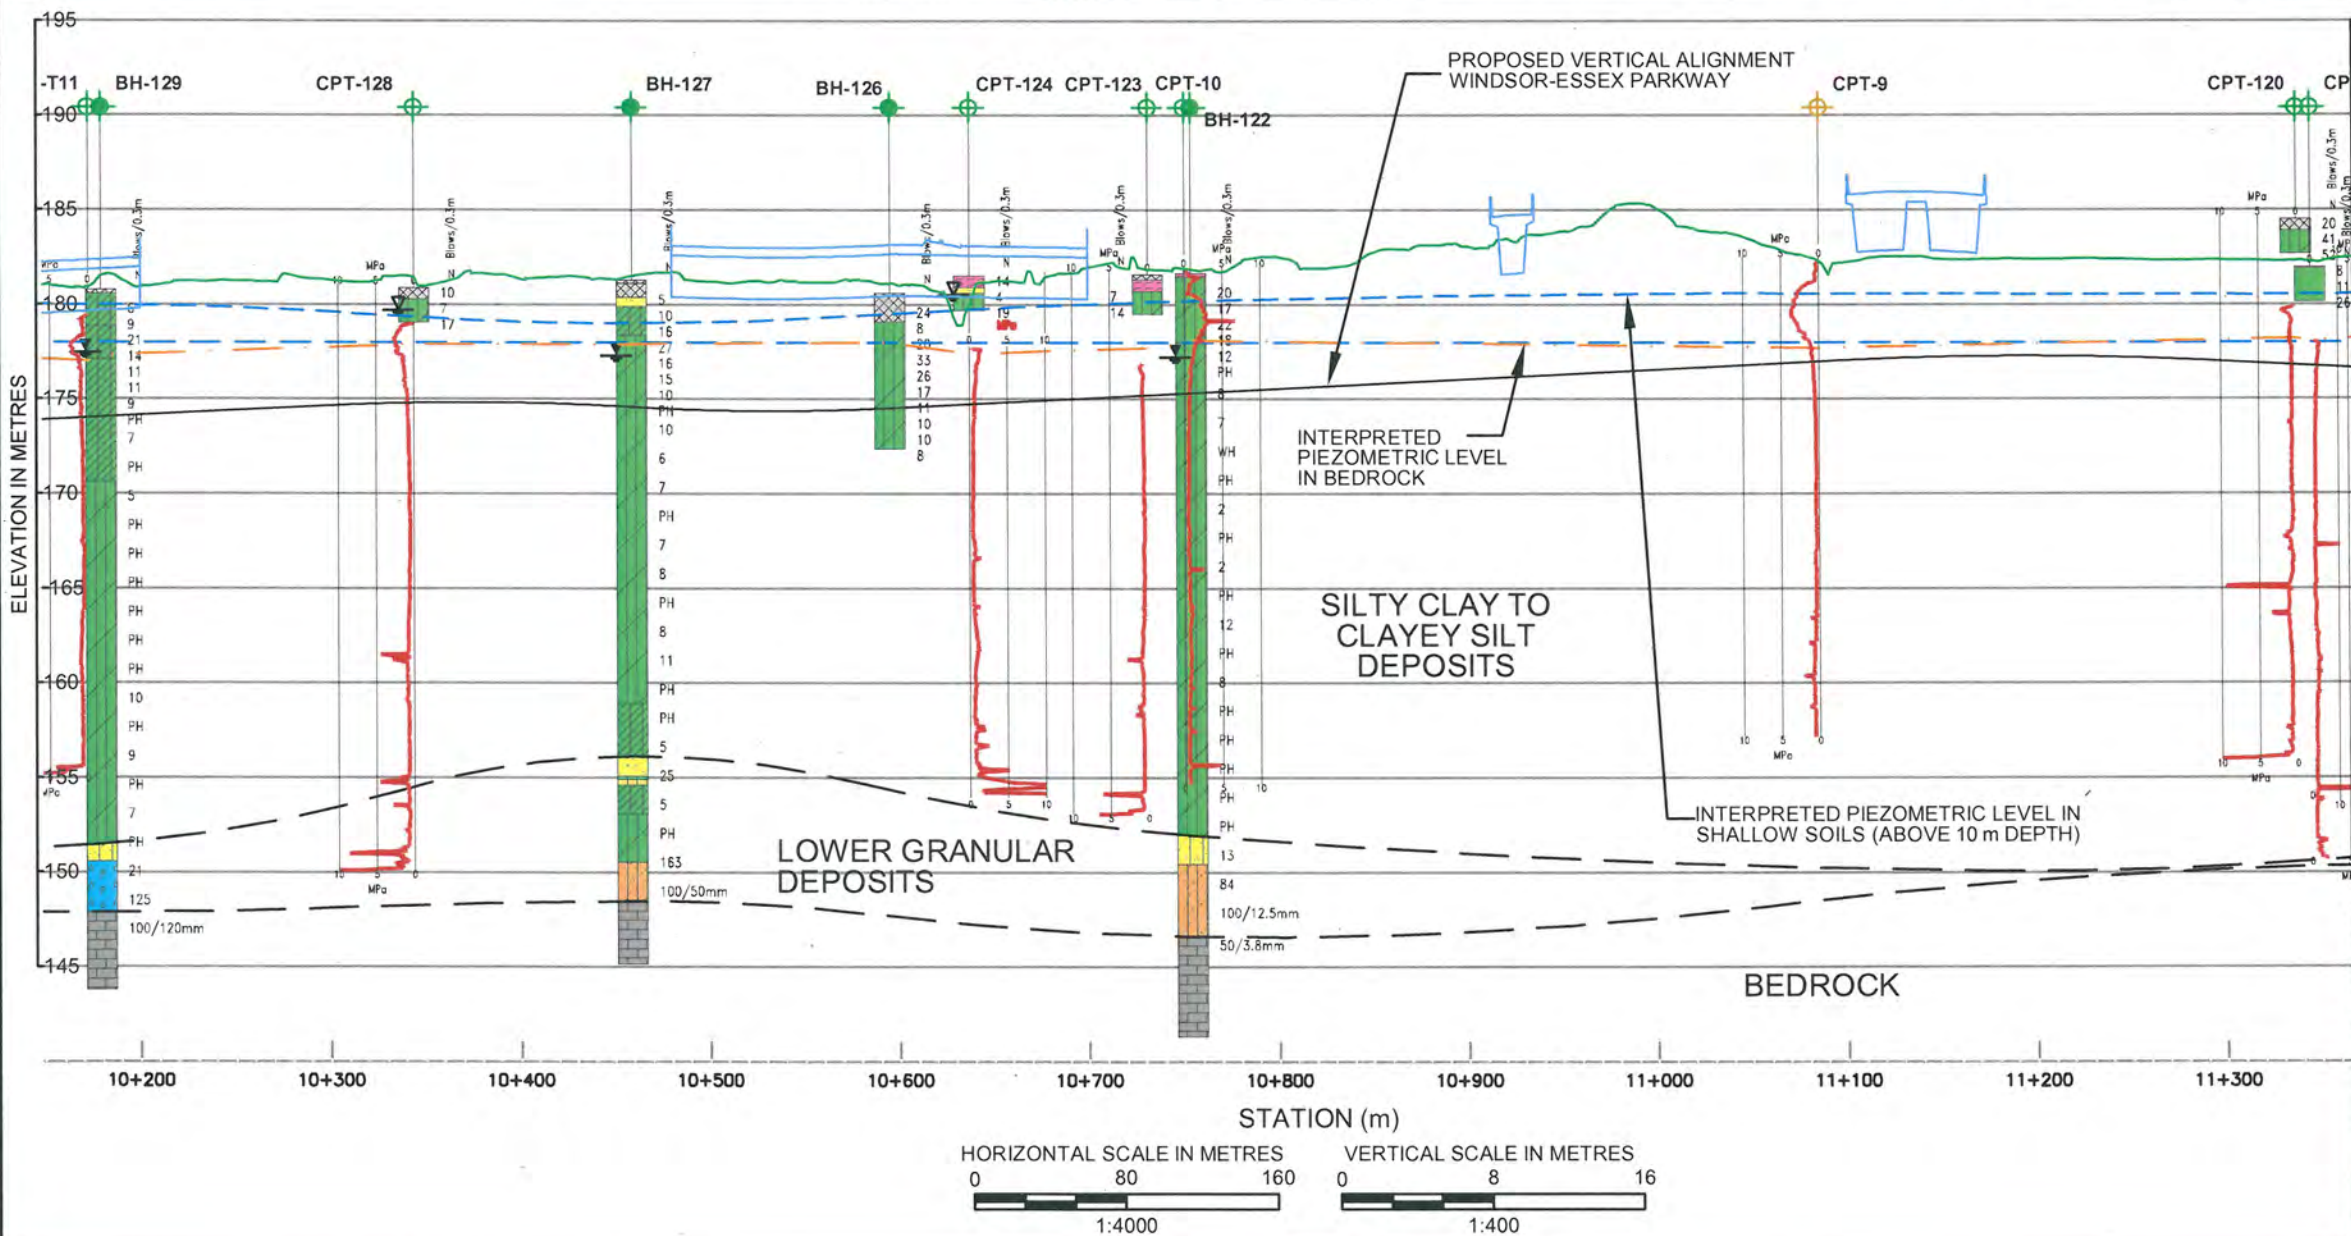
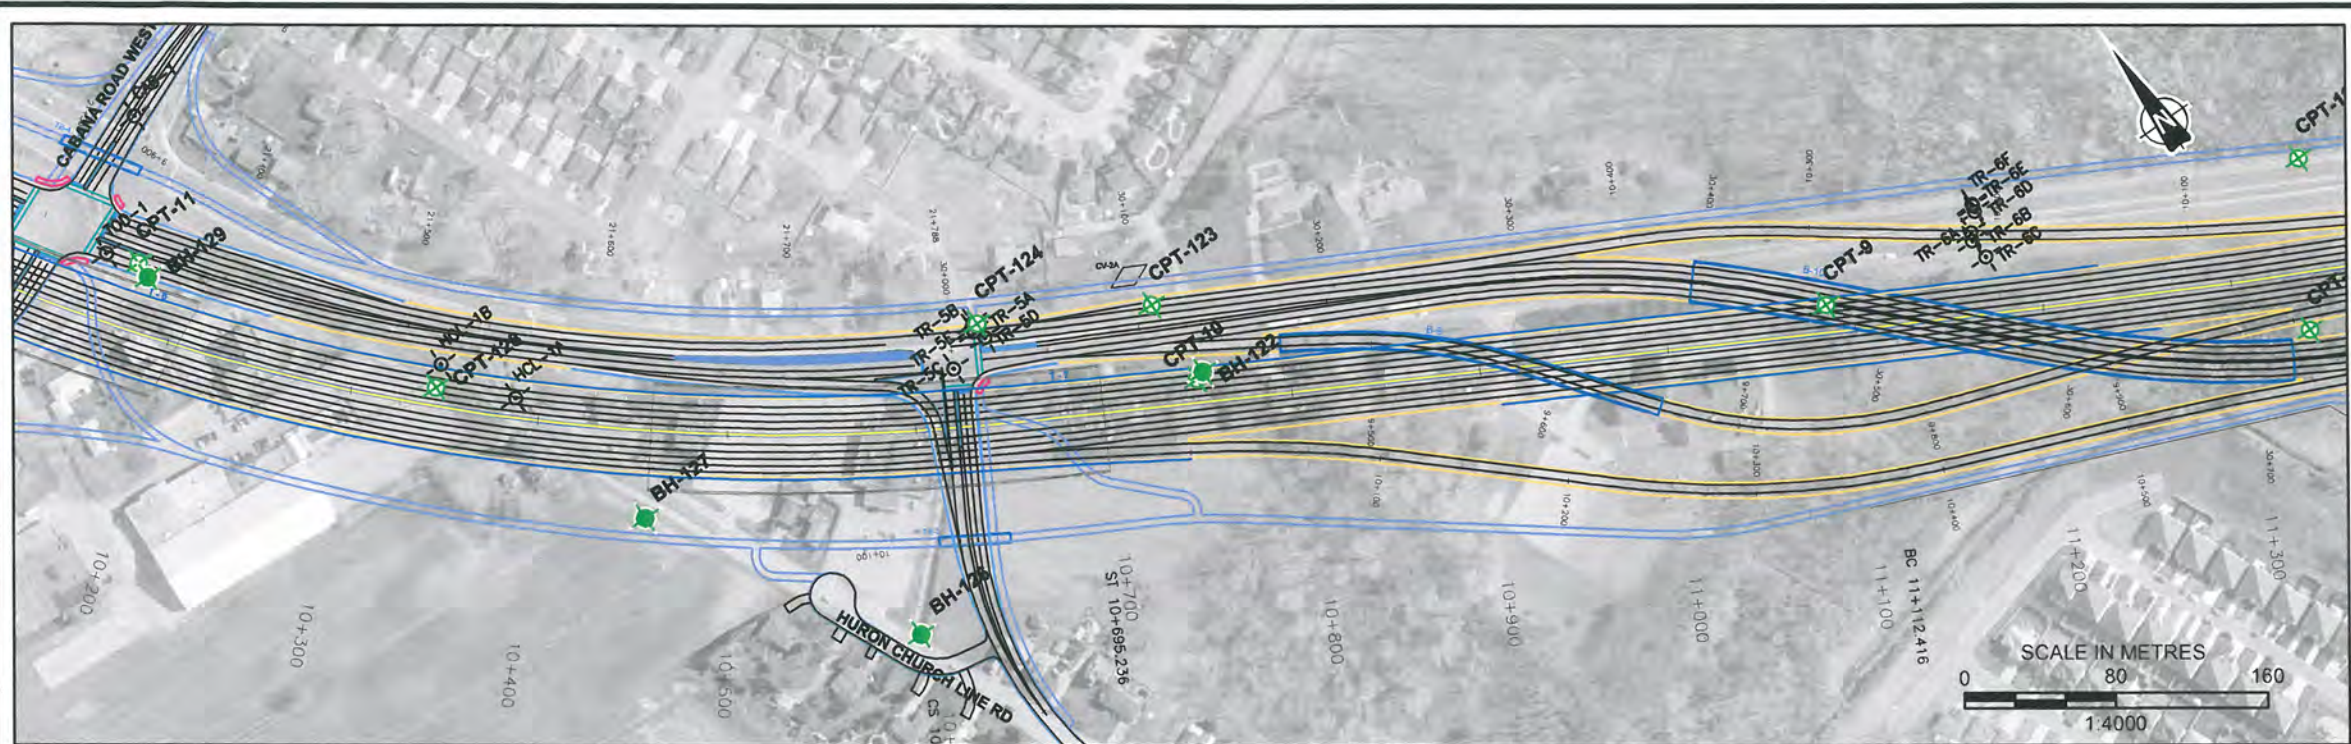
5.1F

**TITLE**  
INTERPRETED STRATIGRAPHIC PROFILE  
STN 10+300 TO 11+300

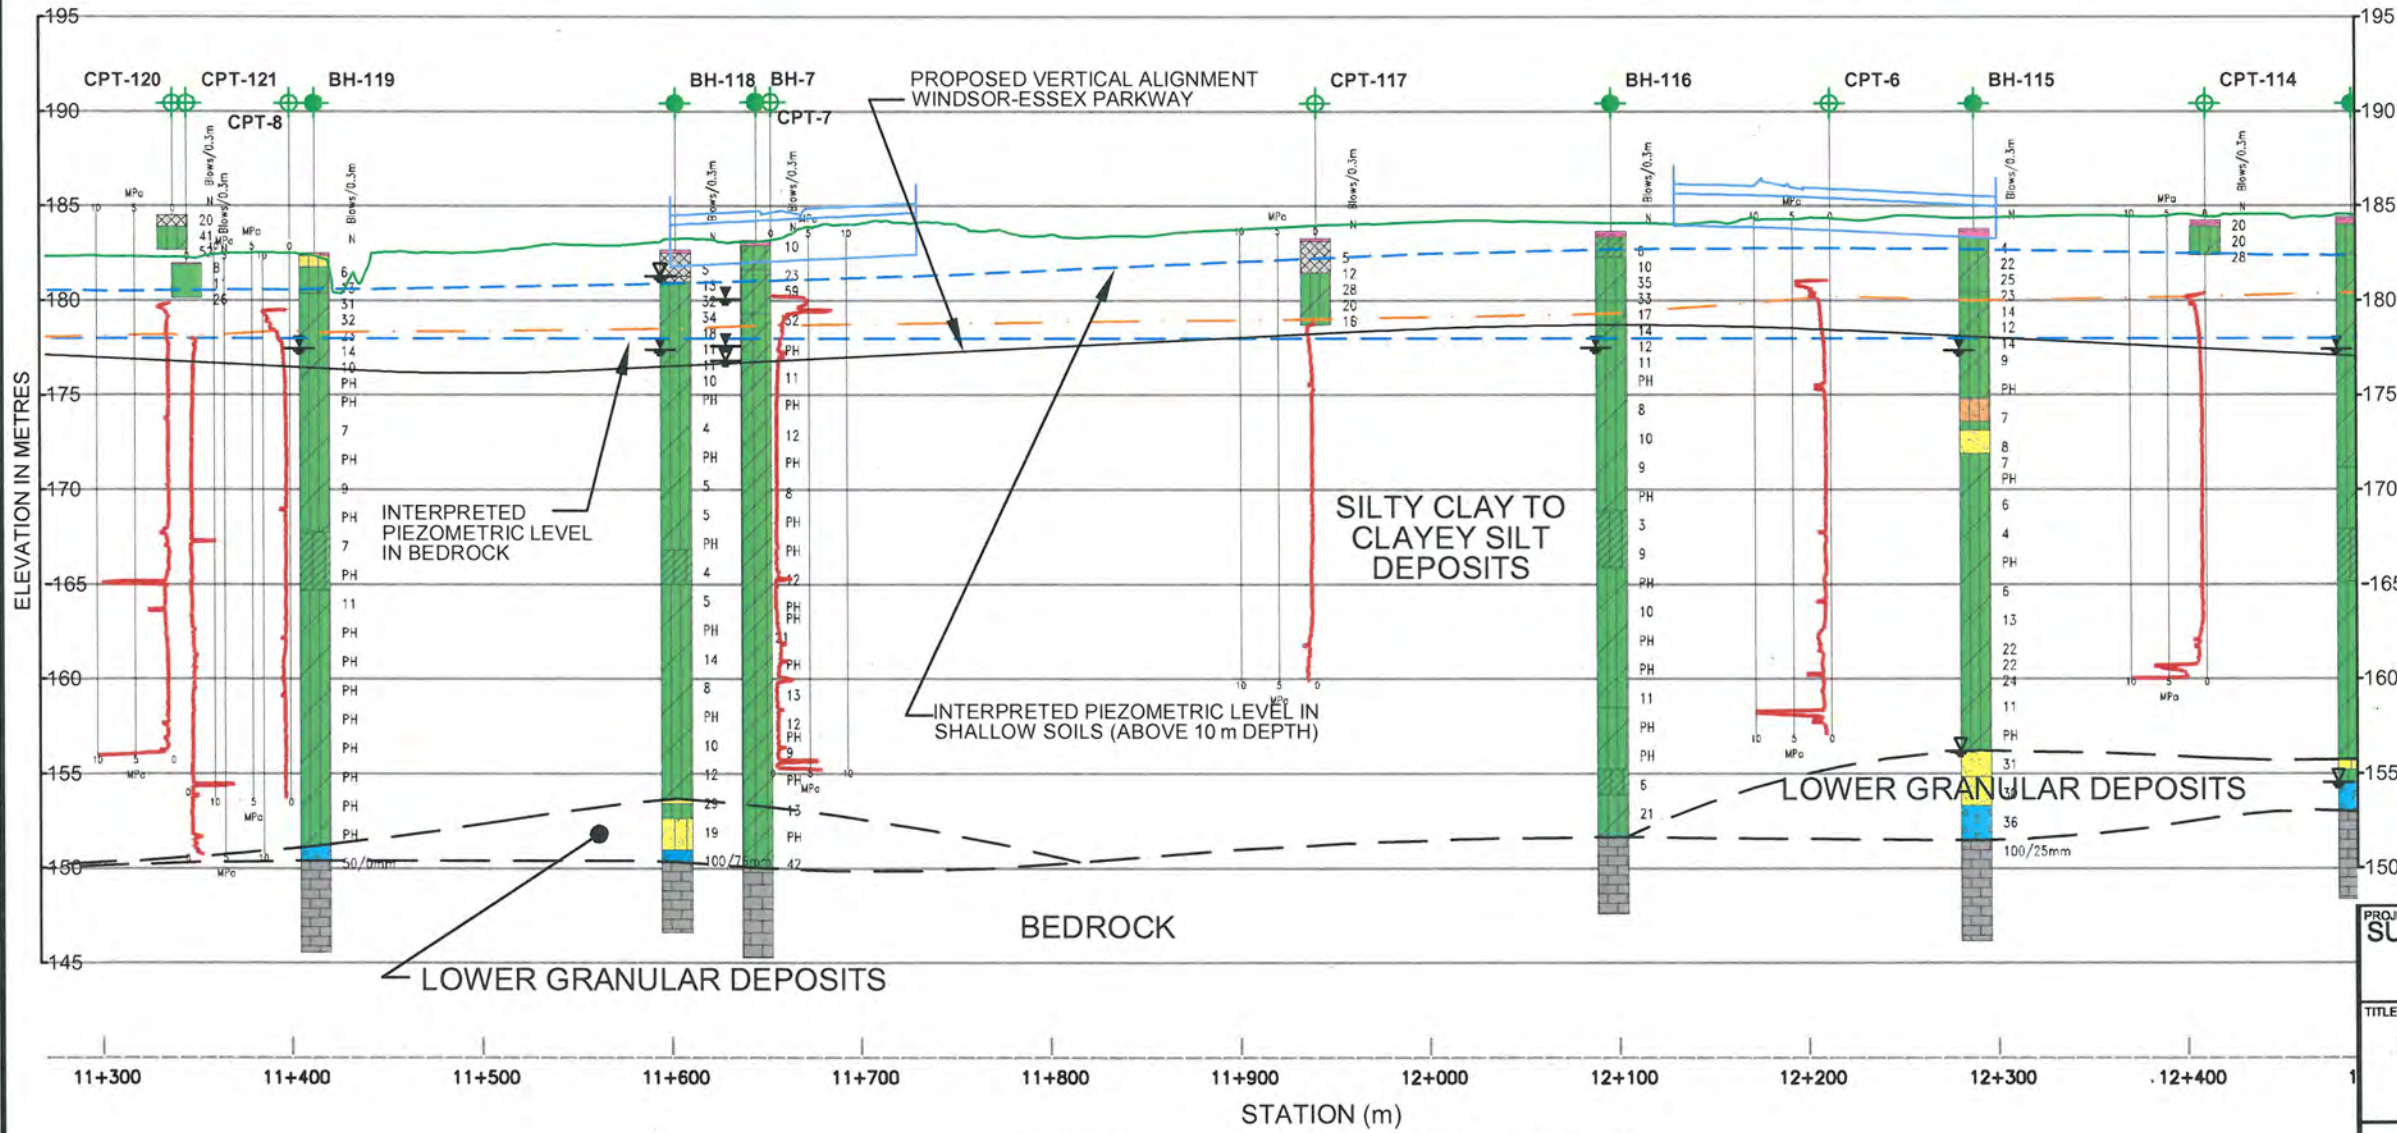
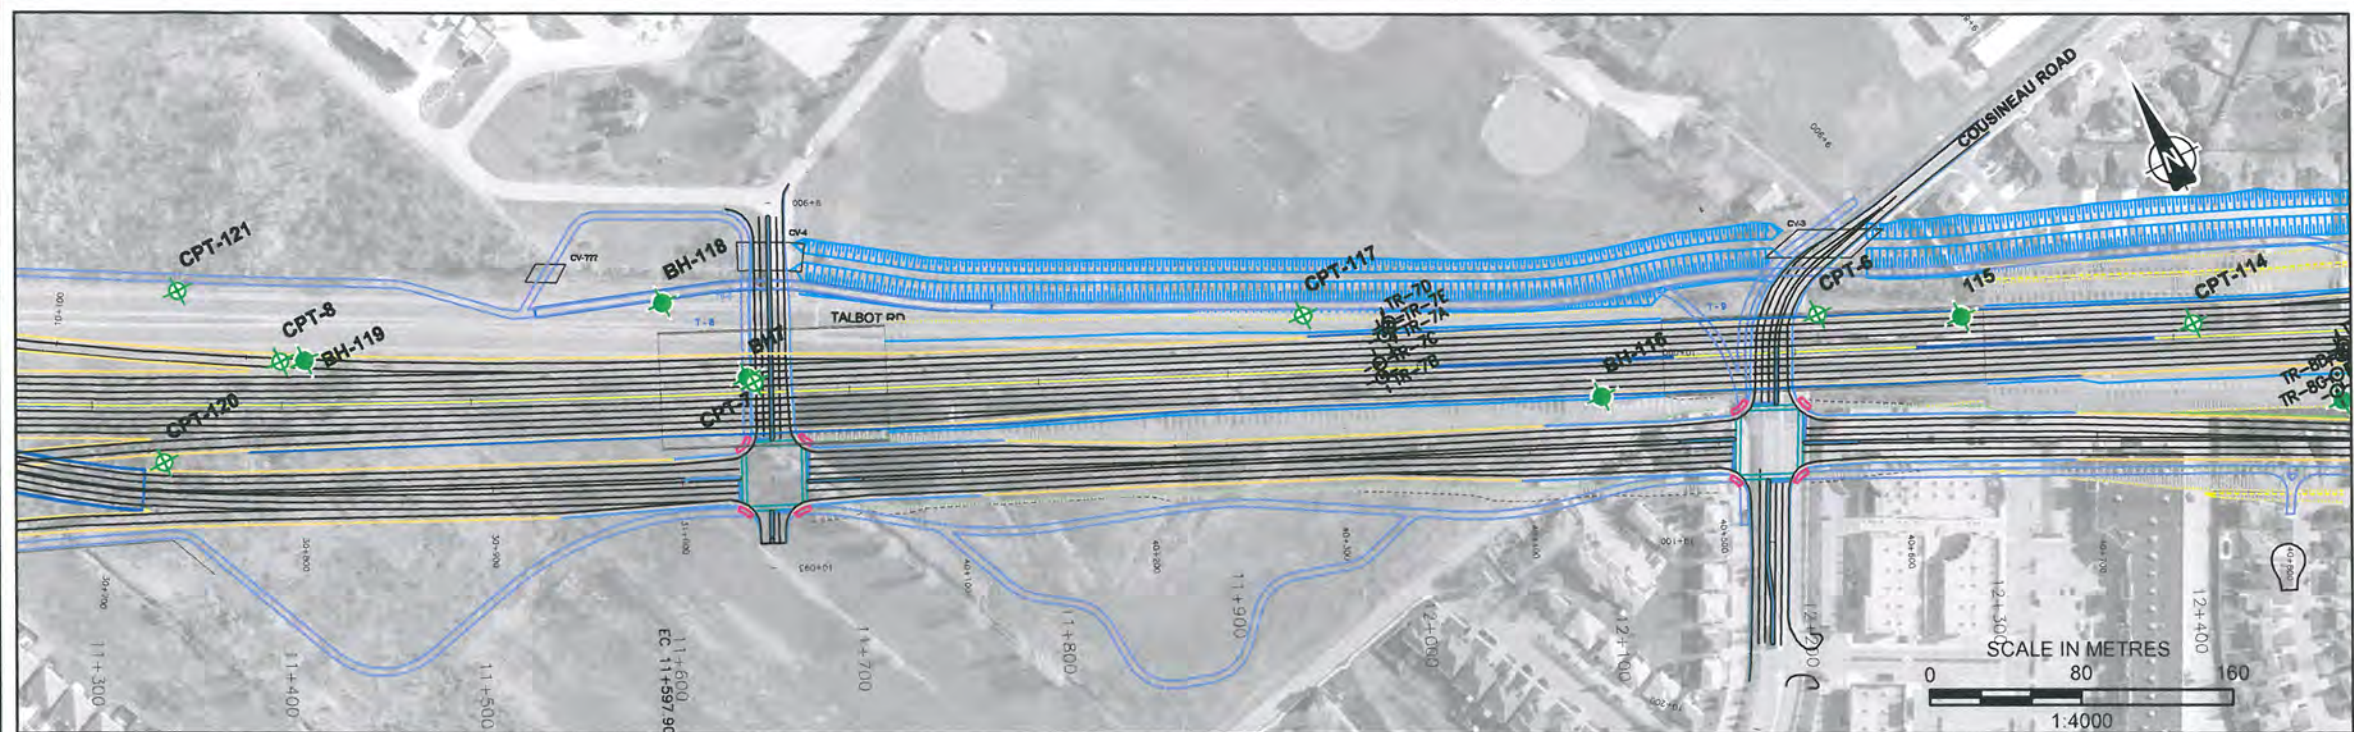
PROJECT No. 07-1130-207-0			FILE No. 0711302070-R02051		
CADD JDR/WDF Dec. 02/09			SCALE AS SHOWN REV. 1		
CHECK SJS DEX/ky			5.1G

TITLE  
INTERPRETED STRATIGRAPHIC PROFILE  
STN 11+300 TO 12+500

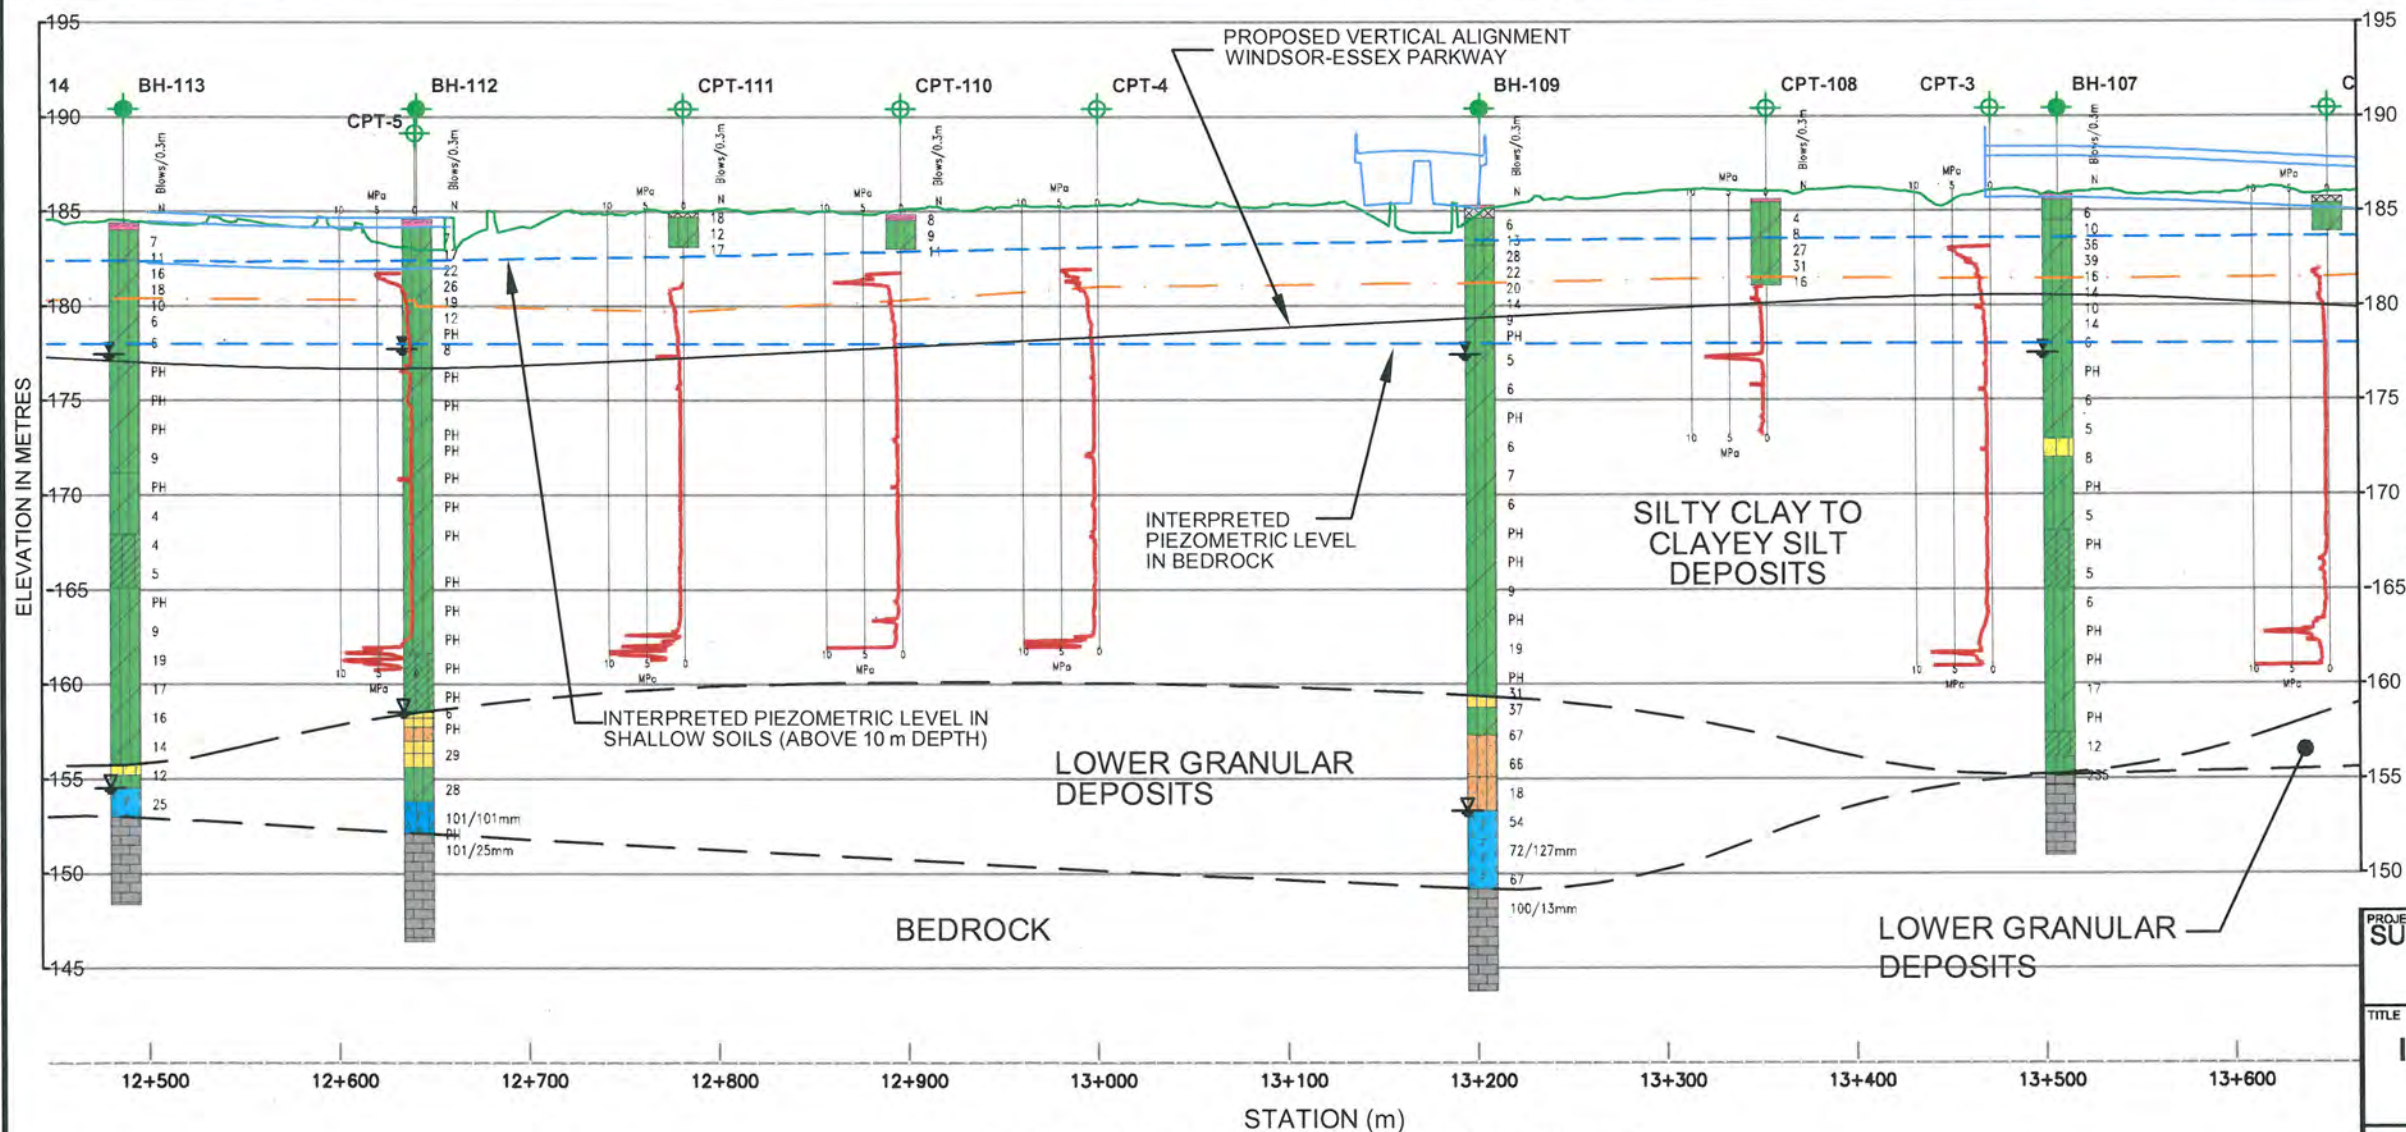
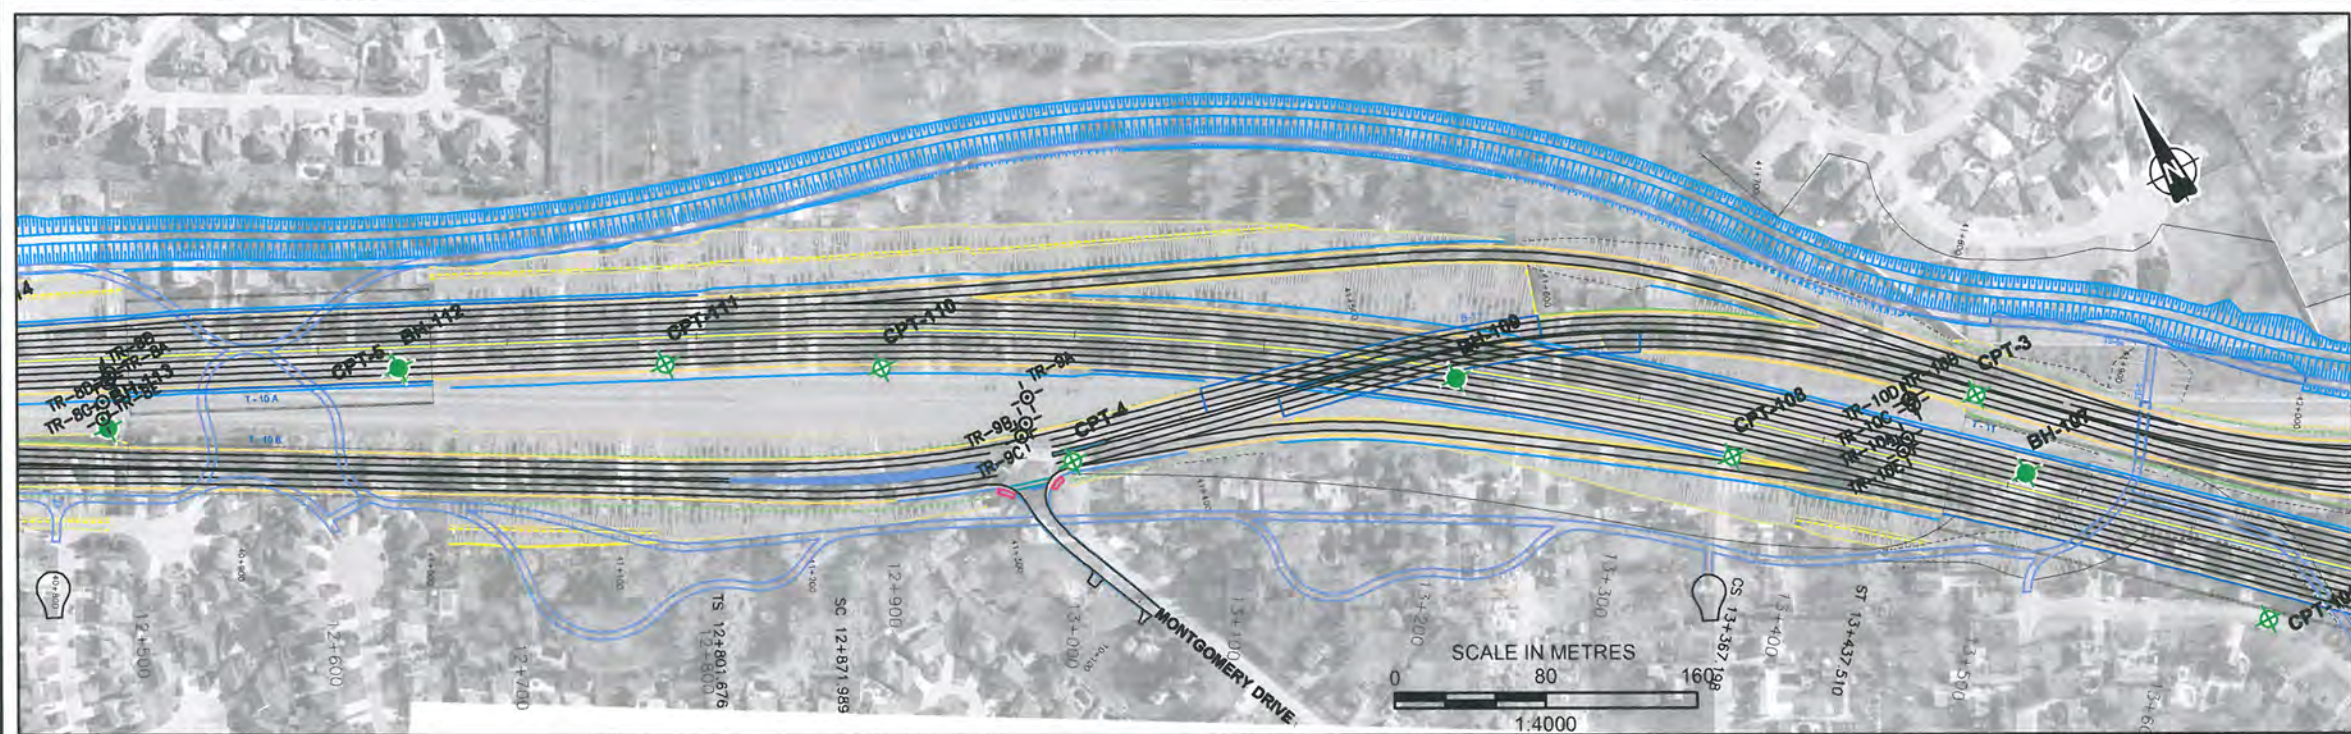
PROJECT No.	07-1130-207-0	FILE No.	0711302070-R02051
CADD	JDR/WDF	Dec. 02/09	SCALE AS SHOWN
CHECK	SSB	Dec 09	REV. 1
			5.1H

## TITLE INTERPRETED STRATIGRAPHIC PROFILE STN 12+500 TO 13+600

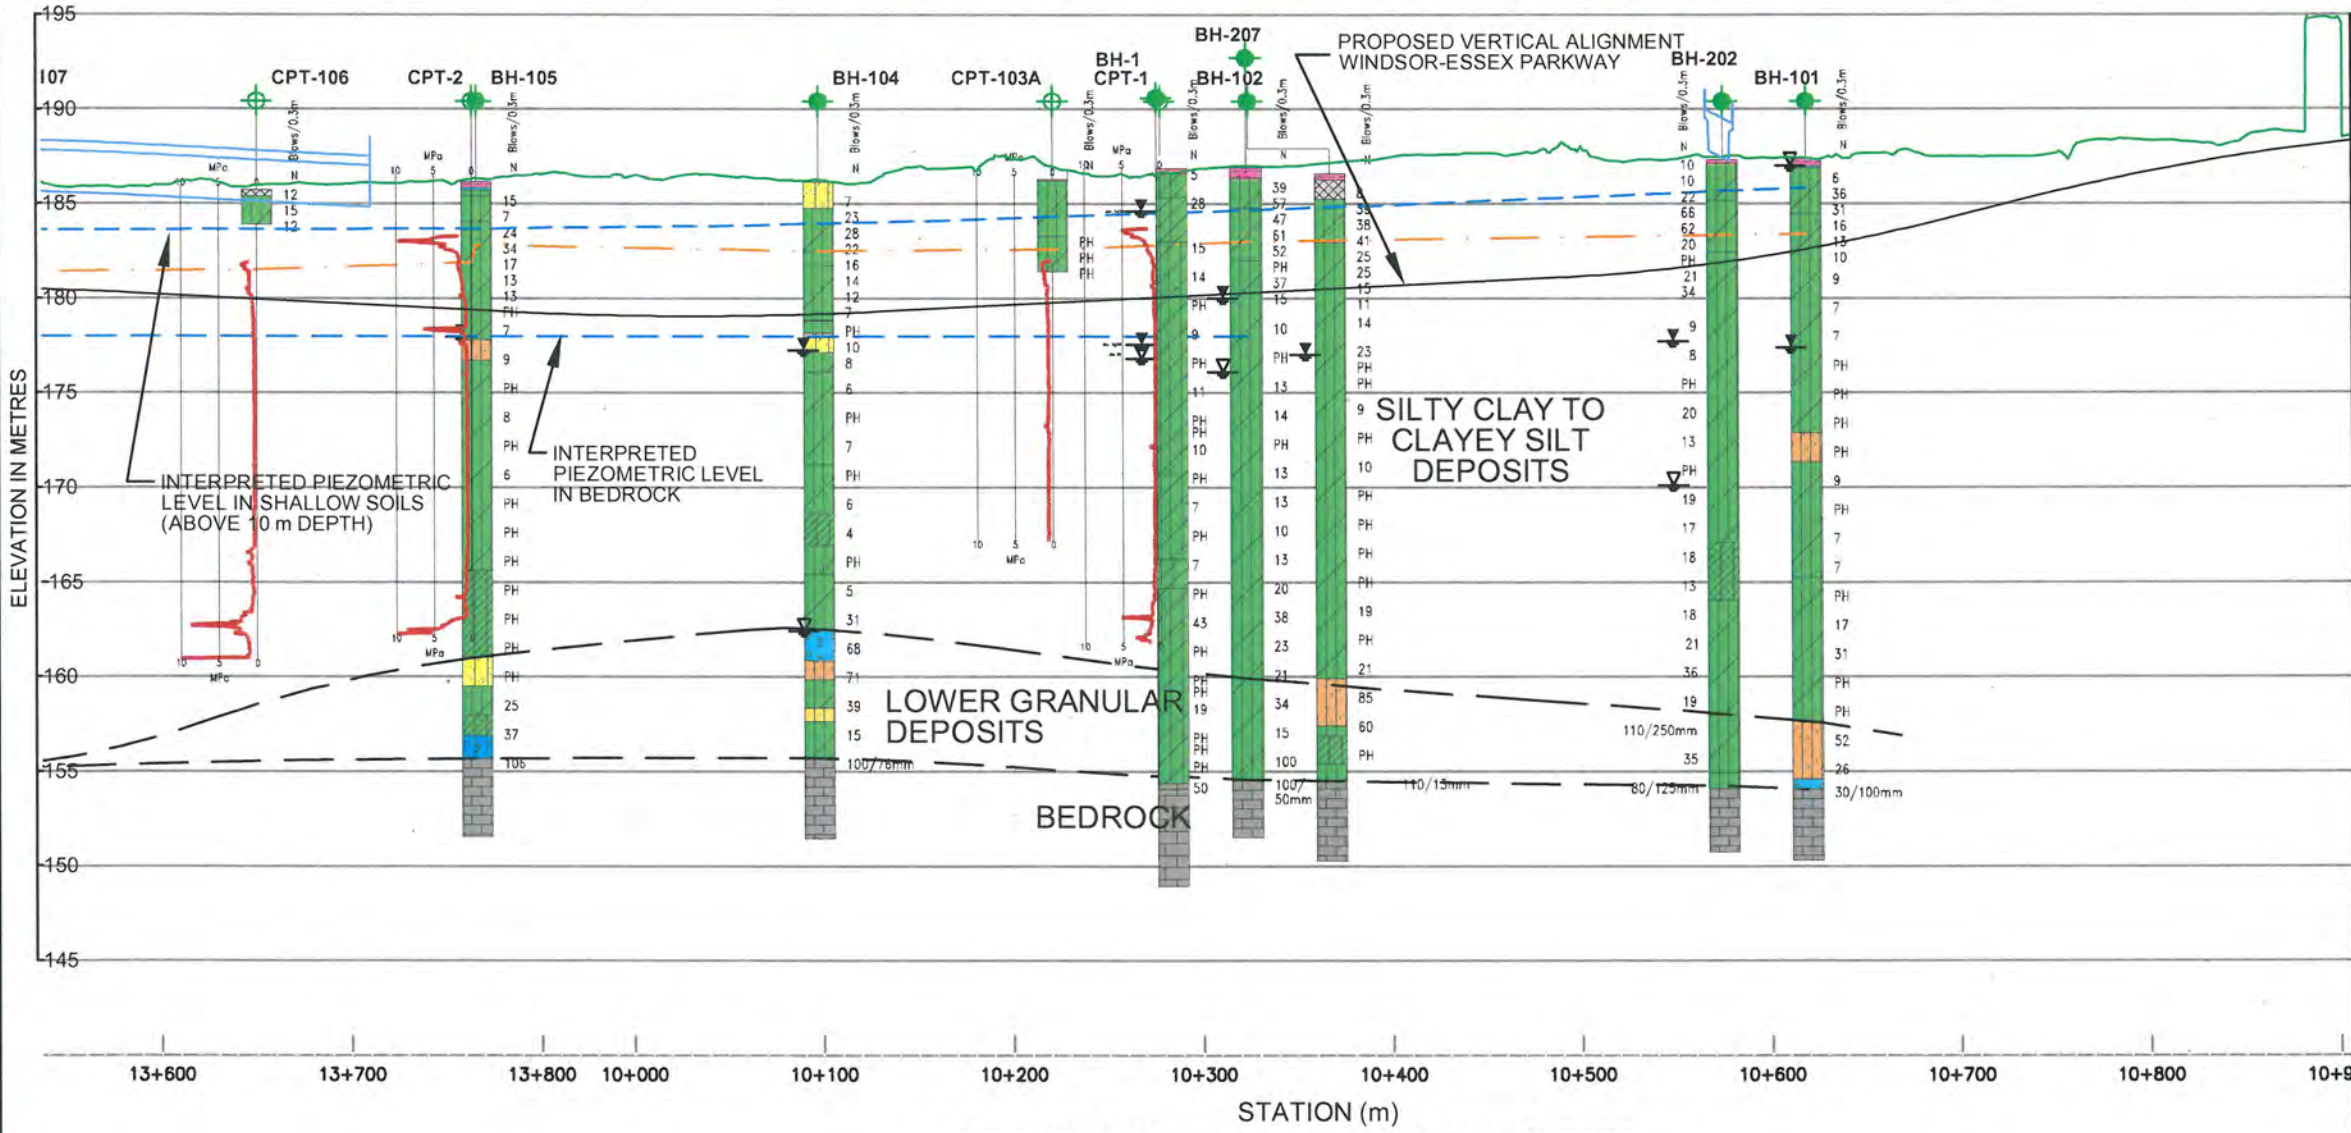
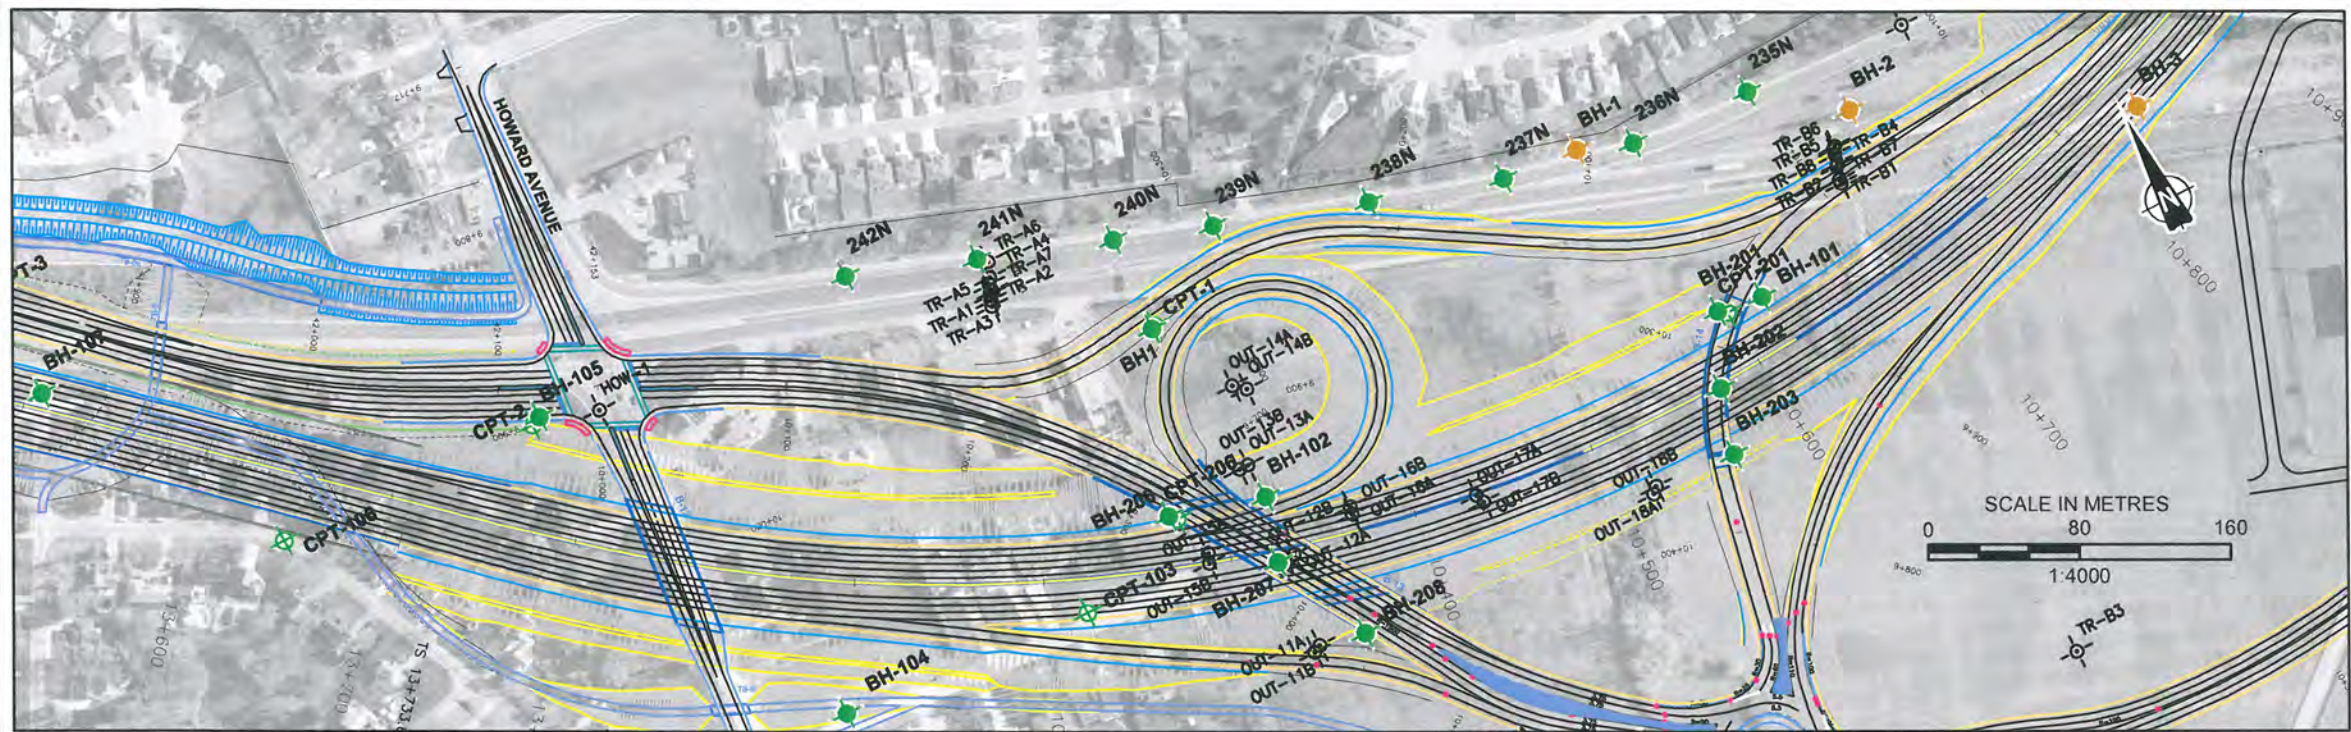
**TITLE**  
INTERPRETED STRATIGRAPHIC PROFILE  
STN 13+600 TO 13+848  
STN 10+000 TO 10+900

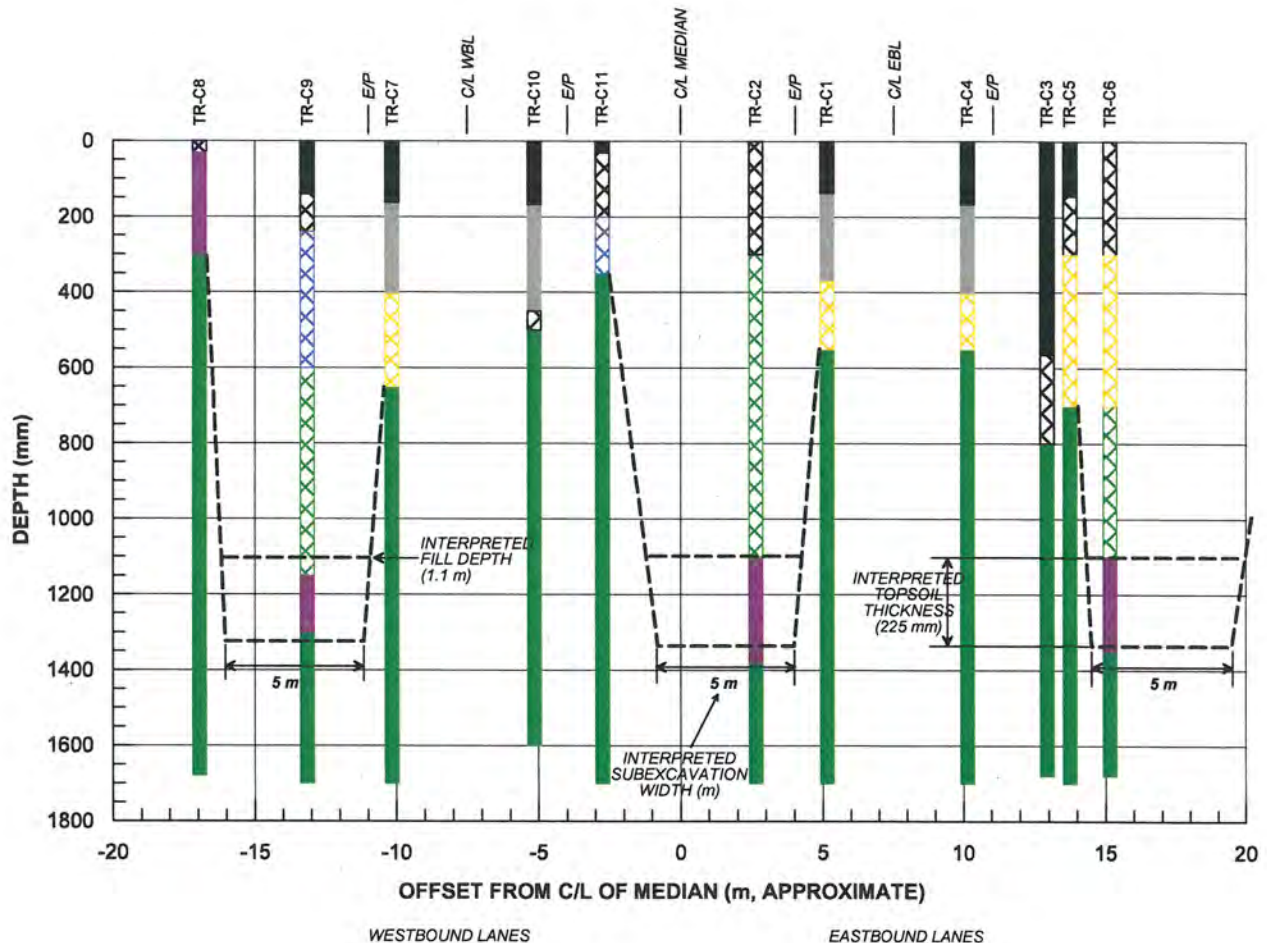
**INTERPRETED CROSS SECTION  
EXISTING HIGHWAY 401  
STATION 10+900 TO STATION 11+300 (APPROXIMATE)**

- NOTES:
1. E/P - EDGE OF PAVEMENT.
  2. ALL DIMENSIONS ARE APPROXIMATE AND FOR ILLUSTRATION PURPOSES ONLY.
  3. FIGURE TO BE READ IN CONJUNCTION WITH ACCOMPANYING REPORT

- ASPHALT
- CONCRETE
- GRANULAR BASE
- SAND FILL
- SAND & GRAVEL FILL
- CLAYEY FILL
- CLAYEY SILT/SILTY CLAY
- TOPSOIL

PROJECT			
SUBSURFACE CONDITIONS INTERPRETATION REPORT			
WINDSOR-ESSEX PARKWAY			
WINDSOR, ONTARIO			
TITLE			
INTERPRETED PAVEMENT AND			
SHALLOW SUBSURFACE CONDITIONS			
EXISTING HIGHWAY 401			
PROJECT No.		05-1140-003	
FILE No.		DRIC PAVT 5-2-A.grf	
DRAWN		MEB	
CHECK		SJB	
DATE		Dec 7-09	
SCALE		AS SHOWN	
REV.		1	
FIGURE 5.2A

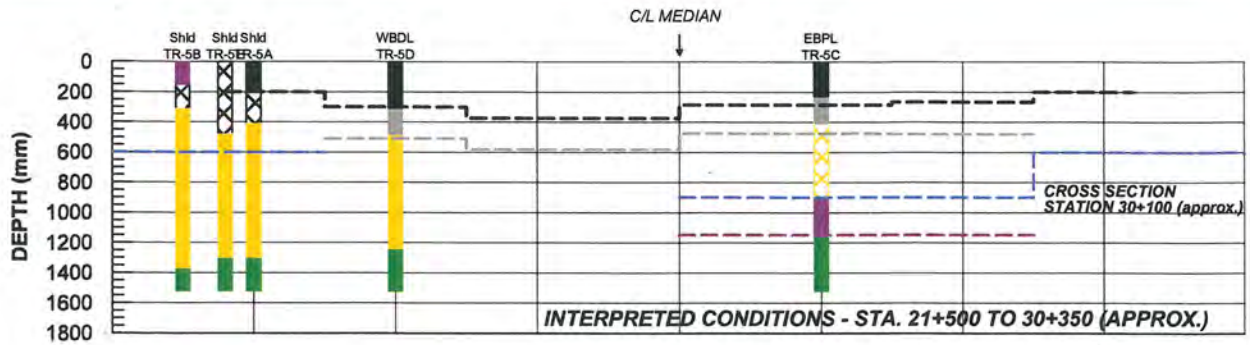
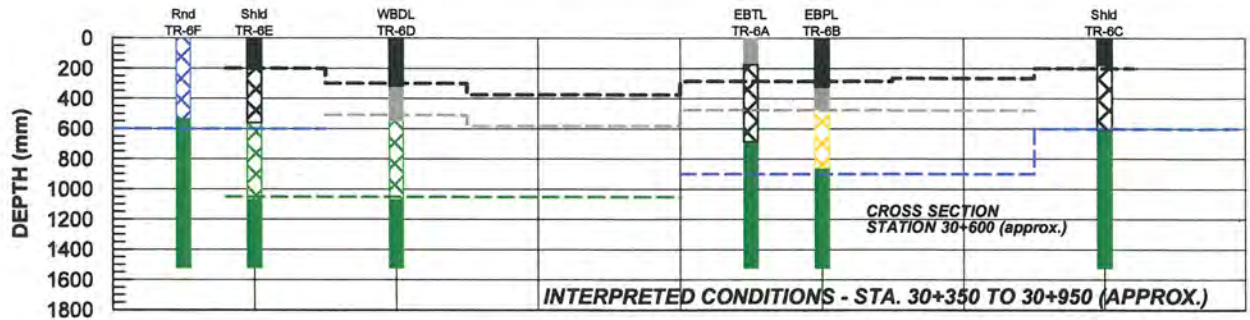
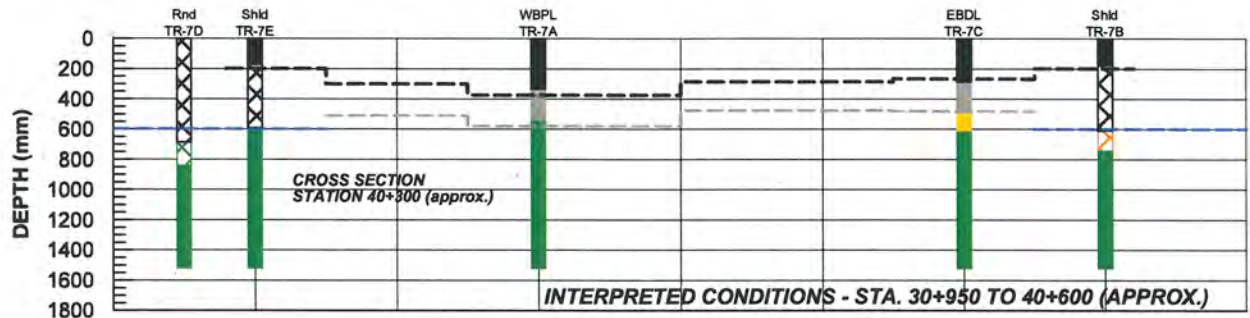
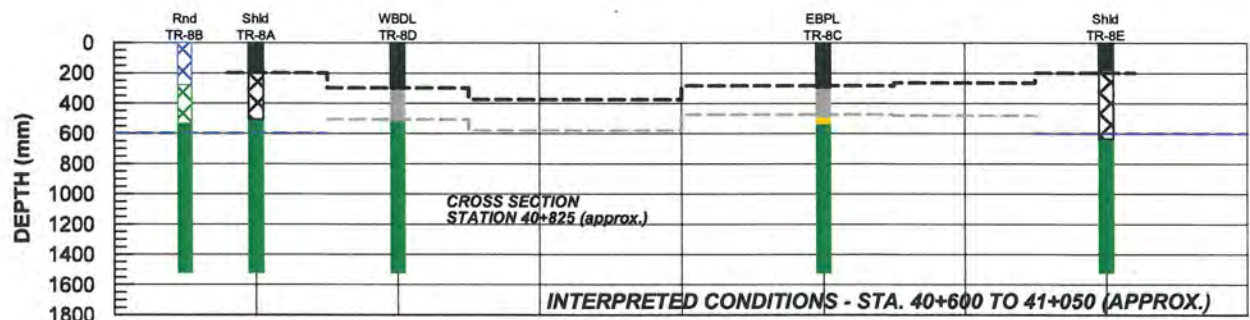
FIGURE 5.2B

CROSS SECTIONS

TITLE  
INTERPRETED PAVEMENT AND  
SHALLOW SUBSURFACE CONDITIONS  
EXISTING HIGHWAY 3/TALBOT ROAD

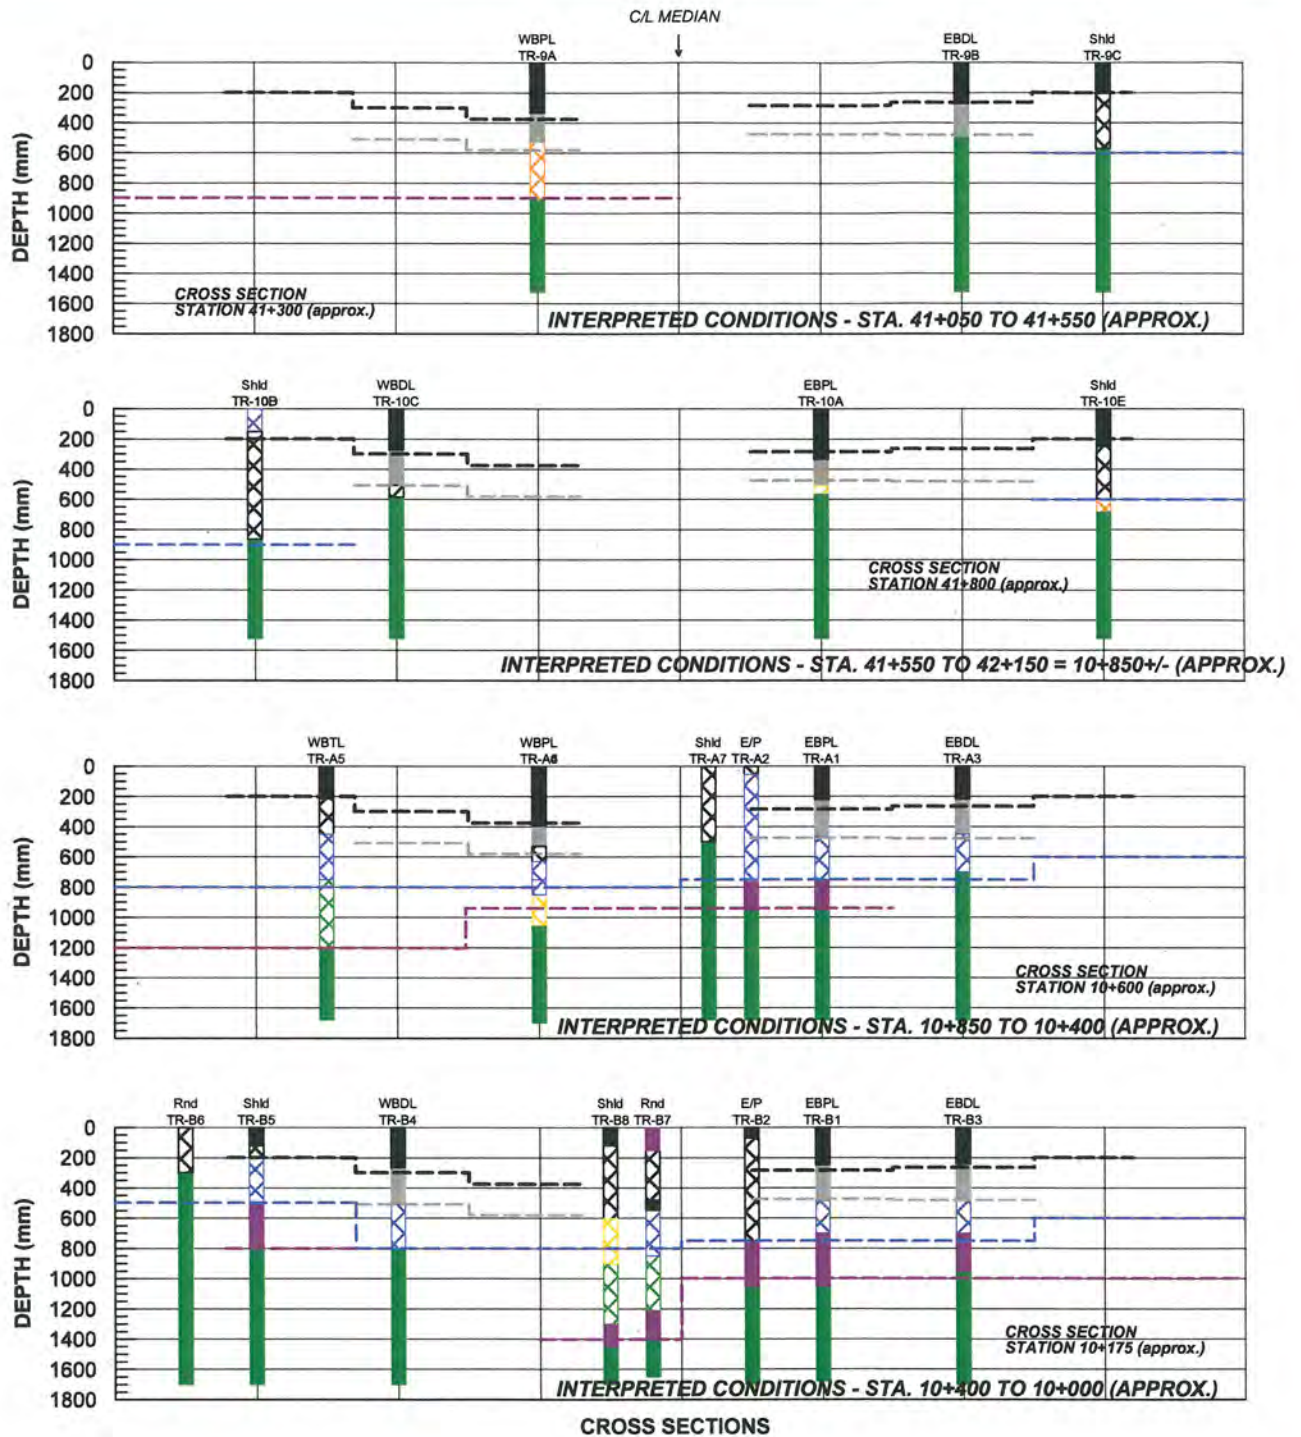
PROJECT			
SUBSURFACE CONDITIONS INTERPRETATION REPORT			
WINDSOR-ESSEX PARKWAY			
WINDSOR, ONTARIO			
TITLE			
INTERPRETED PAVEMENT AND SHALLOW SUBSURFACE CONDITIONS EXISTING HIGHWAY 3/TALBOT ROAD			
PROJECT No.	05-1140-003	FILE No.	DRIC PAVT 5-2-C.grf
DRAWN	MEB	Dec 7-09	SCALE AS SHOWN/REV. 1
CHECK	5/5/09	12/1/09	FIGURE 5.2C
