## **WINDSOR-ESSEX PARKWAY**

# **Subsurface Conditions Interpretation Report**

**Report Number:** 07-1130-207-0-R02 / 05-1140-003

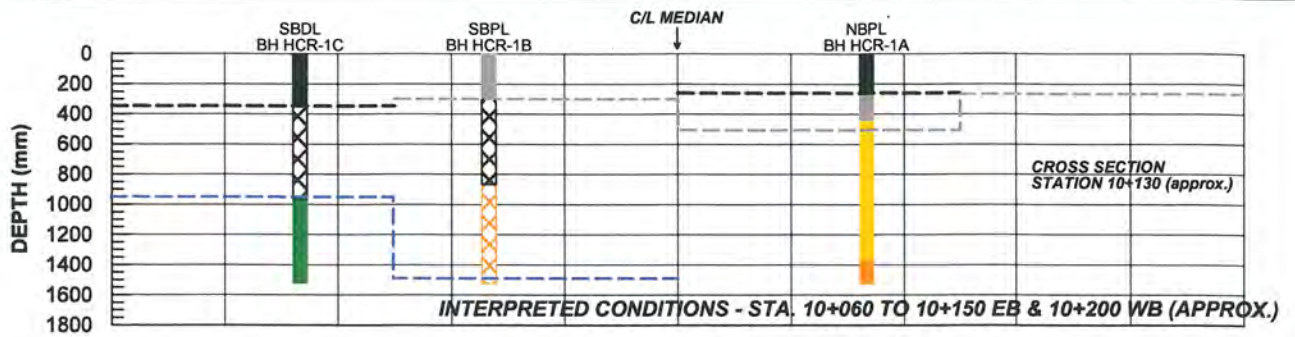
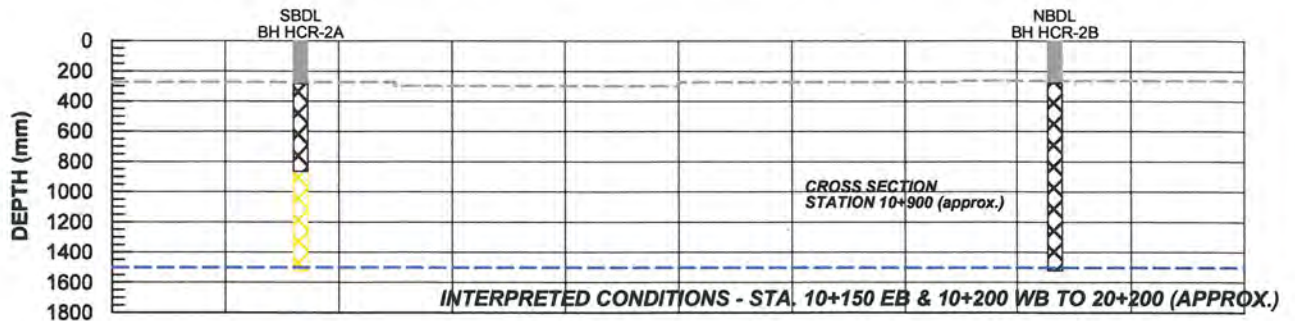
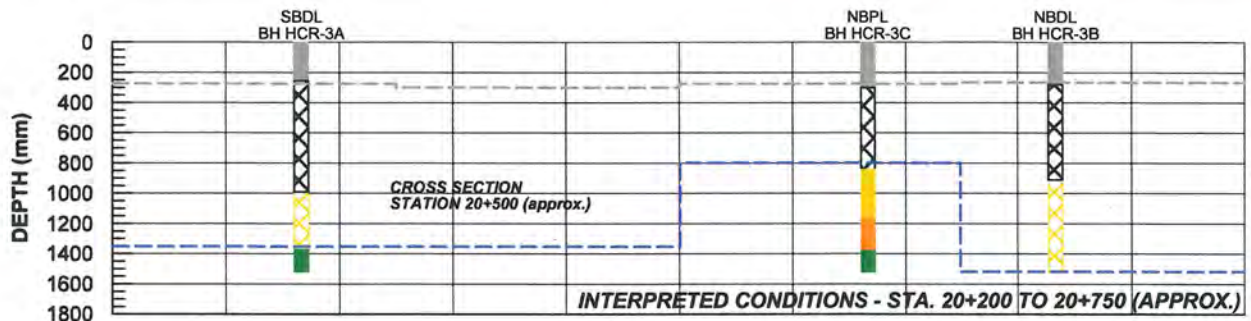
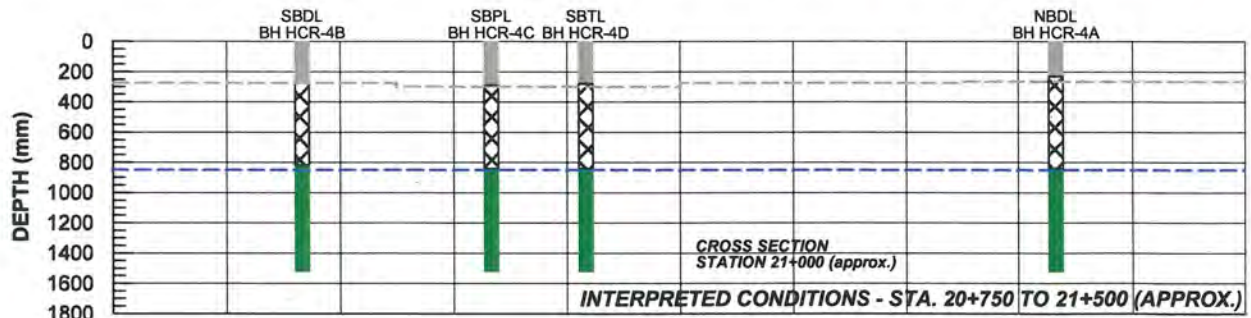
PROJECT SUBSURFACE CONDITIONS INTERPRETATION REPORT WINDSOR-ESSEX PARKWAY WINDSOR, ONTARIO			
TITLE <b>INTERPRETED PAVEMENT AND SHALLOW SUBSURFACE CONDITIONS EXISTING HURON CHURCH ROAD</b>			
PROJECT No.	05-1140-003	FILE No.	DRIC PAVT 5-2-D.grf
DRAWN	MEB	Dec 7, 09	SCALE AS SHOWN/REV. 1
CHECK	5/8	Dec 10	FIGURE 5.2D

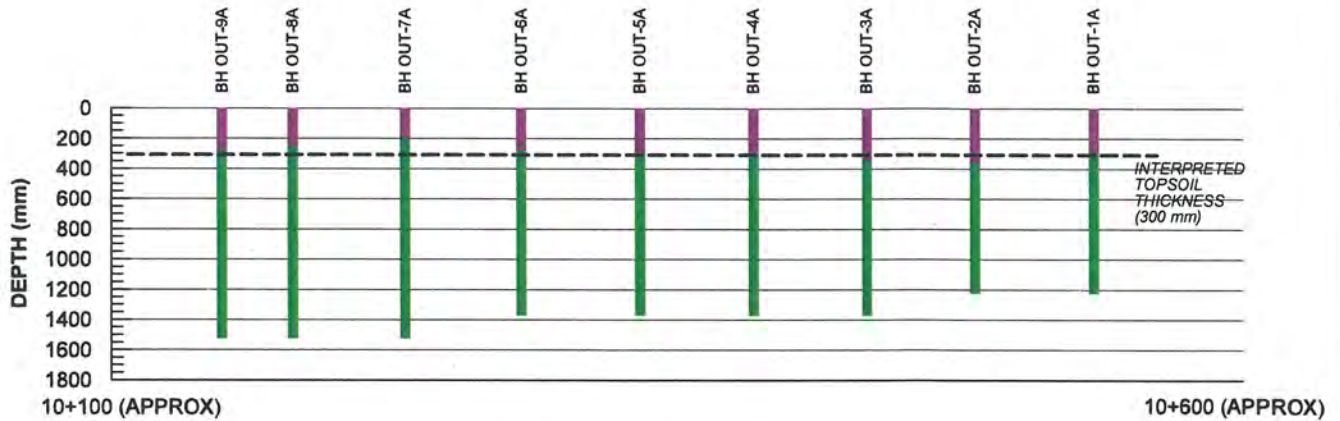
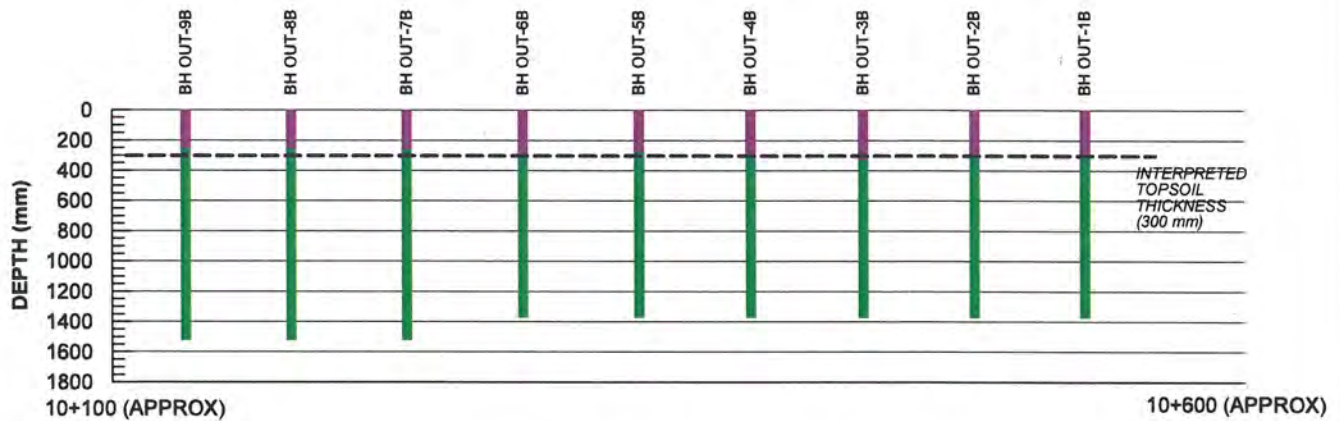
**INTERPRETED PROFILE  
PROPOSED HIGHWAY 3 REALIGNMENT  
STATION 10+100 TO STATION 10+600 (APPROXIMATE)**

PROJECT SUBSURFACE CONDITIONS INTERPRETATION REPORT WINDSOR-ESSEX PARKWAY WINDSOR, ONTARIO			
TITLE <b>INTERPRETED PAVEMENT AND SHALLOW SUBSURFACE CONDITIONS PROPOSED HIGHWAY 3 REALIGNMENT</b>			
PROJECT No. 05-1140-003		FILE No. DRIC PAVT 5-2-E.grf	
DRAWN MEB		Dec 7-99	
CHECK <i>SJB</i>		<i>10/10/99</i>	
Golder Associates LONDON, ONTARIO		SCALE AS SHOWN REV. 1 <b>FIGURE 5.2E</b>

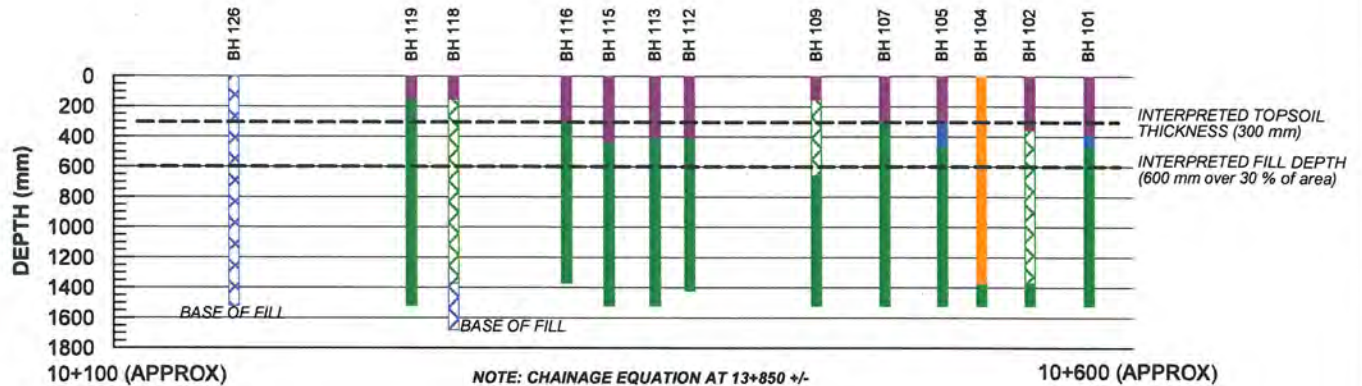
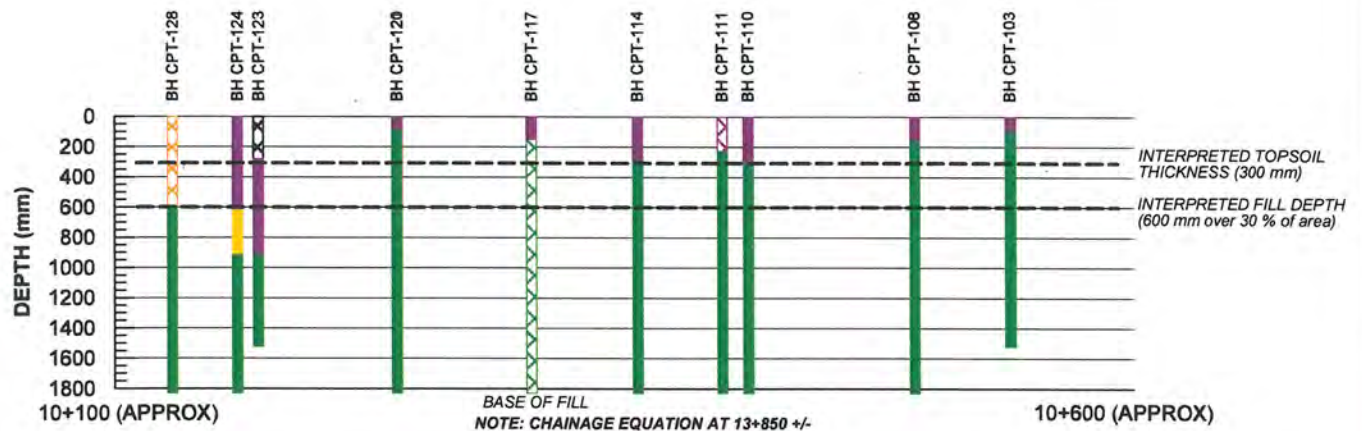
**INTERPRETED PROFILE  
PROPOSED WINDSOR-ESSEX PARKWAY AND SERVICE ROADS  
HIGHWAY 3/TALBOT ROAD CORRIDOR**

<b>PROJECT</b> SUBSURFACE CONDITIONS INTERPRETATION REPORT WINDSOR-ESSEX PARKWAY WINDSOR, ONTARIO			
<b>TITLE</b> INTERPRETED PAVEMENT AND SHALLOW SUBSURFACE CONDITIONS PROPOSED WINDSOR-ESSEX PARKWAY AND SERVICE ROADS HIGHWAY 3/TALBOT ROAD CORRIDOR			
<b>PROJECT No.</b> 05-1140-003		<b>FILE No.</b> DRIC PAVT 5-2-F.grf	
<b>DRAWN</b> MEB		<b>Dec 7-09</b>	
<b>CHECK</b> <i>SJB</i>		<b>SCALE</b> AS SHOWN	
		<b>FIGURE 5.2F</b>

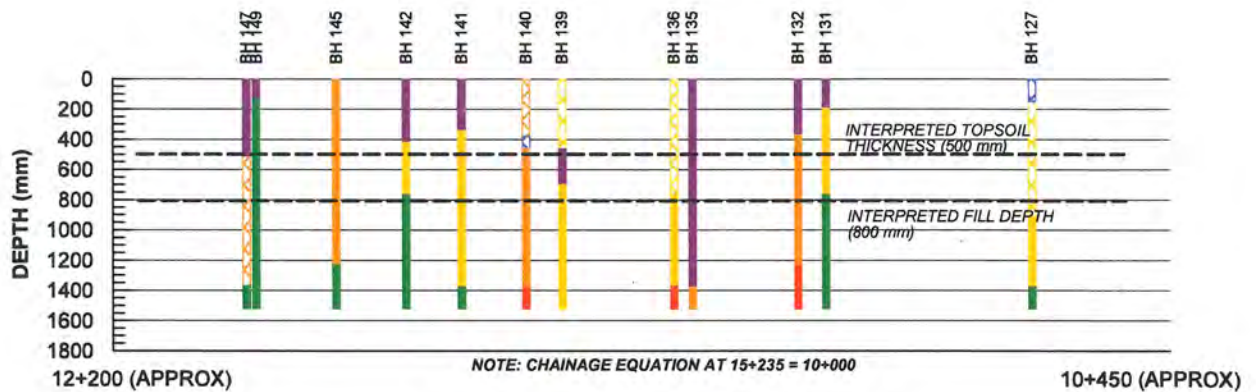
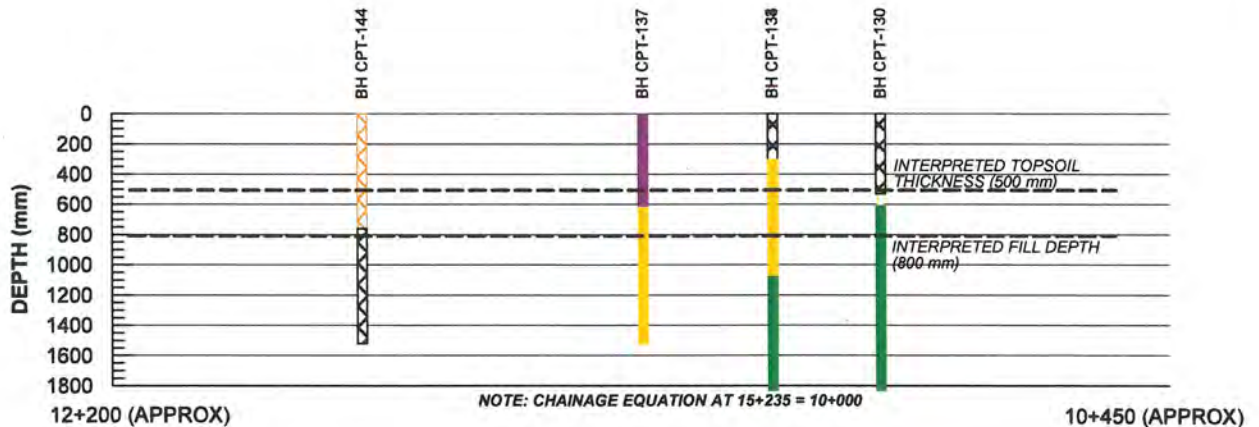
**INTERPRETED PROFILE  
PROPOSED WINDSOR-ESSEX PARKWAY AND SERVICE ROADS  
HURON CHURCH ROAD CORRIDOR**

<b>PROJECT</b> SUBSURFACE CONDITIONS INTERPRETATION REPORT WINDSOR-ESSEX PARKWAY WINDSOR, ONTARIO			
<b>TITLE</b> INTERPRETED PAVEMENT AND SHALLOW SUBSURFACE CONDITIONS PROPOSED WINDSOR-ESSEX PARKWAY AND SERVICE ROADS HURON CHURCH ROAD CORRIDOR			
<b>PROJECT No.</b> 05-1140-003		<b>FILE No.</b> DRIC PAVT 5-2-G.grf	
<b>DRAWN</b> MEB	<b>Dec 7-09</b>	<b>SCALE</b> AS SHOWN <b>REV.</b> 1	
<b>CHECK</b> <i>SSS</i>	<i>DRIC</i>	<b>FIGURE 5.2G</b>	
<b>Golder Associates</b> LONDON, ONTARIO

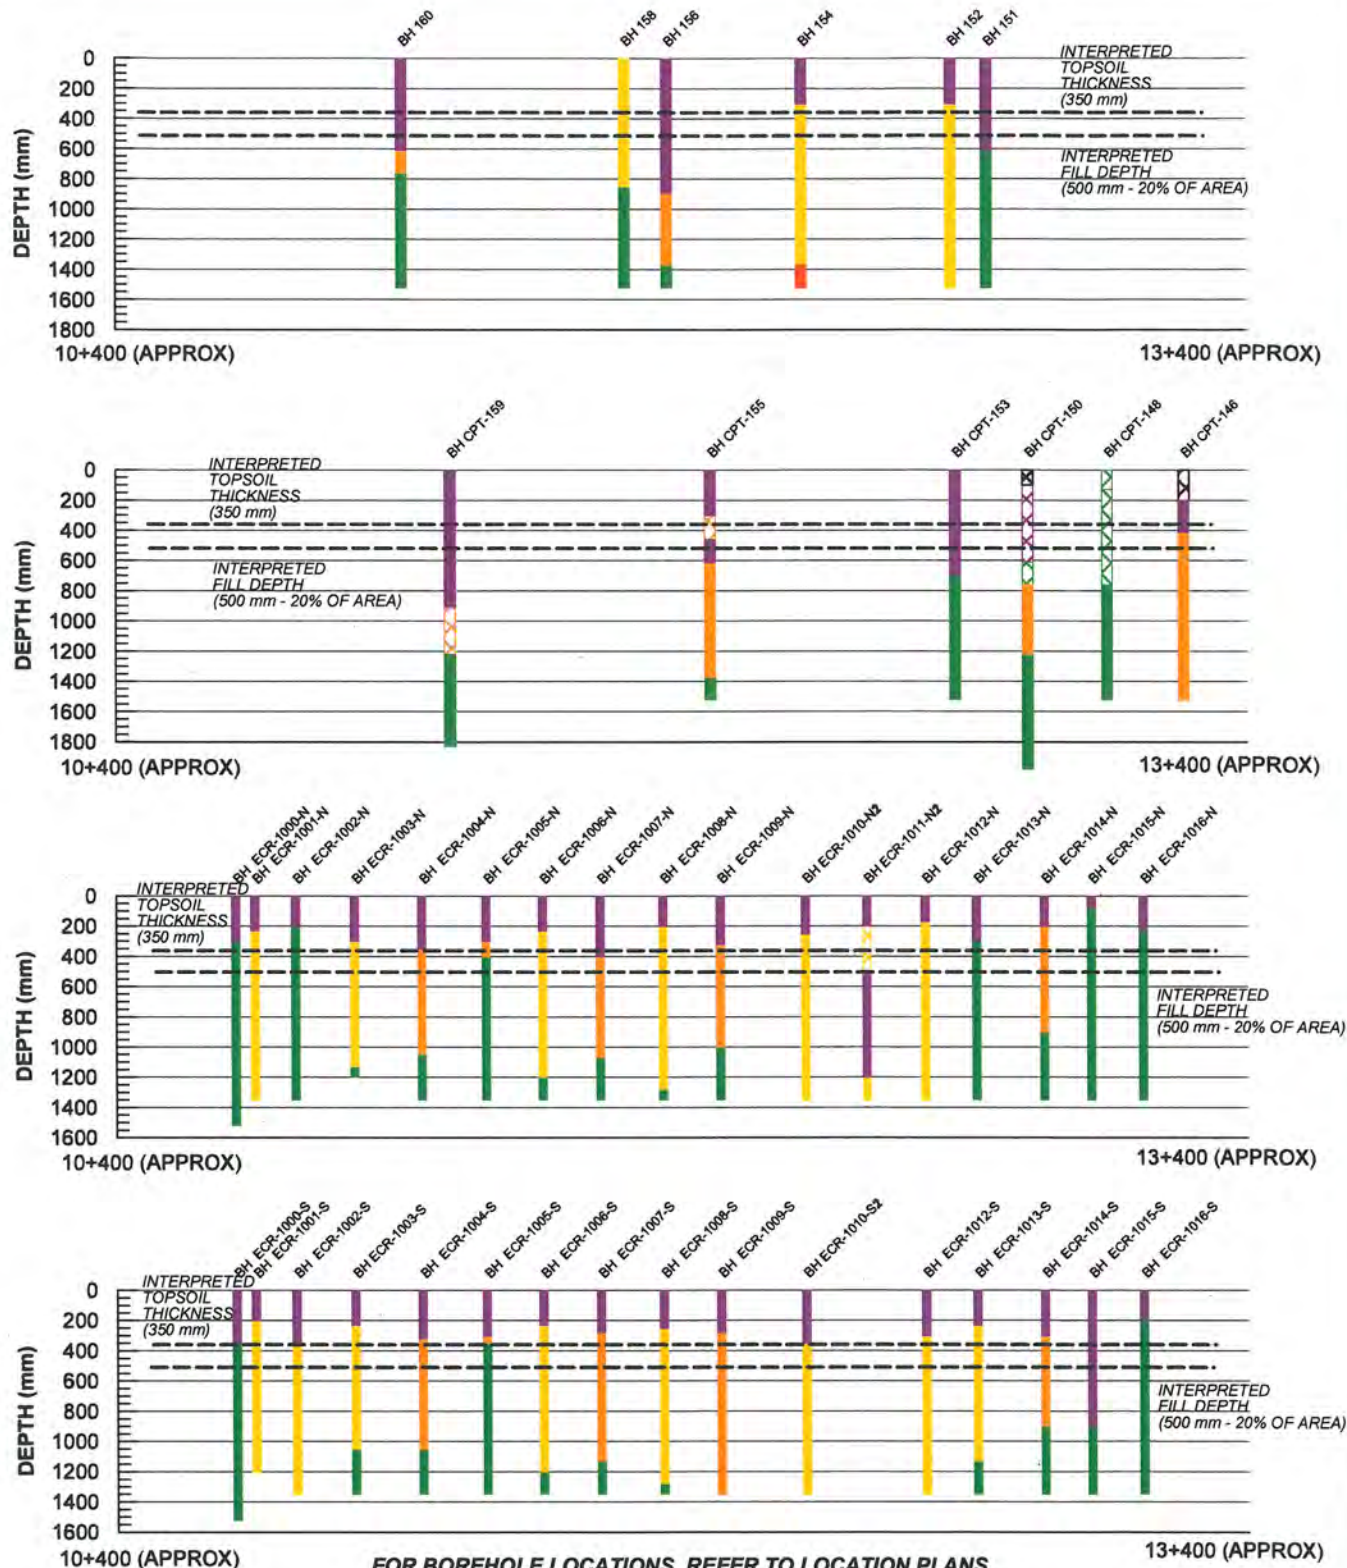
FIGURE 5.2H

TITLE  
INTERPRETED PAVEMENT AND  
SHALLOW SUBSURFACE CONDITIONS  
PROPOSED WINDSOR-ESSEX PARKWAY AND SERVICE ROADS  
E.C. ROW EXPRESSWAY CORRIDOR

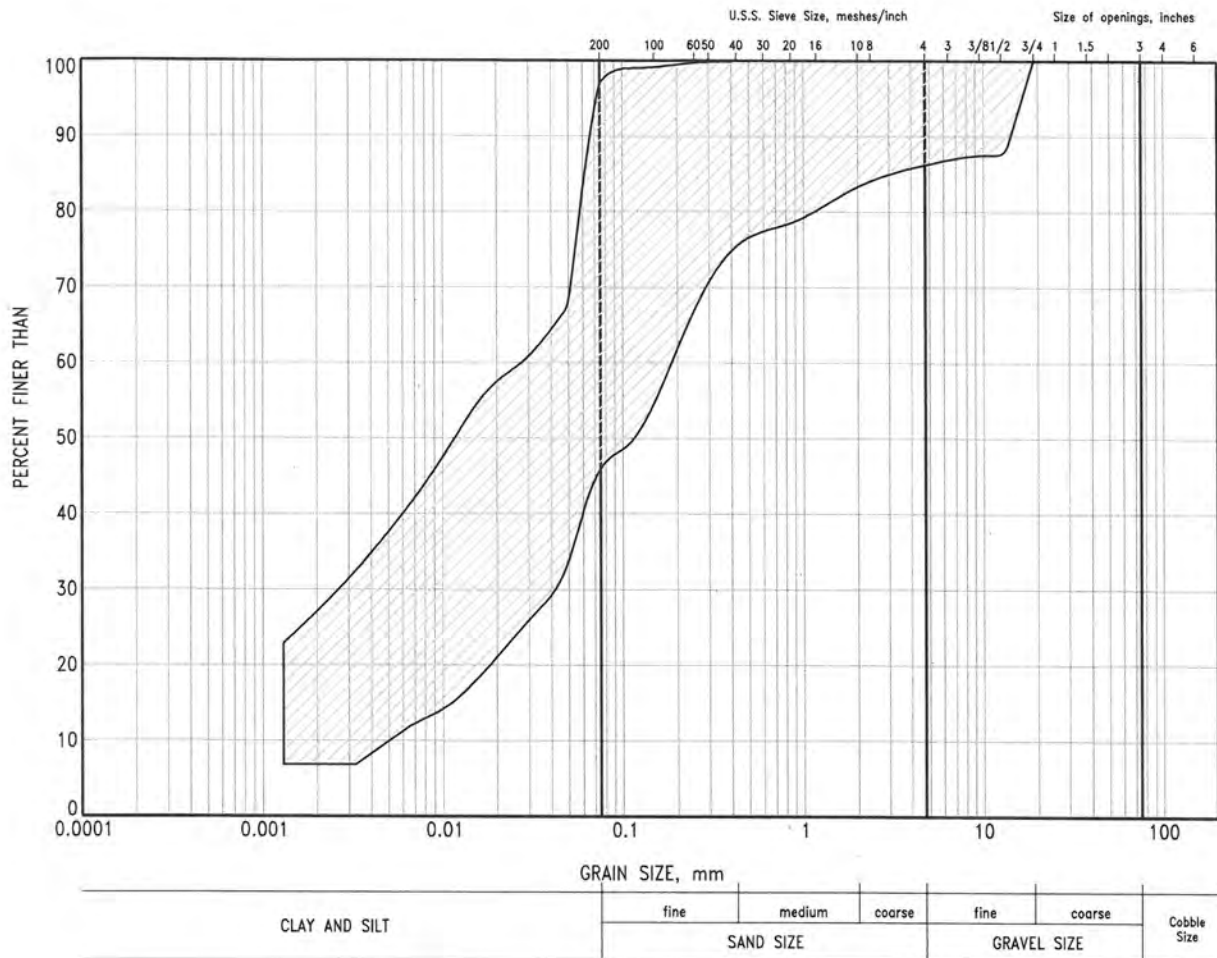
<b>Golder Associates</b> LONDON, ONTARIO			<b>FIGURE 5.3</b>

The grain size distribution envelope shown above is based on all grain size distribution analyses conducted on samples obtained from the Upper Granular Deposits. For individual test results refer to the Geotechnical Data Report referenced in section 3.1. The samplers used for the explorations limit the maximum particle size that can be sampled and tested to about 40mm. Larger particles are known to be present in the deposit as discussed in the report text.

PROJECT <b>SUBSURFACE CONDITIONS INTERPRETATION REPORT</b>			
<b>WINDSOR-ESSEX PARKWAY</b>			
<b>WINDSOR, ONTARIO</b>			
TITLE <b>GRAIN SIZE DISTRIBUTION ENVELOPE</b>			
<b>UPPER GRANULAR DEPOSITS</b>			
PROJECT No. 07-1130-207-0		FILE No. 0711302070-R02053	
CADD	LMK	Dec. 02/09	SCALE AS SHOWN
CHECK	SJS	Dec 10/09	REV. 1

Figure 5.3: Grain Size Distribution Envelope, Silty Sand to Sandy Silt

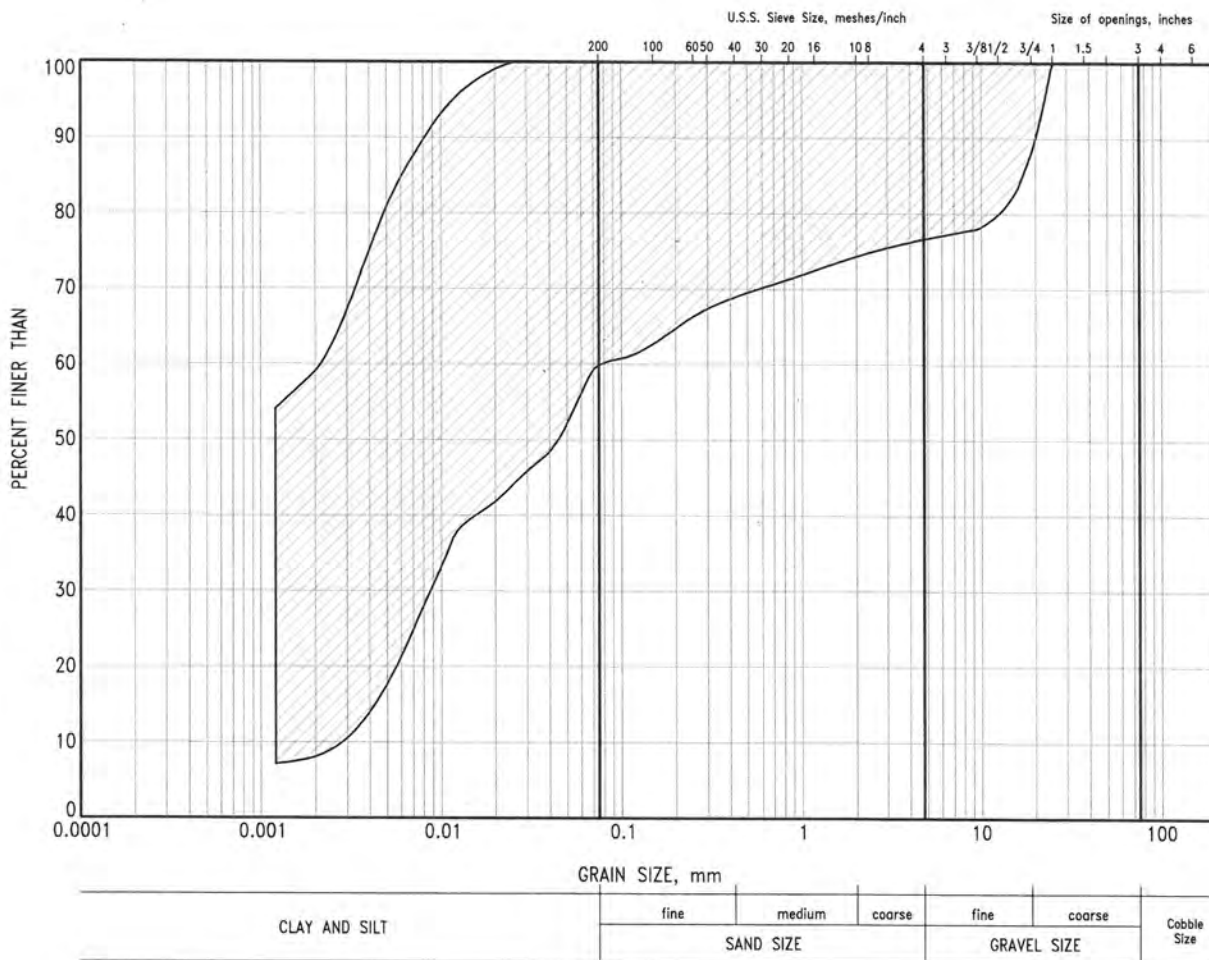
PROJECT No. 07-1130-207-0		FILE No. 0711302070-R02054	
CADD	LMK	Dec. 02/09	SCALE AS SHOWN
CHECK	SJB	DEL/KF	REV. 1
FIGURE 5.4

The grain size distribution envelope shown above is based on all grain size distribution analyses conducted on samples obtained from the Silt and Clay Deposits. For individual test results refer to the Geotechnical Data Report referenced in section 3.1. The samplers used for the explorations limit the maximum particle size that can be sampled and tested to about 40mm. Larger particles are known to be present in the deposit as discussed in the report text.

Figure 5.4: Grain Size Distribution Envelope, Clayey Silt to Silty Clay

Gravel sized particles constituted between about 0 and 5 percent (by weight) of the tested materials. A summary of grain size distribution data for this deposit is provided on Figure 5.4. Results of Atterberg Limits determinations are summarized and illustrated on Figure 5.6. The plasticity index ranged between less than 5 and 31 per cent with an average of about 16 per cent for the entire deposit. The natural water content measured on selected samples of this deposit ranged between about 10 and 30 percent but was typically between 20 and 25 percent. The higher water contents are typically associated with the middle portion of the deposit. Table 5.14, below, summarizes the interpreted classification characteristics of this deposit overall and Figures 5.7A to 5.7I present interpreted water content profiles for some geographic locations along the project alignment. These profiles are considered representative of the 50<sup>th</sup> percentile values below the crust boundary as defined above, with the 10<sup>th</sup> and 90<sup>th</sup> percentile values assumed to be minus or plus a water content of 5 per cent from these given profiles, respectively. Above the crust boundary, the interpreted water content values are summarized in the table below.

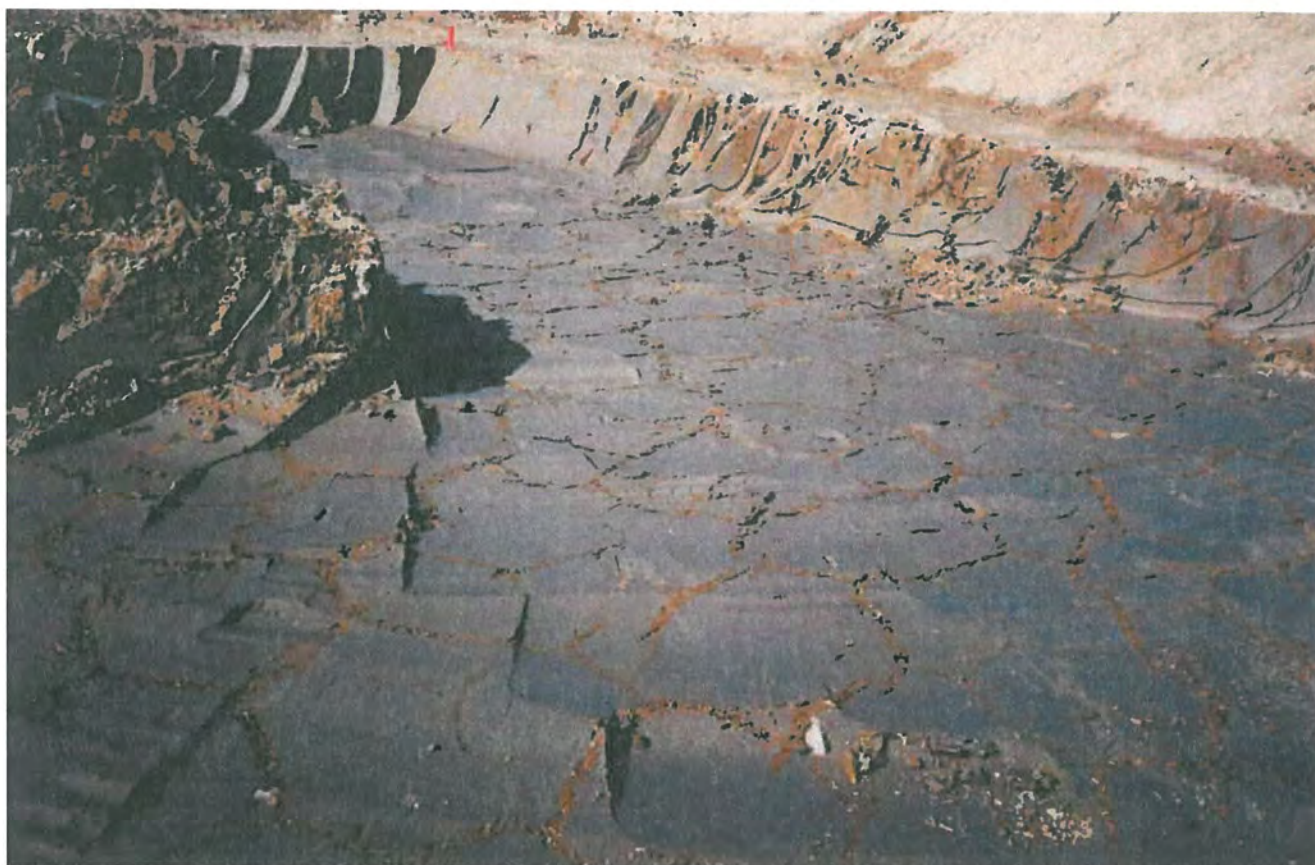
Natural fissuring of silty clay to clayey silt deposit exposed during excavation in Sarnia, Ontario.

PROJECT				SUBSURFACE CONDITIONS INTERPRETATION REPORT WINDSOR-ESSEX PARKWAY WINDSOR, ONTARIO			
TITLE				FISSURING OF CLAYEY SILT TO SILTY CLAY DEPOSITS			
PROJECT No. 07-1130-2070/05-1140-003				FILE No. 0711302070-R02055			
CADD				SCALE			
SJB				NA REV 1			
DEC 2009							
CHECK				5.5

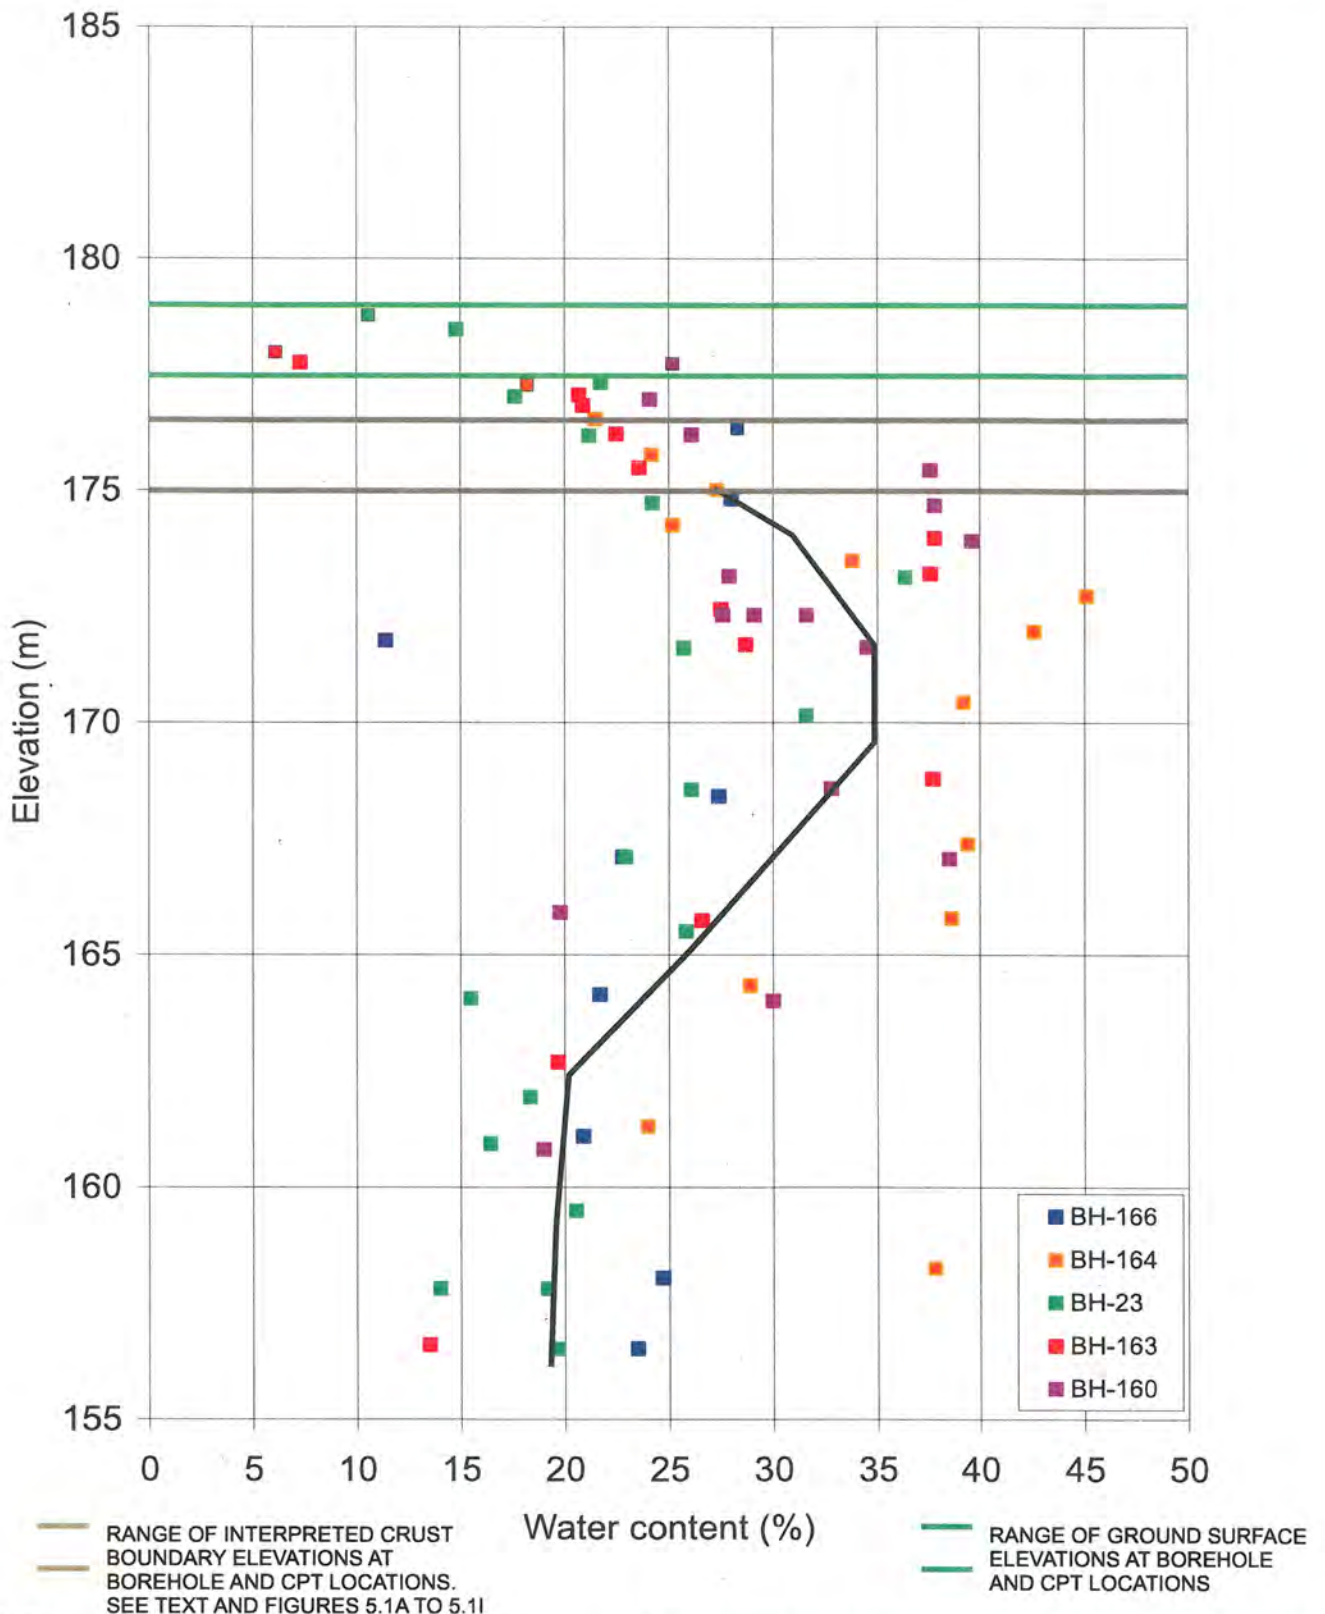
1. THIS FIGURE IS TO BE READ WITH THE REPORT TITLED "SUBSURFACE CONDITIONS INTERPRETATION REPORT, WINDSOR-ESSEX PARKWAY"
2. THIS FIGURE REPRESENTS A SUMMARY OF LABORATORY WATER CONTENT DETERMINATION AND THE INTERPRETED WATER CONTENT PROFILE AS DESCRIBED IN THE TEXT OF THE REPORT REFERENCED ABOVE.
3. THE PROFILE PROVIDED ABOVE IS CONSIDERED TO BE REPRESENTATIVE OF THE 50TH PERCENTILE VALUES AND THE 90TH AND 10TH PERCENTILE VALUES ARE TO BE TAKEN AS THE 50TH PERCENTILE WATER CONTENT PLUS OR MINUS A WATER CONTENT OF 5%, RESPECTIVELY

PROJECT <b>SUBSURFACE CONDITIONS INTERPRETATION REPORT</b>			
TITLE <b>WINDSOR-ESSEX PARKWAY WINDSOR, ONTARIO</b>			
INTERPRETED WATER CONTENT PROFILE STATION 9+900 to 11+100			
PROJECT No. 07-1130-2070/05-1140-003		FILE No. 0711302070-R02057	
CADD	SUB	DEC 09	SCALE AS SHOWN REV. 1
CHECK	<i>[Signature]</i>	<i>[Signature]</i>	<b>5.7A</b>

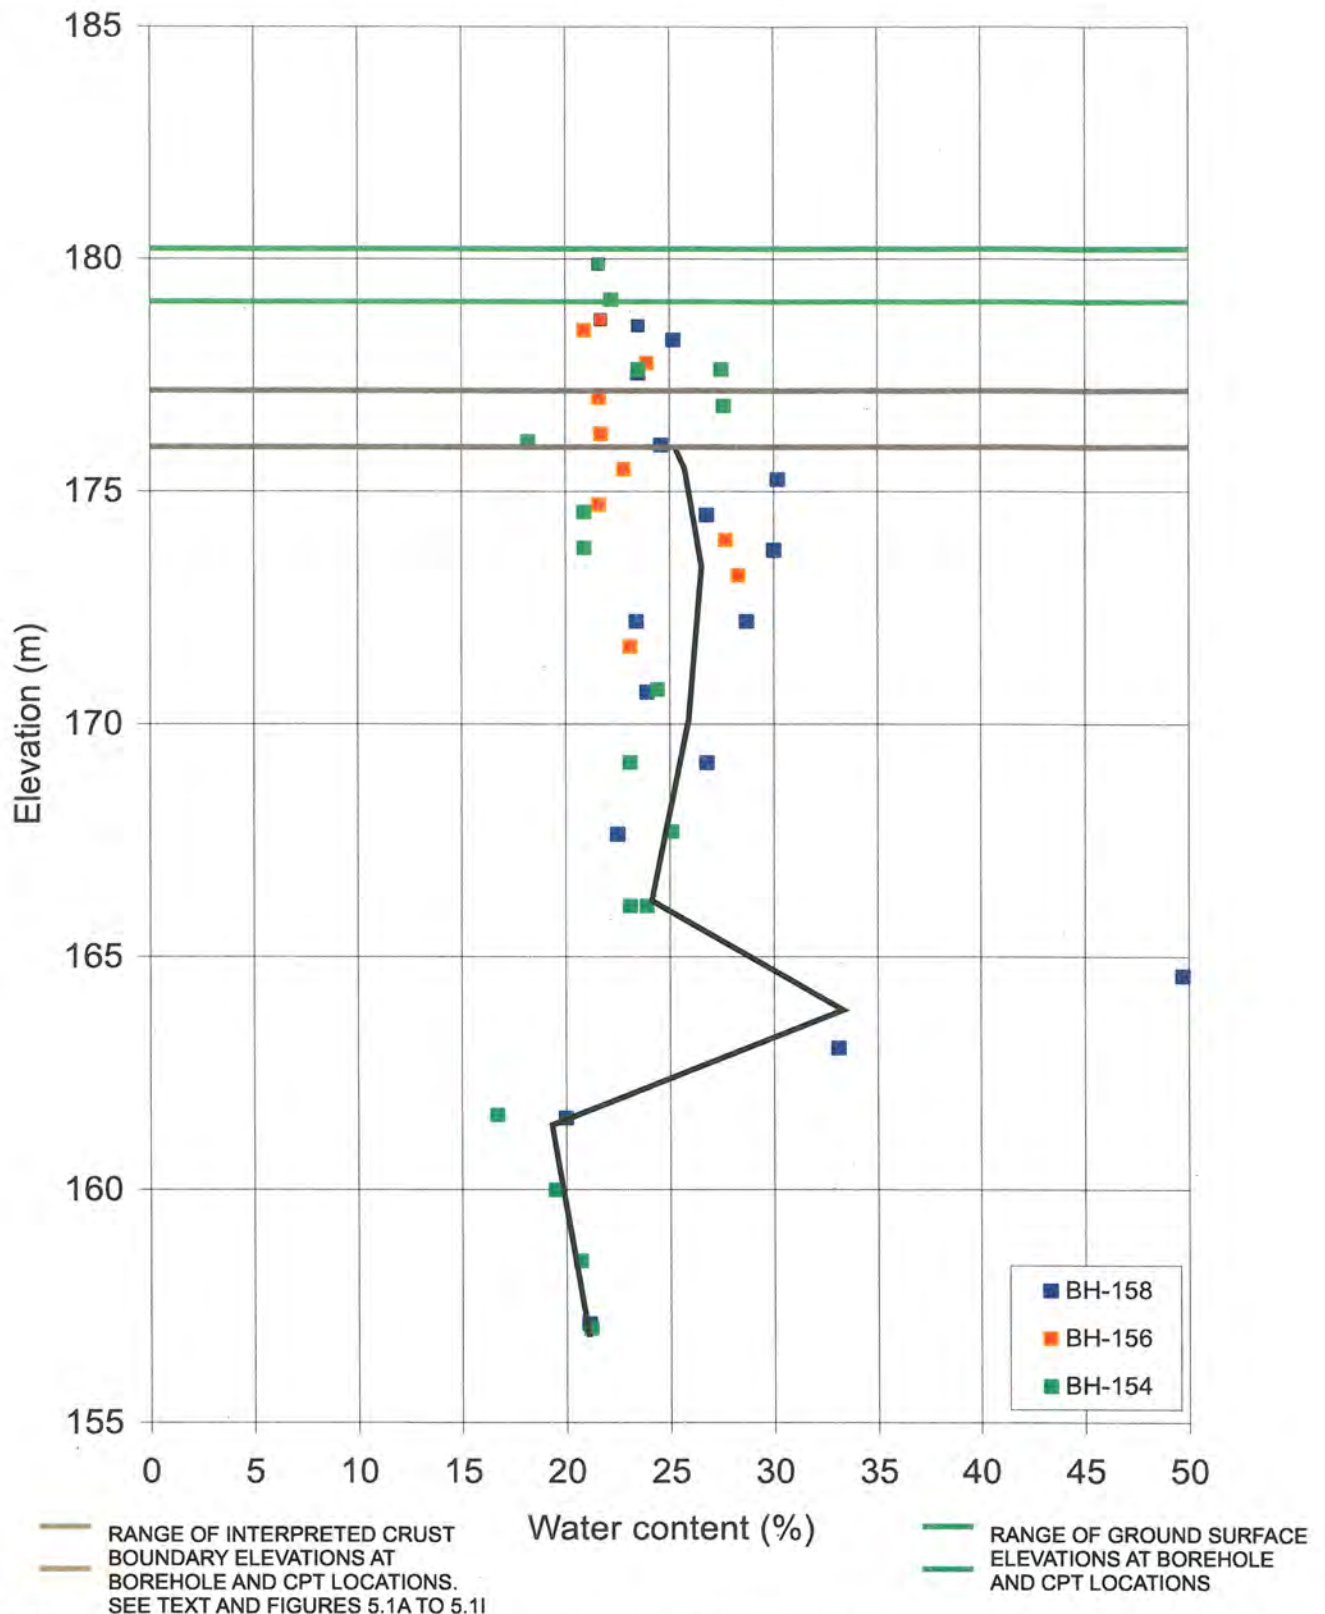
1. THIS FIGURE IS TO BE READ WITH THE REPORT TITLED "SUBSURFACE CONDITIONS INTERPRETATION REPORT, WINDSOR-ESSEX PARKWAY"
2. THIS FIGURE REPRESENTS A SUMMARY OF LABORATORY WATER CONTENT DETERMINATION AND THE INTERPRETED WATER CONTENT PROFILE AS DESCRIBED IN THE TEXT OF THE REPORT REFERENCED ABOVE.
3. THE PROFILE PROVIDED ABOVE IS CONSIDERED TO BE REPRESENTATIVE OF THE 50TH PERCENTILE VALUES AND THE 90TH AND 10TH PERCENTILE VALUES ARE TO BE TAKEN AS THE 50TH PERCENTILE WATER CONTENT PLUS OR MINUS A WATER CONTENT OF 5%, RESPECTIVELY

PROJECT <b>SUBSURFACE CONDITIONS INTERPRETATION REPORT</b>			
<b>WINDSOR-ESSEX PARKWAY</b>			
<b>WINDSOR, ONTARIO</b>			
TITLE			
<b>INTERPRETED WATER CONTENT PROFILE</b>			
<b>STATION 11+100 to 12+100</b>			
PROJECT No. 07-1130-2070/05-1140-003		FILE No. 0711302070-R02057	
CADD	SUB	DEC 09	SCALE AS SHOWN REV. 1
CHECK	<i>[Signature]</i>	<i>[Signature]</i>	<b>5.7B</b>

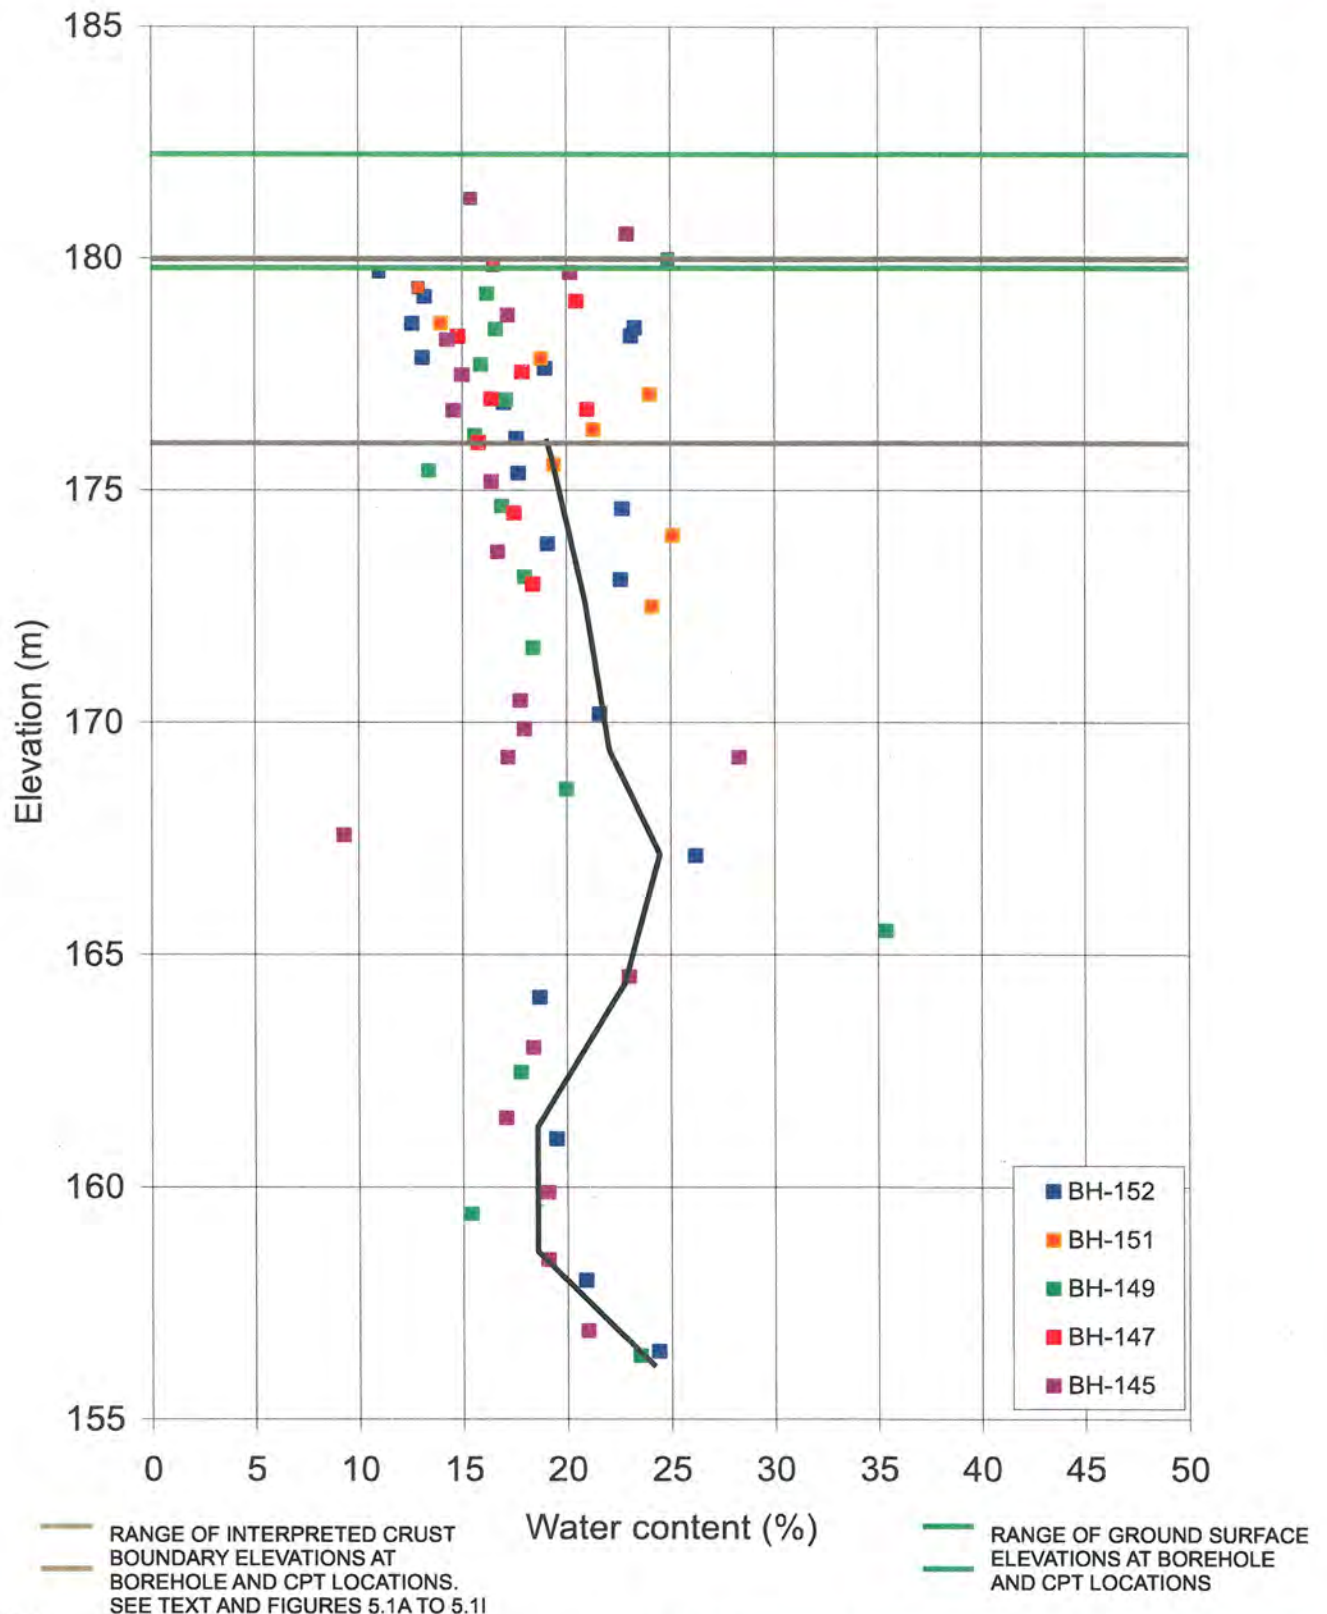
1. THIS FIGURE IS TO BE READ WITH THE REPORT TITLED "SUBSURFACE CONDITIONS INTERPRETATION REPORT, WINDSOR-ESSEX PARKWAY"
2. THIS FIGURE REPRESENTS A SUMMARY OF LABORATORY WATER CONTENT DETERMINATION AND THE INTERPRETED WATER CONTENT PROFILE AS DESCRIBED IN THE TEXT OF THE REPORT REFERENCED ABOVE.
3. THE PROFILE PROVIDED ABOVE IS CONSIDERED TO BE REPRESENTATIVE OF THE 50TH PERCENTILE VALUES AND THE 90TH AND 10TH PERCENTILE VALUES ARE TO BE TAKEN AS THE 50TH PERCENTILE WATER CONTENT PLUS OR MINUS A WATER CONTENT OF 5%, RESPECTIVELY

PROJECT <b>SUBSURFACE CONDITIONS INTERPRETATION REPORT</b>			
TITLE <b>WINDSOR-ESSEX PARKWAY WINDSOR, ONTARIO</b>			
INTERPRETED WATER CONTENT PROFILE STATION 12+100 to 13+000			
PROJECT No. 07-1130-2070/05-1140-003		FILE No. 0711302070-R02057	
CADD	SUB	DEC 09	SCALE AS SHOWN REV 1
CHECK	<i>WY</i>	<i>Dec 09</i>	<b>5.7C</b>

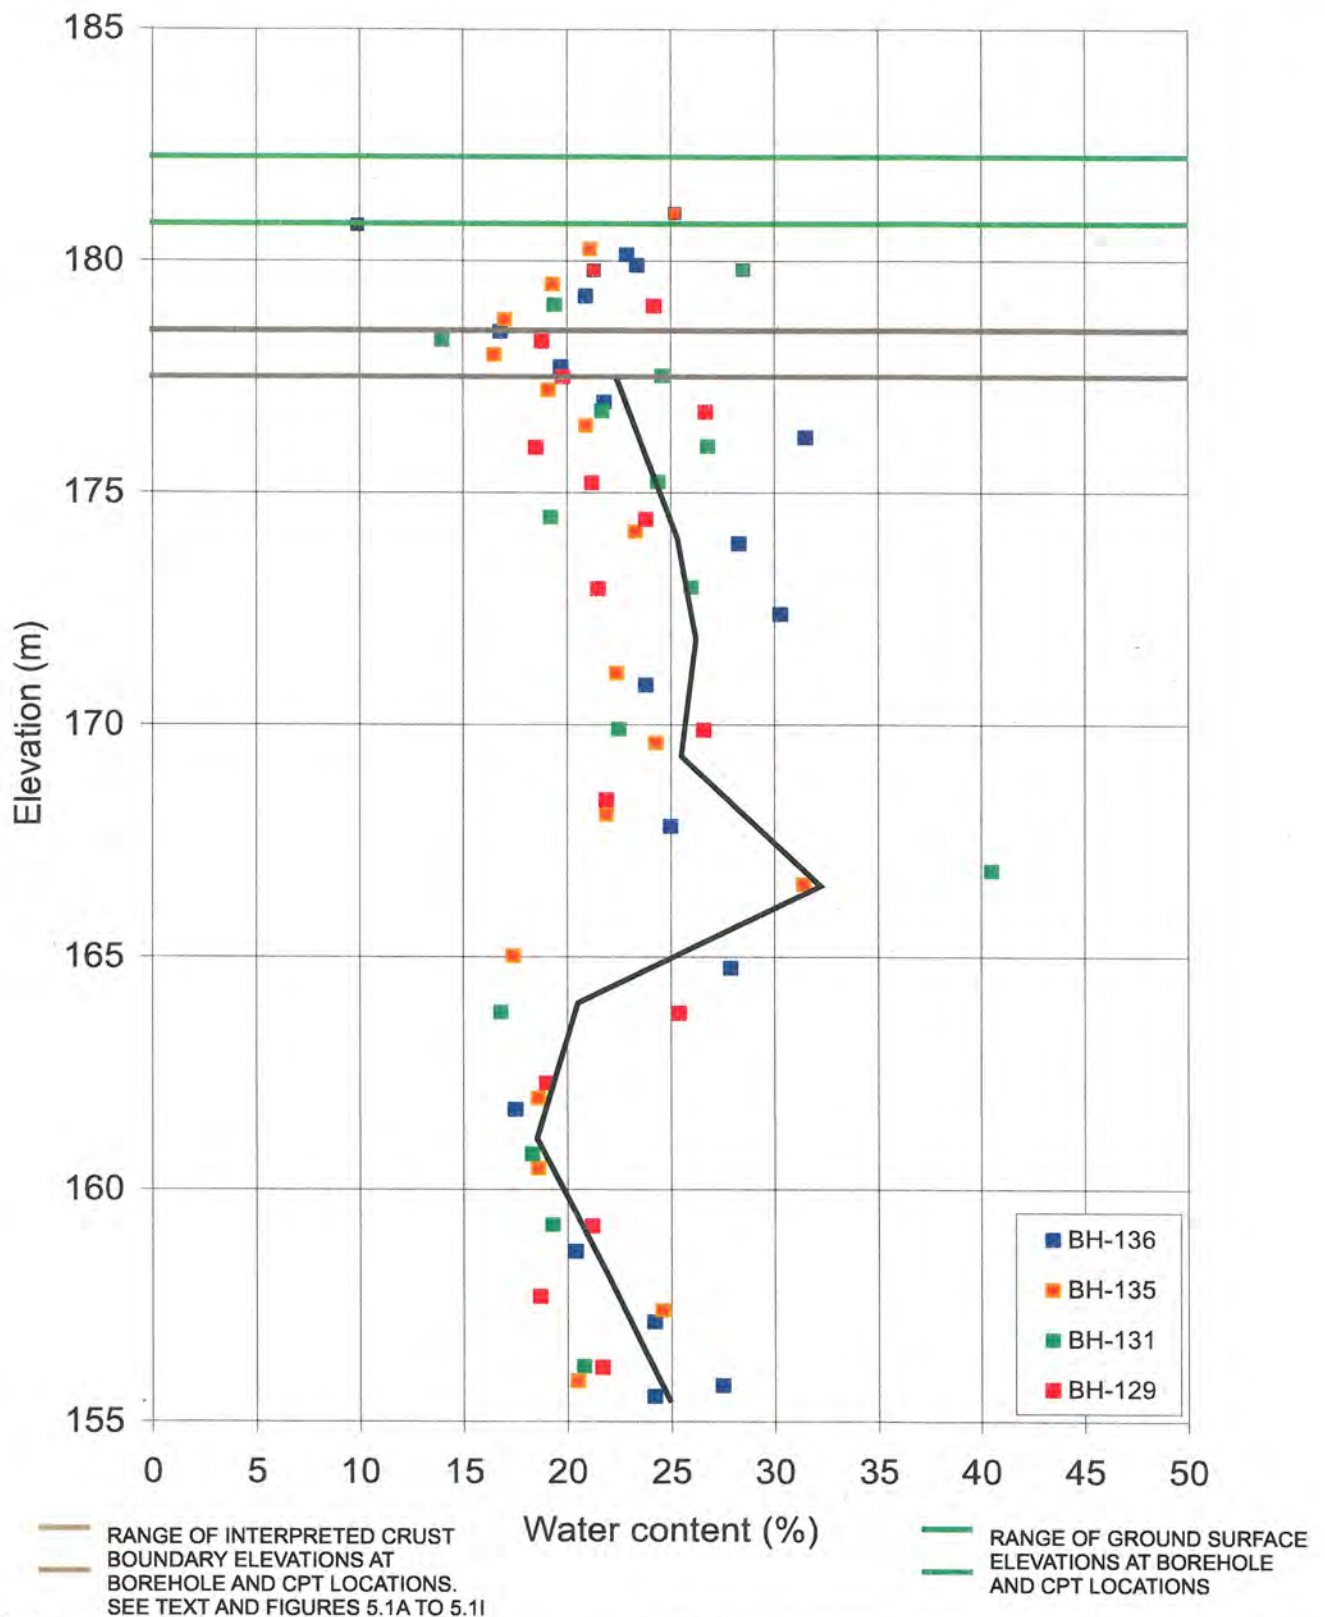
1. THIS FIGURE IS TO BE READ WITH THE REPORT TITLED "SUBSURFACE CONDITIONS INTERPRETATION REPORT, WINDSOR-ESSEX PARKWAY"
2. THIS FIGURE REPRESENTS A SUMMARY OF LABORATORY WATER CONTENT DETERMINATION AND THE INTERPRETED WATER CONTENT PROFILE AS DESCRIBED IN THE TEXT OF THE REPORT REFERENCED ABOVE.
3. THE PROFILE PROVIDED ABOVE IS CONSIDERED TO BE REPRESENTATIVE OF THE 50TH PERCENTILE VALUES AND THE 90TH AND 10TH PERCENTILE VALUES ARE TO BE TAKEN AS THE 50TH PERCENTILE WATER CONTENT PLUS OR MINUS A WATER CONTENT OF 5%, RESPECTIVELY

PROJECT <b>SUBSURFACE CONDITIONS INTERPRETATION REPORT</b>			
<b>WINDSOR-ESSEX PARKWAY</b>			
<b>WINDSOR, ONTARIO</b>			
TITLE			
<b>INTERPRETED WATER CONTENT PROFILE</b>			
<b>STATION 13+900 to 10+300</b>			
PROJECT No. 07-1130-2070/05-1140-003		FILE No. 0711302070-R02057	
CADD	SJR	DEC 09	SCALE AS SHOWN REV. 1
CHECK	<i>MY</i>	<i>DEC 09</i>	<b>5.7E</b>

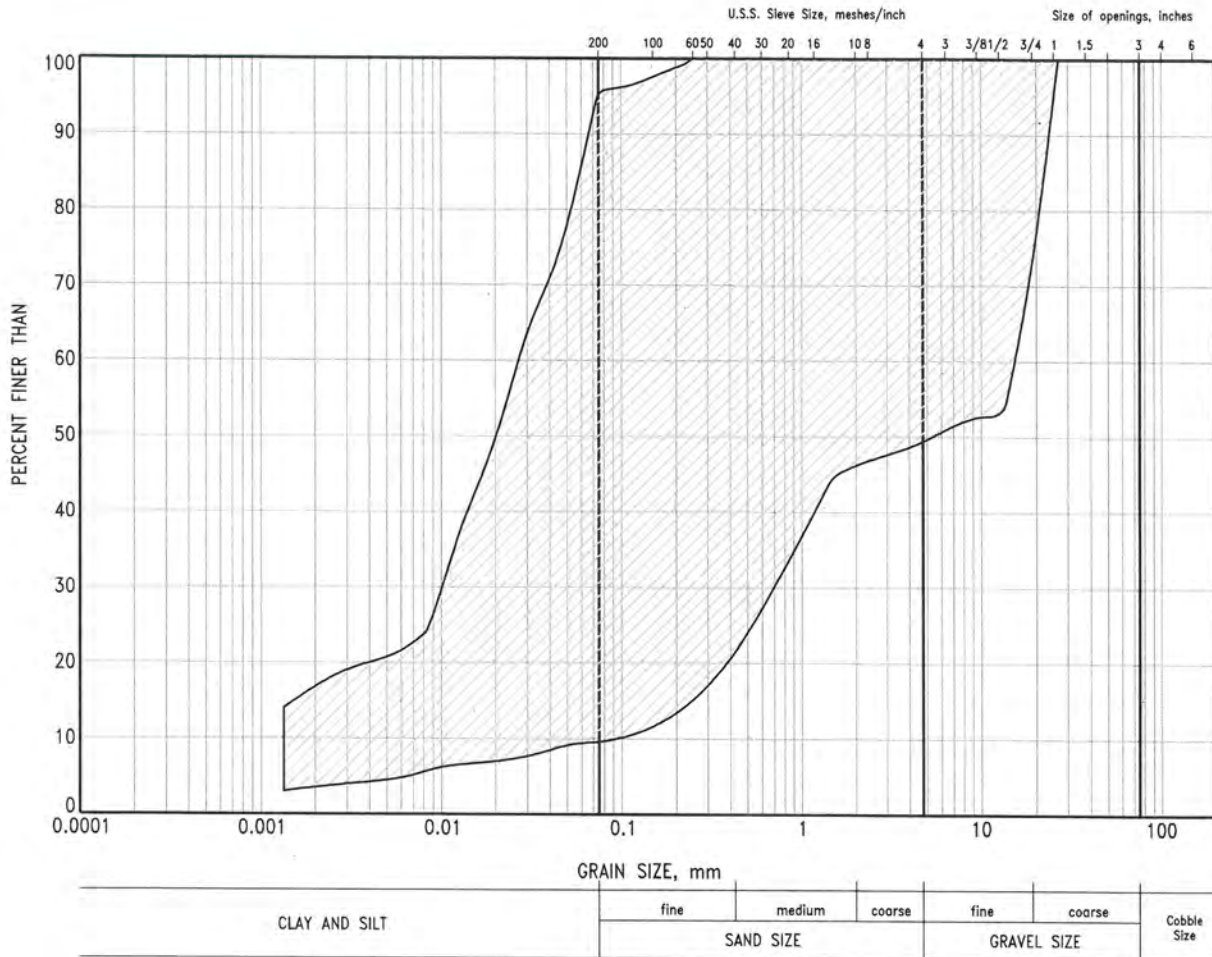
<b>Golder Associates</b> LONDON, ONTARIO			<b>FIGURE 5.8</b>

The grain size distribution envelope shown above is based on all grain size distribution analyses conducted on samples obtained from the Lower Granular Deposits. For individual test results refer to the Geotechnical Data Report referenced in section 3.1. The samplers used for the explorations limit the maximum particle size that can be sampled and tested to about 40mm. Larger particles are known to be present in the deposit as discussed in the report text.

PROJECT			
<b>SUBSURFACE CONDITIONS INTERPRETATION REPORT</b>			
<b>WINDSOR-ESSEX PARKWAY</b>			
<b>WINDSOR, ONTARIO</b>			
TITLE			
<b>GRAIN SIZE DISTRIBUTION ENVELOPE</b>			
<b>LOWER GRANULAR DEPOSITS</b>			
PROJECT No.		07-1130-207-0	
FILE No.		0711302070-R02058	
CADD	LMK	Dec. 02/09	SCALE AS SHOWN
CHECK	SJB	Dec. 02/09	REV. 1

Figure 5.8: Grain Size Distribution Envelope, Silty Sand and Gravel
