## **WINDSOR-ESSEX PARKWAY**

# **Subsurface Conditions Interpretation Report**

**Report Number:** 07-1130-207-0-R02 / 05-1140-003

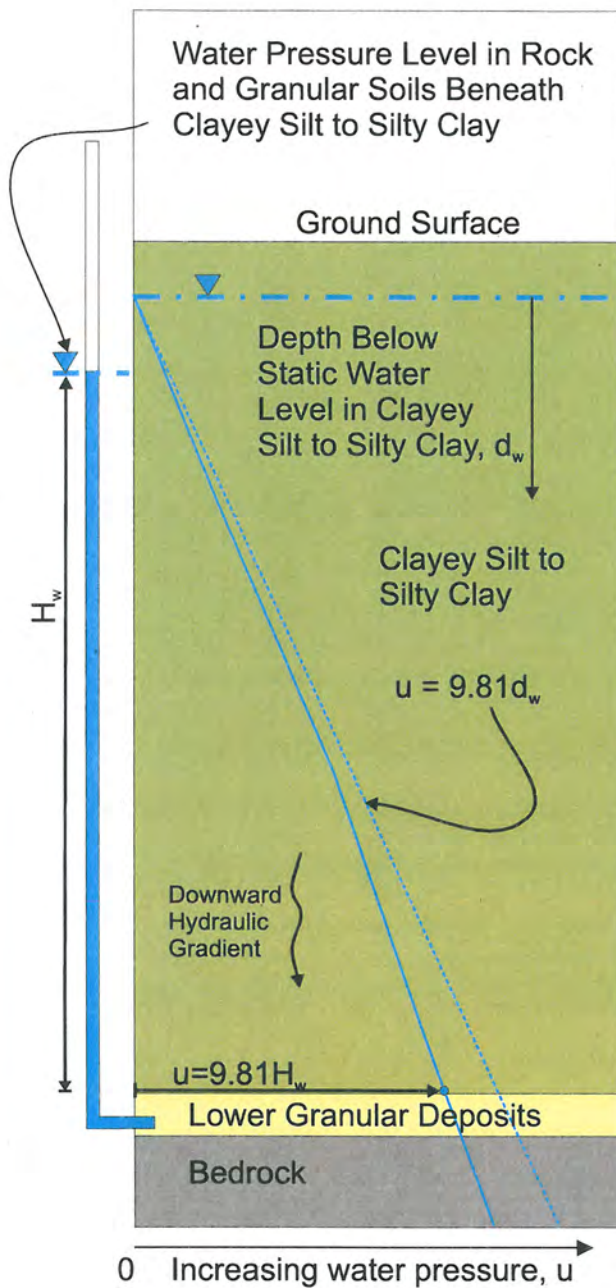
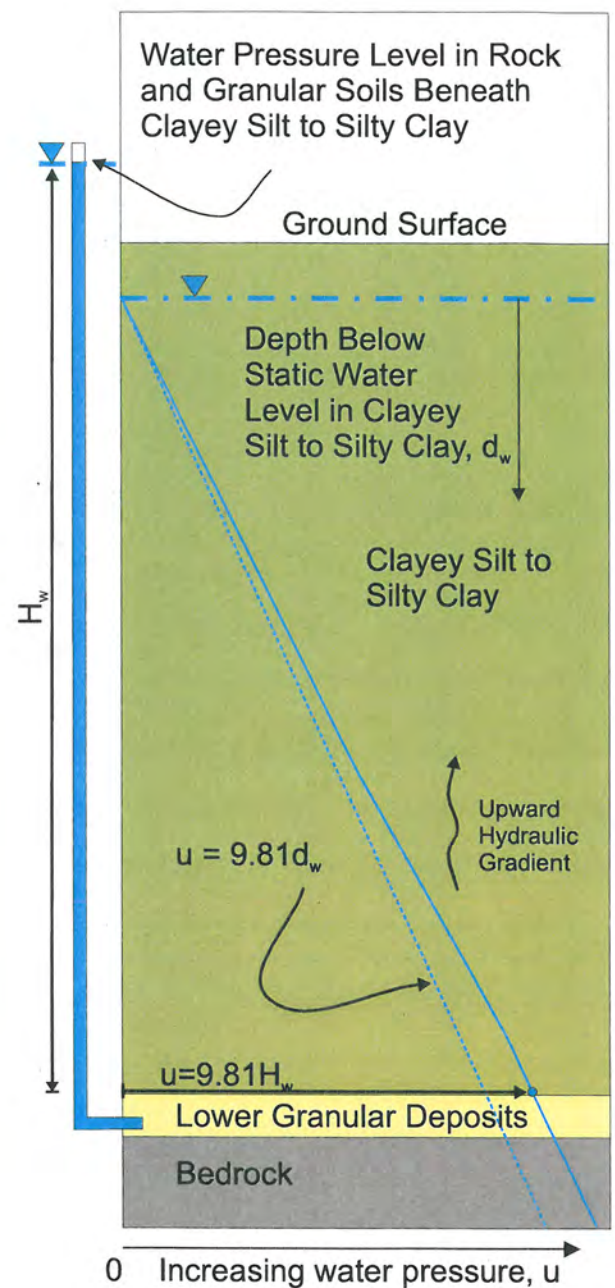
$u$  = water pressure

$H_w$  = head of water in bedrock or Lower Granular Deposits

PROJECT			
SUBSURFACE CONDITIONS INTERPRETATION REPORT			
WINDSOR-ESSEX PARKWAY			
WINDSOR, ONTARIO			
TITLE			
ILLUSTRATION OF UPWARD AND DOWNWARD			
HYDRAULIC GRADIENTS			
PROJECT No.		07-1130-2070	FILE No.
CADD		SJB	DEC 09
CHECK		M	Jew
SCALE		AS SHOWN REV 1	
5.9

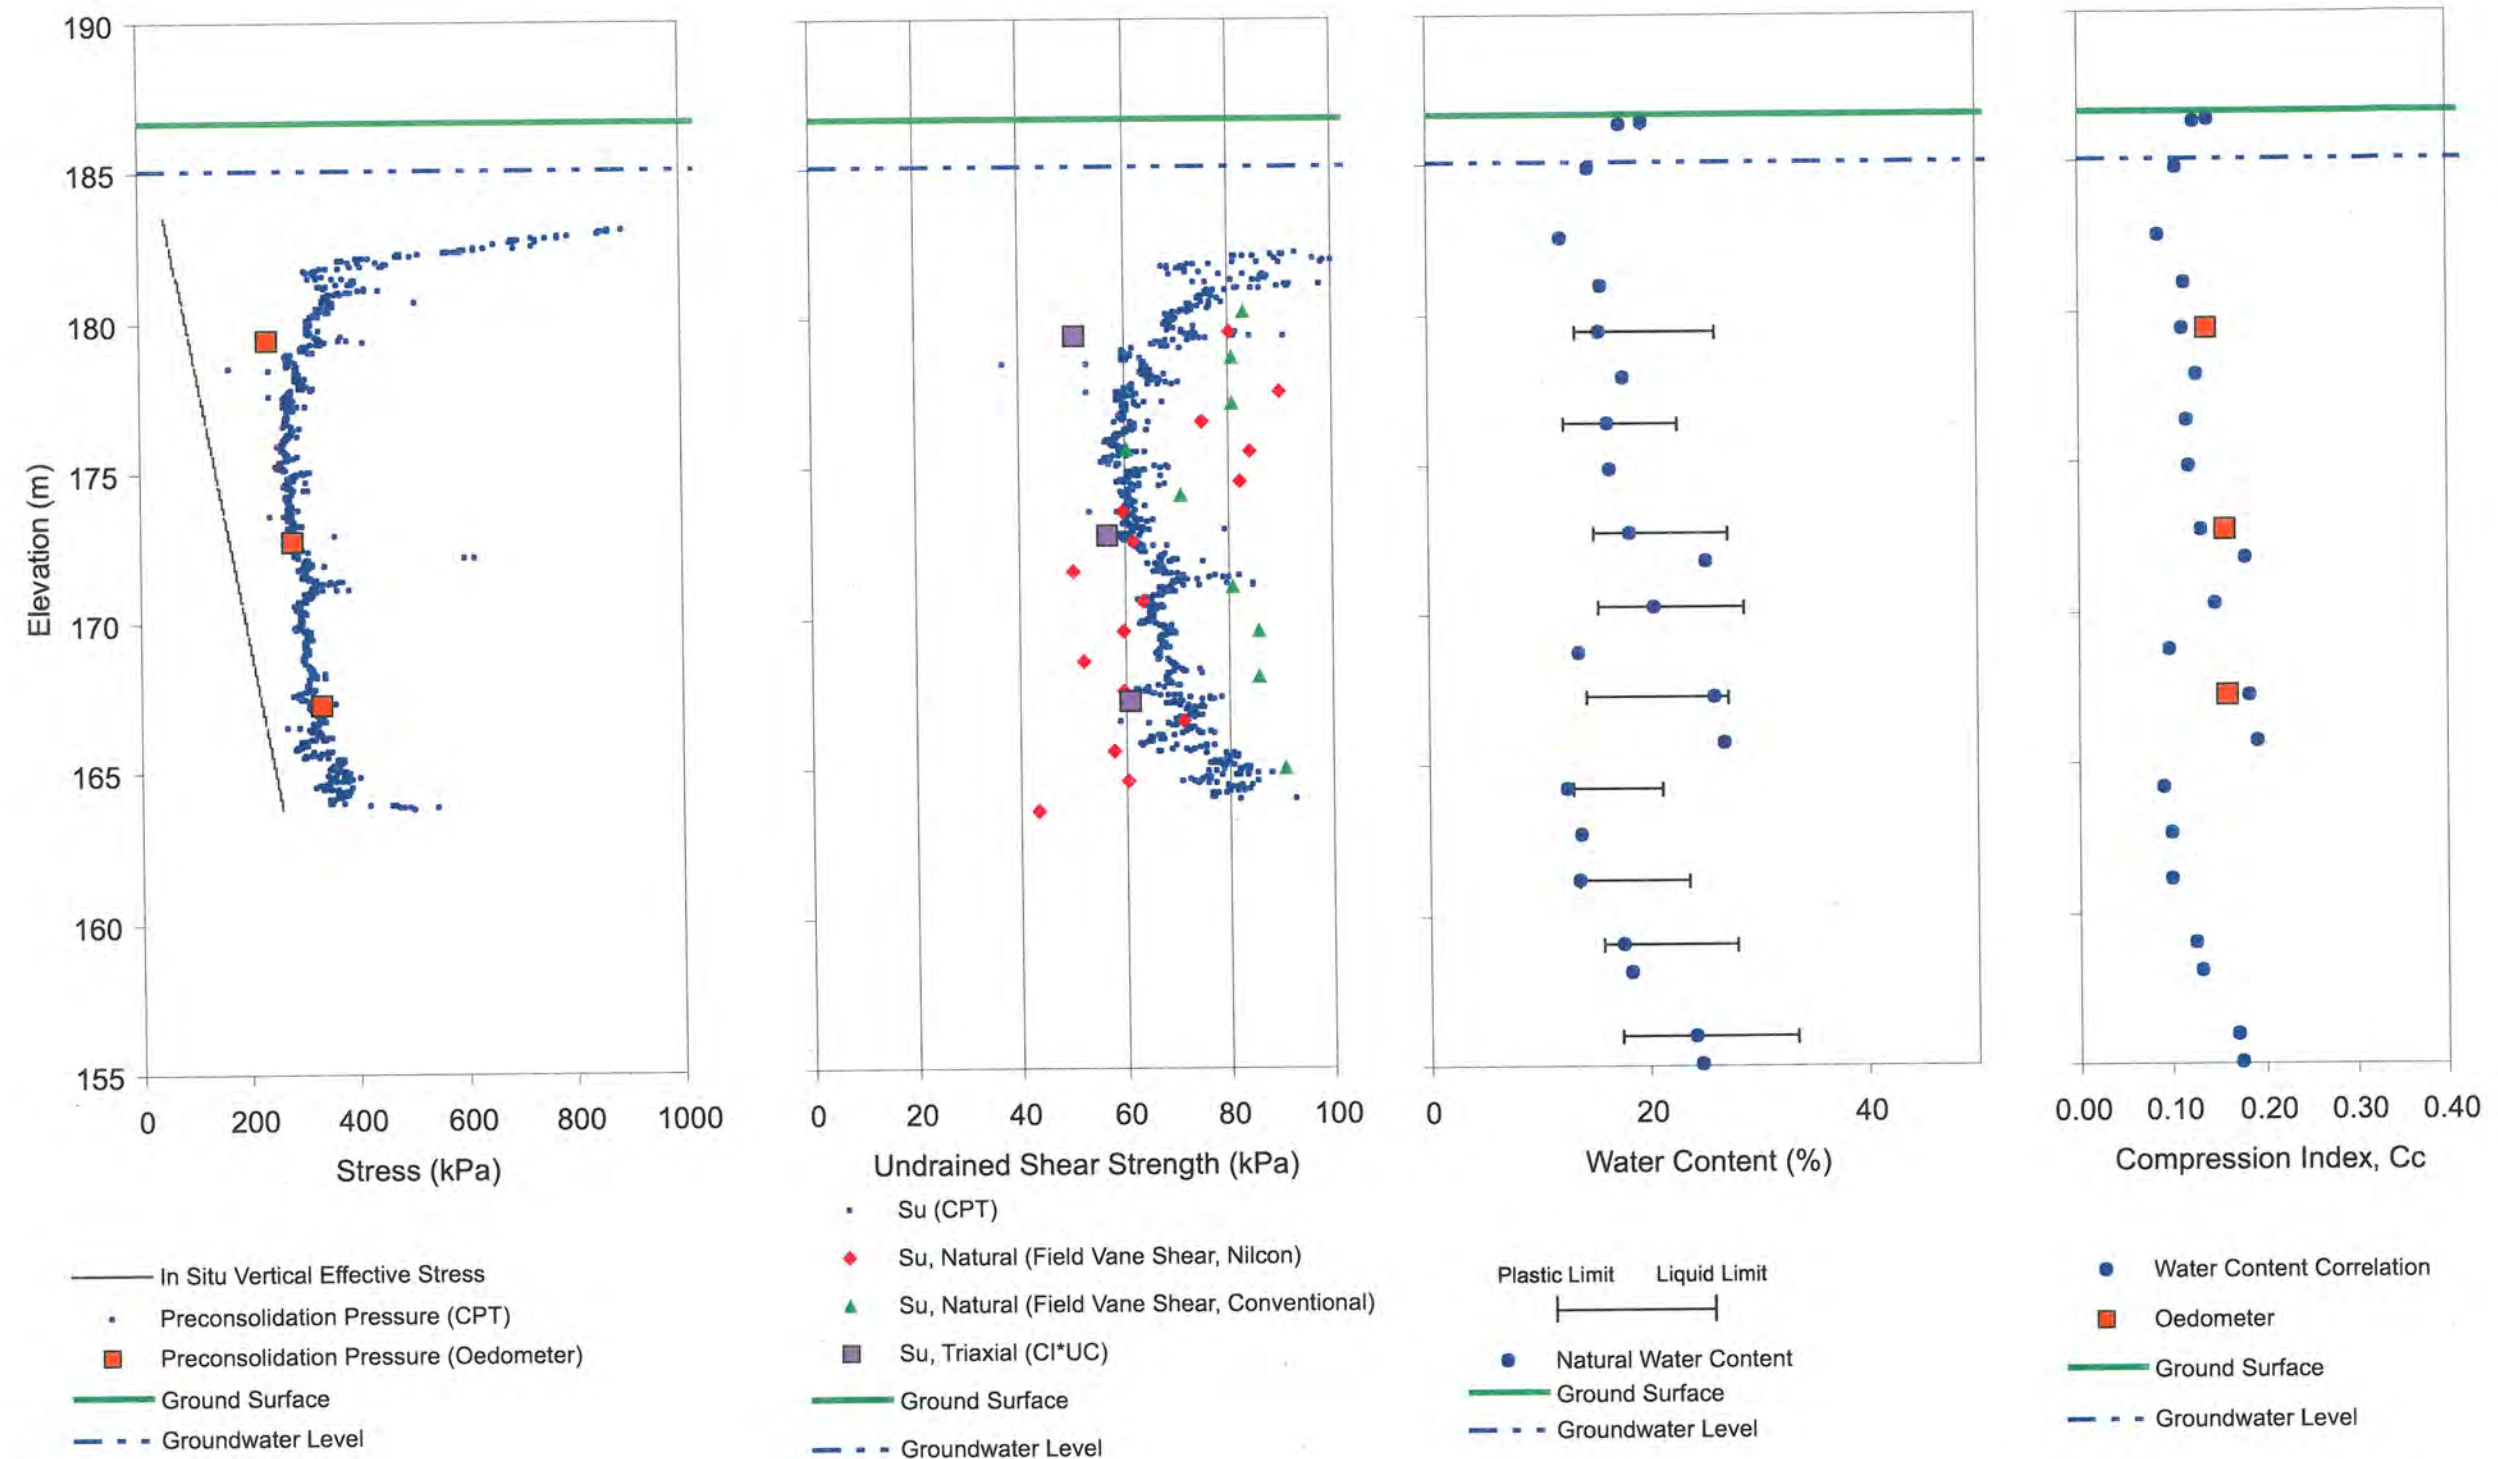
1. THIS FIGURE IS TO BE READ WITH THE REPORT TITLED "SUBSURFACE CONDITIONS INTERPRETATION REPORT, WINDSOR-ESSEX PARKWAY"
2. THIS FIGURE REPRESENTS A SUMMARY OF FIELD AND LABORATORY TESTING DATA AS DISCUSSED IN THE TEXT OF THE REPORT REFERENCED ABOVE.

PROJECT			
SUBSURFACE CONDITIONS INTERPRETATION REPORT			
WINDSOR-ESSEX PARKWAY			
WINDSOR, ONTARIO			
TITLE			
SUMMARY OF SUBSURFACE TEST DATA			
BOREHOLE BH-1/CPT-1			
PROJECT No.		07-1130-2070	
FILE No.		0711302070-R02081	
CADD	SUB	DESIGN	SCALE AS SHOWN REV. 1
CHECK	mm	DEC 09	6.1A

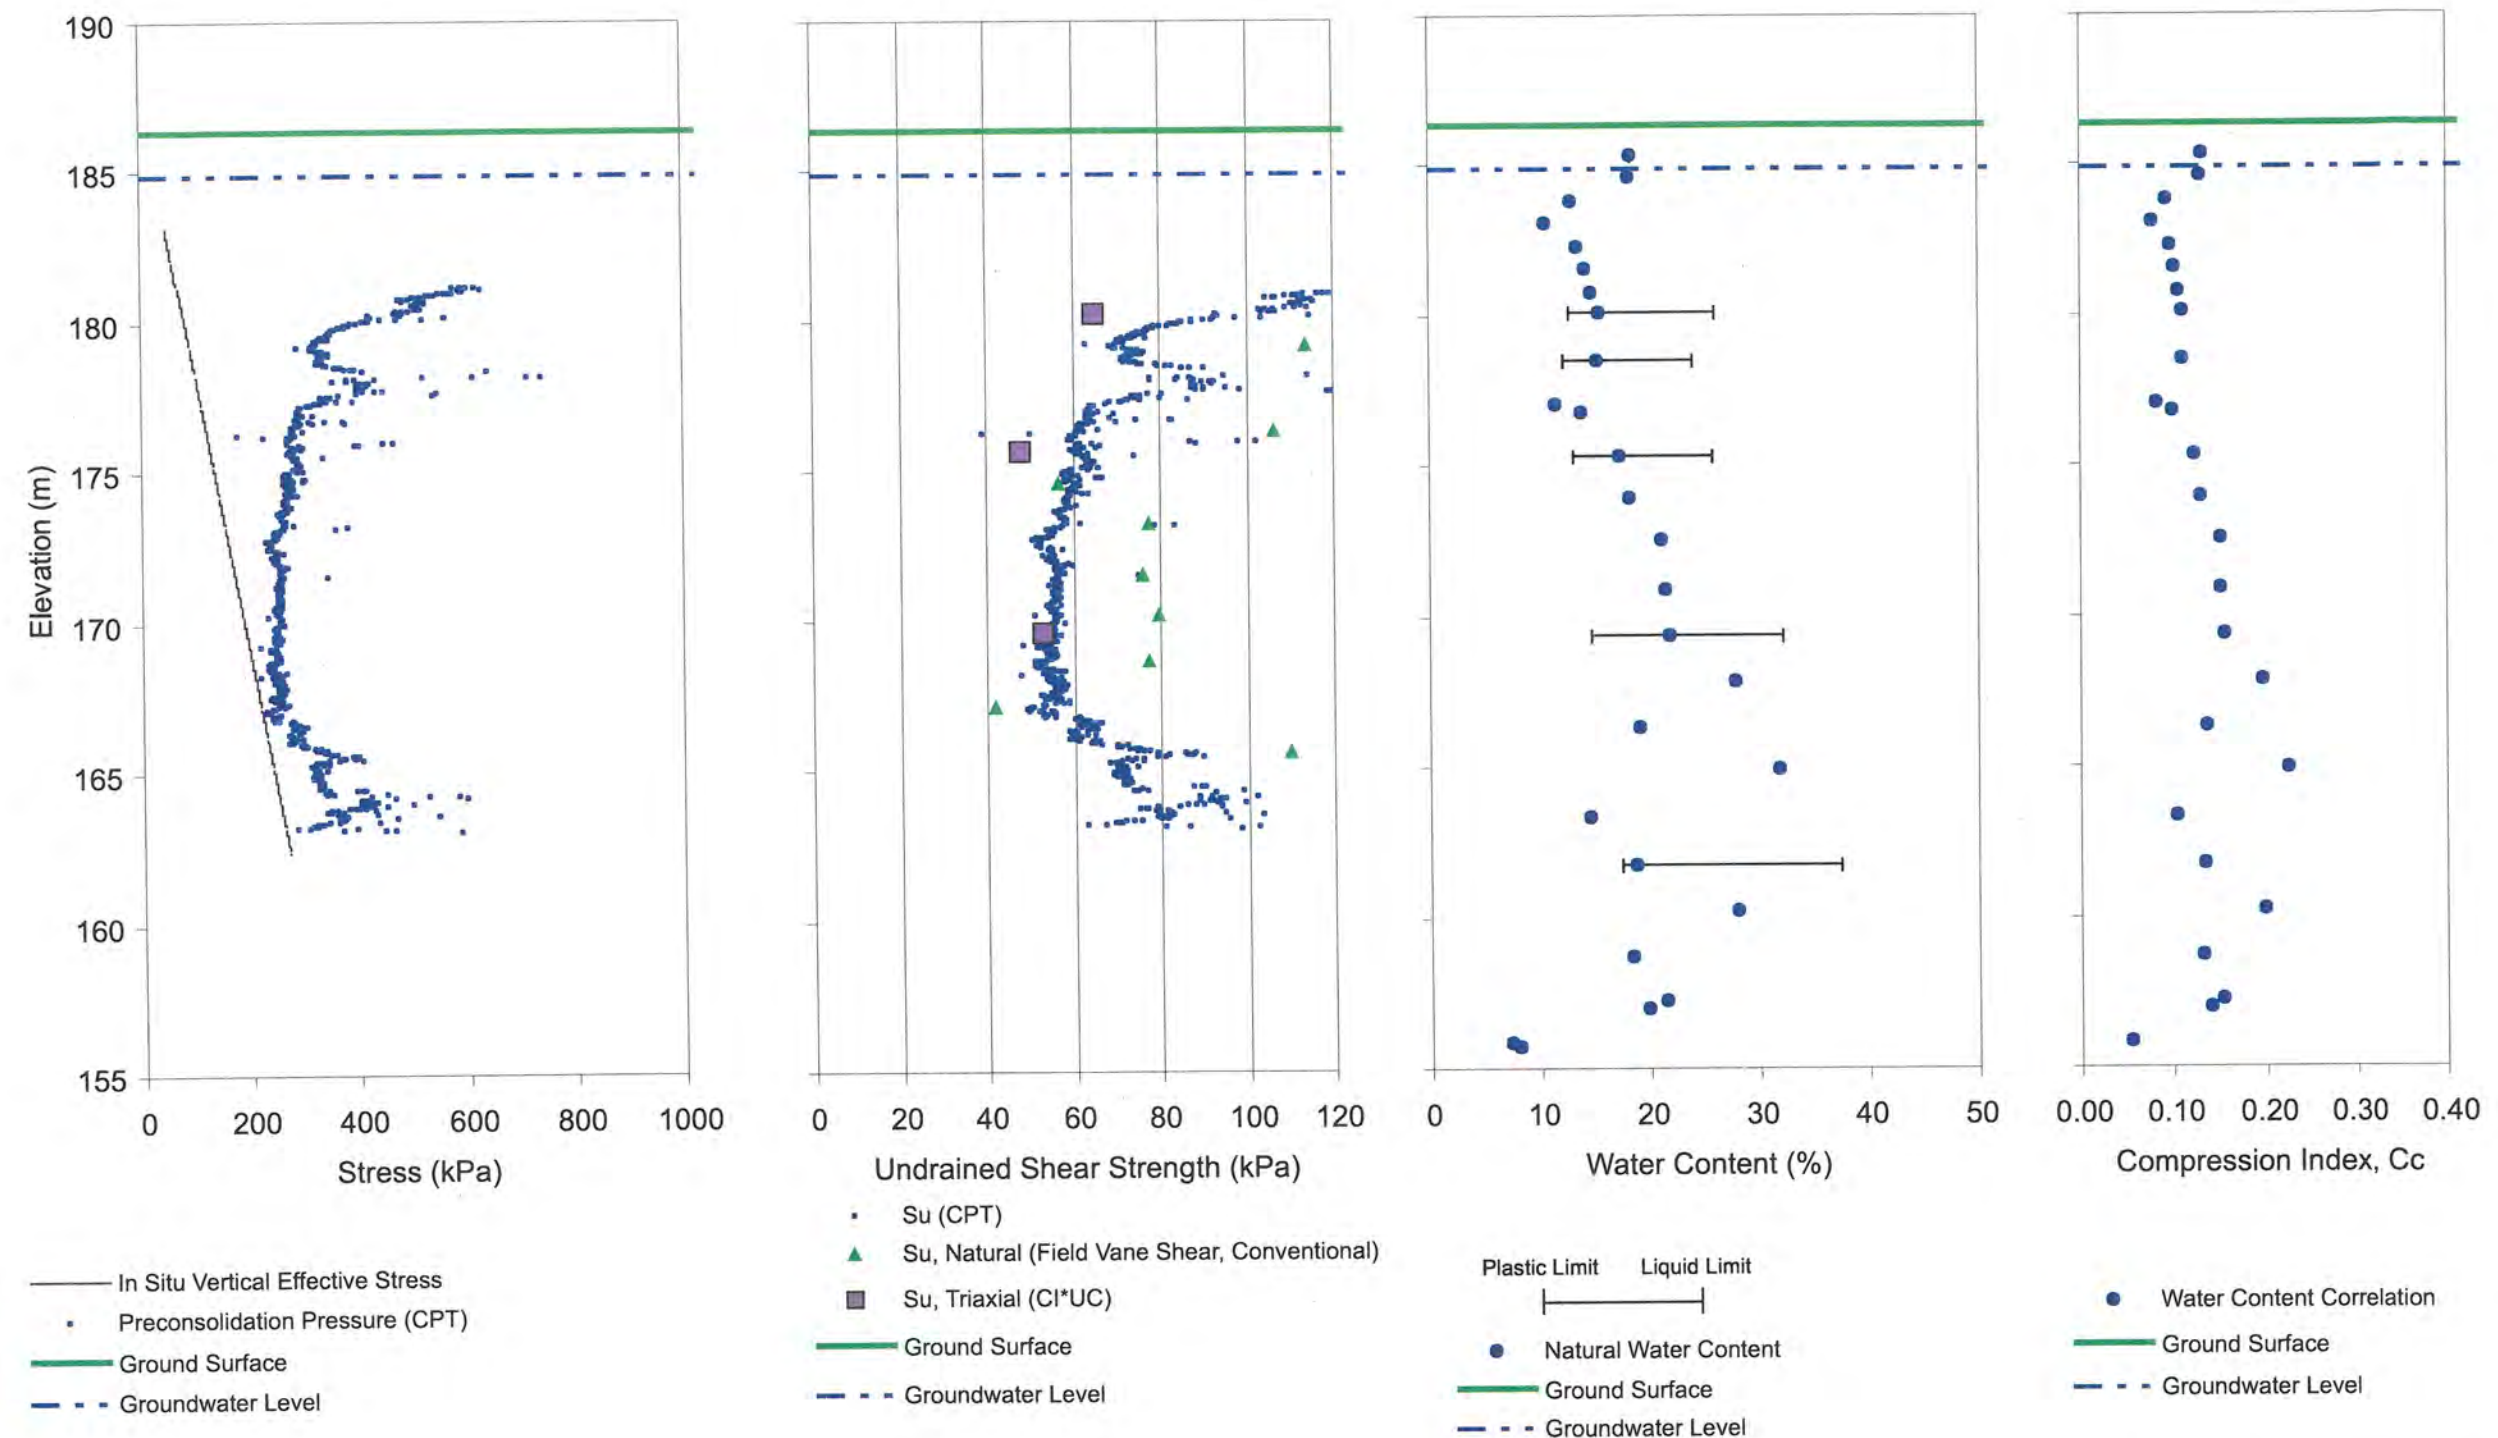
1. THIS FIGURE IS TO BE READ WITH THE REPORT TITLED "SUBSURFACE CONDITIONS INTERPRETATION REPORT, WINDSOR-ESSEX PARKWAY"
2. THIS FIGURE REPRESENTS A SUMMARY OF FIELD AND LABORATORY TESTING DATA AS DISCUSSED IN THE TEXT OF THE REPORT REFERENCED ABOVE.

PROJECT			
SUBSURFACE CONDITIONS INTERPRETATION REPORT			
WINDSOR-ESSEX PARKWAY			
WINDSOR, ONTARIO			
TITLE			
SUMMARY OF SUBSURFACE TEST DATA			
BOREHOLE BH105/CPT-2			
PROJECT No.		FILE No.	
07-1130-2070		0711302070-R02081	
CADD	SJB	DEC 09	SCALE AS SHOWN REV. 1
CHECK	AV	DEC 09	6.1B

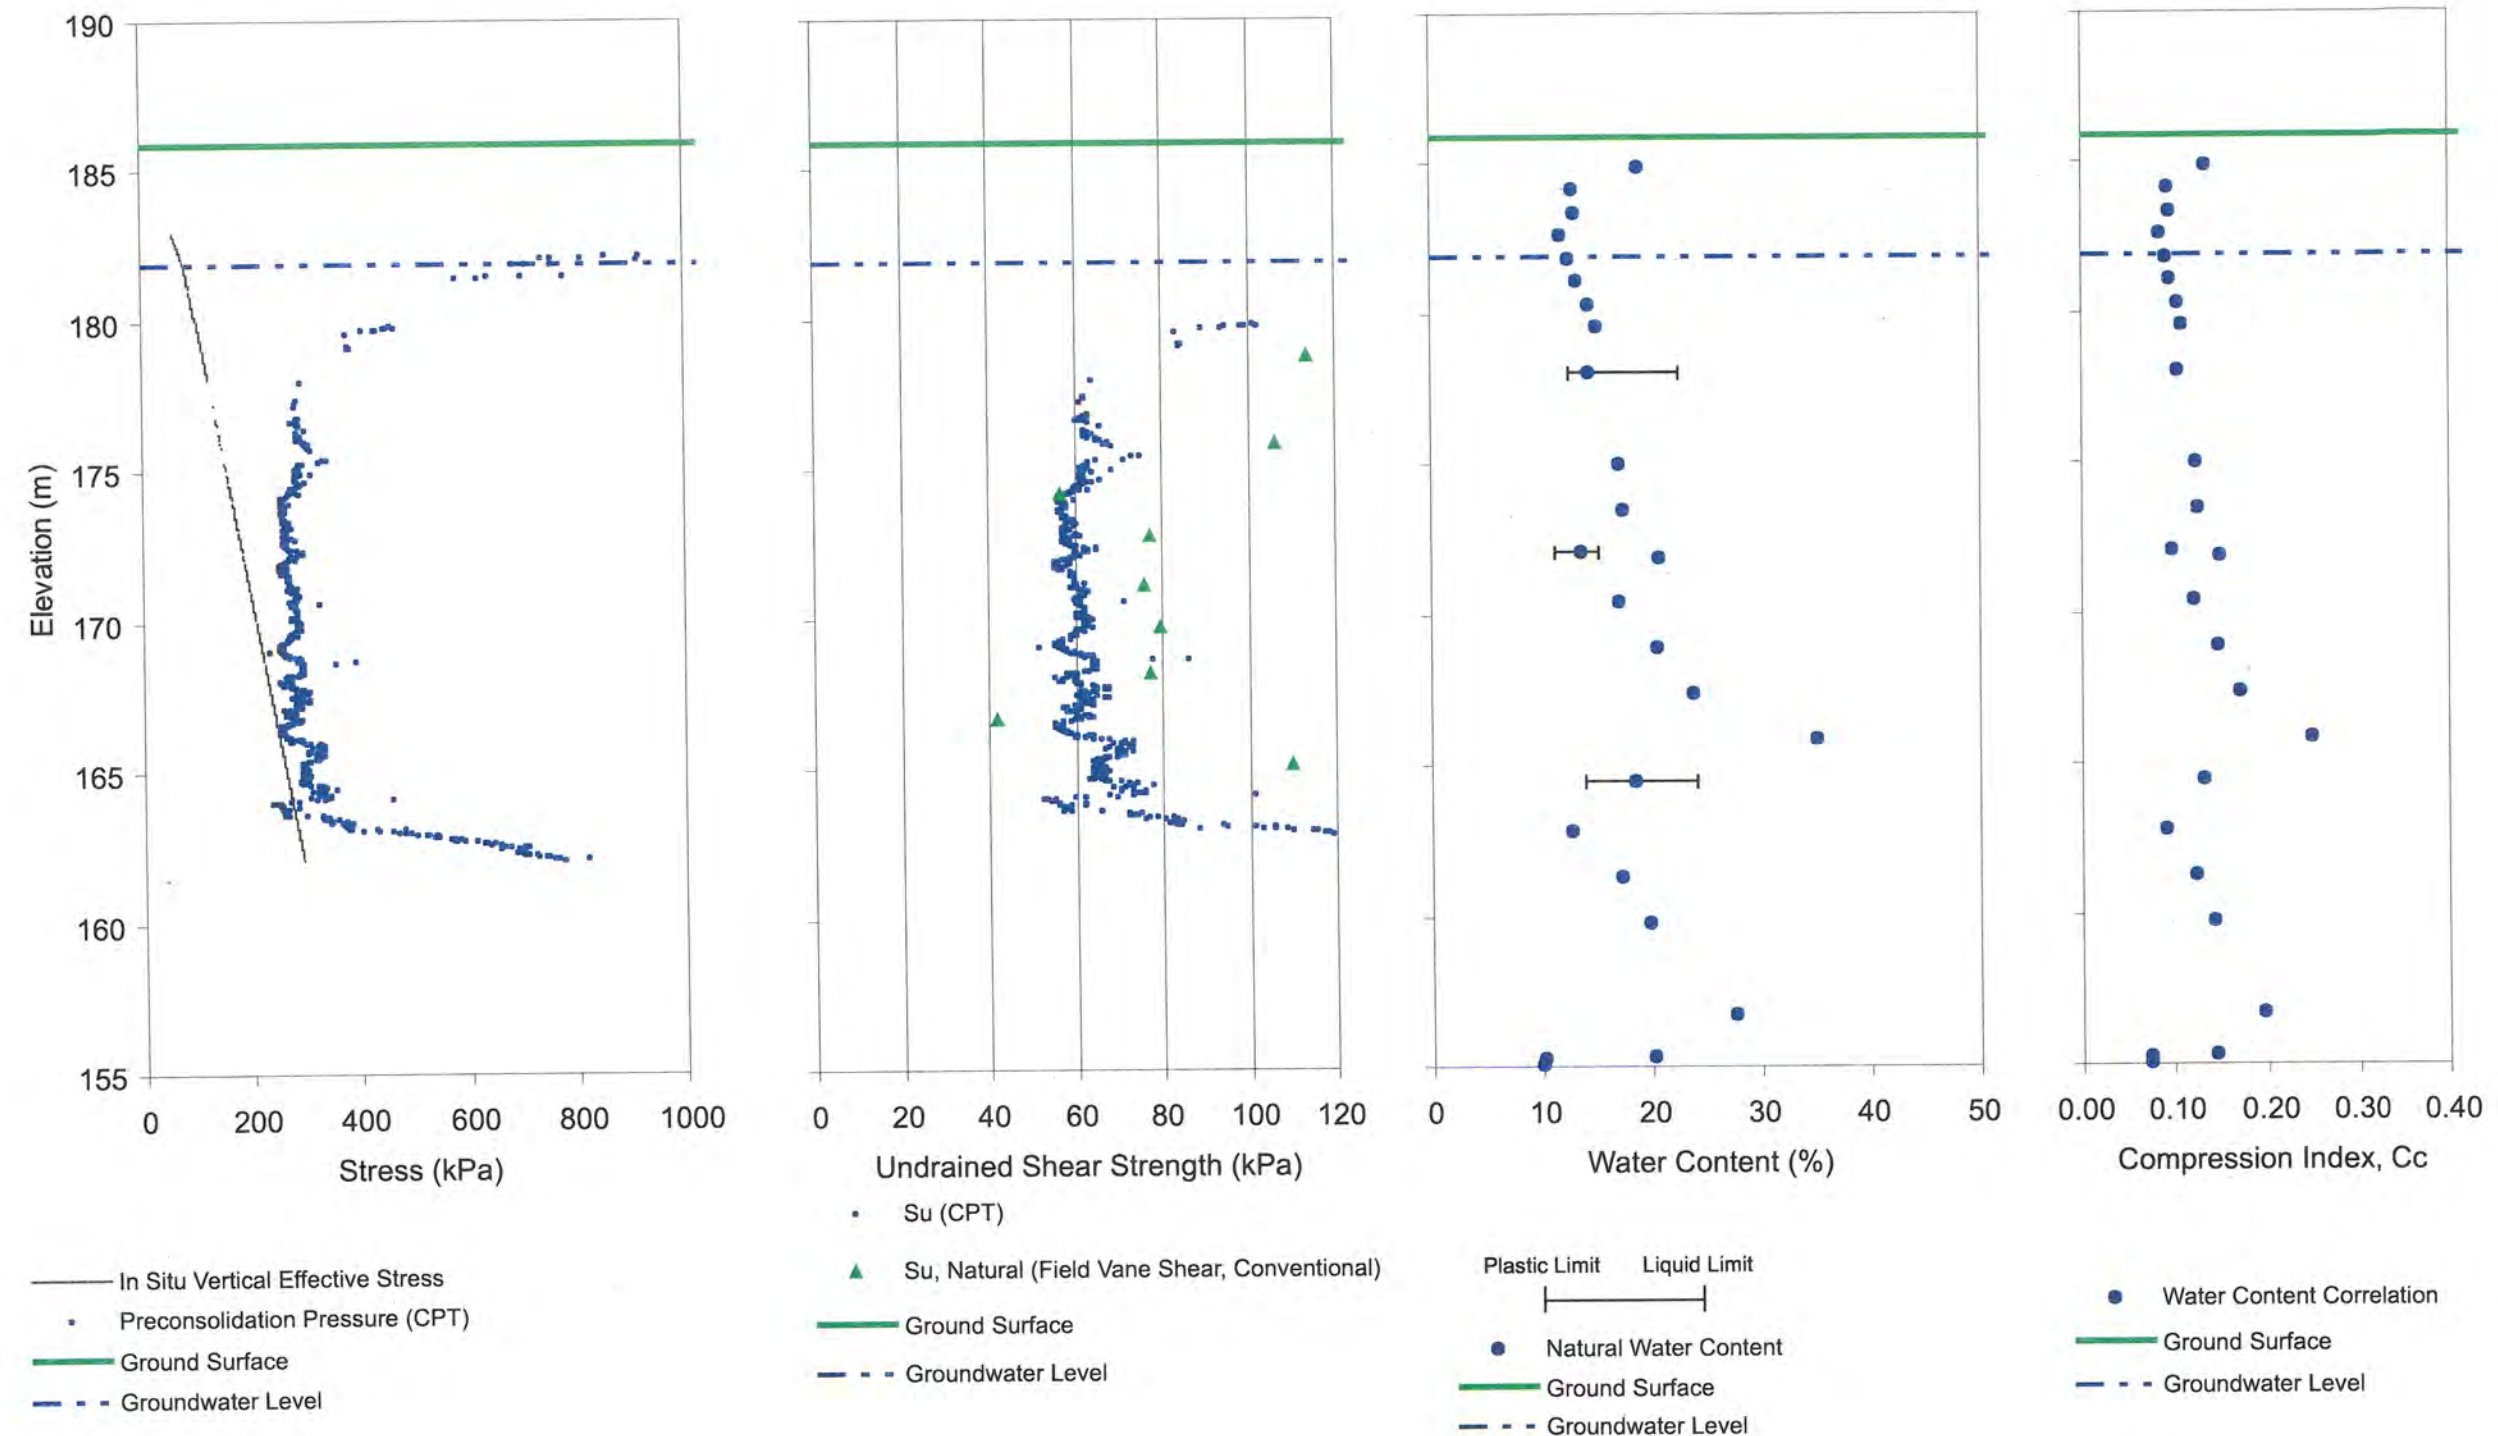
1. THIS FIGURE IS TO BE READ WITH THE REPORT TITLED "SUBSURFACE CONDITIONS INTERPRETATION REPORT, WINDSOR-ESSEX PARKWAY"
2. THIS FIGURE REPRESENTS A SUMMARY OF FIELD AND LABORATORY TESTING DATA AS DISCUSSED IN THE TEXT OF THE REPORT REFERENCED ABOVE.

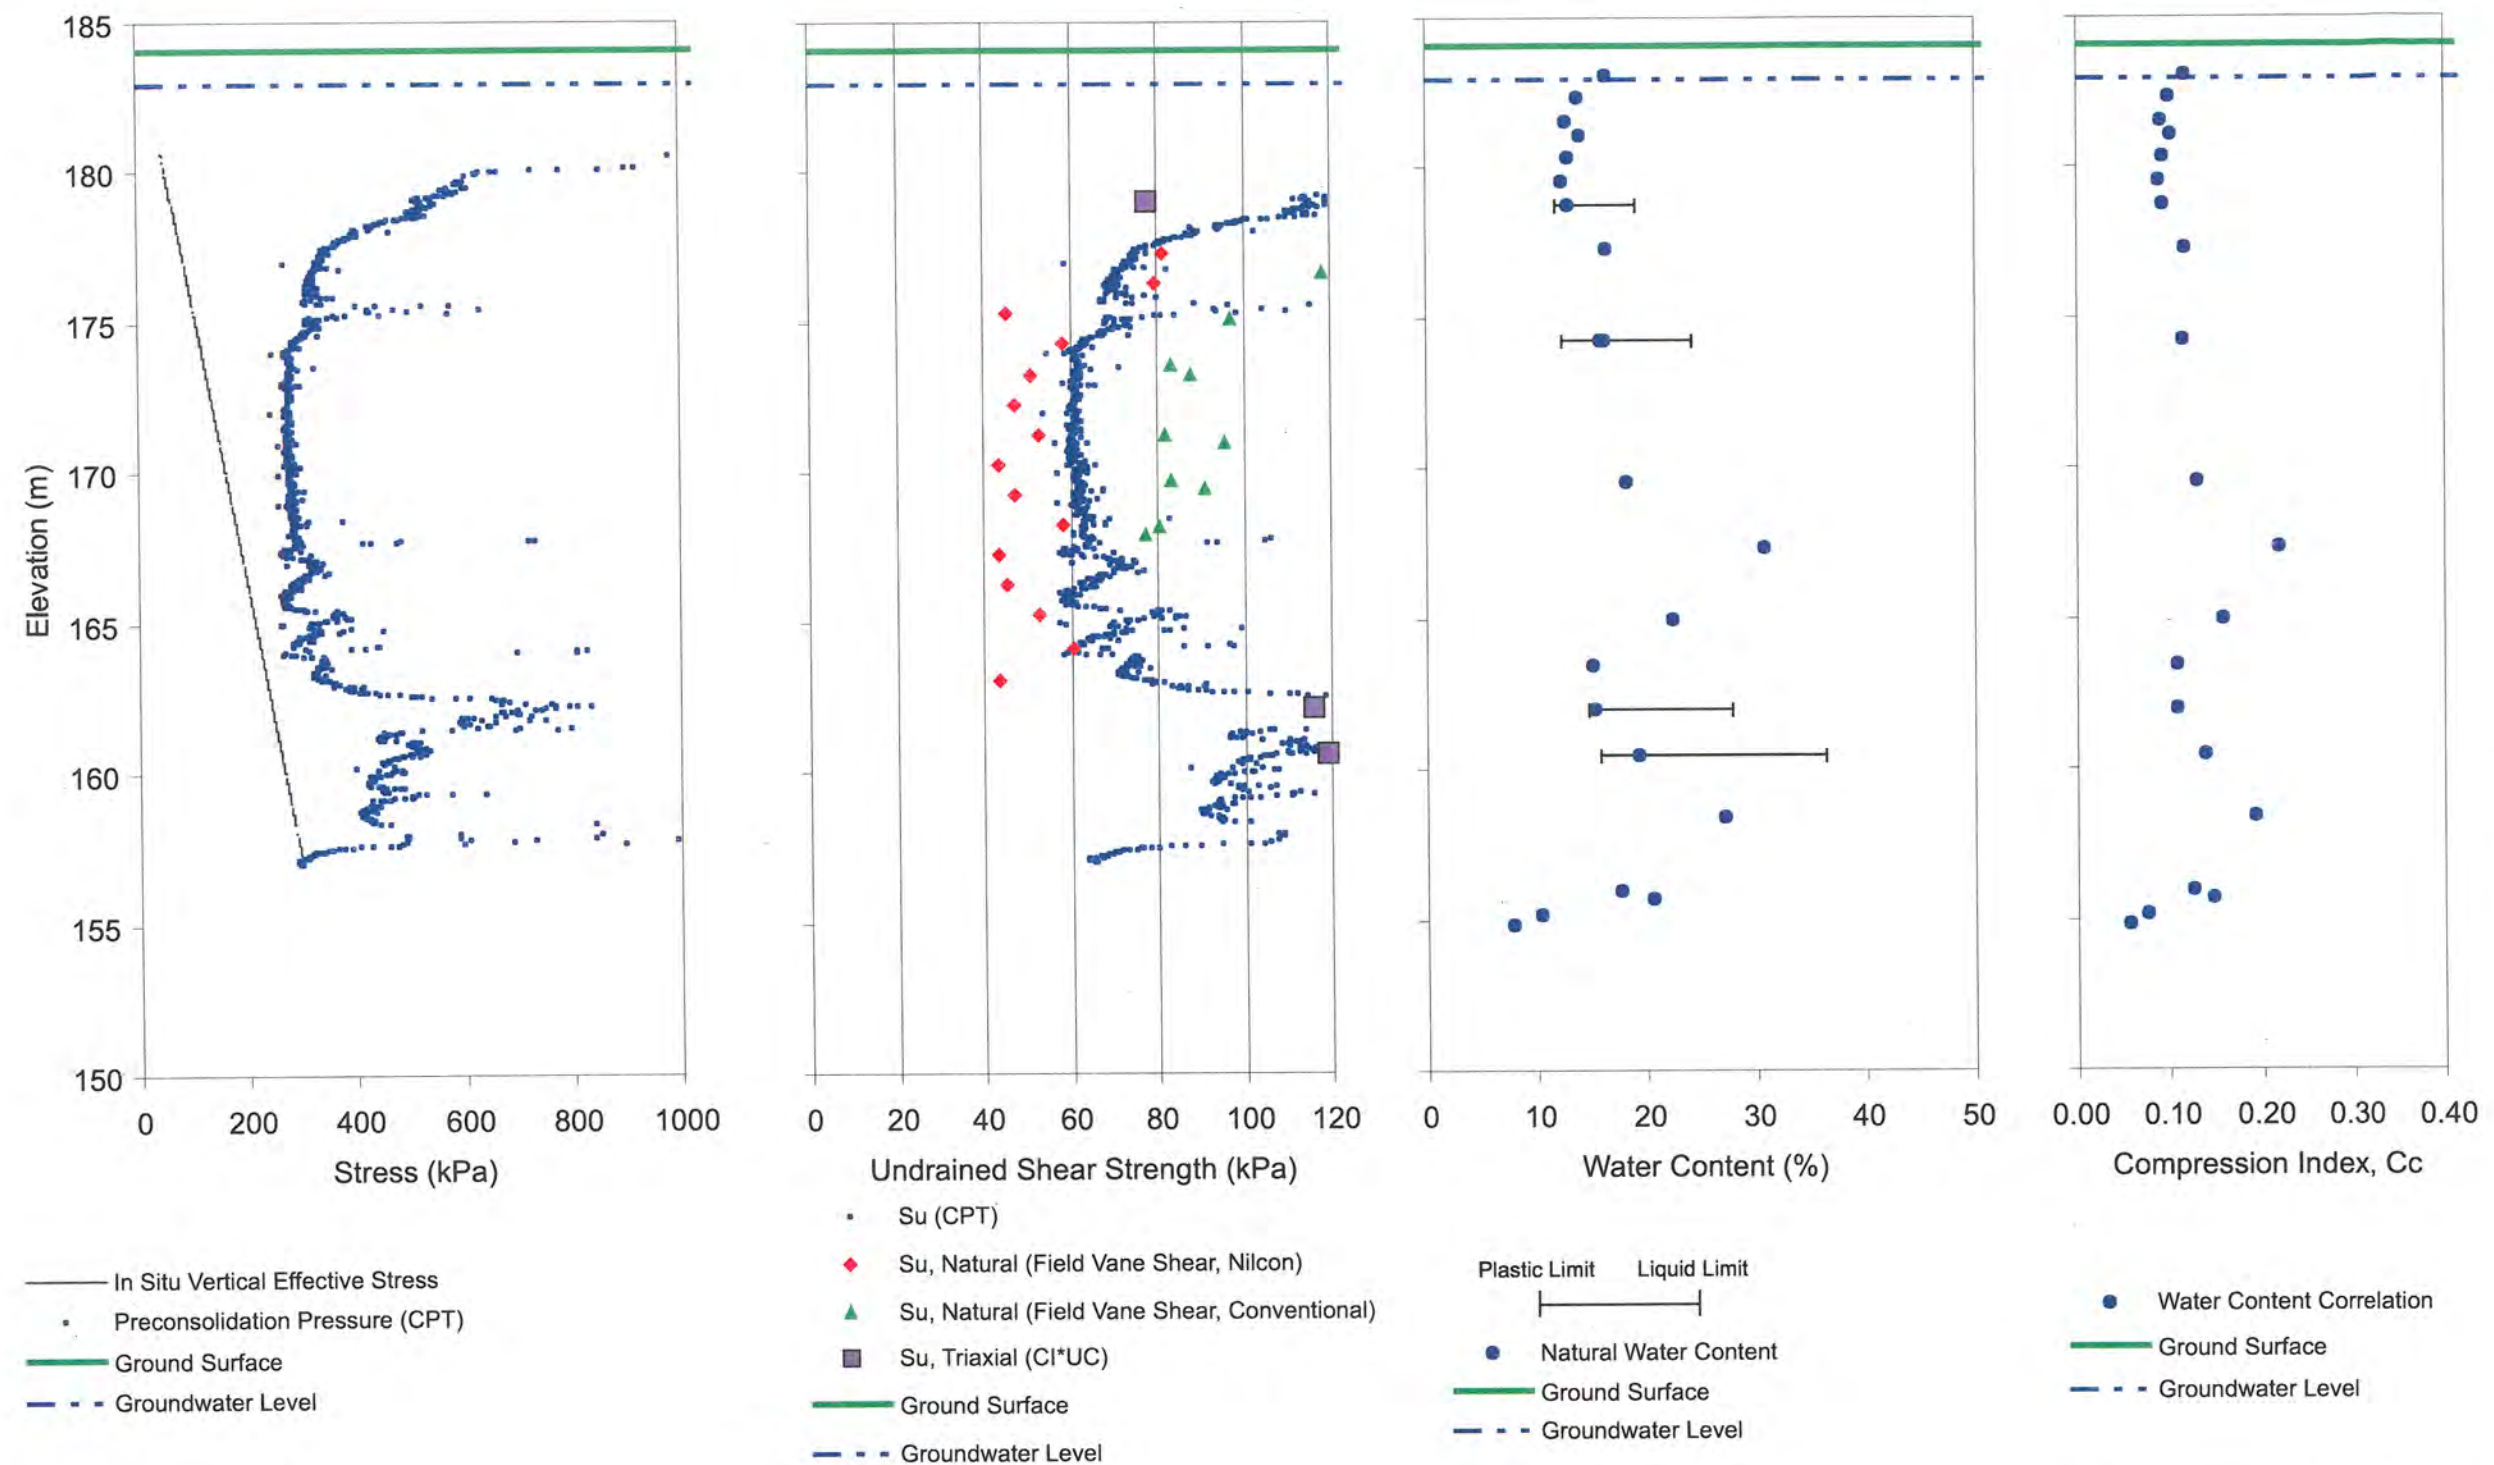
1. THIS FIGURE IS TO BE READ WITH THE REPORT TITLED "SUBSURFACE CONDITIONS INTERPRETATION REPORT, WINDSOR-ESSEX PARKWAY"
2. THIS FIGURE REPRESENTS A SUMMARY OF FIELD AND LABORATORY TESTING DATA AS DISCUSSED IN THE TEXT OF THE REPORT REFERENCED ABOVE.

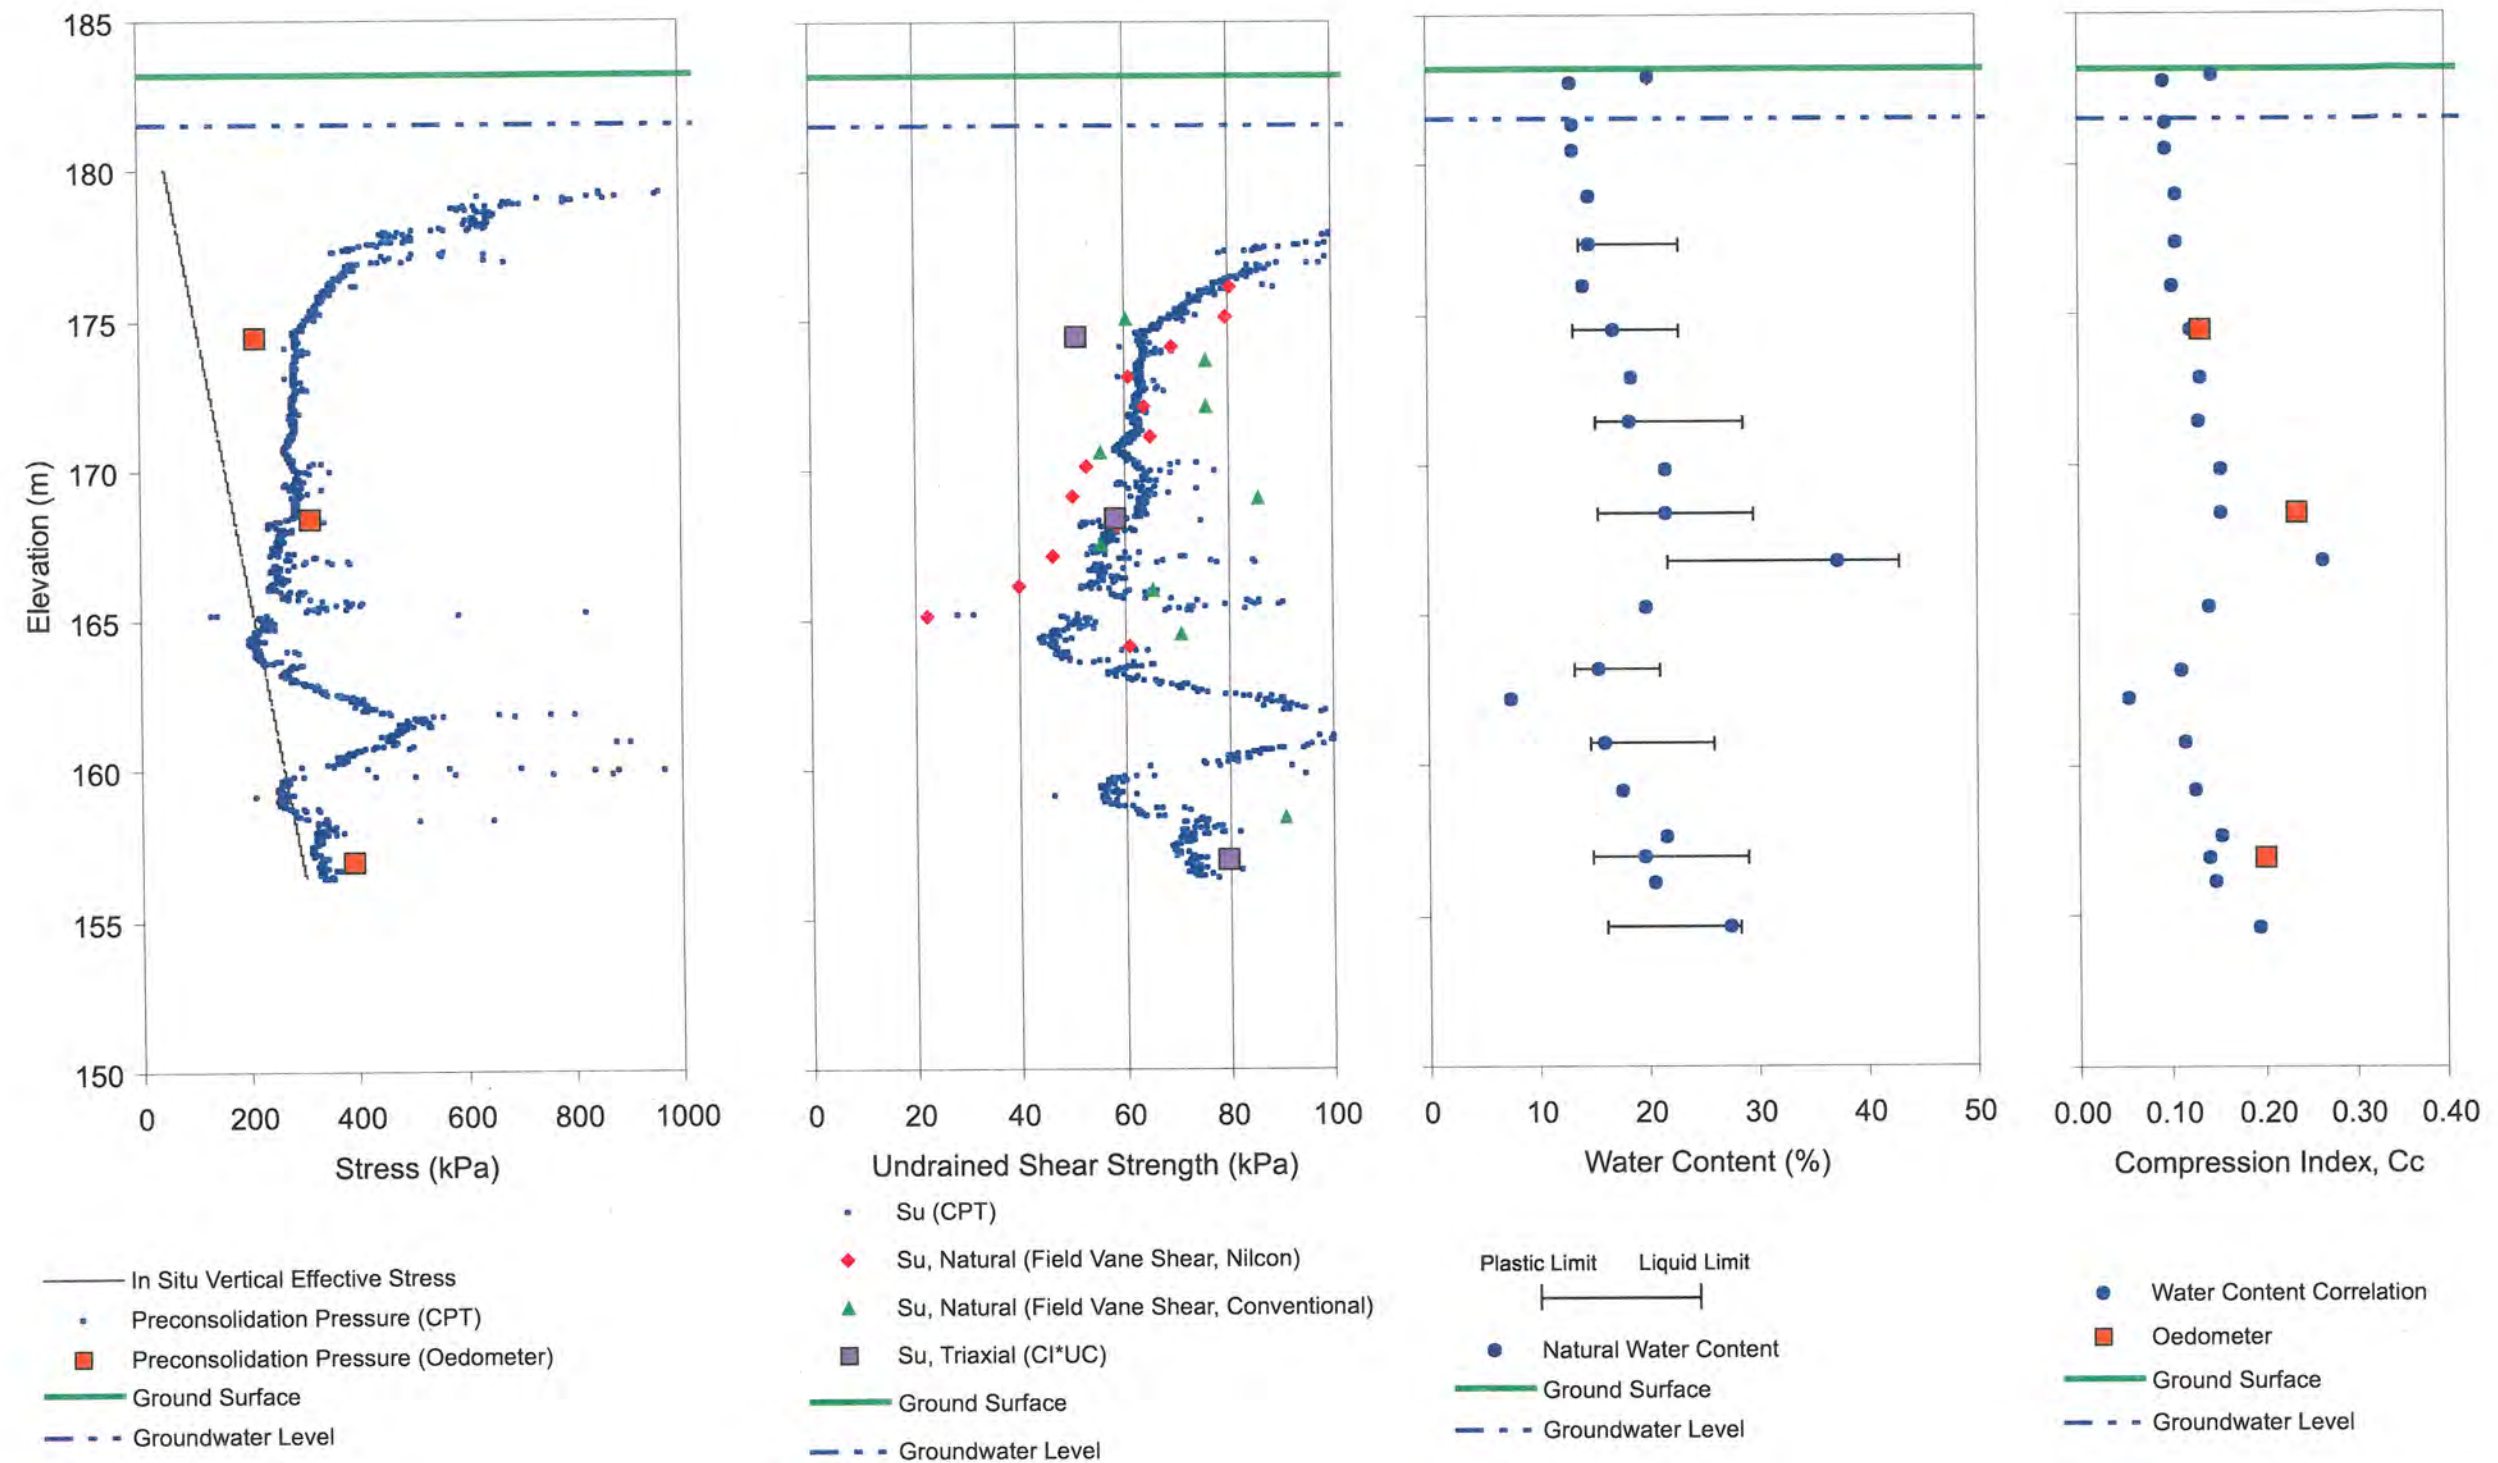
PROJECT			
SUBSURFACE CONDITIONS INTERPRETATION REPORT			
WINDSOR-ESSEX PARKWAY			
WINDSOR, ONTARIO			
TITLE			
SUMMARY OF SUBSURFACE TEST DATA			
BOREHOLE BH-7/CPT-7			
PROJECT No.		07-1130-2070	
FILE No.		0711302070-R02081	
SCALE		AS SHOWN REV. 1	
CADD		SJR	
CHECK		DEC 09	
Golder Associates		6.1E

1. THIS FIGURE IS TO BE READ WITH THE REPORT TITLED "SUBSURFACE CONDITIONS INTERPRETATION REPORT, WINDSOR-ESSEX PARKWAY"
2. THIS FIGURE REPRESENTS A SUMMARY OF FIELD AND LABORATORY TESTING DATA AS DISCUSSED IN THE TEXT OF THE REPORT REFERENCED ABOVE.
