## **WINDSOR-ESSEX PARKWAY**

# **Subsurface Conditions Interpretation Report**

**Report Number:** 07-1130-207-0-R02 / 05-1140-003

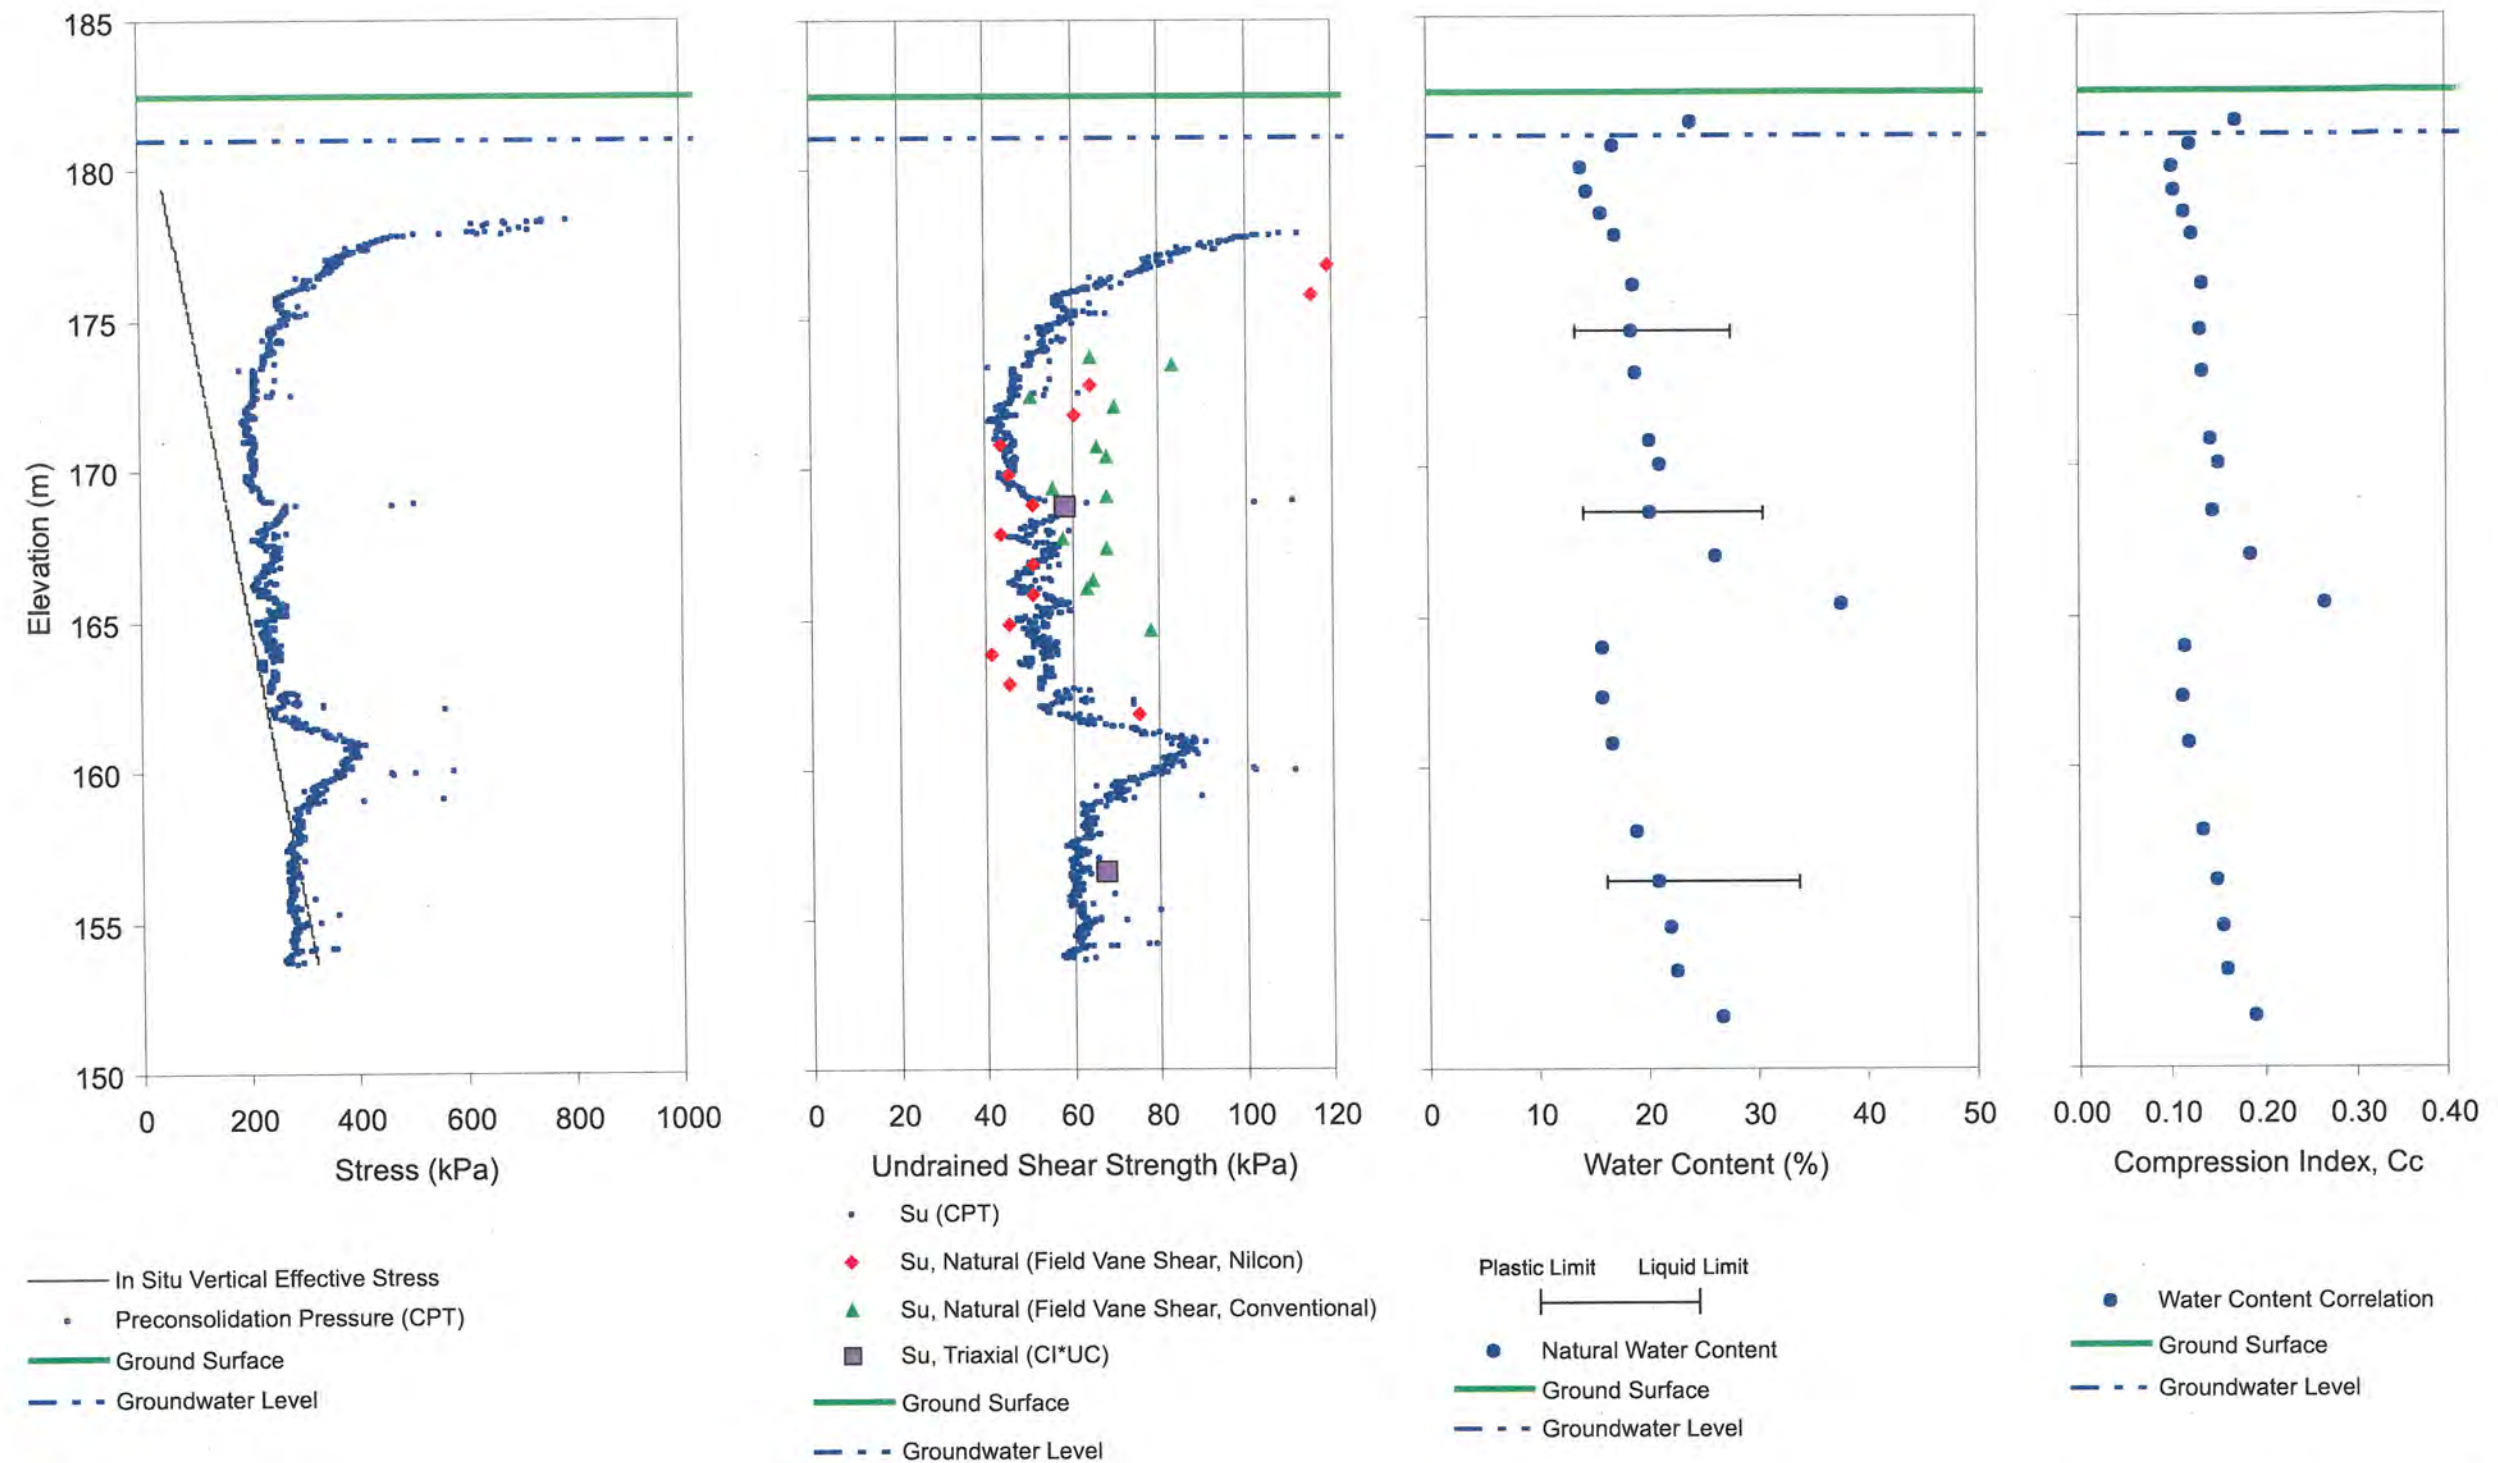
PROJECT <b>SUBSURFACE CONDITIONS INTERPRETATION REPORT</b> WINDSOR-ESSEX PARKWAY WINDSOR, ONTARIO			
TITLE <b>SUMMARY OF SUBSURFACE TEST DATA</b> BOREHOLE BH-119/CPT-8			
PROJECT No. 07-1130-2070		FILE No. 0711302070-R02081	
CADD	SJB	DEC 09	SCALE AS SHOWN REV. 1
CHECK	MY	DEC 09	6.1F

1. THIS FIGURE IS TO BE READ WITH THE REPORT TITLED "SUBSURFACE CONDITIONS INTERPRETATION REPORT, WINDSOR-ESSEX PARKWAY"
2. THIS FIGURE REPRESENTS A SUMMARY OF FIELD AND LABORATORY TESTING DATA AS DISCUSSED IN THE TEXT OF THE REPORT REFERENCED ABOVE.

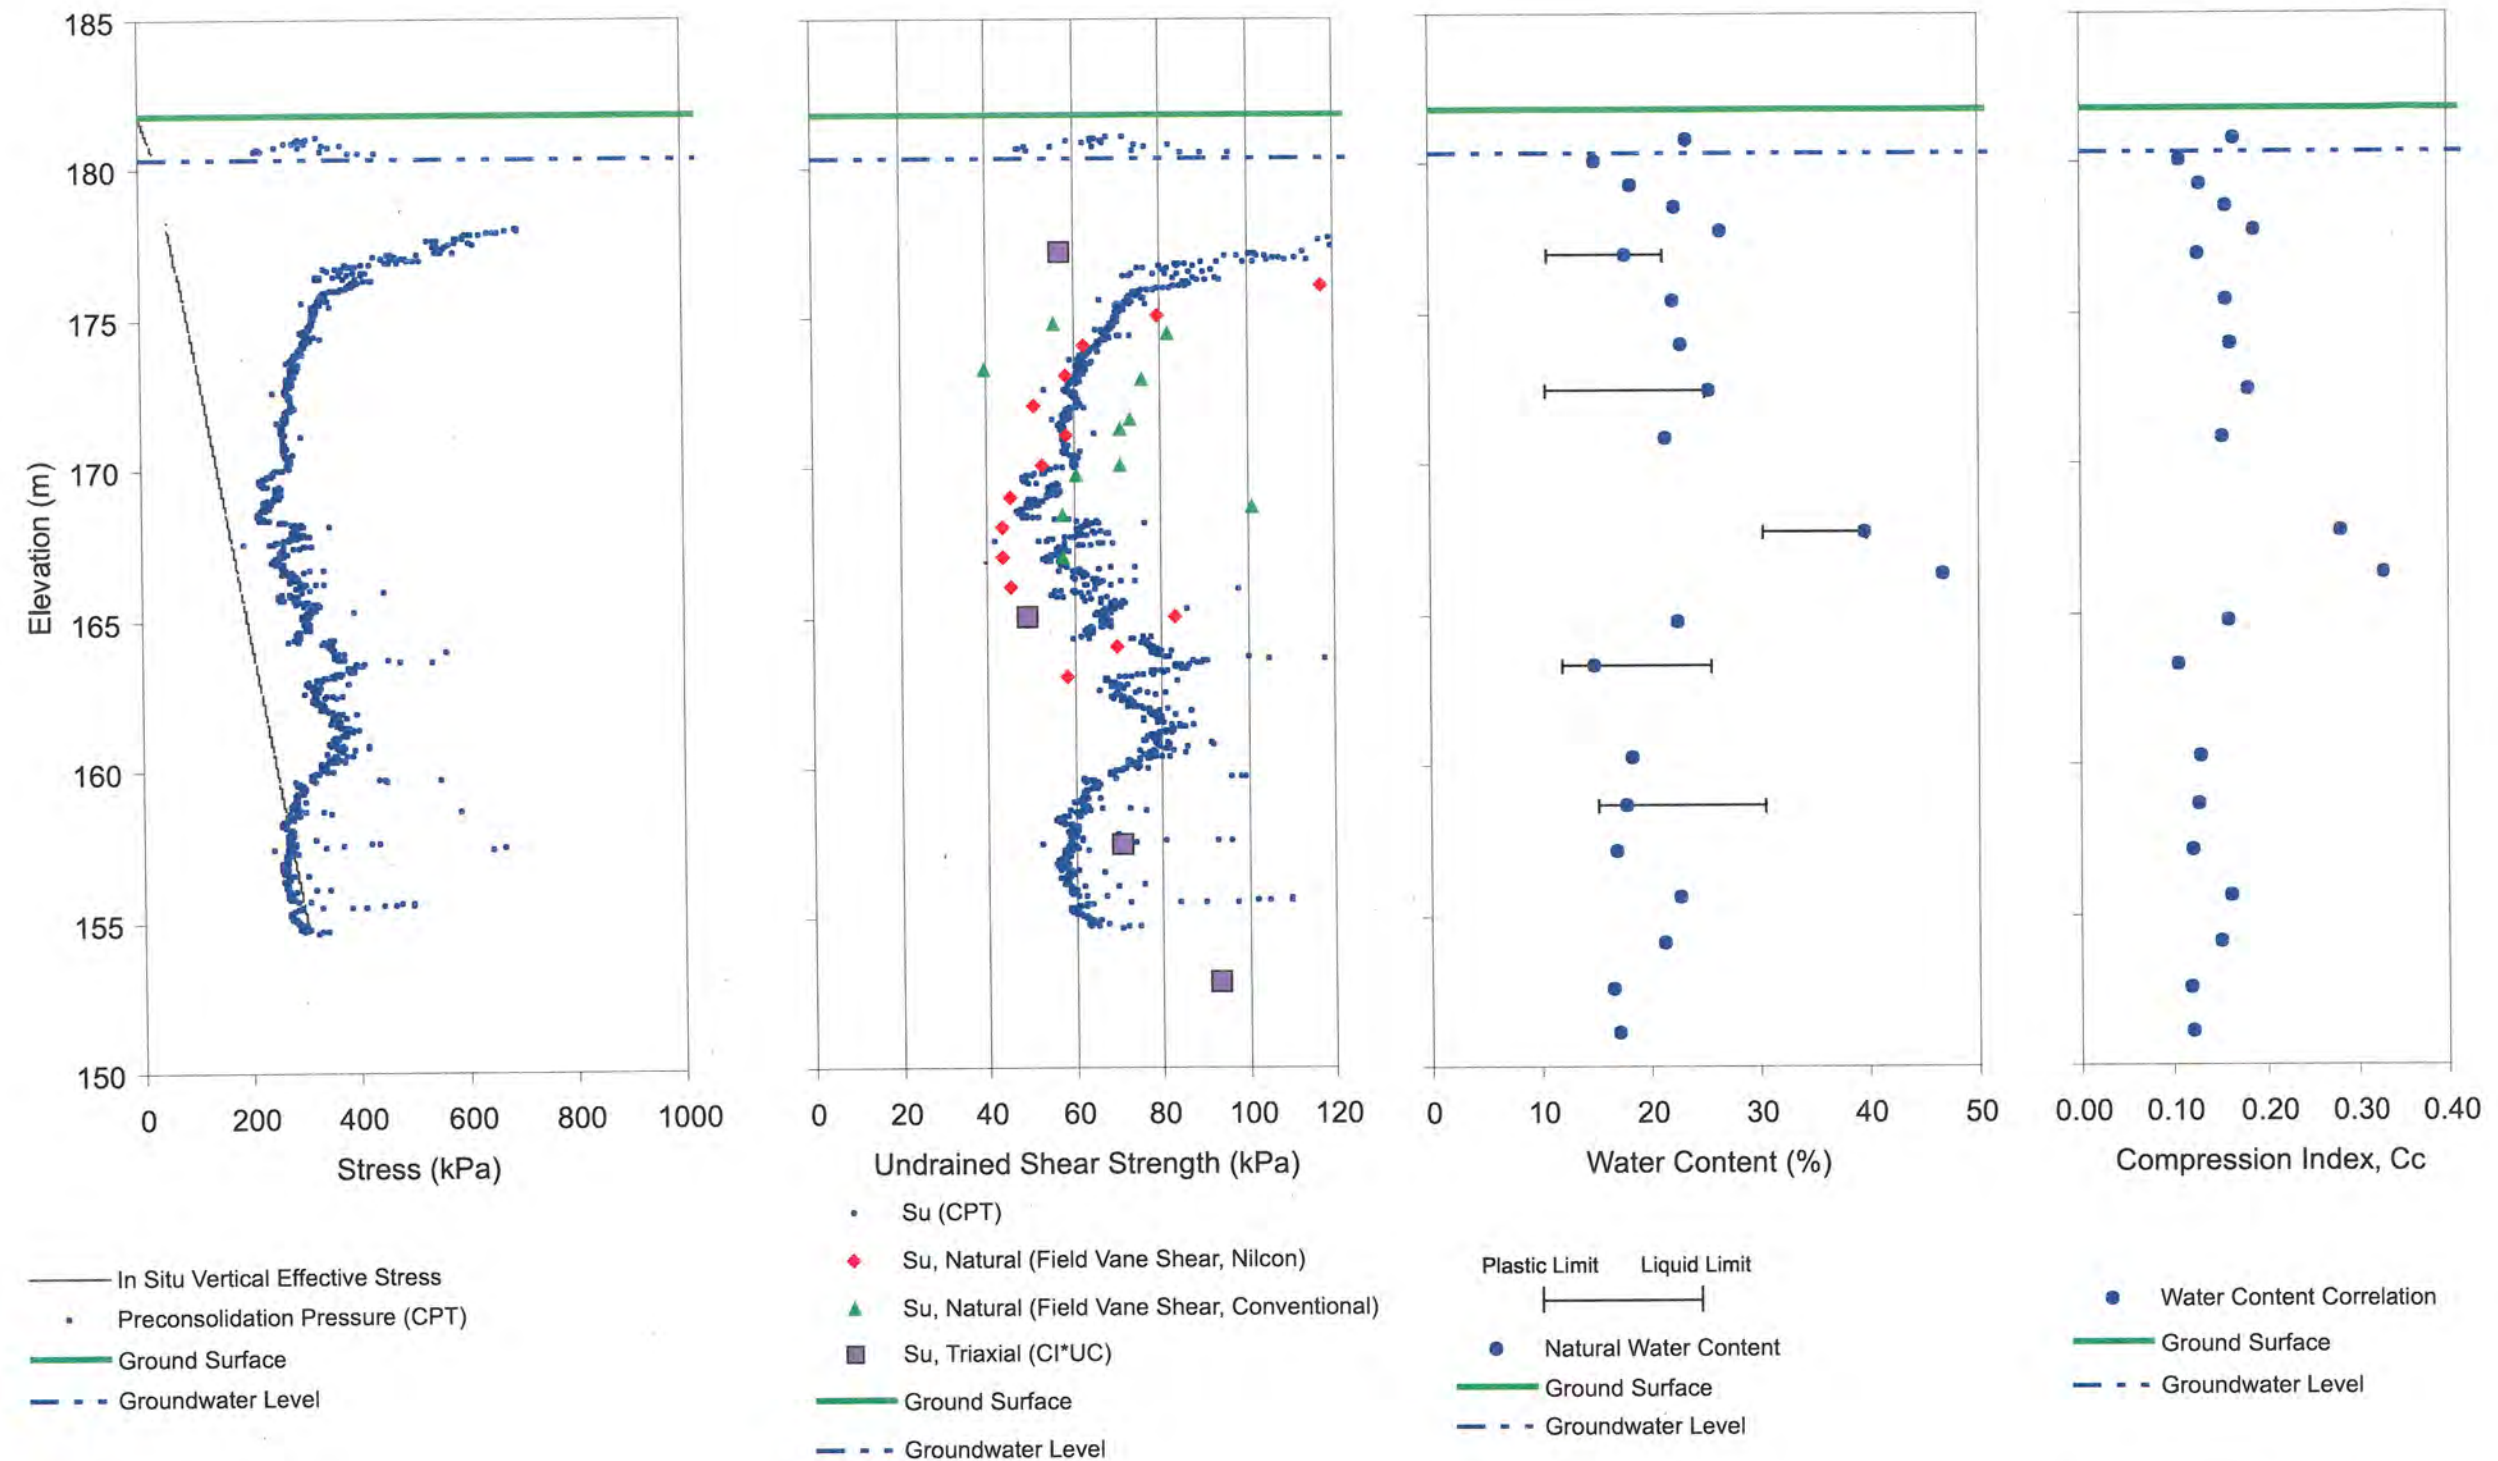
PROJECT			
SUBSURFACE CONDITIONS INTERPRETATION REPORT			
WINDSOR-ESSEX PARKWAY			
WINDSOR, ONTARIO			
TITLE			
SUMMARY OF SUBSURFACE TEST DATA			
BOREHOLE BH-122/CPT-10			
PROJECT No.		07-1130-2070	FILE No.
CADD		SUB	DEC 09
CHECK		my	6.1G
SCALE		AS SHOWN	REV 1

1. THIS FIGURE IS TO BE READ WITH THE REPORT TITLED "SUBSURFACE CONDITIONS INTERPRETATION REPORT, WINDSOR-ESSEX PARKWAY"
2. THIS FIGURE REPRESENTS A SUMMARY OF FIELD AND LABORATORY TESTING DATA AS DISCUSSED IN THE TEXT OF THE REPORT REFERENCED ABOVE.

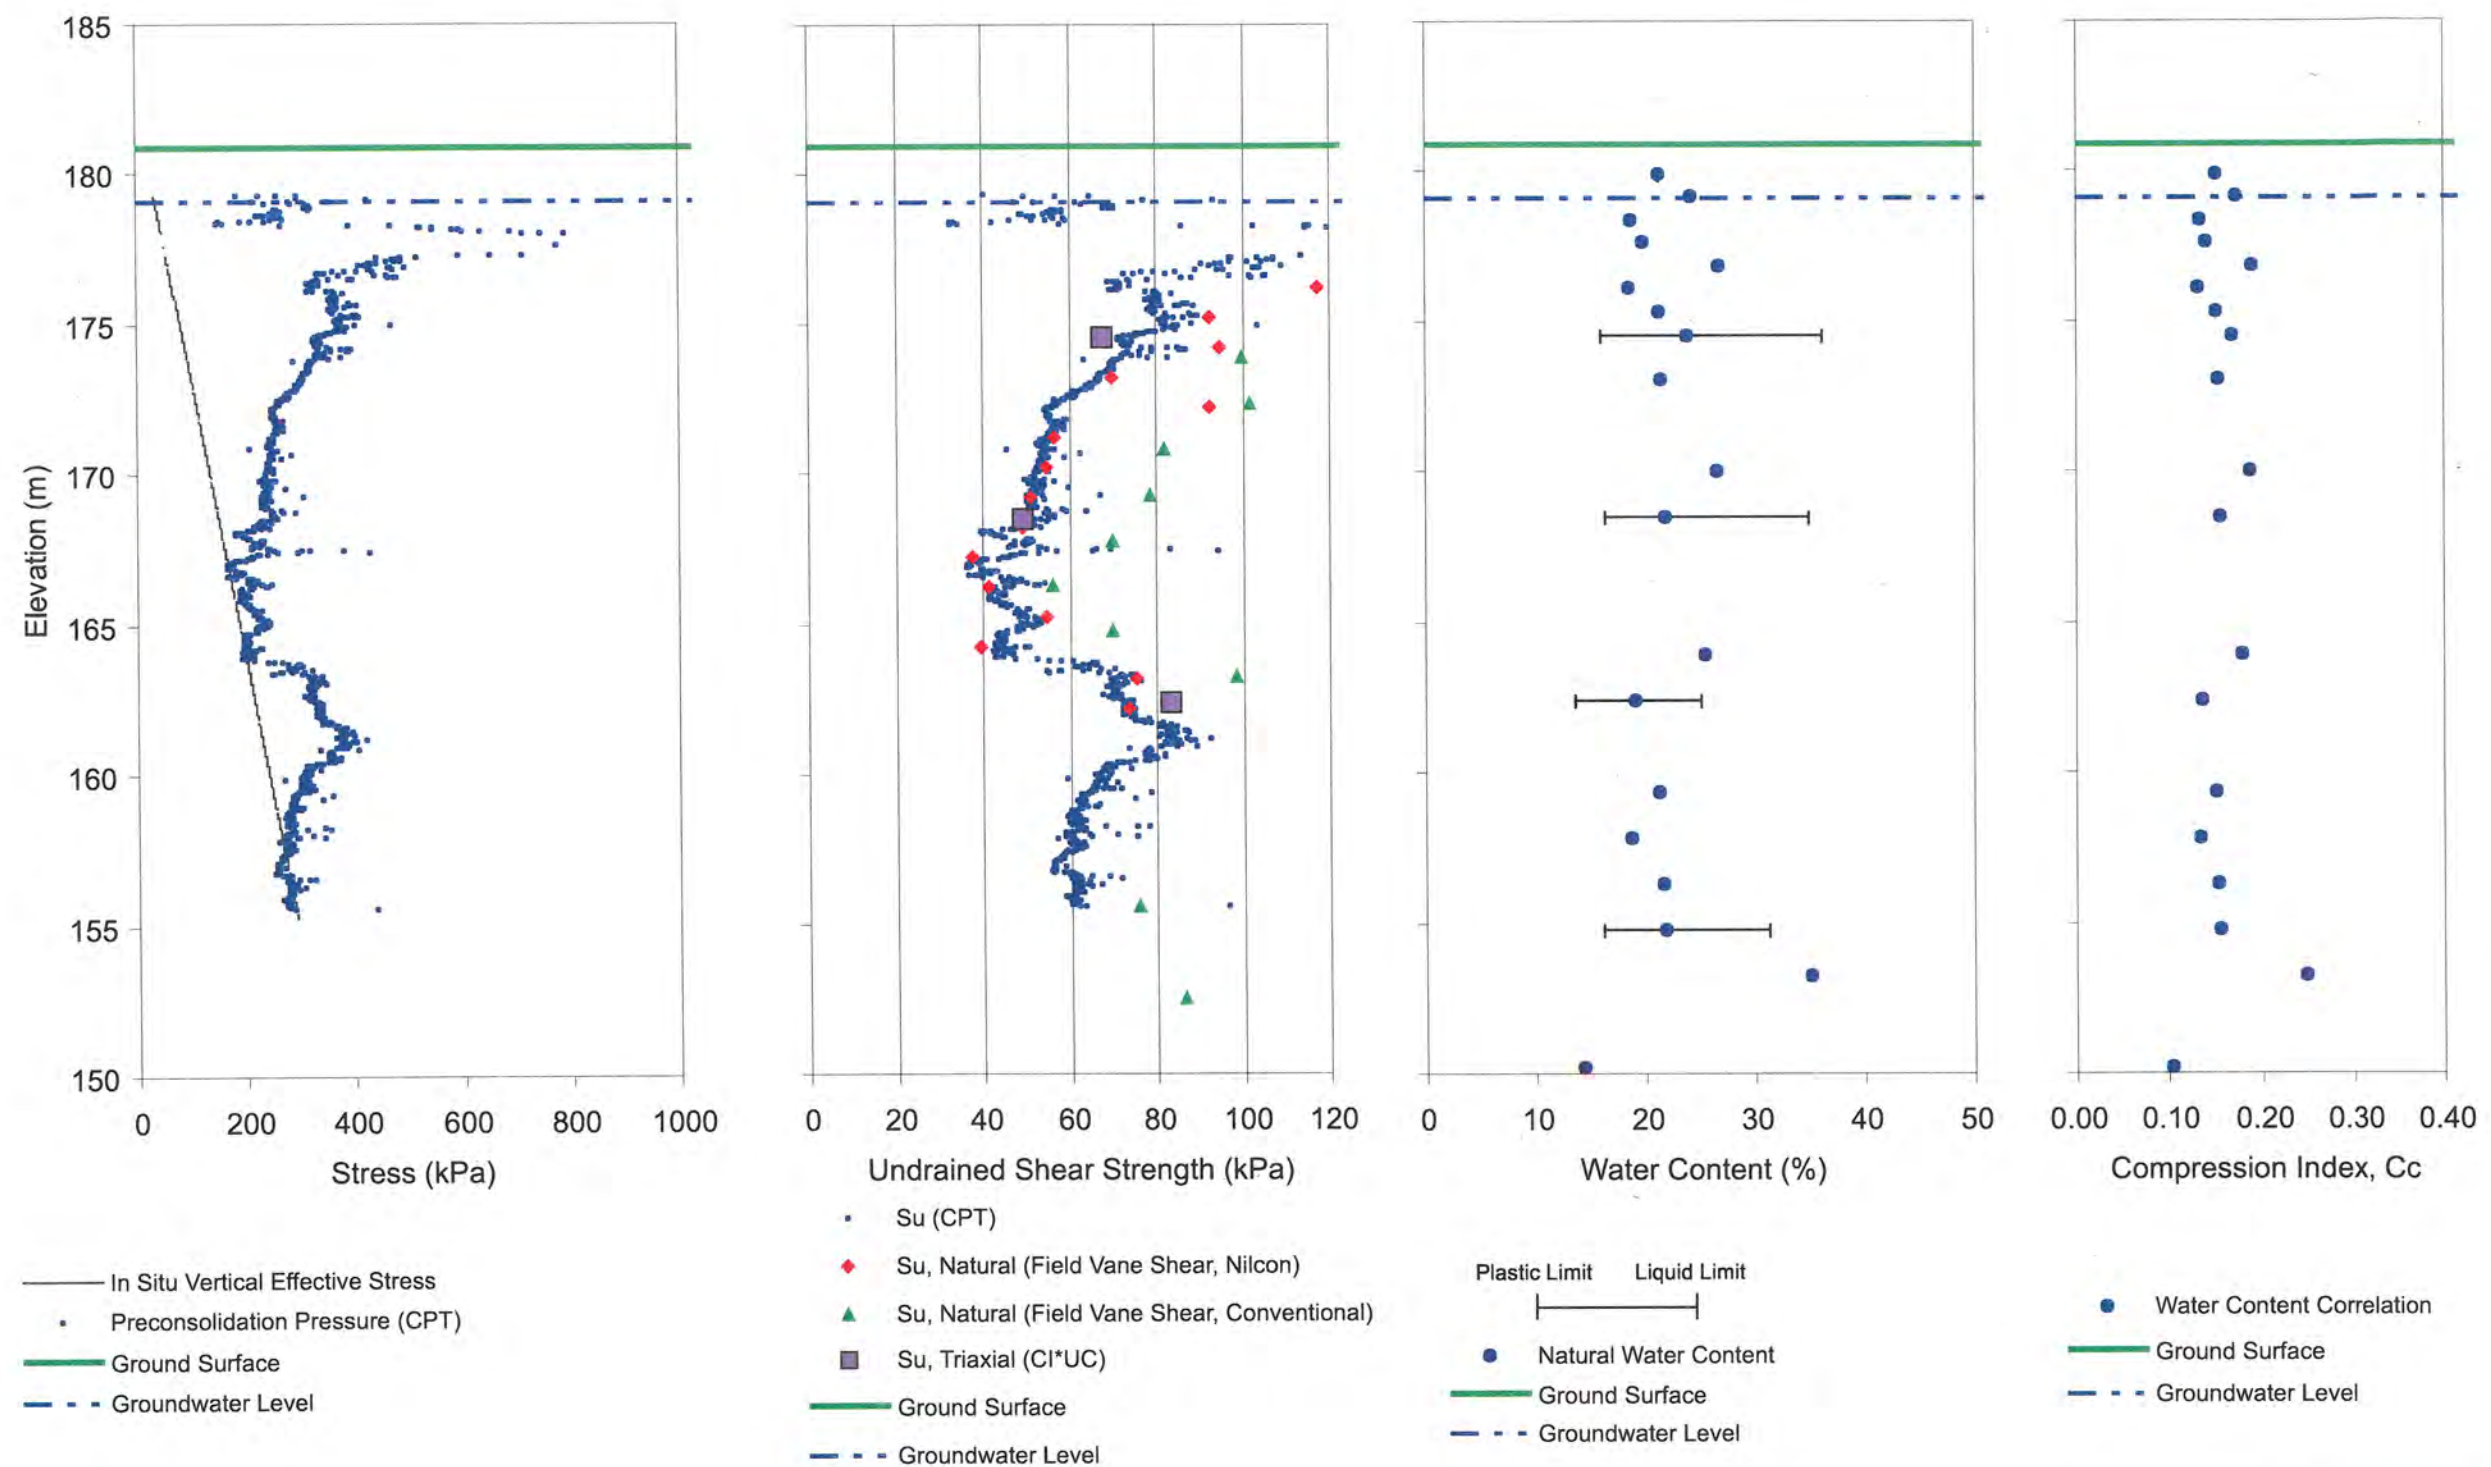
PROJECT			
SUBSURFACE CONDITIONS INTERPRETATION REPORT			
WINDSOR-ESSEX PARKWAY			
WINDSOR, ONTARIO			
TITLE			
SUMMARY OF SUBSURFACE TEST DATA			
BOREHOLE BH-129/CPT-11			
PROJECT No. 07-1130-2070		FILE No. 0711302070-R02061	
CADD	SJB	DEC 09	SCALE AS SHOWN REV 1
CHECK	M	K	6.1H

1. THIS FIGURE IS TO BE READ WITH THE REPORT TITLED "SUBSURFACE CONDITIONS INTERPRETATION REPORT, WINDSOR-ESSEX PARKWAY"
2. THIS FIGURE REPRESENTS A SUMMARY OF FIELD AND LABORATORY TESTING DATA AS DISCUSSED IN THE TEXT OF THE REPORT REFERENCED ABOVE.

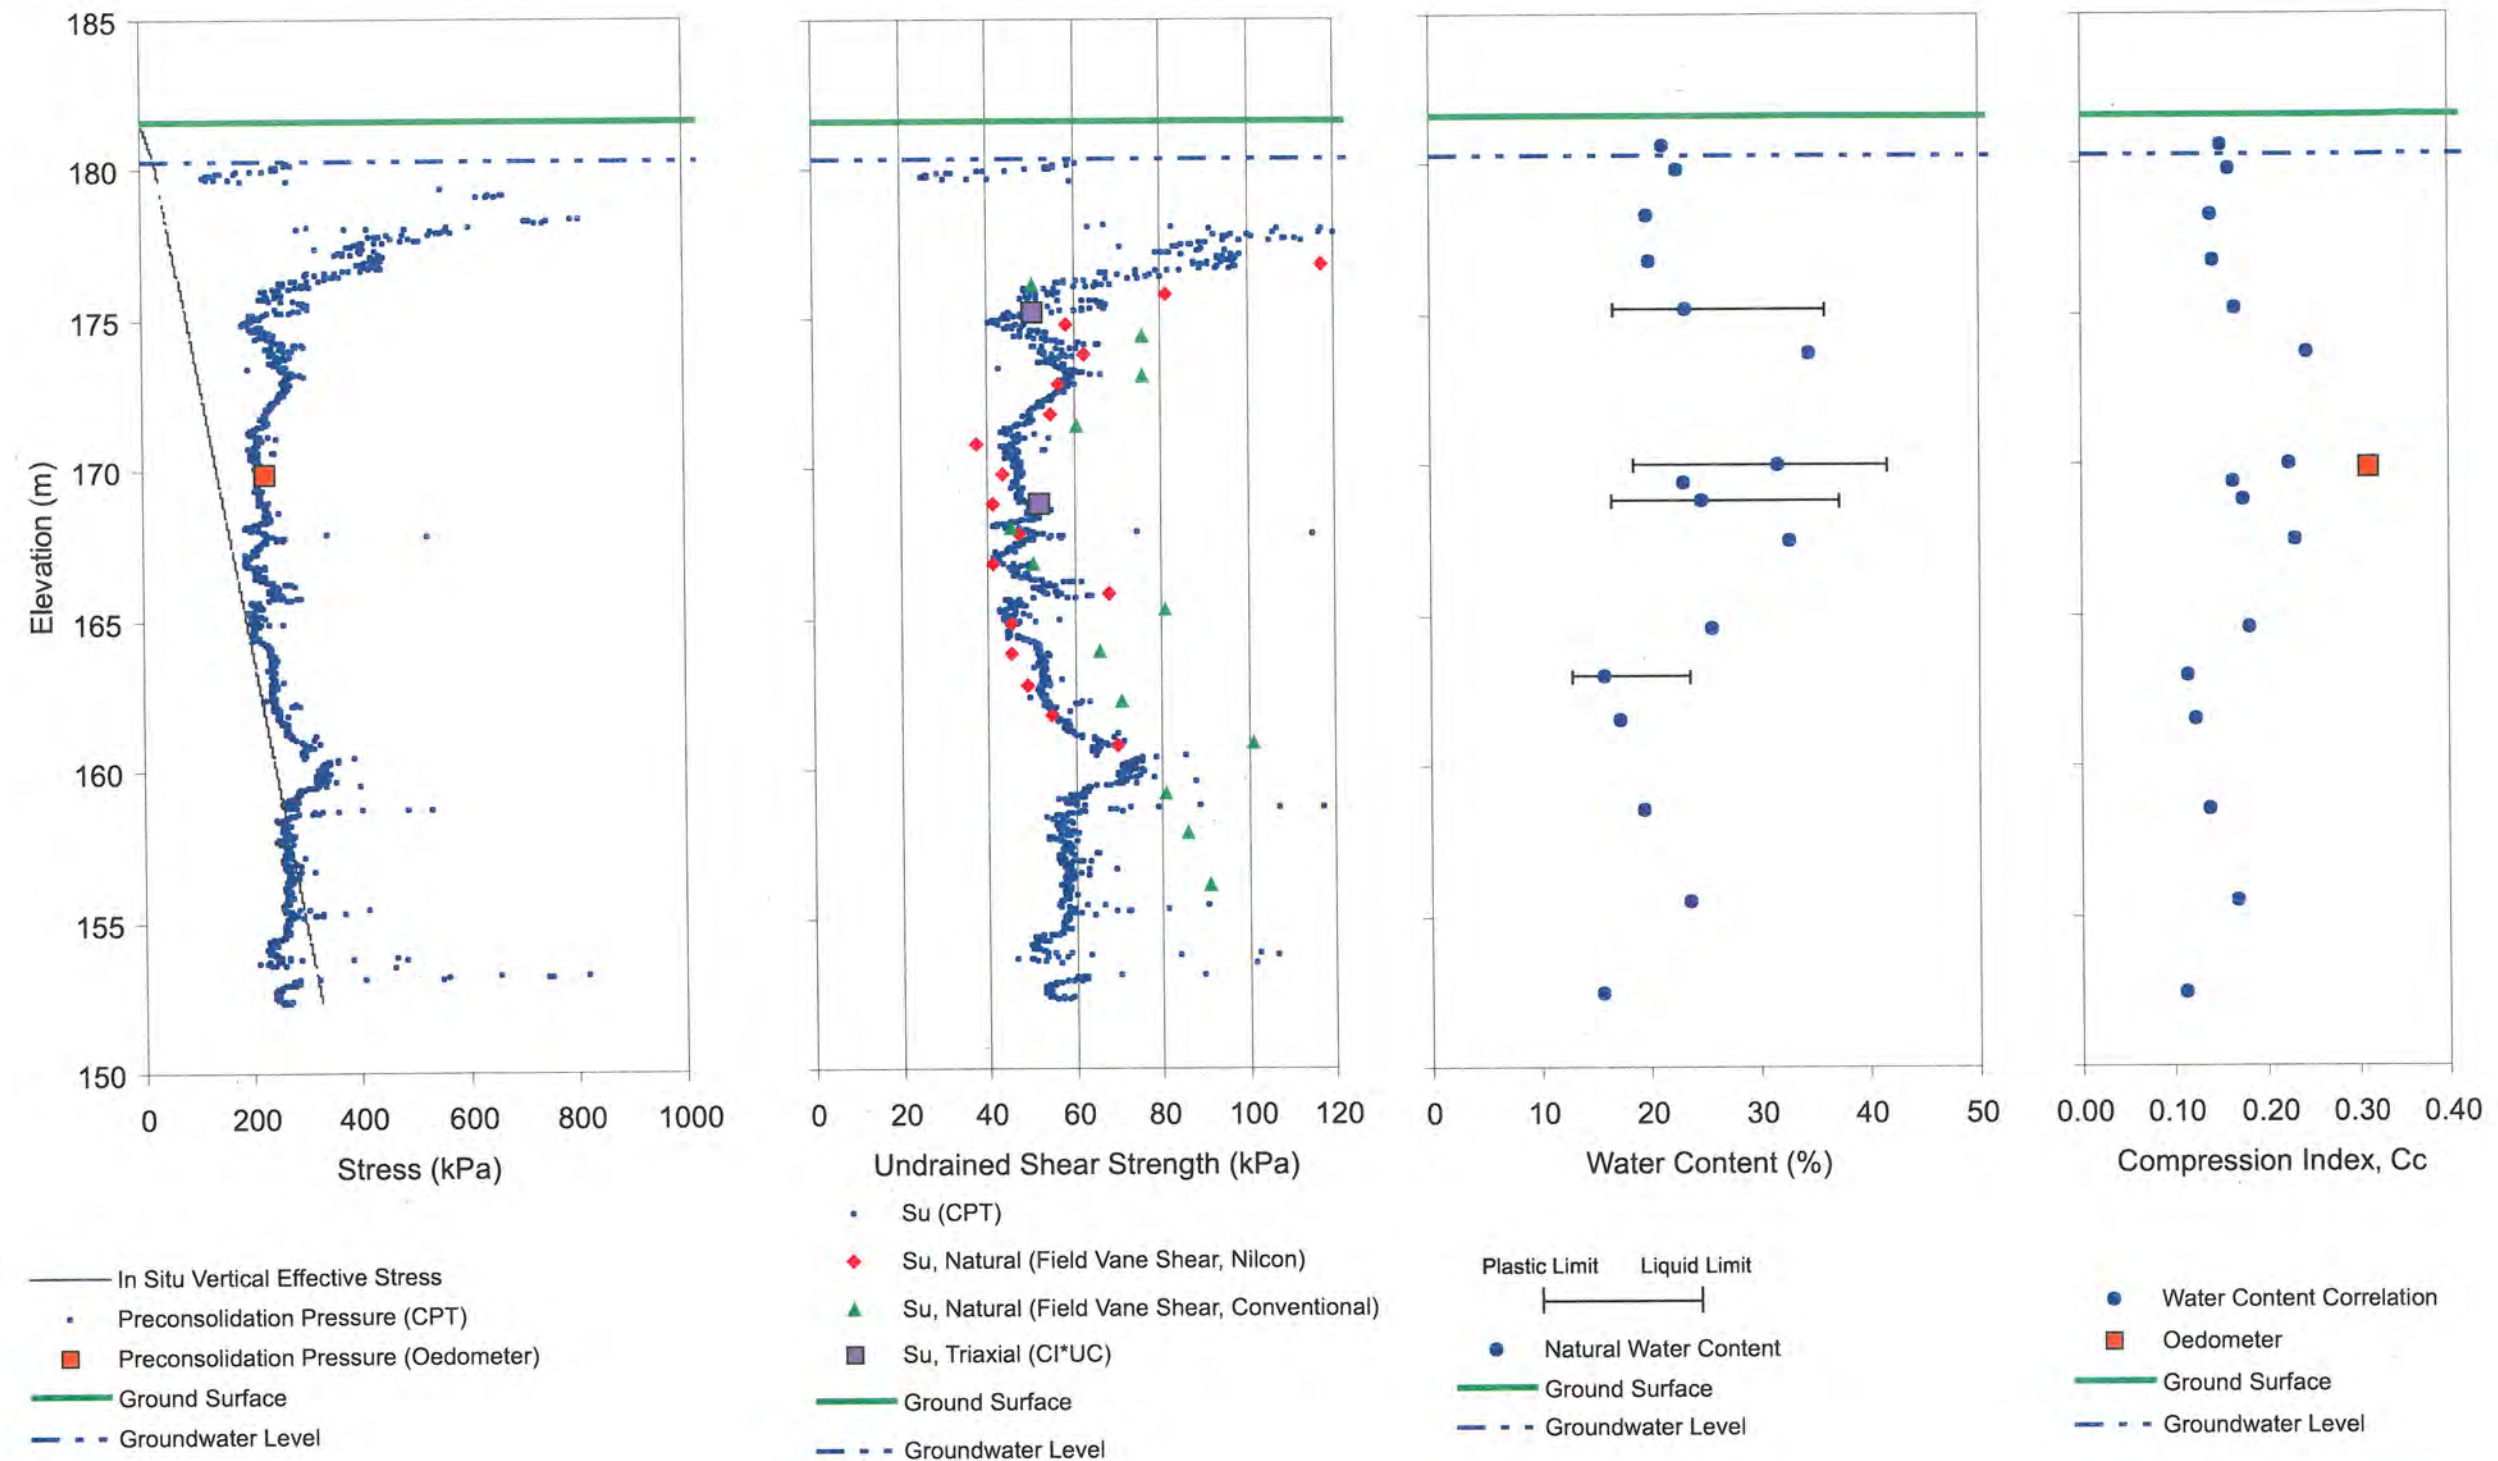
PROJECT			
SUBSURFACE CONDITIONS INTERPRETATION REPORT			
WINDSOR-ESSEX PARKWAY			
WINDSOR, ONTARIO			
TITLE			
SUMMARY OF SUBSURFACE TEST DATA			
BOREHOLE BH-132/CPT-12			
PROJECT No. 07-1130-2070		FILE No. 0711302070-R02061	
CADD	SJB	DEC 09	SCALE AS SHOWN REV. 1
CHECK	<i>M. Dwyer</i>		6.11

1. THIS FIGURE IS TO BE READ WITH THE REPORT TITLED "SUBSURFACE CONDITIONS INTERPRETATION REPORT, WINDSOR-ESSEX PARKWAY"
2. THIS FIGURE REPRESENTS A SUMMARY OF FIELD AND LABORATORY TESTING DATA AS DISCUSSED IN THE TEXT OF THE REPORT REFERENCED ABOVE.

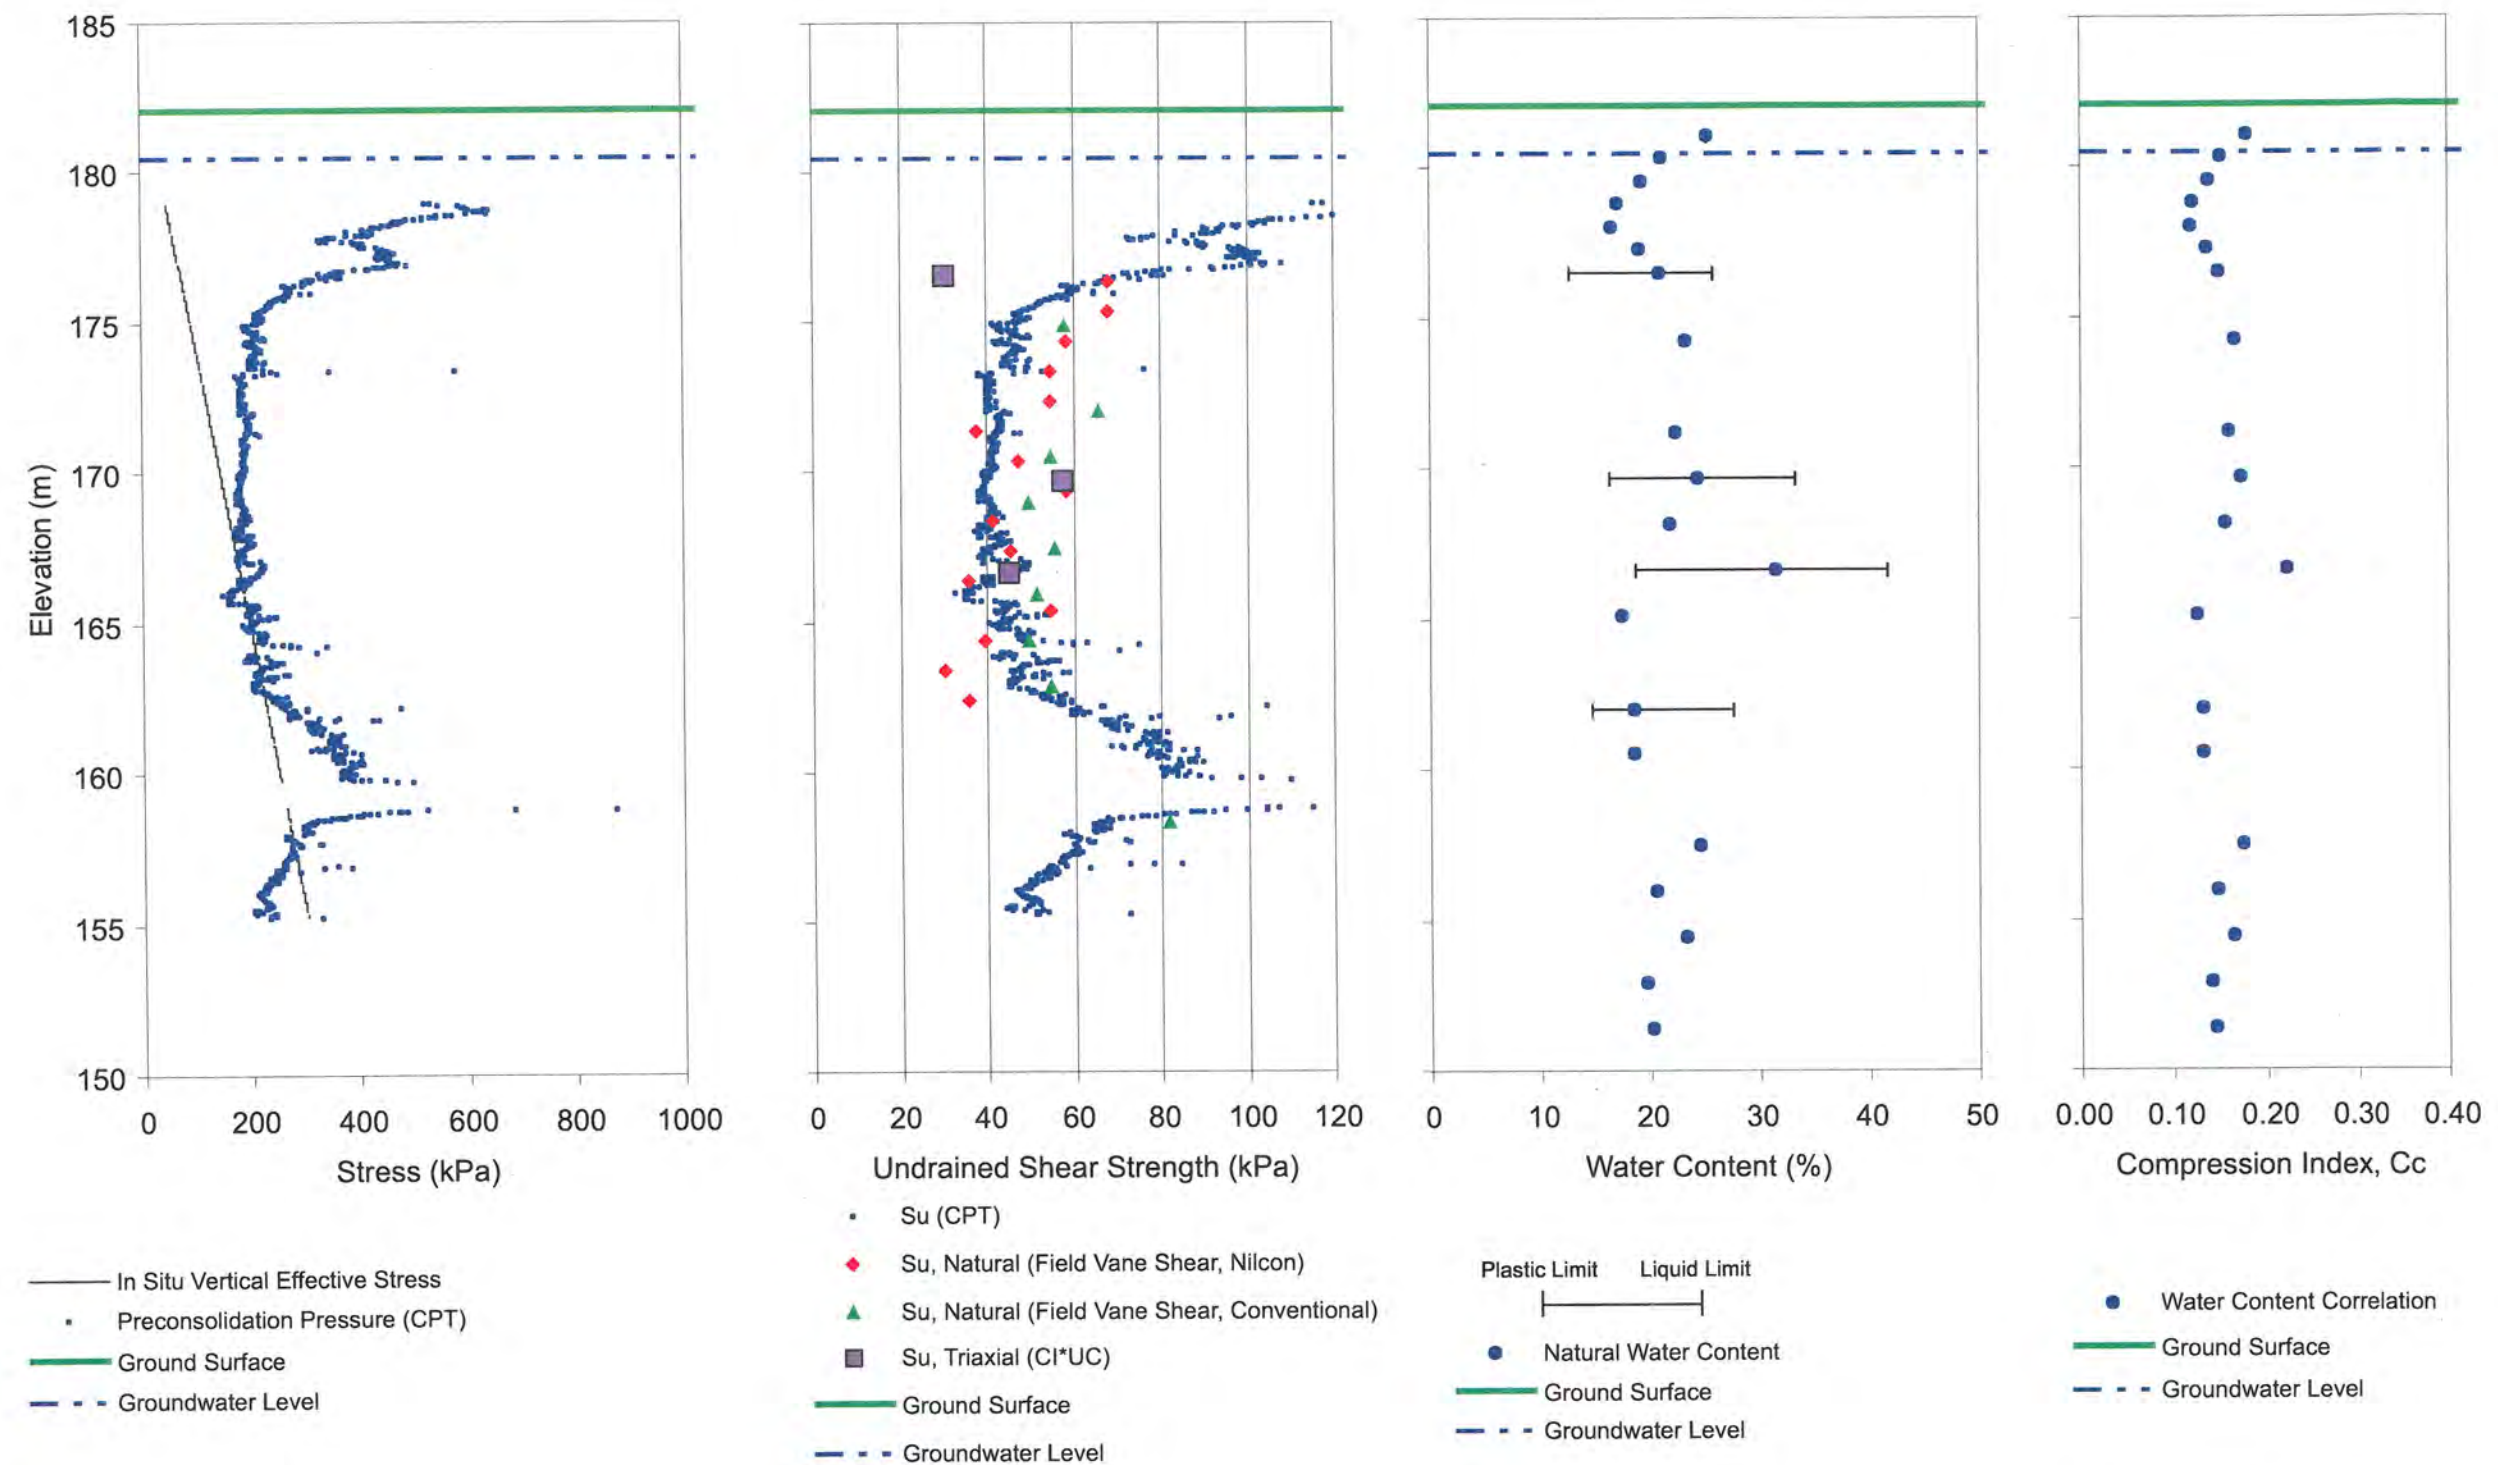
PROJECT			
SUBSURFACE CONDITIONS INTERPRETATION REPORT			
WINDSOR-ESSEX PARKWAY			
WINDSOR, ONTARIO			
TITLE			
SUMMARY OF SUBSURFACE TEST DATA			
BOREHOLE BH-135/CPT-13			
PROJECT No. 07-1130-2670		FILE No. 0711302070-R02061	
CADD	SJB	DEC 09	SCALE AS SHOWN REV. 1
CHECK	AW	DEC 09	6.1J

1. THIS FIGURE IS TO BE READ WITH THE REPORT TITLED "SUBSURFACE CONDITIONS INTERPRETATION REPORT, WINDSOR-ESSEX PARKWAY"
2. THIS FIGURE REPRESENTS A SUMMARY OF FIELD AND LABORATORY TESTING DATA AS DISCUSSED IN THE TEXT OF THE REPORT REFERENCED ABOVE.

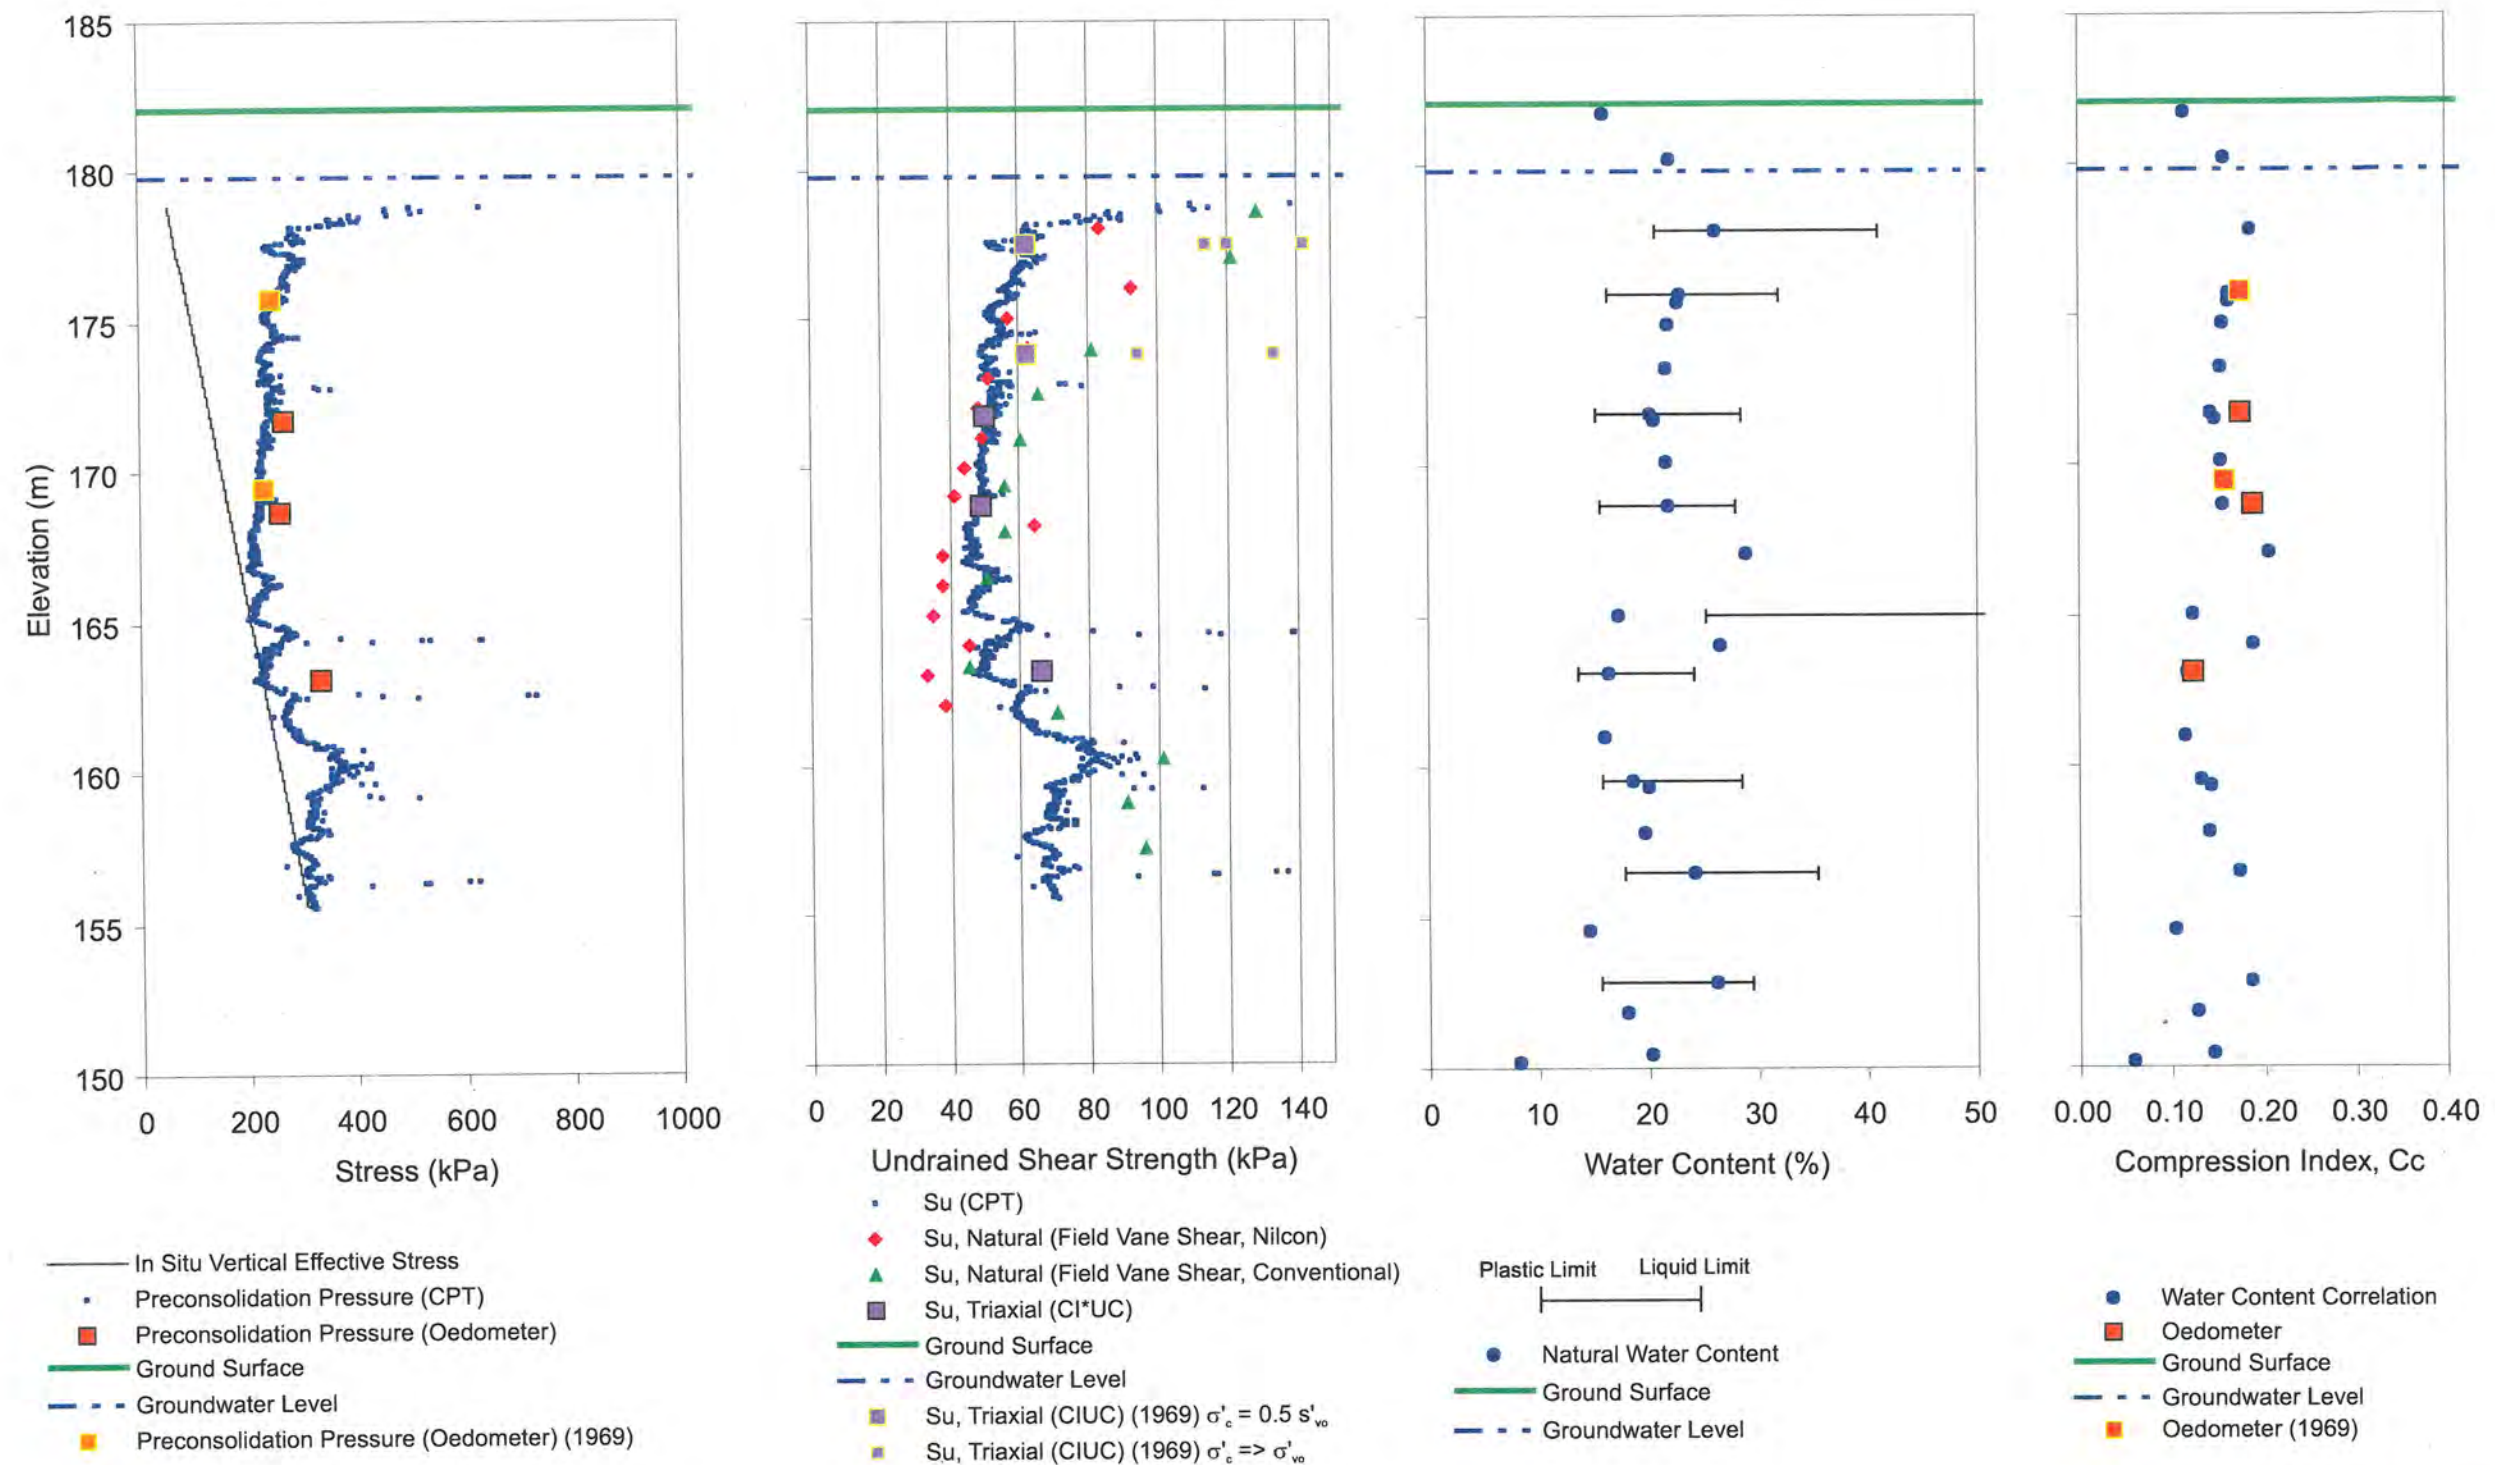
PROJECT			
SUBSURFACE CONDITIONS INTERPRETATION REPORT			
WINDSOR-ESSEX PARKWAY			
WINDSOR, ONTARIO			
TITLE			
SUMMARY OF SUBSURFACE TEST DATA			
BOREHOLE BH-14/CPT-14			
PROJECT No. 07-1130-2070		FILE No. 0711302070-R02061	
CADD	SUB	DEC 09	SCALE AS SHOWN REV 1
CHECK	Mr. [Signature]		6.1K

1. THIS FIGURE IS TO BE READ WITH THE REPORT TITLED "SUBSURFACE CONDITIONS INTERPRETATION REPORT, WINDSOR-ESSEX PARKWAY"
2. THIS FIGURE REPRESENTS A SUMMARY OF FIELD AND LABORATORY TESTING DATA AS DISCUSSED IN THE TEXT OF THE REPORT REFERENCED ABOVE.
