## **WINDSOR-ESSEX PARKWAY**

# **Subsurface Conditions Interpretation Report**

**Report Number:** 07-1130-207-0-R02 / 05-1140-003

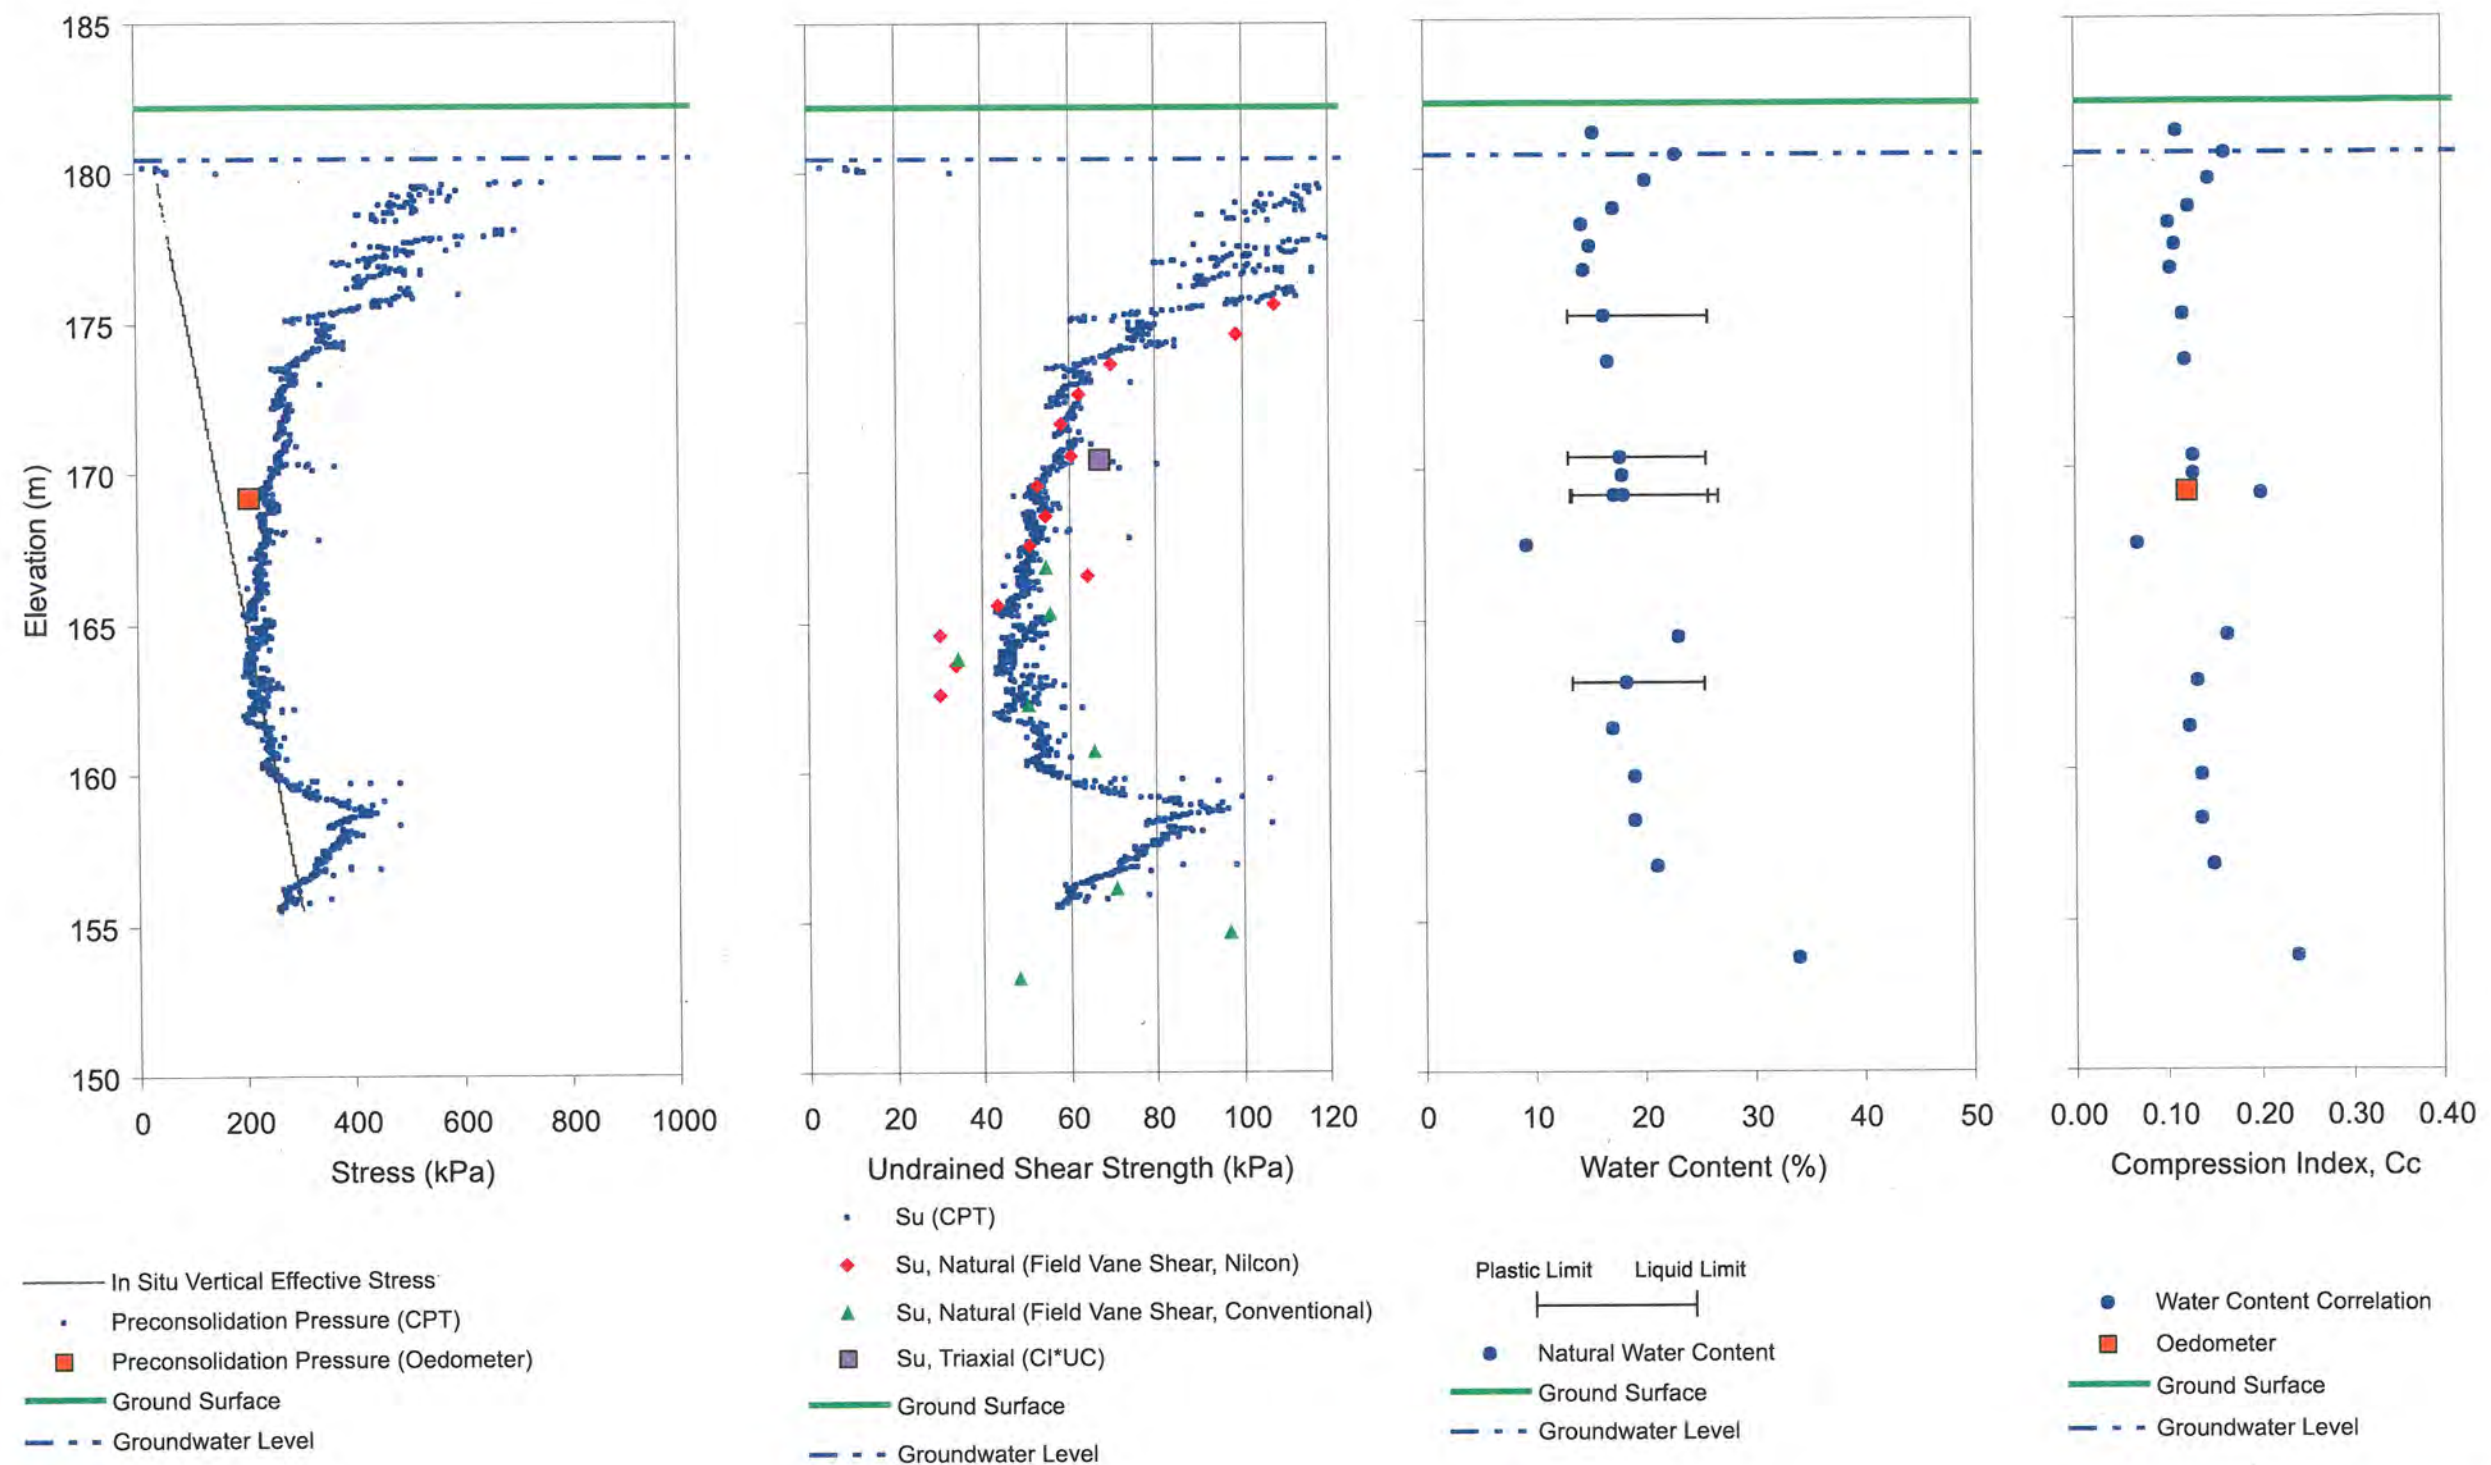
PROJECT			
SUBSURFACE CONDITIONS INTERPRETATION REPORT			
WINDSOR-ESSEX PARKWAY			
WINDSOR, ONTARIO			
TITLE			
SUMMARY OF SUBSURFACE TEST DATA			
BOREHOLE BH-145/CPT-145			
PROJECT No.		FILE No.	
07-1130-2070		0711302070-R02061	
CADD		SCALE	
SJB		AS SHOWN	
CHECK		REV. 1	
DEC 09		6.1L

1. THIS FIGURE IS TO BE READ WITH THE REPORT TITLED "SUBSURFACE CONDITIONS INTERPRETATION REPORT, WINDSOR-ESSEX PARKWAY"
2. THIS FIGURE REPRESENTS A SUMMARY OF FIELD AND LABORATORY TESTING DATA AS DISCUSSED IN THE TEXT OF THE REPORT REFERENCED ABOVE.

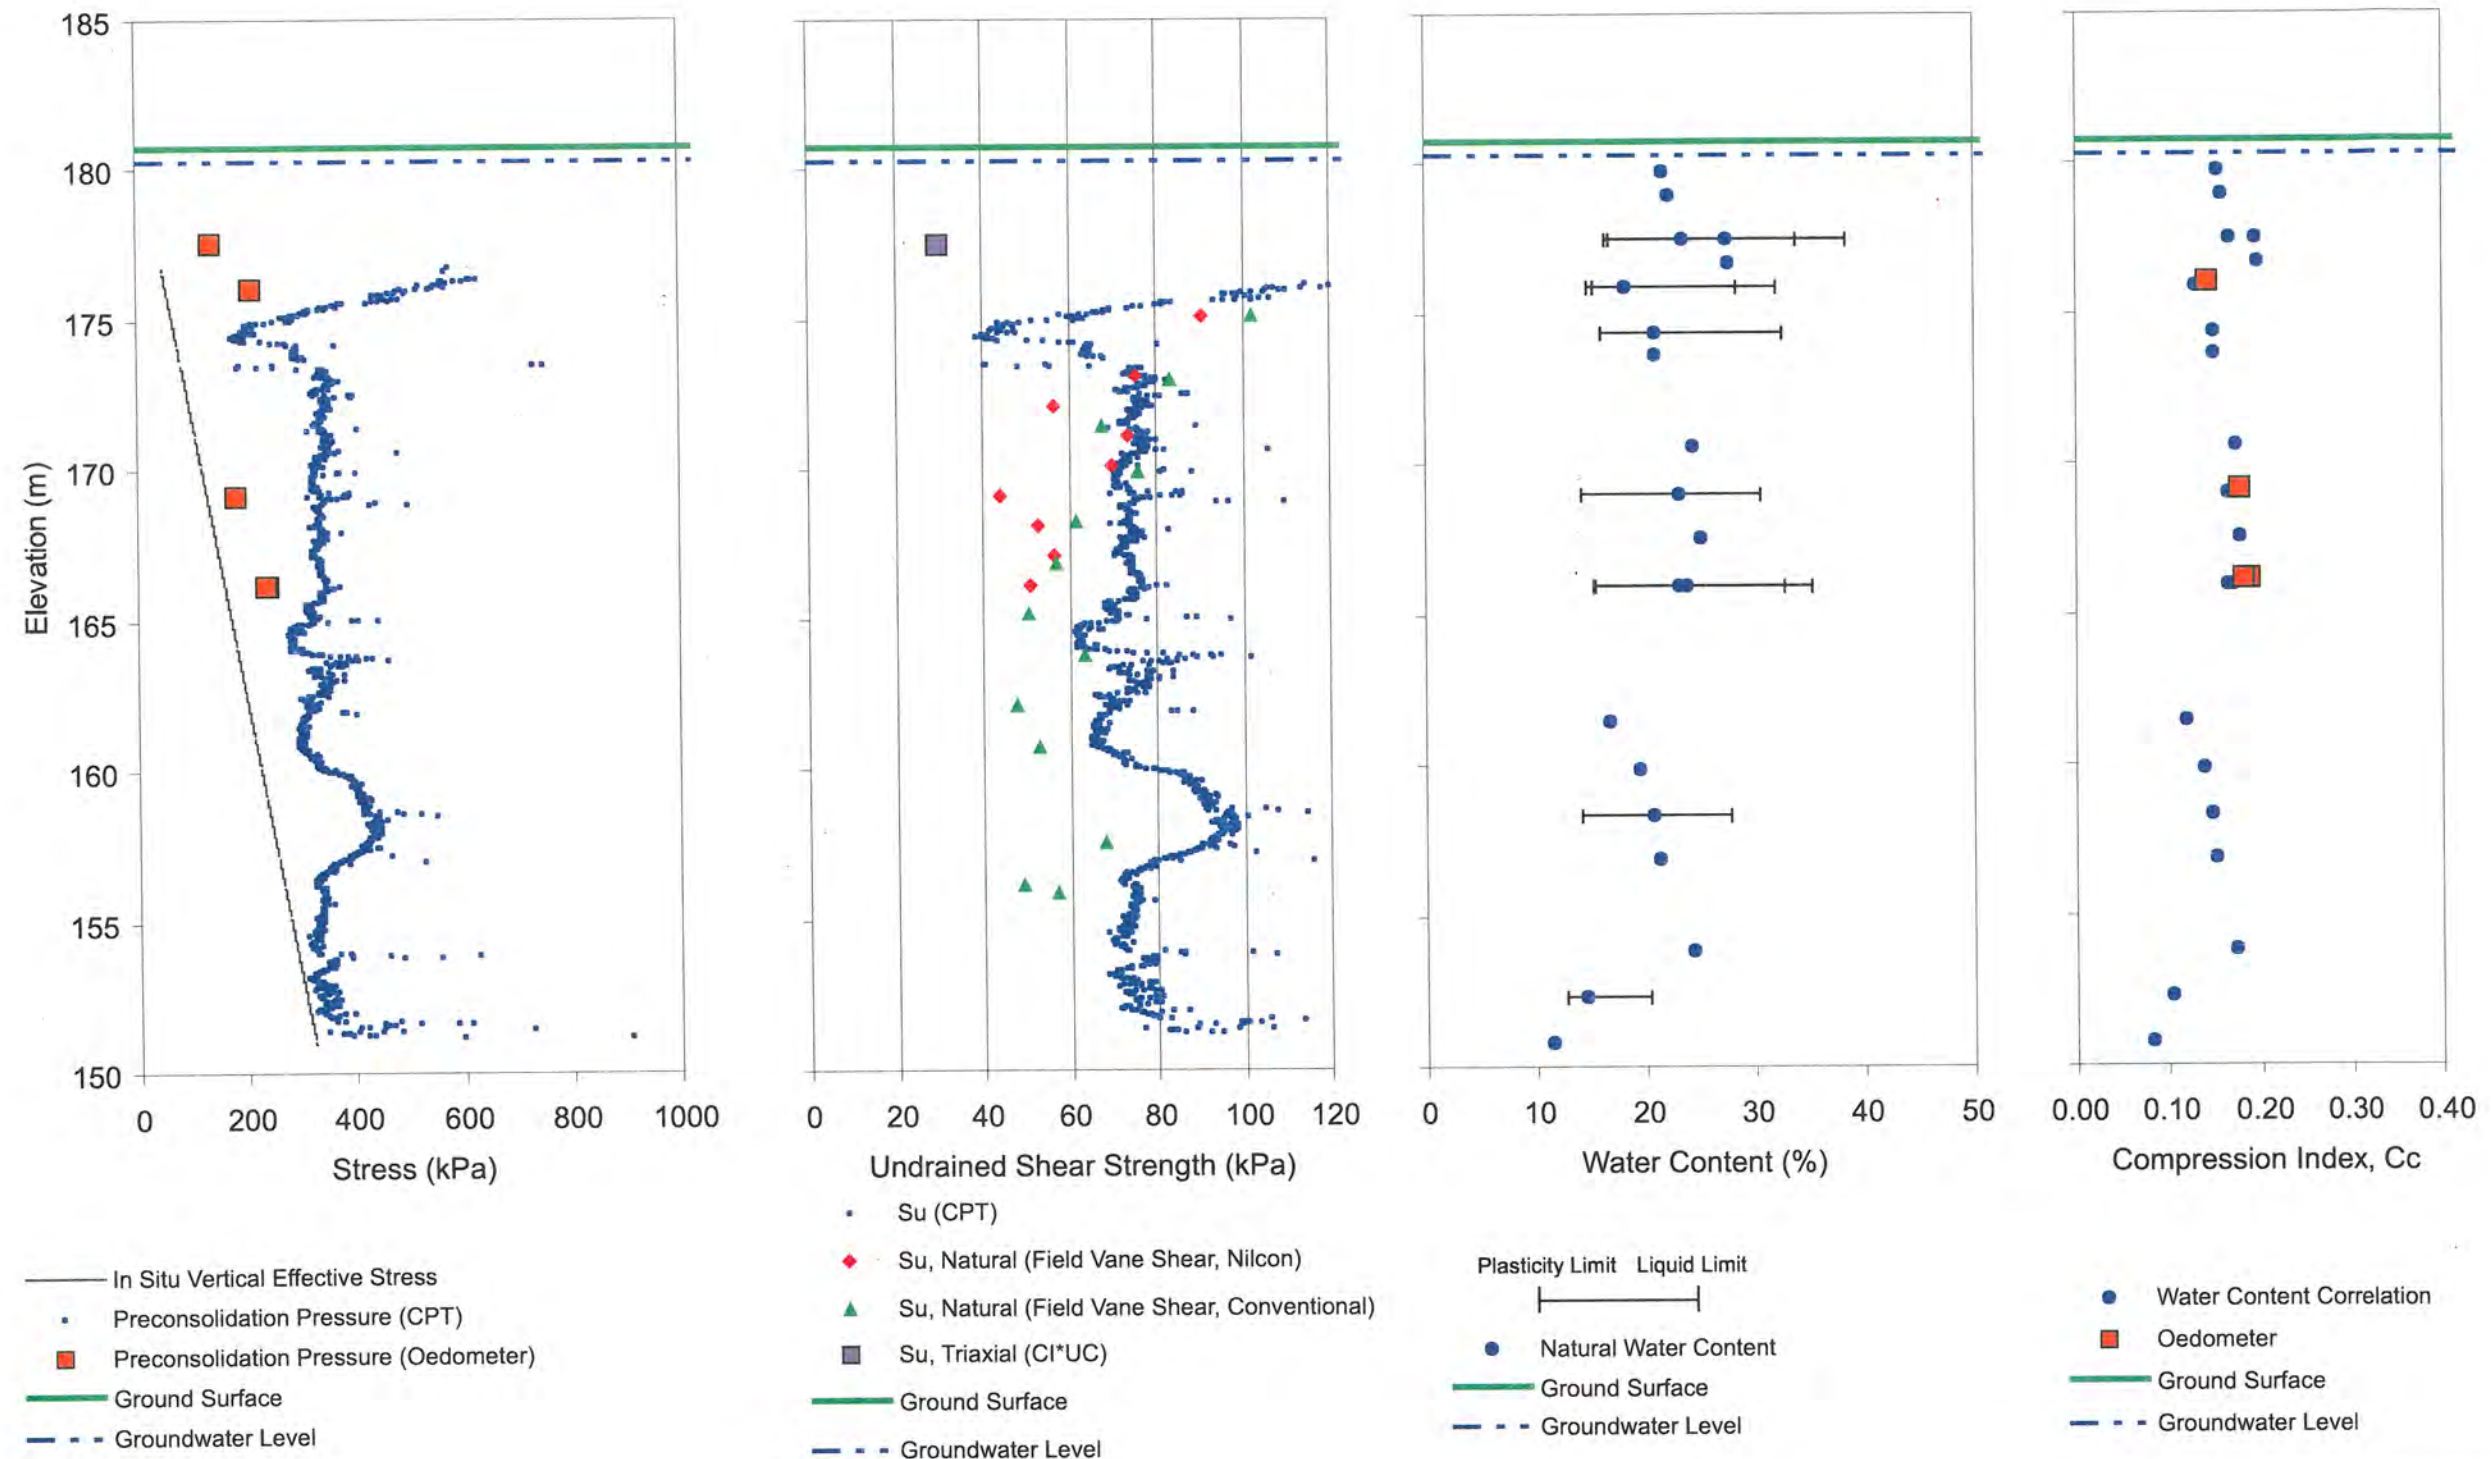
1. THIS FIGURE IS TO BE READ WITH THE REPORT TITLED "SUBSURFACE CONDITIONS INTERPRETATION REPORT, WINDSOR-ESSEX PARKWAY"
2. THIS FIGURE REPRESENTS A SUMMARY OF FIELD AND LABORATORY TESTING DATA AS DISCUSSED IN THE TEXT OF THE REPORT REFERENCED ABOVE.

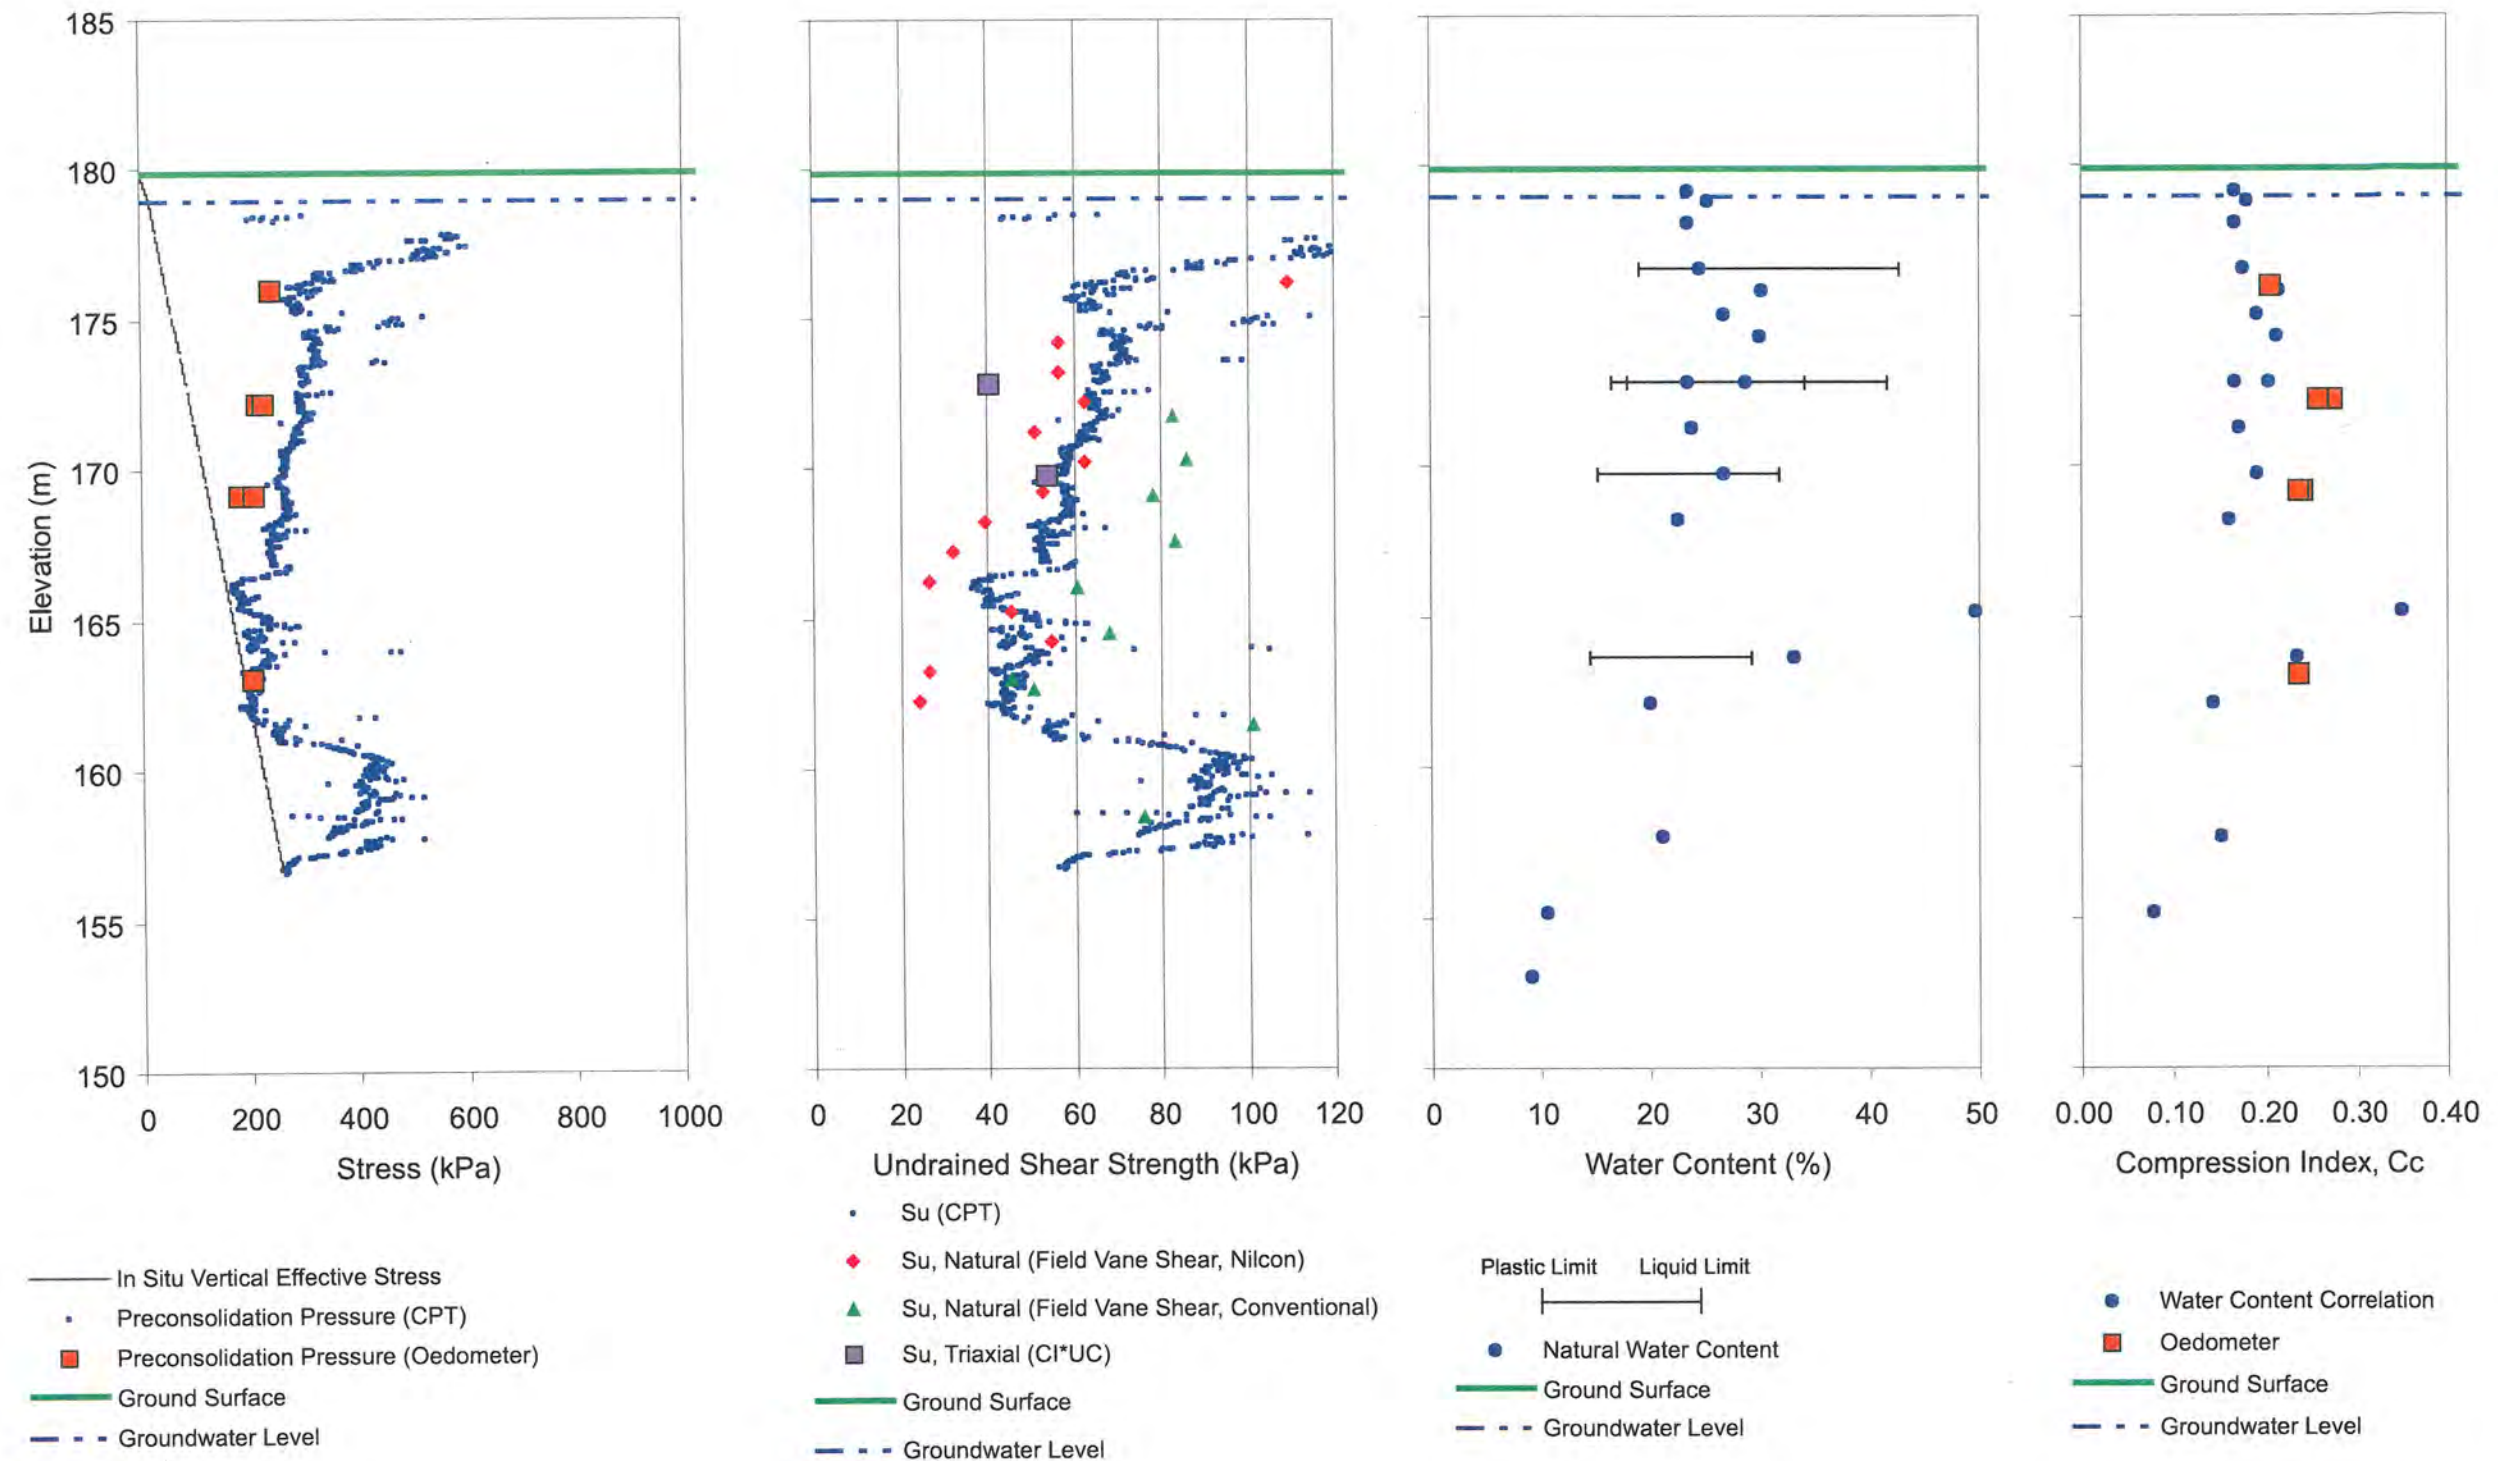
PROJECT			
SUBSURFACE CONDITIONS INTERPRETATION REPORT			
WINDSOR-ESSEX PARKWAY			
WINDSOR, ONTARIO			
TITLE			
SUMMARY OF SUBSURFACE TEST DATA			
BOREHOLE BH-158/CPT-21			
PROJECT No.		07-1130-2070	
FILE No.		0711302070-R02081	
CADD	SJB	DEC 09	SCALE AS SHOWN REV 1
CHECK	mt	Duo9	6.1N

1. THIS FIGURE IS TO BE READ WITH THE REPORT TITLED "SUBSURFACE CONDITIONS INTERPRETATION REPORT, WINDSOR-ESSEX PARKWAY"
2. THIS FIGURE REPRESENTS A SUMMARY OF FIELD AND LABORATORY TESTING DATA AS DISCUSSED IN THE TEXT OF THE REPORT REFERENCED ABOVE.

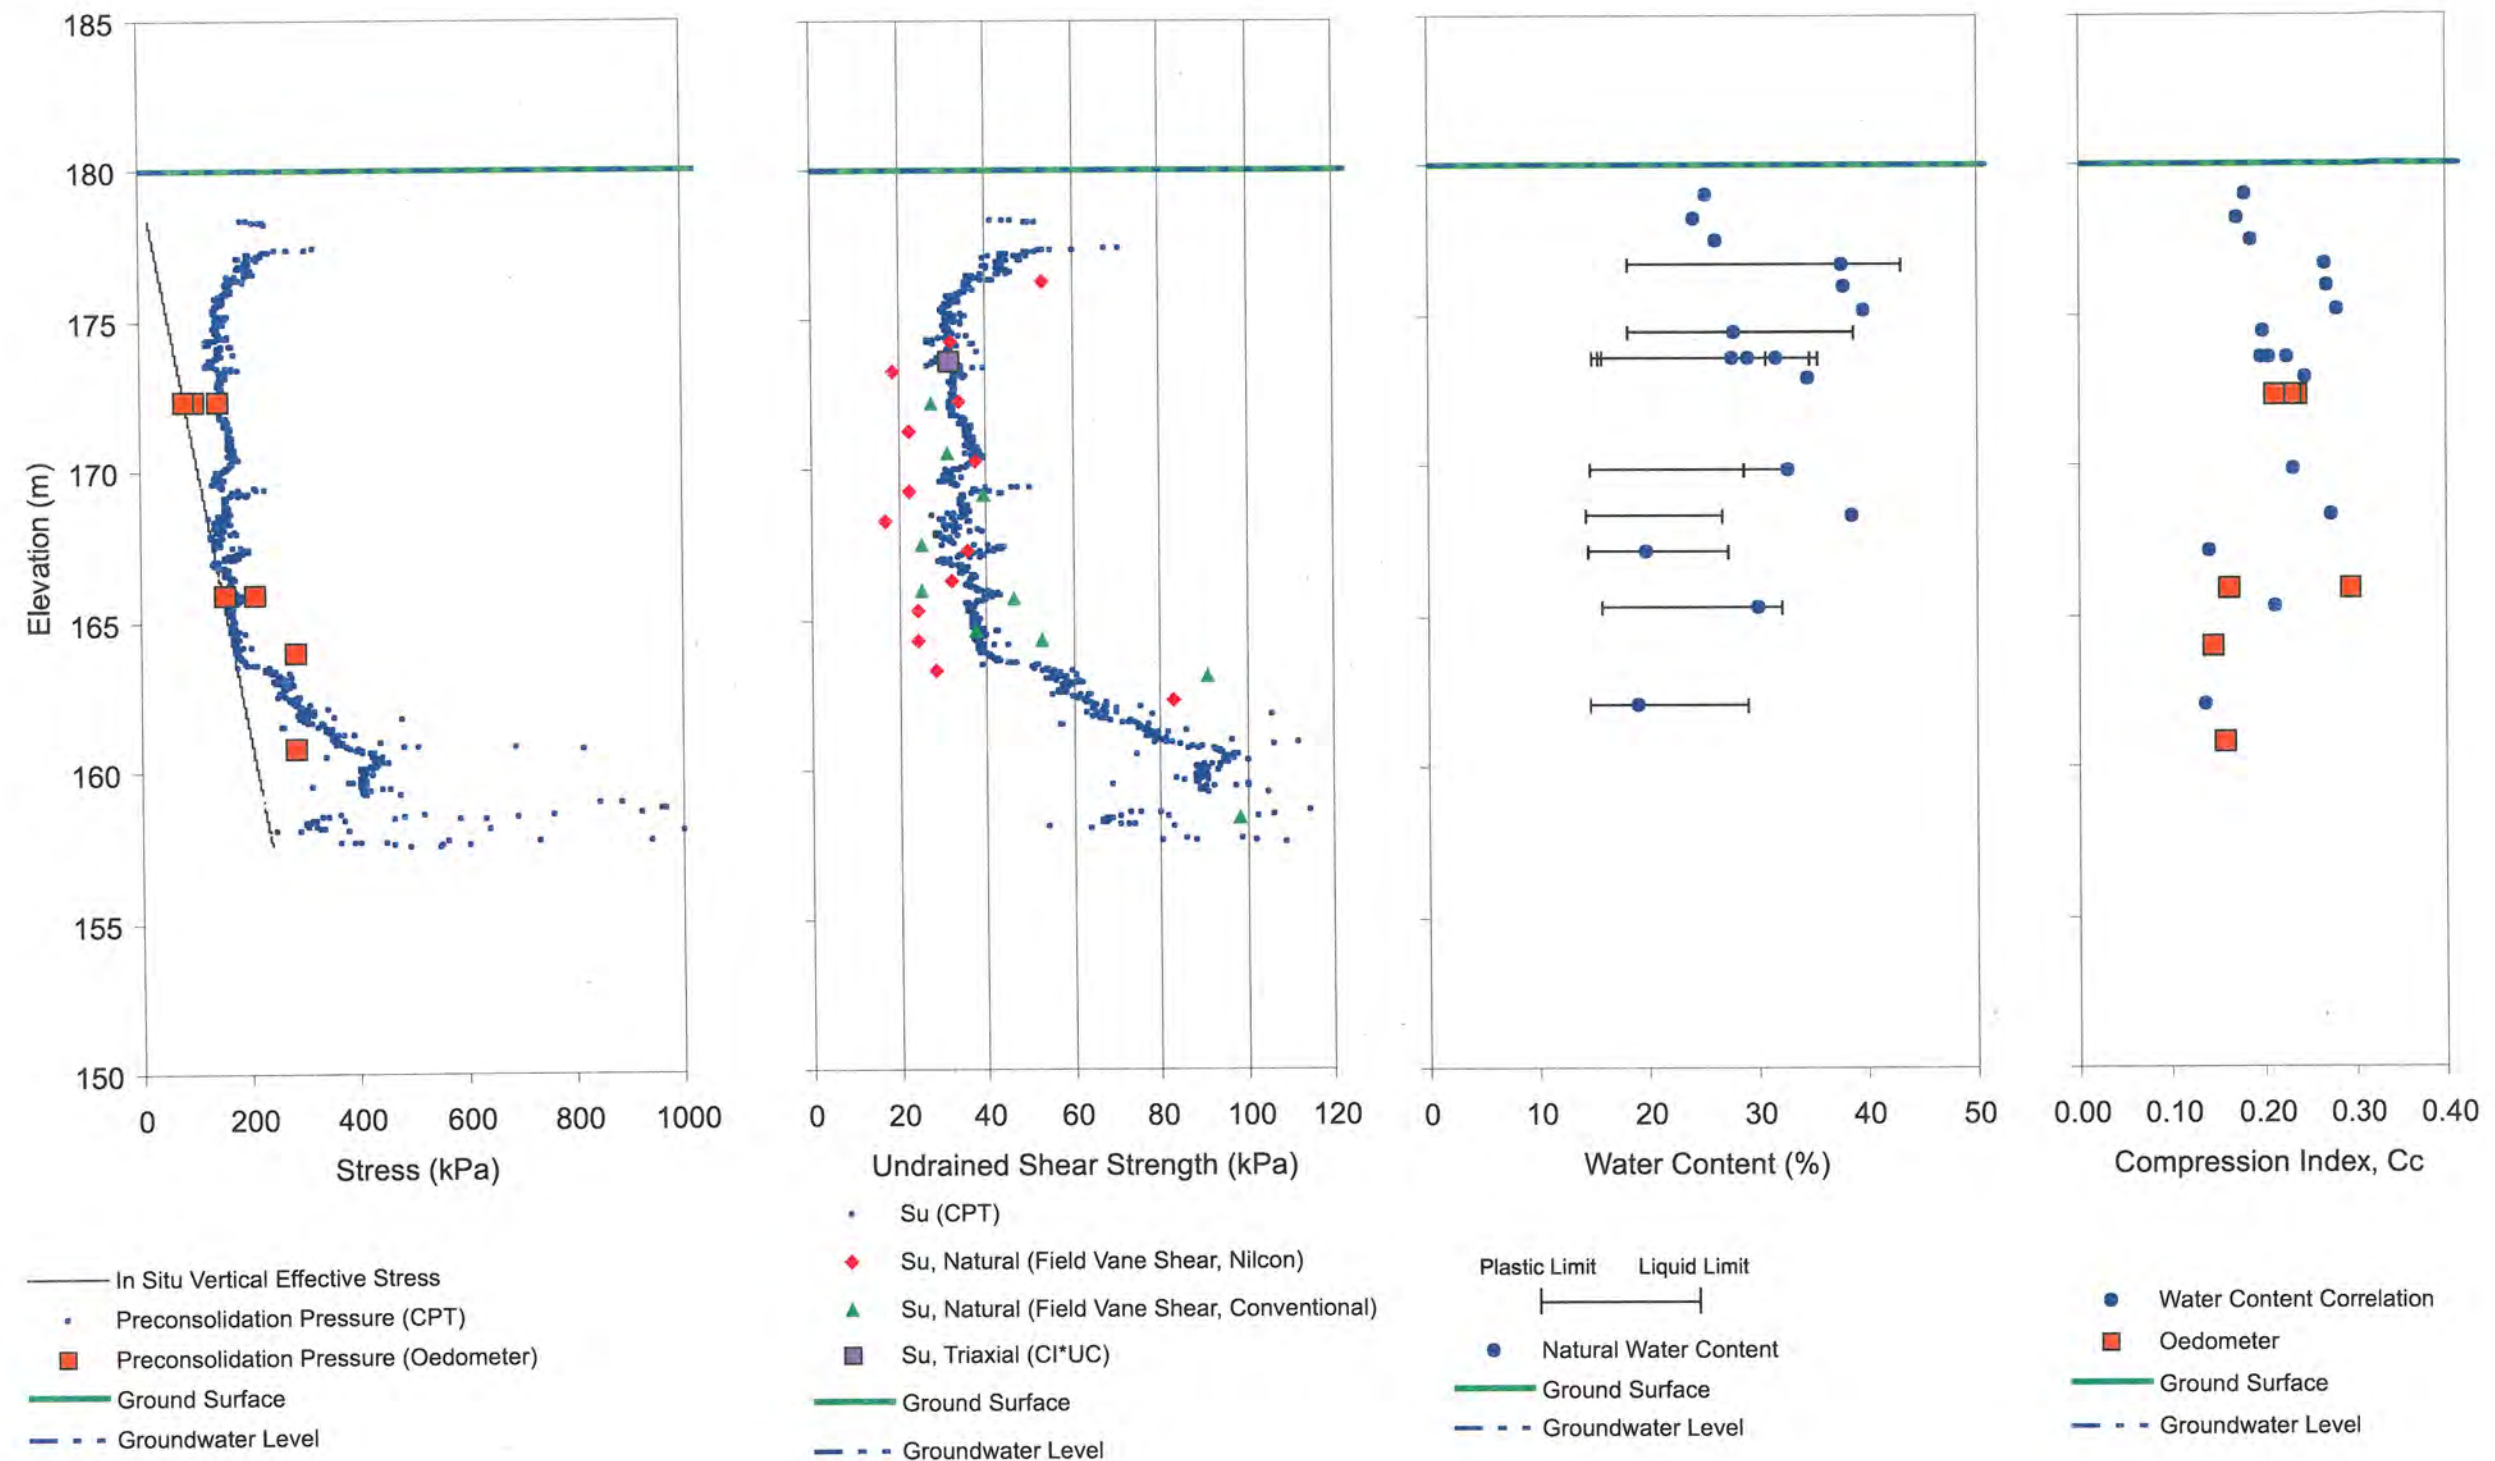
PROJECT			
SUBSURFACE CONDITIONS INTERPRETATION REPORT			
WINDSOR-ESSEX PARKWAY			
WINDSOR, ONTARIO			
TITLE			
SUMMARY OF SUBSURFACE TEST DATA			
BOREHOLE BH-160/CPT-160			
PROJECT No. 07-1130-2070		FILE No. 0711302070-R02061	
CADD	SJB	DEC 09	SCALE AS SHOWN REV 1
CHECK	M. DUBOIS		6.10

1. THIS FIGURE IS TO BE READ WITH THE REPORT TITLED "SUBSURFACE CONDITIONS INTERPRETATION REPORT, WINDSOR-ESSEX PARKWAY"
2. THIS FIGURE REPRESENTS A SUMMARY OF FIELD AND LABORATORY TESTING DATA AS DISCUSSED IN THE TEXT OF THE REPORT REFERENCED ABOVE.

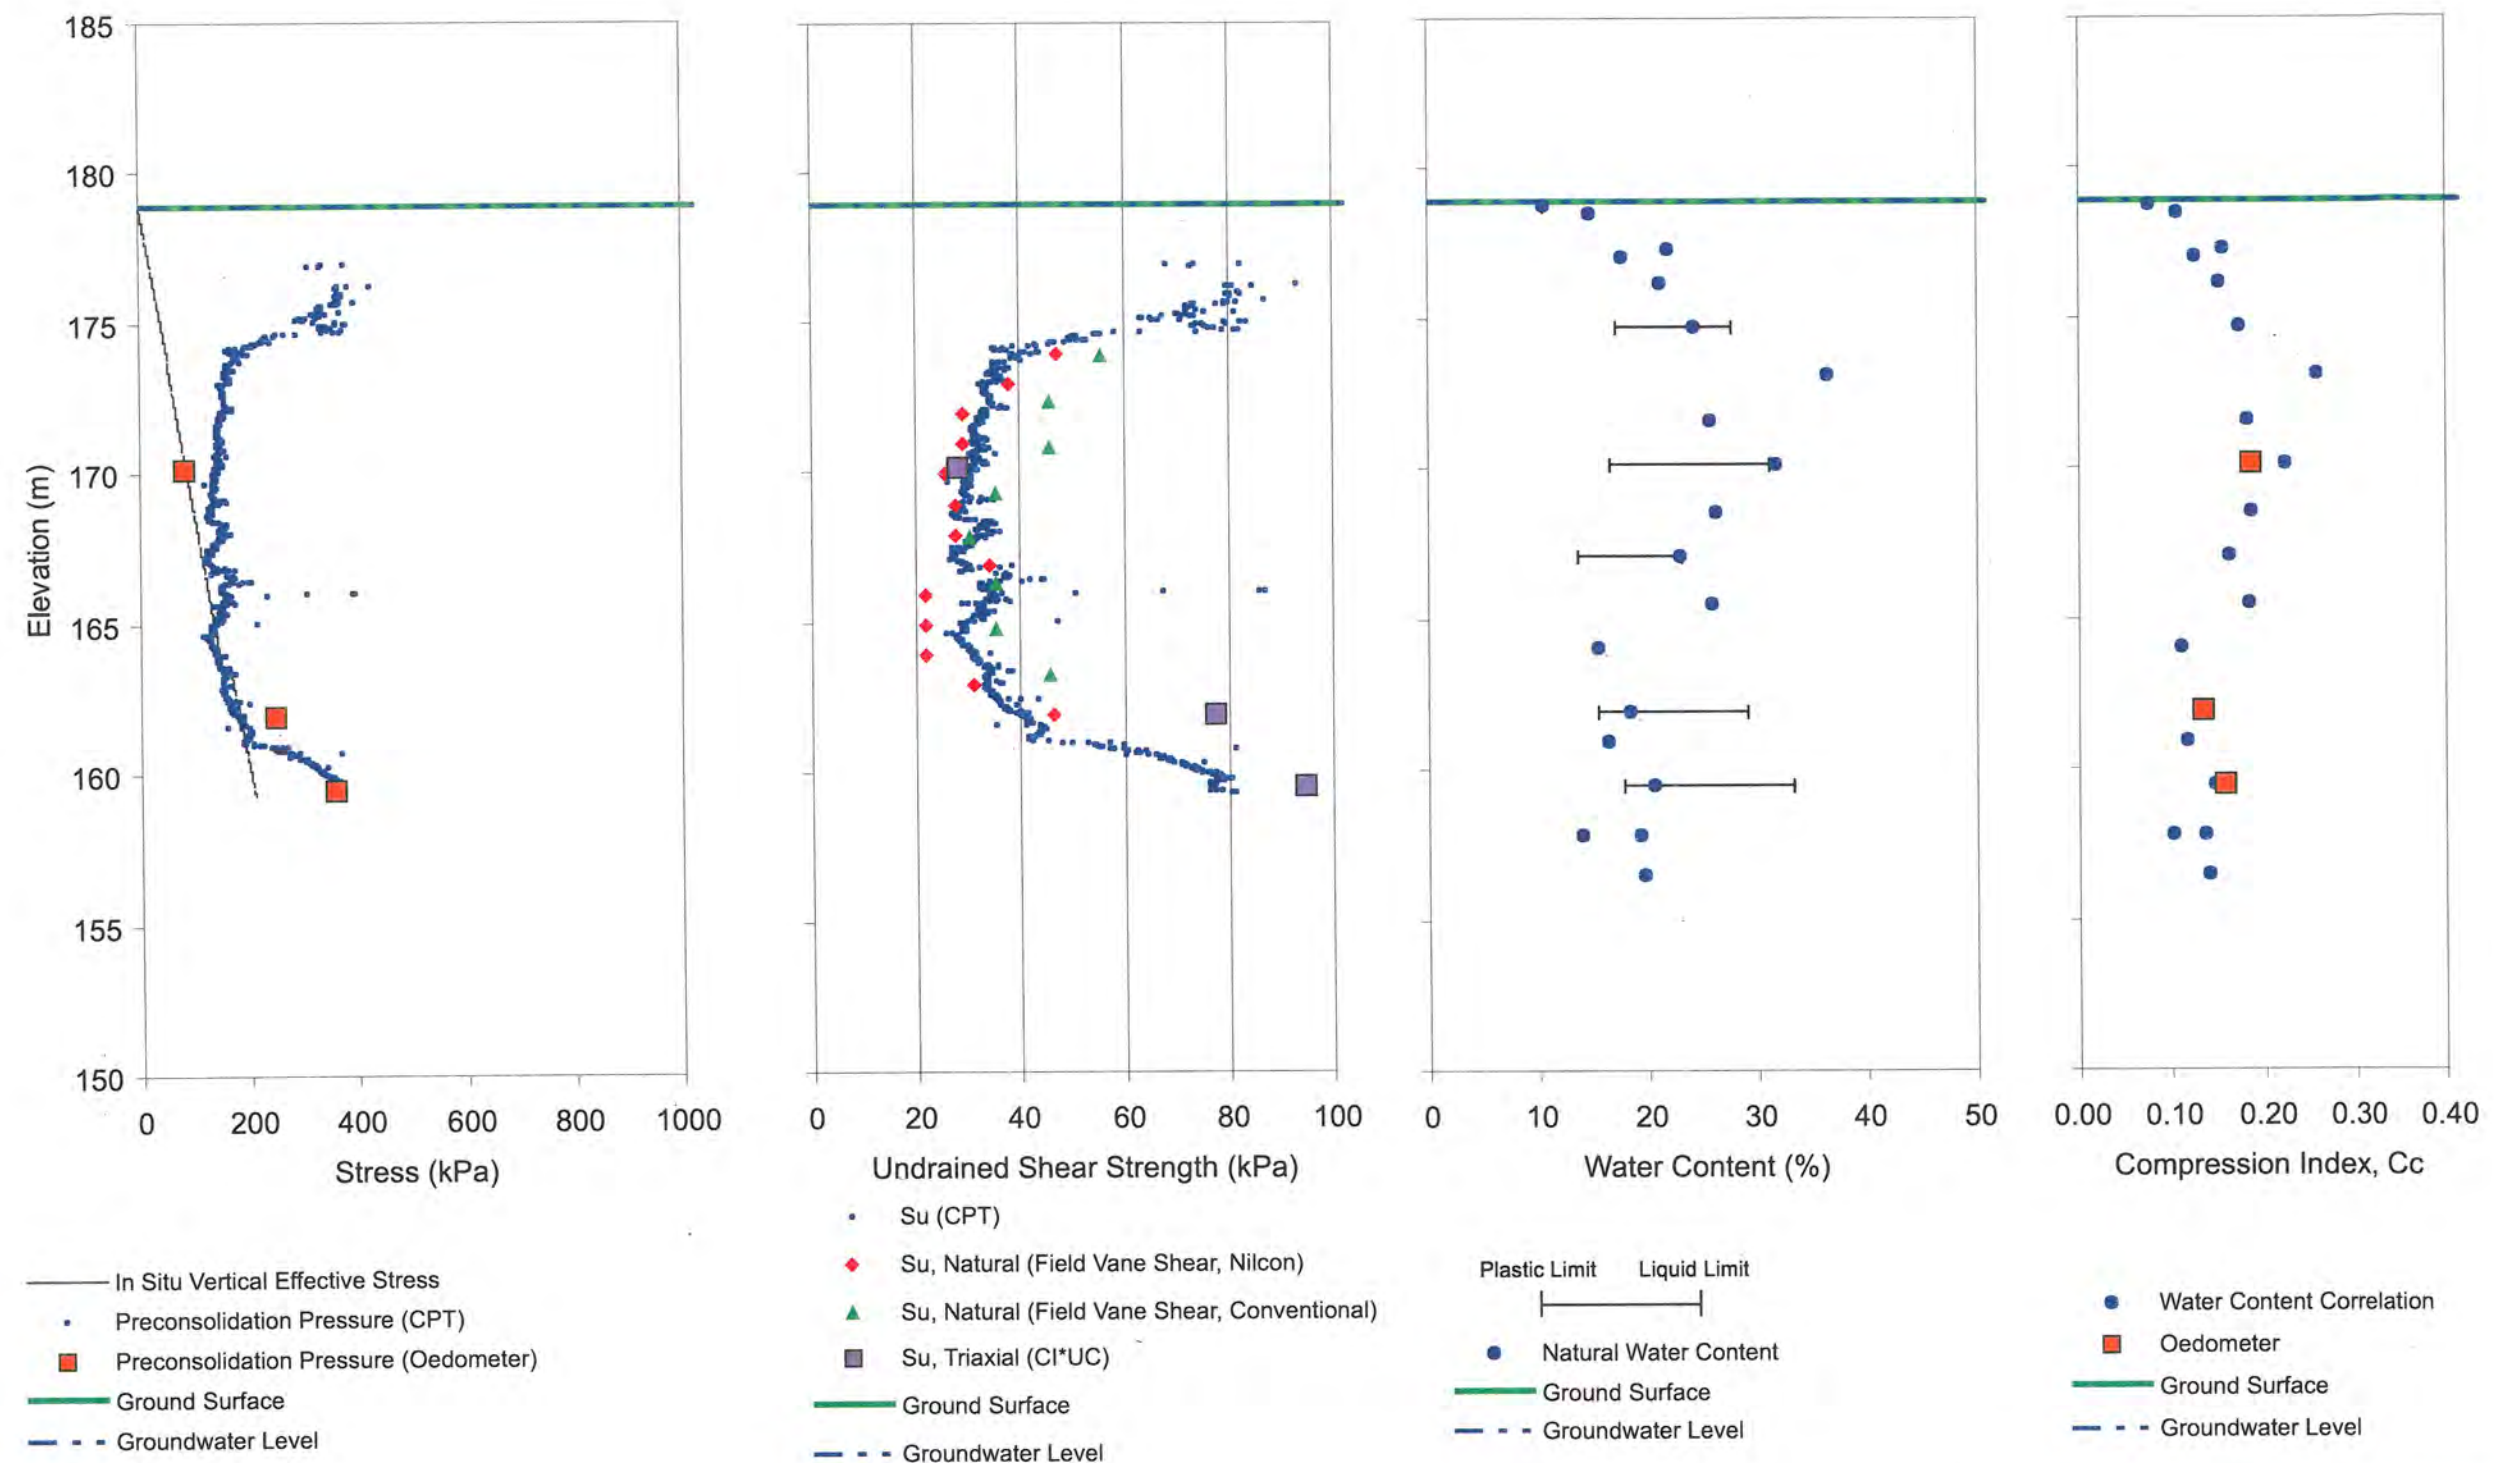
1. THIS FIGURE IS TO BE READ WITH THE REPORT TITLED "SUBSURFACE CONDITIONS INTERPRETATION REPORT, WINDSOR-ESSEX PARKWAY"
2. THIS FIGURE REPRESENTS A SUMMARY OF FIELD AND LABORATORY TESTING DATA AS DISCUSSED IN THE TEXT OF THE REPORT REFERENCED ABOVE.

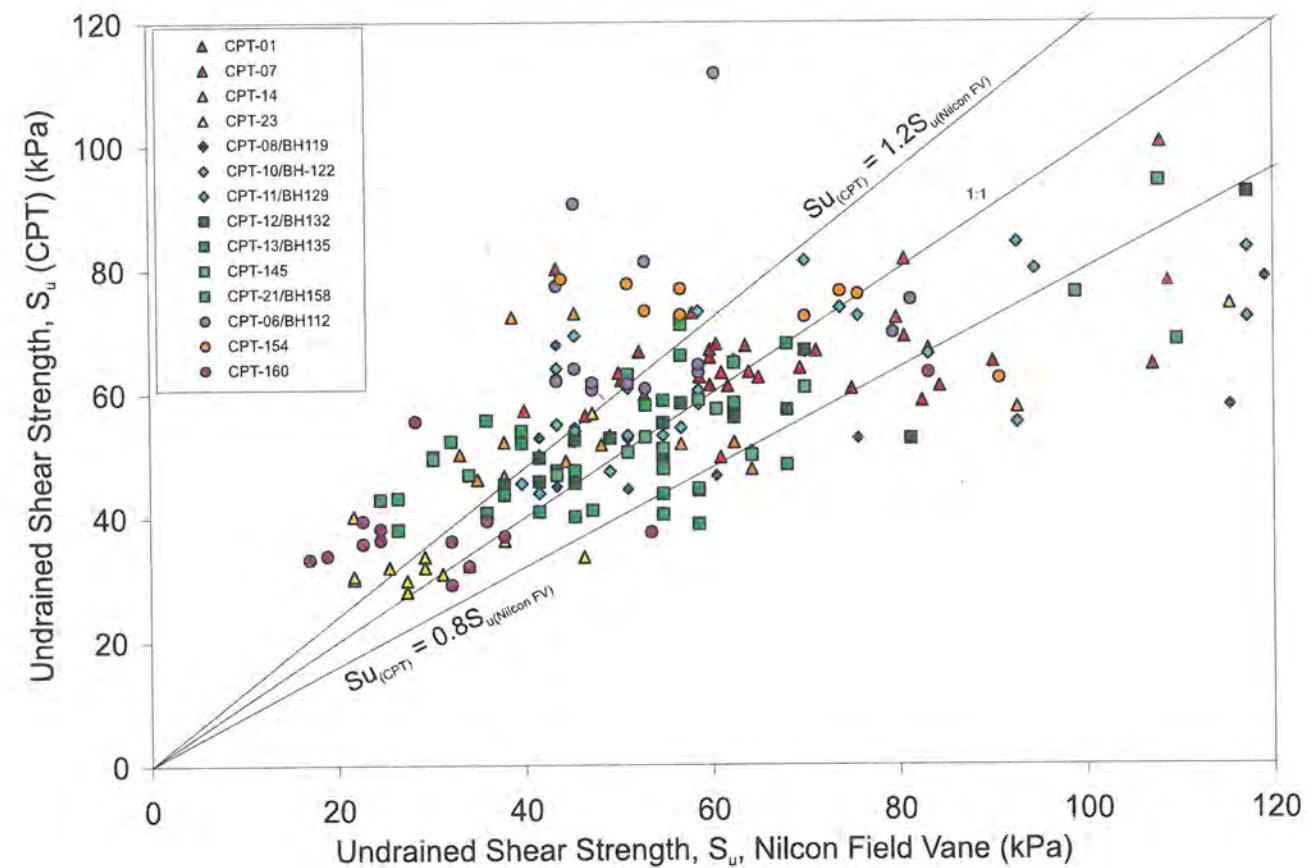
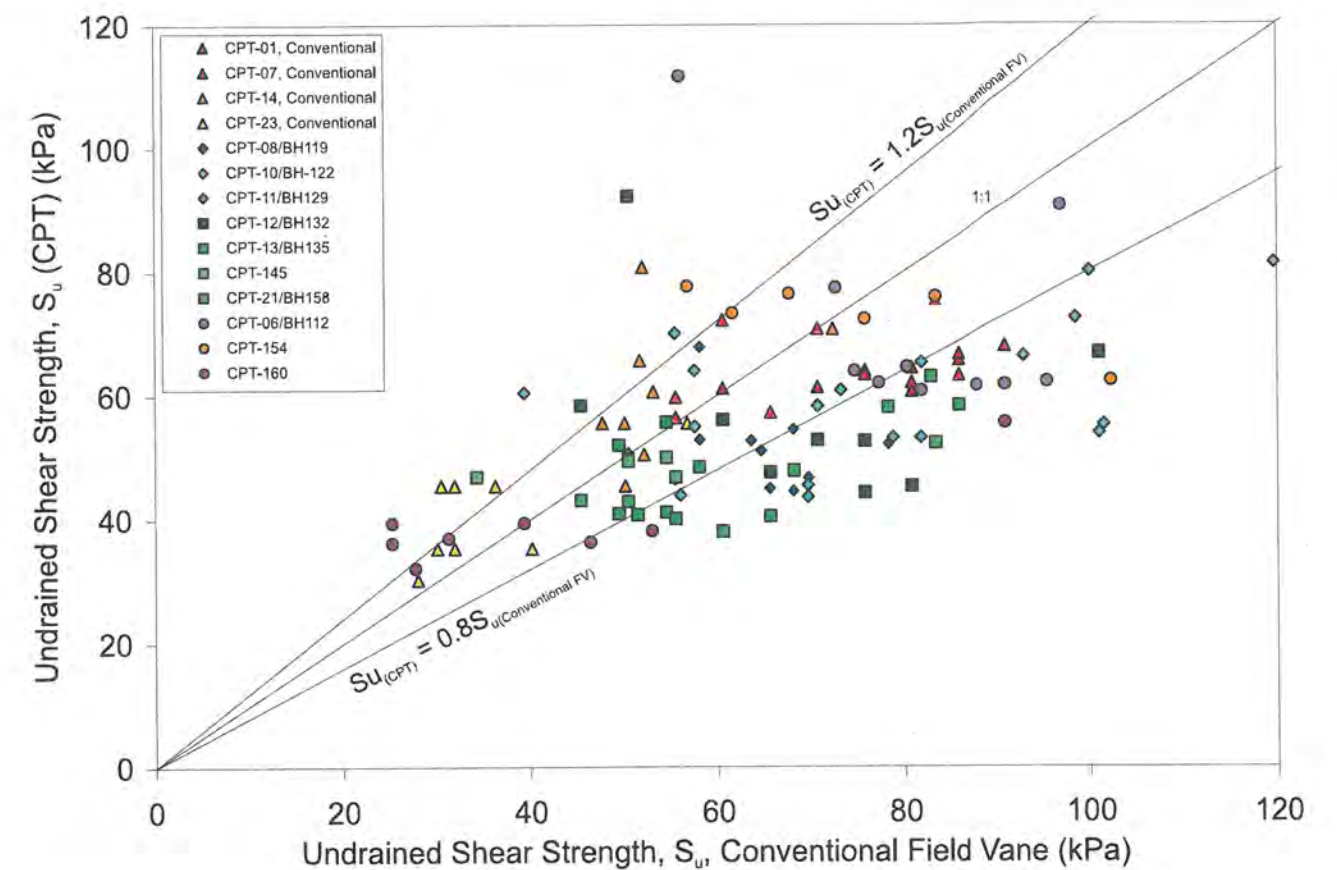
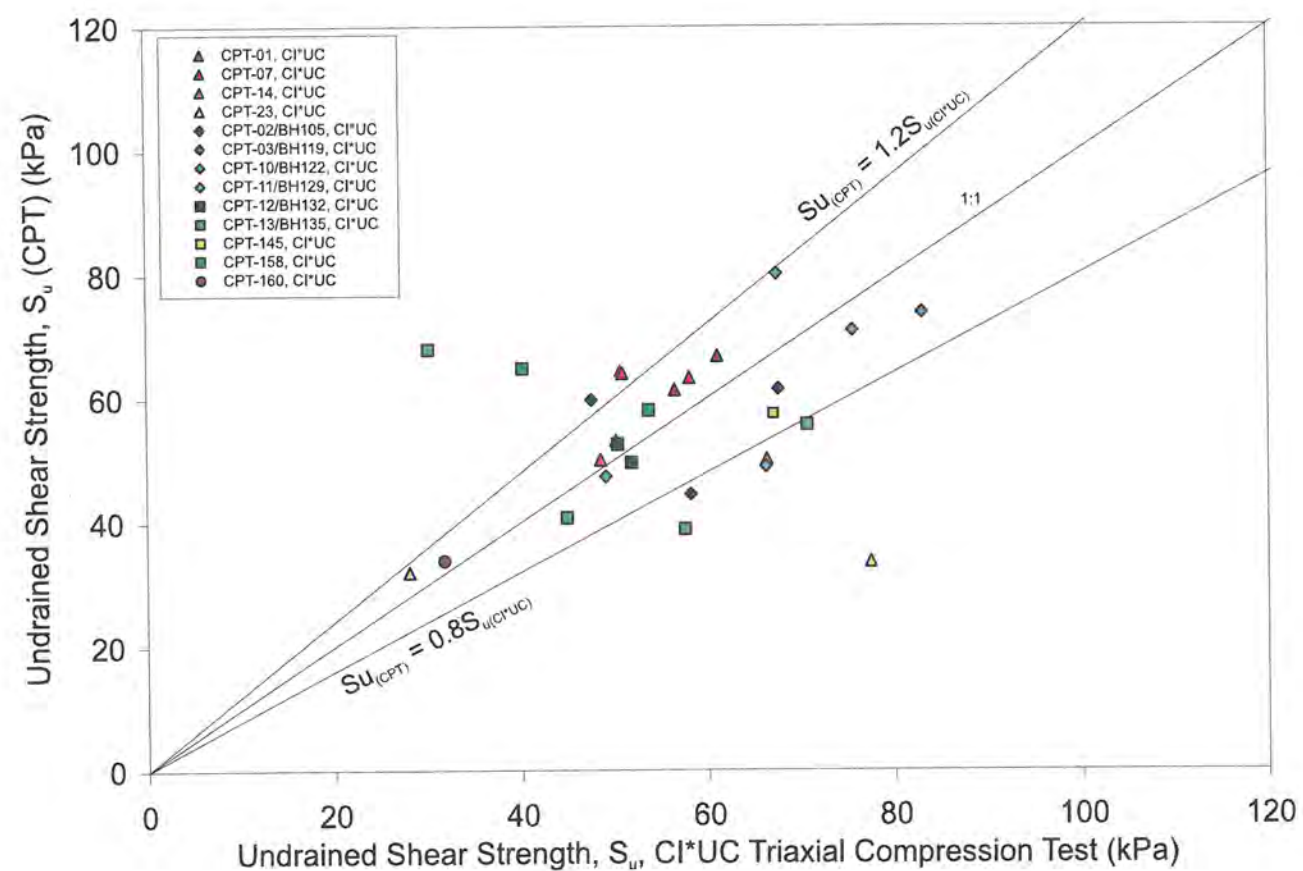
PROJECT			
SUBSURFACE CONDITIONS INTERPRETATION REPORT			
WINDSOR-ESSEX PARKWAY			
WINDSOR, ONTARIO			
TITLE			
DATA SUMMARY			
UNDRAINED SHEAR STRENGTH			
CPT, LABORATORY AND FIELD VANE TESTS			
PROJECT No. 0711302070		FILE No. 0711302070-R02062	
CADD	SJB	DEC 09	SCALE AS SHOWN
CHECK	MJ	DEC 09	6.2

1. THIS FIGURE IS TO BE READ WITH THE REPORT TITLED "SUBSURFACE CONDITIONS INTERPRETATION REPORT, WINDSOR-ESSEX PARKWAY"
2. THIS FIGURE REPRESENTS A SUMMARY OF FIELD AND LABORATORY TESTING DATA AS DISCUSSED IN THE TEXT OF THE REPORT REFERENCED ABOVE.
