## **WINDSOR-ESSEX PARKWAY**

# **Subsurface Conditions Interpretation Report**

**Report Number:** 07-1130-207-0-R02 / 05-1140-003

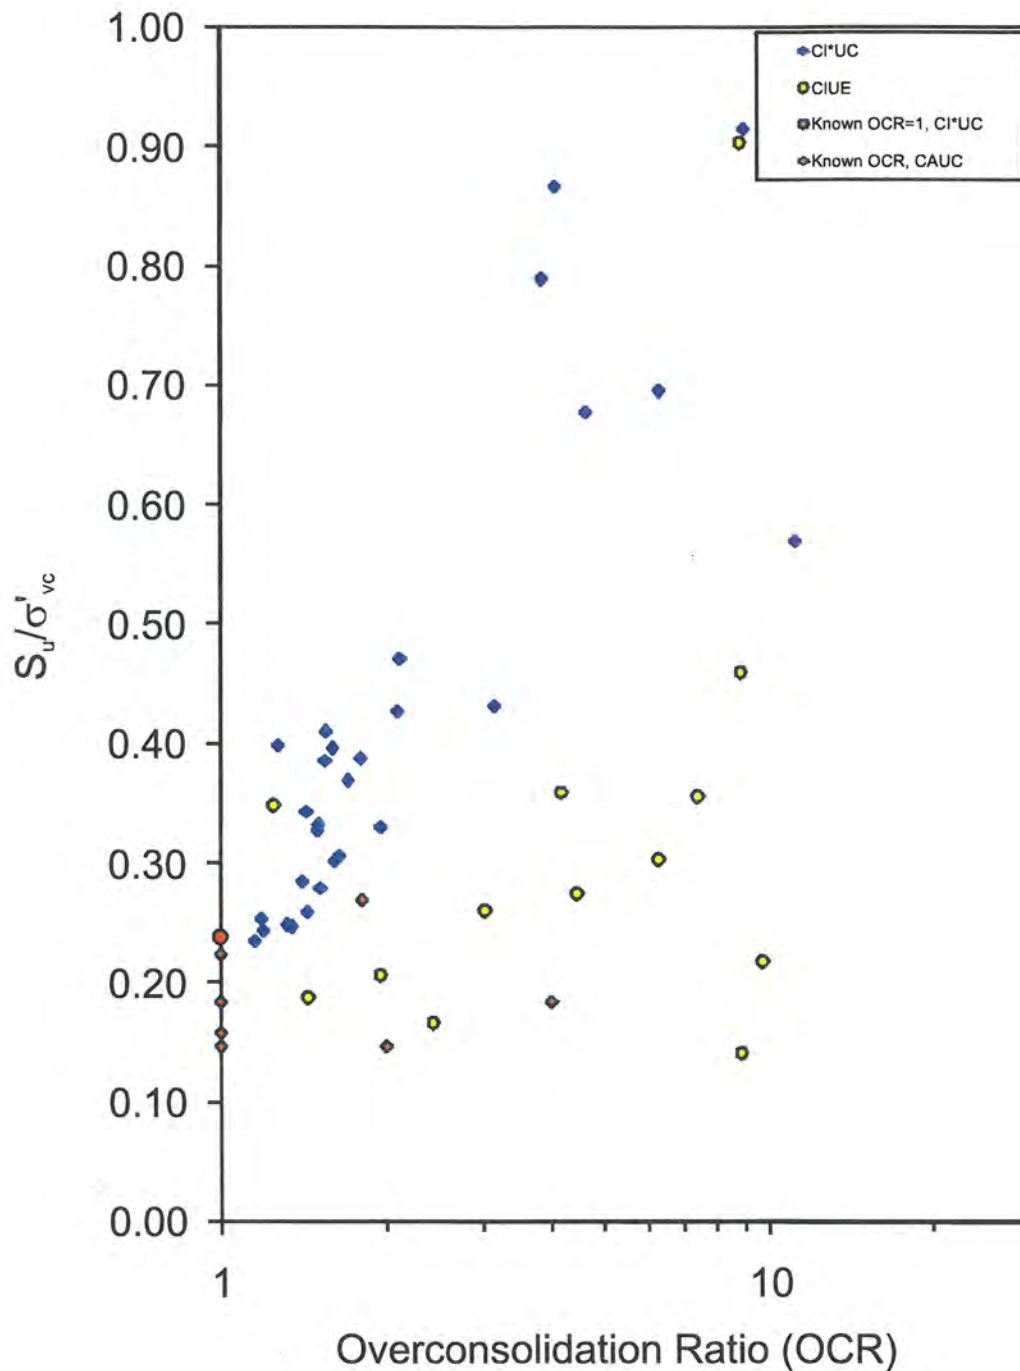
PROJECT			
SUBSURFACE CONDITIONS INTERPRETATION REPORT WINDSOR-ESSEX PARKWAY WINDSOR, ONTARIO			
TITLE			
DATA SUMMARY LABORATORY UNDRAINED SHEAR STRENGTH DATA COMPARISON			
PROJECT No.		07-1130-2070	
FILE No.		0711302070-R02083	
CADD	SUB	DEC 09	SCALE AS SHOWN REV 1
CHECK	<i>WJ</i>	<i>Duch</i>	6.3

1. THIS FIGURE IS TO BE READ WITH THE REPORT TITLED "SUBSURFACE CONDITIONS INTERPRETATION REPORT, WINDSOR-ESSEX PARKWAY"
2. THIS FIGURE REPRESENTS A SUMMARY OF LABORATORY TESTING DATA AS DISCUSSED IN THE TEXT OF THE REPORT REFERENCED ABOVE

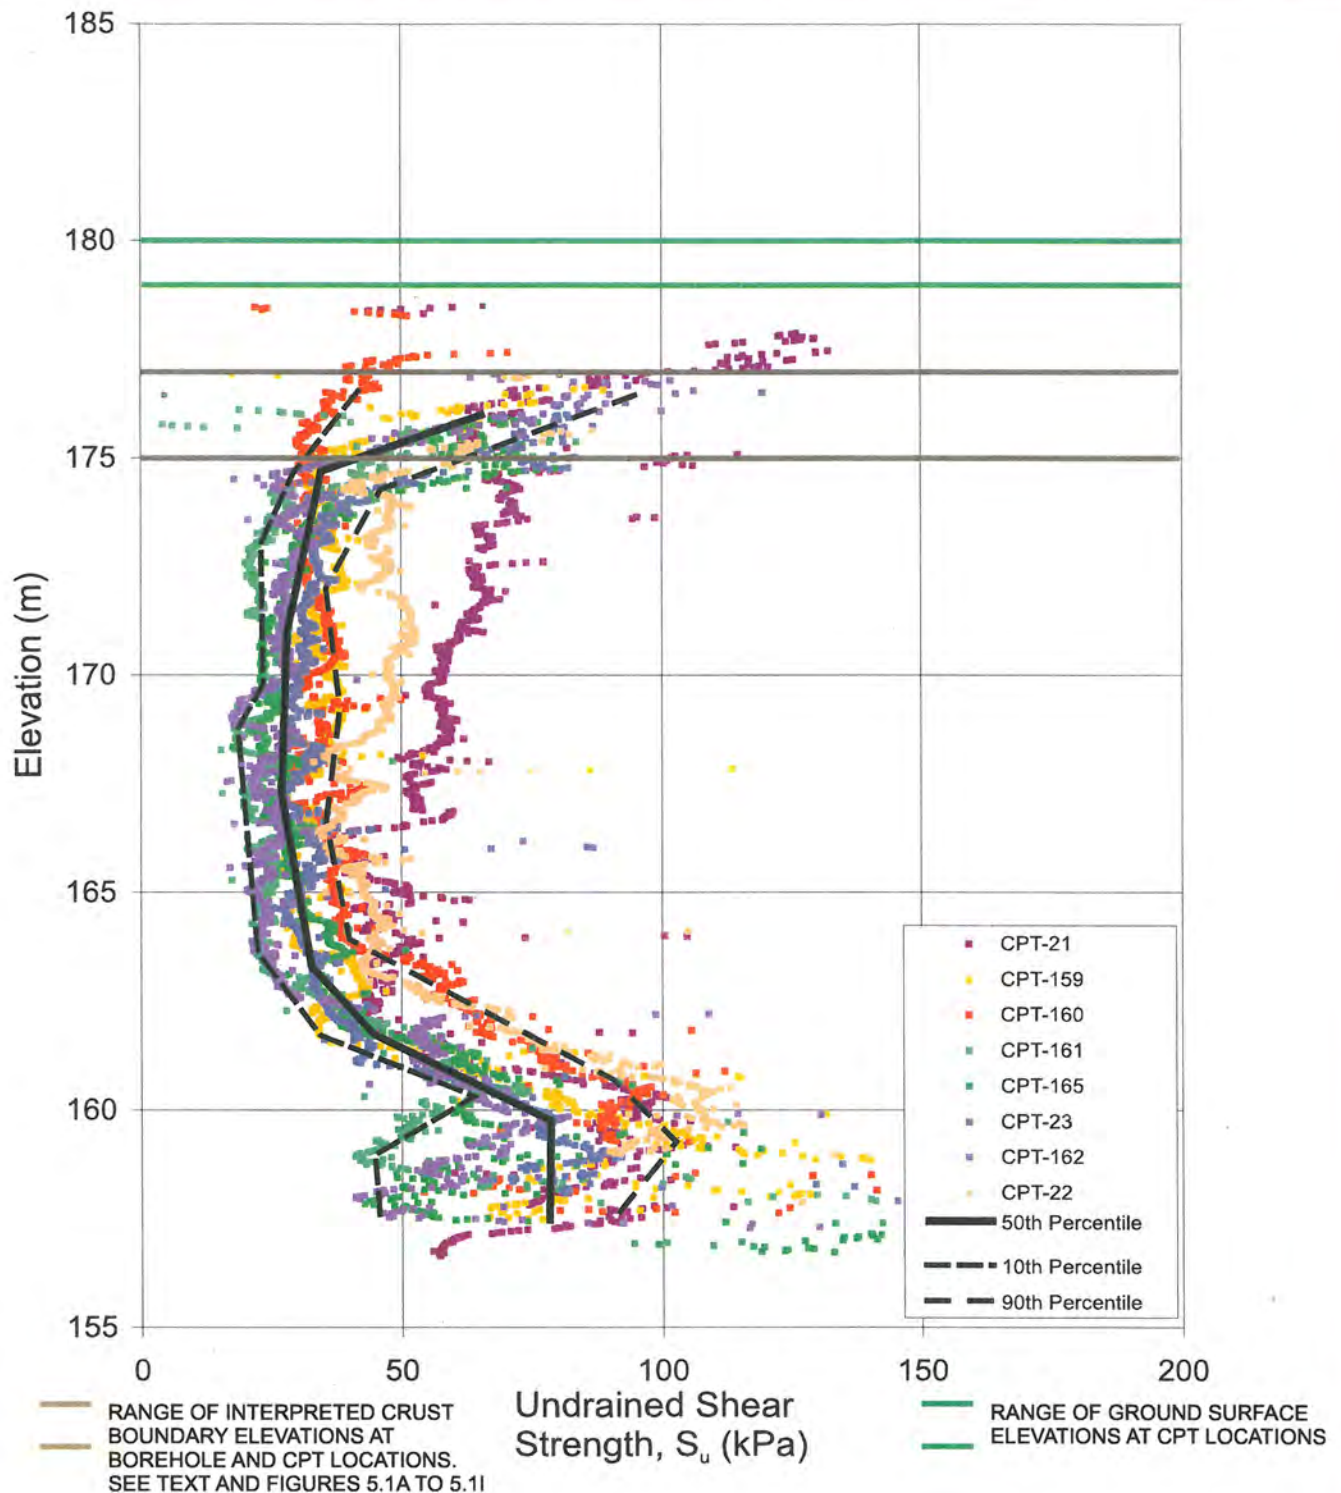
PROJECT No. 07-1130-2070		FILE No. 0711302070-R02064	
CADD		SCALE AS SHOWN REV. 1	
CHECK		DEC 09	
		6.4A

1. THIS FIGURE IS TO BE READ WITH THE REPORT TITLED "SUBSURFACE CONDITIONS INTERPRETATION REPORT, WINDSOR-ESSEX PARKWAY"
2. THIS FIGURE REPRESENTS A SUMMARY OF FIELD CPT DATA AND THE INTERPRETED UNDRAINED SHEAR STRENGTH PROFILE AS DESCRIBED IN THE TEXT OF THE REPORT REFERENCED ABOVE.

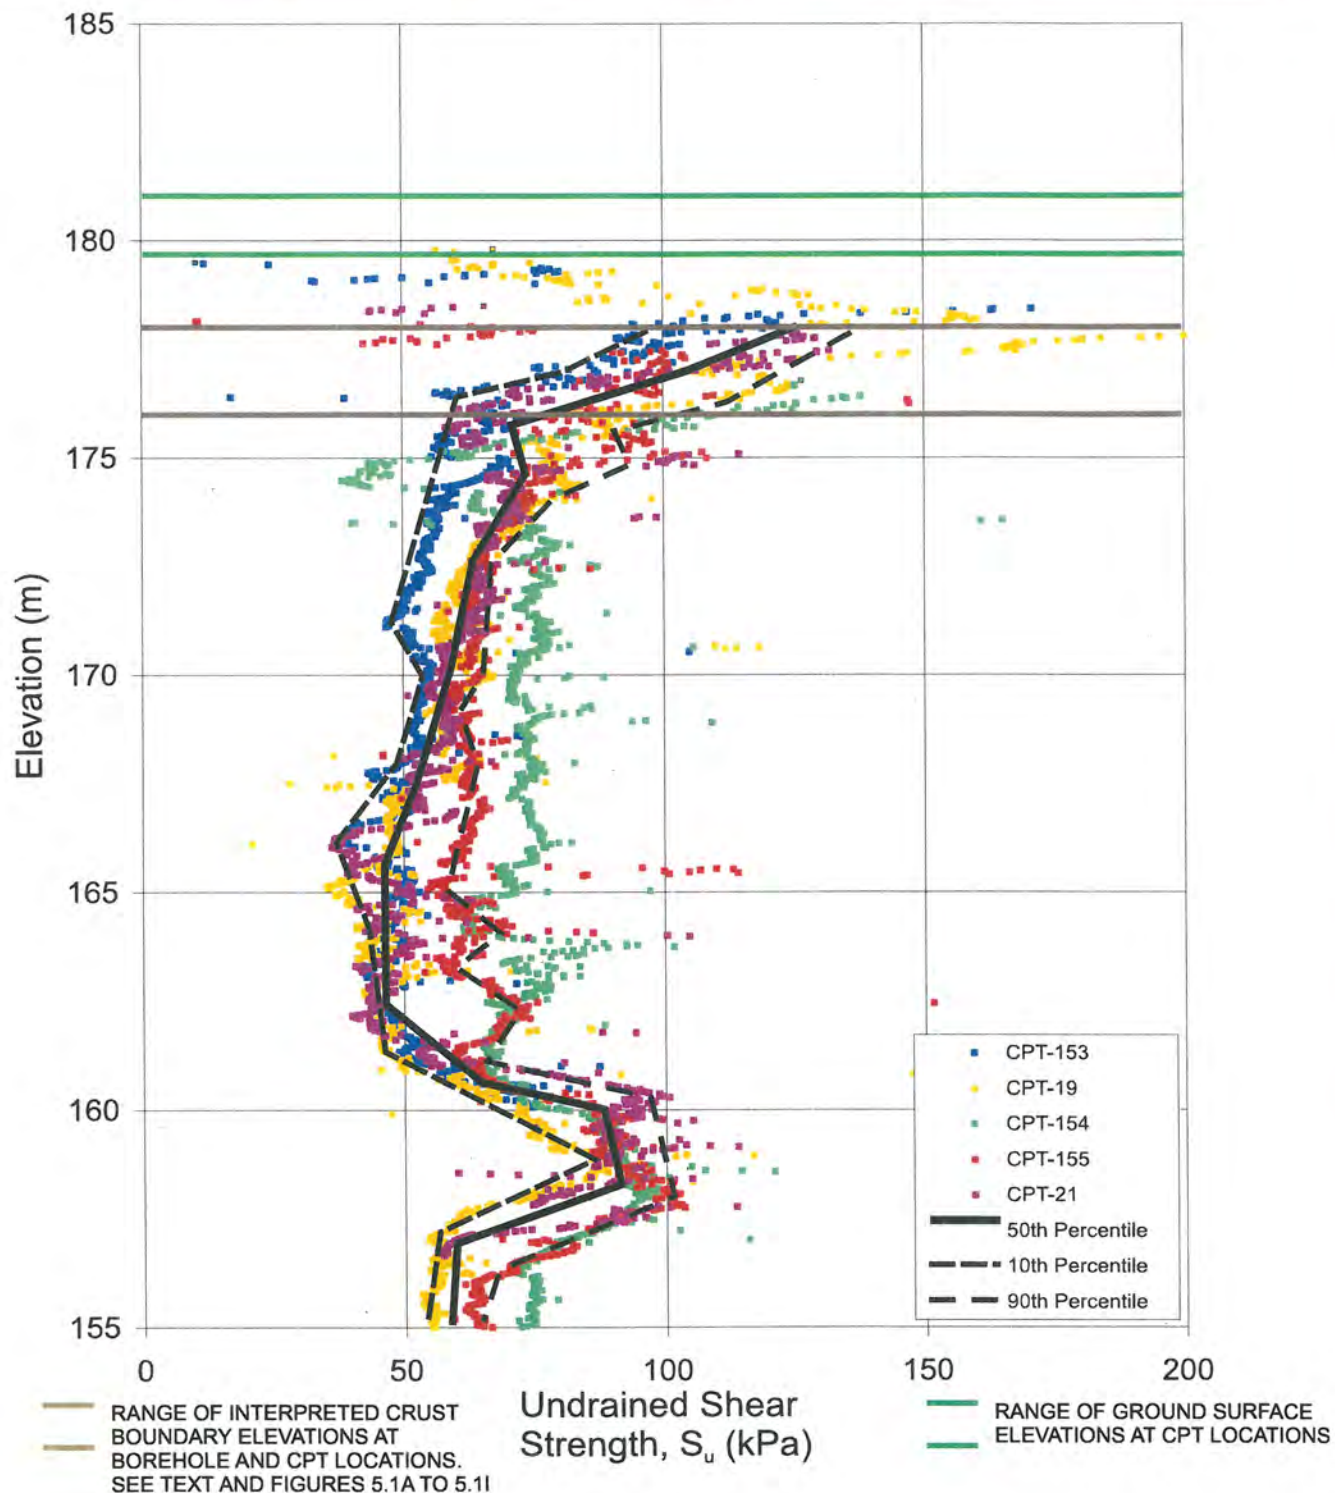
PROJECT No. 07-1130-2070		FILE No. 0711302070-R02064	
CADD	SJB	DEC 09	SCALE AS SHOWN REV. 1
CHECK	M. DeG		6.4B

1. THIS FIGURE IS TO BE READ WITH THE REPORT TITLED "SUBSURFACE CONDITIONS INTERPRETATION REPORT, WINDSOR-ESSEX PARKWAY"
2. THIS FIGURE REPRESENTS A SUMMARY OF FIELD CPT DATA AND THE INTERPRETED UNDRAINED SHEAR STRENGTH PROFILE AS DESCRIBED IN THE TEXT OF THE REPORT REFERENCED ABOVE.

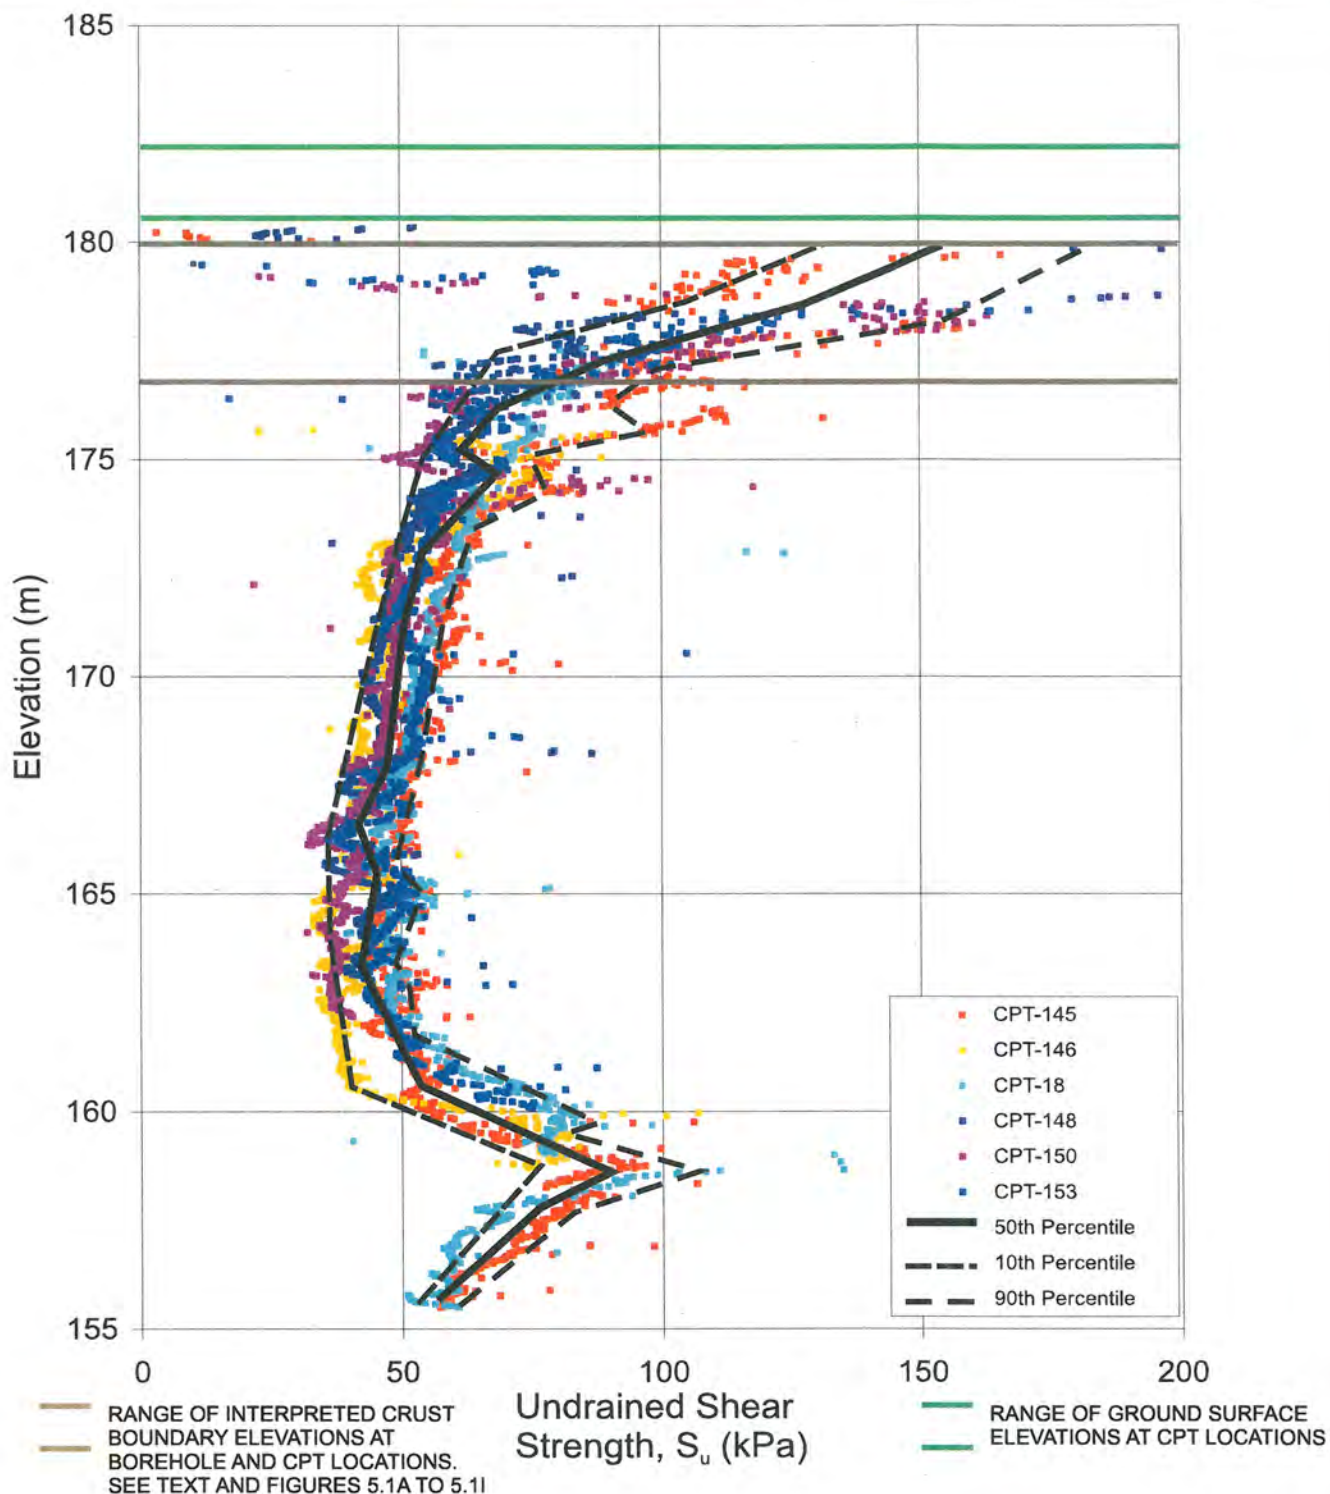
PROJECT No.	07-1130-2070	FILE No.	0711302070-R02064
CADD	SJB	DEC 09	SCALE AS SHOWN REV. 1
CHECK	AW	DEC 09	6.4C

1. THIS FIGURE IS TO BE READ WITH THE REPORT TITLED "SUBSURFACE CONDITIONS INTERPRETATION REPORT, WINDSOR-ESSEX PARKWAY"
2. THIS FIGURE REPRESENTS A SUMMARY OF FIELD CPT DATA AND THE INTERPRETED UNDRAINED SHEAR STRENGTH PROFILE AS DESCRIBED IN THE TEXT OF THE REPORT REFERENCED ABOVE.

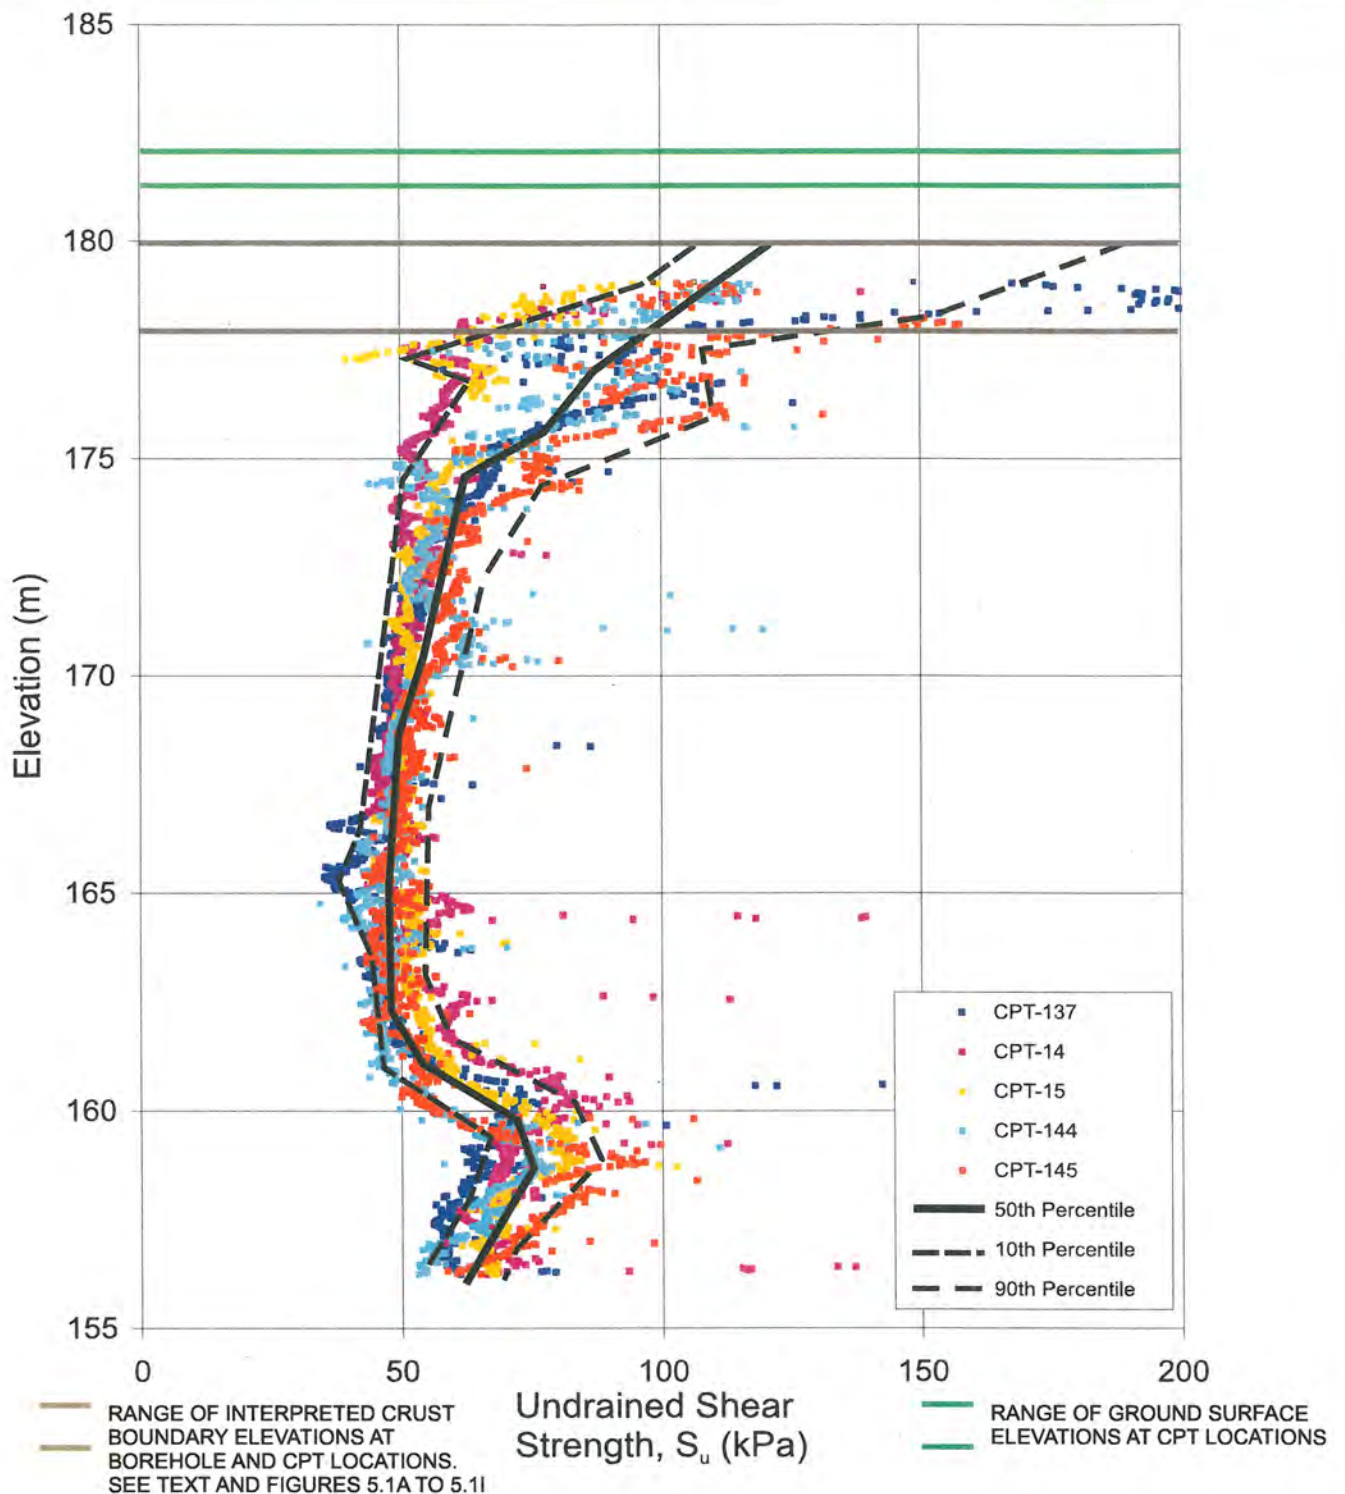
PROJECT No. 07-1130-2070		FILE No. 0711302070-R02064	
CADD	SJB	DEC 09	SCALE AS SHOWN REV. 1
CHECK	<i>WY Dickson</i>		<b>6.4D</b>

1. THIS FIGURE IS TO BE READ WITH THE REPORT TITLED "SUBSURFACE CONDITIONS INTERPRETATION REPORT, WINDSOR-ESSEX PARKWAY"
2. THIS FIGURE REPRESENTS A SUMMARY OF FIELD CPT DATA AND THE INTERPRETED UNDRAINED SHEAR STRENGTH PROFILE AS DESCRIBED IN THE TEXT OF THE REPORT REFERENCED ABOVE.

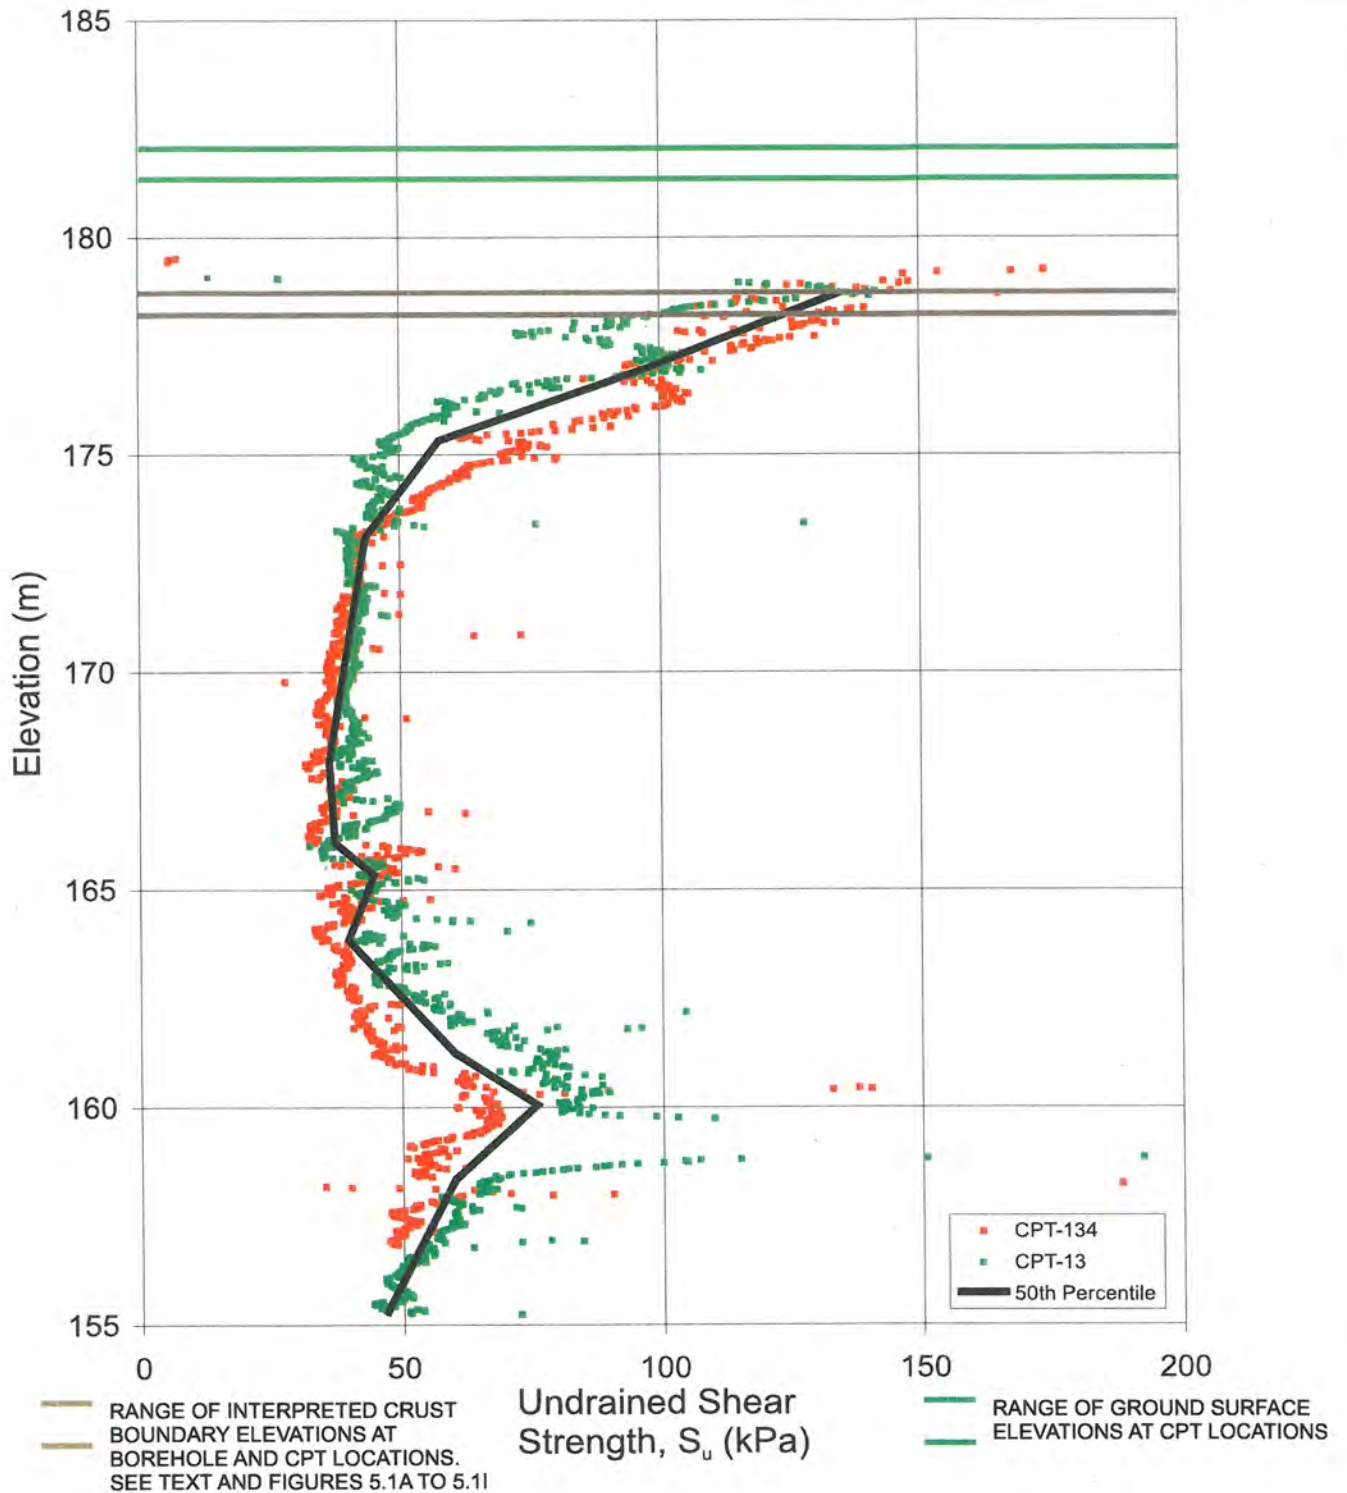
PROJECT No. 07-1130-2070		FILE No. 0711302070-R02084
CADD	SJB	DEC 08
CHECK	<i>[Signature]</i>	<i>[Signature]</i>
SCALE AS SHOWN REV. 1		<b>6.4E</b>

1. THIS FIGURE IS TO BE READ WITH THE REPORT TITLED "SUBSURFACE CONDITIONS INTERPRETATION REPORT, WINDSOR-ESSEX PARKWAY"
2. THIS FIGURE REPRESENTS A SUMMARY OF FIELD CPT DATA AND THE INTERPRETED UNDRAINED SHEAR STRENGTH PROFILE AS DESCRIBED IN THE TEXT OF THE REPORT REFERENCED ABOVE.

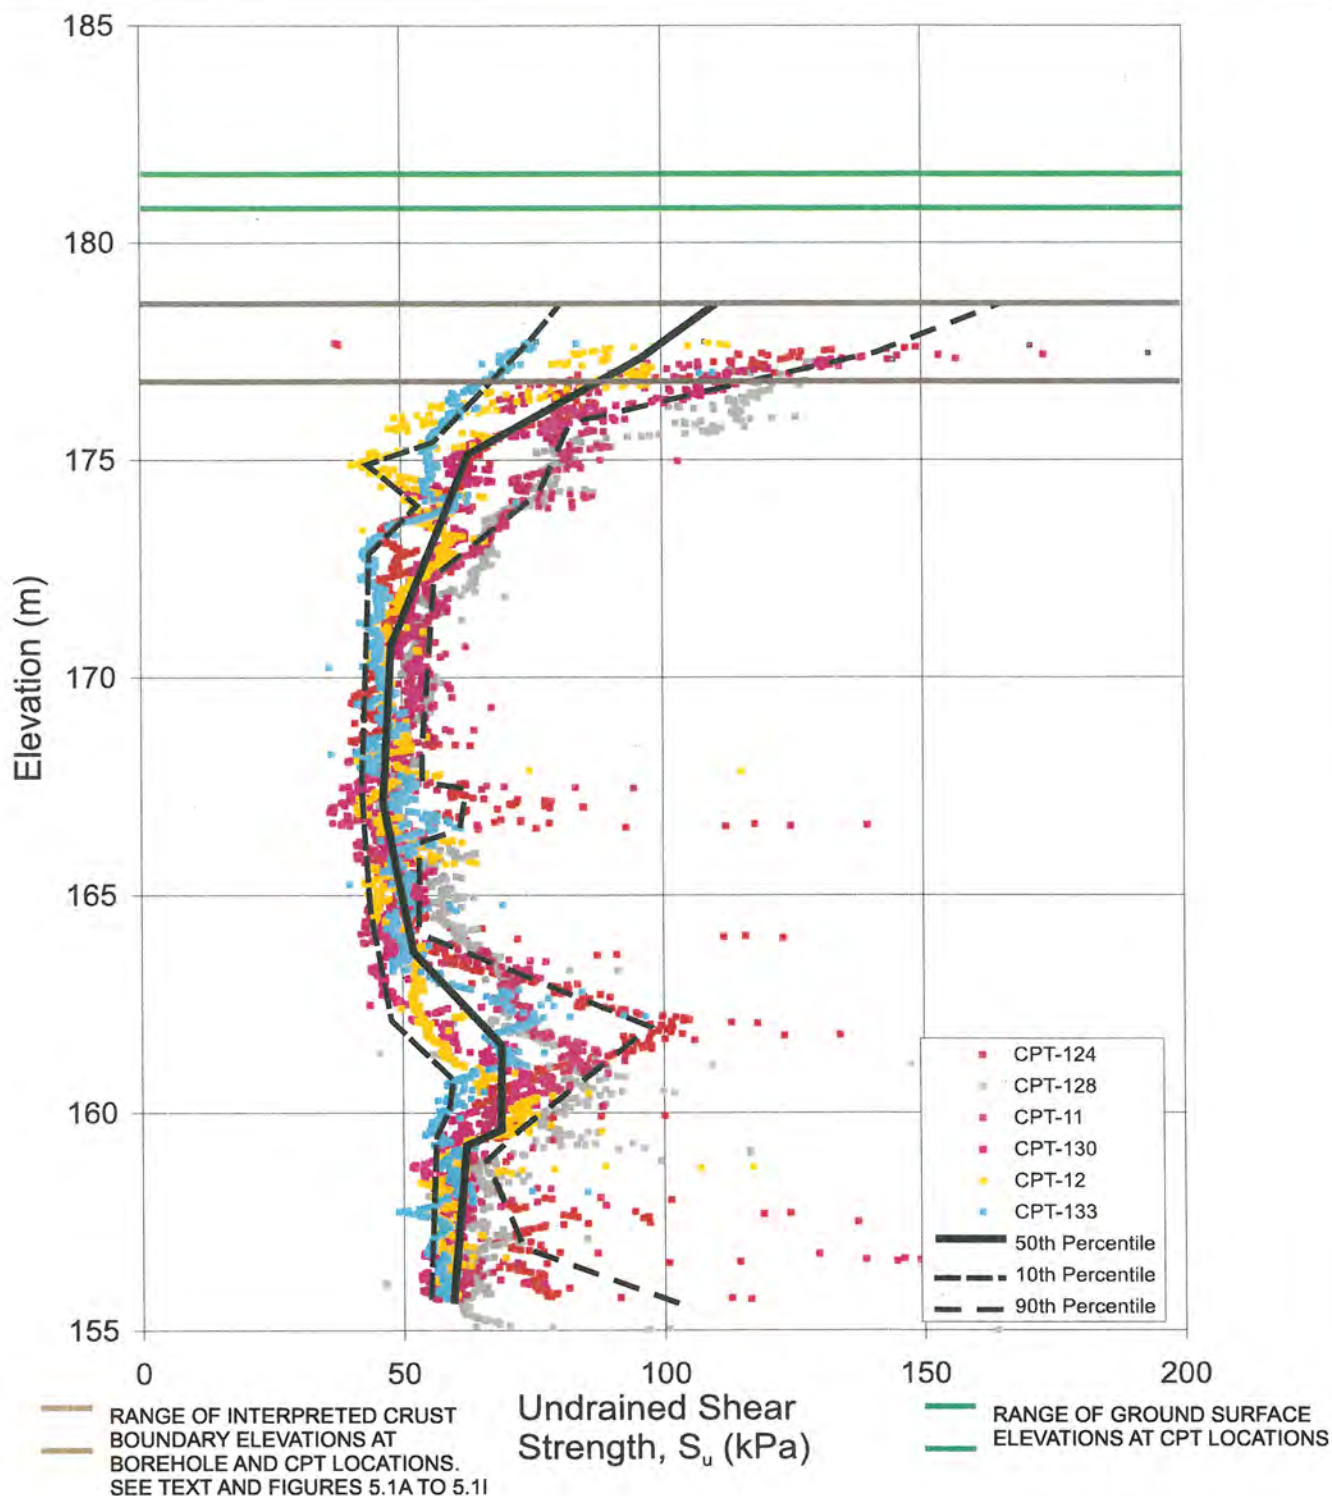
PROJECT No. 07-1130-2070		FILE No. 0711302070-R02084	
CADD	SJB	DEC 09	SCALE AS SHOWN REV. 1
CHECK	mt	Dec 09	6.4F

1. THIS FIGURE IS TO BE READ WITH THE REPORT TITLED "SUBSURFACE CONDITIONS INTERPRETATION REPORT, WINDSOR-ESSEX PARKWAY"
2. THIS FIGURE REPRESENTS A SUMMARY OF FIELD CPT DATA AND THE INTERPRETED UNDRAINED SHEAR STRENGTH PROFILE AS DESCRIBED IN THE TEXT OF THE REPORT REFERENCED ABOVE.

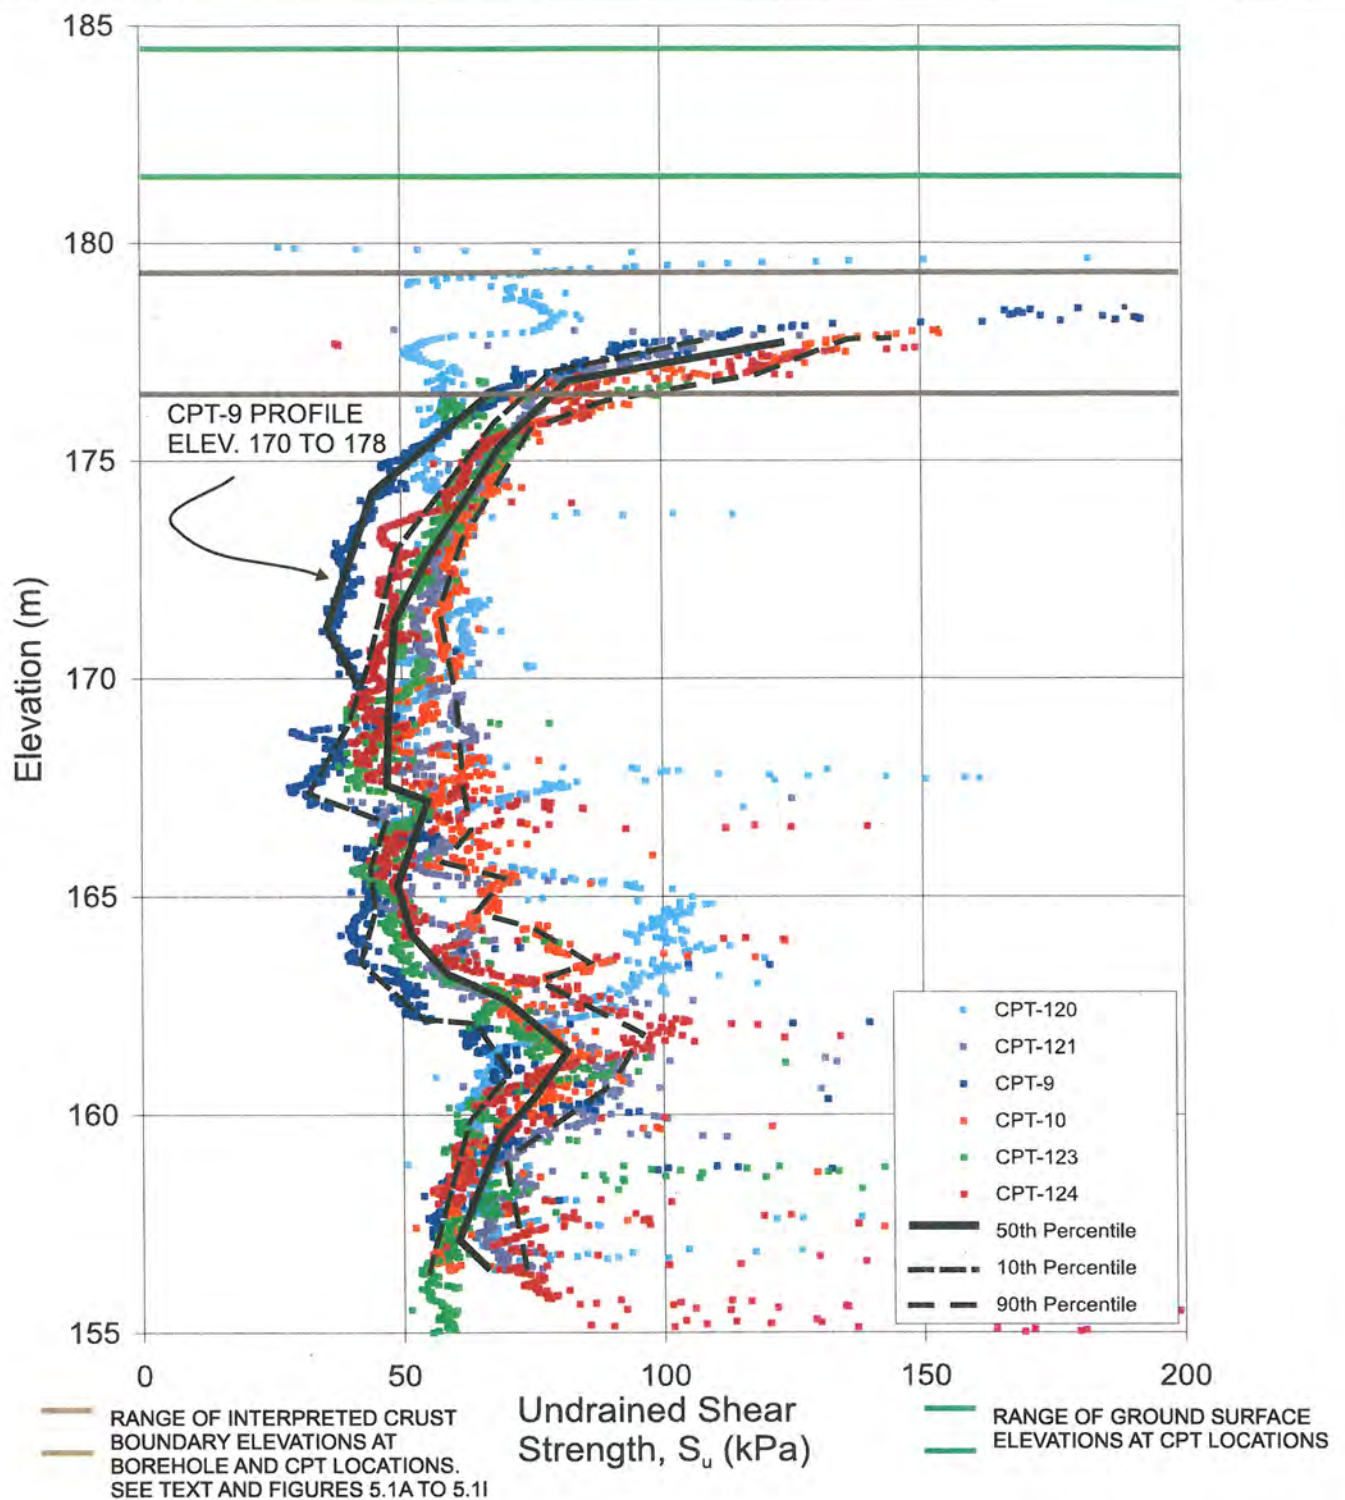
PROJECT No. 07-1130-2070		FILE No. 0711302070-R02084	
CADD	SJB	DEC 08	SCALE AS SHOWN REV. 1
CHECK	mt	DEC 08	6.4G

1. THIS FIGURE IS TO BE READ WITH THE REPORT TITLED "SUBSURFACE CONDITIONS INTERPRETATION REPORT, WINDSOR-ESSEX PARKWAY"
2. THIS FIGURE REPRESENTS A SUMMARY OF FIELD CPT DATA AND THE INTERPRETED UNDRAINED SHEAR STRENGTH PROFILE AS DESCRIBED IN THE TEXT OF THE REPORT REFERENCED ABOVE.

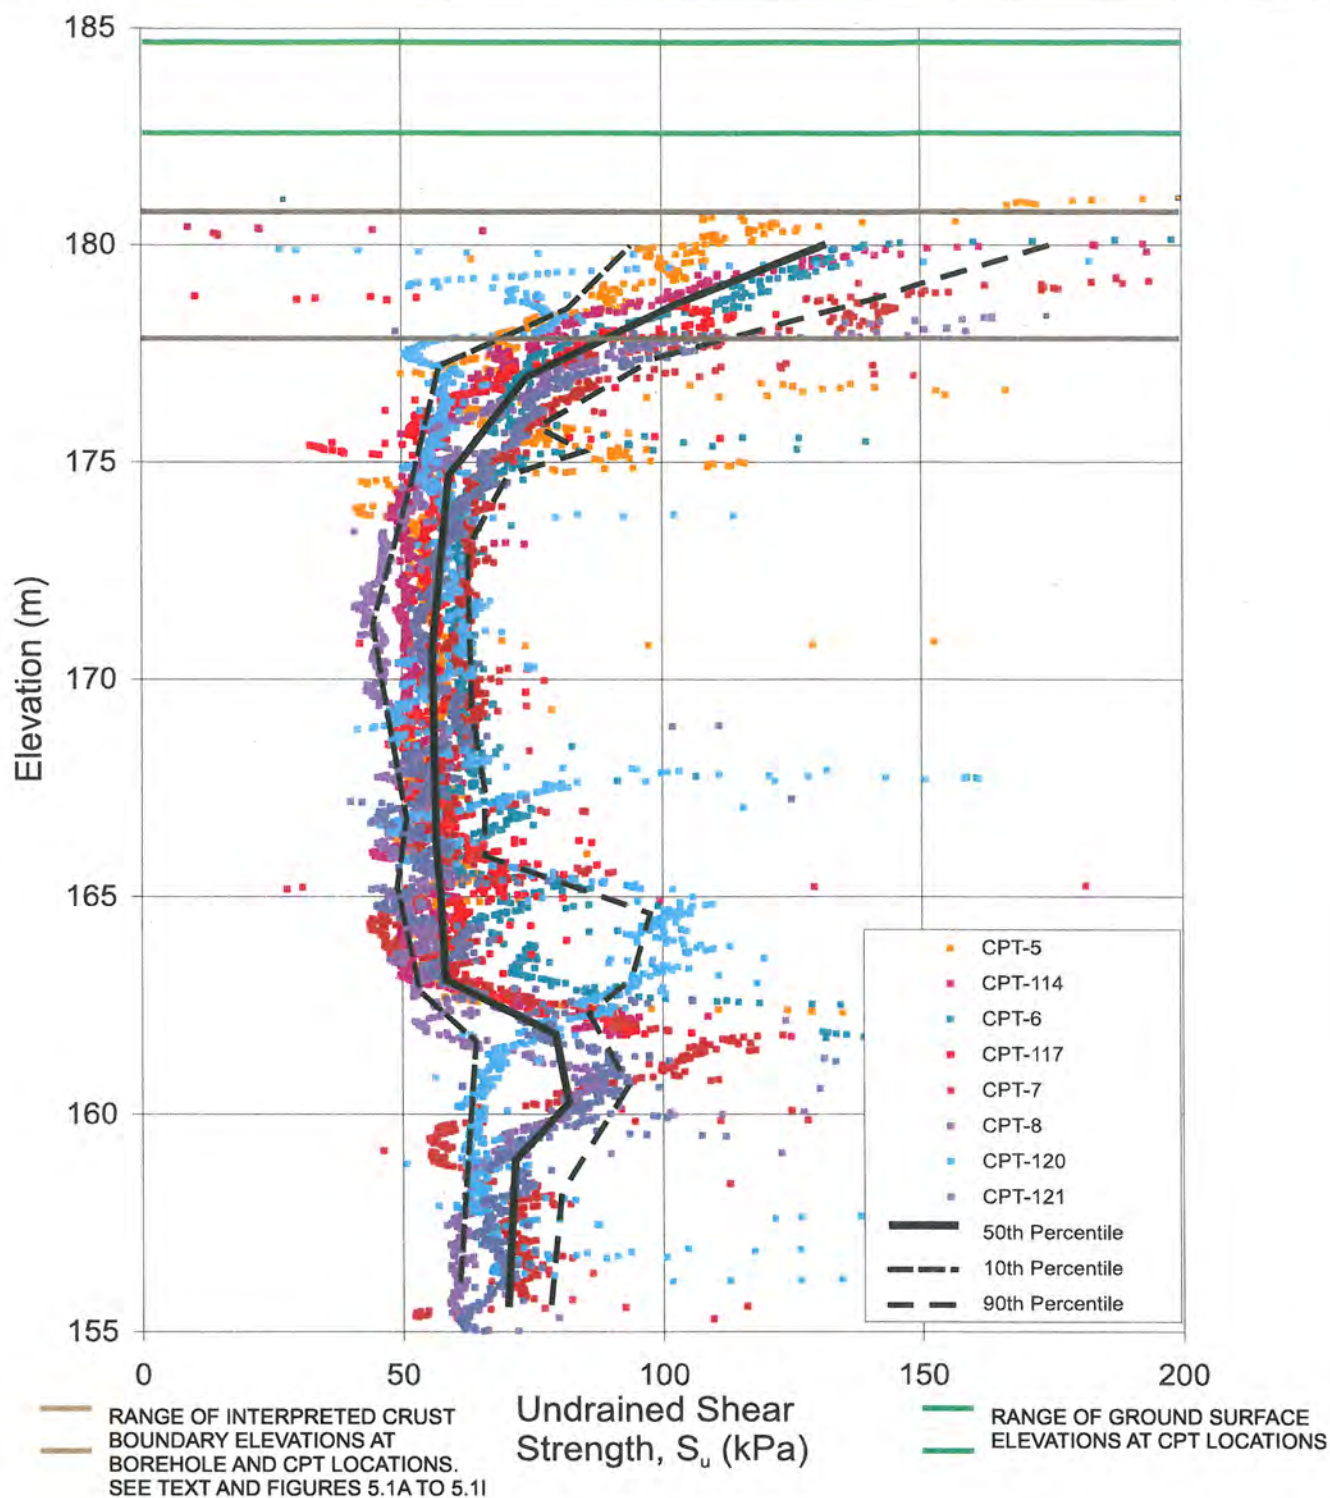
PROJECT No.	07-1130-2070	FILE No.	0711302070-R02084
CADD	SJB	DEC 09	SCALE AS SHOWN REV. 1
CHECK	MT	DEC 09	6.4H

1. THIS FIGURE IS TO BE READ WITH THE REPORT TITLED "SUBSURFACE CONDITIONS INTERPRETATION REPORT, WINDSOR-ESSEX PARKWAY"
2. THIS FIGURE REPRESENTS A SUMMARY OF FIELD CPT DATA AND THE INTERPRETED UNDRAINED SHEAR STRENGTH PROFILE AS DESCRIBED IN THE TEXT OF THE REPORT REFERENCED ABOVE.

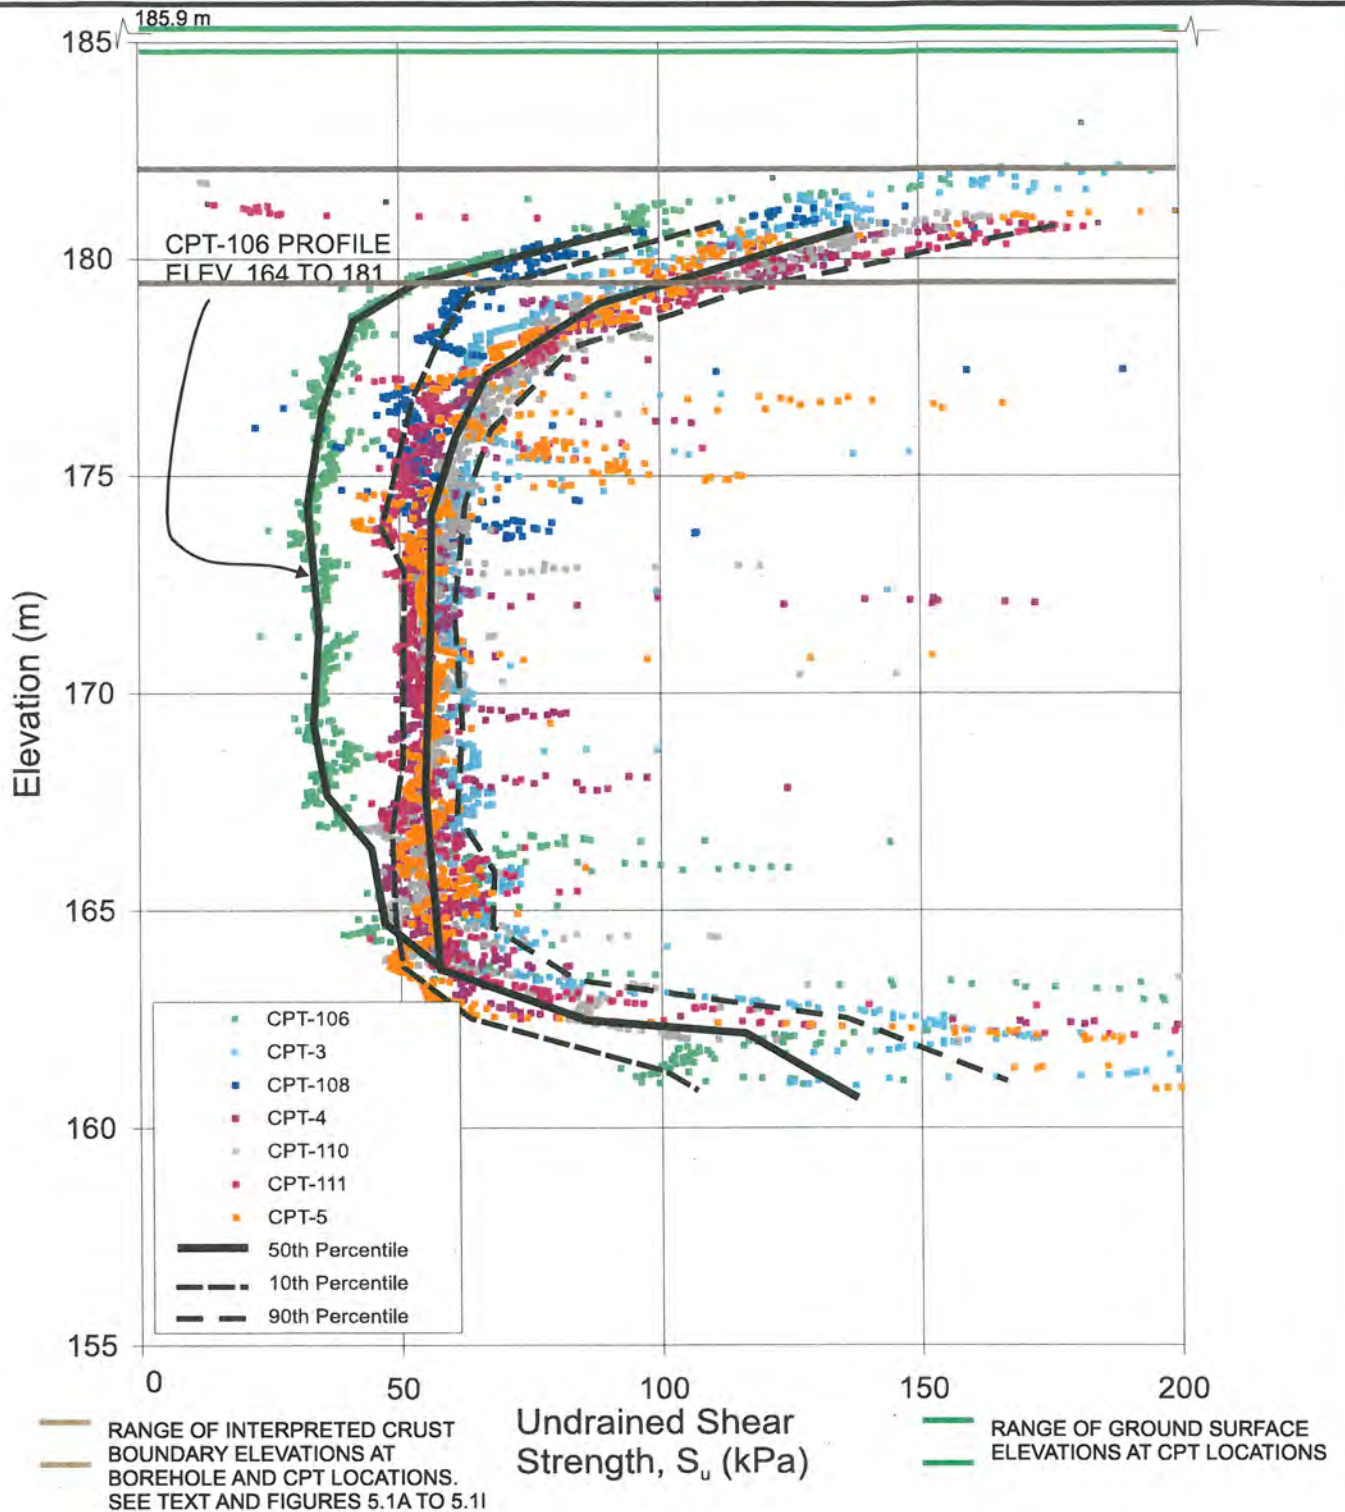
1. THIS FIGURE IS TO BE READ WITH THE REPORT TITLED "SUBSURFACE CONDITIONS INTERPRETATION REPORT, WINDSOR-ESSEX PARKWAY"
2. THIS FIGURE REPRESENTS A SUMMARY OF FIELD CPT DATA AND THE INTERPRETED UNDRAINED SHEAR STRENGTH PROFILE AS DESCRIBED IN THE TEXT OF THE REPORT REFERENCED ABOVE.

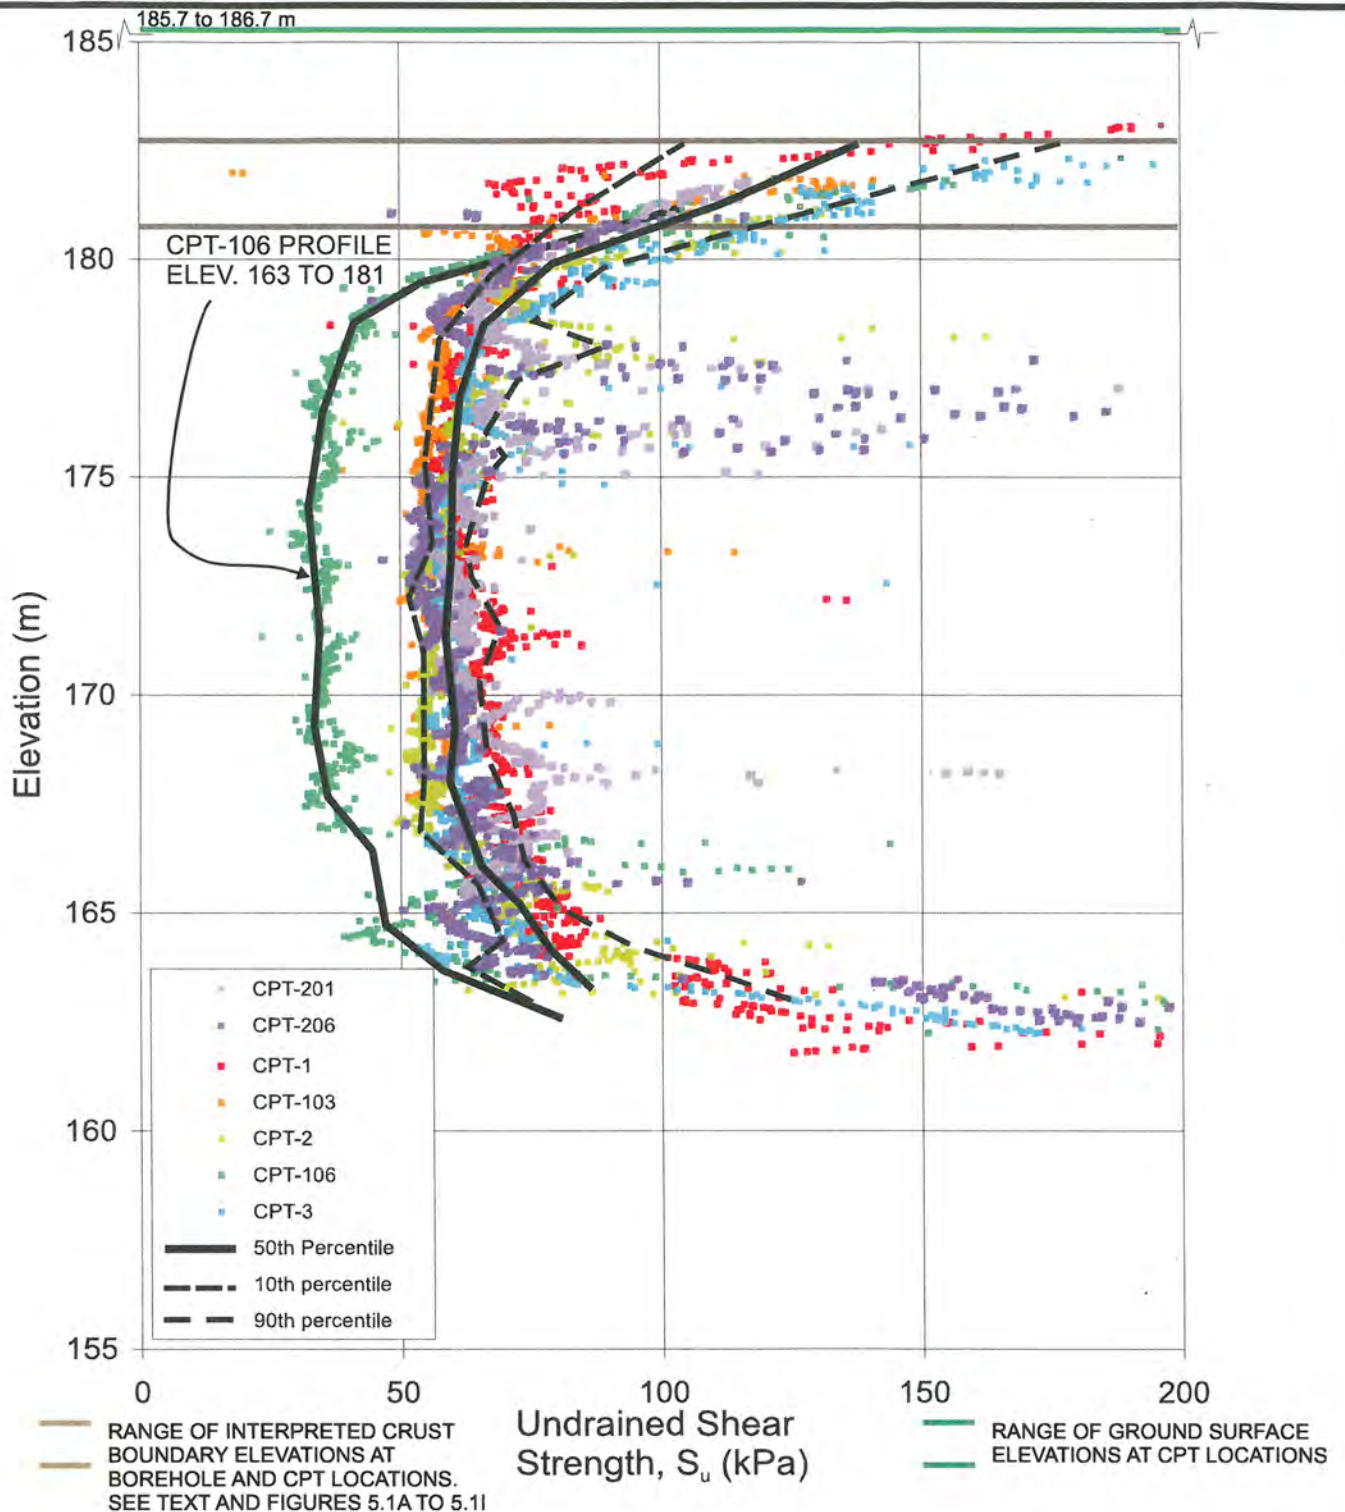
1. THIS FIGURE IS TO BE READ WITH THE REPORT TITLED "SUBSURFACE CONDITIONS INTERPRETATION REPORT, WINDSOR-ESSEX PARKWAY"
2. THIS FIGURE REPRESENTS A SUMMARY OF FIELD CPT DATA AND THE INTERPRETED UNDRAINED SHEAR STRENGTH PROFILE AS DESCRIBED IN THE TEXT OF THE REPORT REFERENCED ABOVE.
